KIRWYND REAL ESTATE SERVICES

DEFAULT TEMPLATE

1234 Main St.
South Farmington NS B0P1W0

01/23/2018 9:00AM

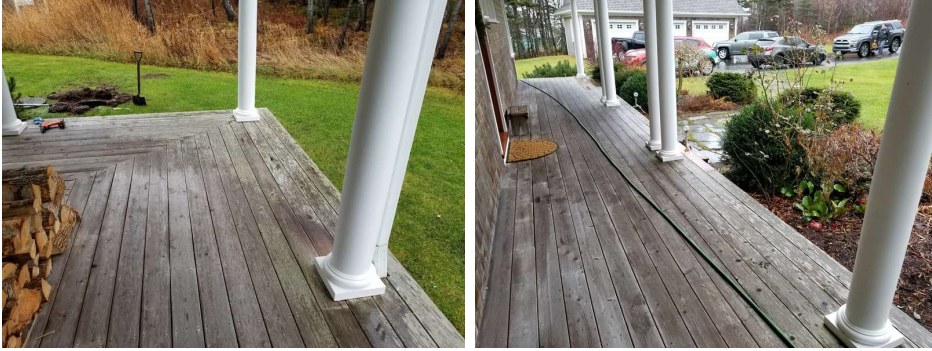
Stoop, Steps: Moderate Planking Deterioration

Deck planking (the walking surface) had moderate wear or deterioration visible at the time of the inspection. Routine maintenance will improve its lifespan.

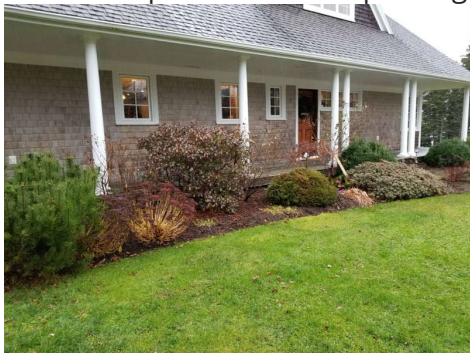
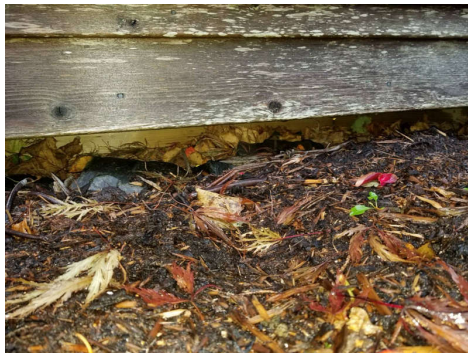
Bark mulch was in contact with the wood beam supporting the deck structure. Whether treated or not, it is important to keep wood free of debris that retains moisture and will cause eventual decay. Recommend clearing mulch so there is at least 6 of space between wood and mulch or soil below.

Contact a qualified landscaper or gardener.

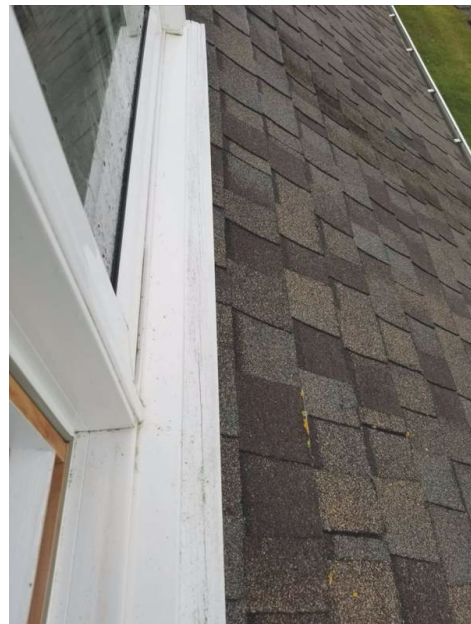
1.7.1 Window/Door Frames & Trim

As part of routine maintenance, re-staining areas of deteriorated finish coating at wood window sills is advised to help protect frames from wood decay resulting from exposure to moisture and sunlight. All exterior painted wood surfaces should be annually examined and sealed, re-caulked and re-stained as needed.

Contact a qualified painter.

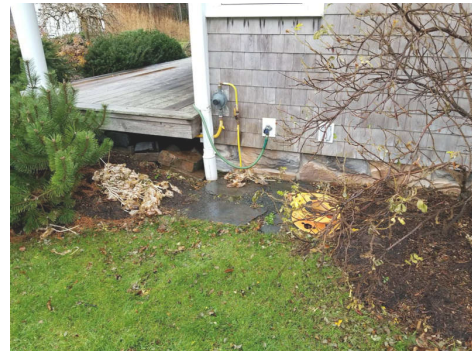
1.10.1 Grading & Surface Drainage

There were low spots visible near the foundation wall which will collect water and can increase the potential for foundation seepage. Recommend filling or re-grading the affected areas as needed in order to create the proper slope away from the home while maintaining adequate clearances from the top of the foundation wall.

Contact a qualified landscaper or gardener.

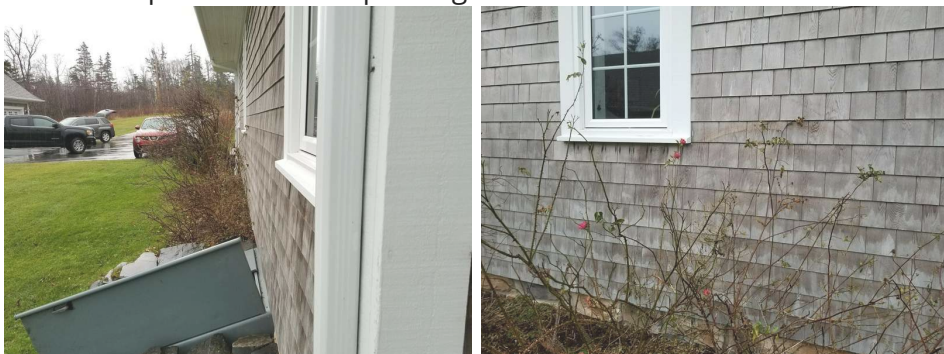
1.11.1 Vegetation Affecting

SIDING CONTACT

Overgrown shrubs were in contact with the structure at the exterior of the home. Vegetation too close to the structure can potentially cause harm through decay by increasing moisture retention from reducing light and airflow, damage to screens and siding from branches abrading surfaces and leaves providing a path for moisture and insects into the home. Shrubs and bushes should be maintained at a distance of at least 18-inches from the structure. In many cases, it may be more practical to relocate shrubs to a different area or simply remove them.

Contact a qualified landscaper or gardener.

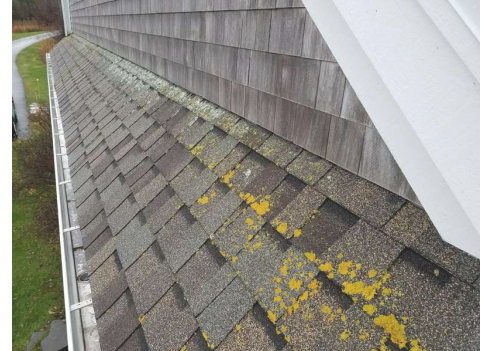
Portions of the asphalt shingles covering the roof of the home had lichens growing on them. Lichens are plant-like organisms that may do long-term, very mild damage to shingles. They are generally considered to be a cosmetic concern only. Efforts to remove them may result in granule loss where they were attached to shingles. For this reason, removal should be performed by qualified professionals.

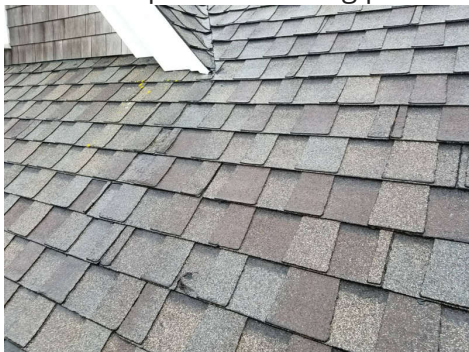
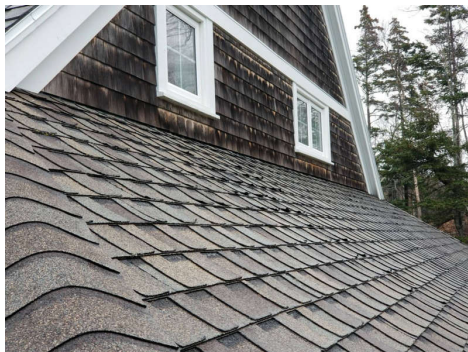
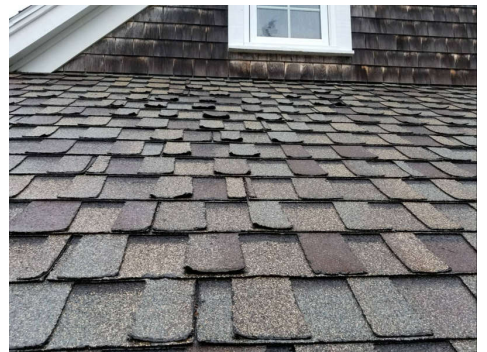
2.2.2 Roof Covering

DEFECTIVE SHINGLES

Accelerated deterioration of the roof covering material appeared to be the result of a manufacturing defect. These shingles appeared to be approaching the end of their useful service life, and will require replacement long before their rated lifespan rating. Some areas appeared to be in need of replacement at this time (most notably below the south dormer valleys) in order to reduce the risk of damage to the home that may result from leaking. You are advised to have the roof covering reviewed by a qualified roofing contractor in order to determine whether a pro-rated manufacturers warranty may be applicable and to provide a quote and estimated time line for replacement.

Contact a qualified roofing professional.

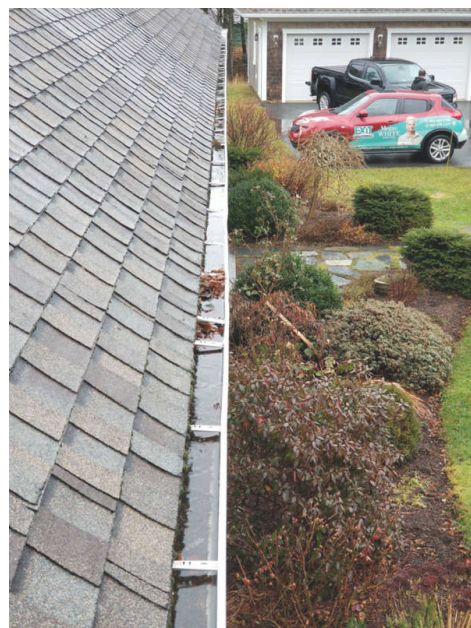
2.6.1 Roof Drainage System

Debris visible in the gutters at the time of the inspection should be removed to encourage proper drainage. Recommend having the gutters cleaned now and at least once a year thereafter in order to ensure proper drainage and to help limit the potential for moisture back up and ice damming.

Contact a handyman or DIY project

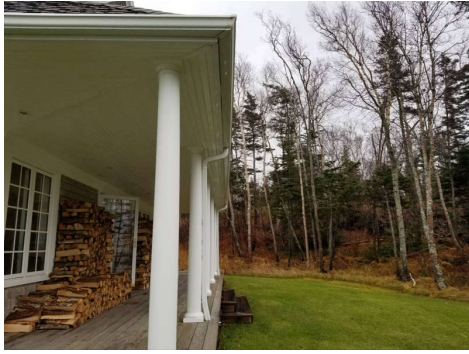
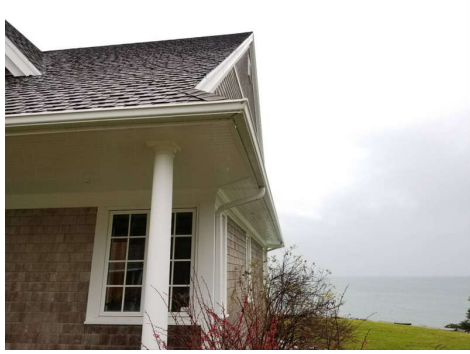
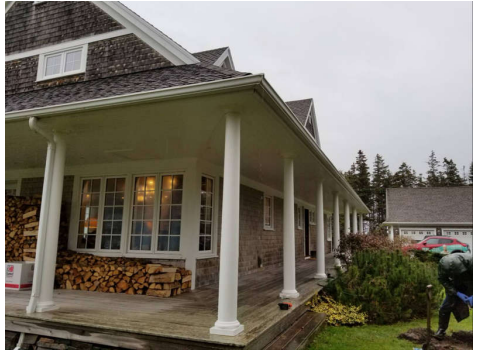
2.6.2 Roof Drainage System

LEAKING AT JOINTS

The gutters were leaking at various areas and needed maintenance such as the application of an appropriate sealant. All work should be performed by a qualified contractor.

Contact a qualified handyman.

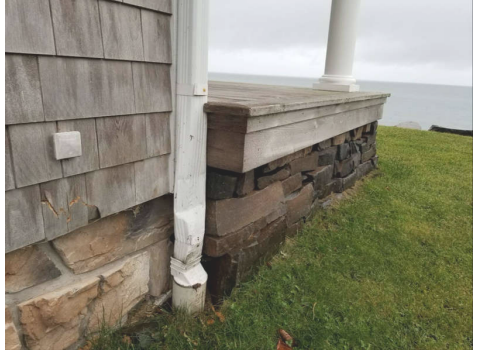
2.6.3 Roof Drainage System

DAMAGED DOWNSPOUT

A downspout designed to discharge roof drainage was damaged or in disrepair and may limit its ability to function as designed. Recommend repair to help protect the home structure.

Contact a qualified professional.

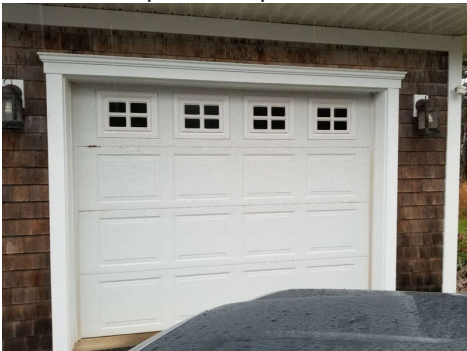
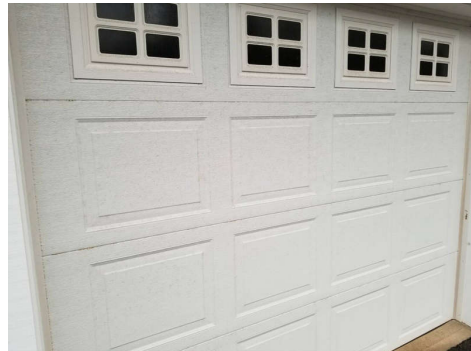
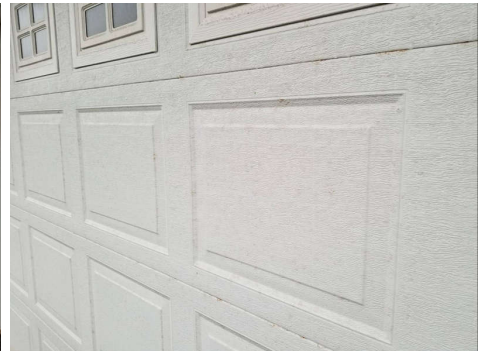
3.3.1 Garage Door(s)

RUST

Weathered/rusted garage door panels were observed. This is not uncommon for age and location. Recommend maintenance be performed to help protect the panels from further deterioration.

Contact a qualified painter.

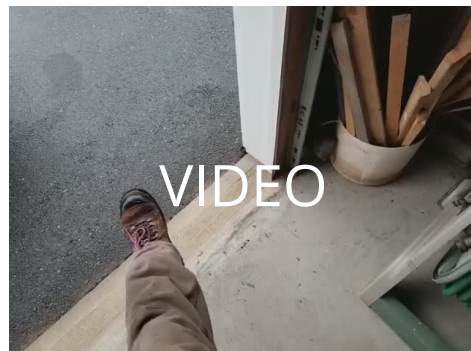
3.4.1 Garage Door Opener(s)

An automatic-reverse photoelectric sensor at an overhead garage door was inoperable. Photoelectric sensors are devices installed to prevent injury by raising the vehicle door if the sensor detects a person on a position in which they may be injured by the descending door. Installation of photo sensors in new homes has been required by building codes since 1993. Correction of this condition is advised.

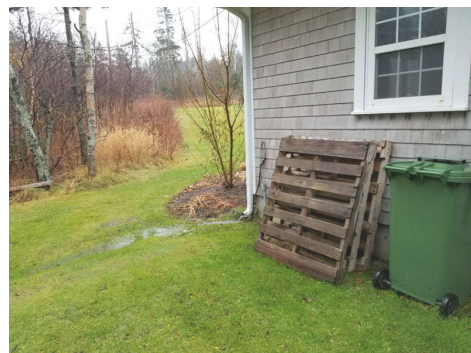
3.5.1 Exterior

ADD EXTENSIONS

Downspouts discharged roof drainage in close proximity to the foundation. This condition can result in excessively high moisture levels in soil at the foundation and can cause damage related to soil/foundation movement. Recommend the installation of downspout extensions to discharge roof drainage a minimum of 3 feet from the foundation wall.

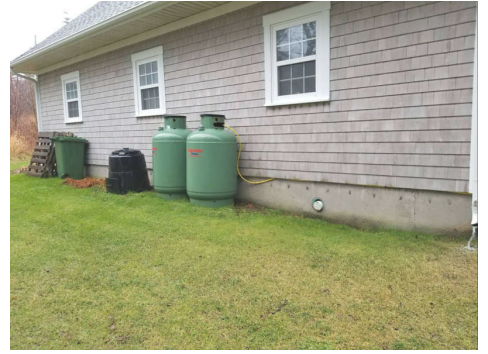
There were low spots visible near the foundation wall which will collect moisture. This condition can result in excessively high moisture levels in soil at the foundation which may cause damage related to soil/foundation movement. Proper filling and re-grading of the area to divert water away from the foundation is recommended. The ground should slope away from the structure a minimum of one-inch per foot for a distance of at least six feet from the foundation.

Contact a qualified landscaper or gardener.

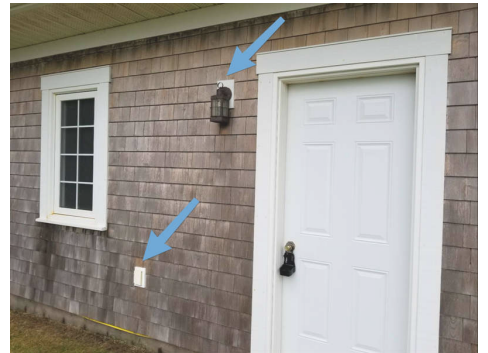
3.5.4 Exterior

No flashing was installed above exterior mounting blocks as is required by good building practice, leaving gaps through which moisture may penetrate the wall assembly or damage exposed end grain. At minimum, the application of an appropriate sealant is advised to help prevent moisture intrusion until such a time as the mounting blocks are replaced in the future. Because sealants will eventually dry, shrink and crack, all sealant-dependant areas should be inspected on an annual basis and sealant re-applied as necessary.

Contact a handyman or DIY project

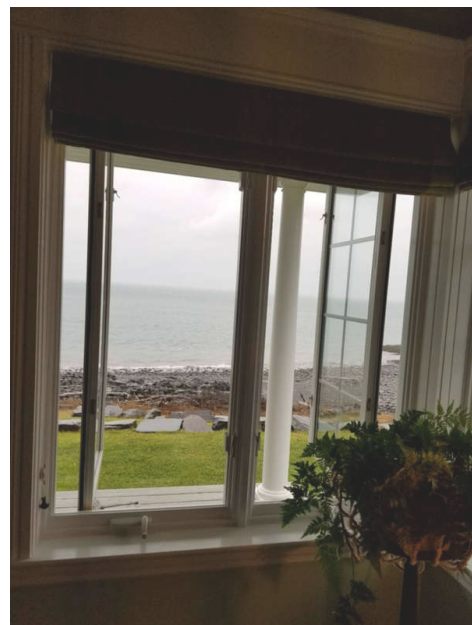
6.5.1 Windows

SCREENS REMOVED

There were screens missing from the majority of windows throughout the home. A large group of screens were located in storage. You should ask to have the screens installed for the pre-closing walk-through. This allows the opportunity to verify screens were present at all of the windows, that they fit properly, and were all in acceptable condition.

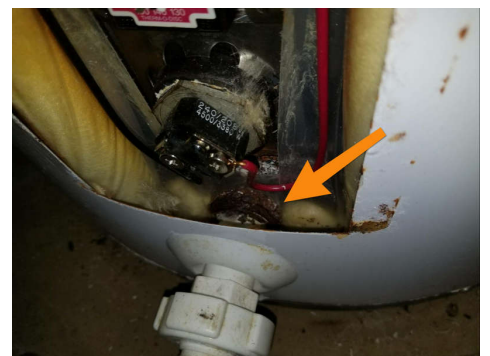
PAST DESIGN LIFE

The water heater was past its typically expected life span. Some corrosion was observed within the unit near the element. As water heaters may fail at any time, and often without any warning, it is advised that the water heater be replaced at this time, prior to it's failure. The client should be aware that significant flooding can occur if the water heater fails. If replacement is put aside until a later time, it is recommended that a catch pan with drain, or a water alarm be installed by a qualified person to help prevent damage in the case of water leaks.

Contact a qualified plumbing contractor.
