PREMIER HOME INSPECTIONS OF THE CSRA

YOUR CUSTOM HOME INSPECTION REPORT

1234 Main St.
North Augusta, SC 29841

Buyer Name
06/01/2019 9:00AM

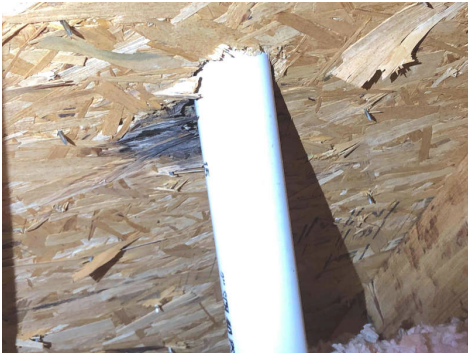
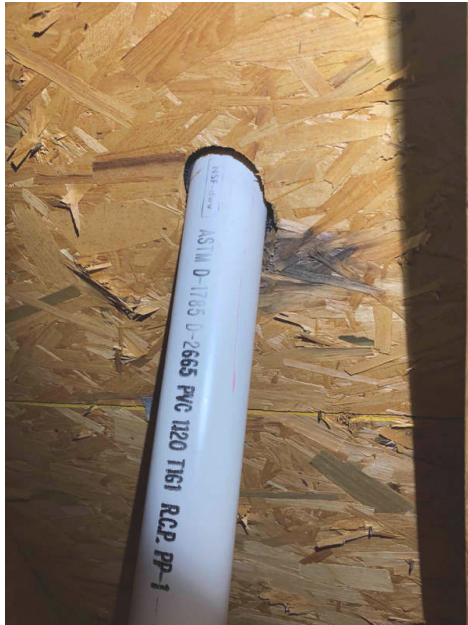
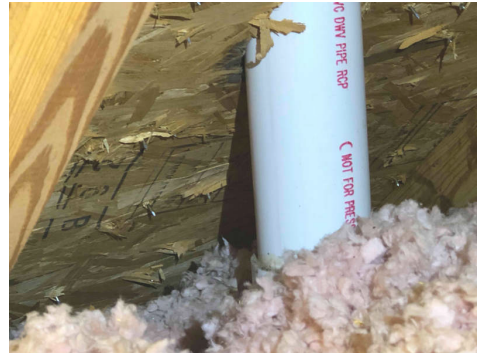
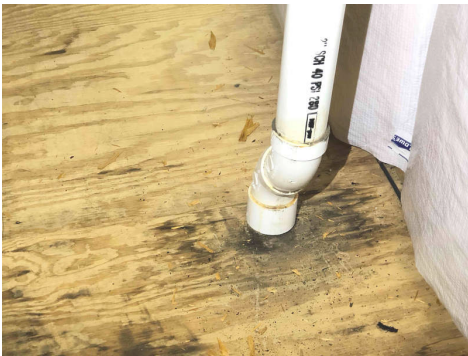
2.2.1 Roof Structure,Attic, & Ventilation

STAINING OBSERVED

VENT STACKS ON BACK RIGHT SIDE OF ATTIC

Staining on the roof decking was observed at the time of the inspection. There was no active or abnormal moisture readings observed at the time of the inspection. Monitor

*Staining was observed below the vent stacks on the right side of the attic space. Given the high temps with no previous rain. The areas should be monitored to ensure no active staining is present.

Recommend monitoring.

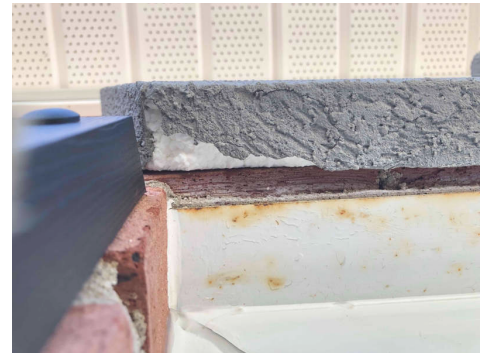
3.1.1 Siding, Flashing, Fascia, Soffits, & Trim

STUCCO DAMAGED

LOWER PORTION OF STUCCO TRIM (FRONT FAR RIGHT GARAGE WINDOW)

The stucco trim over the far right front garage window exhibited minor damages. No subsequent damages were observed however repairs should be made to prevent moisture related or insect related damages.

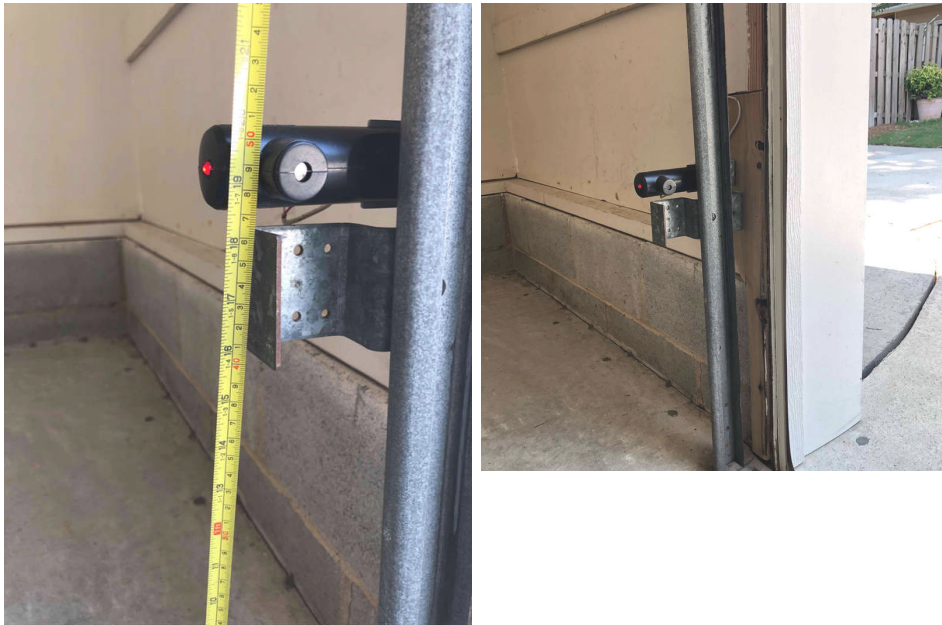
4.2.1 Garage Door & Door Opener

GARAGE DOOR SENSORS TOO HIGH

The garage door safety sensors were mounted too high up.

**As a general rule, garage door sensors should be mounted not more than six inches above the floor. That's because they might not trigger properly otherwise, and people or animals could get trapped under the door as it closes. The object under the door needs to break the sensor's infrared beam in order for the sensor to work. If the sensors are too high up, a person or small animal in that spot won't break the beam — so the door will continue to close.*

The sensors were mounted at a height of approximately 19 inches.

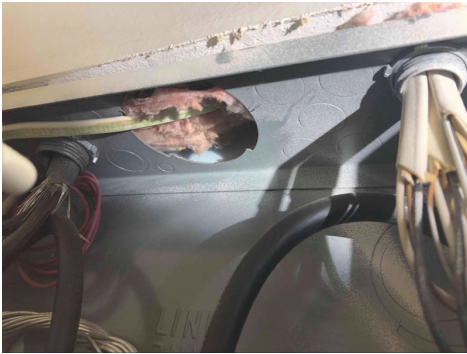
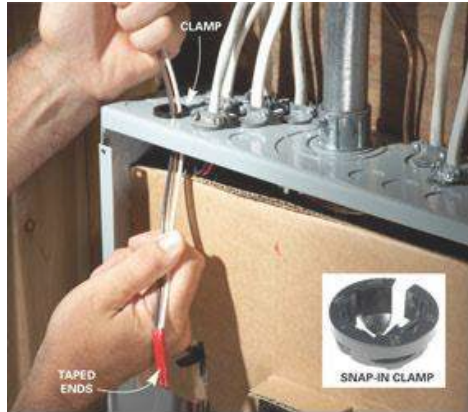
7.1.1 Main Service & Grounding, Distribution Panel, Branch Circuit Wiring, Breakers, & Fuses

MISSING SECURE CLAMP (NM CONNECTOR)

TOP OF PANEL

Secure Clamps (NM Connectors) should be installed where missing. The Secure Clamps are designed to prevent damages to the wire sheathing in the event the wiring rubs against the distribution panel edges. In addition, by protecting the wire sheathing from damages, shock hazards in the electric panel are also diminished.

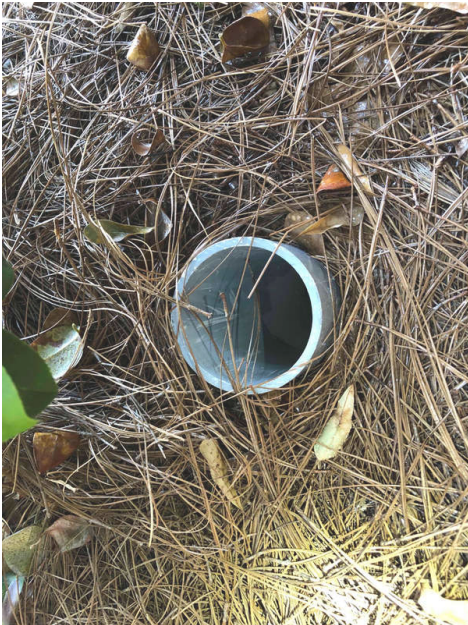
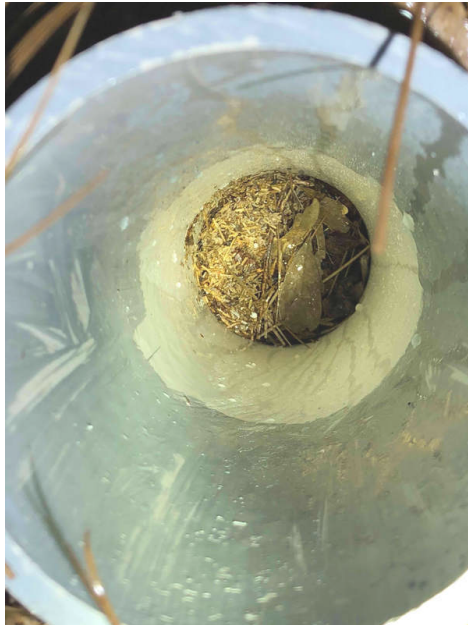
8.1.2 Main Water Shut-off, Distribution & Supply

CLEAN OUT MISSING CAP

FRONT LEFT SIDE OF HOME

The plumbing clean out located on the front left side of the home was missing a cap. Debris was observed in the drain line. Debris should be cleaned out and a cap installed.

Contact a qualified plumbing contractor.

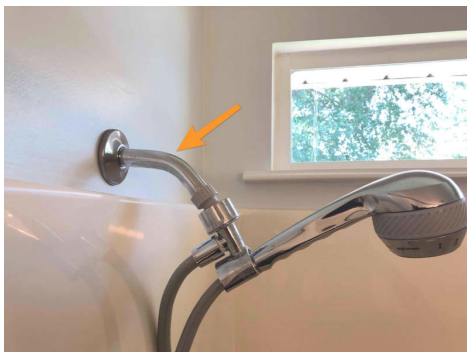
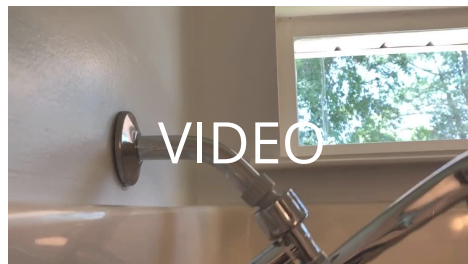
10.2.1 Bathrooms

LOOSE SHOWER HEAD PLUMBING

UPSTAIRS HALL BATHROOM

The plumbing to the shower head was loose at the time of the inspection. Secure the plumbing line to prevent potential damages.

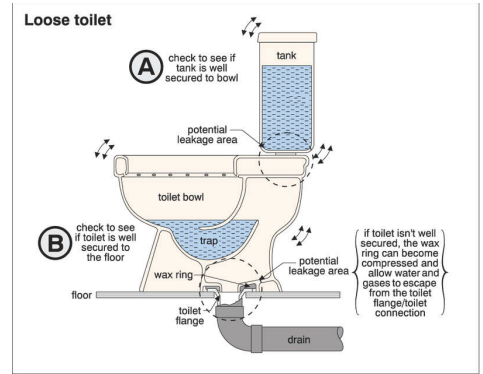
10.2.2 Bathrooms

TOILET BOWL LOOSE

DOWNSTAIRS HALF BATH,

A loose toilet causes the wax ring gasket to lose its seal. This can cause leaking. Continued use of a loose toilet can also cause damage to the drain flange. Replace the wax ring and evaluate the flange for damage.

Contact a handyman or DIY project
