SARANAC LAKE INSPECTION SERVICES

RESIDENTIAL REPORT

1234 Main St.
Saranac Lake NY 12983

Buyer Name
03/15/2018 9:00AM

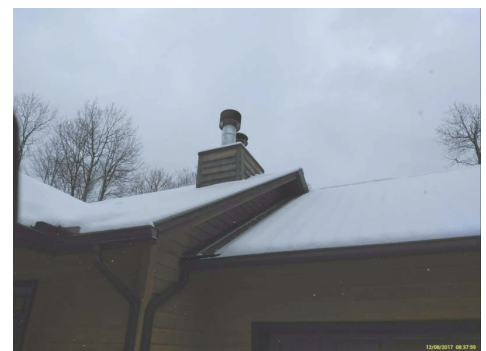
2.2.1 Roof Penetrations

UNFINISHED WOOD AROUND CHIMNEY

The chase around the chimneys appeared to be covered in unfinished wood. Wood on the exterior of a house should be finished in order to extend the life of the wood and help protect from moisture intrusion. Recommend a qualified contractor to repair as needed.

Contact a qualified painter.

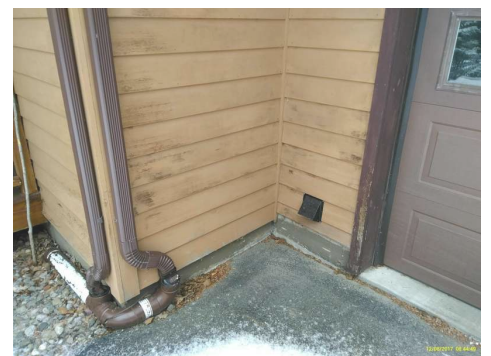
3.1.1 Siding, Flashing & Trim

CHIPPING AND PEELING PAINT

There were various areas of chipping and peeling paint around the house on the siding and exterior trim. Paint prevents exterior wood from the elements and increases the lifespan of the wood. Recommend scraping and repainting as needed, or contacting a qualified contractor to repair as needed.

Contact a qualified painter.

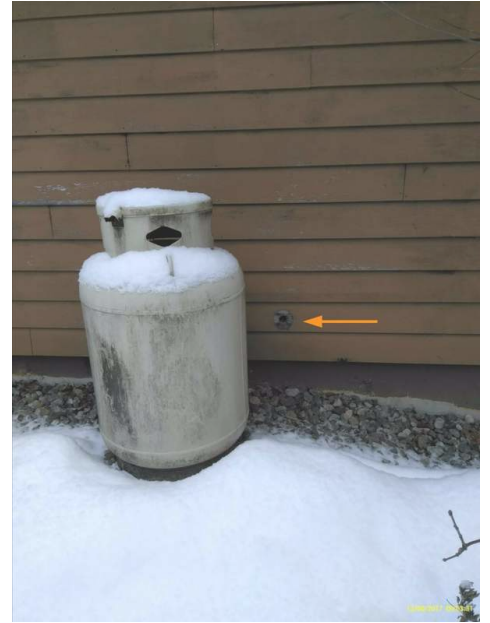
3.1.2 Siding, Flashing & Trim

HOLE IN SIDING

There was a hole in the siding along the back wall of the attached garage. It appears as though there used to be a propane line entering the wall at this point, but there was not one at the time of the inspection. Any holes in the exterior of the house should be sealed to prevent moisture or pests from entering. Recommend a qualified contractor to repair as needed.

Contact a qualified siding specialist.

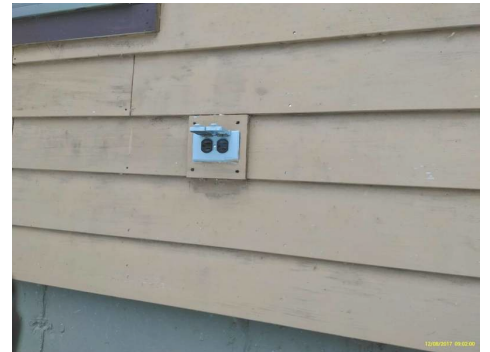
3.1.4 Siding, Flashing & Trim

NON GFCI OUTLETS

The exterior outlets were not GFCI (ground fault circuit interrupter) protected. GFCI outlets are recommended any location where there may be water present to reduce the risk of electric shock, such as the exterior of a house, the garage, or near any plumbing fixtures. Recommend a qualified contractor to repair as needed.

Contact a qualified electrical contractor.

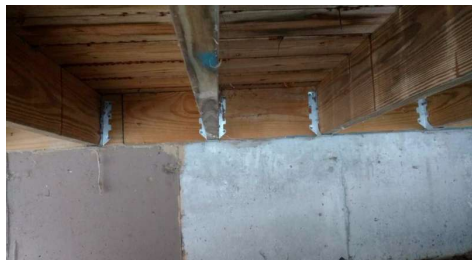
3.3.1 Decks, Balconies, Porches & Steps

IMPROPER DECK SUPPORT

The deck ledger boards for both the front and back porches did not have adequate fasteners. Proper fasteners have the strength to prevent a deck from pulling away or dropping. Recommend a qualified contractor to repair as needed.

Underneath the front porch.

Contact a qualified deck contractor.

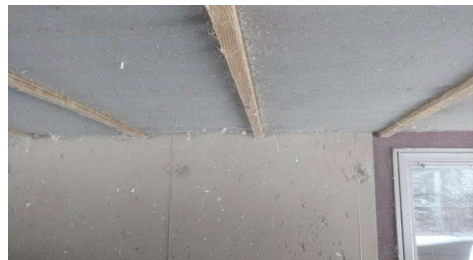
Underneath the back porch, when viewed with a flashlight the ledger was visible, but not able to be photographed.

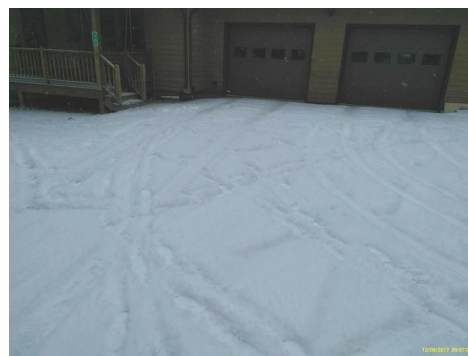
SNOW COVER

The snow cover at the time of the inspection prevented viewing of any walkways, and the driveway. The condition of these elements must be excluded from this inspection.

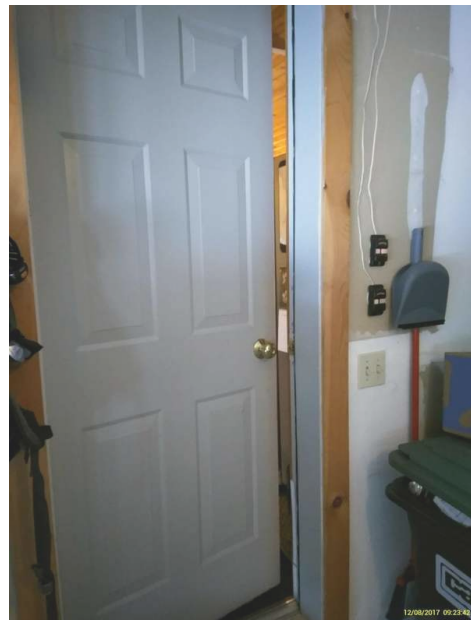
5.5.1 Occupant Door (From garage to inside of home)

SELF CLOSING MECHANISM NOT STRONG ENOUGH

The entrance door to the house did not fully self close at the time of the inspection. While equipped with proper hinges, they did not provide adequate force to fully close the door. A self closing door is important in slowing the spread of fire from the garage to the rest of the house, and preventing carbon monoxide from running vehicles from entering the house. Recommend a qualified contractor to repair as needed.

Contact a qualified professional.

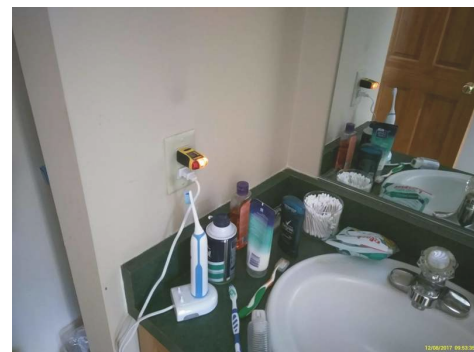
7.3.1 Outlets

GFCI INOPERABLE

When tested, the GFCI (ground fault circuit interrupter) outlet did not trip. GFCI outlets help prevent electric shock in the event of an electric device coming in contact with water. Recommend a qualified contractor to repair as needed.

Contact a qualified electrical contractor.

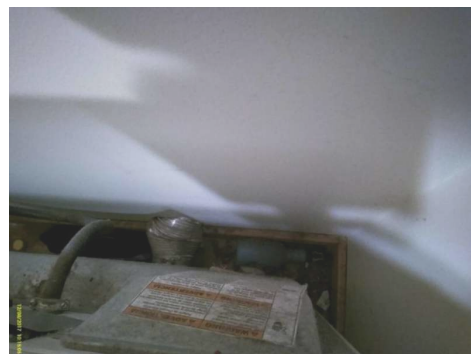
11.2.1 Dryer

CRUSHED DRYER VENT

The vent pipe for the dryer was crushed. Restricting the air flow exiting a dryer can cause lint to accumulate, increasing the chance of fire. Recommend a qualified contractor to repair as needed.

Contact a qualified professional.

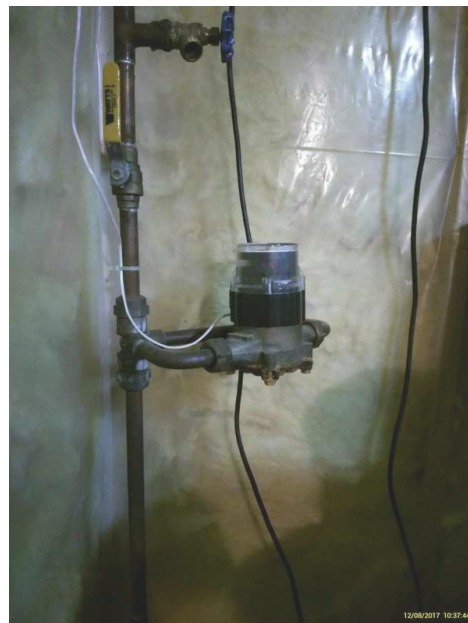
14.3.1 Water Supply, Distribution Systems & Fixtures

WATER SUPPLY NOT BONDED

The water supply system did not appear to be bonded to the electrical system. Proper bonding of the water to the electrical system helps prevent possible electric shock in the event of electric appliances negatively interacting with the plumbing system. Recommend a qualified contractor to repair as needed.

Contact a qualified electrical contractor.

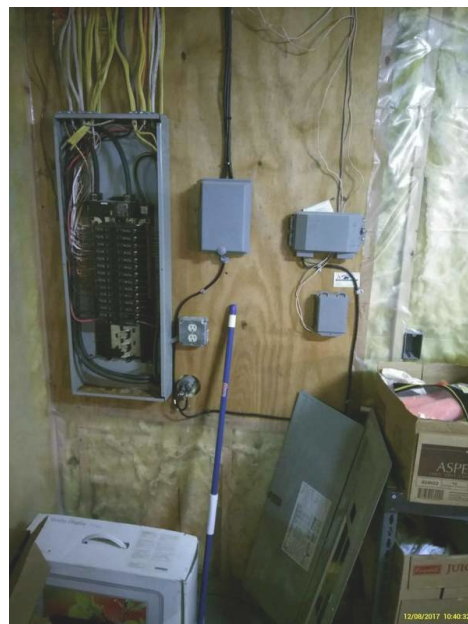
15.1.1 Main & Subpanels, Service & Grounding, Main Overcurrent Device

COVER REMOVED

The electrical panel cover was not in place at the time of the inspection. It is not recommended that the face of the panel be removed for long periods of time to reduce the risk of electric shock. Recommend a qualified contractor to repair as needed.

Contact a qualified electrical contractor.
