YOUR INSPECTION REPORT

1234 Main St.
Buzzards Bay MA 02532

Buyer Name
02/26/2019 9:00AM

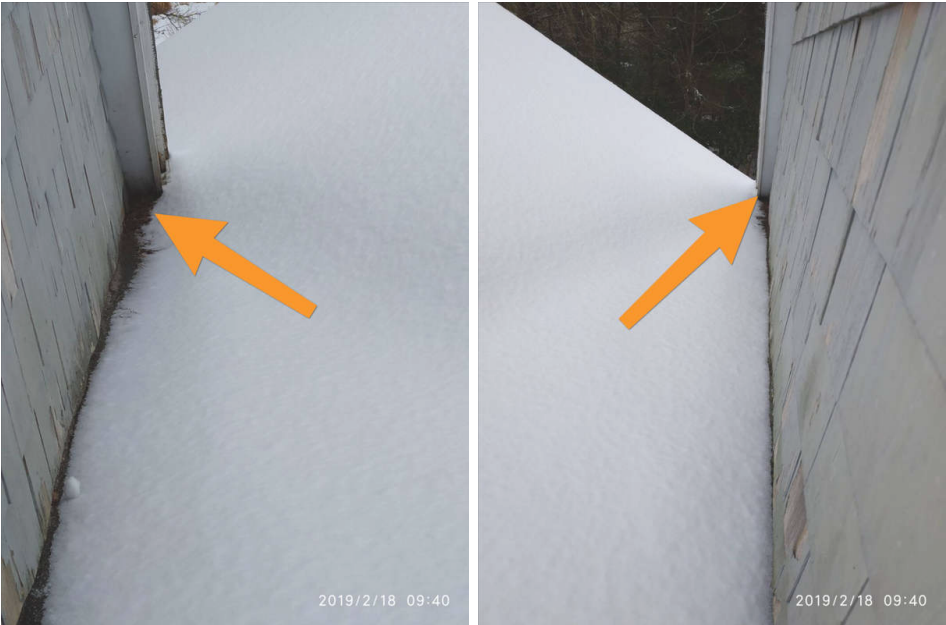
Ponding (pools of standing water) was found at one or more locations on the flat or low-slope roof surface. Even on a flat roof, water should be removed by a drainage system so that any remaining water evaporates within 48 hours after it rains. Prolonged standing water can result in roof leaks. This is a conducive condition for wood-destroying organisms. Recommend that a qualified contractor evaluate and repair as necessary to prevent ponding.

Contact a qualified roofing professional.

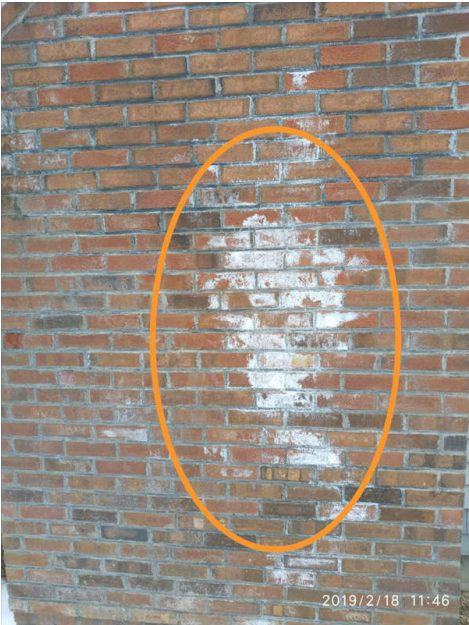
Efflorescence was visible on the lower exterior of the chimney. While not definitive, it can be an indicator of past moisture intrusion into the chimney body. It is recommended you have the chimney inspected before closing by a chimney sweep (as advised elsewhere in this report)

Contact a qualified chimney sweep.

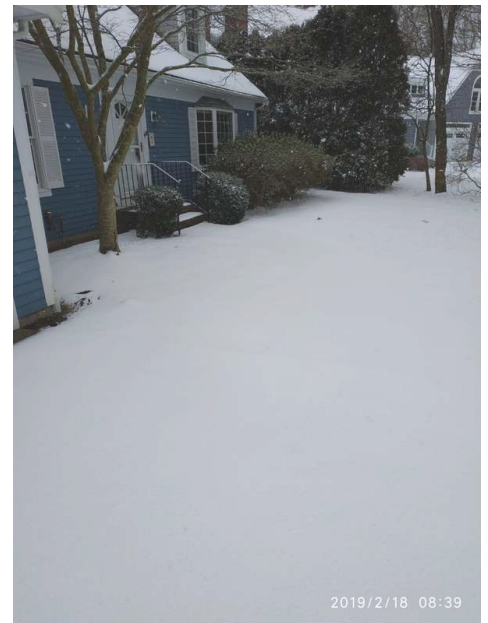
SNOW - GRADING

Snow cover prevented observing the pitch of grade. See Additional Comments regarding grading.

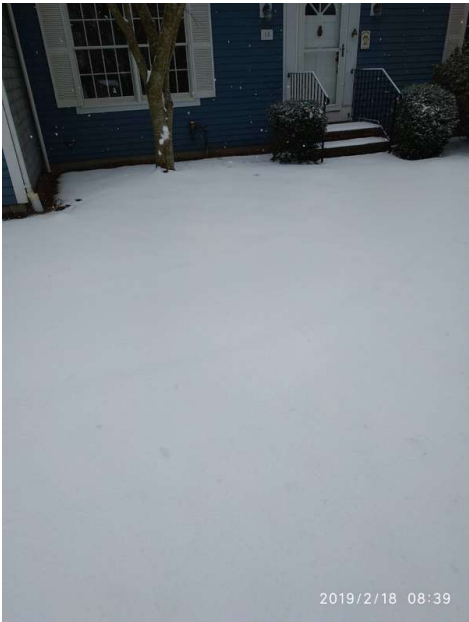
SNOW - WALKWAYS

Walkway was covered with snow and ice at time of inspection. Was unable to determine its condition.

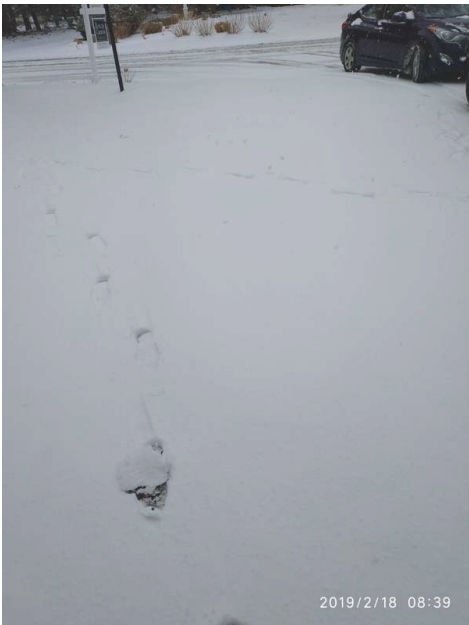
SNOW - DRIVEWAY

Driveway was covered with snow at time of inspection. Was unable to determine its condition.

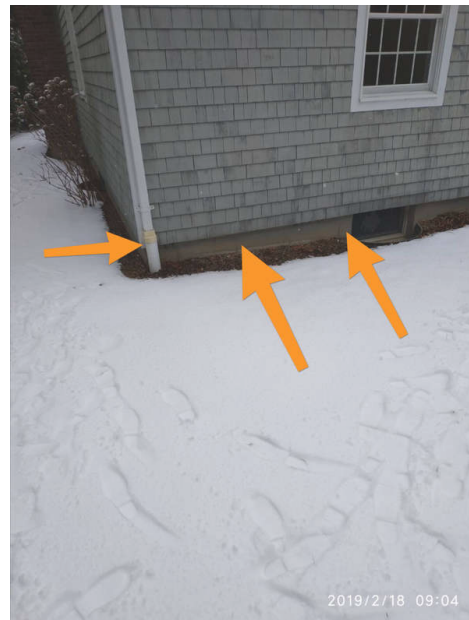
Grade in some areas around the dwelling is pitched towards the foundation. This creates a ponding effect around the foundation and may allow water penetration into the basement. Improper grading is conducive to wood destroying insect infestation. Recommend correcting grades to pitch away from the foundation in all cases. As a guide, the ground should fall off 6 within the first 10 out from the foundation.

Contact a qualified landscaping contractor

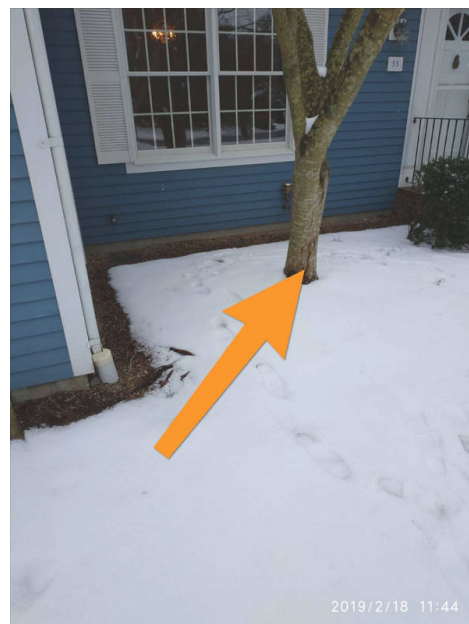
3.2.1 Vegetation

ROOTS/TREES WITHIN 10 FEET

Roots from any tree located near the house may cause foundation damage as the tree grows and the root system expands. If signs of damage appear (such as cracks) the tree may need to be removed. The potential for damage from tree roots varies with tree species. Suggest removal of all trees within 10 feet of house.

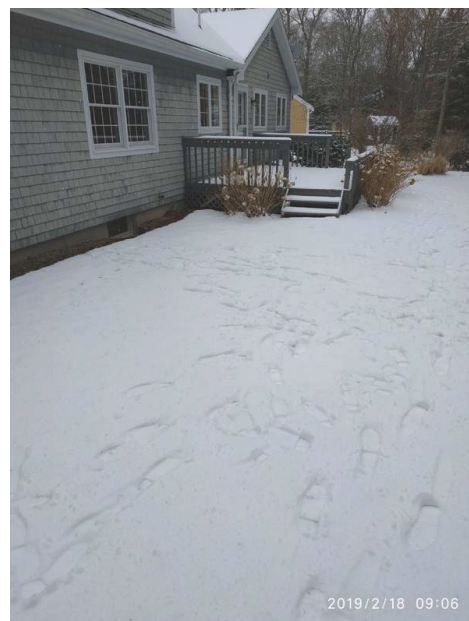
REAR

There is no visual access beneath deck. Condition of structural components could not be ascertained.

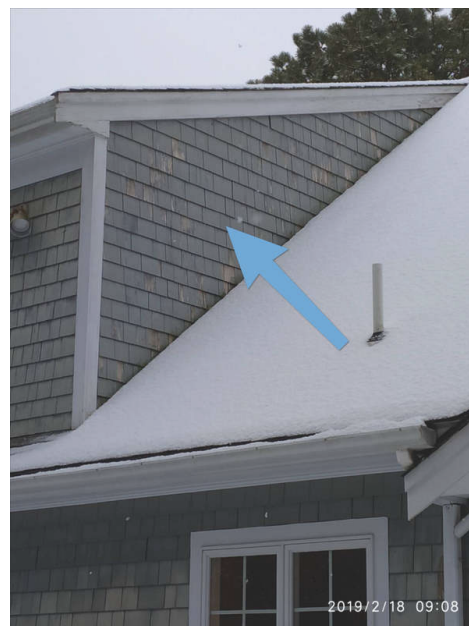
4.5.1 Siding

PAINT FAILING

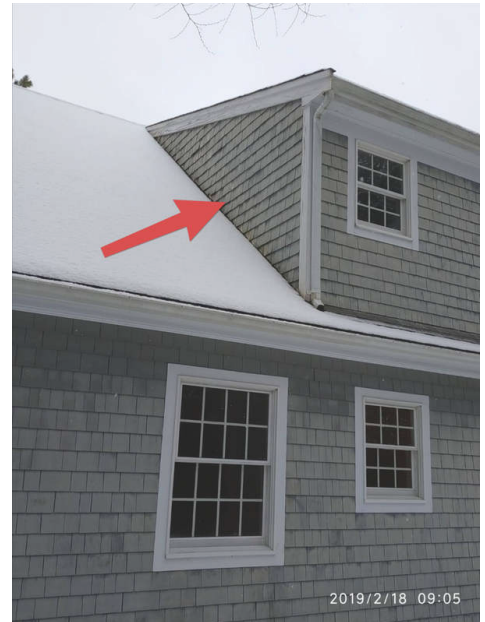
4.5.2 Siding

SHINGLES IN CONTACT WITH ROOF

Contact your builder.

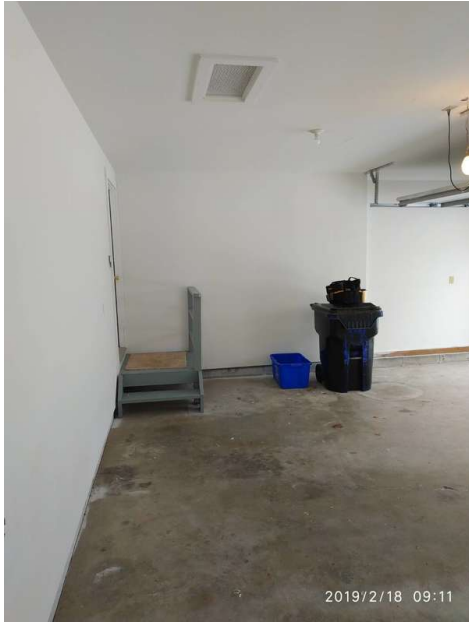
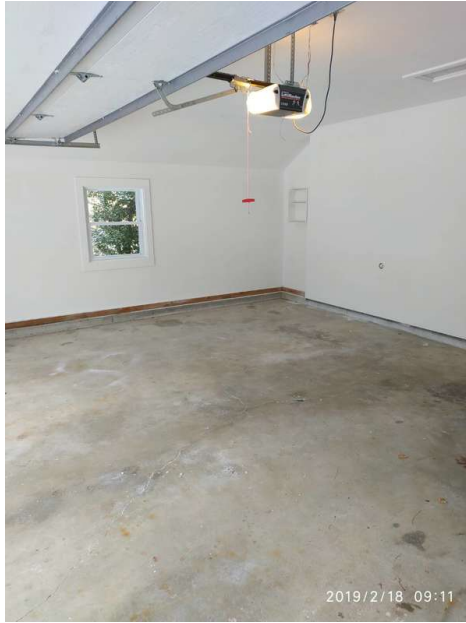
GARAGE - FINISHED INTERIOR

Fixed ceiling and wall covering in garage prevented observation of structure.

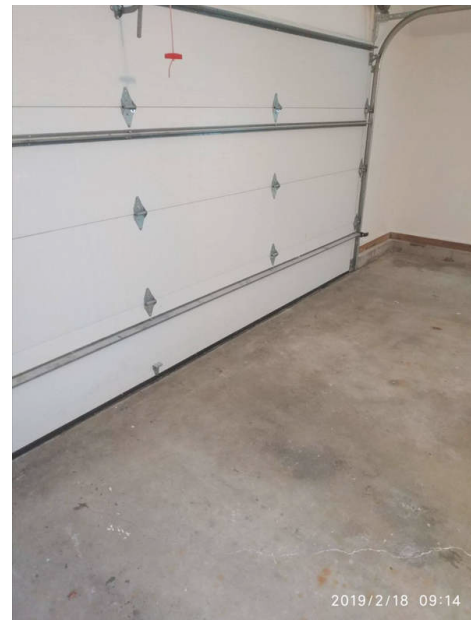
5.4.2 Garage Doors/Openers

NO RESISTANCE REVERSAL

Contact a qualified garage door contractor.

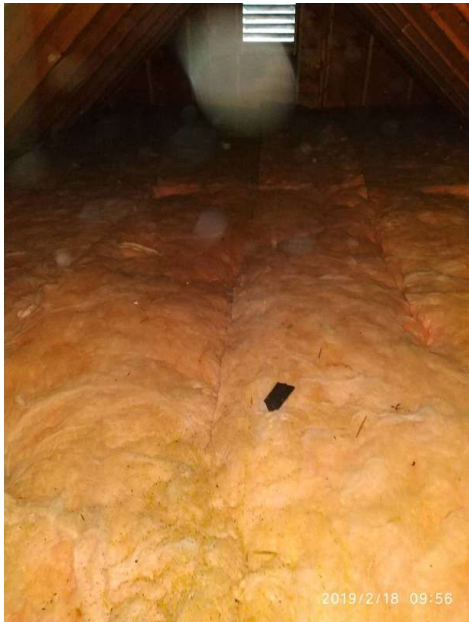
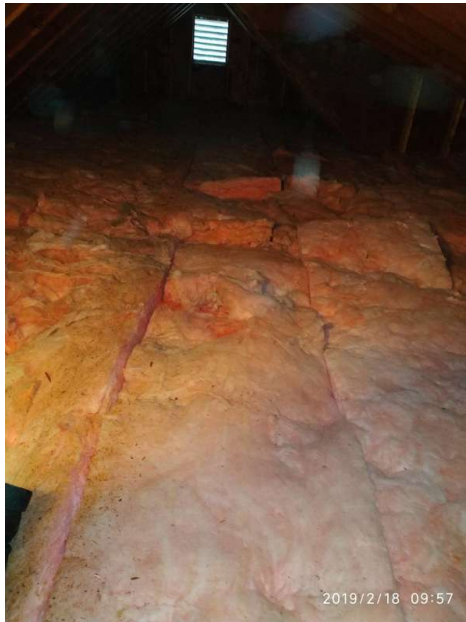
NO SAFE FOOTING

Due to complete insulation cover and lack of secure footing, was only able view attic from near the access point, and observe from there only with a flashlight. Commentary and ratings are based on what I could see from this point.

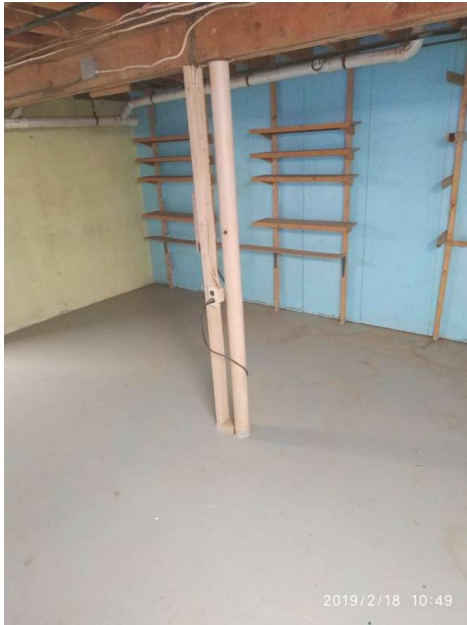
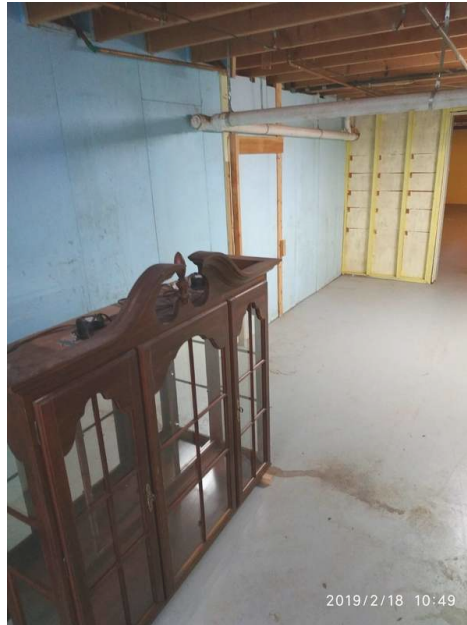
FINISHED (PART)

Partially finished basement obstructed viewing of structural components, including foundation walls, girders, columns, subfloor, sills and rim joist. Ratings given refer to area viewable in unfinished areas only

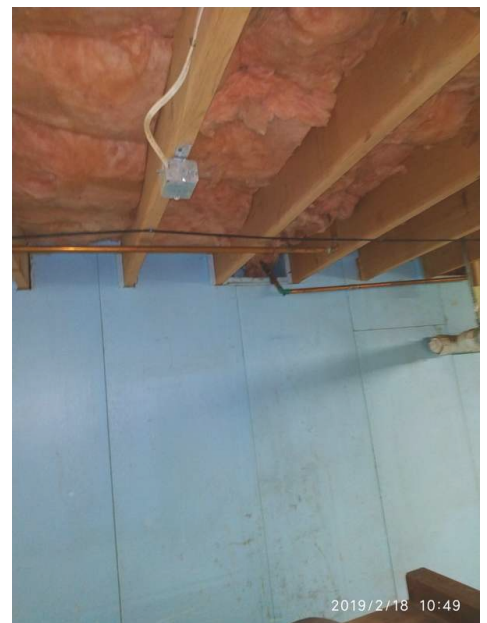
SUB FLOOR

Basement insulation prevented observation of the sub floor.

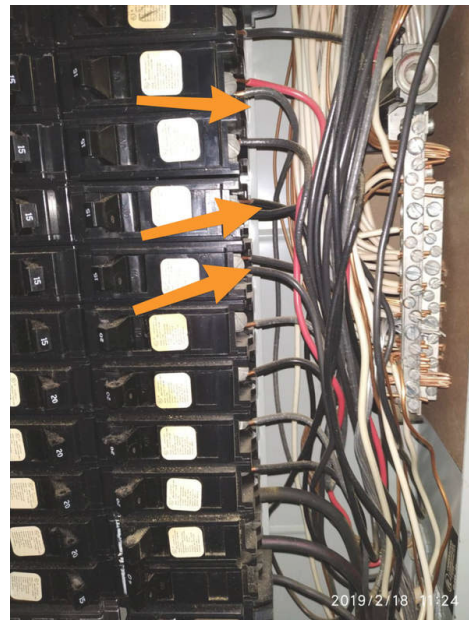
9.2.4 Main Distribution Panel

PIGGY BACK MULTIPLE

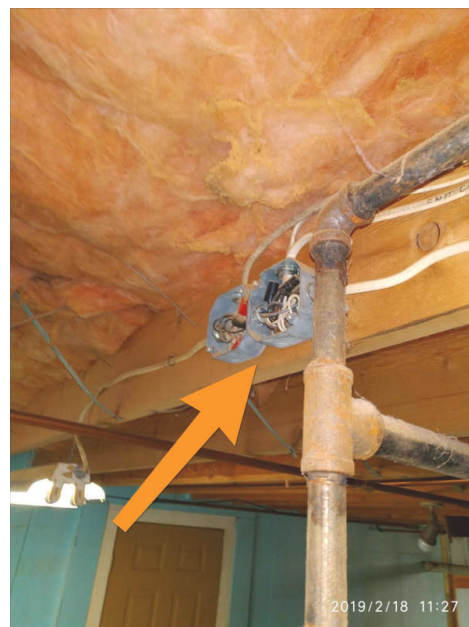
9.3.1 Branch Circuit Conductors and Wiring

COVER MISSING

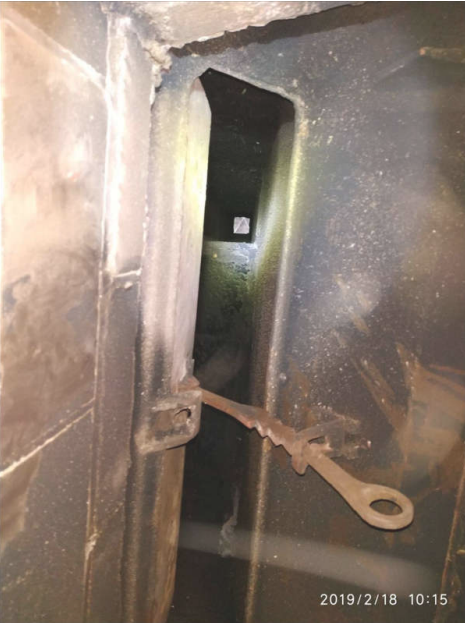
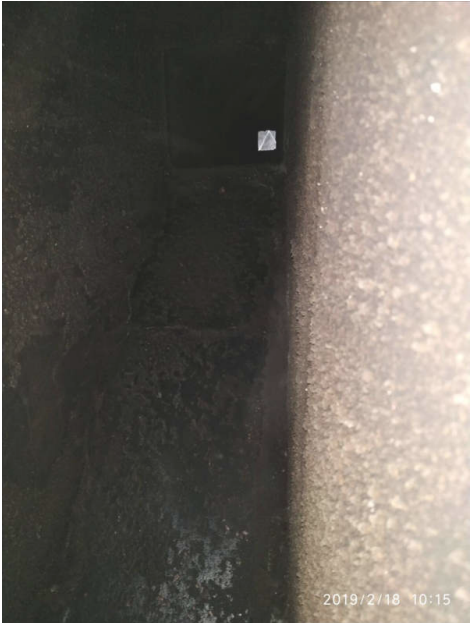
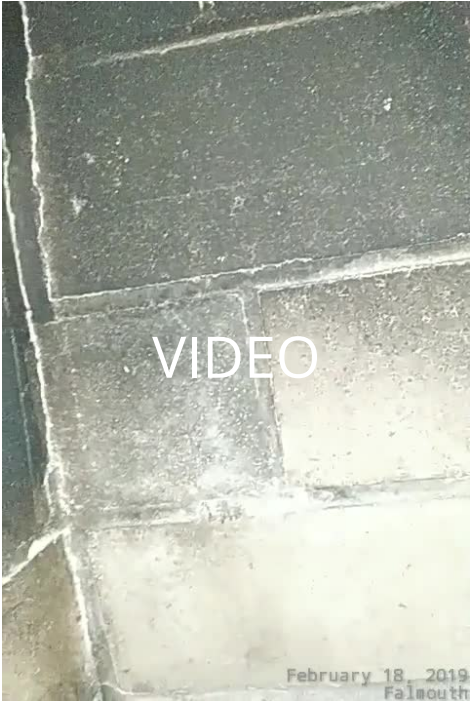
12.1.2 Fireplaces

SOOT ACCUMULATION

Contact a qualified chimney sweep.

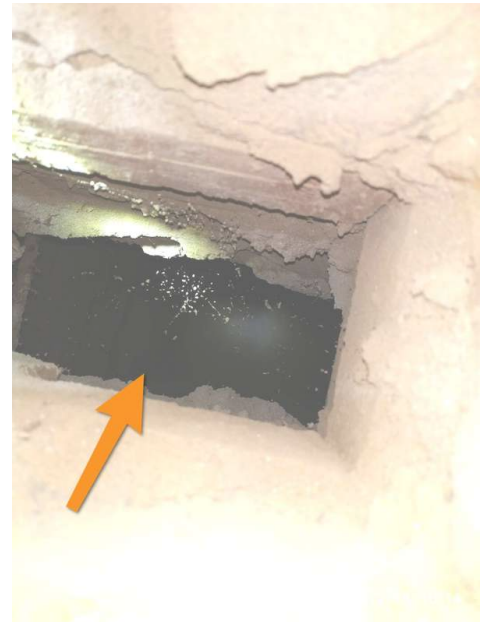
12.1.3 Fireplaces

CLEAN OUT FULL
BASEMENT

Contact a handyman or DIY project
