SINGULAR HOME INSPECTIONS RESIDENTIAL INSPECTION

1234 Main St.
Katy Tx 77449

04/02/2019 9:00AM

PROPERTY INSPECTION REPORT

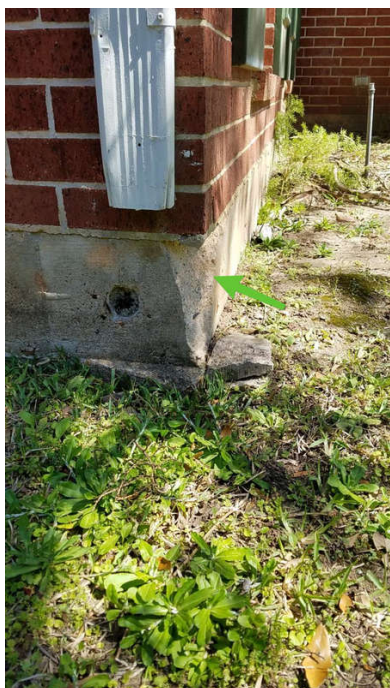
Front Left

Corner Pop:

One or more of the foundation perimeter beam corners were observed to be sheared off (corner pop). This is a common condition in slab on grade foundations. This condition does not adversely affect the performance of the foundation. However, in some cases, some cosmetic improvements may be desired.

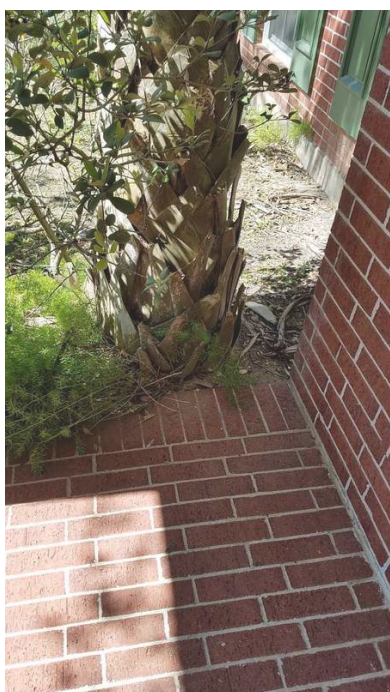
Trees Too Close:

Tree(s) in close proximity of the foundation was observed. Client should consider the installation of a root barrier to reduce the possibility of damage to the foundation from tree roots and moisture removal.

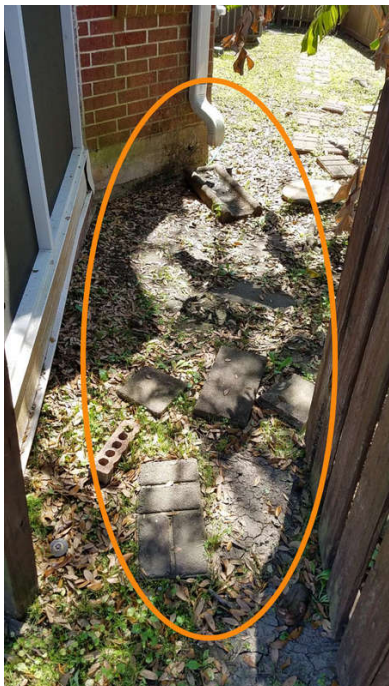
Rear Left

Neutral to Negative Drainage:

The home appears to have areas of neutral or negative drainage at grade which will route runoff from precipitation to the foundation. Excessive moisture content in soil supporting the foundation can cause foundation and other structural damage from undermining, heaving or settling, depending on soil composition, moisture content and other conditions. The ground should slope away from the home - inch per foot for a distance of at least six feet from the foundation. The Inspector recommends re-grading these areas to improve drainage near the foundation.

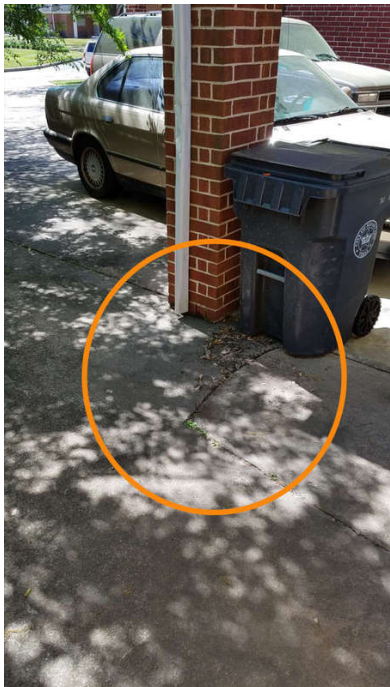
Standing water observed, which could indicate poor drainage and/or grading. Recommend monitor and/or have landscaper correct.

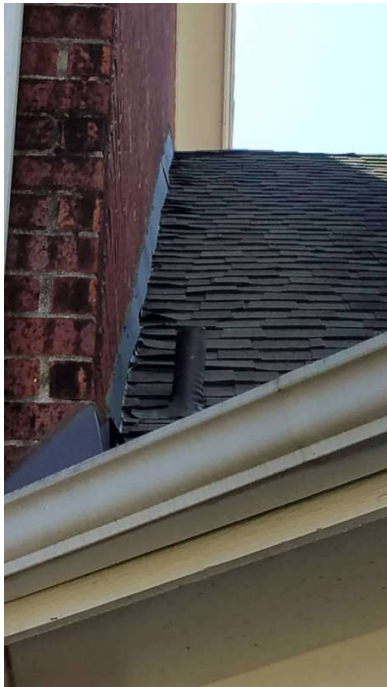
Rear

The roofing material observed to have loose and/or lifting shingles in various locations. The damage may have been caused by a previous wind storm and should be further evaluated.

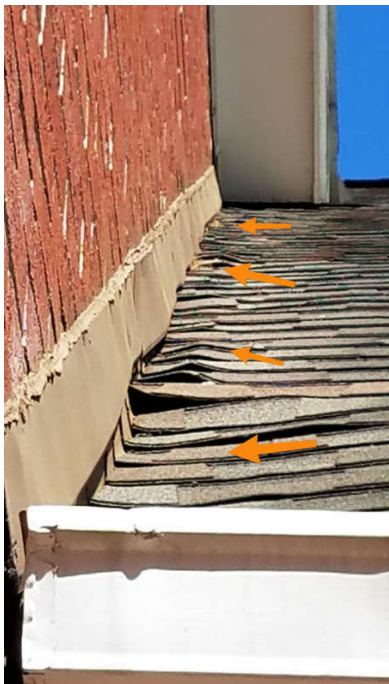
Right, Garage

The flashing is lifting and/or pulling loose and should be re-secured.

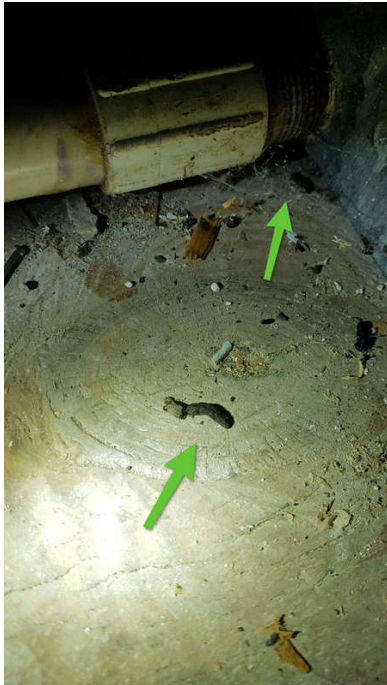
Attic

Visible evidence of rodent activity was observed in the attic area. It is recommended to have a Certified Pest Control Operator further evaluate this condition and make corrections as necessary.

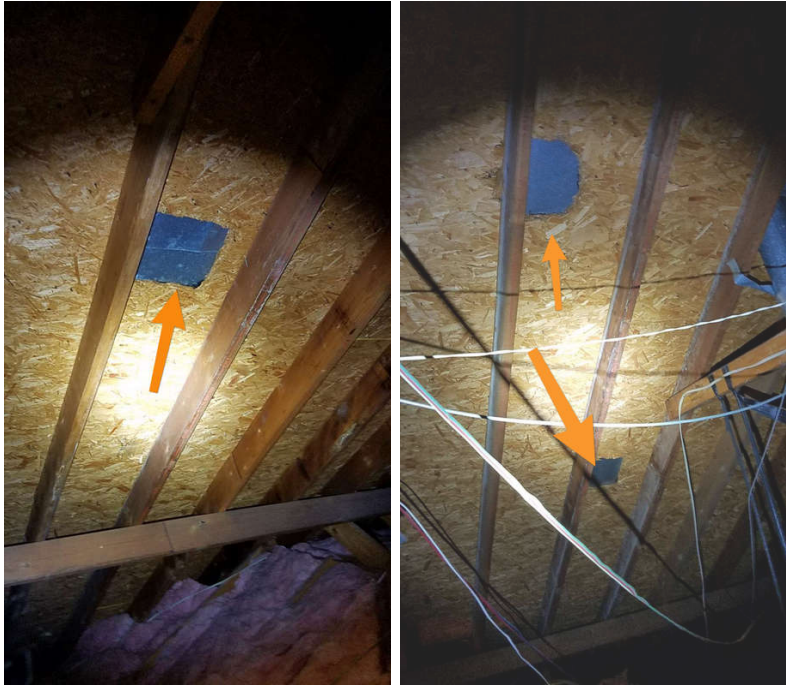
Attic

Some roof sheathing (decking) deterioration and/or damage was observed in one or more locations. This condition should be further evaluated by a qualified roofer and repaired as necessary

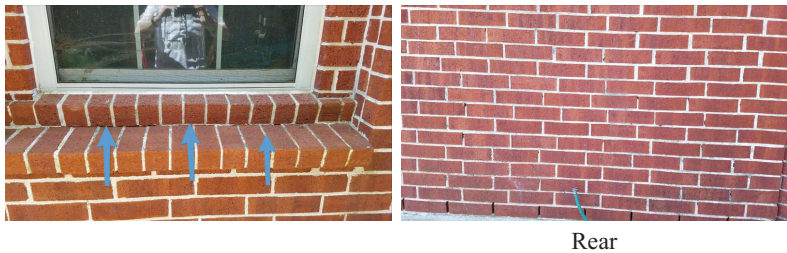
Mortar improvements are recommended for the exterior masonry veneer

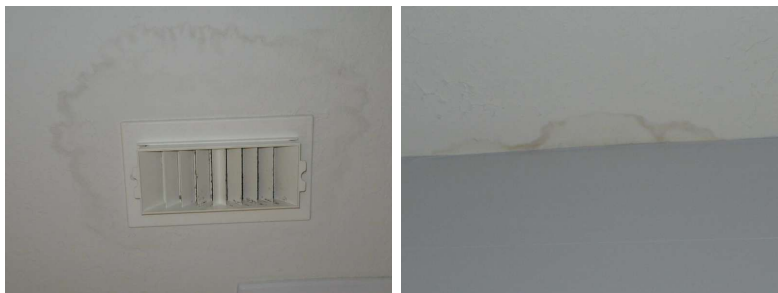
Water stains were observed on the ceiling finish. The cause and remedy should be further evaluated and corrected as necessary.

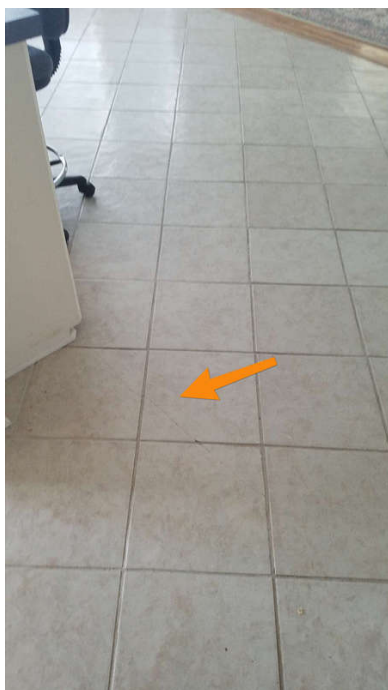
Upstairs gameroom

The floor tile(s) were observed to be cracked and/or damaged.

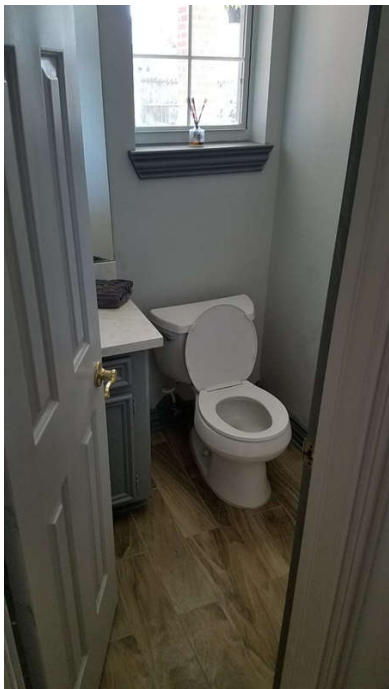
1/2 Bath

One or more doors was found to be difficult to open/close. This is typical after homes begin to settle.

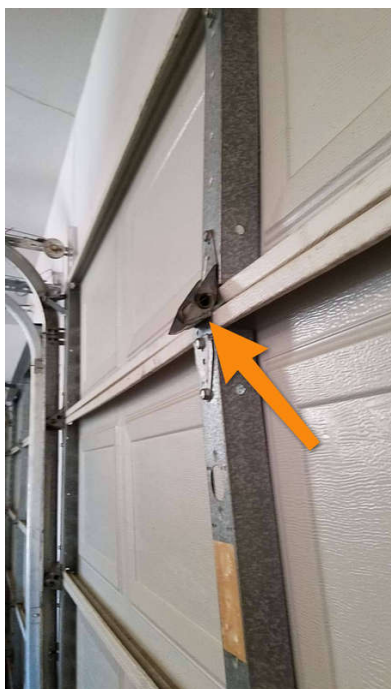
Some of the overhead garage door hinges were observed to be loose and should be re-secured.

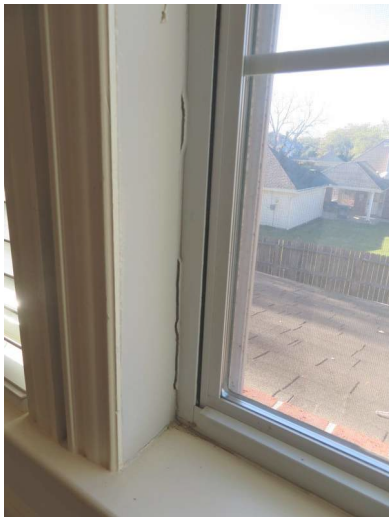
The interior window sill(s) have some deteriorated and/or damaged.

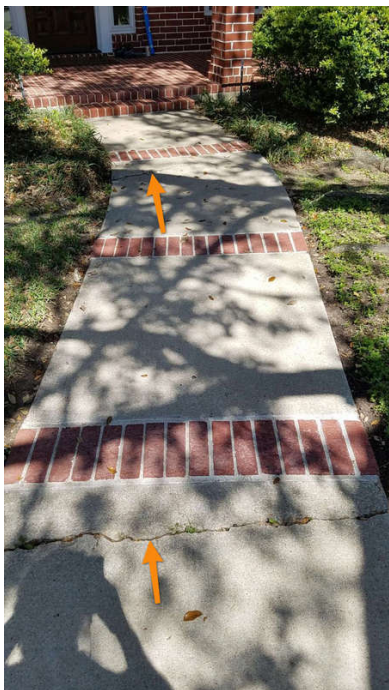
Front

The sidewalk has settled somewhat. If this condition persists or if the sidewalk becomes a trip hazard, improvements should be undertaken.

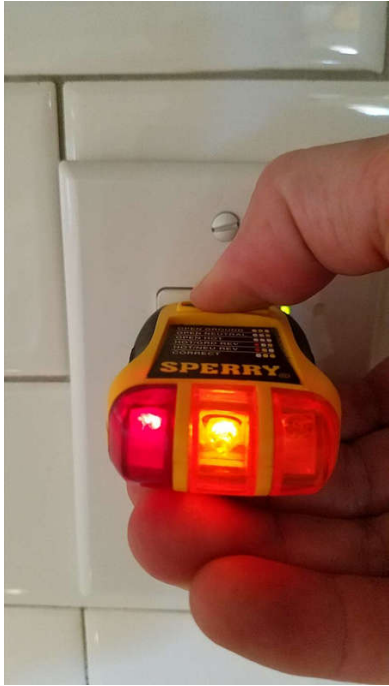
Kitchen

One or more of the ground fault circuit interrupter (GFCI) devices does not appear to be functioning properly at the time of this inspection. Recommend further evaluation by a licensed electrician and repair as needed.

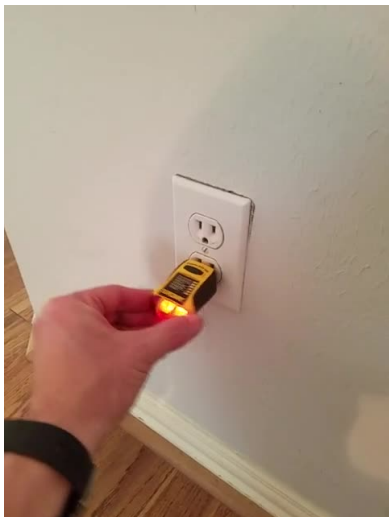
One or more of the receptacles were observed to be loose at the wall mount. Recommend a licensed electrician evaluate and repair or replace as necessary.

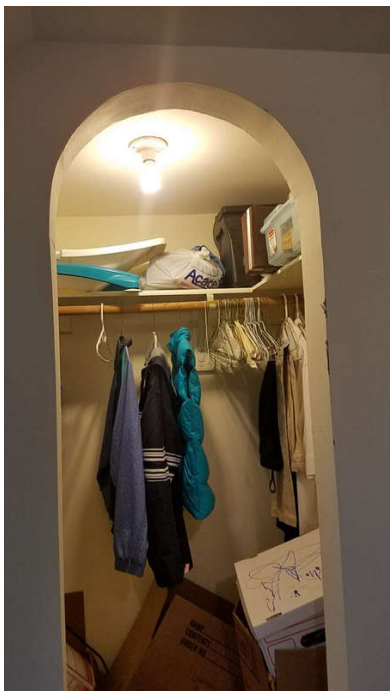
Upstairs Bedroom Closet

One or more of the closet light fixtures appear to be installed without globes and/or covers. Safety precautions should be taken around these light fixtures. This is an as built condition however we are required by TREC to note this as a deficiency.

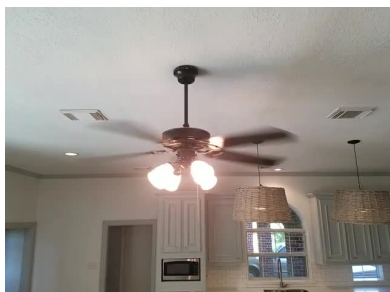
The ceiling fan is not balanced properly and wobbles when operated.

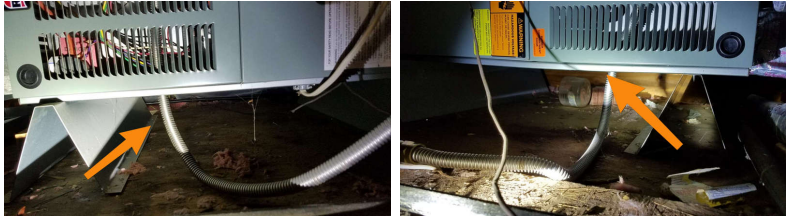
3: No sediment trap

The heater gas supply line is not equipped with a sediment trap just before the gas appliance connector. This condition does not meet current installation requirements and should be corrected.

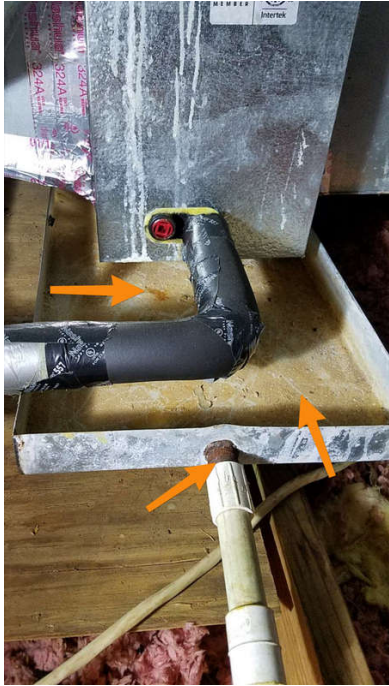
Upstairs unit

The auxiliary/secondary drain pan under the coil housing has some water staining and/or a rust build-up. This would indicate that the pan has held water in the past and should be closely monitored.

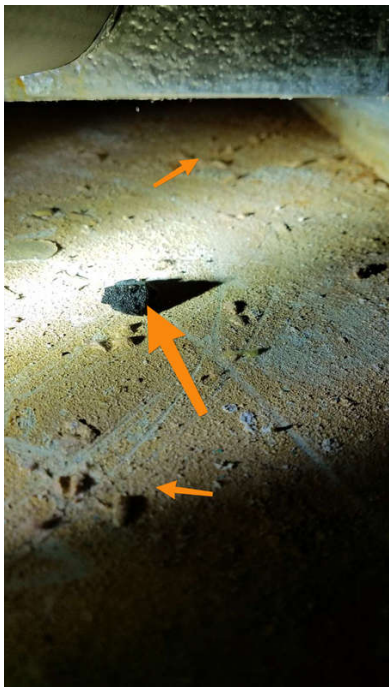
Upstairs unit

The auxiliary/secondary drain pan under the coil housing should be free of all debris. The debris in the pan could clog the drain line and cause water to leak to the interior of the house.

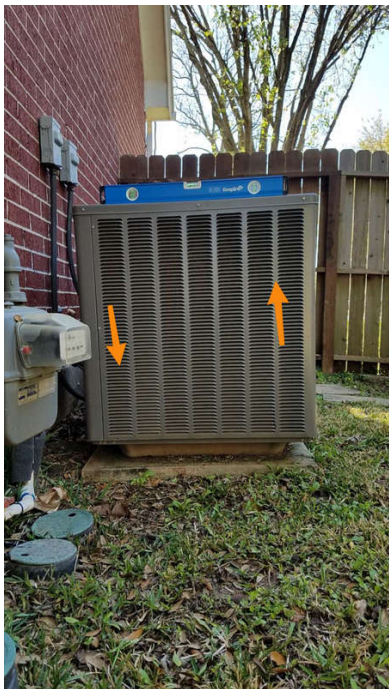
The outdoor unit of the air conditioning system is out of level. It is recommended that the outside condenser/coils be within 1-inch of level.

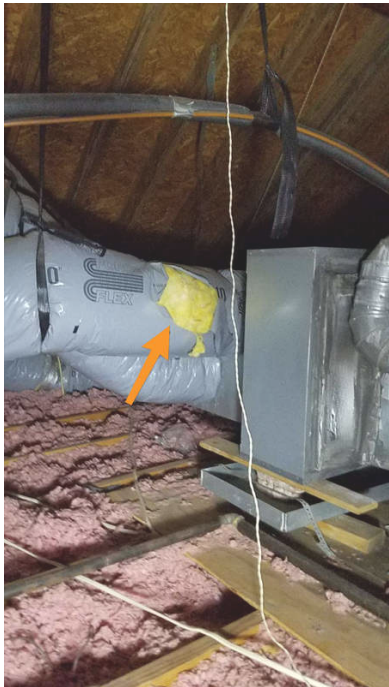
Attic

Ductwork insulated covering was observed to be damaged and/or pulling loose.

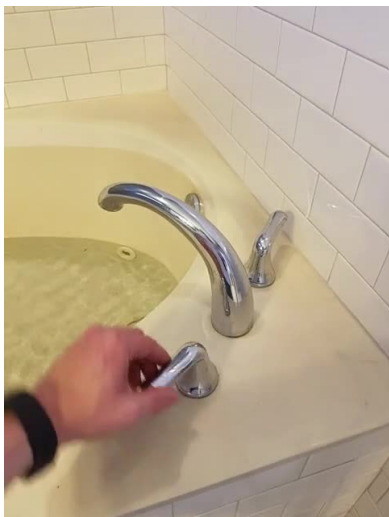
1: "Water Hammering"

Water hammering is a term used to describe noise produced by a destructive force known as hydraulic shock. Water hammering develops in a piping system when an instantaneous change in the velocity of flowing water occurs, or when water flowing at a given velocity is stopped abruptly. A quick closure of a valve, for example, creates some form of shock. The shock wave is accompanied by a pressure surge that can expand the wall of the pipe. Recommend further evaluation by a licensed plumber and repair or replace as necessary.

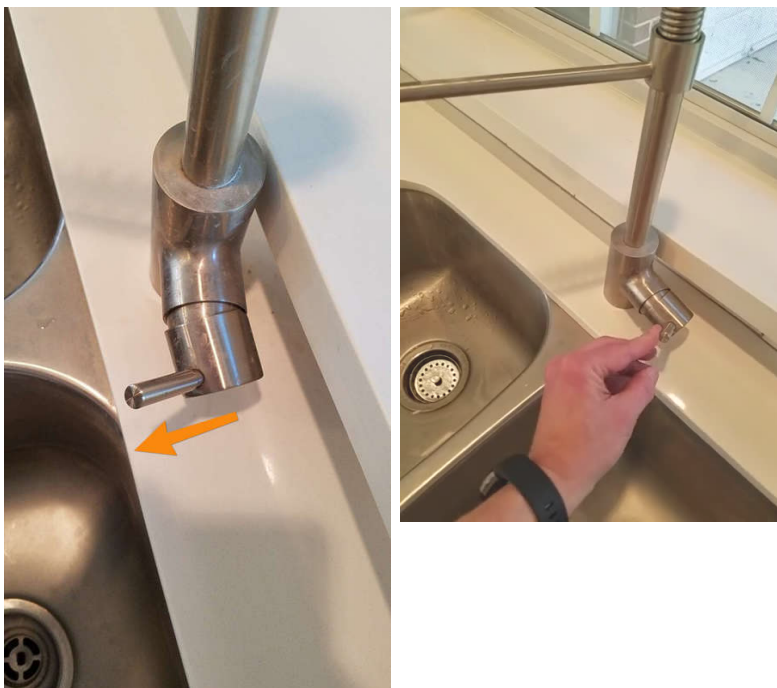
Kitchen

The faucet cold water supply is inoperative. The cause and remedy should be further evaluated.

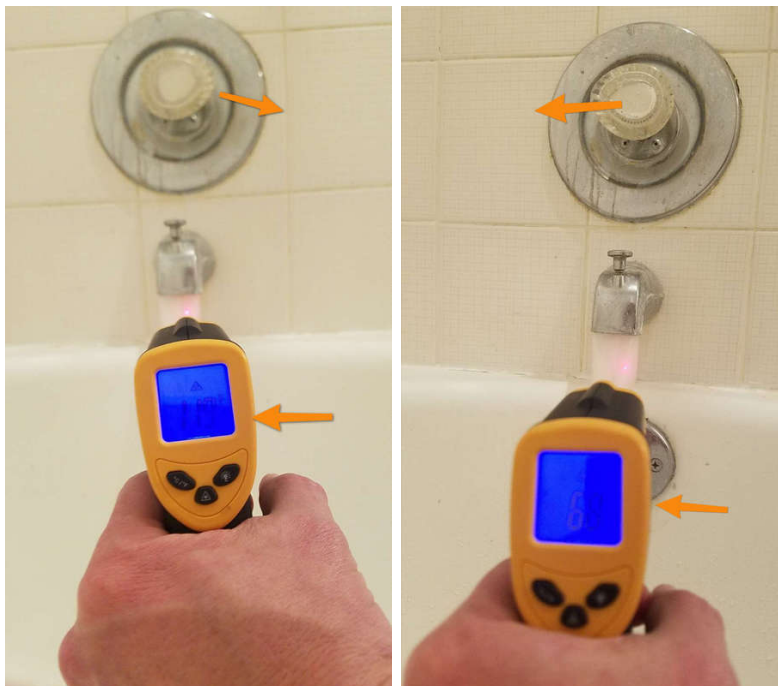
The faucets hot/cold water orientation is reversed.

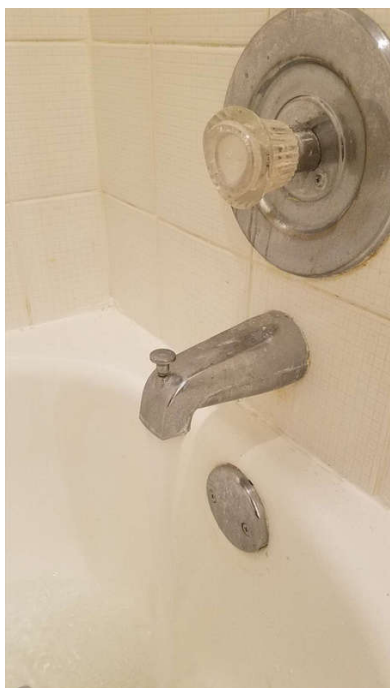
Upstairs Bathroom Left

The bathtub shower head diverter is not functioning properly.

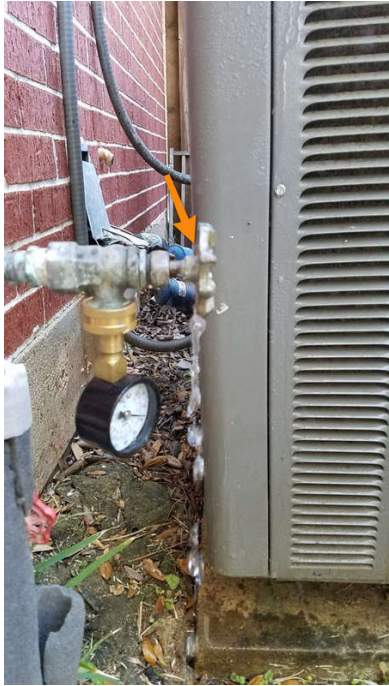
Left

The exterior water hose bib (faucet) is leaking at the handle when operated.

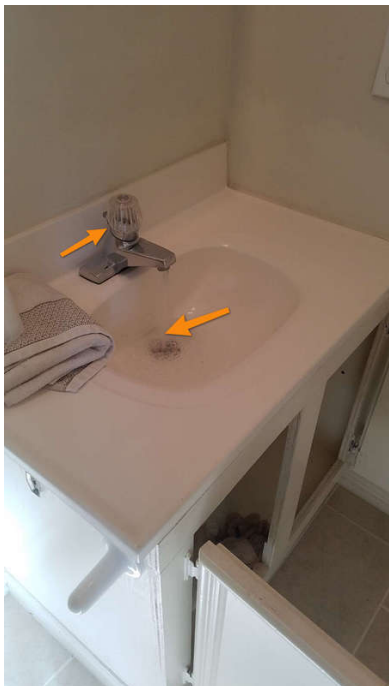
Upstairs Garage Apt.

The sink hardware was installed incorrectly. It did not properly hold water as a result.

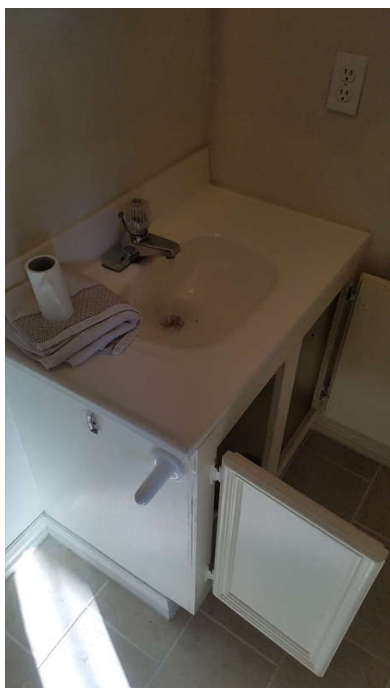
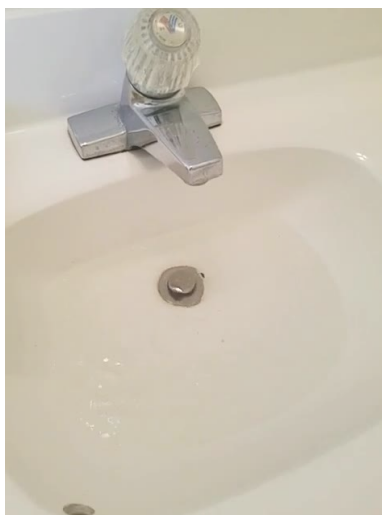
Upstairs Garage apt

The sink was observed to drain slowly, suggesting that an obstruction may exist.

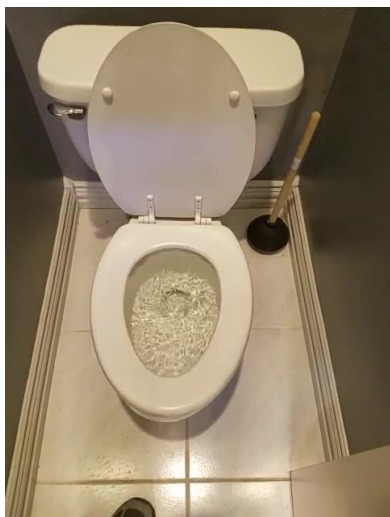
A toilet was slow to drain.

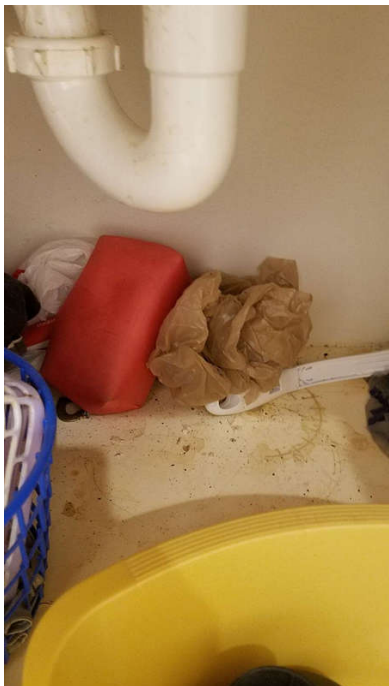
Upstairs Bathroom Left

Previous water leaks were observed at and/or around the drain connections under the sink. This would indicate previous problems and should be closely monitored and corrected when necessary.

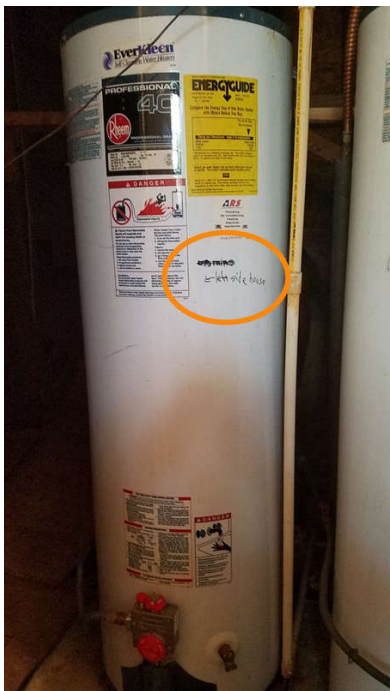
The water heater is making a rumbling noise when operated. This is a good indicator that there is a lot of sediment in the bottom of the water heater tank. Cleaning and servicing is recommended.

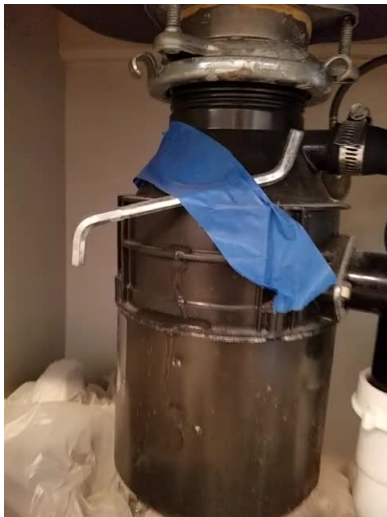
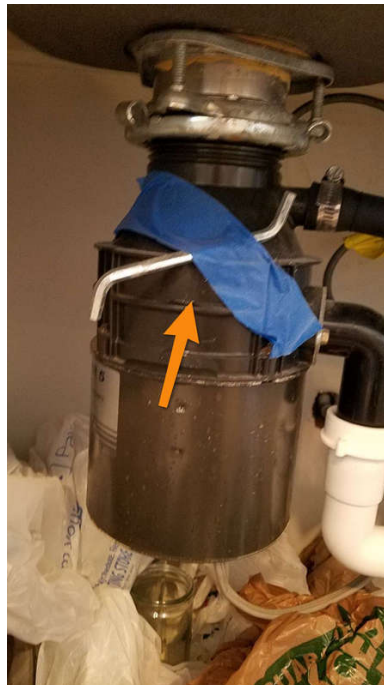
Kitchen

The food waste disposer is leaking water into the cabinet area. This condition should be further evaluated and corrected as necessary.
