# PROSITE PROPERTY INSPECTIONS

## GENERAL HOME INSPECTION REPORT

1234 Main St.  
Gulf Breeze FL 32563

Buyer Name  
02/05/2019 9:00AM

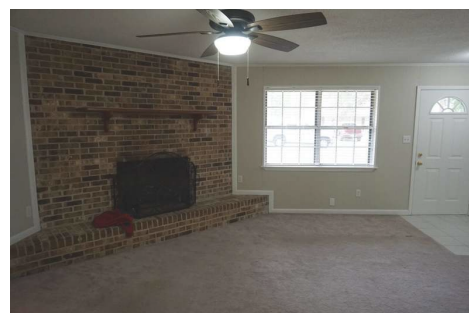
This property has one or more fuel burning appliances, and no carbon monoxide alarms were visible. This is a safety hazard. Recommend installing one or more carbon monoxide alarms as necessary and as per the manufacturer's instructions.

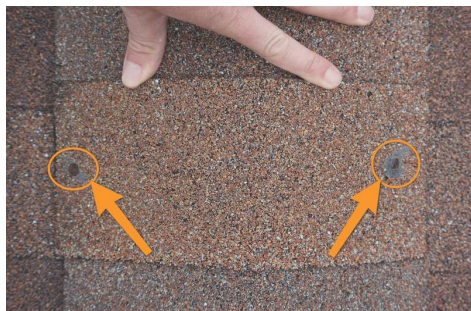
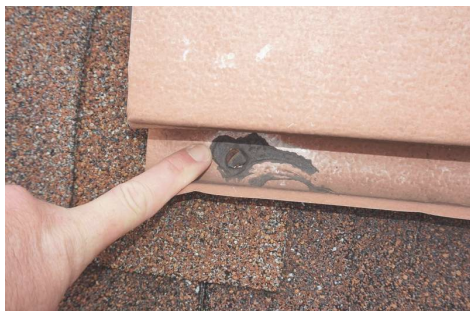
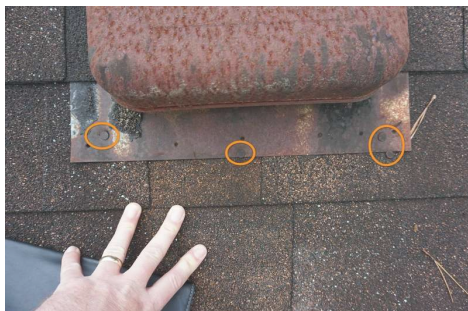
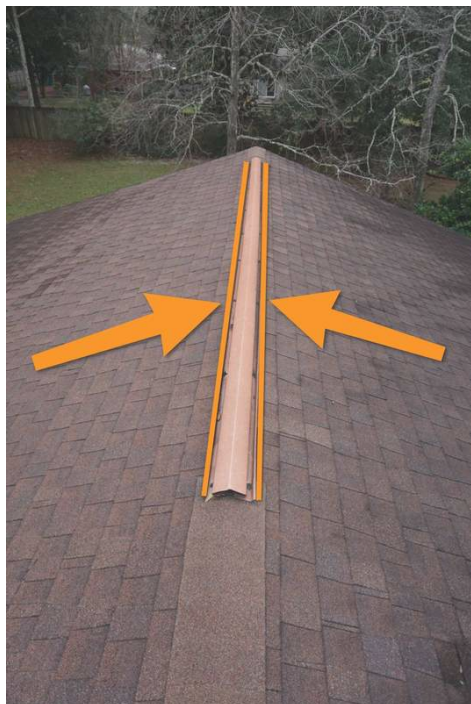
Exposed nail heads observed. This a potential pathway for moisture intrusion. Although there was no evidence of a leak, we recommend sealing these areas and annually in the future by a licensed roofing contractor.

Contact a qualified roofing professional.

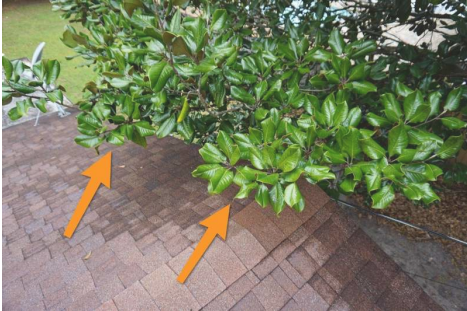
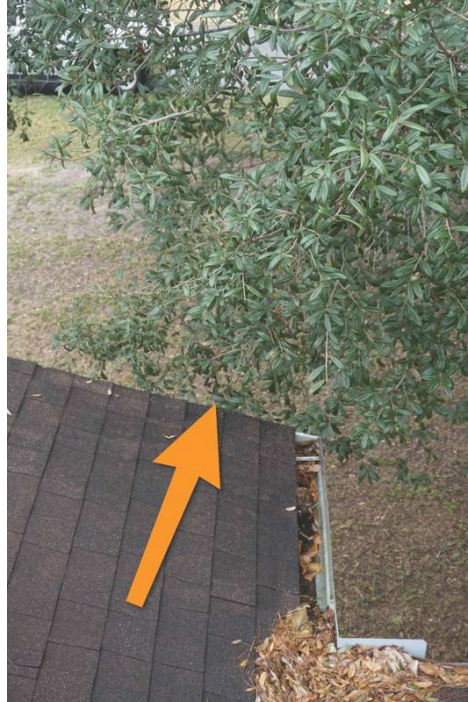
## 2.1.2 General

Vegetation such as trees, shrubs, and/or vines overhung the roof surface or were in close contact with the roof edge. Organic debris such as leaves or needles are likely to accumulate in gutters and on the roof surface. Gutters can overflow and cause water to come in contact with the building exterior or water can accumulate around the foundation. This is a conducive condition for wood-destroying organisms. Vegetation in contact with the roof can damage the roof surface and/or the roof drainage system. Recommend pruning vegetation so as to not be in close contact with the roof and to not overhang the roof surface. If vegetation is too tall then it should be pruned at least 10 feet above the roof surface.

Contact a qualified tree service company.

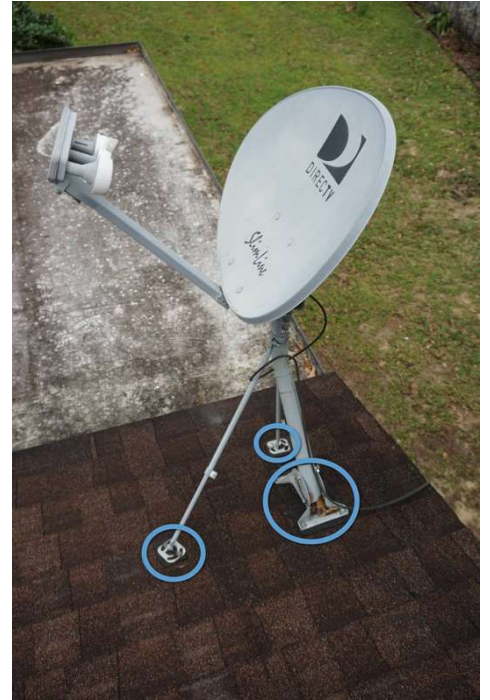
## 2.1.3 General

Satellite dish was mounted on the roof should be inspected at the least annually, leaks can occur around mounting brackets and may need sealant applied to prevent leaks by a licensed roofing contractor.

Contact a qualified roofing professional.

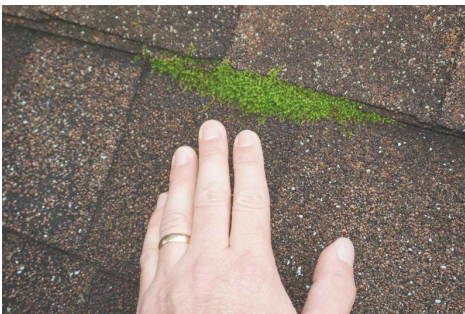
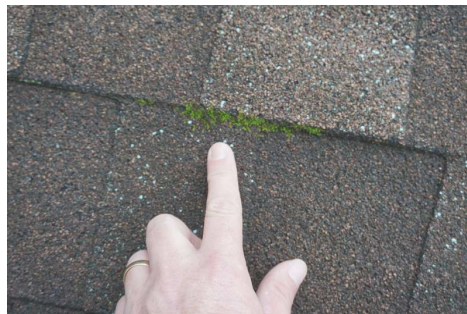
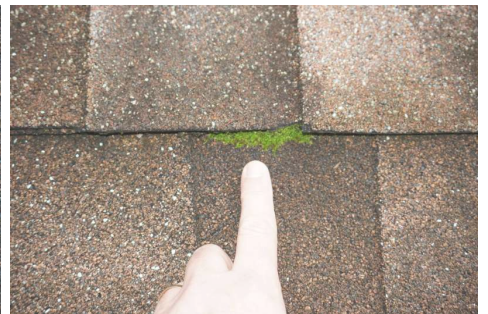
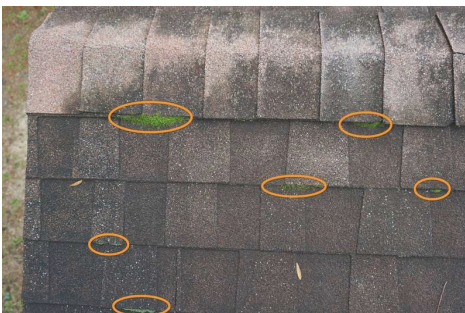
2.1.4 General

**MOSS GROWTH**

Moss was growing on the roof. As a result, roofing material can lift or be damaged. Leaks can result and/or the roof surface can fail prematurely. Efforts should be made to kill the moss during its growing season (wet months). Typically, zinc or phosphate-based chemicals are used for this and must be applied periodically. Recommend further evaluation and removing moss by a licensed roofing contractor. Roof should also be evaluated by a licensed roofing contractor once moss is removed.

Contact a qualified roofing professional.

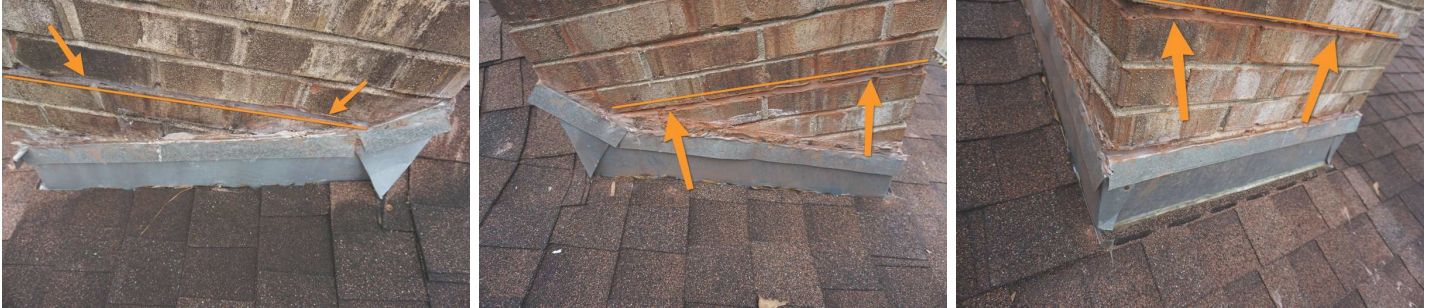
2.2.1 Chimney

Roofing sealant was observed at the chimney's mortar joint in one or more areas. This is not standard practice for repairing masonry mortar joints. The masonry chimney's mortar is may be deteriorated and should be further evaluated for deterioration. Recommend having a qualified chimney service contractor or masonry contractor evaluate and repair as necessary. This will likely require re-pointing the mortar.

Contact a qualified chimney contractor.

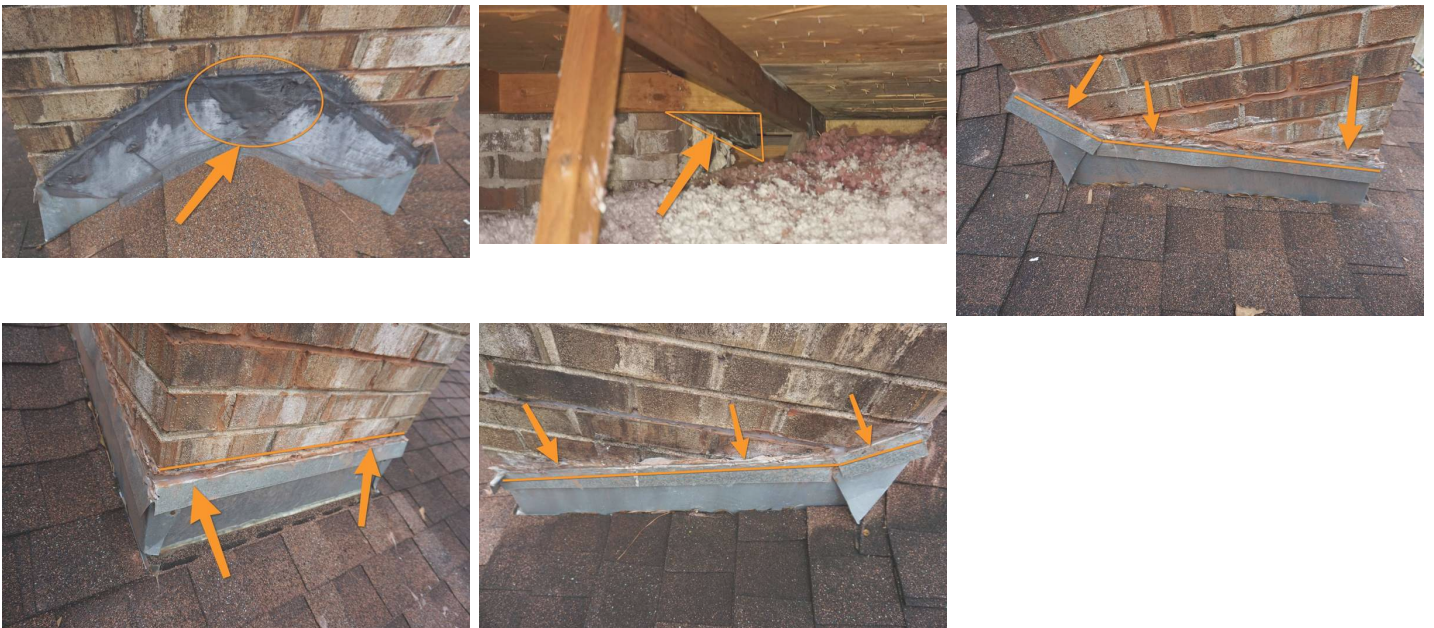
2.2.2 Chimney

Chimney flashing was not professionally installed. Leaks can occur as a result. This is conducive for wood destroying organisms. Moisture stains were evident at the roof structure around the chimney area in the attic space. The inspector was not able to traverse into this area to test for moisture due to low height. Excessive roofing sealant was observed at the chimney flashing which may also indicate problems with past moisture intrusion in this area. Roof decking and roof structure must be evaluated during repairs/replacement. Recommend evaluation and replacement of chimney flashing by a licensed roofing contractor.

Contact a qualified roofing professional.

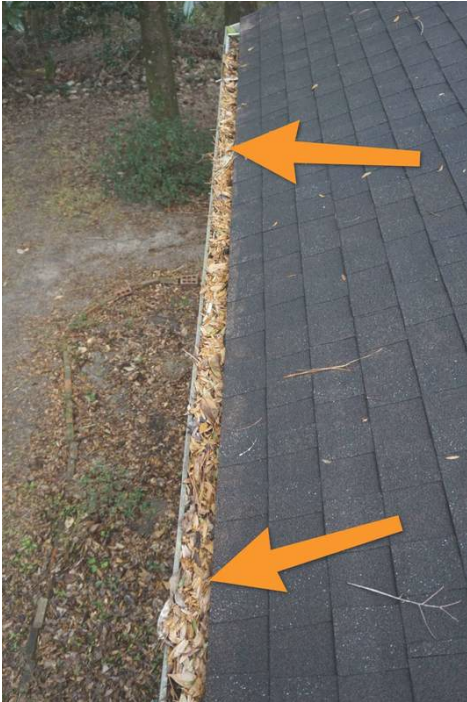
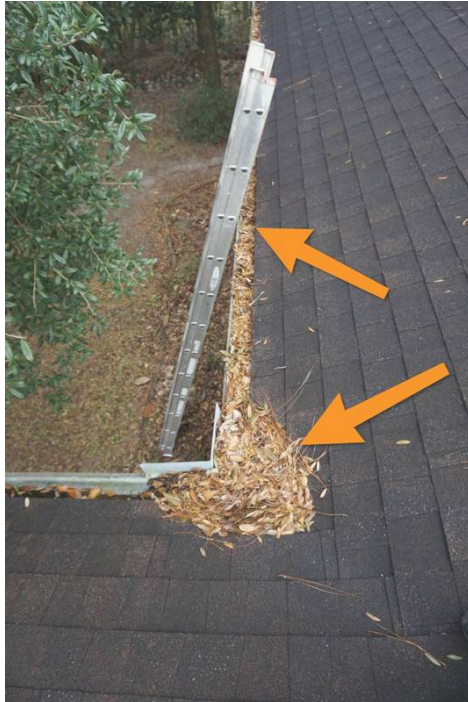
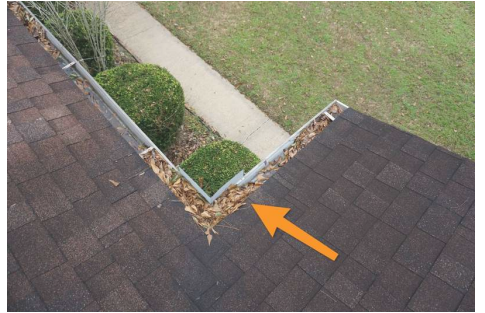
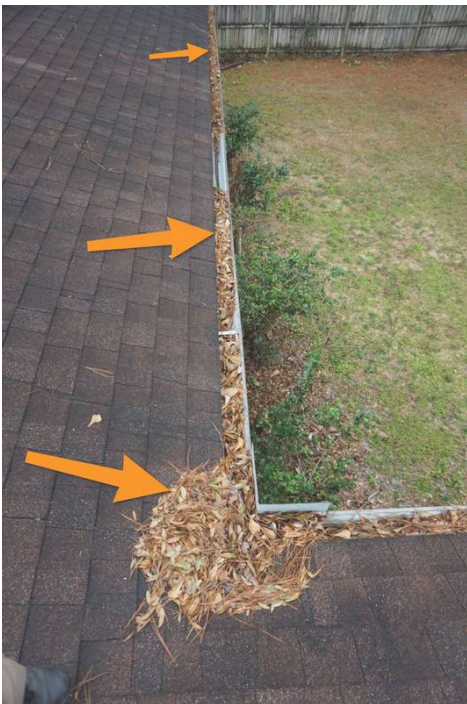
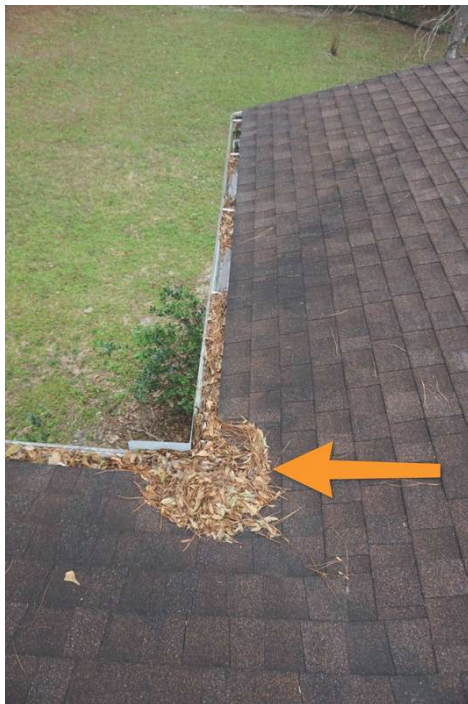
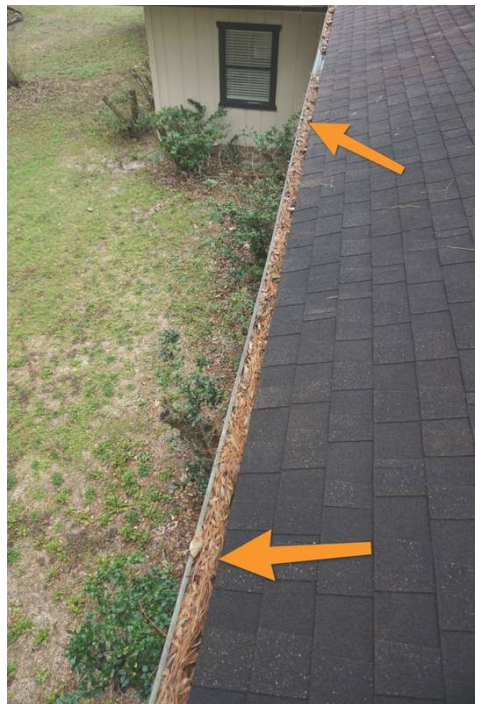
2.3.1 Gutters/drains

Significant amounts of debris have accumulated in one or more gutters or downspouts. Gutters can overflow and cause water to come in contact with the building exterior, or water can accumulate around the foundation. This is a conducive condition for wood-destroying organisms. Recommend cleaning gutters and downspouts now and as necessary in the future.

Contact a handyman or DIY project

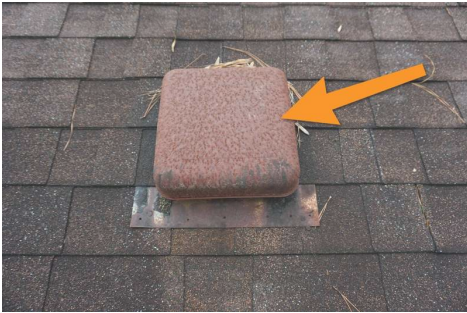
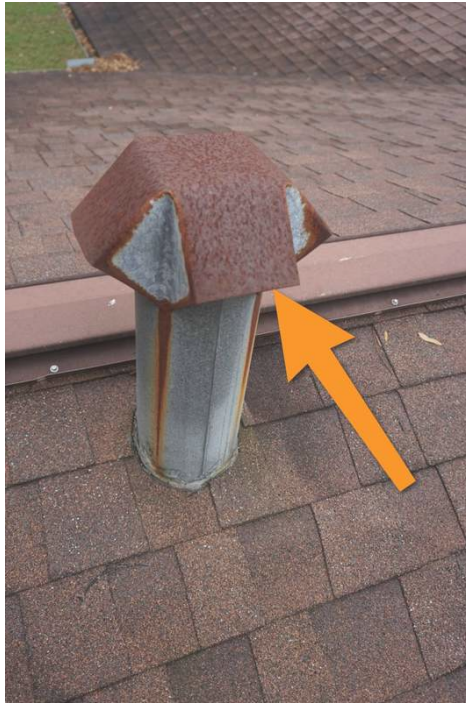
## 2.4.1 Flashing/Vents

**RUSTY APPURTENANCES**

Roof-top appurtenance such as vents were significantly corroded. Metal may deteriorate to the point of needing replacement. Leaks can occur around such items if flashing or sealant doesn't form a waterproof seal with the corroded metal. This can be a conducive condition for wood-destroying organisms. Recommend that a licensed roofing contractor repair as necessary. For example, by cleaning rust and repainting with a rust-inhibiting paint.

Contact a qualified roofing professional.

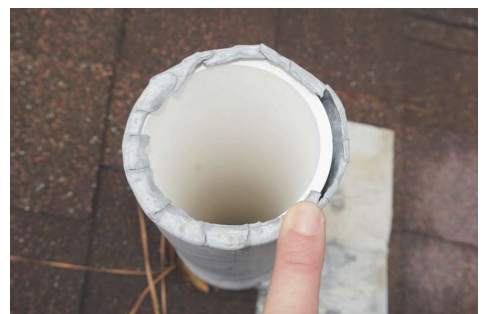
## 2.4.2 Flashing/Vents

Lead flashing at one or more plumbing vent pipes was improperly installed. For example, shorter than the vent pipe or not bent over the edge of the vent pipe. Properly installed, the flashing should extend up and over the top edge of the pipe, and be bent down into the pipe. Otherwise, rain water can flow between the pipe and the flashing, resulting in leaks. This is a conducive condition for wood-destroying organisms. Recommend that a licensed roofing contractor repair per standard building practices.

Contact a qualified roofing professional.

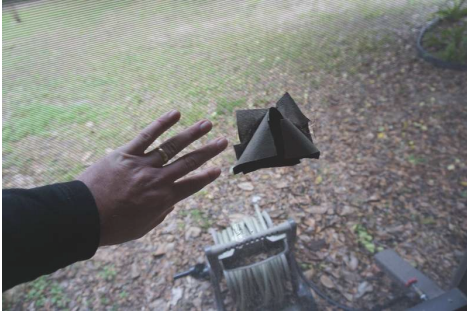
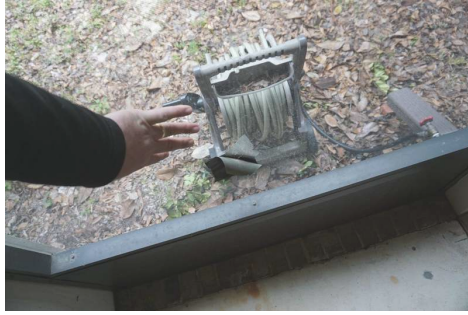
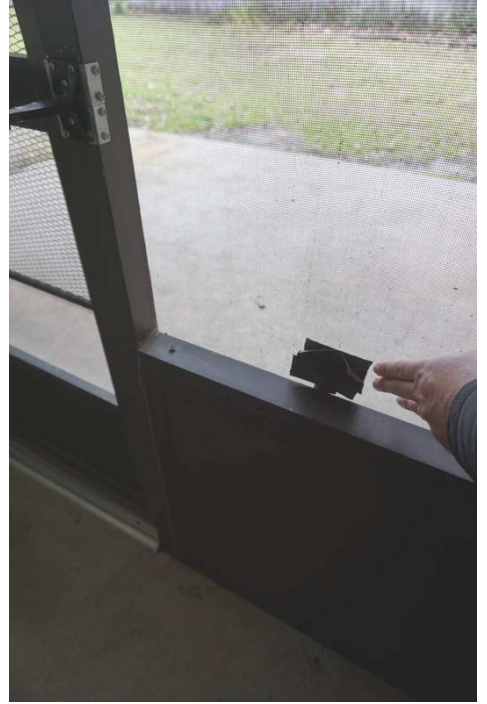
One or more screens were damaged or torn or missing in the screen patio. A certified contractor should make the necessary repairs.

Contact a qualified handyman.

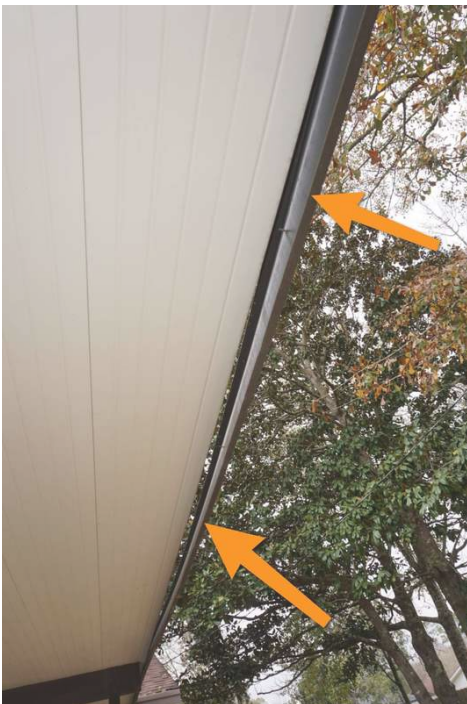
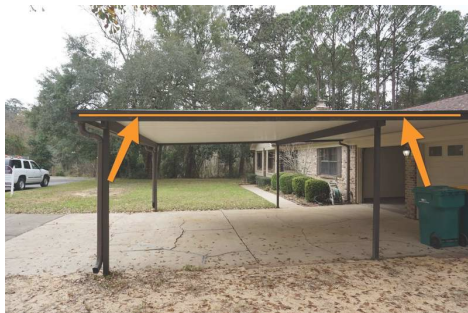
3.2.2 Driveway, Walkway, Patio

**CARPORT RAKE TRIM - LOOSE**

Carport rake trim located on the north side was loose. Recommend evaluation and repairs by a qualified professional.

Contact a qualified professional.

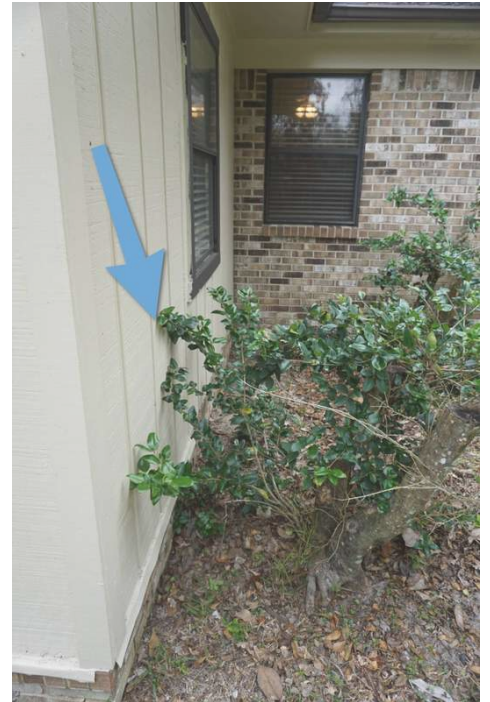
## 3.3.1 Exterior issues

Vegetation observed within close contact of the house. This can create a pathway for insects and/or wood destroying organisms into the home interior. Recommend trimming vegetation by a qualified landscape professional.

Contact a qualified landscaping contractor

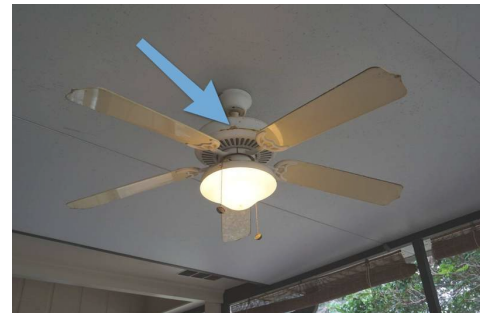
## 3.4.1 Electrical

Ceiling fan was inoperable. Recommend asking the property owner(s) about this, and if necessary, having a licensed electrical contractor evaluate and repair as necessary.

Contact a qualified electrical contractor.

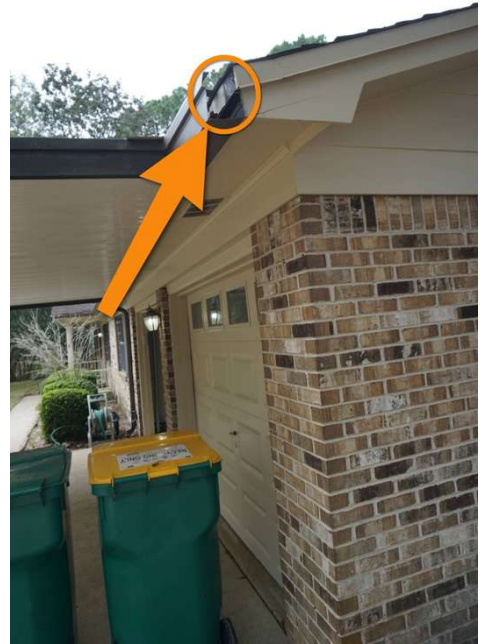
## 3.7.1 Gutters and Flashing

**GUTTER END CAP MISSING**

Gutter end cap located at the front exterior north corner was missing. Rainwater may come in contact with the building exterior or accumulate around the foundation as a result. This can be a conducive condition for wood-destroying organisms. Recommend that a qualified person install or repair end caps where missing.

Contact a qualified professional.

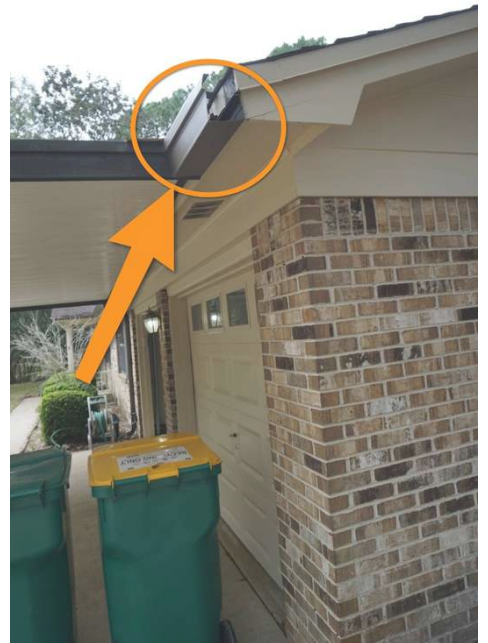
3.7.2 Gutters and Flashing

There is no downspout installed at the front exterior north corner gutter system. This can cause water to accumulate around the homes foundation and cause soil a erosion. Also standing water could occur as well as low spots around the home. Downspouts should be installed as needed.

Contact a qualified professional.

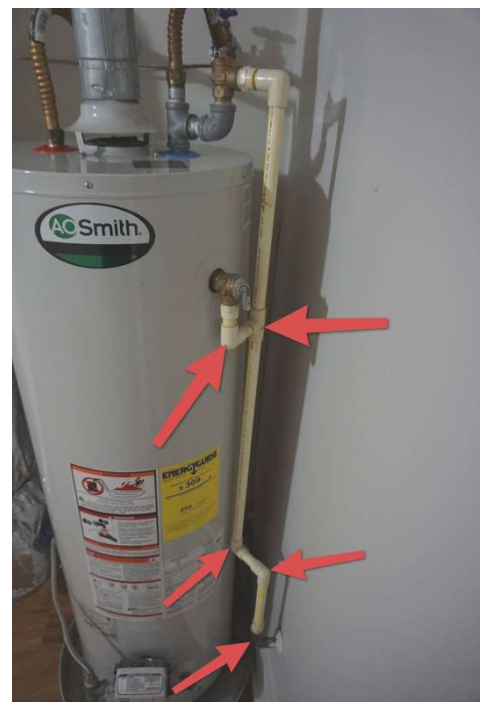
### 5.1.1 Water Heater

The temperature/pressure relief valve drain line has more than 4 elbows in it. This is a potential safety hazard due to the risk of explosion. Typically these valves are limited to 4 elbows or less in the drain line so venting is not restricted. A qualified plumber should evaluate and repair as necessary so the drain line complies with the temperature-pressure relief valve manufacturer's installation instructions.

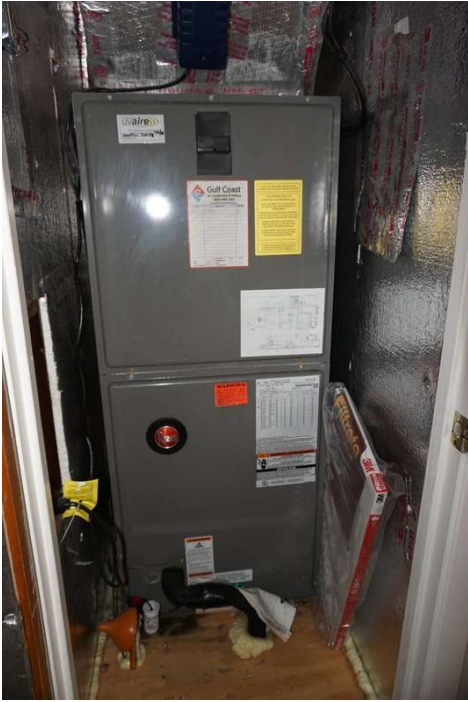
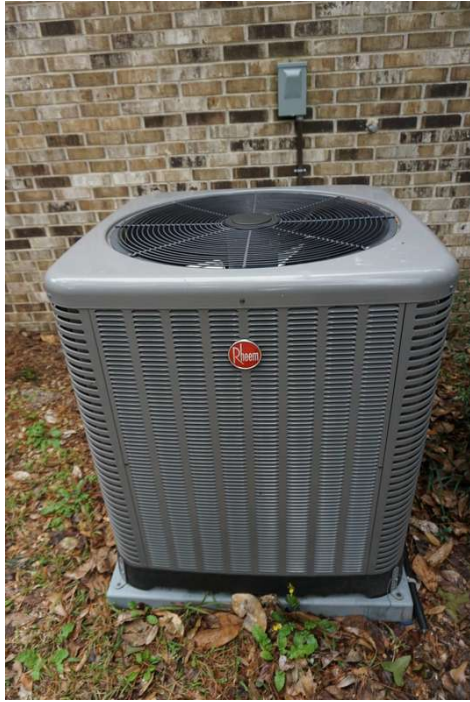
The last service date of this system appears to be more than one year ago, or the inspector was unable to determine the last service date. The client(s) should ask the property owner(s) when it was last serviced. If unable to determine the last service date, or if this system was serviced more than one year ago, a licensed heating and cooling contractor should inspect, clean, and service this system, and make repairs if necessary. This servicing should be performed annually in the future.

Contact a qualified HVAC professional.

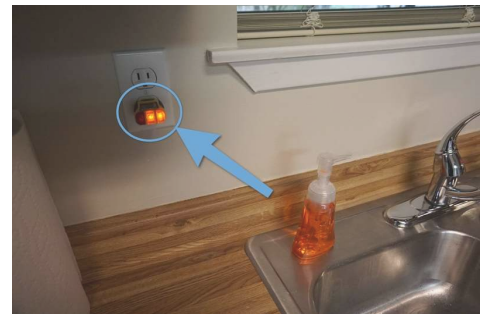
#### 8.4.1 Electrical

#### **GFCI UPGRADE RECOMMENDED**

Contact a qualified electrical contractor.

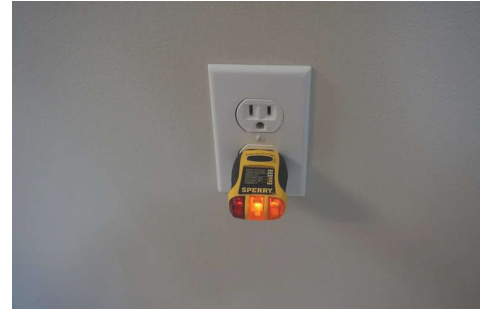
## 8.4.2 Electrical

Modern 3-slot electric receptacle in the kitchen was found with an open ground. This is a shock hazard when appliances that require a ground are used with these receptacles. Examples of such appliances include computers and related hardware, refrigerators, freezers, portable air conditioners, clothes washers, aquarium pumps, and electrically operated gardening tools. Recommend that a licensed electrical contractor repair as necessary so all receptacles are grounded per standard building practices.

Contact a qualified electrical contractor.

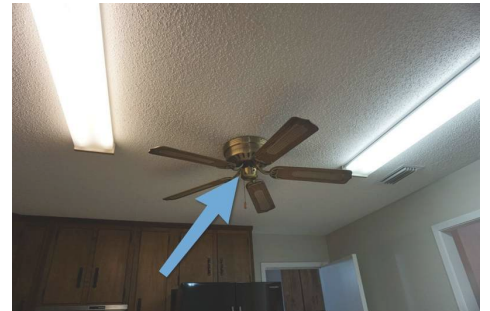
## 8.4.3 Electrical

One or more ceiling fans appear to be inoperable. Recommend asking the property owner(s) about this, and if necessary, having a qualified electrician evaluate and repair as necessary.

Contact a qualified electrical contractor.

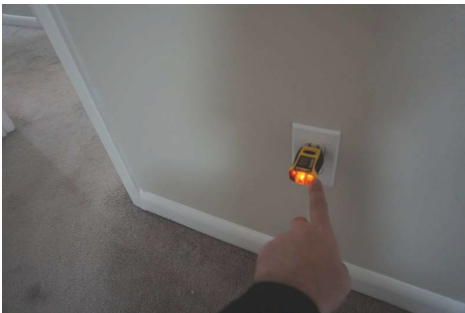
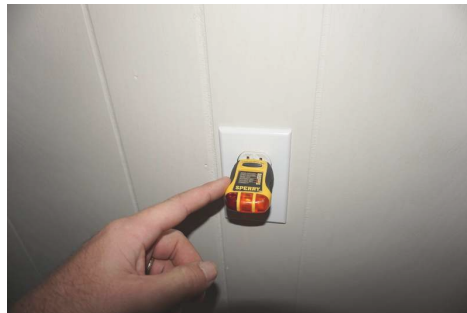
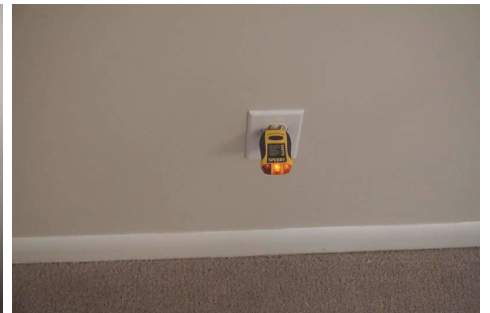
Modern, 3-slot electric receptacles were found with an open ground located in the living room, dining room and master bedroom. This is a shock hazard when appliances that require a ground are used with these receptacles. Examples of such appliances include computers and related hardware, refrigerators, freezers, portable air conditioners, clothes washers, aquarium pumps, and electrically operated gardening tools. Recommend that a licensed electrical contractor repair as necessary so all receptacles are grounded per standard building practices.

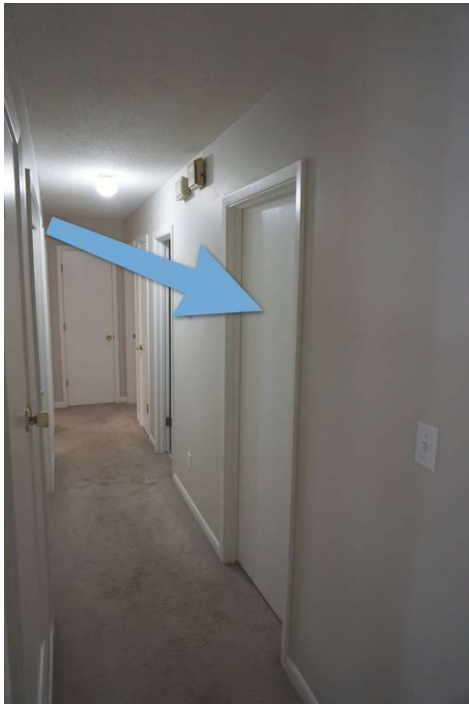
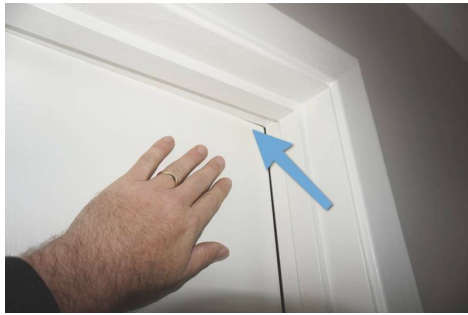
Interior door binds in jamb and cannot be closed and latched, or are difficult to open and close. A qualified contractor should evaluate and repair as necessary. For example, adjusting jamba or trimming doors.

Contact a qualified door repair/installation contractor.

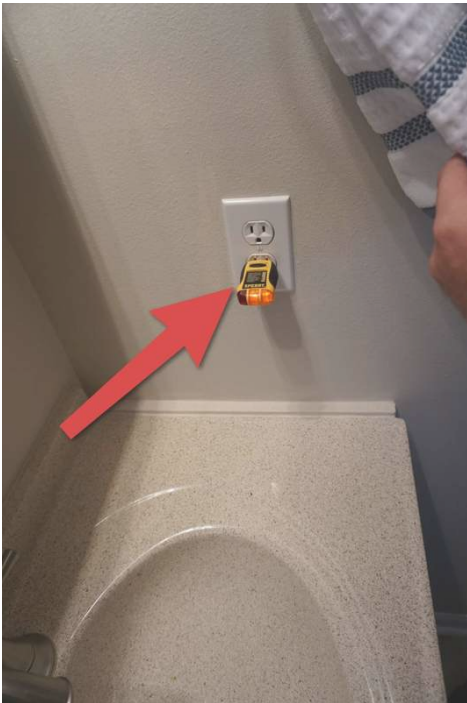
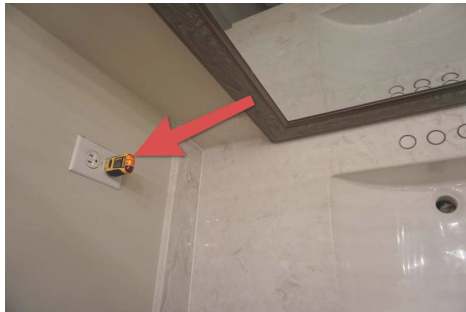
**GFCI MISSING**

One or more electric receptacles at the bathroom(s) had no visible ground fault circuit interrupter (GFCI) protection, or the inspector was unable to determine if GFCI protection was present. If not GFCI-protected, receptacles in wet areas pose a shock hazard. Recommend that a licensed electrical contractor evaluate and install GFCI protection if necessary and per standard building practices. General guidelines for GFCI-protected receptacles include the following locations:

Contact a qualified electrical contractor.

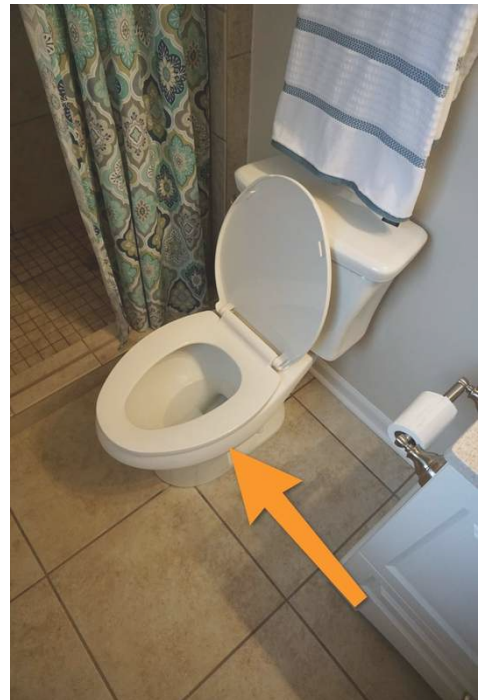
**TOILET - LOOSE**

Toilets was loose. Plumbing leaks can occur as a result. A licensed plumbing contractor should remove the toilet(s) for further evaluation and repairs if necessary. A new wax ring should be installed and toilet(s) should be securely anchored to the floor to prevent movement and leaking.

Contact a qualified plumbing contractor.

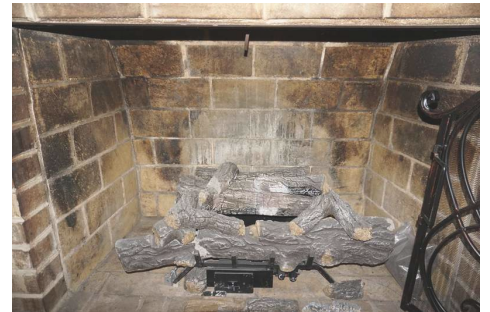
LIVING ROOM

Gas fireplace did not respond when the controls were operated. This may be due to the pilot light being turned off, the gas supply being turned off, or any number of other reasons. As a result, these appliances were not fully evaluated. As per the Standards of Practice for both the National Association of Certified Home Inspectors (NACHI) and the American Society of Home Inspectors (ASHI) the inspector does not operate gas shut off valves or light pilot lights during inspections. Recommend consulting with the property owner(s) as to how the fireplace(s) and/or stove(s) operate, and/or having a gas appliance contractor evaluate and repair if necessary.

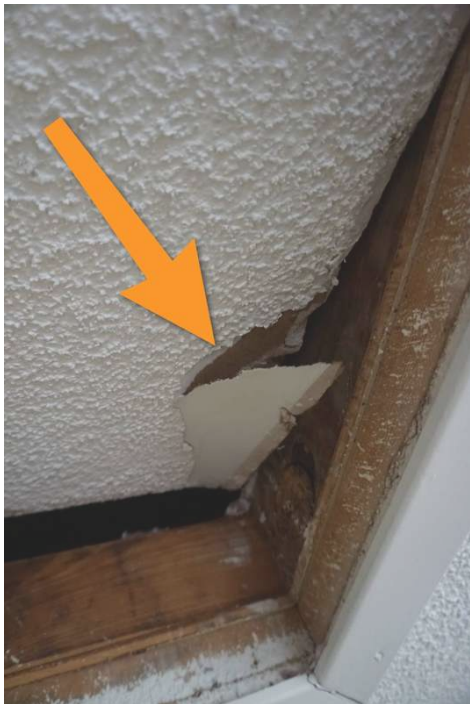
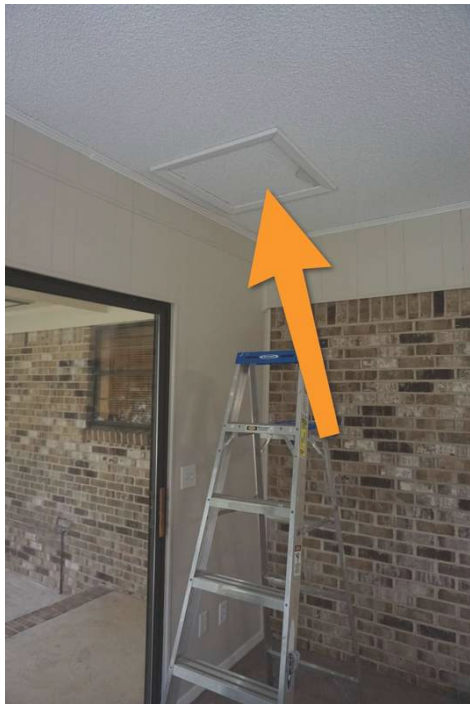
### ACCESS COVER DAMAGE

The drywall access cover was damaged. The exit to cover should be replaced as a repair is not adequate. Recommend replacement by a qualified professional.

Contact a qualified professional.

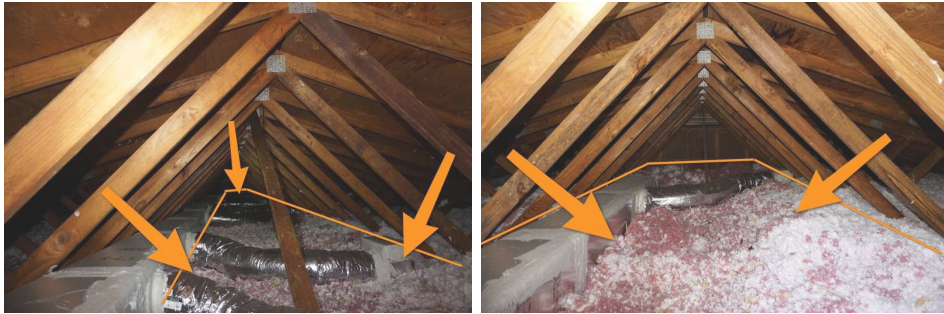
The ceiling insulation in one or more areas in the attic space was compacted or uneven. Heating and cooling costs may be higher due to reduced energy efficiency. Recommend that a qualified professional repair, replace or install insulation as necessary and per standard building practices (typically R-30).

Contact a qualified insulation contractor.

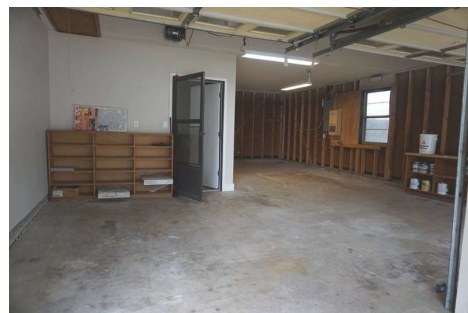
#### GFCI UPGRADE RECOMMENDED

Contact a qualified electrical contractor.
