HOME INSPECTION REPORT

1234 Main St.
Naches WA 98937

01/24/2018 9:00AM

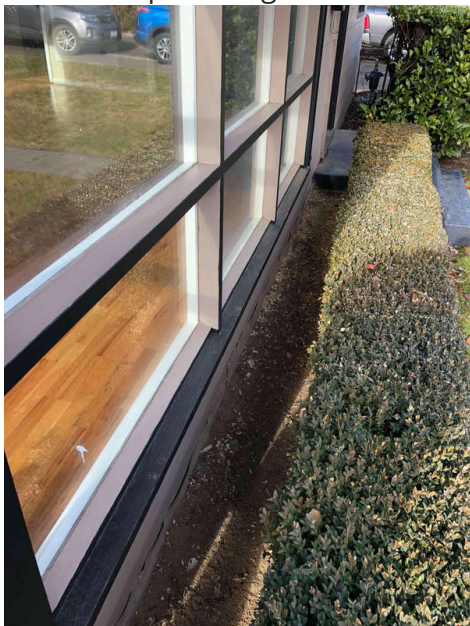
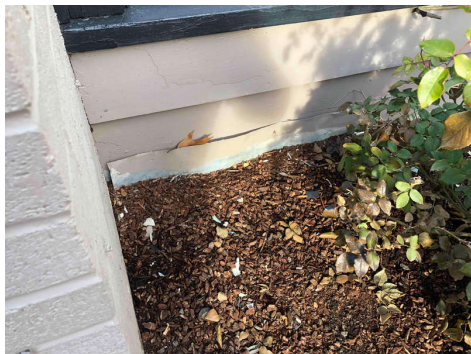
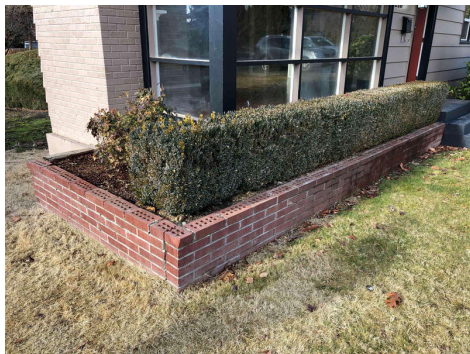
2.1.1 Vegetation, Grading & Drainage

UNFAVORABLE CONDITION

Garden beds and planter boxes installed against exterior siding or foundation may pose a risk of moisture damage to structure and are generally not recommended. Recommend further evaluation and repair/remedy as needed.

Contact a qualified general contractor.

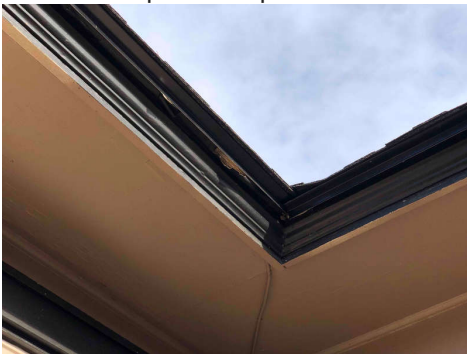
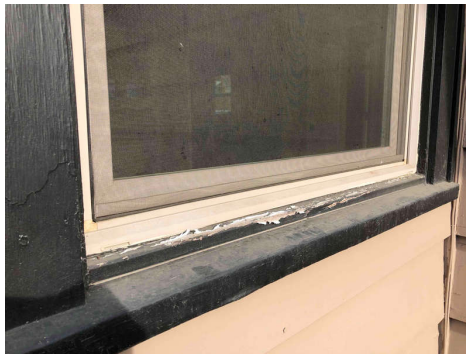
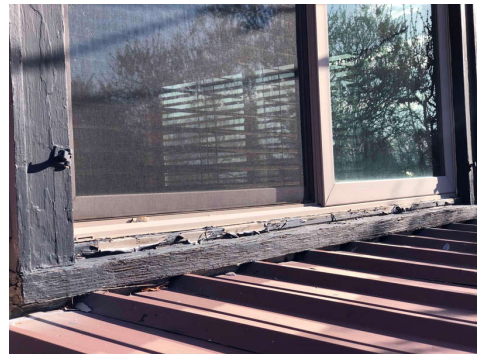
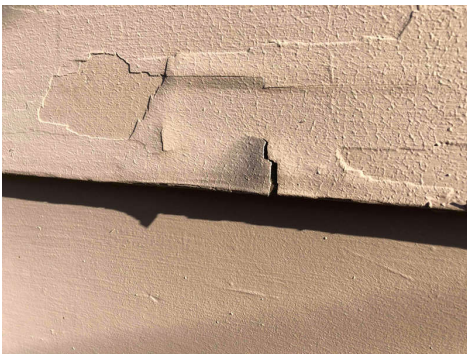
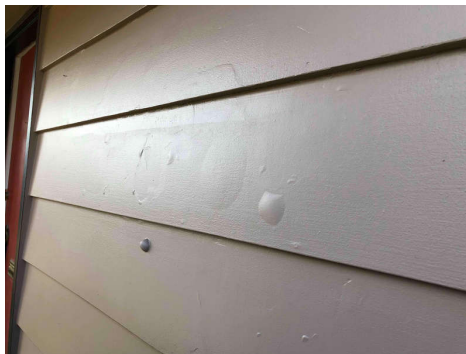
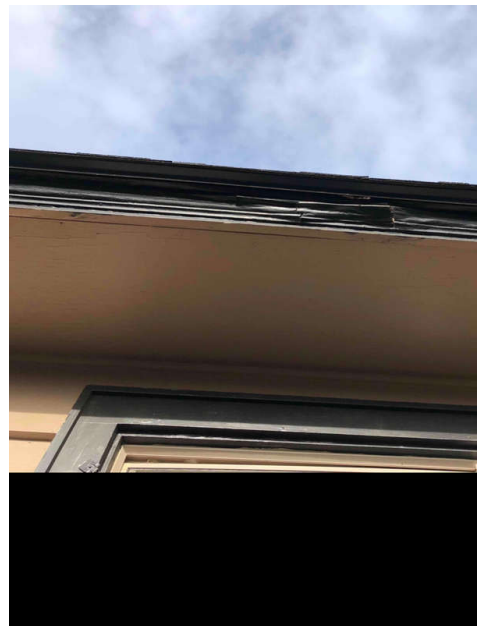
3.1.1 Siding, Flashing & Trim

PAINT PEELING

THROUGHOUT EXTERIOR

Peeling paint noted at exterior. Recommend maintaining paint/seal at all exterior wood siding, trim, posts, decks, etc. as needed to prevent possible compromise.

Contact a qualified painter.

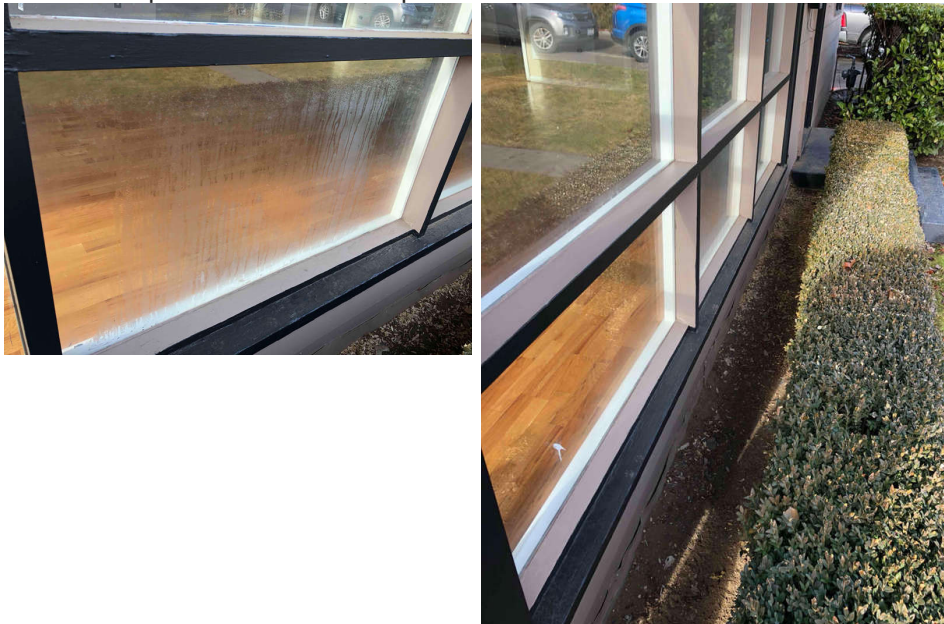
3.2.1 Exterior Doors & Windows

FAILED SEALS

FRONT ENTRY

Condensation between window panes indicates a failed seal. Recommend qualified professional further evaluate and repair or replace as needed.

Contact a qualified window repair/installation contractor.

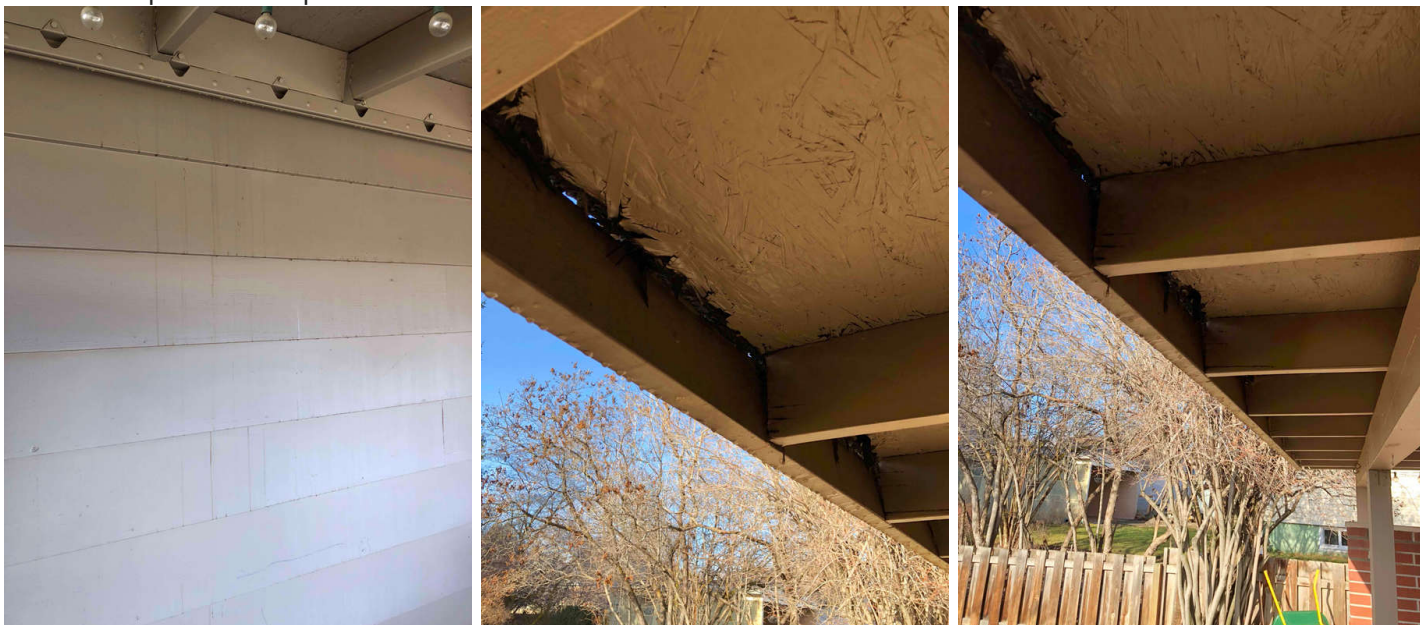
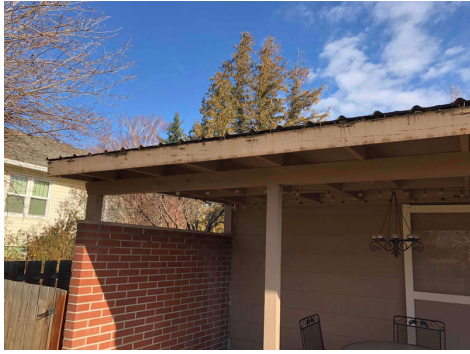
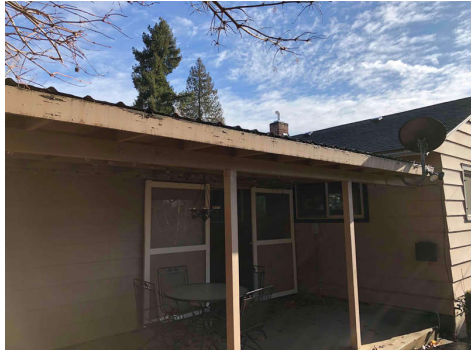
3.3.1 Decks, Balconies, Porches & Steps

DETERIORATED TRIM

PATIO COVER

Moisture damage and deterioration noted at patio cover eaves and sheathing. Saturated trim and ledger boards may trap moisture against structural wood framing causing eventual rot/deterioration and potential structural compromise. Recommend further evaluation by a qualified professional and repair.

Contact a qualified carpenter.

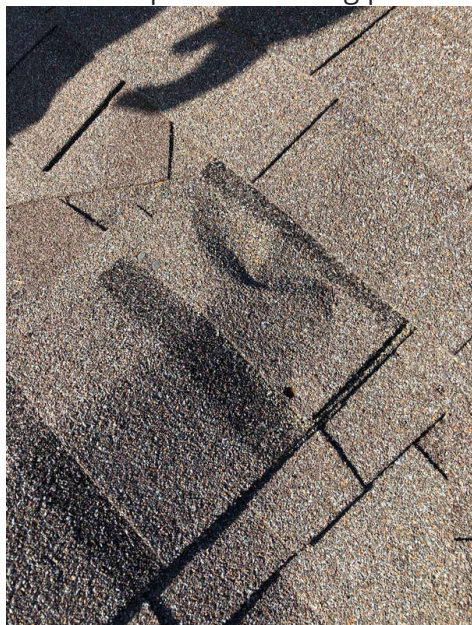
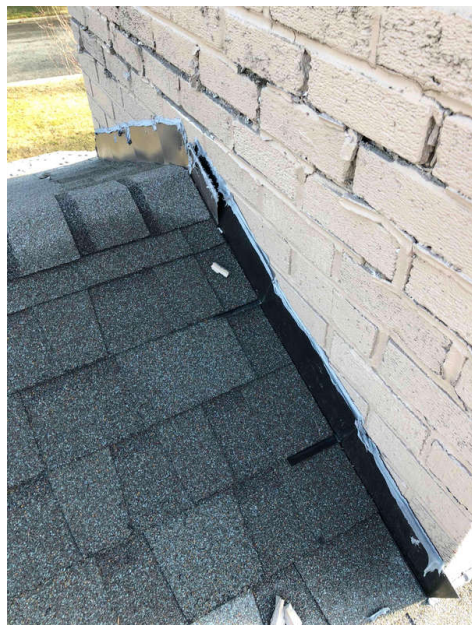
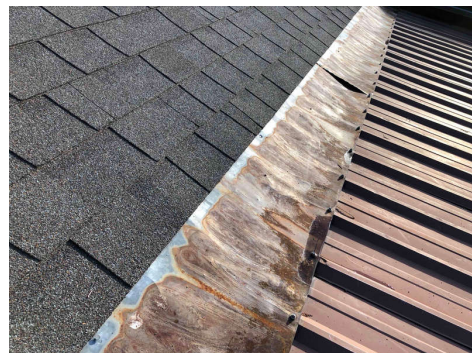
4.1.1 Coverings

MINOR MAINTENANCE NEEDED

Some lifted shingles, loose flashing and exposed nail heads observed. Lifted shingles due to nail pops may be more susceptible to wind damage. Exposed nail heads and loose flashing should be sealed to prevent possible moisture intrusion.

Contact a qualified roofing professional.

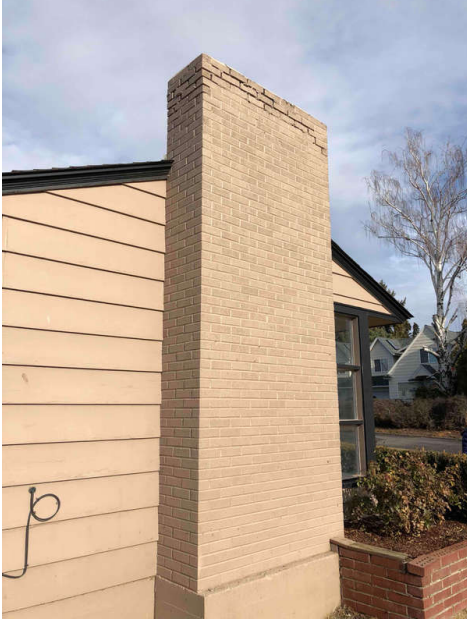
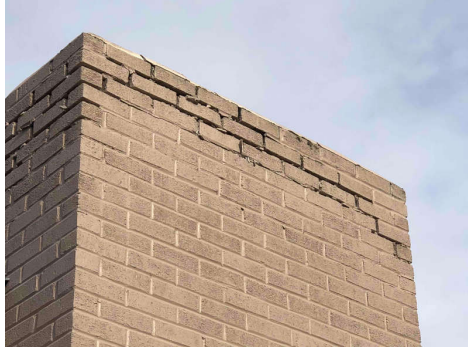
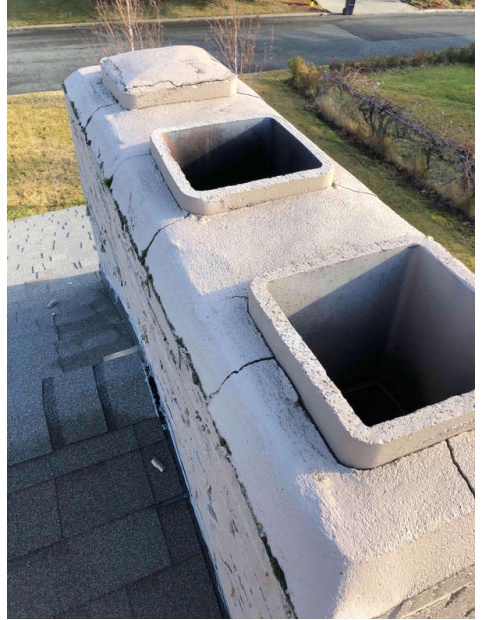
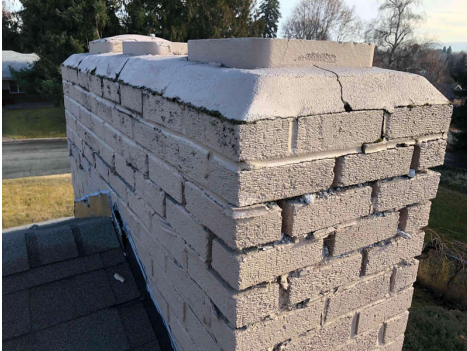
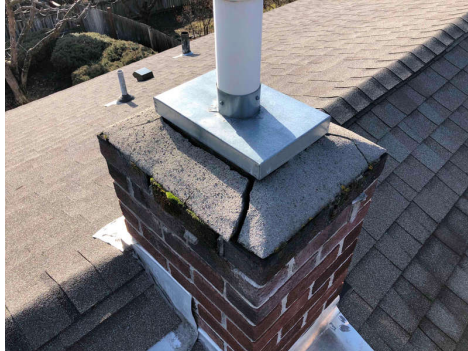
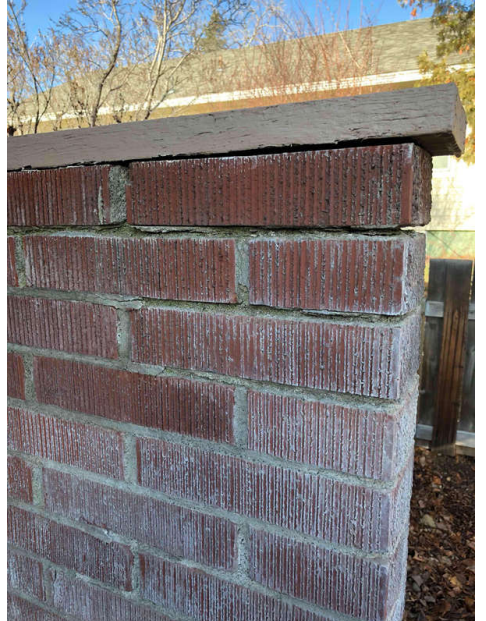
4.4.1 Chimney & Vent Systems

DETERIORATED MORTAR

Deterioration at mortar joints may allow for further moisture penetration risking eventual structural compromise and potential loose/falling bricks. Recommend repair.

*Chimney and Garage wall (minor)

Contact a qualified masonry professional.

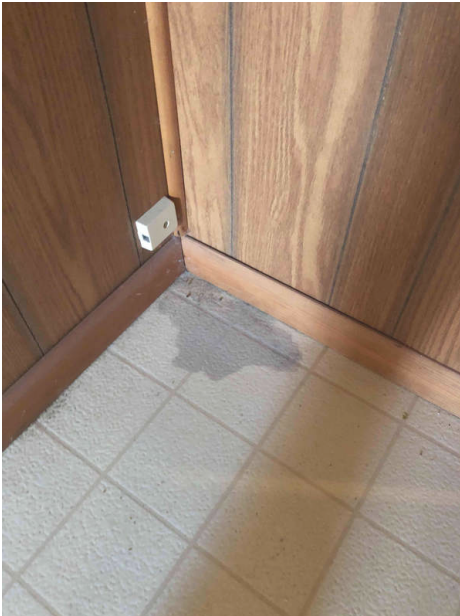
Floors: Past Moisture Basement

Some possible evidence of past moisture observed at flooring. No moisture present or active leaks observed at time of inspection. Recommend monitor.

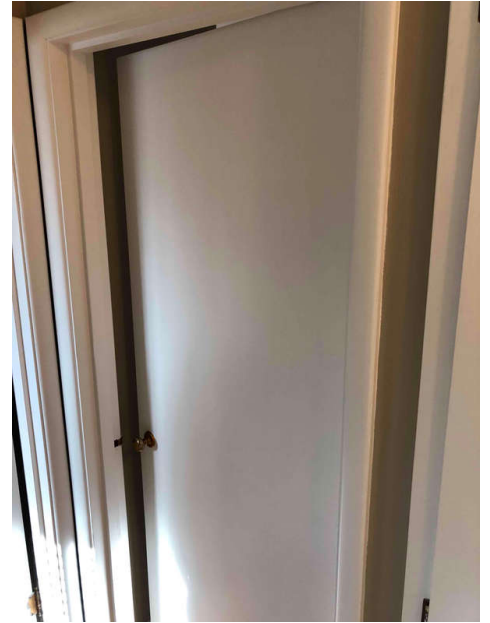
5.5.1 Doors

DOOR STICKS

BEDROOM

Some interior doors stick/rub or do not latch smoothly/properly and may be in need of adjustment or repair.

Contact a qualified door repair/installation contractor.

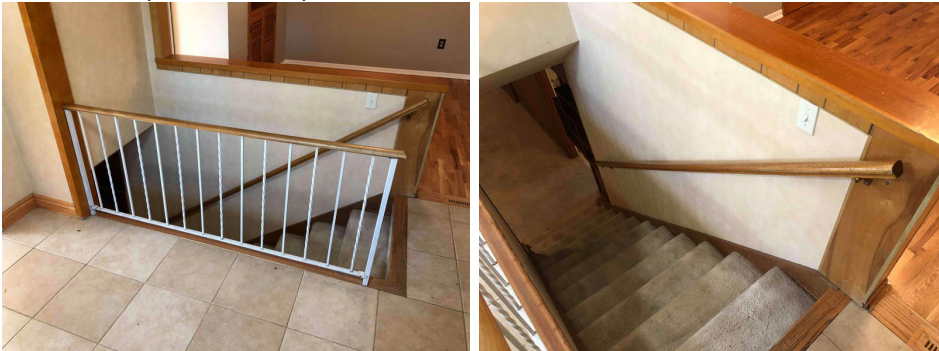
5.6.1 Steps, Stairways & Railings

RAILING UNSAFE

Interior stairs and landings must have a proper hand railing/guardrail system installed with a minimum height of 36" above walking surface. Vertical baluster spacing must not exceed 4" between balusters. Low or horizontal railings may present a safety hazard for children. Hand railing must be secure/stable and supported throughout. Recommend a qualified professional further evaluate and repair to local safety standards.

Contact a qualified carpenter.

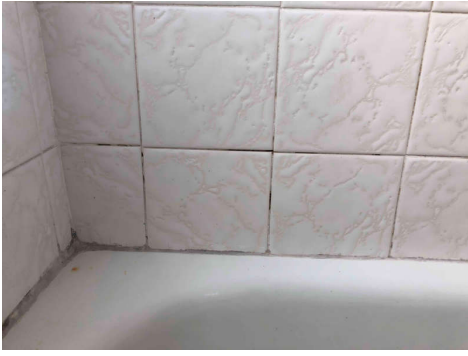
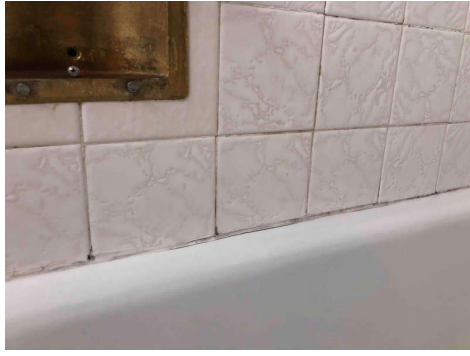
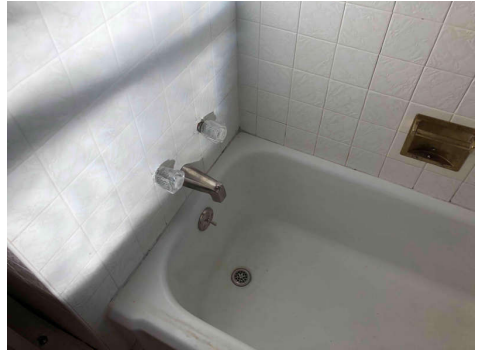
5.7.1 Bathrooms

CAULK/SEAL

Recommend maintaining a proper seal at all tub-to-floor and tub-to-wall transitions. Tub/Shower penetrations (tub spout or shower head) must be caulked/sealed to prevent moisture intrusion and possible compromise.

Contact a qualified handyman.

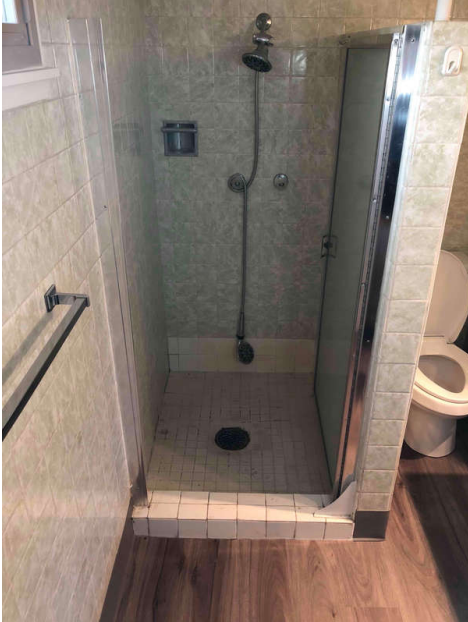
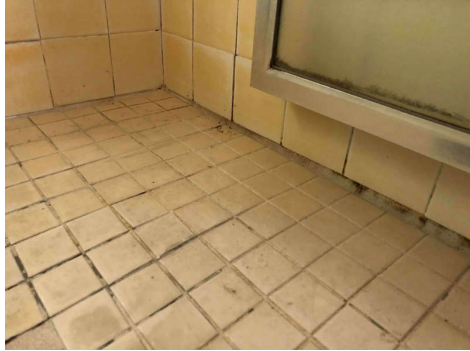
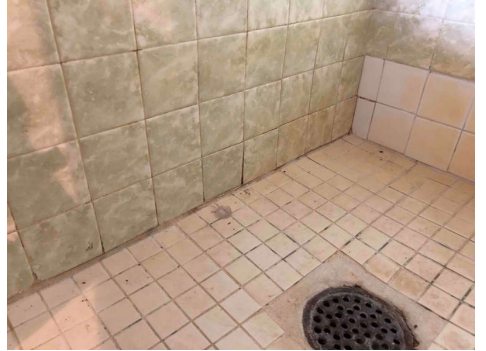
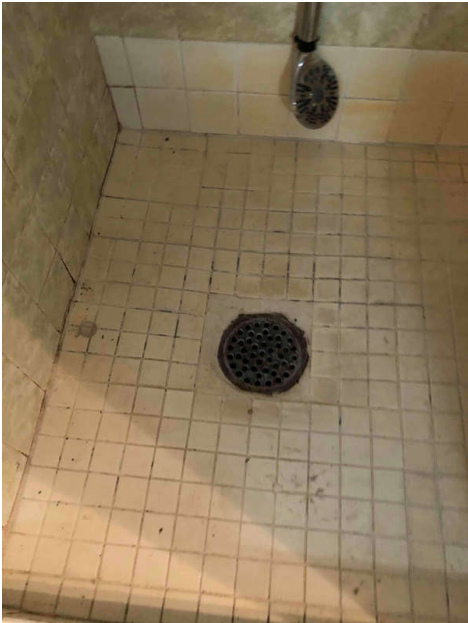
5.7.2 Bathrooms

CAULK/SEAL TILE SHOWER

Recommend maintaining proper seal at tile shower walls, pan and all tub-to-wall, tub-to-floor transitions to prevent possible moisture intrusion and potential damage. Some cracking noted at tile grout lines.

Contact a qualified tile contractor

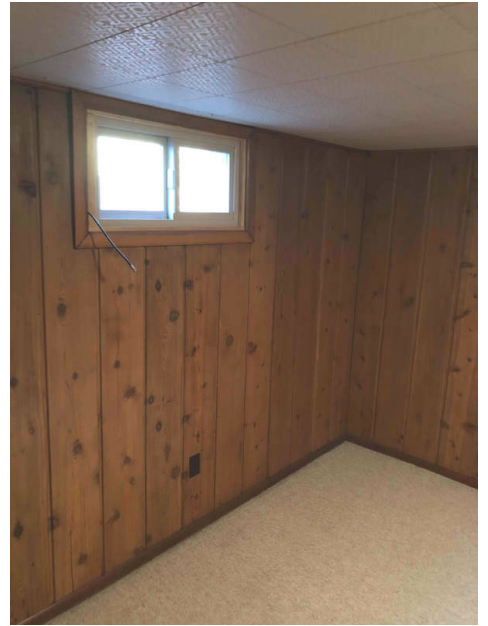
5.10.1 Installed Safety Equipment

Safety Hazard**BASEMENT EGRESS**

Some basement living space/s do not meet modern safety standards for fire/emergency egress (secondary means of exit). Although this home may predate such codes, it is an important consideration when using these rooms for living or sleeping quarters. Inspector recommends installing proper means of secondary egress at all bedroom/sleeping areas for optimal safety.

Contact a qualified general contractor.

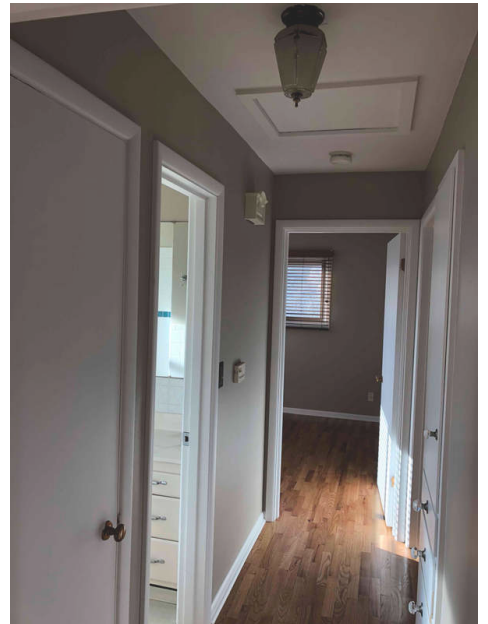
5.10.2 Installed Safety Equipment

Safety Hazard**CARBON MONOXIDE DETECTORS**

Carbon Monoxide Detectors are required to be installed on each floor and outside all bedroom/sleeping areas. Inspector was unable to confirm/identify Carbon Monoxide Detectors in all required locations at time of inspection. Recommend repair.

Recommended DIY Project

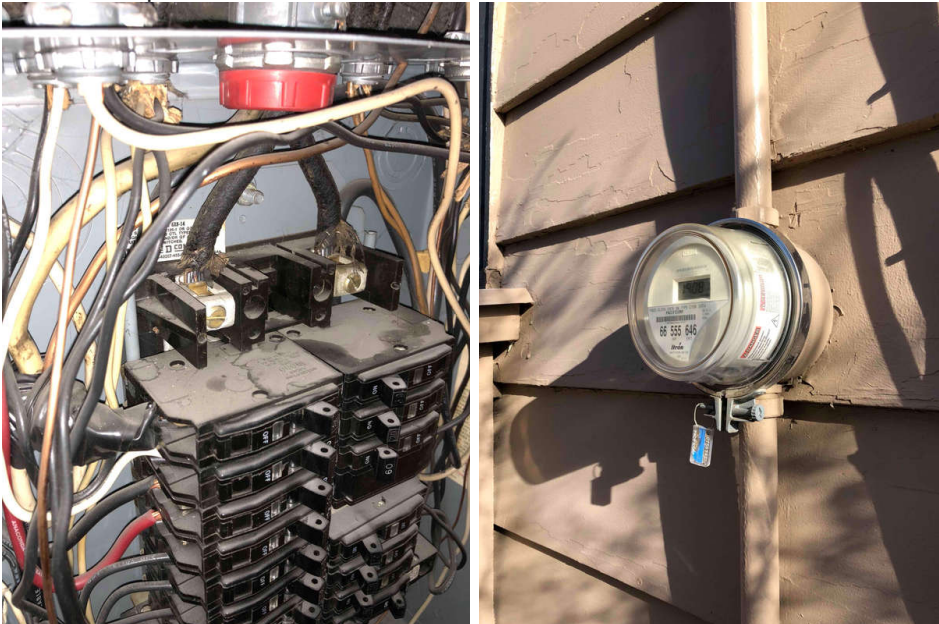
6.1.1 Service Entrance Conductors

60 AMP METER BASE

Round Meter Base and/or undersized Incoming Service Lines indicate a possible 60-125amp Service. Although this is not a defect in and of its self, Inspector recommends further evaluation by a qualified Electrician if any additions or alteration are considered. 60-125 amp Service may be considered under sized by todays standard electrical usage.

Contact a qualified electrical contractor.

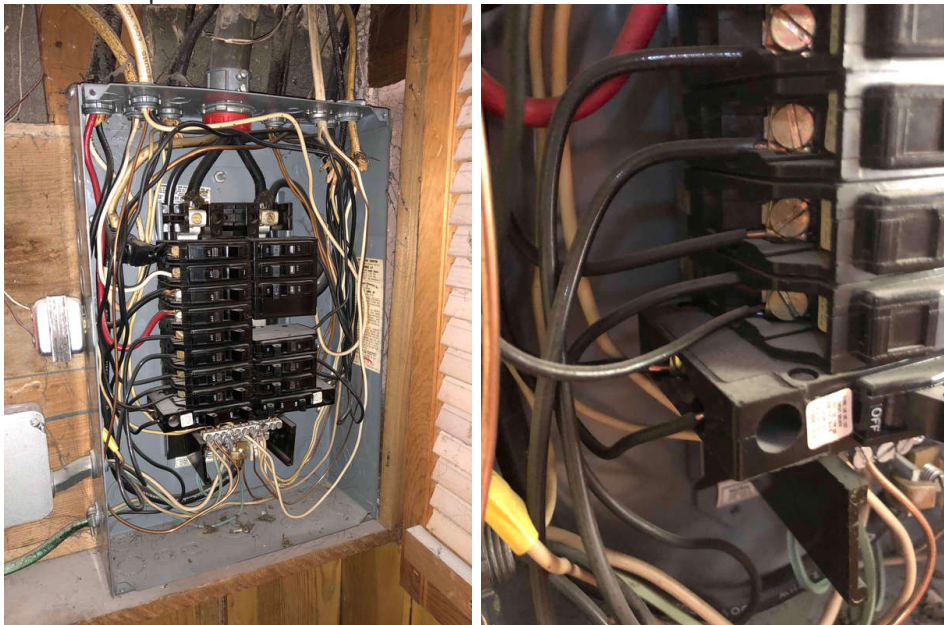
6.2.1 Main Service Panel and Grounding

DOUBLE TAPPING

Double tapping of circuit breaker is generally not recommended or allowable and may be indication that panel has been tampered with or work performed by an unqualified person. Recommend further evaluation by a qualified professional and repair or replace as needed.

Contact a qualified electrical contractor.

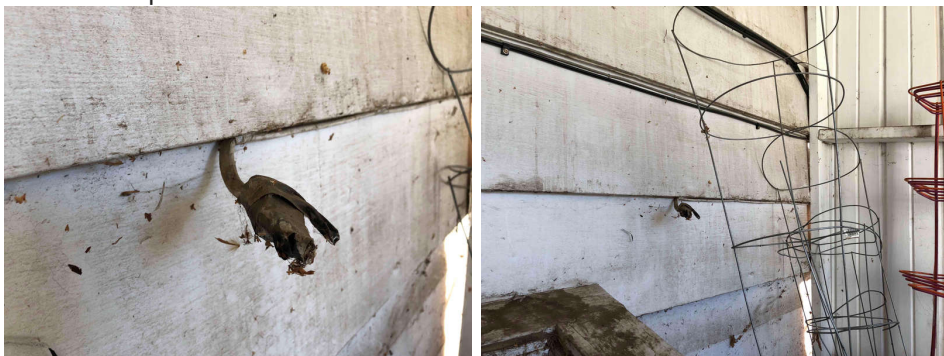
6.3.1 Branch Circuit Conductors

EXPOSED ENDS & SPLICES

EXTERIOR BASEMENT STAIRWELL

Wire splices/connections and terminations must be secured/protected in an approved junction box (or removed completely if not in use). Potential safety hazard. Recommend a qualified professional repair as needed.

Contact a qualified electrical contractor.

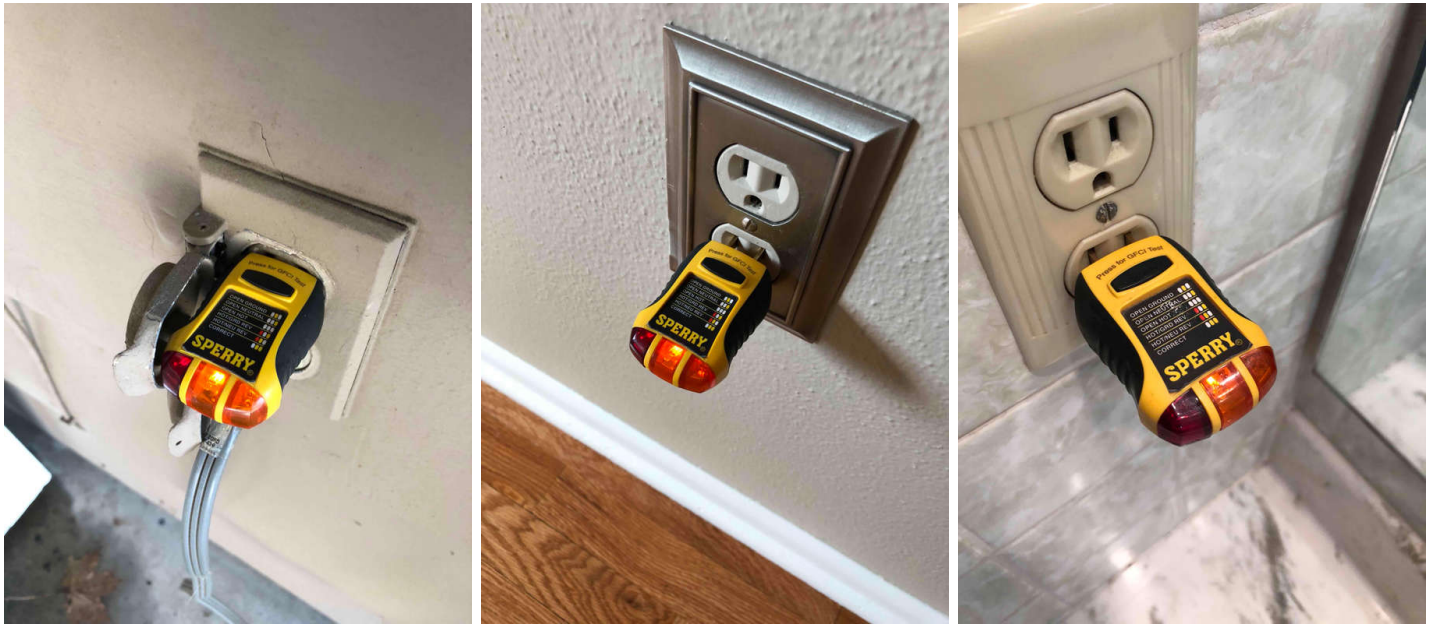
6.5.1 Polarity and Grounding of Receptacles

"OPEN GROUND"

THROUGHOUT

Inspector noted ungrounded or "open ground" three-prong outlet/s at time of inspection. Recommend a qualified professional further evaluate and repair or replace as needed.

Contact a qualified electrical contractor.

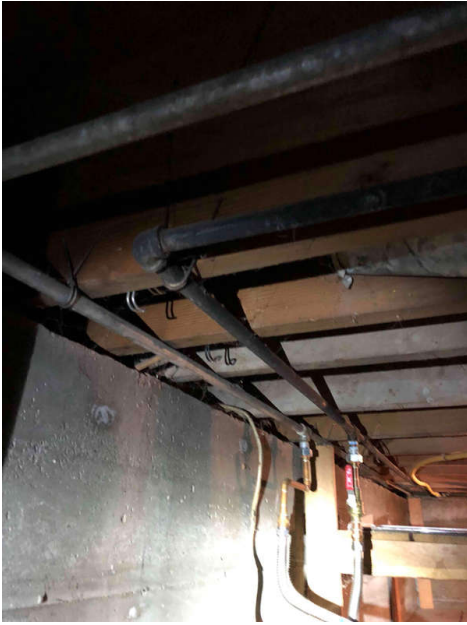
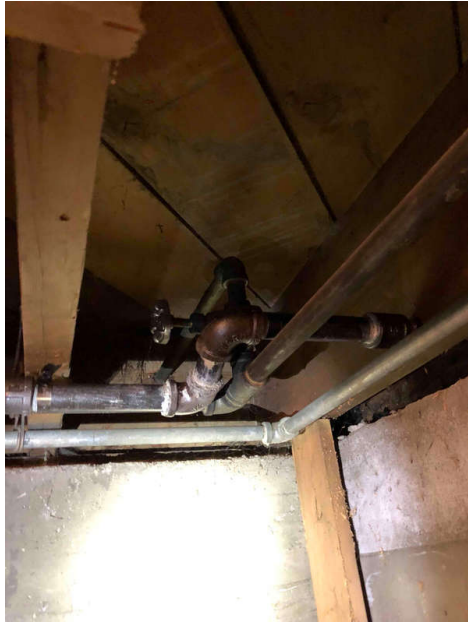
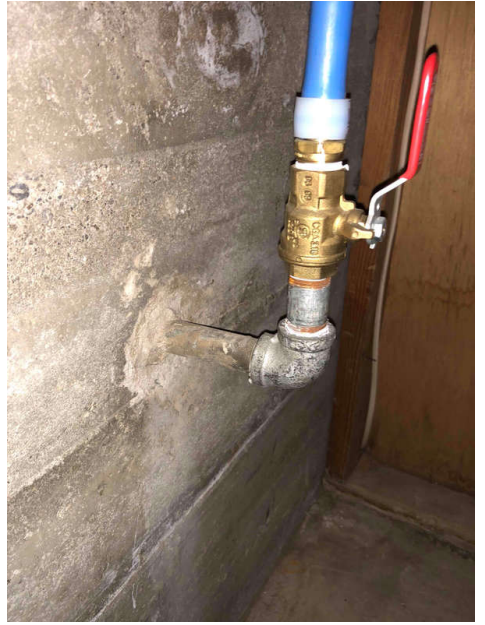
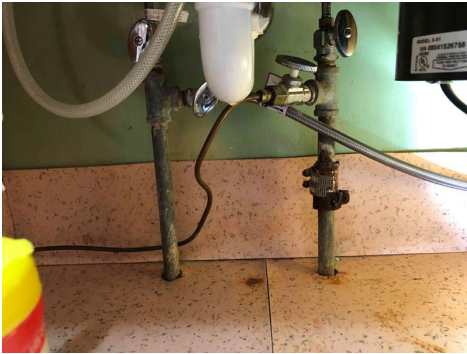
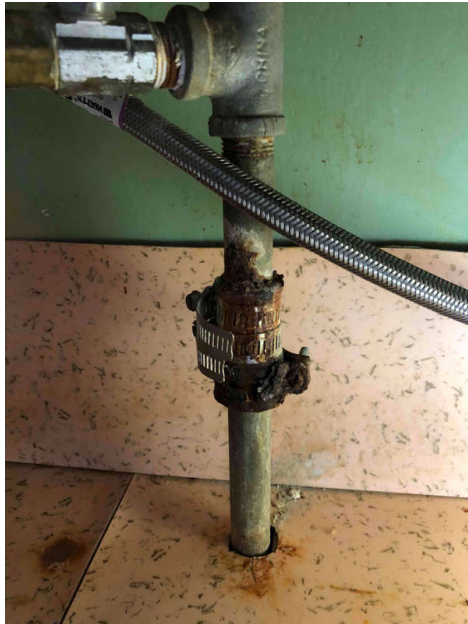
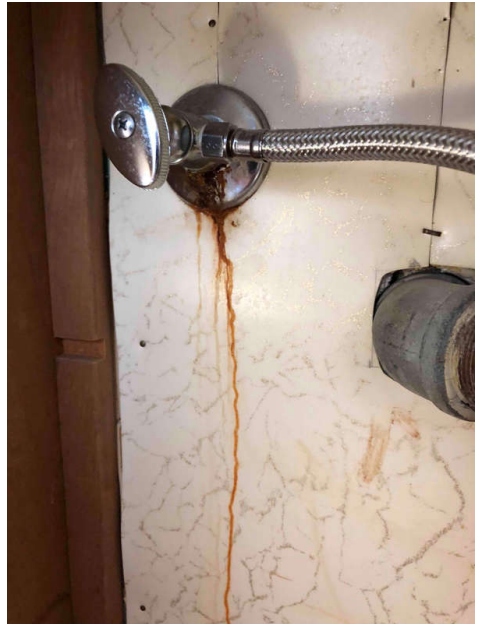
7.1.1 Supply Plumbing

GALVANIZED PIPING

THROUGHOUT

Galvanized supply piping observed. Galvanized supply piping should be considered a Deferred Cost Item and may be at or nearing the end of its estimated useful life. Anticipate future maintenance and/or replacement. Recommend further evaluation by a qualified professional.

*Some evidence of past leaks and past repairs noted.

Contact a qualified plumbing contractor.

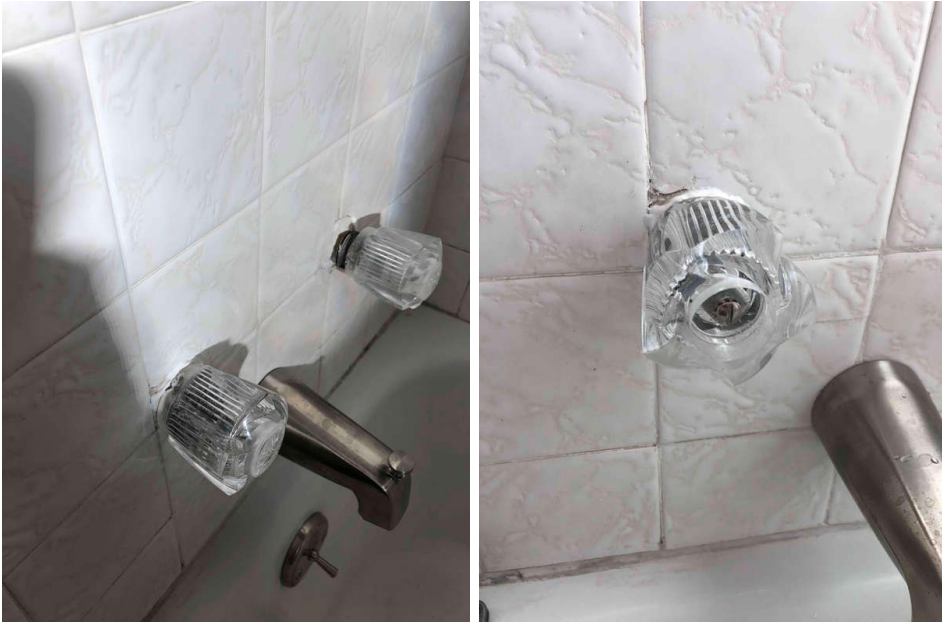
7.2.1 Fixtures / Faucets

FIXTURE DAMAGED

BATHROOM

Fixture damaged or not operating properly and may be in need of repair. Recommend further evaluation and repair or replace as needed.

Contact a qualified plumbing contractor.

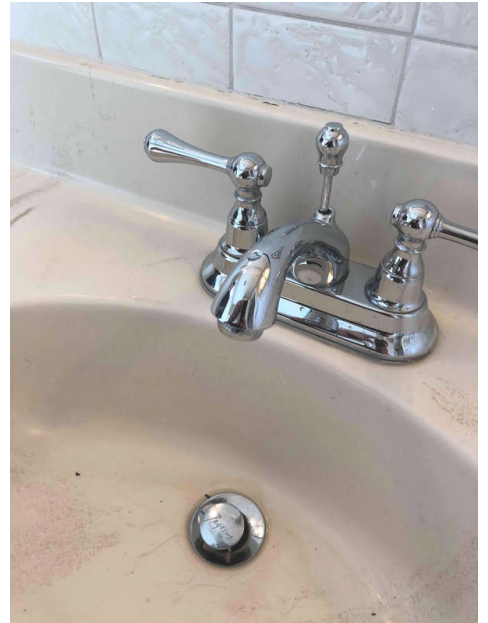
7.3.1 Drain / Waste, & Vent Systems

DRAIN STOP NOT OPERATING

BATHROOM

Mechanical drain stop/plug not operating properly. Recommend repair.

Contact a qualified professional.

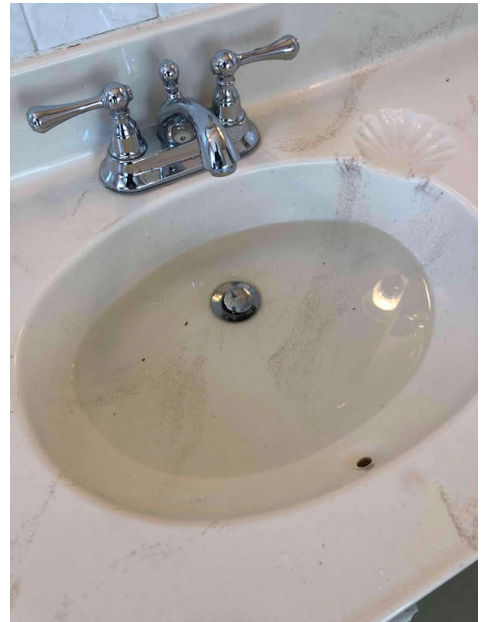
7.3.2 Drain / Waste, & Vent Systems

POOR/SLOW DRAINAGE

BATHROOM

Poor restricted drainage was observed at time of inspection. Recommend a qualified plumber evaluate and repair/remedy as needed.

Contact a qualified plumbing contractor.

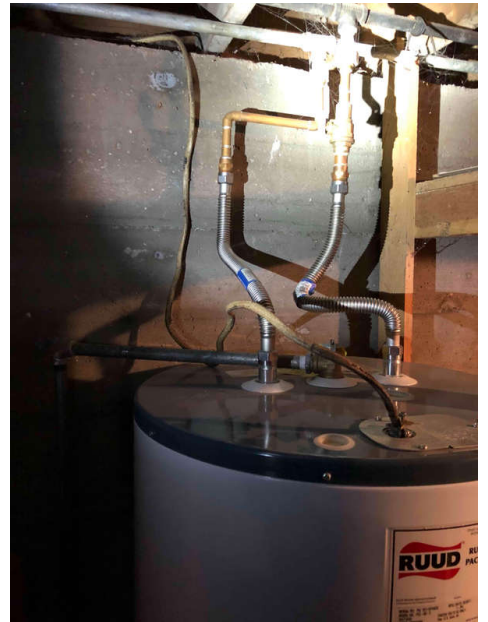
8.1.1 Equipment

WIRING NOT SECURE

Wiring must be secured and protected from accidental damage. Recommend a qualified professional further evaluate and repair as needed.

Contact a qualified electrical contractor.

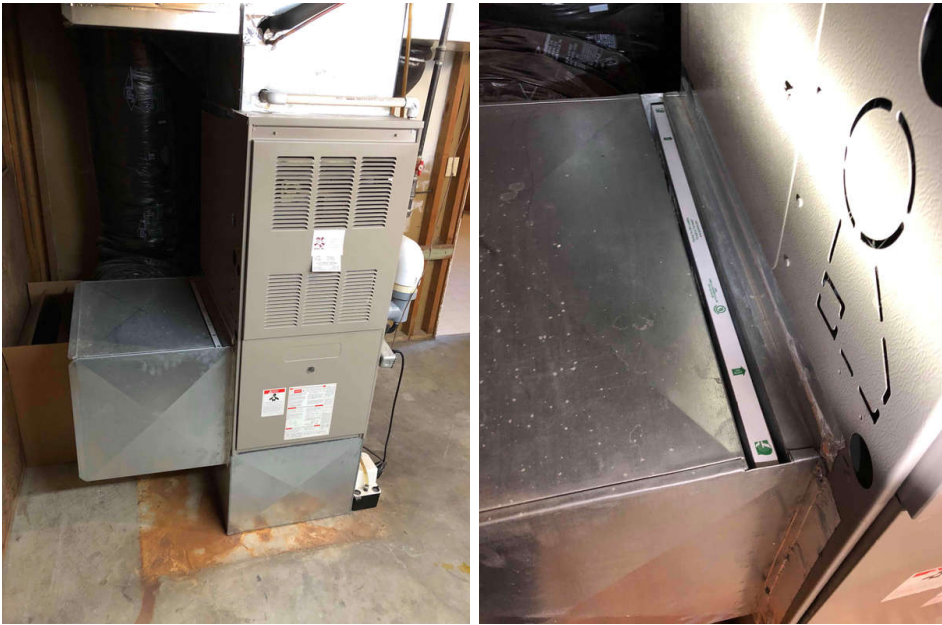
Furnace Filter cover improper or not installed. System air leaks will result in decreased system efficiency and unneeded maintainace due to dirty coils. Recommend repair or replace as needed.

Contact a qualified HVAC professional.

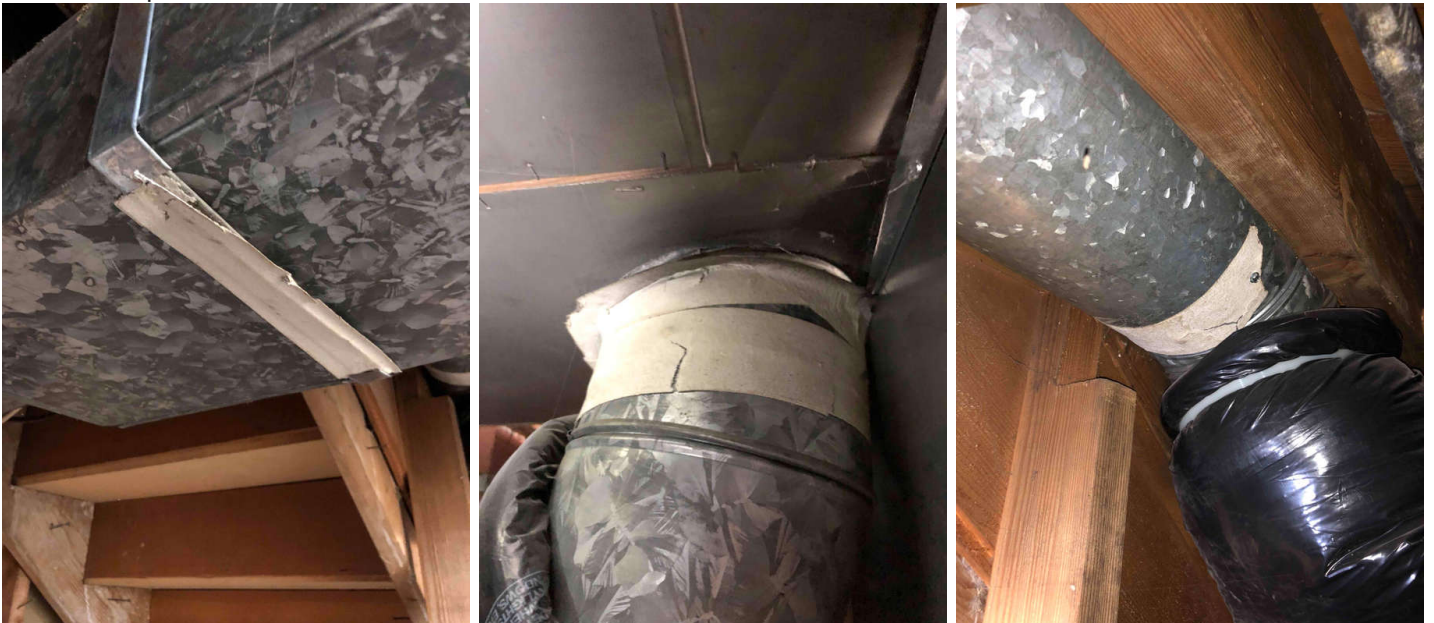
9.2.1 Distribution Systems

Safety Hazard

Contact a qualified environmental contractor

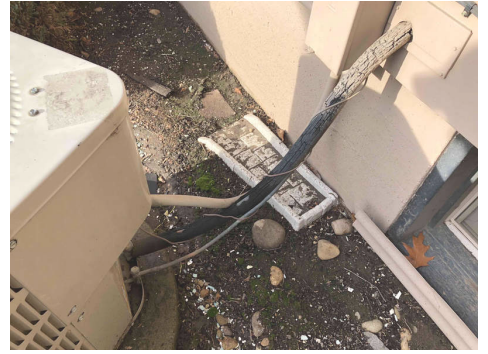
10.1.1 Cooling Equipment

INSULATION MISSING OR DAMAGED

Missing or damaged insulation on refrigerant line can reduced system efficiency and produce condensation leading to possible moisture damage in some installation situations. Recommend repair or replace as needed.

Contact a qualified HVAC professional.

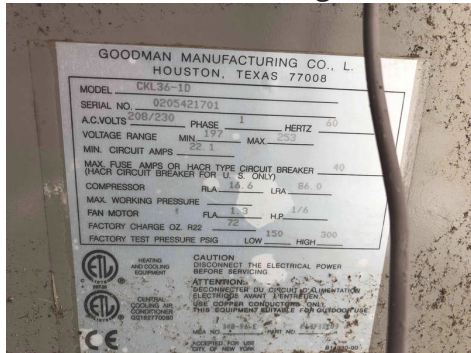
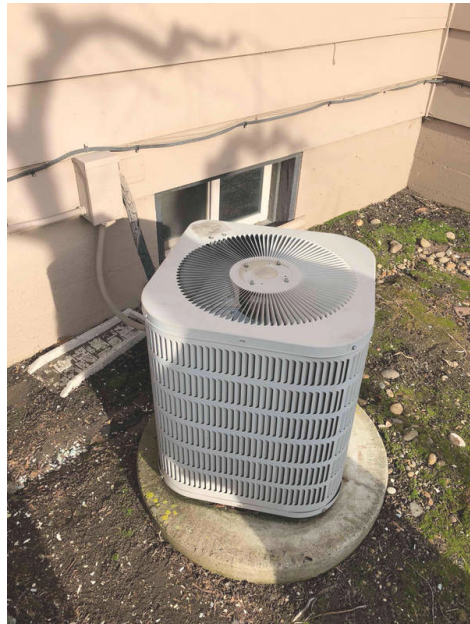
10.1.2 Cooling Equipment

DEFERRED COST ITEM

AC appears to be 15 years old or more and should be considered a Deferred Cost Item. This comment is based off of an estimated life expectancy of 15-20 years. Anticipate maintenance and/or future replacement. Recommend regular maintenance and inspection by a qualified HVAC professional.

Recommend monitoring.

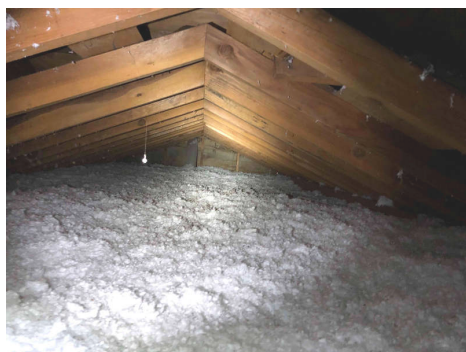
Roof Structure & Attic: Restricted Access**Living Room Attic**

Inspector did not attempt to traverse some attic space due to new blown-in Insulation and restricted access (living room).

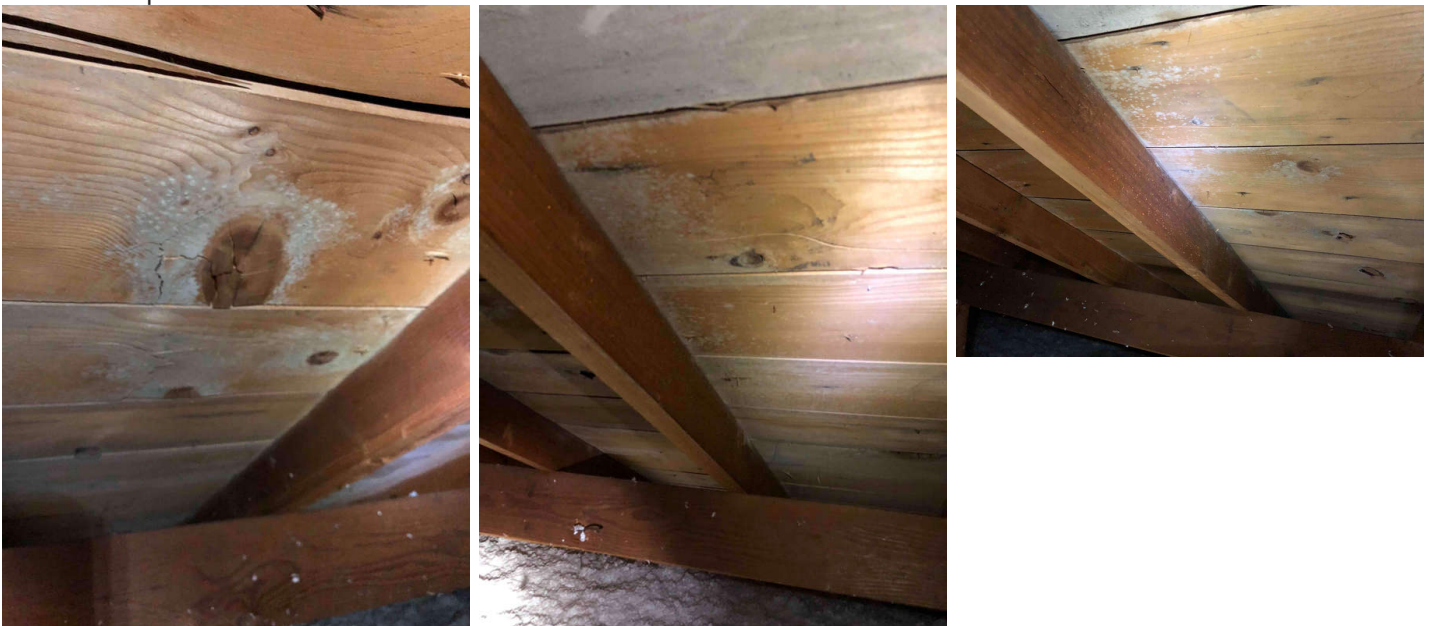
Attic venting is possibly insufficient or restricted for adequate attic ventilation/circulation. Modern standards recommend 1.5 square feet of venting area for every 300 square feet of attic floor space and a combination of high and low venting source. Recommend an attic ventilation contractor further evaluate and remedy.

Black spotty staining and/or white biological growth noted at some attic sheathing and/or framing. Possible Mold, possible health risk. Recommend further evaluation and testing by a qualified Environmental Contractor and repair/remedy as needed.

Contact a qualified environmental contractor

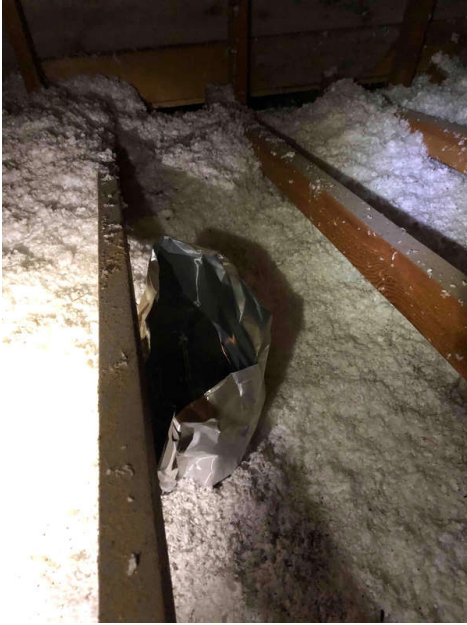
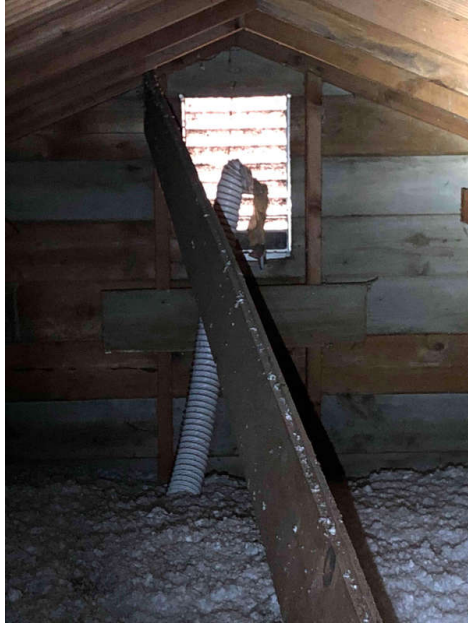
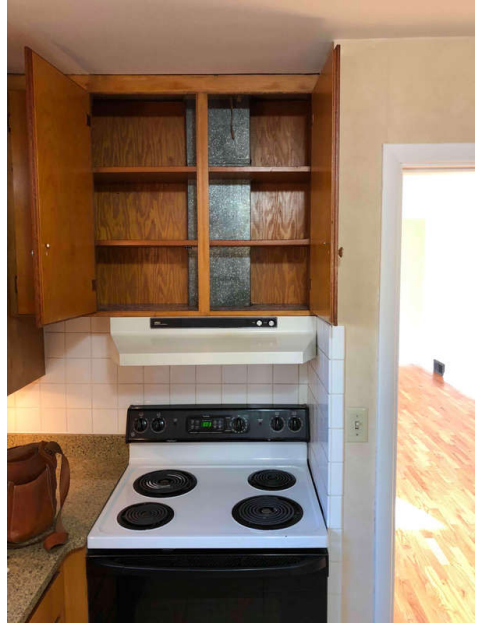
12.1.2 Attic

Bathroom and Kitchen exhaust vent/s were not a secured/sealed termination to exterior. Condition conducive to excessive moisture in attic space. Recommend repair or replace as needed.

*Some spotty staining or suspicious growth observed around Kitchen exhaust vent. See Ventilation

Contact a qualified general contractor.

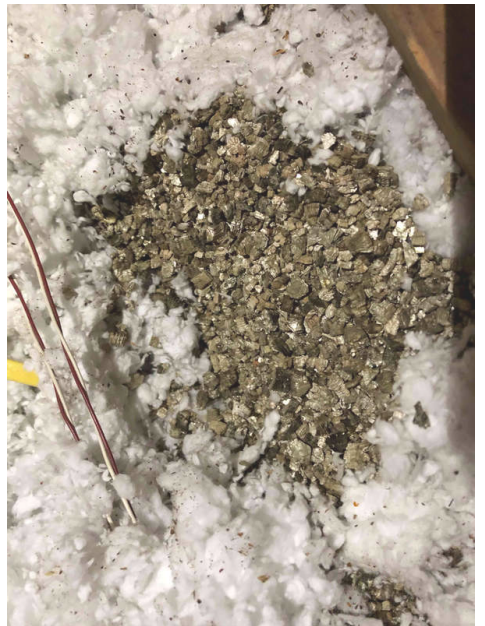
12.1.3 Attic

VERMICULITE INSULATION

Vermiculite insulation noted in attic space. Vermiculite insulation is known to contain asbestos and may be considered a health risk. Recommend further evaluation and testing by a qualified environmental contractor and repair/remedy as needed.

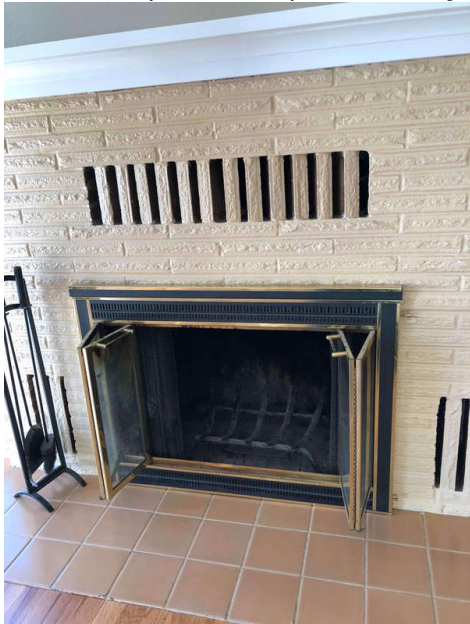
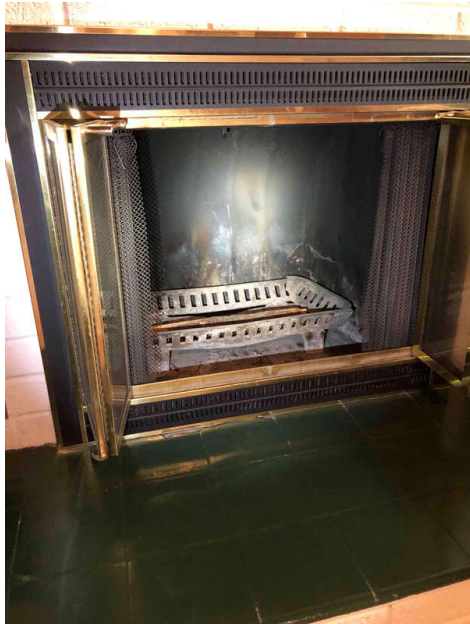
GENERAL RECOMMENDATION

Regular maintenance and inspection is required with all fossil fuel burning appliance flues. Recommend having all fireplace and wood burning appliance flues serviced and inspected by a qualified chimney professional prior to use.

Contact a qualified repair chimney contractor.

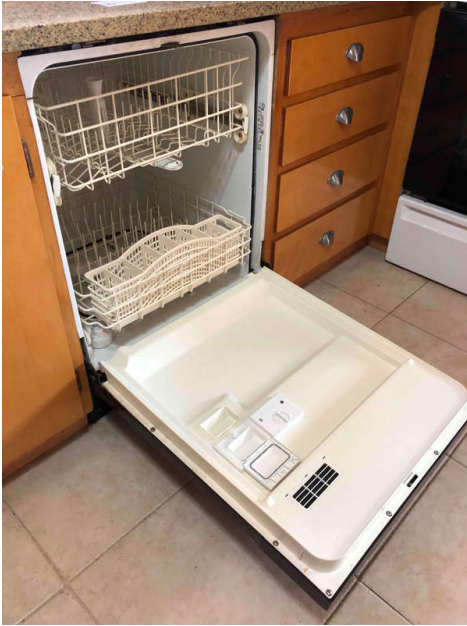
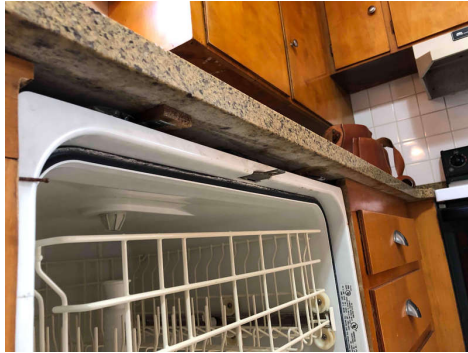
Dishwasher was not properly secured to cabinets/countertop and may be prone to tipping. Recommend repair.

*Dishwasher door spring was damaged or not operating properly.

Contact a qualified appliance repair professional.
