RESIDENTIAL INSPECTION REPORT

1234 Main St.
Chilhowie VA 24319

Buyer Name
12/11/2018 9:00AM

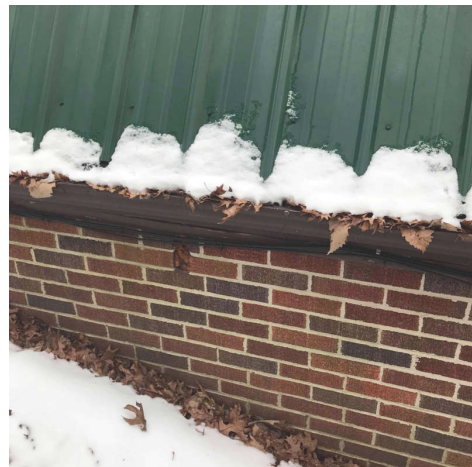
Significant amounts of debris have accumulated in one or more gutters or downspouts. Gutters can overflow and cause water to come in contact with the building exterior, or water can accumulate around the foundation. This is a conducive condition for wood-destroying organisms. Recommend cleaning gutters and downspouts now and as necessary in the future.

Recommended DIY Project

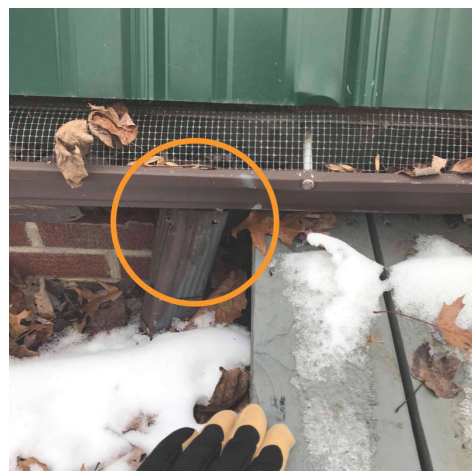
2.2.2 Gutters/drains

DAMAGED/MISSING

One or more gutters or downspouts were damaged or missing. Rainwater can come in contact with the building exterior or accumulate around the building foundation as a result. Recommend that a qualified person repair as necessary.

Contact a qualified professional.

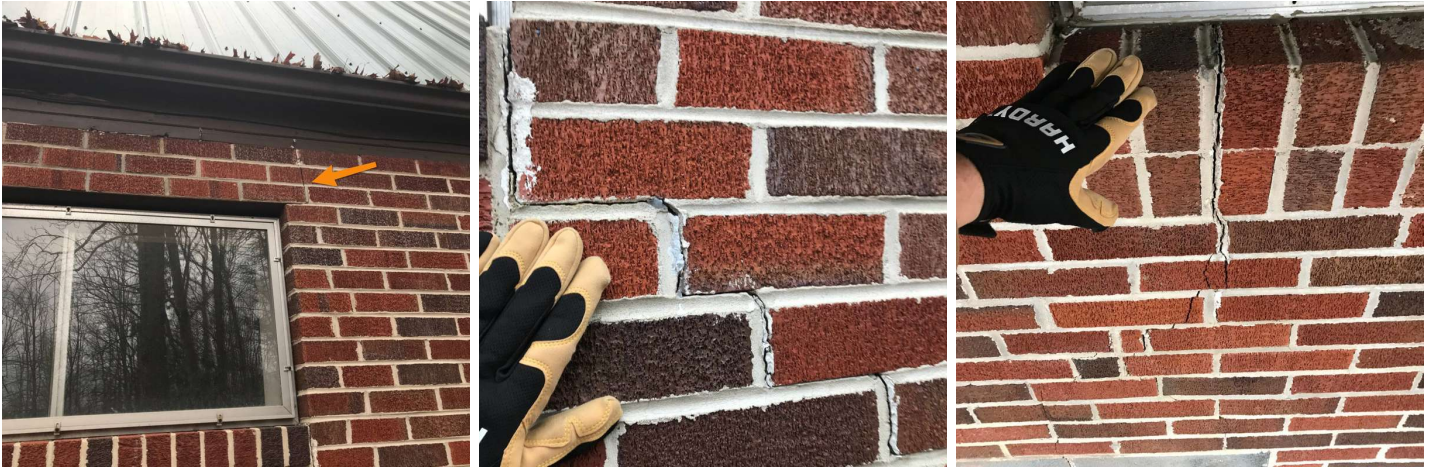
EXPANSION CRACKS IN MASONRY WALL

Expansive cracks are often seen above and around window and door openings where the opening itself relieves the crack. This type of crack has a consistent width and it is this that distinguishes from other more serious cracks. An expansive crack is of no real structural significance, although it may allow water into the cavity in brick built houses, and subsequent cause deterioration of the wall ties. Therefore filling the crack with a mastic or sealastic compound is recommended.

Contact a qualified professional.

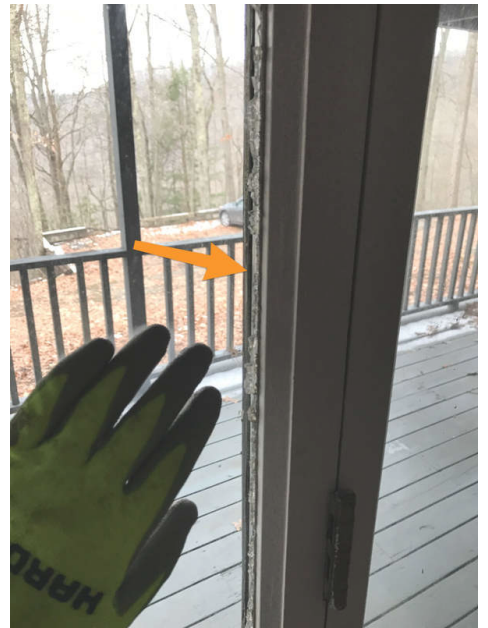
3.5.1 Windows and Door

BROKEN WINDOW

The interior window pane of the basement exterior door is broken. A licensed window repair contractor should replace the glass as needed.

Contact a qualified window repair/installation contractor.

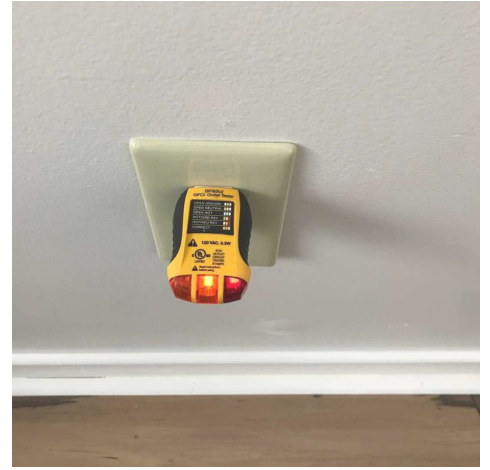
One or more electric receptacles had reverse-polarity wiring, where the hot and neutral wires were reversed. This is a shock hazard. Recommend that a qualified electrician repair as necessary.

Contact a qualified electrical contractor.

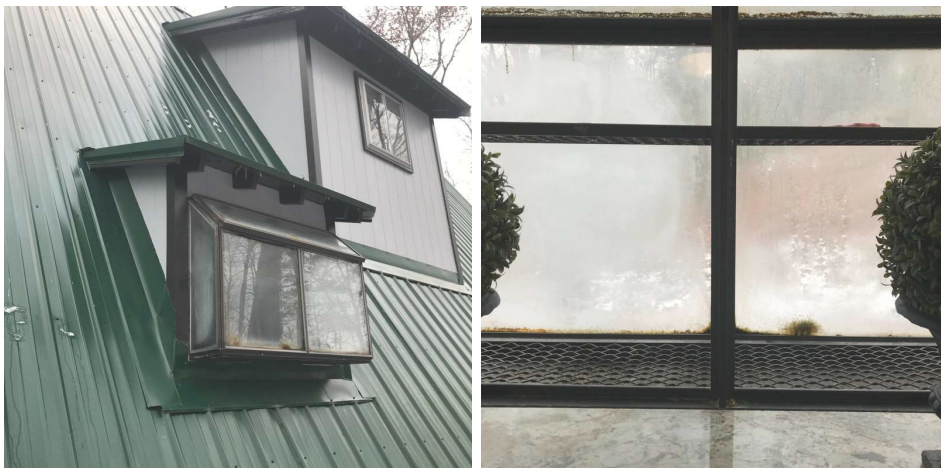
Seals between double-pane glass in one or more windows appear to have failed based on condensation or stains between the panes of glass. A qualified contractor should evaluate and replace glass where necessary.

The client(s) should be aware that evidence of broken seals may be more or less visible from one day to the next depending on the temperature, humidity, sunlight, etc. Windows or glass doors other than those that the inspector identified may also have failed seals and need glass replaced too.

Contact a qualified window repair/installation contractor.

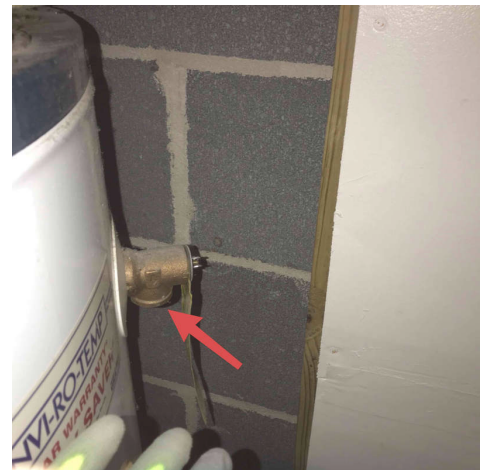
TPR DRAIN MISSING

No drain line is installed for the temperature-pressure relief valve. This is a potential safety hazard due to the risk of scalding if someone is standing next to the water heater when the valve opens. A qualified plumber should install a drain line as per standard building practices. For example, extending to 6 inches from the floor, or routed so as to drain outside.

Contact a qualified plumbing contractor.

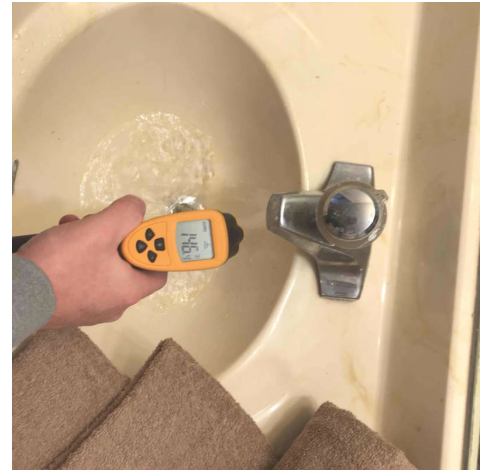
The hot water temperature is greater than 120 degrees Fahrenheit. This is a safety hazard due to the risk of scalding. The thermostat should be adjusted so the water temperature doesn't exceed 120 degrees.

Contact a qualified plumbing contractor.

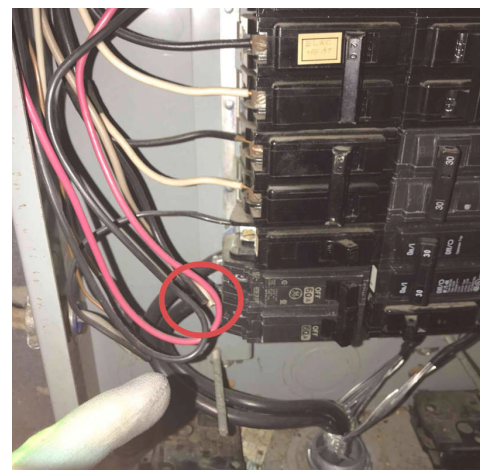
One or more wires inside panel were loose, and were not terminated. This poses a safety hazard for shock and/or fire. Recommend that a qualified electrician remove any abandoned wiring or repair as necessary. For example, by trimming wires to length and installing wire nuts.

Contact a qualified electrical contractor.

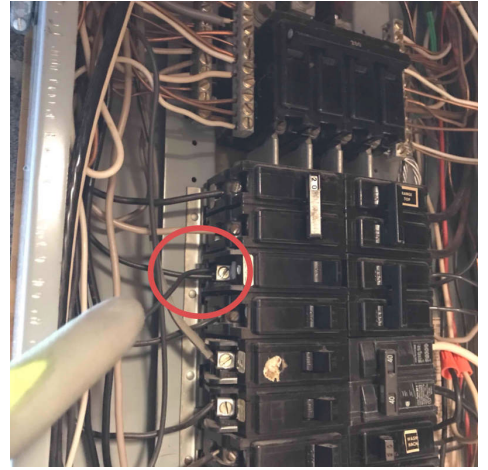
7.3.1 Circuit Breakers

One or more circuit breakers in panel were "double tapped," where two or more wires were installed in the breaker's lug. Most breakers are designed for only one wire to be connected. This is a safety hazard since the lug bolt can tighten securely against one wire but leave other(s) loose. Arcing, sparks and fires can result. Recommend that a qualified electrician repair as necessary.

Contact a qualified electrical contractor.

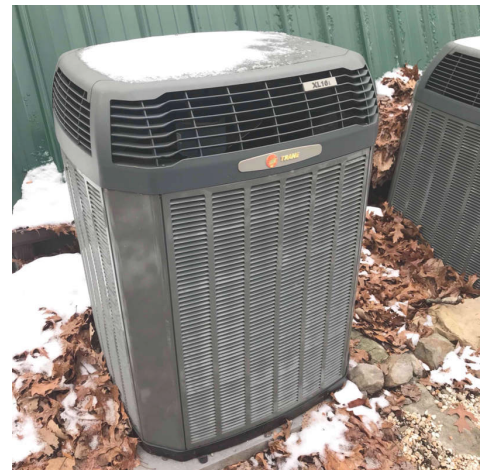
The outside condensing unit is not level. Damage may occur if it is more than ten degrees off from level. A qualified contractor should evaluate and make repairs as necessary, such as replacing the pad that the condensing unit is installed on.

Contact a qualified HVAC professional.

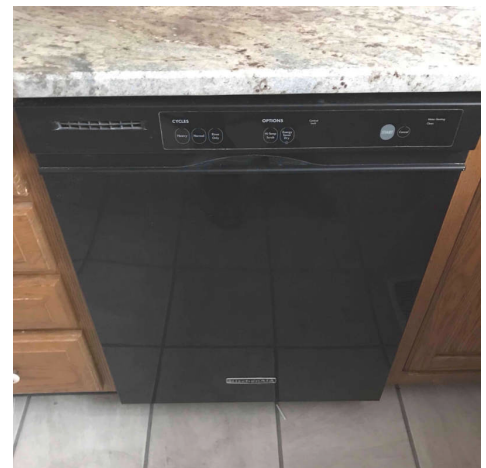
The controls for the dishwasher did not function as expected. The control panel for the dishwasher should be evaluated. The client(s) should ask the property owner(s) about this, and if necessary, the dishwasher should be replaced, or a qualified appliance technician should evaluate and repair.

Contact a qualified appliance repair professional.

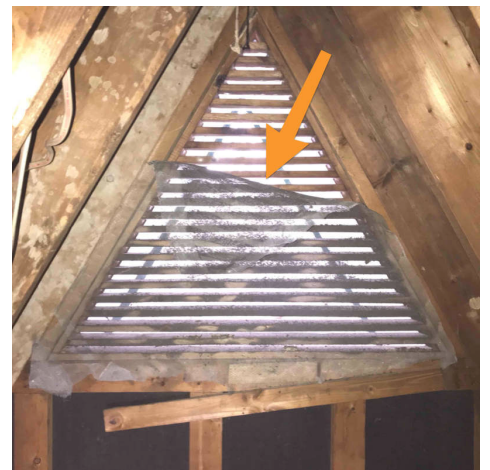
DAMAGED SCREEN

One or more attic or roof vent screens were missing, deteriorated or substandard. Recommend that a qualified person replace or repair screens as necessary to prevent birds or vermin from entering the attic.

Contact a qualified general contractor.

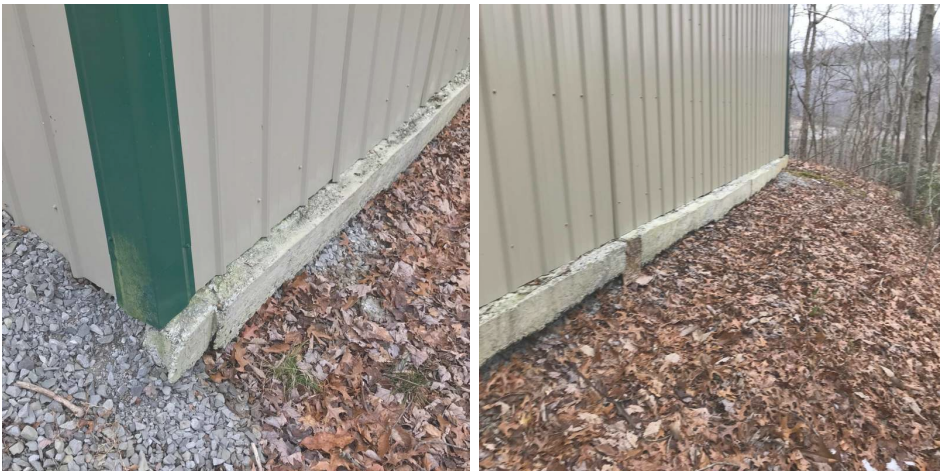
EROSION OBSERVED

Erosion has created voids beneath the slab on the outer sections of the slab. No signs of structural issues were observed at the time of inspection. Further evaluation by a qualified contractor is recommended.

Contact a qualified professional.
