THI THE HOME INSPECTOR LLC

RESIDENTIAL PROPERTY INSPECTION REPORT

1234 Main St. Ringgold GA 30736

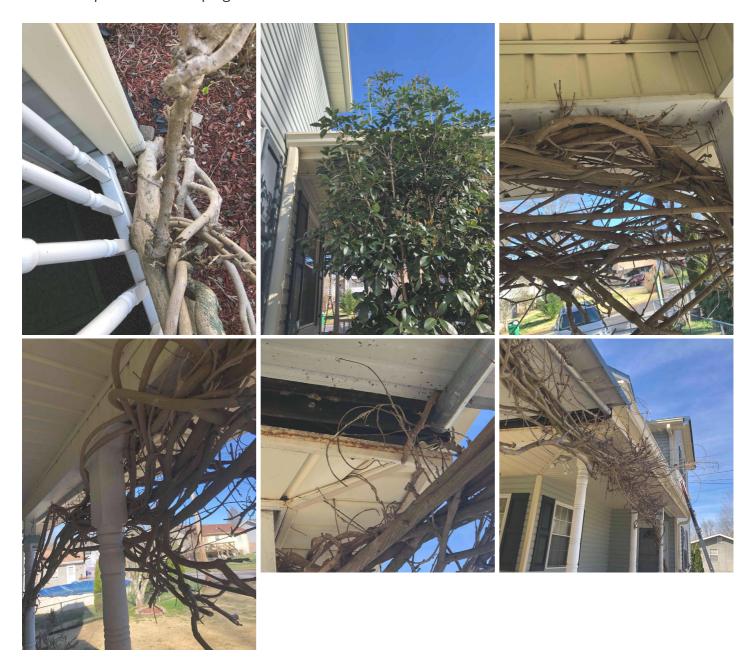
There was vegetation in contact with the home in areas. Pruning or removal of any plants that are in contact with the home is recommended by a qualified person to eliminate pathways of wood destroying insects, and to allow moisture to adequately dry behind these areas after rainfall events.

Contact a qualified landscaping contractor
