SUMMARY

122 Marcotte Crescent, Saskatoon Sk
s7k7p5

Jason & Shaunna Gervais
May 14, 2018

Cary Wiedman
interNACHI certified...
Viking Inspection Service
3062706236
viking.inspection.service@gmail.com

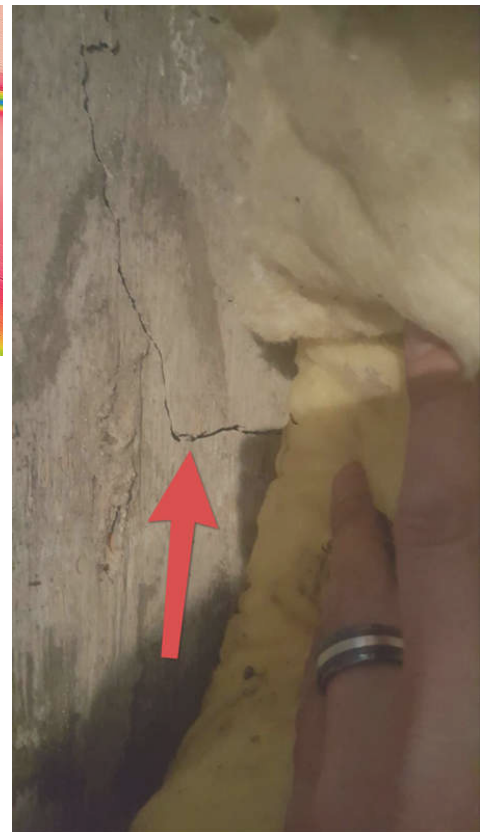
REAR OF HOME

4.4.1 Wall Structure

CRACKS - MAJOR

Major cracking observed in wall structure. This could be from moisture intrusion at the structure and/or soil movement. Recommend a qualified contractor evaluate and advise on course of action. The area that shows cracks has a negative grade towards the home.

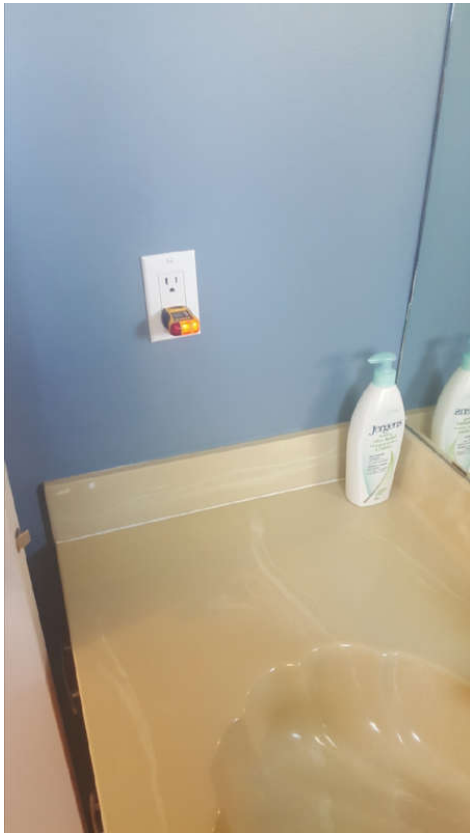
NO GFCI PROTECTION INSTALLED

No GFCI protection present in all locations. Recommend licensed electrician upgrade by installing ground fault receptacles in all locations.

Main floor bathroom, no gfci
