## SUMMARY

122 Marcotte Crescent, Saskatoon Sk  
s7k7p5

Jason & Shaunna Gervais  
May 14, 2018

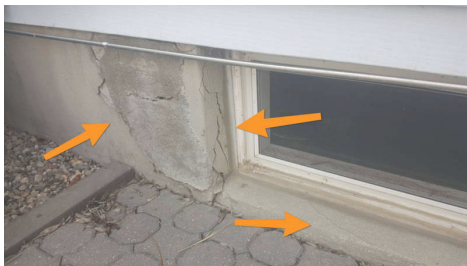
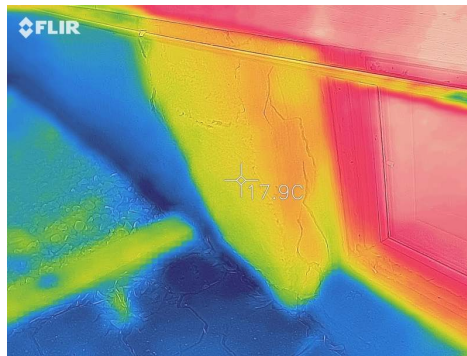
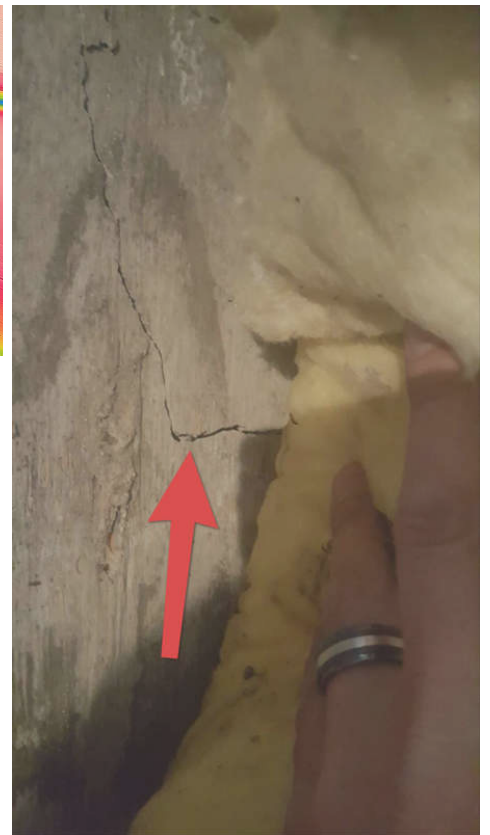
REAR OF HOME

## CRACKS - MAJOR

Major cracking observed in wall structure. This could be from moisture intrusion at the structure and/or soil movement. Recommend a qualified contractor evaluate and advise on course of action. The area that shows cracks has a negative grade towards the home.

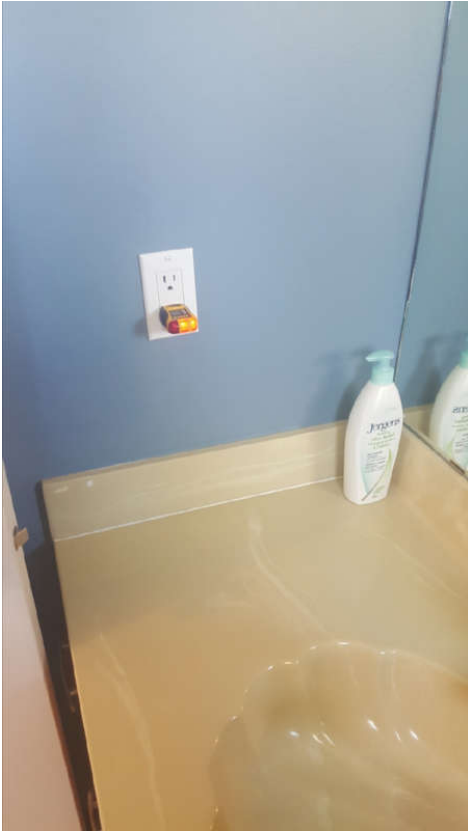
No GFCI protection present in all locations. Recommend licensed electrician upgrade by installing ground fault receptacles in all locations.

Main floor bathroom, no gfci
