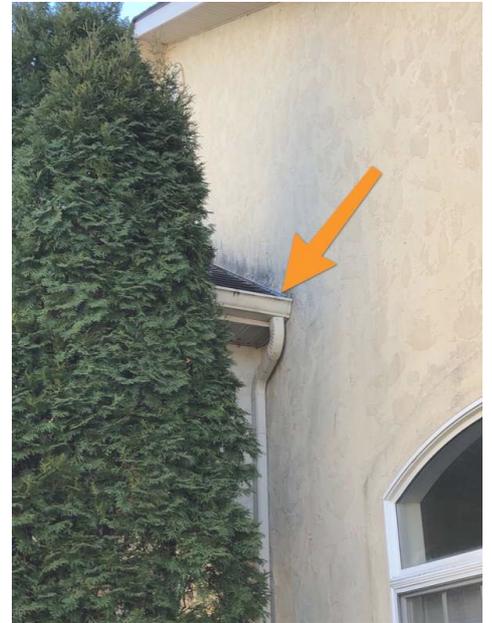
EVIDENCE OF WATER INTRUSION

Siding showed signs of water intrusion. This could lead to further siding deterioration and/or mold. Recommend a qualified siding contractor evaluate and repair.

Contact a qualified siding specialist.

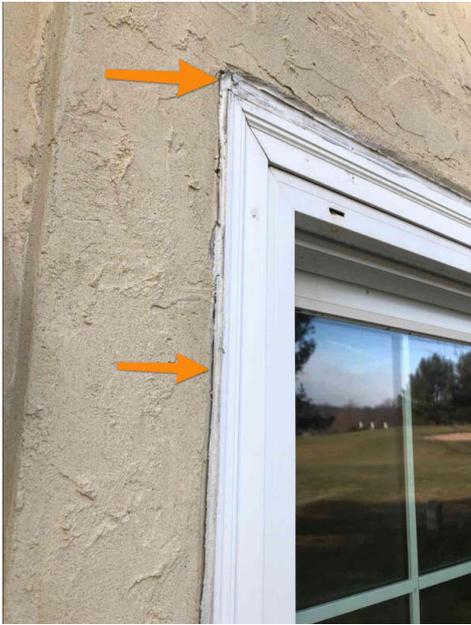
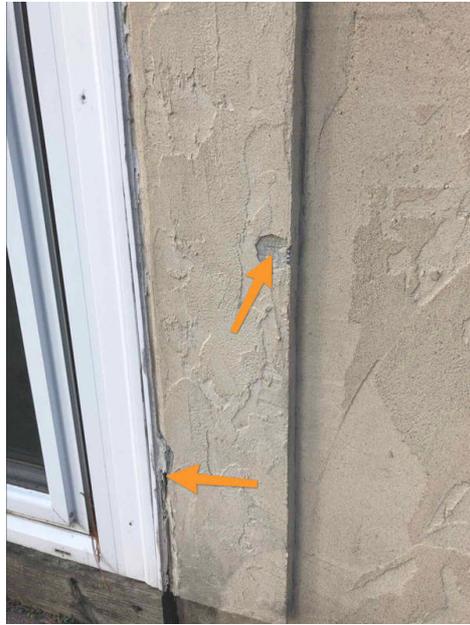
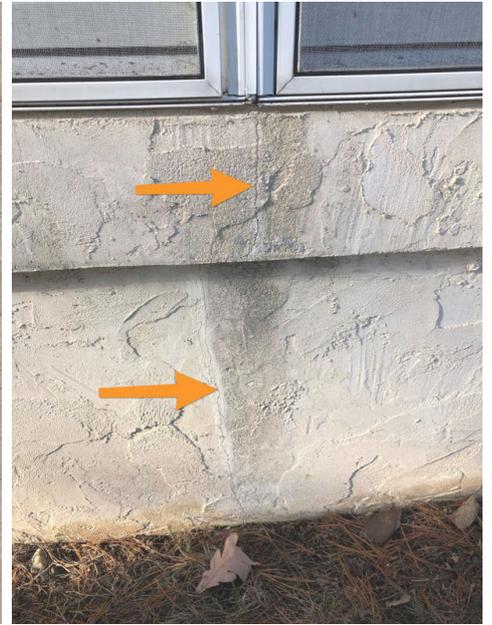
Back

MINOR STUCCO CRACKING

At the time of inspection the stucco exterior showed signs of cracking. This can cause daage to the substrate. Hidden damage may exist. Moisture can become trapped behind stucco and can cause moisture problems to the wood framing behind the stucco or crack the stucco. I was unable to determine if the stucco was applied at the proper thickness, if the wall penetrations were properly flashed, or if the wall sheathing was properly wrapped prior to stucco installation to prevent moisture damage to the sheathing behind. Cracking was noted in many locations. I recommend a qualified professional to evaluate and recommend repairs.

Contact a stucco repair contractor

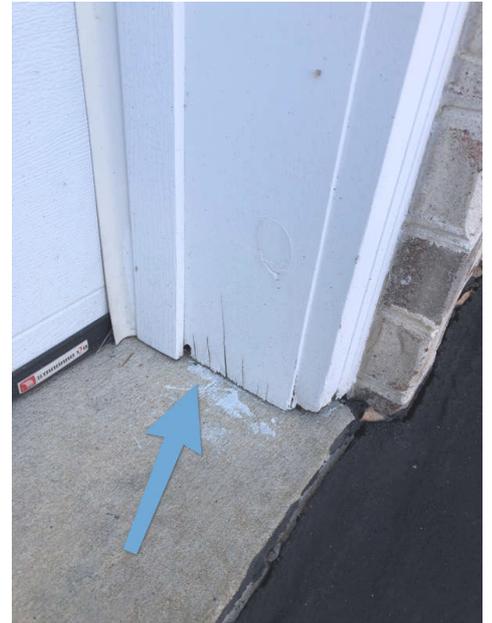
Front

ROTTEN WOOD TRIM

At the time of inspection I found signs of minor rotten wood trim. Recommend patching and painting or covering with maintenance free material.

Recommendation
Contact a qualified carpenter.

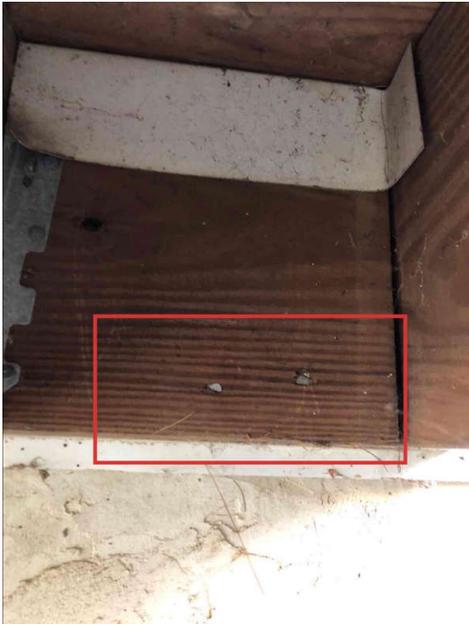
DECK LEDGER ATTACHMENT

At the time of inspection the deck ledge did not appear to be attached properly to the house. Deck ledger should be designed to resist 3,000 lb. lateral load (force pulling away from ledger) in order to prevent collapse. I recommend a qualified professional evaluate and repair as necessary.

only nails are visible

Recommendation
Contact a qualified deck contractor.

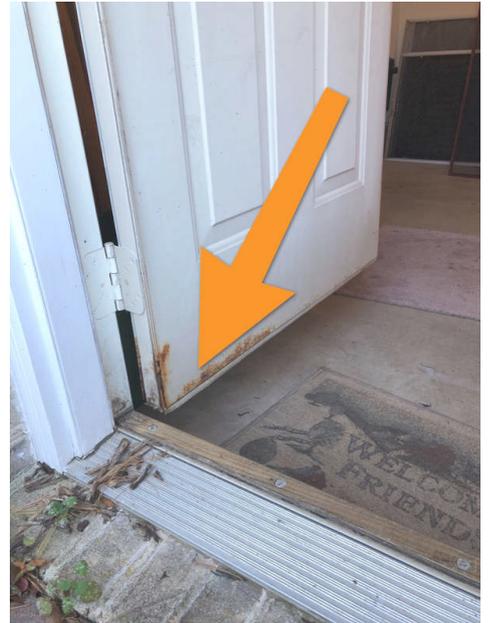
Garage door

RUSTED METAL DOOR

At the time of inspection the side garage door was rusted and swelled at the bottom. The door is failing to seal properly and is vulnerable to penetration by force or moisture. I recommend a qualified professional to evaluate and replace the door.

Recommendation
Contact a qualified carpenter.

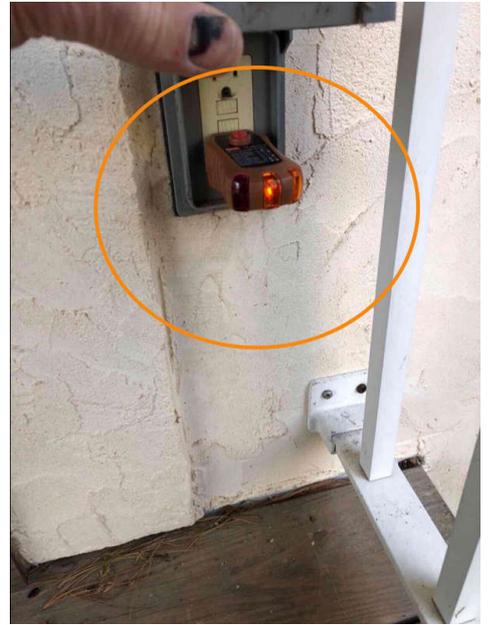
deck porch

GFCI OUTLET(S) DEFECTIVE

At the time of the inspection, I observed one or more Ground Fault Circuit Interrupters (GFCI) did not respond to testing, did not re-set, was slow to re-set or made a buzzing sound when re-set. This indicates that the condition of GFCI(s) is deteriorating and presents a safety issue. I recommend the replacement of the failed receptacle(s) by a qualified professional to ensure proper functioning.

Recommendation
Contact a qualified electrical contractor.

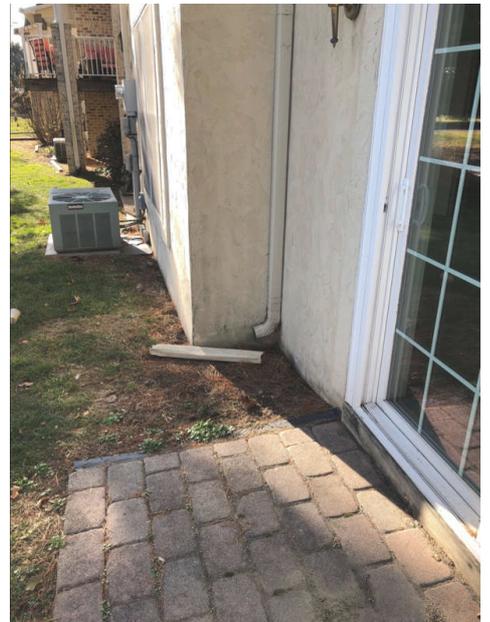
Back

DOWNSPOUTS DRAIN NEAR HOUSE

One or more downspouts drain too close to the home's foundation. This can result in excessive moisture in the soil at the foundation, which can lead to foundation/structural movement. Recommend a qualified contractor adjust downspout extensions to drain at least 6 feet from the foundation.

Contact a qualified roofing professional.

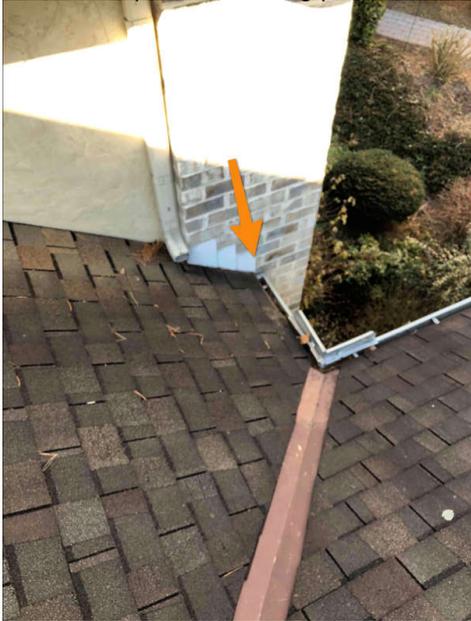
above deck porch

KICKOUT FLASHING MISSING

- The need for kickout flashing developed fairly recently and the builder may not have been aware that one was required.
- Kickout flashing is critical anywhere a roof and exterior wall intersect and where the wall continues past the lower roof-edge and gutter.
- If a kickout flashing is absent in this location, large amounts of water may miss the gutter, penetrate the siding, and become trapped inside the wall causing damage.

Recommendation
Contact a qualified roofing professional.

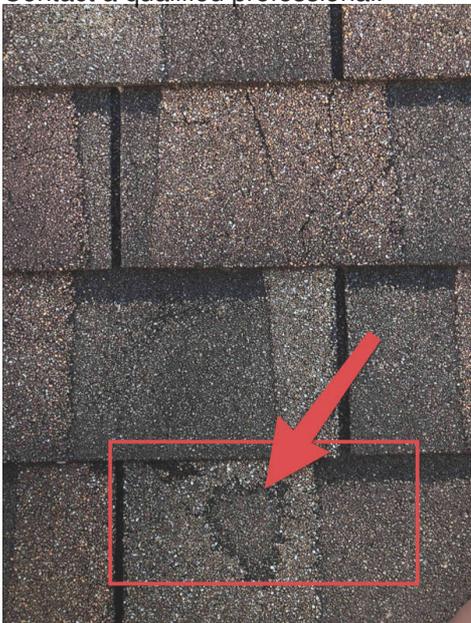
ROOF NEARING THE END OF LIFE 1-5

At 22 years, the roof appeared to be at the end of its life. Significant wear was evident. I recommend a qualified professional to evaluate and replace the roof in 1-5 years.

wear spot

Recommendation
Contact a qualified professional.

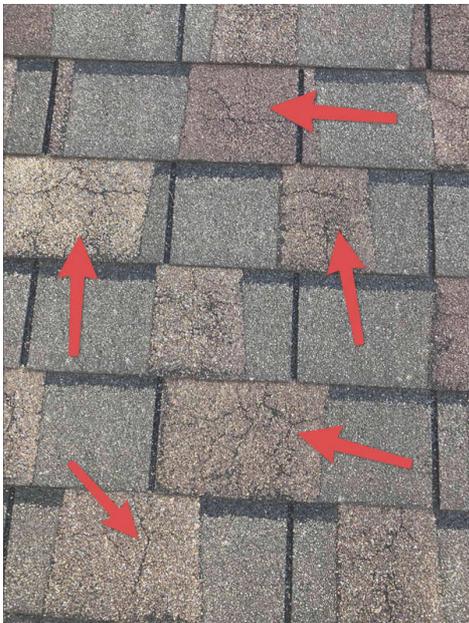
cracking shingles

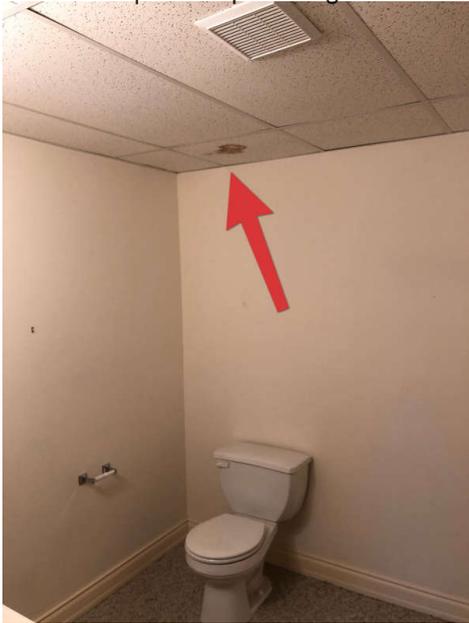
Basement Bathroom

ACTIVE LEAK

At the time of inspection I observed an active water leak beneath the 1st floor shower stall. Moisture damage can progress quickly and cause significant damage. I recommend a qualified professional evaluate and repair the leak(s).

Recommendation
Contact a qualified plumbing contractor.

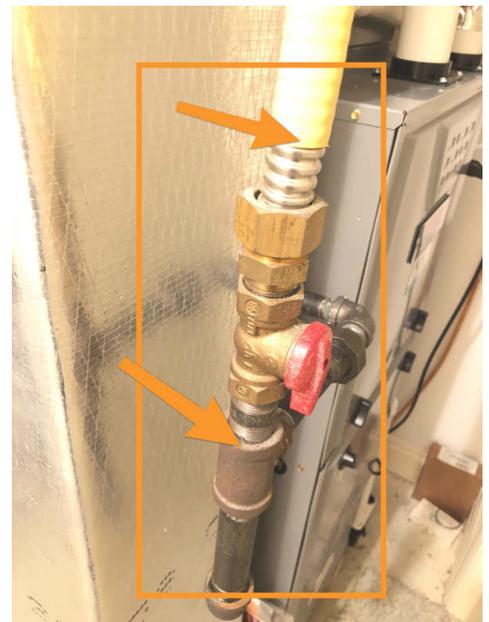
CSST PIPING NOT BONDED

The CSST gas piping did not appear to be properly bonded. CSST gas piping may be vulnerable to damage during a lightning storm if not properly bonded. A licensed electrician is recommended to evaluate and properly bond the gas piping as necessary.

Bond to ground

Recommendation
Contact a qualified electrical contractor.

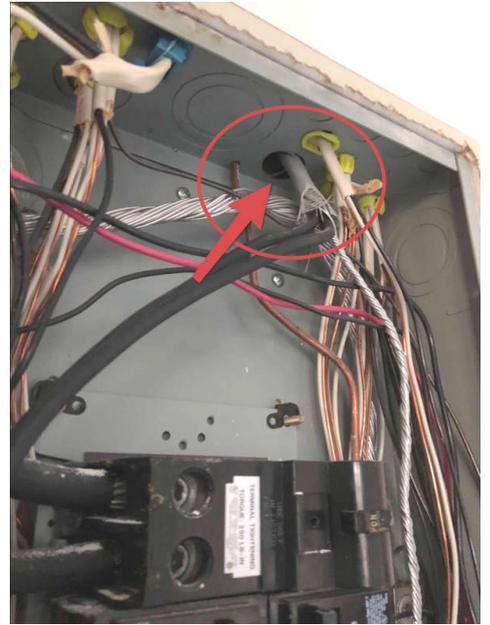
MAIN PANEL BASEMENT

MISSING WIRE BUSHING

At the time of inspection there was one or more missing wire bushing at the main panel. This is a potential fire hazard because the wire could rub against the sharp panel housing and cause sparking. I recommend a qualified professional to install a new bushing.

Contact a qualified electrical contractor.

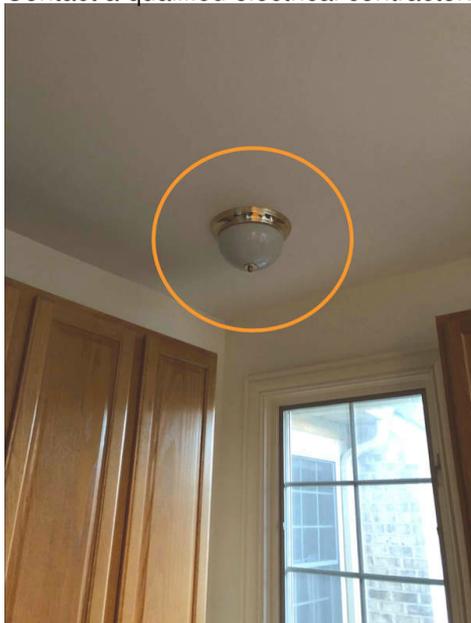
Kitchen

LIGHT INOPERABLE

One or more lights are not operating. New light bulb possibly needed.

Contact a qualified electrical contractor.

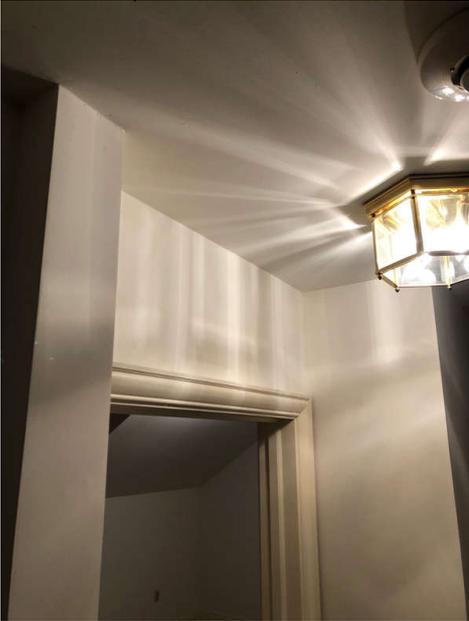
Outside bedroom in hall

CO DECECTOR MISSING

Safety -- At the time of the inspection, there were carbon monoxide detectors missing in the hall outside the bedrooms. Carbon monoxide is a toxic gas that can cause injury or death. Without a CO detector, high levels of carbon monoxide cannot be detected. I recommend installing a CO detector outside all sleeping areas.

Recommendation
Contact a qualified electrical contractor.

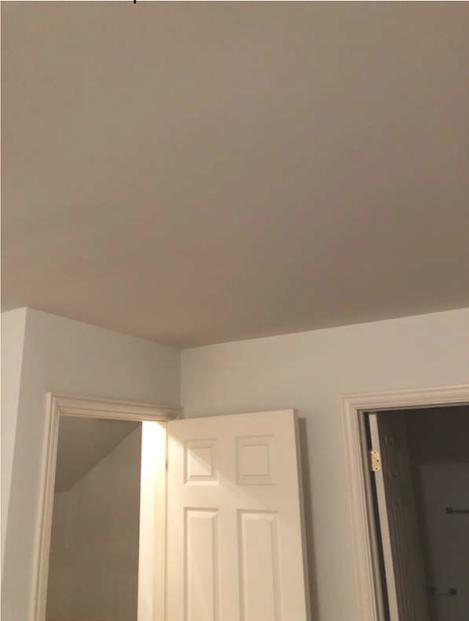
2nd Floor Bedroom

SMOKE DETECTOR(S) MISSING

Safety -- At the time of the inspection there were smoke detectors missing in areas that are now required to have smoke detectors installed. I recommend a qualified professional evaluate and install smoke detectors where they are missing.

Recommendation
Contact a qualified electrical contractor.

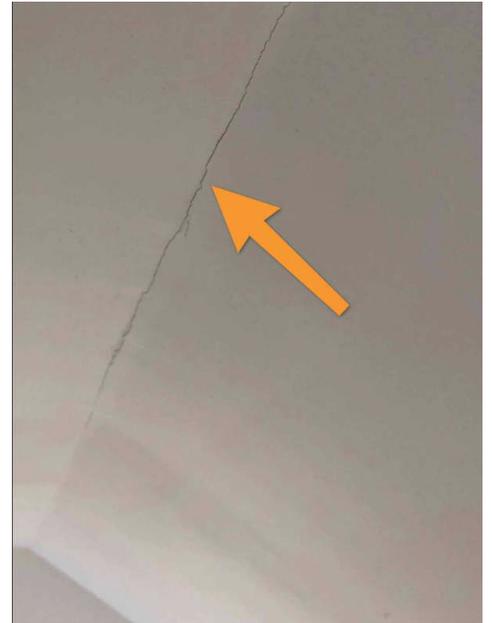
cathedral ceiling dining room

CRACKING IN CATHERDRAL CEILING

At the time of inspection I observed an significant crack at the corner of the exterior family room wall and the cathedral ceiling. This appears to be a result of seasonal expansion and contraction of the wood framing members. The exact cause can not be determined. I recommend a qualified professional to evaluate and if necessary remove sections of the wall and ceiling drywall in order to determine the exact cause. The crack does not appear to present a structural concern.

Contact a qualified drywall contractor.

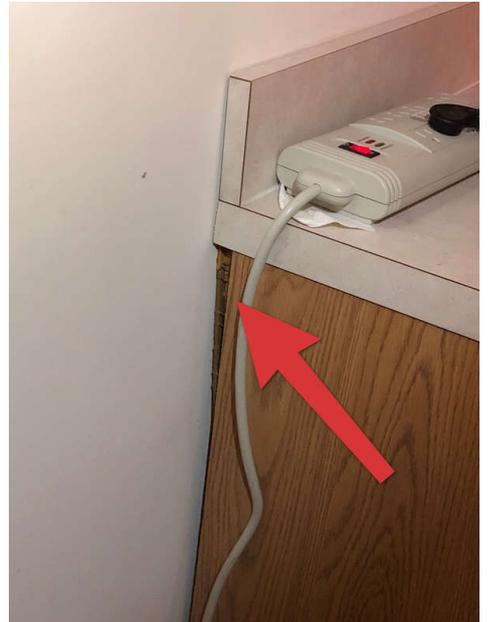
Kitchen

CABINET RACKED

At the time of inspection one of the kitchen cabinets appeared to be racked. This resulted in a drawer not seating properly. I recommend a qualified professional to evaluate and repair.

Contact a qualified carpenter.

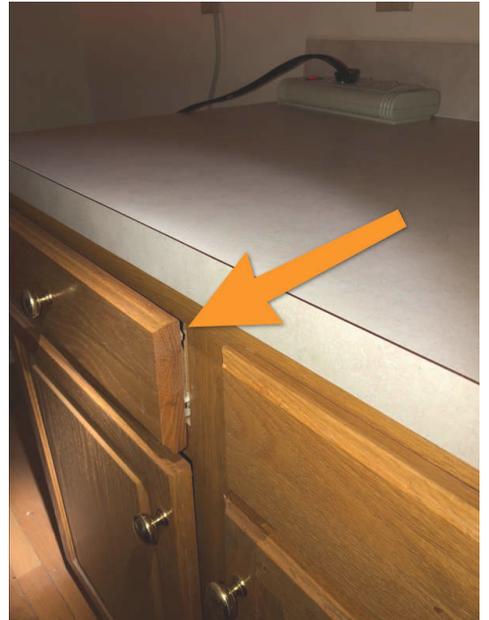
DRAWER NOT SEATING PROPERLY

At the time of inspection one of the kitchen drawers was not seating properly. I recommend a qualified professional to evaluate and repair.

Contact a qualified carpenter.

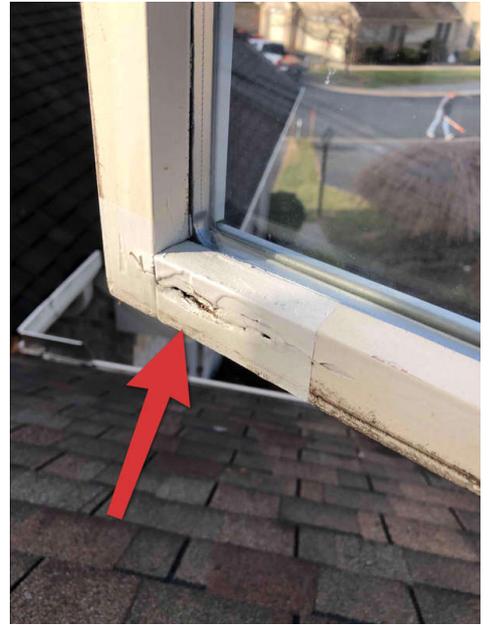
BEDROOM 2

ROTTEN SASH

At the time of inspection the one or more sash appears to rotten, but are operational. Further deterioration will affect the operation of the window. I recommend a qualified professional to evaluate and replace with a new window.

Contact a qualified window repair/installation contractor.

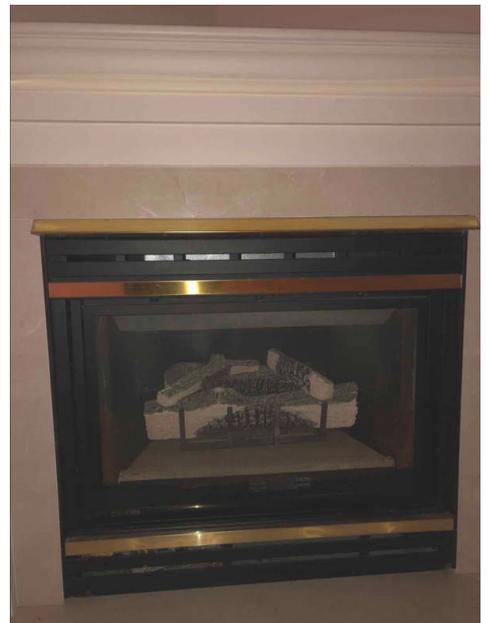
GAS FIREPLACE NOT FUNCTIONING

At the time of inspection I could not get the gas fireplace to operate. It appeared that the gas was on but the pilot would not stay on. I recommend a qualified professional to evaluate in order to make the fireplace operational.

Recommendation
Contact a qualified professional.

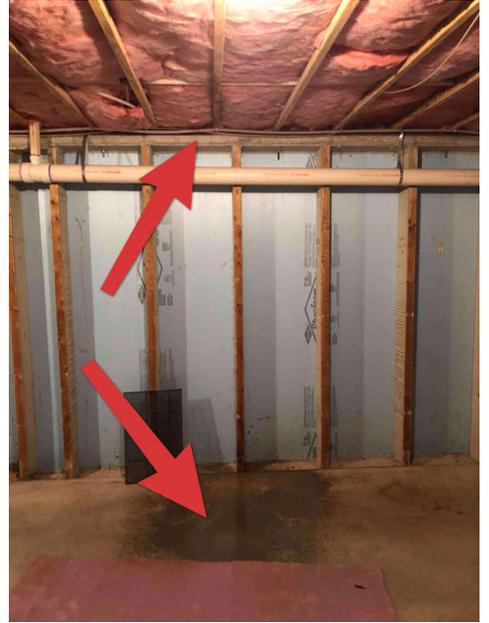
LEAKING DUSHWASHER

At the time of inspection the dishwasher was leaking when the cycle was run. At the time of inspection I observed an active water leak beneath the 1st floor shower stall. Moisture damage can progress quickly and cause significant damage. I recommend a qualified professional evaluate and repair the leak.

Evidence of leak

Recommendation
Contact a qualified plumbing contractor.

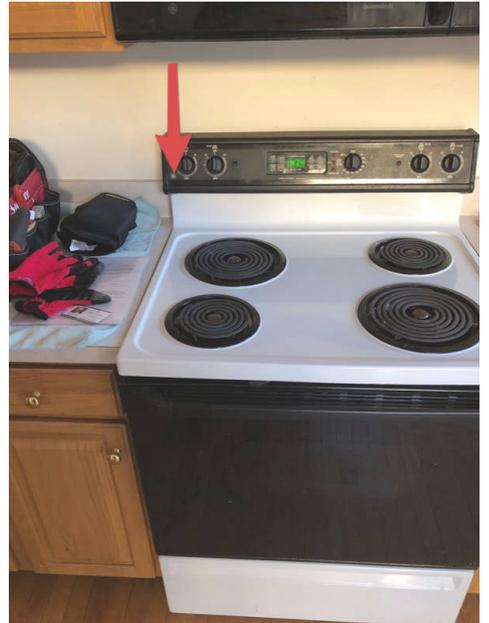
Kitchen

ANTI-TIP DEVICE MISSING

Range was not fastened to the floor. This poses a safety hazard to children. Recommend a qualified contractor secure range so it can't tip.

Recommendation
Contact a qualified handyman.
