SUMMARY

1234 Main St. Rochester NH 03867

Buyer Name
10/23/2018 9:00AM

Robert Jenkins
Certified Professional Inspector,
InterNACHI, Member ASHI, Licensed
New Hampshire Home Inspector,
Licensed New Hampshire Master
Electrician, ITC Level 1 Certified
Infrared Thermographer
Reveal Home Inspection, LLC
603-817-8318
bobj776@gmail.com

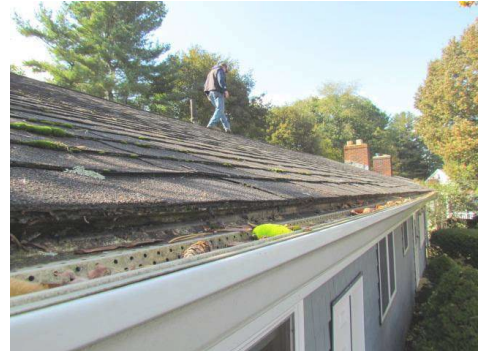
FRONT, RIGHT SIDE

ROOF SAG

Observed roof that was sagging/uneven. Recommend further review to determine cause of the sag and repair as necessary.

Contact a qualified professional.

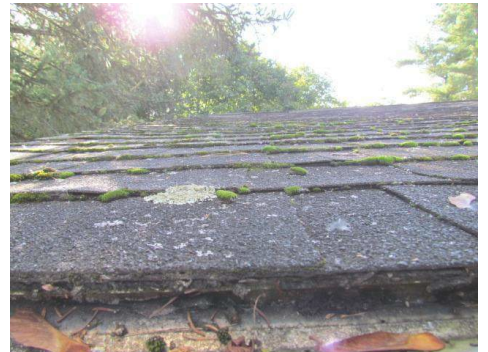
FRONT, LEFT SIDE

MOSS BUILDUP

Recommend removal of moss from roofing materials.

Contact a handyman or DIY project

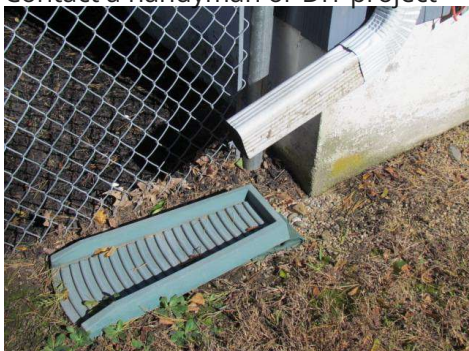
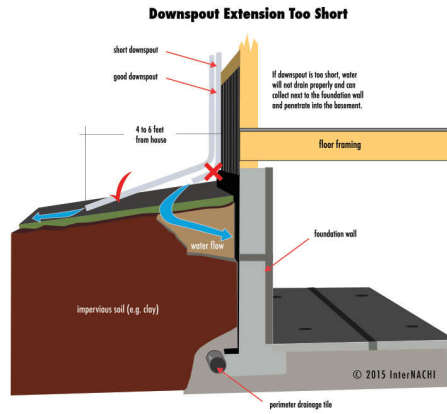
FRONT AND REAR OF HOUSE

DOWNSPOUTS DRAIN NEAR FOUNDATION

One or more downspouts drain too close to the foundation which may cause water to enter into the home. Recommend to adjust downspout extensions to drain at least 6 feet from the foundation.

Contact a handyman or DIY project

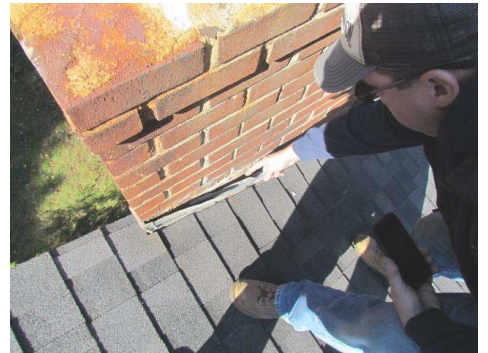
CHIMNEY

LOOSE/SEPARATED

Flashings observed to be loose or separated, which can lead to water intrusion and/or mold. Recommend a qualified roofing contractor repair.

Contact a qualified roofing professional.

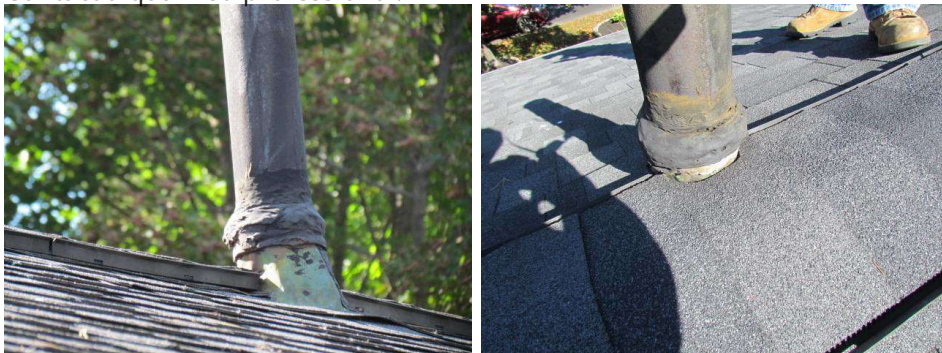
PIPE FLASHING BOOT

Pipe flashing is not installed correct. This could allow water into the attic.

Contact a qualified professional.

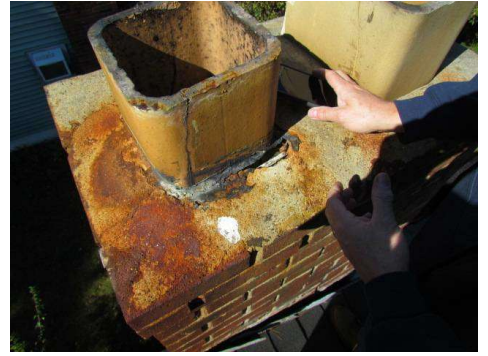
CHIMNEY CAP MISSING

No chimney cap was observed. This is important to protect from moisture intrusion and protect the chimney. Recommend a qualified roofer or chimney expert install.

Contact a qualified roofing professional.

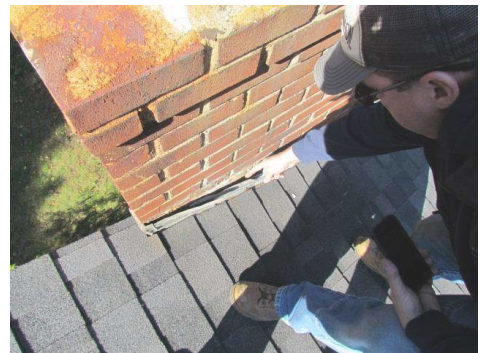
CHIMNEY FLASHING

Improper flashing around the chimney. This is important to protect from moisture intrusion around the chimney. Recommend a qualified roofer or chimney expert install.

Contact a qualified roofing professional.

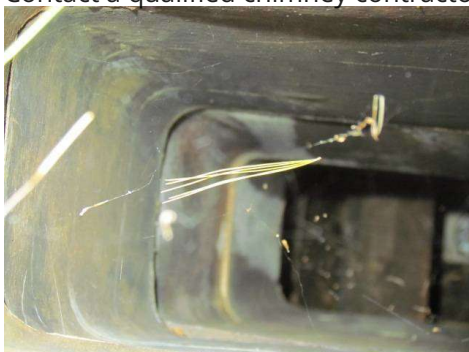
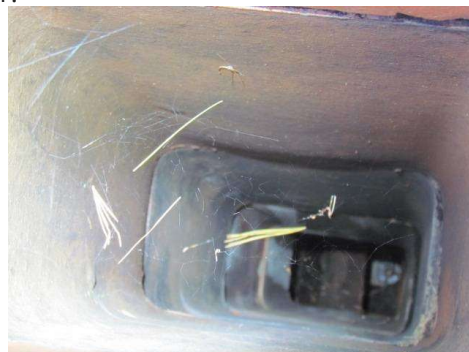
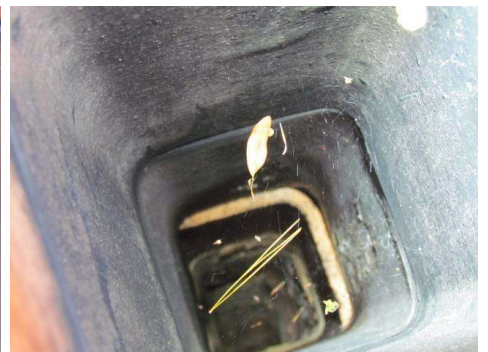
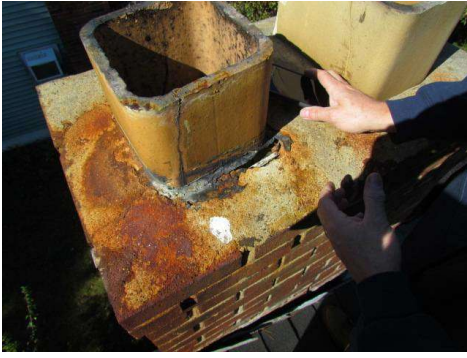
CHIMNEY FLUE DAMAGE

Both flues of the chimney appear to have damage. Damage is external as well as internal. Suggest a chimney professional evaluates to be sure the chimney is safe to use.

Contact a qualified chimney contractor.

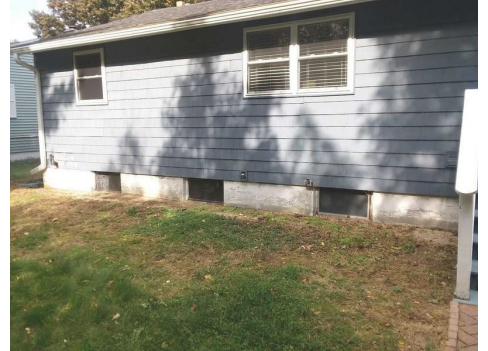
WINDOW WELL

Recommend site professional evaluate possible need for window wells on basement windows at rear of house.

Contact a qualified waterproofing contractor

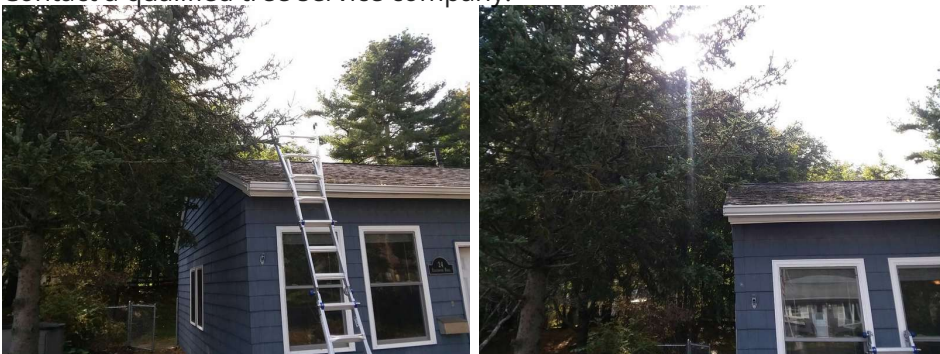
FRONT, LEFT

TREE OVERHANG

Trees observed overhanging the roof. This can cause damage to the roof and prevent proper drainage. Recommend a qualified tree service trim to allow for proper drainage.

Contact a qualified tree service company.

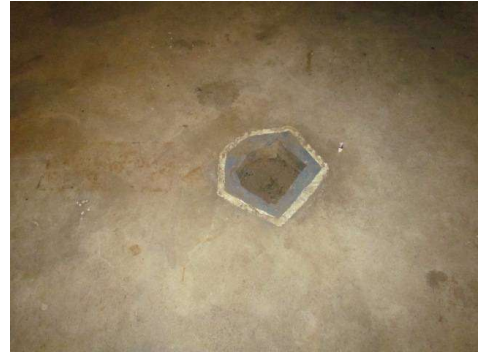
BASEMENT FLOOR

**HOLE IN BASEMENT
FLOOR**

A hole in the basement floor is a trip hazard. hole should be filled in to eliminate hazard.

Contact a qualified professional.

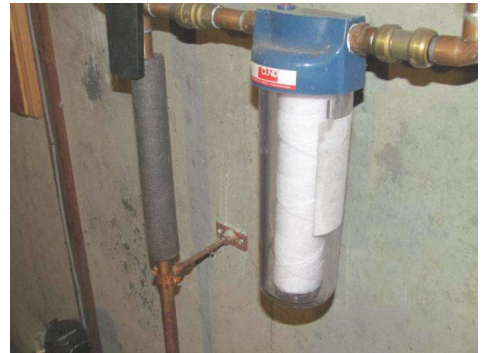
BASEMENT

**WATER
FILTER/SOFTENER**

Water filter/softener was excluded from the scope of inspection. Recommend a water conditioning company (such as Culligan) inspect the systems and provide evaluation of ensure unit(s) is/are functionally correctly.

Contact a qualified professional.

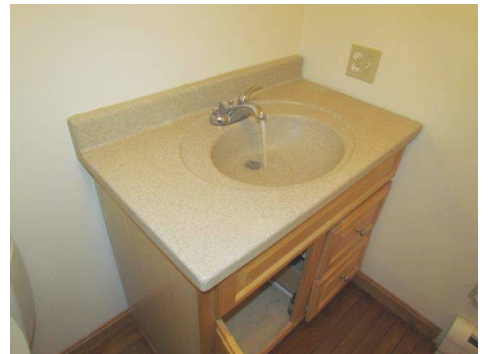
BATH ROOM

SINK - POOR DRAINAGE

Sink had slow/poor drainage. Recommend a qualified plumber repair.

Contact a qualified plumbing contractor.

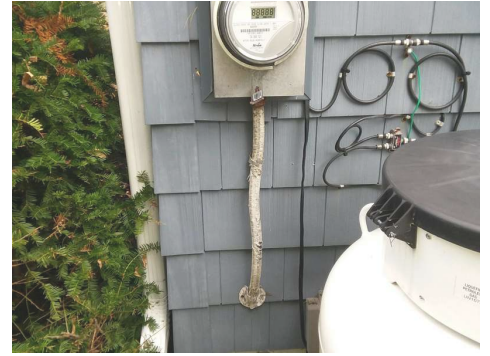
SERVICE ENTRANCE CABLE

FRAYED SHEATHING

Wires on service entrance are damaged or frayed. Recommend contacting your electric utility company or a qualified electrician to evaluate and repair.

Contact a qualified electrical contractor.

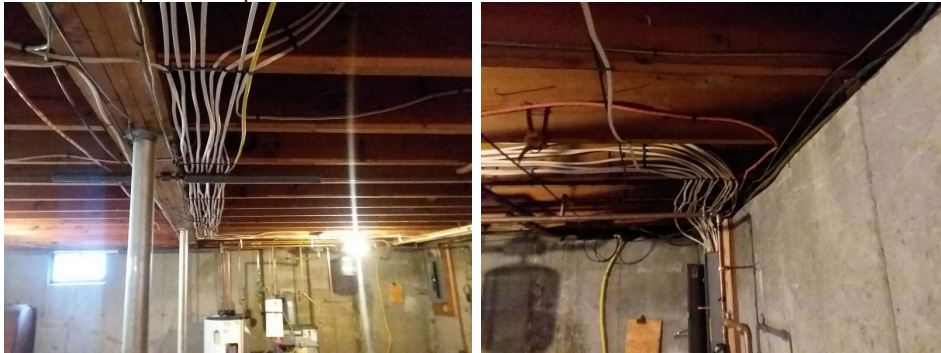
BASEMENT

IMPROPER WIRING

Improper electrical wiring, Cables should be run through bored holes or stapled to nail board attached to floor joists.

Contact a qualified professional.

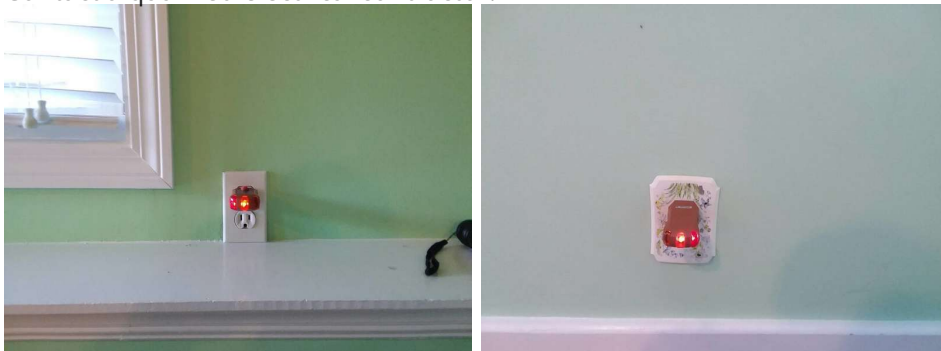
FAMILY ROOM, BED ROOM

REVERSE POLARITY

One or more receptacles have been wired with reverse polarity. This can create a shock hazard. Recommend licensed electrician evaluate & repair.

Contact a qualified electrical contractor.

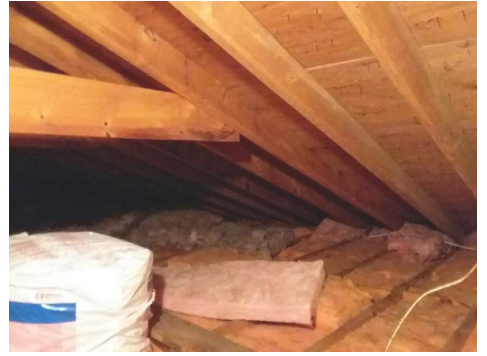
ATTIC

DAMAGED

Insulation appears to have been pulled out and/or damaged. Recommend a qualified insulation contractor evaluate and repair.

Contact a qualified insulation contractor.

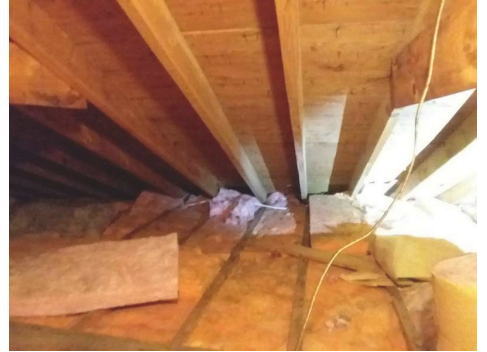
ATTIC

BLOCKED SOFFIT VENTS

Soffit vents appear to be blocked with insulation in the attic. Access to the attic was limited due to a lack of a walkway. Recommend further evaluation to determine condition of attic ventilation.

Recommend monitoring.

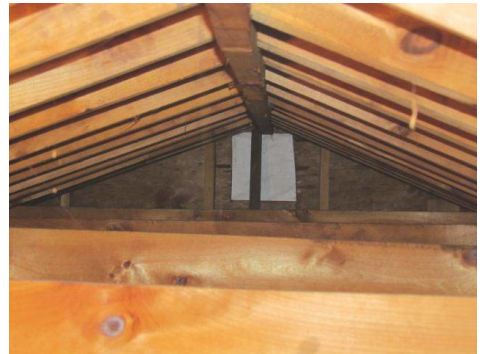
ATTIC GABLE ENDS

GABLE VENT COVERED

Gable vent appears to be covered with tyvek. Vents should be unobstructed to allow air flow in attic.

Contact a qualified insulation contractor.

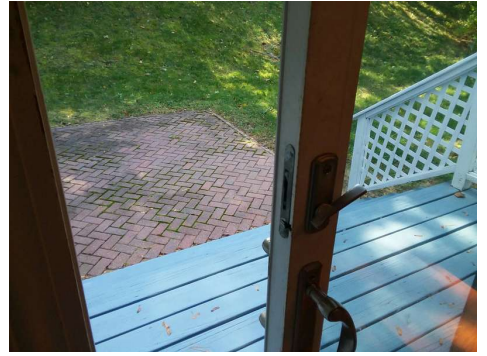
REAR SLIDER

DOOR DOESN'T LATCH

Door doesn't latch properly. Recommend handyman repair latch and/or strike plate.

Contact a qualified handyman.

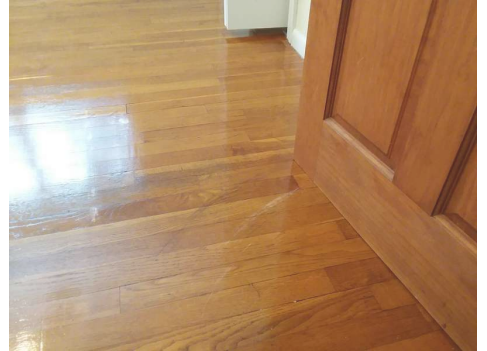
MIDDLE BED ROOM

DOOR STICKS

Door sticks and is tough to open. Recommend sanding down offending sides. Here is a helpful DIY article on how to fix a sticking door.

Contact a qualified handyman.

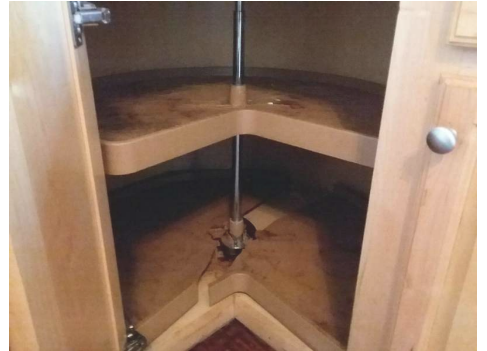
CABINETS DAMAGED

Cabinets had visible damage at time of inspection. Recommend a qualified cabinets contractor evaluate and repair.

Contact a qualified cabinet contractor.

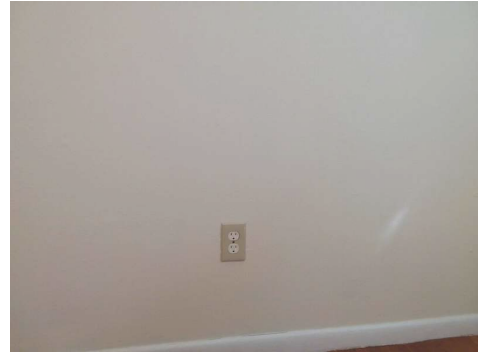
MIDDLE BED ROOM

RECEPTACLE - FOREIGN OBJECT

Appears to be a foreign object stuck in the receptacle. Recommend removal of item so that receptacle is usable.

Contact a qualified electrical contractor.

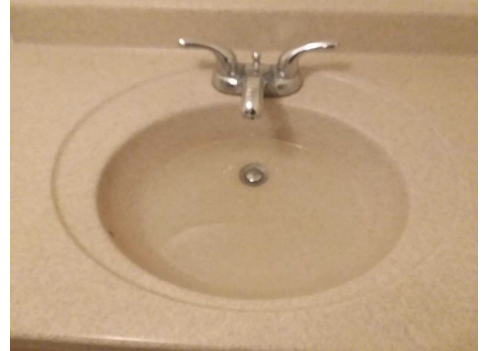
BATH ROOM

SINK - POOR DRAINAGE

Sink had slow/poor drainage. Recommend a qualified plumber repair.

Contact a qualified plumbing contractor.

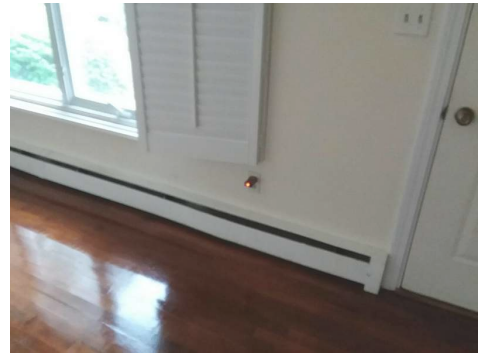
UNGROUND RECEPTACLE

One or more receptacles are ungrounded. To eliminate safety hazards, receptacles in kitchen, bathrooms, garage & exterior should be grounded. As a safety upgrade, recommend that these receptacles be grounded.

Contact a qualified electrical contractor.

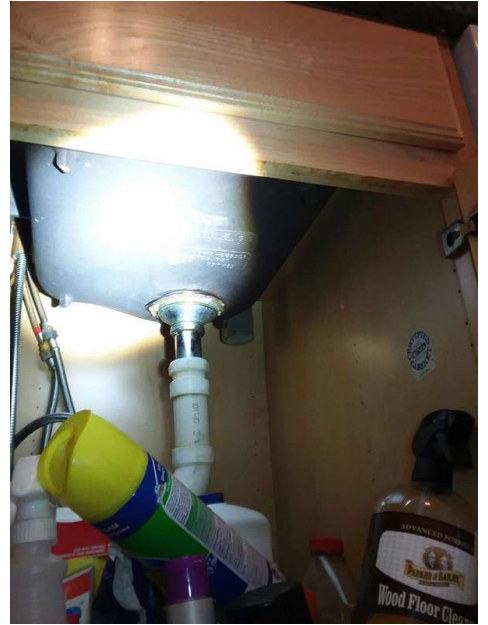
UNDER KITCHEN SINK

LEAKING DRAIN PIPE

A drain, waste and/or vent pipe showed signs of a leak. Recommend a qualified plumber evaluate and repair.

Contact a qualified plumbing contractor.

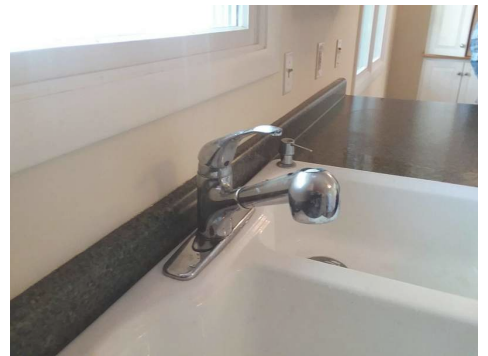
KITCHEN SINK

FAUCET LEAKS

Faucet leaks

Contact a qualified professional.

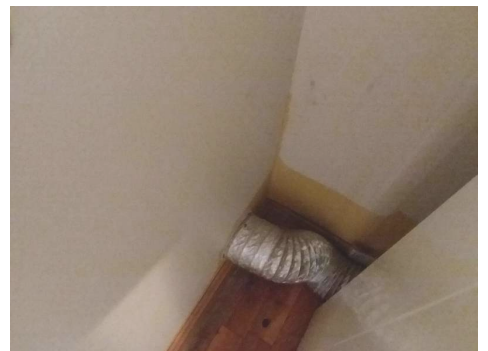
LAUNDRY ROOM

DRYER VENT MATERIAL

As an upgrade, recommend replacing flexible dryer vent with a metal product that has a smooth interior finish and eliminate the use of plastic dryer vent.

Contact a handyman or DIY project
