# SUMMARY 1234 Main St.Durham NC 27712

Buyer Name 05/28/2018 9:00AM

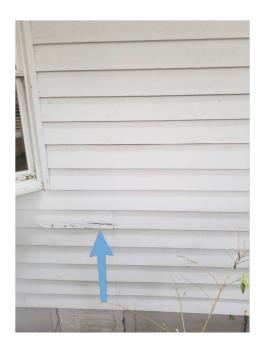
REAR OF HOUSE BESIDE BAY WINDOW

## **EVIDENCE OF WATER INTRUSION**

Siding showed signs of water intrusion. This could lead to further siding deterioration and/or mold. Recommend a qualified siding contractor evaluate and repair.

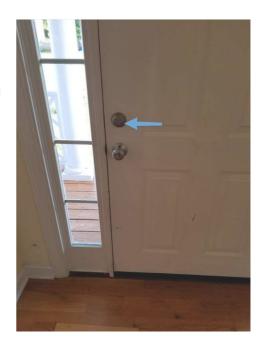
FRONT DOOR

#### **KEYED DEADBOLT**

The locking mechanism on the front door is operated from the inside with a key. This should operable with an easily accessible handle. This is important in case of an emergent need to escape the premises. A competent handyman or Locksmith should be able to install an proper deadbolt.

Recommendation Contact a handyman or DIY project

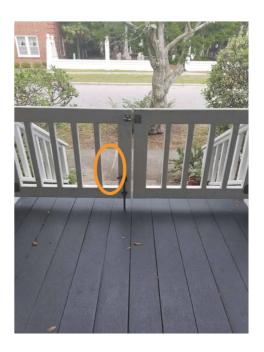
FRONT PORCH GATE

**RAILING UNSAFE**

There is an unsafe opening in the railing. The spacing on the rail should not exceed 4". An opening greater than 4" is a serious safety hazard especially for children as their head or other body part can become trapped.

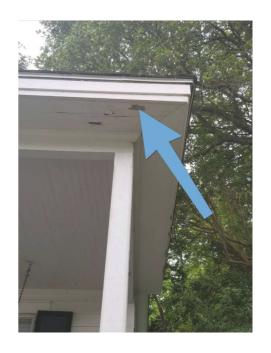
FRONT CORNER - WEST

#### PAINT/FINISH FAILING

The paint or finish is failing. This can lead to deterioration and rot of the material. Recommend that the araes be properly prepared and painted / finished.

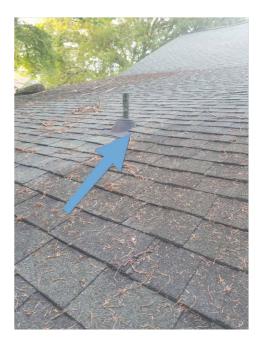
ABOVE REAR PORCH

#### **VENT BOOT LEAKING**

The plumbing vent for the washing machine is leaking in to the porch flood light. This is a safety concern as it could cause a fire or shock hazard. The vent boot should be properly sealed to prevent any water from leaking in to the ceiling structure and the exterior light fixture.

Contact a qualified roofing professional.

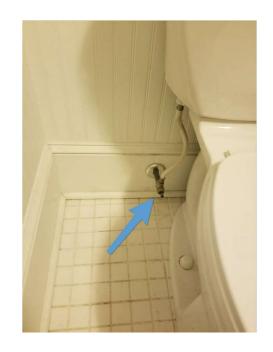
HALL BATH

## SHUTOFF VALVE HANDLE MISSING

The shutoff valve handle is missing. This prevents the valve from functioning. In the event of an overflowing fixture, the water would not be able to turned off in a timely fashion.

Contact a qualified plumbing contractor.

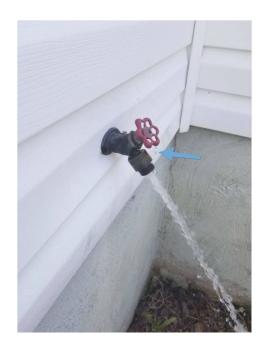
## **OUTSIDE SPIGOT LEAKING**

The rear outside spigot is leaking at the handle when it is turned on. This causes water to spray on the siding making for a permanently moist surface which can lead to rot and pest intrusion. It also wastes water increasing the utility bill.

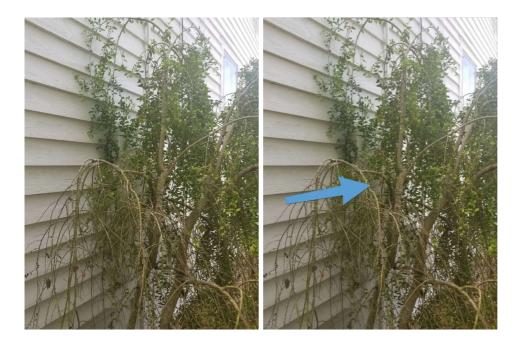
## **VEGETATION TOO CLOSE TO PANEL**

There is a decorative tree planted near the panel. This tree has completely engulfed the panel which makes it very difficult to access. It needs to be trimmed so it is not making contact with the panel and to allow room for a person to operate the circuit breakers.

Recommended DIY Project

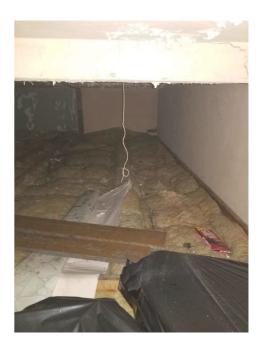
**ATTIC**

## ATTIC INSULATION HAS COMPRESSED

The attic insulation has compressed over time. This will cause the insulation to lose it's optimum R-Value which can increase utility bills for heating and cooling.

Contact a qualified insulation contractor.

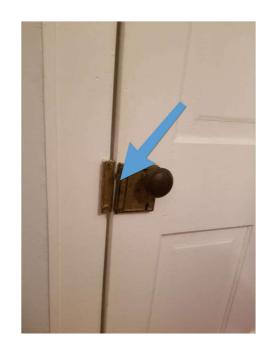
MASTER BEDROOM DOOR

## DOOR DOESN'T LATCH

Door doesn't latch properly. Recommend handyman repair latch and/or strike plate.

Contact a handyman or DIY project

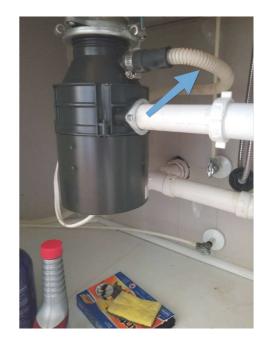
**UNDER SINK**

# **IMPROPERLY INSTALLED DRAIN PIPE**

Dishwasher drain pipe was installed improperly. The dishwasher drain should have high loop installed (achieved by attaching drain to counter top) Recommend a qualified plumber or handyman evaluate and repair.

Contact a qualified plumbing contractor.
