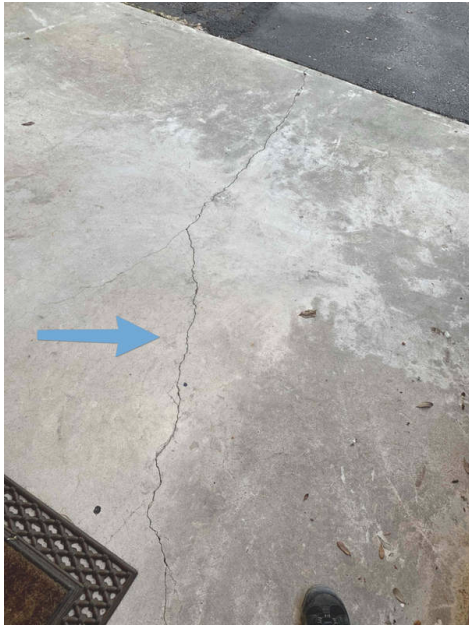
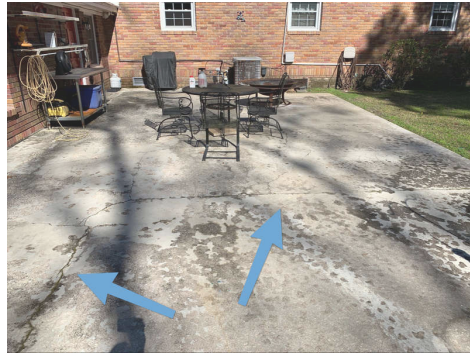
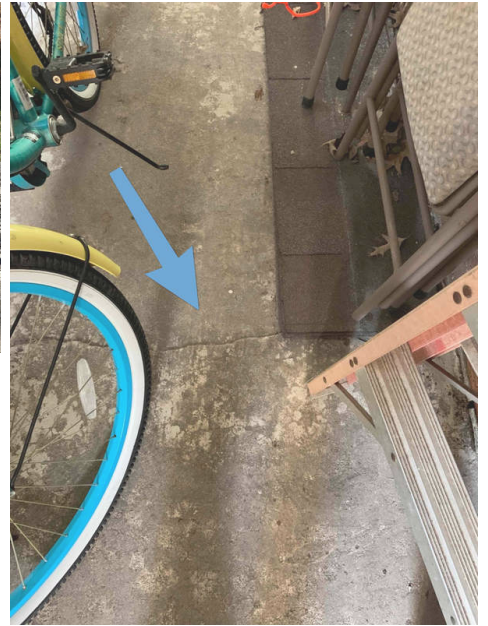
DRIVEWAY, SIDEWALK, PATIO CRACKING

One or more cracks observed, which may indicate movement in the soil (settlement) or expansion/contraction of the material. Recommend monitoring and/or have concrete contractor patch and seal.

Recommendation
Contact a qualified concrete contractor.

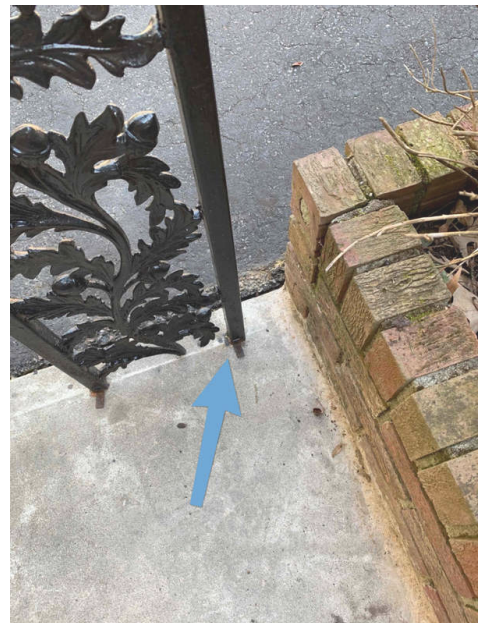
SUPPORT LOOSE AT BOTTOM

Front porch decorative support post is loose at the bottom and unattached from its bracket. Recommend a qualified professional reattached properly.

Recommendation
Contact a qualified professional.

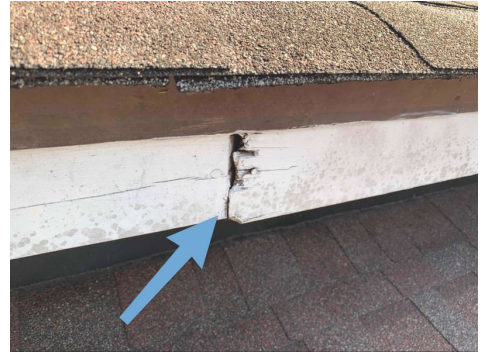
Right side of home

FASCIA - DAMAGED

Minor fascia damage observed. No signs of wood rot currently however the damaged end is exposed to potential water intrusion. Recommend qualified professional repair or replace.

Contact a qualified professional.

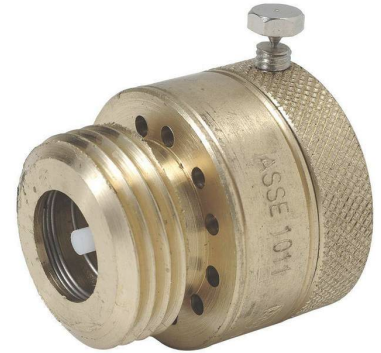
RECOMMEND ANTI-SIPHON VALVE BE INSTALLED

Anti-siphon valves allow water to only flow in one direction. For irrigation purposes, it prevents water from the system from being siphoned back into the water supply line. Essentially, it stops unsafe water from entering a clean water supply such as the water that comes from your faucets or shower heads. Recommend installing an anti-siphon valve.

Contact a handyman or DIY project

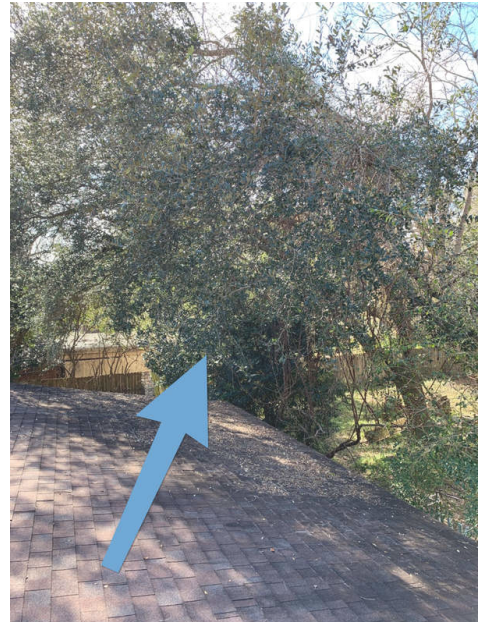
TREE OVERHANG

Trees observed overhanging the roof. This can cause damage to the roof and prevent proper drainage. Recommend a qualified tree service trim to allow for proper drainage.

Contact a qualified tree service company.

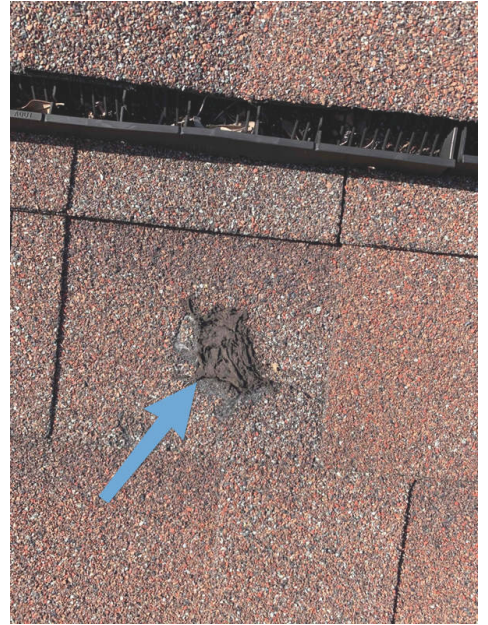
Back side of roof

DAMAGED SHINGLE/ PREVIOUS REPAIR

Damaged shingle was previous repaired with sealant. Recommend monitoring for potential future issues as the sealant deteriorated from UV exposure.

Recommendation
Recommend monitoring.

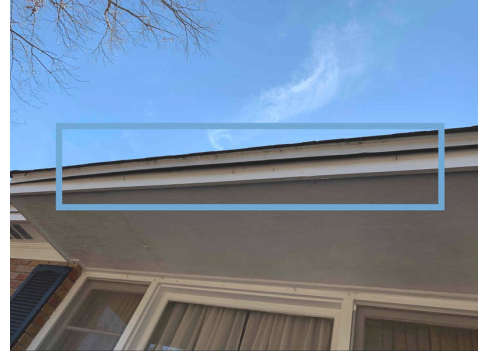
Front side of home

DRIP EDGE LOOSE

Drip edge on the front of the house is significantly bent up. Recommend resealing properly to help prevent possible unwanted pest from entering or losing the drip edge to high winds.

Recommendation
Contact a qualified professional.

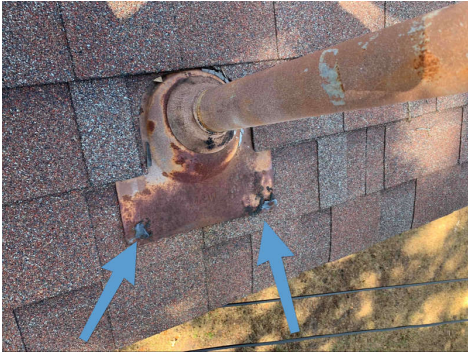
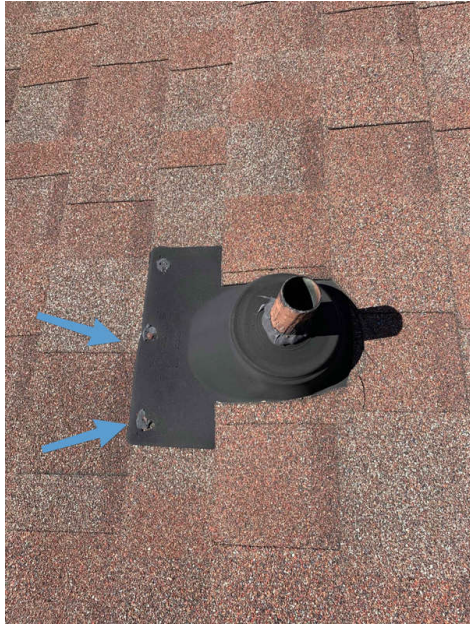
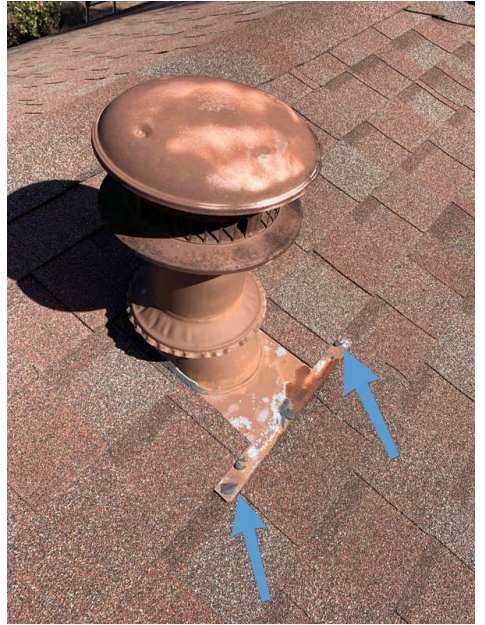
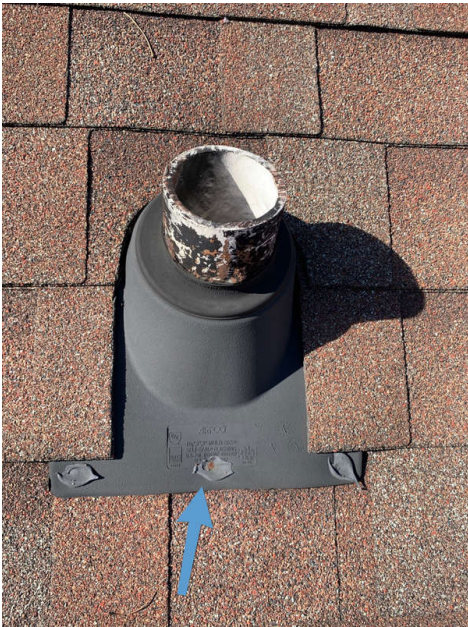
POSSIBLE WATER INTRUSION POINT

Possible water intrusion point where nail heads are exposed. Recommend sealing properly to prevent possible water intrusion and evaluate the other visible sealant and repair as needed.

Recommendation
Contact a qualified professional.

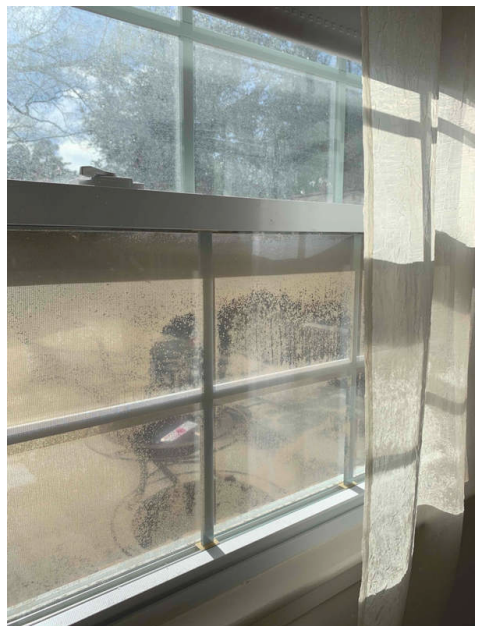
5.2.1 Windows
FAILED SEAL

Observed evidence of condensation between the window panes, which indicates a failed seal. Recommend qualified window contractor evaluate & replace.

Contact a qualified window repair/installation contractor.

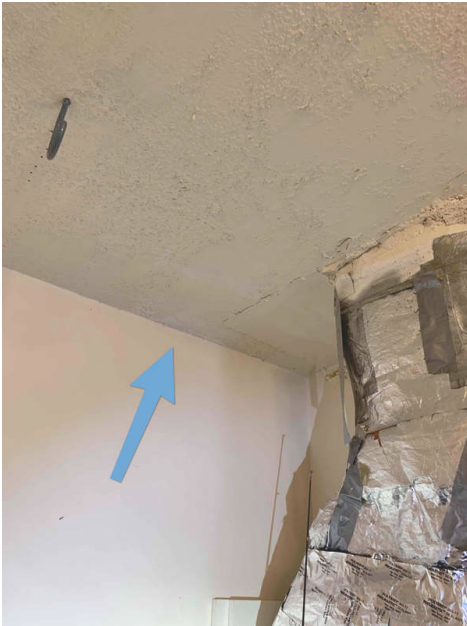
Back storage room

MOISTURE DAMAGE

Visible moisture stains in one or more locations. No signs of active during time of inspection due to dry weather conditions and moisture readings were within normal range so these are likely old issues and/or as a result from sweating/ air leakage around the duct penetrations. Recommend monitoring and repairing or replacing stained materials as needed.

Recommendation
Contact a qualified professional.

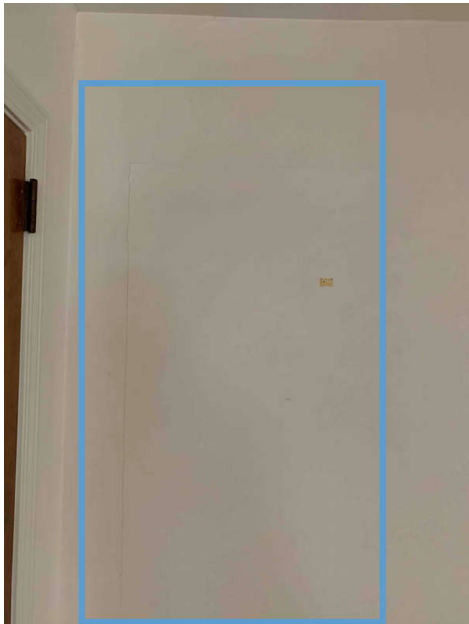
Where old front door used to be

DRYWALL CRACKING

Most likely due to expansion/ contraction of the material or initial settling of the home. No signs of active movement during time of inspection. Monitor for future movement and repair as needed.

Recommendation
Contact a qualified drywall contractor.

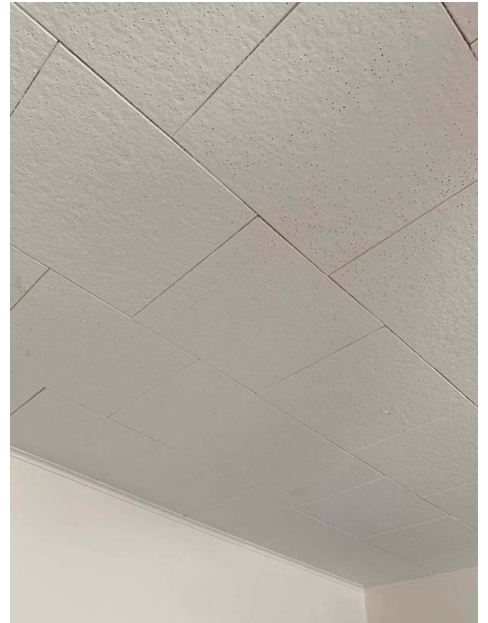
POSSIBLE ASBESTOS CEILING TILES

The original portion of the home has ceiling tiles throughout that may possibly contain asbestos materials because it was common practice at the time the home was built. Asbestos really only becomes a concern if the material is disturbed and the particles become airborne or breathable. Recommend sending a sample to the lab for testing to confirm.

Contact a qualified professional.

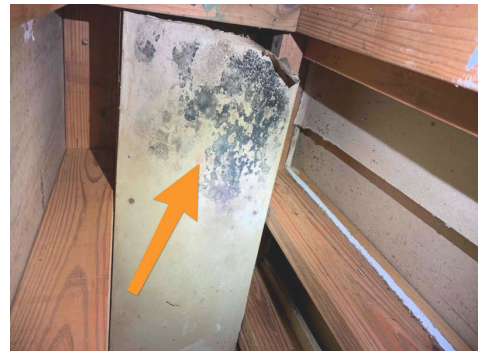
Access panel behind shower wall in MIL Bathroom

POSSIBLE MOLD GROWTH

Observed possible mold growth inside the small access panel behind the shower in the mother-in-law bathroom. Likely a result from moisture intrusion over the years and lack of ventilation. Recommend testing and sending samples to the lab to confirm and have a mold remediation professional properly remove.

Contact a qualified mold inspection professional.

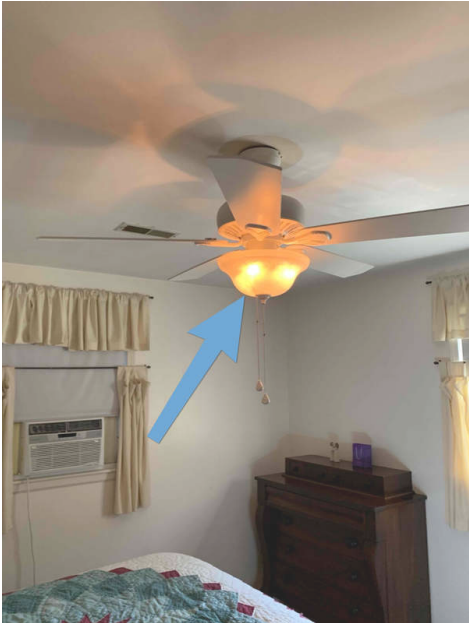
Back right bedroom front portion of home

DID NOT OPERATE

Fan did not operate during time of inspection. Recommend repair or replace by a qualified professional.

Recommendation
Contact a qualified professional.

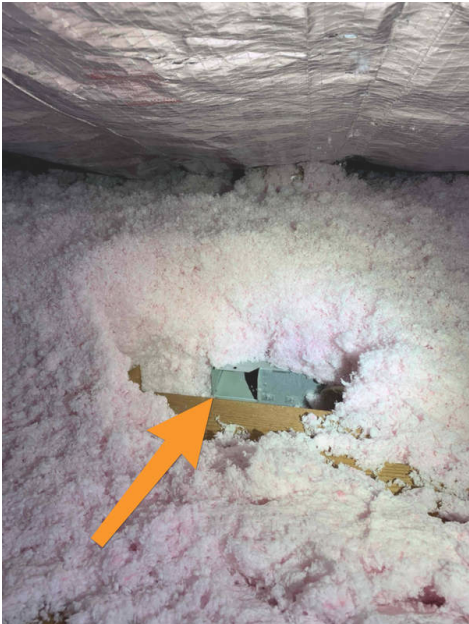
Guest Bathroom Front part of home

BATHROOM VENTS INTO ATTIC

Bathroom fan vents into the attic, which can cause moisture, increased humidity and possible mold growth Recommend a qualified professional properly terminate the exhaust to the exterior.

Recommendation
Contact a qualified professional.

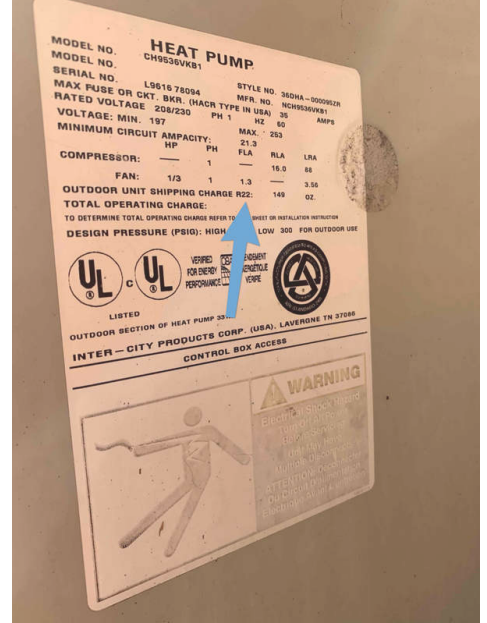
CONTAINS HCFC-22 OR R-22 REFRIGERANT

The AC unit contains HCFC-22 (commonly referred to R-22) refrigerant. This refrigerant is being phased out and will no longer be produced or imported in order to help protect the stratospheric ozone layer. Existing units can continue to use and be serviced with HCFC-22 (R-22) until inventory is depleted, but it may be expensive and/or difficult to obtain.

Contact a qualified HVAC professional.

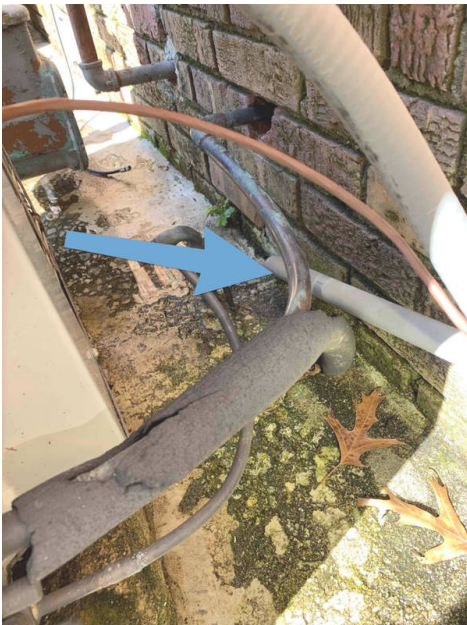
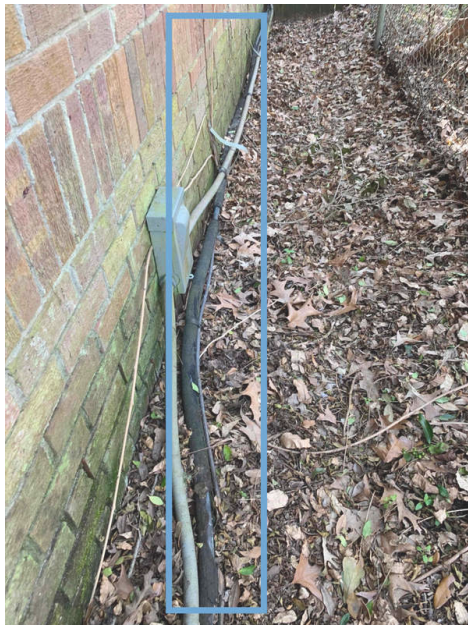
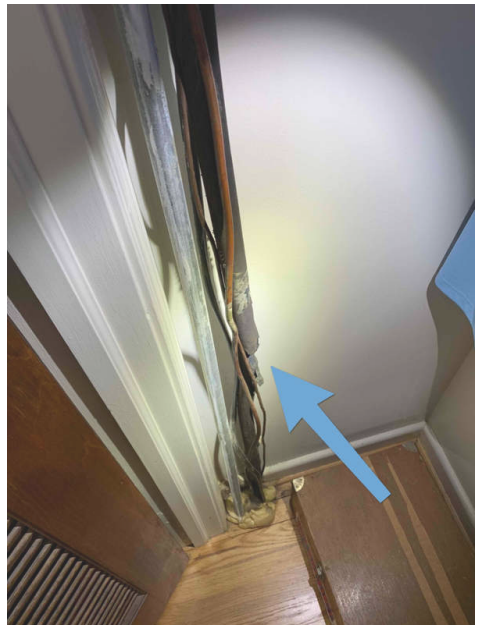
INSULATION DETERIORATING/ MISSING

Deteriorating/ missing insulation on refrigerant line can cause energy loss and condensation. Recommend replacing.

Contact a qualified HVAC professional.

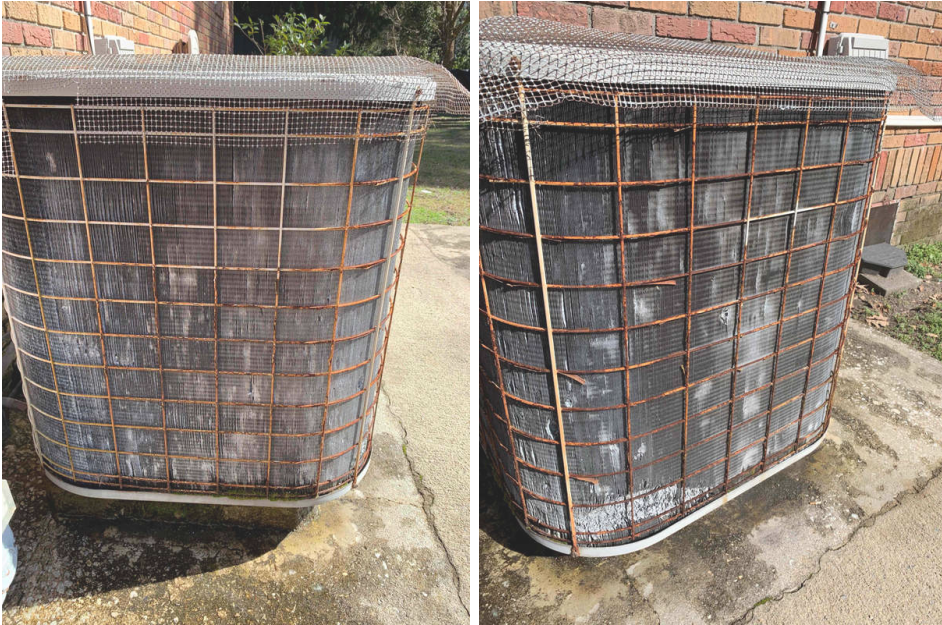
FINS DAMAGED

Bent/ Damaged fins can lead to reduced air flow hindering the efficiency of the unit. Recommend evaluation from a licensed HVAC contractor for replacement.

Contact a qualified HVAC professional.

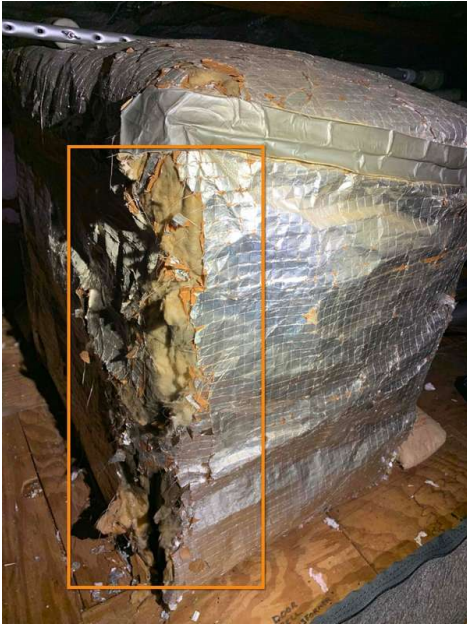
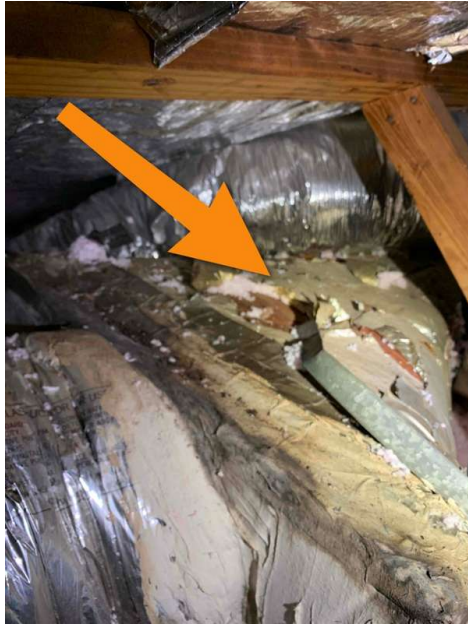
DUCTS INSULATION DETERIORATED

Deteriorated duct insulation was observed in one or more areas which could lead to duct leakage and reduced efficiency. Recommend licensed HVAC contractor repair or replace.

Contact a qualified HVAC professional.

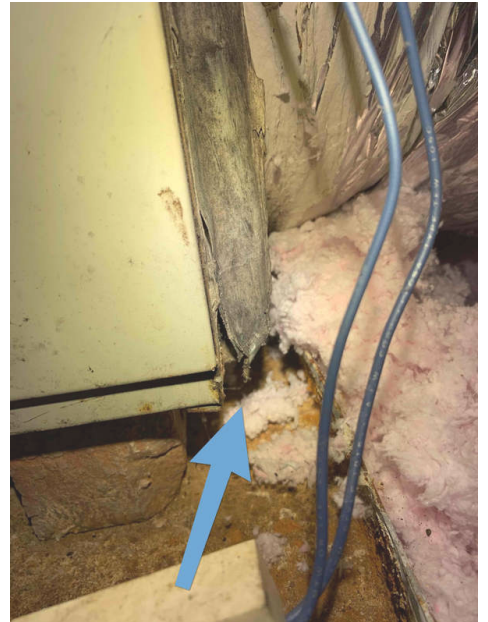
HEIL unit front right corner

RESEAL DUCT

Tape and mastic coming undone resulting in possible air leakage. Recommend a licensed HVAC contractor evaluate and reseal.

Contact a qualified HVAC professional.

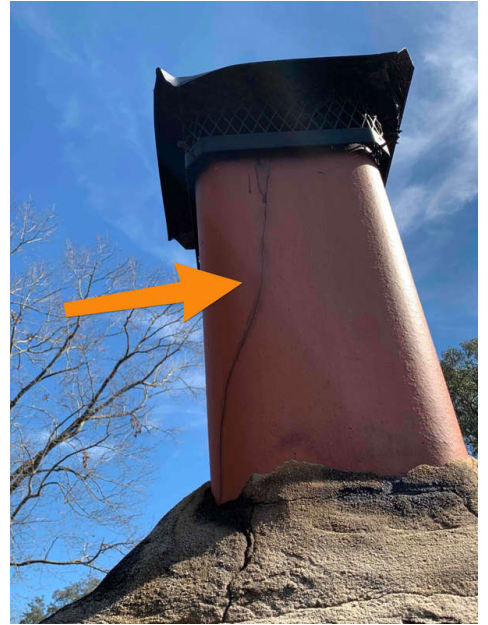
CHIMNEY FLUE CRACKED

The chimney flue had one or more cracks, which can lead to further damage to the chimney structure. Recommend a qualified contractor repair.

Contact a qualified roofing professional.

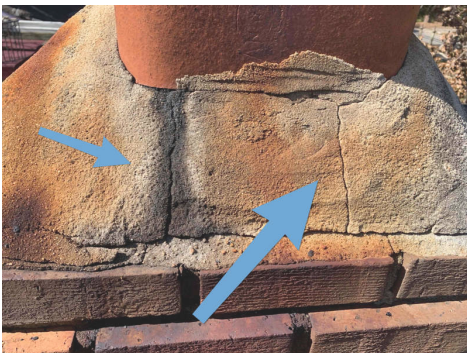
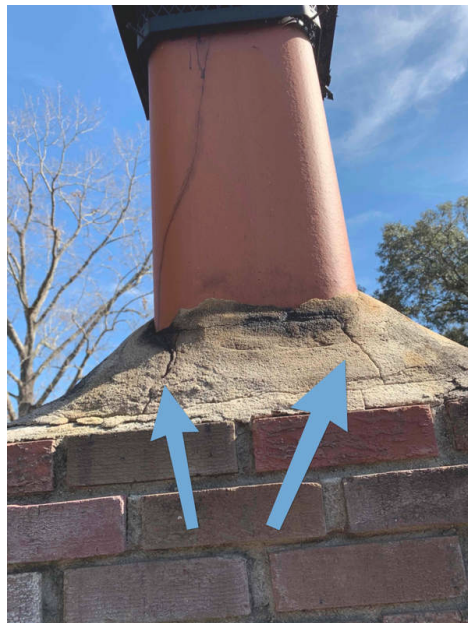
CHIMNEY CAP CRACKED

Chimney cap was cracked in multiple locations. This could allow water to seep through and leak down between the chase and flue causing interior damage. Recommend a licensed chimney contractor evaluate and repair or replace as needed.

Recommendation
Contact a qualified chimney contractor.

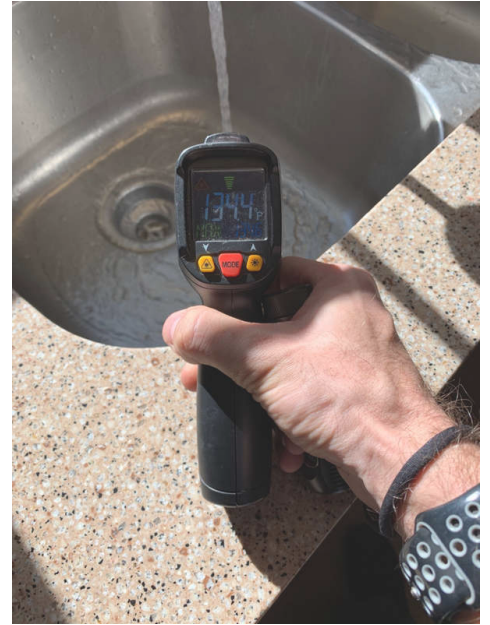
RECOMMEND REDUCING TEMP SETTING

Registered 134 degree water temperature coming from the kitchen sink. It is recommended the water heater temperature be set to 120 degrees F to reduce the risk of scalding.

Recommendation
Contact a handyman or DIY project

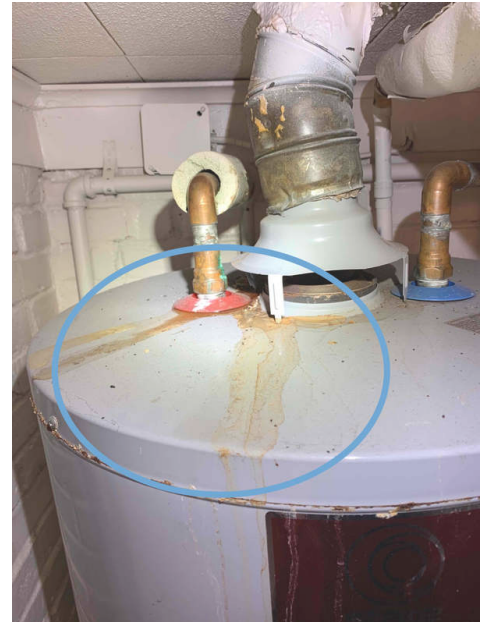
10.3.2 Water Heater
**BACKDRAFTING
PRESENT**

Backdrafting is when exhaust gases spill out into the room and around the water heater rather than safely leaving the house or outdoor structure. Recommend a qualified plumber evaluate the flue and repair as needed to ensure proper drafting takes place.

Recommendation
Contact a qualified plumbing contractor.

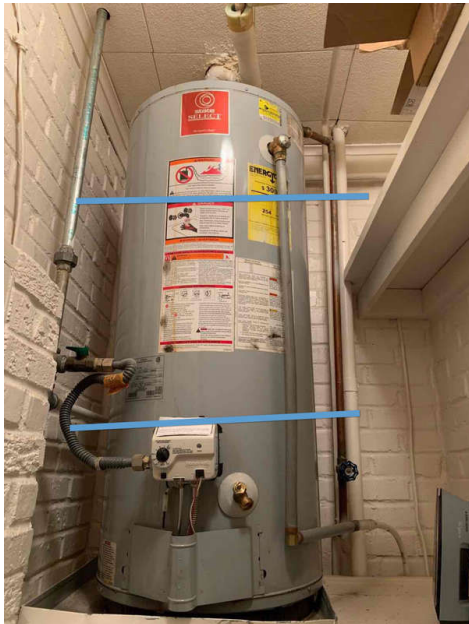
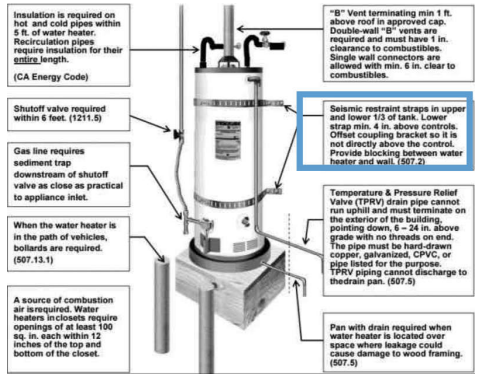
10.3.3 Water Heater
SEISMIC STRAPS MISSING

Water heater is missing seismic straps which are recommended for the area. Recommend a qualified professional install on the top and bottom third of the tank.

Recommendation
Contact a qualified professional.

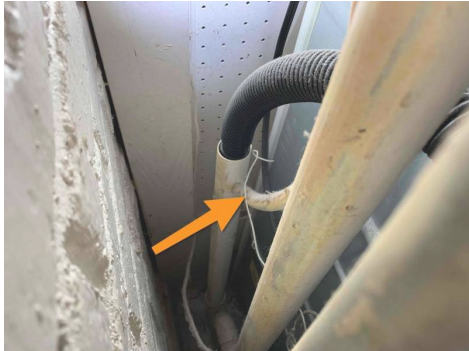
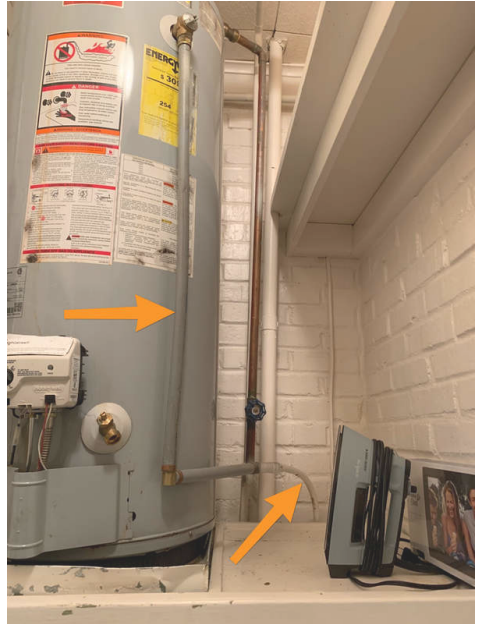
IMPROPER TPRV DISCHARGE PIPE SETUP

The Temperature Pressure Relief Valve (TPRV) connects directly to a drain line which is not proper. There is also a reduction in the diameter of the discharge line. The discharge pipe should remain the same diameter throughout. It should also discharge to the pan, then the pan terminate to the exterior or the discharge line should terminate to the exterior in a readily observable location in a manner that does not cause personal injury or structural damage. Recommend a licensed plumbing contractor evaluate and make the necessary repairs.

Recommendation
Contact a qualified plumbing contractor.

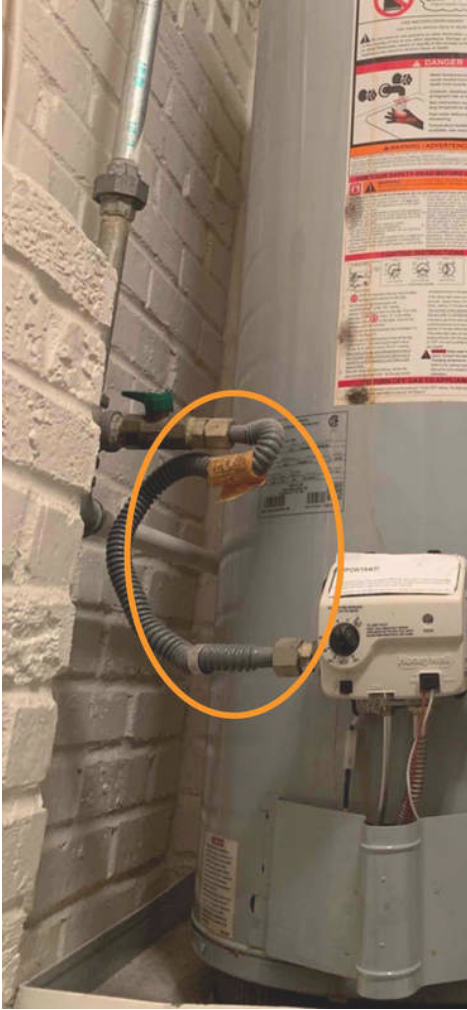
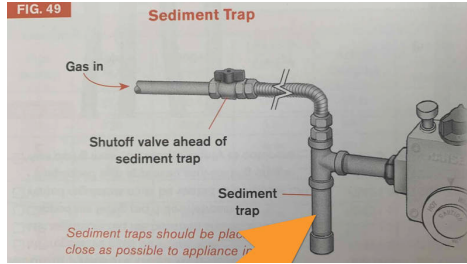
NO SEDIMENT TRAP

There is not a proper sediment trap located behind the shut off valve. They should be placed as close as possible to the unit. These help catch and prevent sediment in the gas from entering the unit potentially causing damage. Recommend a licensed plumbing professional repair.

Contact a qualified plumbing contractor.

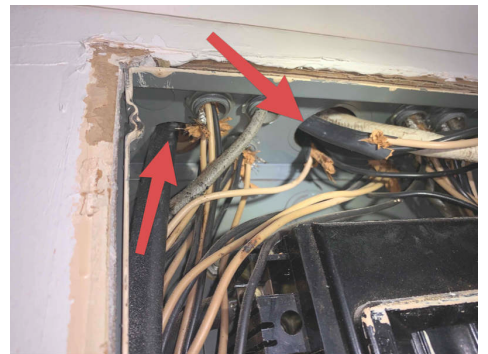
MISSING BUSHINGS

Wire bushings help protect the wire at the point where it enters the panel box. The edges around this area over time can cut into the wiring potentially causing a short or arc creating a potential fire hazard. Recommend a licensed electrician install.

Contact a qualified electrical contractor.

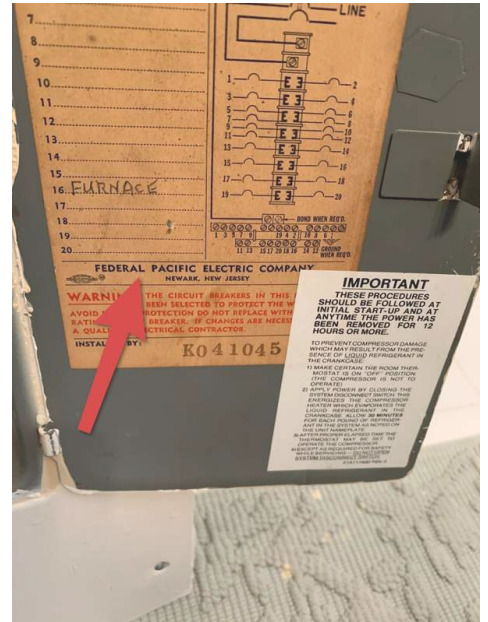
Servicing the original home

FEDERAL PACIFIC PANEL

Federal Pacific service panels are reputed to have a high rate of circuit breaker failure which can result in a fire or shock. Recommend a licensed electrician thoroughly and fully inspect the panel and providing further evaluation on possible panel replacement.

Contact a qualified electrical contractor.

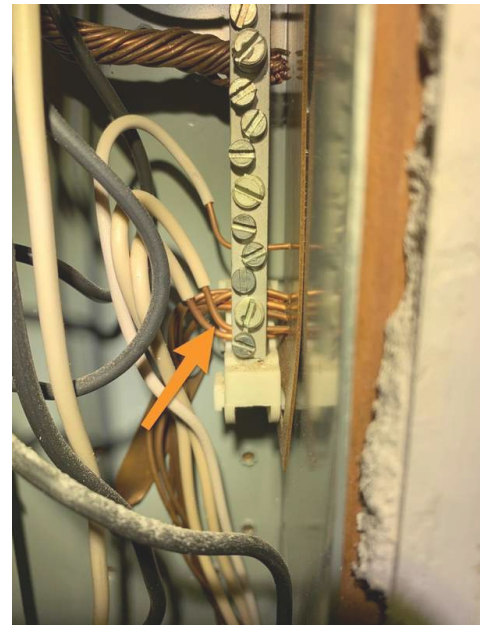
Panel Servicing Mother-In-Law suite

DOUBLE LUGGED NEUTRALS

Should not have more than one neutral under the same screw on the bus bar. This creates an issue if one of the circuits needs to be isolated. Neutral conductors can be current-carrying and can become loose over time producing heat and a potential fire hazard. Recommend qualified electrician evaluate and repair.

Contact a qualified electrical contractor.

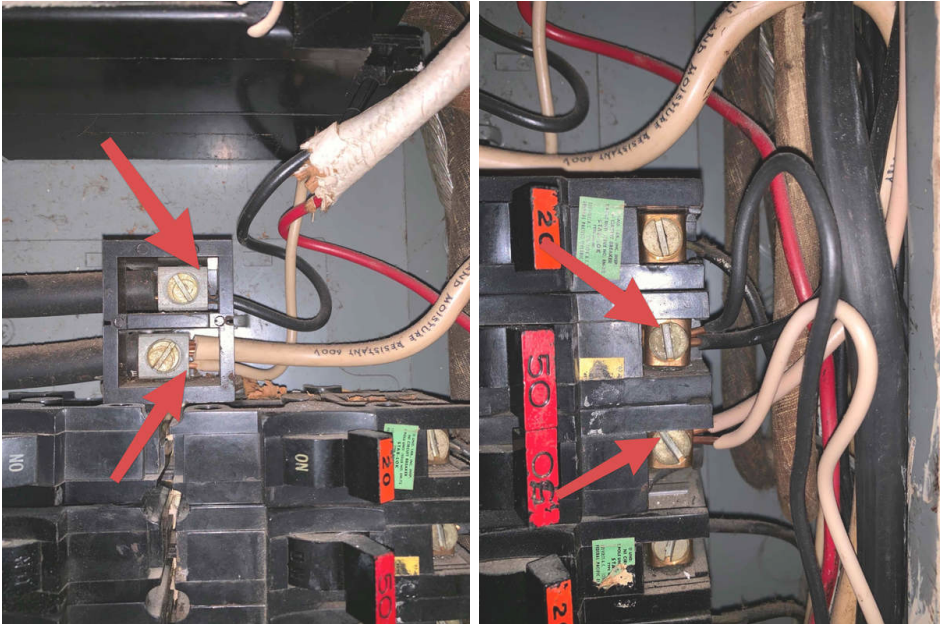
DOUBLE TAPPING/ DOUBLE/TRIPLE LUGGING

The circuit breaker and/or lug isn't designed to hold this many conductors. The conductors could come loose at some point in the future, even if they feel very tight today. Loose conductors can lead to overheating, arcing, and possibly a fire. Recommend a qualified electrician repair or replace.

Contact a qualified electrical contractor.

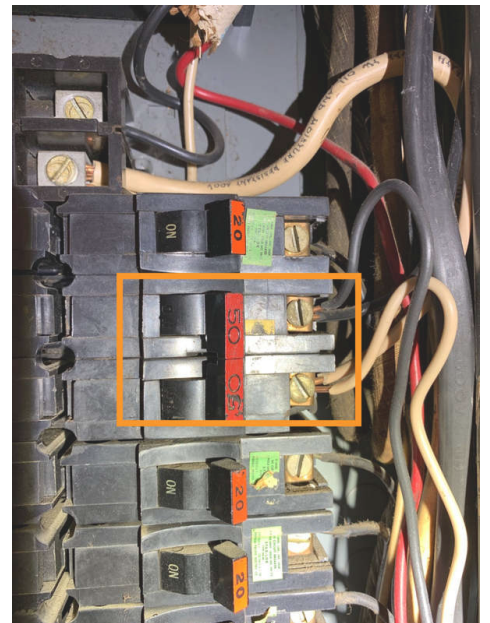
IMPROPERLY SIZED BREAKER

Per the manufacturer data plate the AC UNIT is allowed to have a maximum 35 amp breaker installed as over current protection. There is a 50 amp breaker currently installed. This breaker may have been properly size with the old AC unit. Recommend a licensed electrician replace.

Contact a qualified electrical contractor.

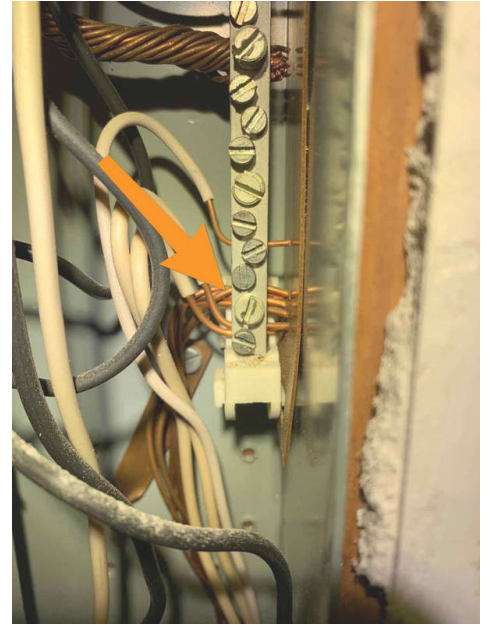
Back panel

TOO MANY GROUNDS UNDER SAME SCREW

Typically a maximum of 2-3 grounds are allowed to be under the same screw on the grounding bus bar depending on wire size. Data label does not specify the maximum number allowed under one screw. Recommend a licensed electrician evaluate and repair as needed.

Recommendation
Contact a qualified electrical contractor.

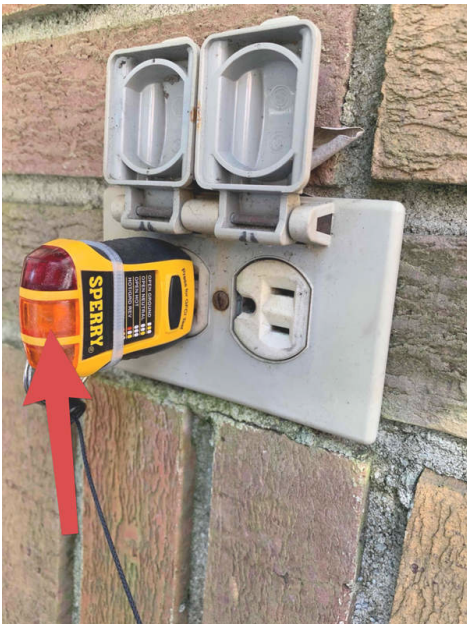
Back patio left of right door

OPEN GROUND

Appears that the original portion of the home and a couple other receptacles do not have grounded receptacles. Original cloth wiring installed during this time period typically only had a hot and neutral conductor. With the upgraded 3 prong receptacles this is deceiving making the occupant believe that a ground is present and protecting the circuit when there is not. Recommend a licensed electrician evaluate and repair to help prevent possible shock, injury or damage to equipment.

Recommendation
Contact a qualified electrical contractor.

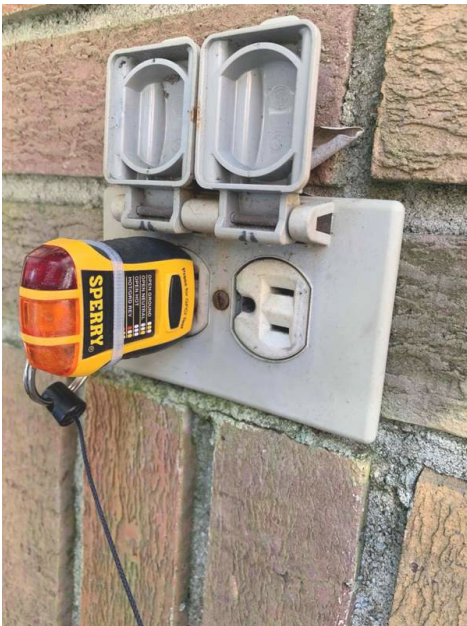
Back patio left of right door

NO GFCI PROTECTION INSTALLED

No GFCI protection present in all locations where the receptacle could come in contact with water or other liquid. Potential safety hazard.

Recommend licensed electrician upgrade by installing ground fault receptacles or breakers for locations specified: **OUTSIDE, BATHROOM, KITCHEN receptacles.**

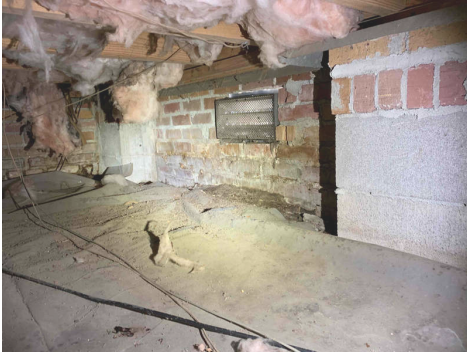
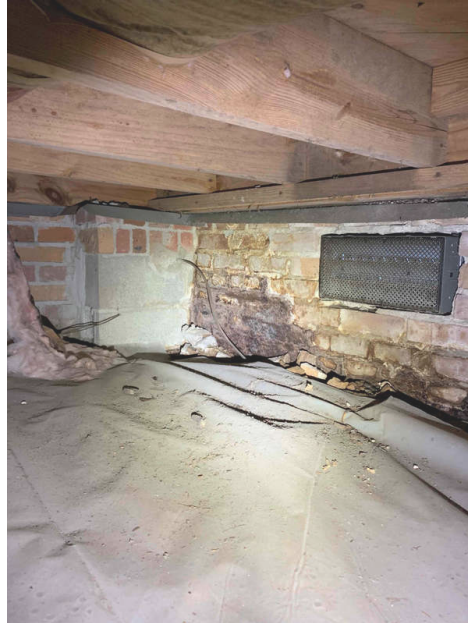
EFFLORESCENCE/ MOISTURE INTRUSION

Efflorescence noted on the crawlspace surface in one or more locations. This a white, powdery deposit that is consistent with long term moisture intrusion. This can compromise the soil's ability to support the home structure and/or lead to mold growth. No other signs of inadequate drainage or grading issues present on the day of inspection. Recommend a qualified foundation contractor evaluate and provide a solution to reduce the moisture entering the crawlspace.

Contact a qualified professional.

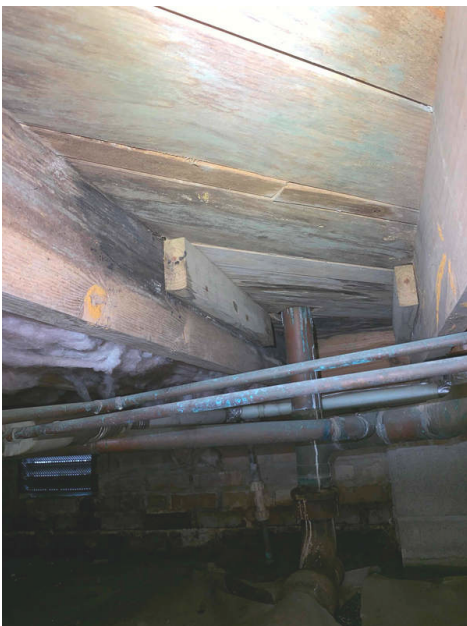
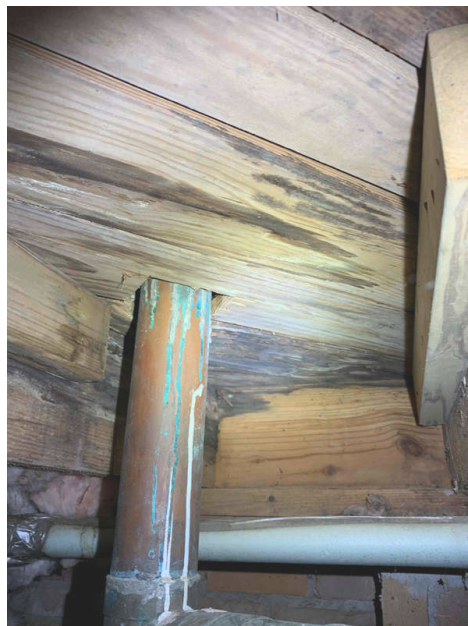
MOISTURE INTRUSION/ WOOD ROT

Observed one or more areas where there were signs of moisture intrusion and rotting on the subfloor and neighboring joists. Did not see any signs of active leaking at time of inspection. Moisture readings were moderately high, around 15-17%. Recommend a qualified contractor evaluate further and identifying the moisture intrusion point, repairing and replace the damaged/ rotted subfloor and joist.

Contact a qualified general contractor.
