**SUMMARY**  
1234 Main St. Merrimack NH 03054  
Buyer Name  
03/13/2019 9:00AM

Chris Caisse  
InterNACHI Certified...  
Platinum Home Inspections  
603.897.5495

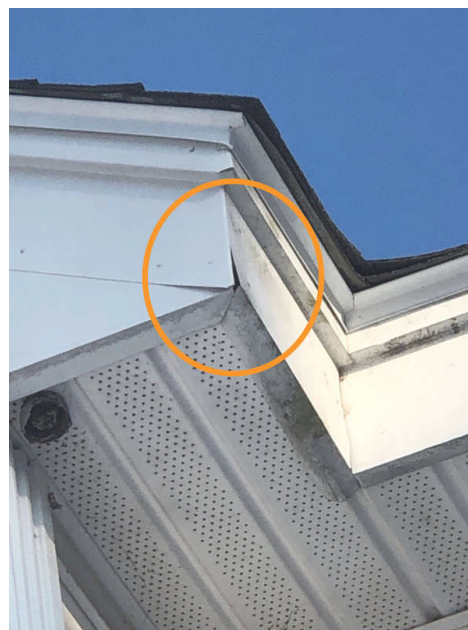
### 2.4.1 Eaves, Soffits & Fascia

#### **GAP**

There is opening, gap or hole in fascia / soffit which should be repaired. This can allow water intrusion and rodent infestation as well as deterioration of the surrounding material.

Contact a qualified roofing professional.

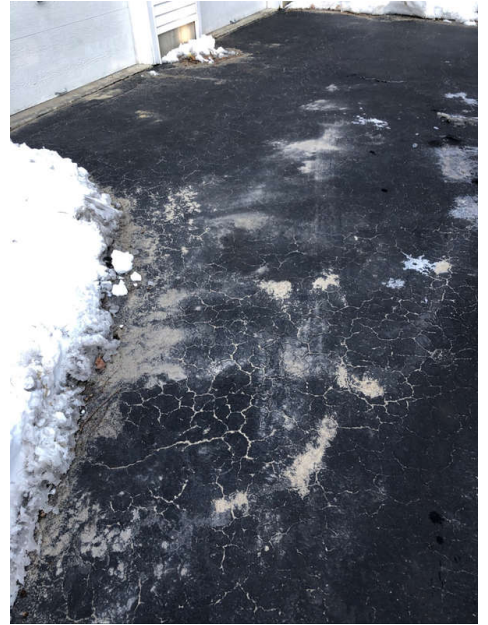
### 3.2.1 Walkways, Patios & Driveways

#### **ASPHALT DRIVEWAY - TYPICAL CRACKING**

Asphalt driveway... this material has typical cracking which is normal for its age recommend seal coating as needed to prolong life expectancy.

Contact a qualified professional.

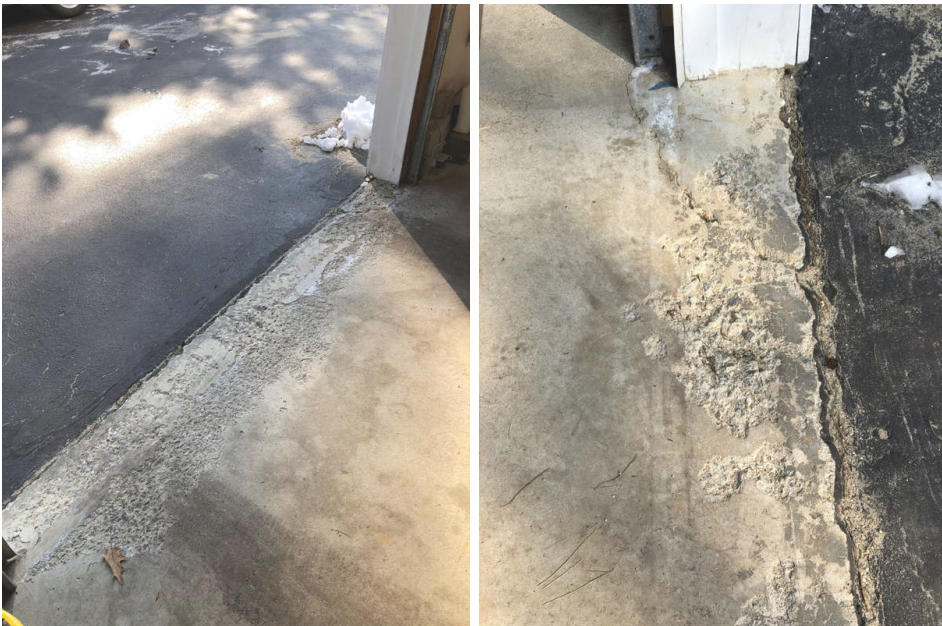
#### 4.2.1 Floor

### CRACKING / SPALLING

Typical cracking/settlement observed in concrete. If trip hazards become present, recommend licensed contractor to repair to prevent injuries.

Contact a qualified concrete contractor.

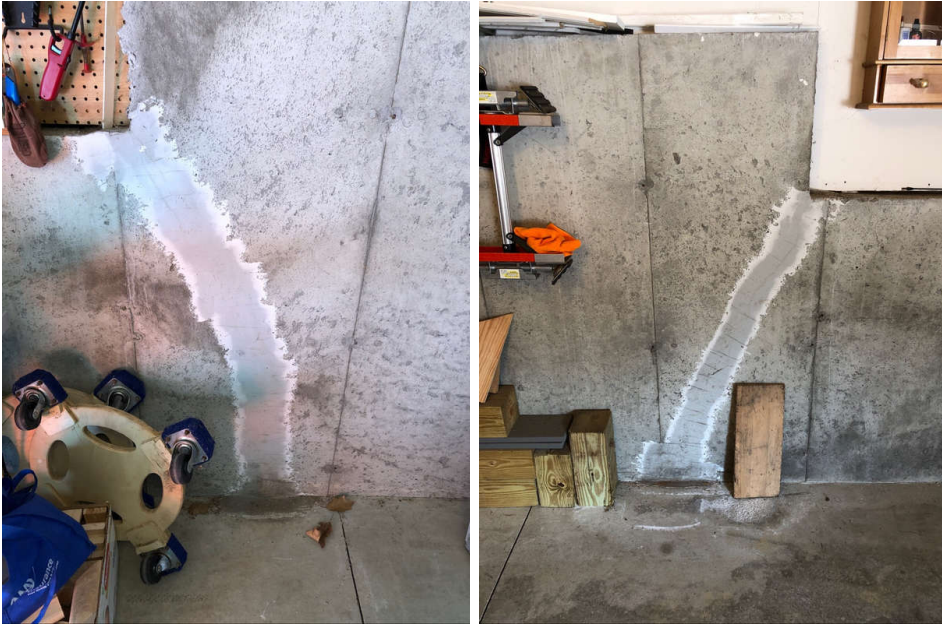
#### 4.3.1 Walls & Firewalls

### REPAIRED STRUCTURE

Garage shows history of movement, which has recently been repaired. Recommend monitoring for future movement and possible moisture intrusion.

Recommend monitoring.

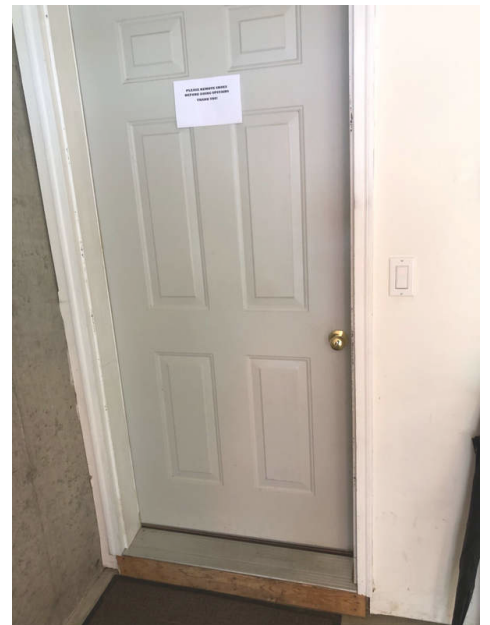
4.5.1 Occupant Door (From garage to inside of home)  
**NOT SELF-CLOSING**

Door from garage to home should have self-closing hinges to help prevent spread of a fire to living space. Recommend a qualified contractor install self-closing hinges.

Recommendation  
Contact a qualified door repair/installation contractor.

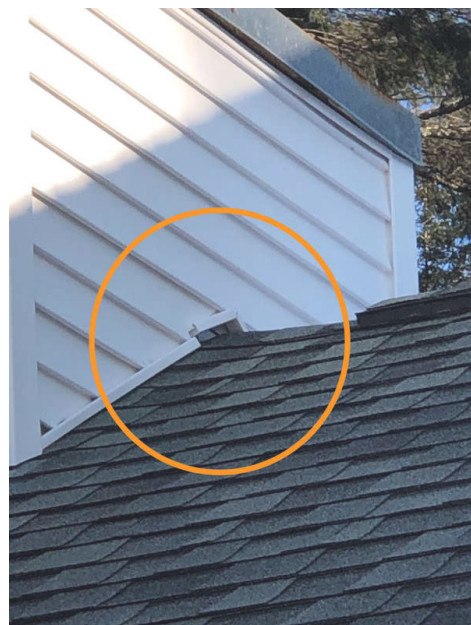
5.1.2 Siding, Flashing & Trim  
**GAPS IN SIDING MATERIAL**

A Gap in siding/trim was observed at the chimney side of the home. This shouldn't be an issue as the proper flashing is present underneath.

Recommendation  
Contact a qualified siding specialist.

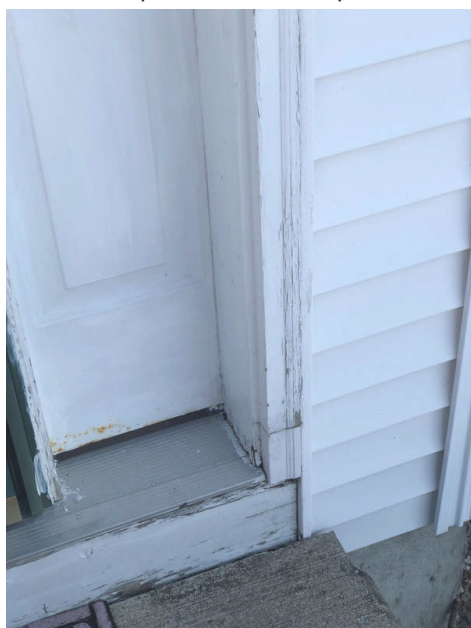
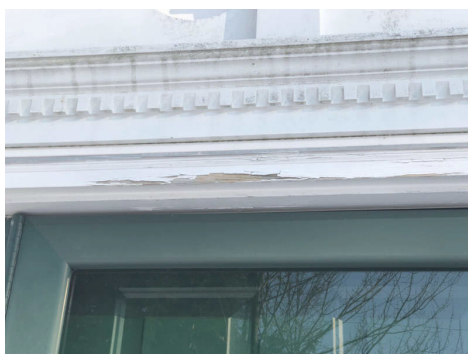
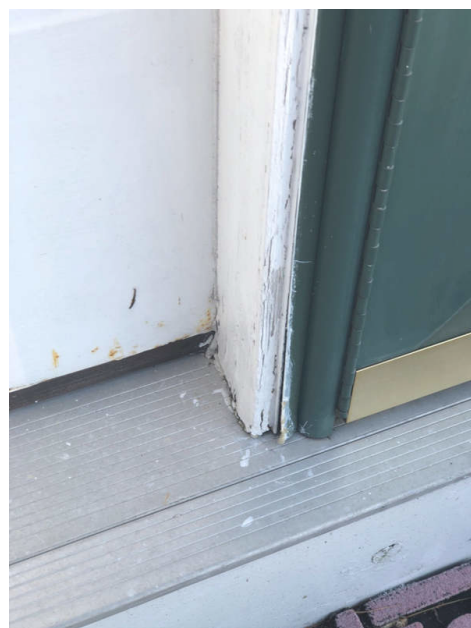
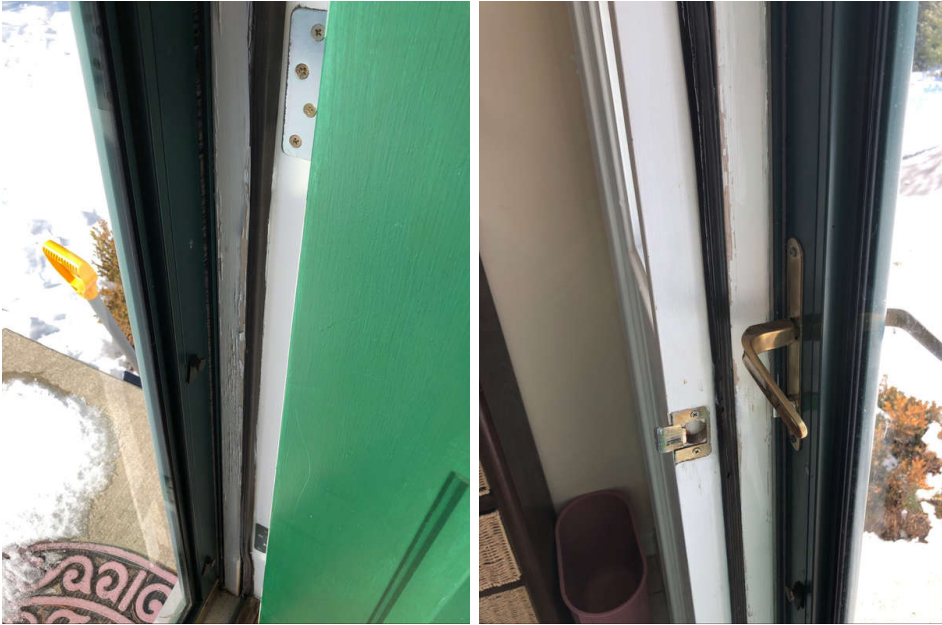
### 5.3.1 Exterior Doors

#### **PAINT/REFINISH NEEDED**

Door finish is worn. Recommend refinish and/or paint to maximize service life.

Recommendation  
Contact a qualified door repair/installation contractor.

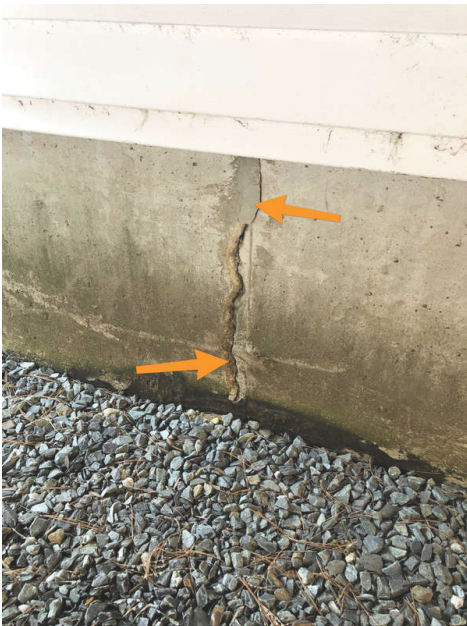
Under Deck

5.5.1 Exterior foundation  
**TYPICAL CRACKING**

Exterior foundation contains typical cracks due to shrinkage and normal freeze thaw cycle. Recommend patching as needed to prevent moisture intrusion.

Recommendation  
Contact a foundation contractor.

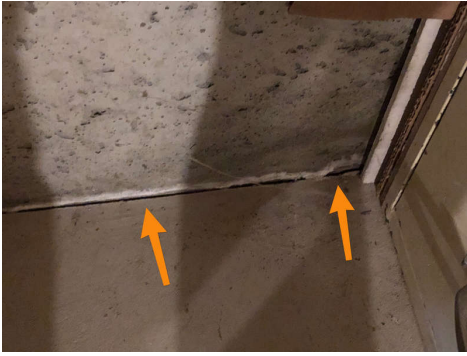
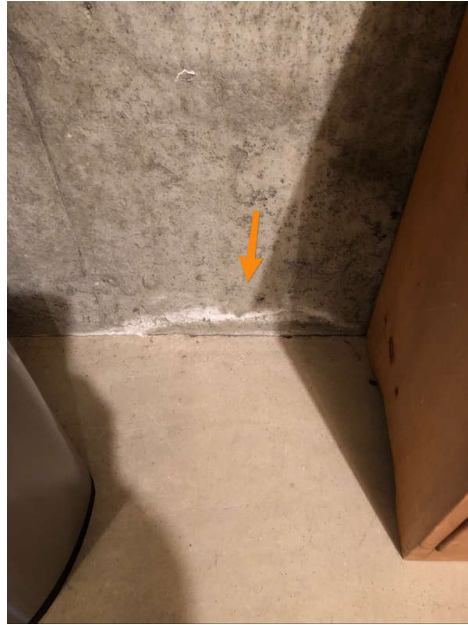
6.2.1 Foundation  
**EFFLORESCENCE**

Evidence of efflorescence was observed on foundation walls/floor. This is an indication of moisture intrusion. Recommend maintaining proper grading, clean (or add) gutters to prevent moisture intrusion. Seal or repair as needed.

Recommendation  
Contact a foundation contractor.

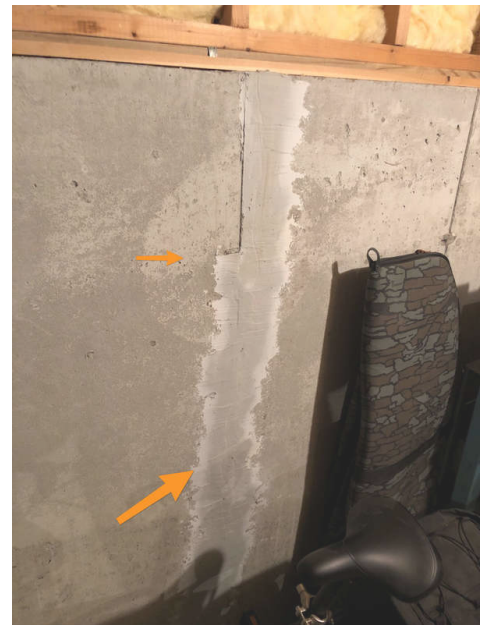
### 6.2.2 Foundation

## FOUNDATION REPAIR

Foundation shows evidence of a previous repair. This may have been a repair of typical shrinkage cracks. No structural damage was observed.

Recommendation  
Recommend monitoring.

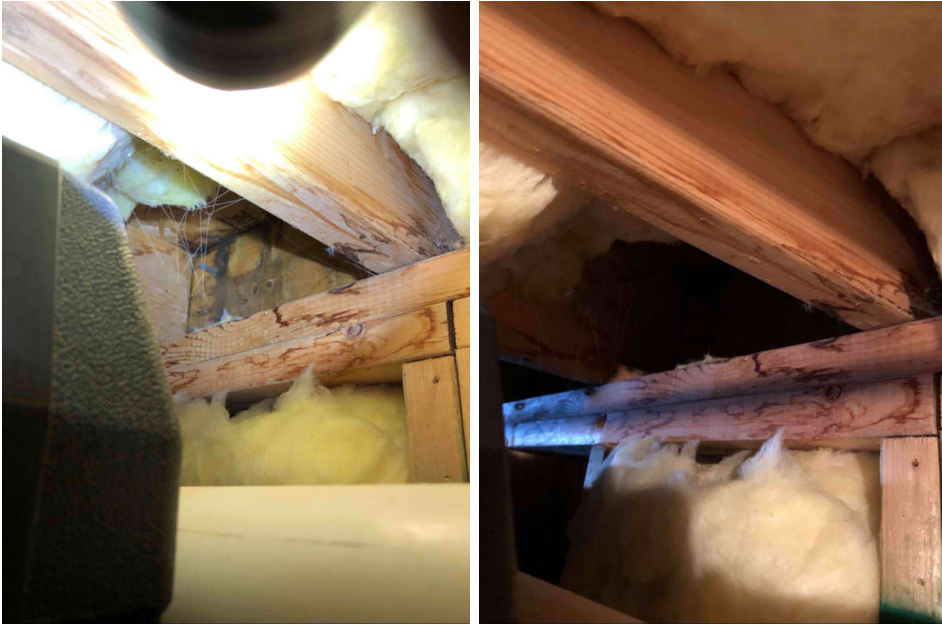
### 6.3.1 Floor & Ceiling Structure

## EVIDENCE OF PRIOR WATER / MOISTURE

There were signs of past water intrusion in the underlying floor structure. This area was dry at the time of inspection. Recommend monitoring and identifying source of moisture and repairing if continues.

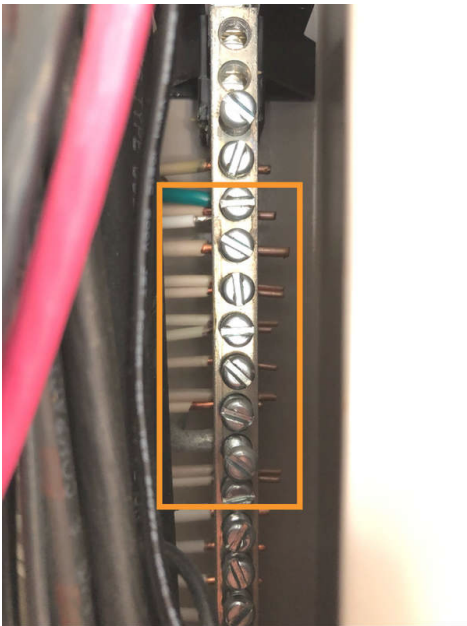
7.1.1 Main & Subpanels, Service & Grounding, Main Overcurrent Device

**DOUBLE TAPS**

Double tapped neutrals at the electrical panel should be repaired by a licensed electrician.

Recommendation  
Contact a qualified professional.

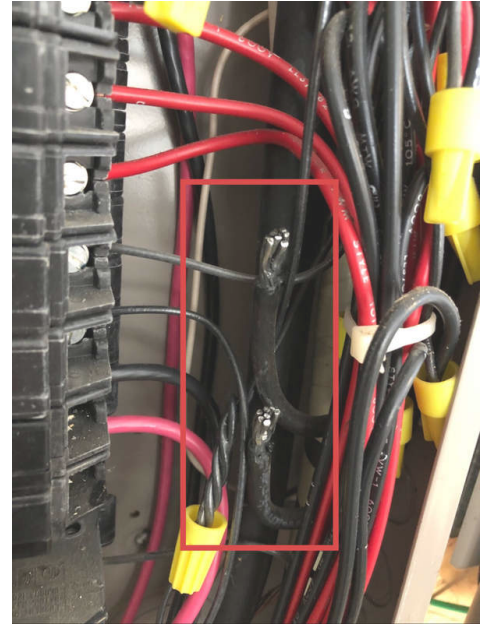
7.1.2 Main & Subpanels, Service & Grounding, Main Overcurrent Device

**UNSAFE ELECTRICAL WIRING OBSERVED**

Evidence of a live disconnected electrical conductor was observed this is a safety hazard recommend licensed electrician to repair to prevent possible injury

Recommendation  
Contact a qualified electrical contractor.

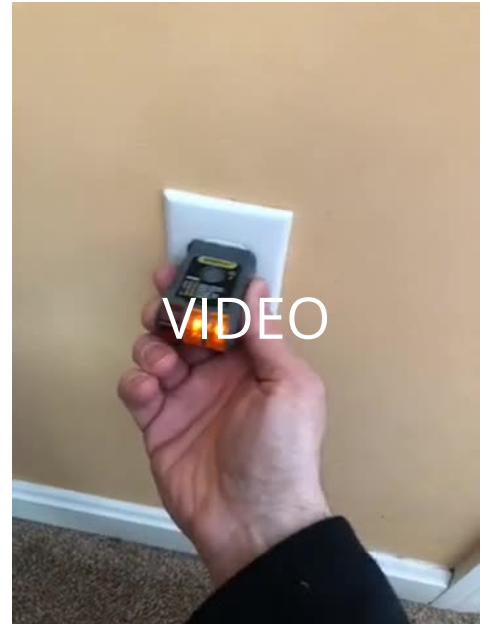
7.3.1 Electrical Fixtures,  
Switches and Receptacles  
**LOOSE RECEPTACLE**

receptacle is not secured to the electrical box.

Recommendation  
Contact a qualified professional.

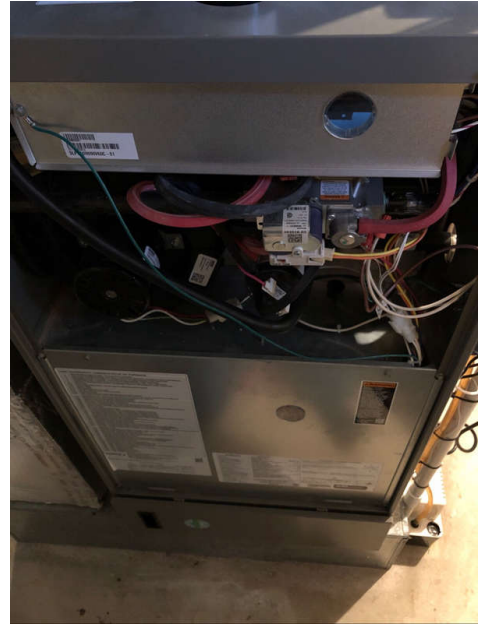
8.1.1 Heating Equipment  
**SEALED CHAMBER**

The furnace was a high-efficiency system and had a sealed combustion chamber which would require invasive measures which lie beyond the scope of the General Home Inspection to inspect. The Inspector recommends that an evaluation be performed by a qualified heating, ventilation and air-conditioning (HVAC) contractor.

Recommendation  
Contact a qualified HVAC professional.

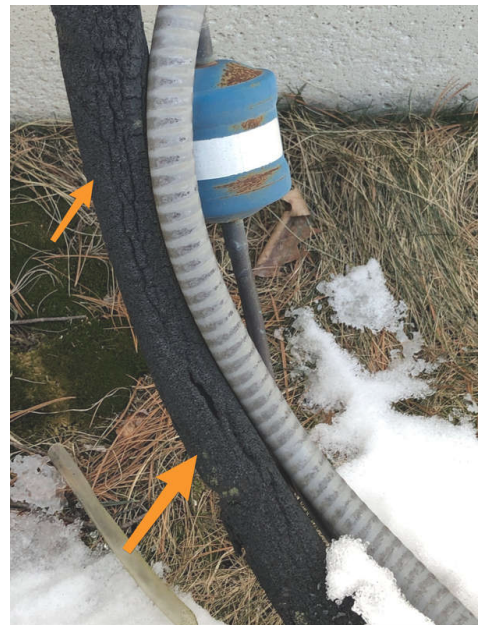
### 8.2.1 Cooling Equipment **INSULATION MISSING OR DAMAGED**

Missing or damaged insulation on refrigerant line can cause energy loss and condensation.

Recommendation  
Contact a qualified HVAC professional.

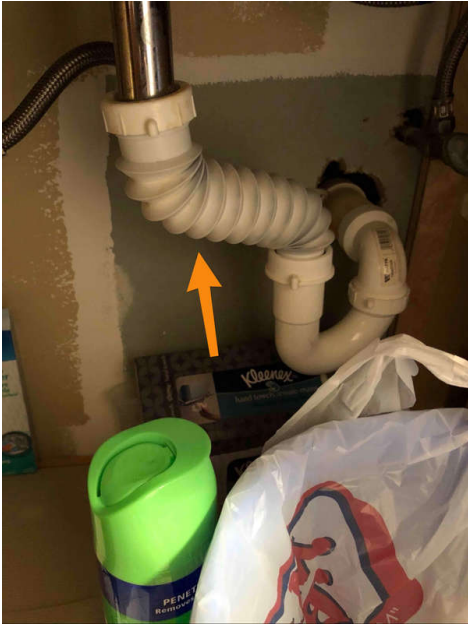
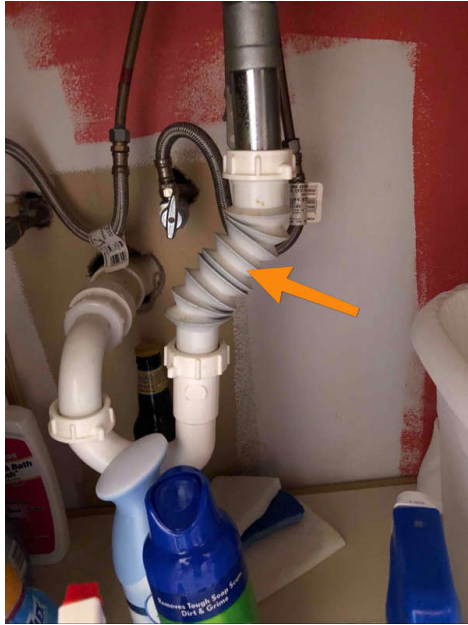
### 9.4.1 Drain, Waste, & Vent Systems (DWV) **ACCORDIAN DRAIN PIPE**

Bathroom drains have accordion style drain pipe present. This style of pipe is not recommend as the zig zag style of pipe can trap hair and gunk as well as slow down the flow of water.

Recommendation  
Contact a qualified plumbing contractor.

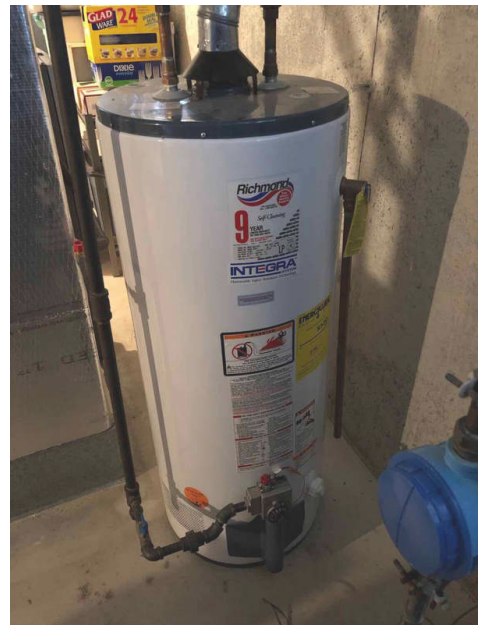
9.5.1 Water Heater System,  
Controls, Flues & Vents  
**NEAR END OF LIFE**

Water heaters have an average life span of 10 years. While operating as it should at the time of inspection, this water heater is approaching normal life expectancy. Recommend budgeting for replacement.

Recommendation  
Contact a qualified plumbing contractor.

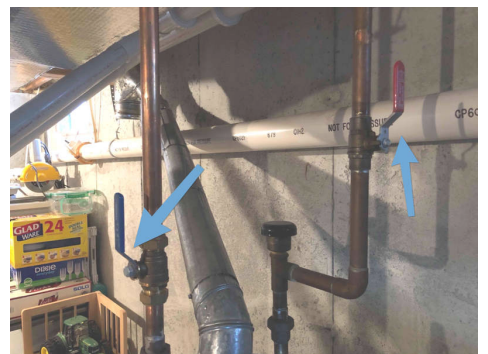
9.5.2 Water Heater System, Controls, Flues & Vents

**HOT/COLD BALL VALVES REVERSED**

The hot and cold ball valves are reversed. The red valve is on the cold water side and the blue on the hot water pipe.

Recommendation  
Contact a qualified professional.

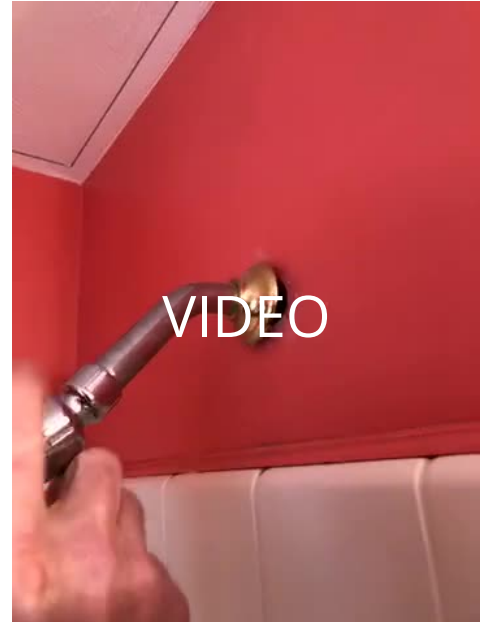
10.4.1 Fixtures, Toilets, Tubs & Showers

### **SHOWER HEAD LOOSE**

Master Bathroom shower piping is loose. Recommend filling the back with spray foam which will insulate and keep the shower head pipe in place.

Contact a qualified professional.

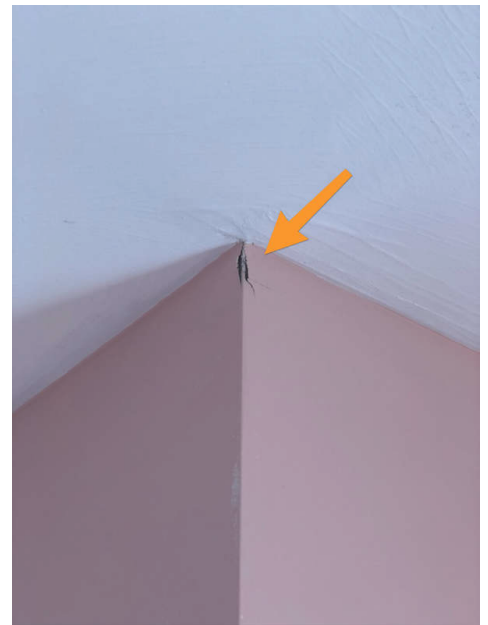
Master Bedroom

### **MINOR CORNER CRACKS**

Minor cracks in walls appeared to be the result of long-term settling. Some settling is not unusual in a home of this age and these cracks are not a structural concern.

Contact a qualified professional.

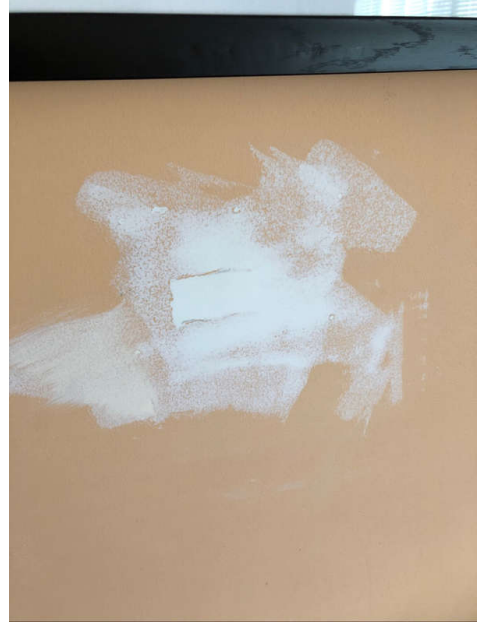
11.5.2 Walls and Ceilings

### **UNFINISHED**

Observed section of drywall in the family room to have been patched but has not been sanded and painted.

Contact a handyman or DIY project

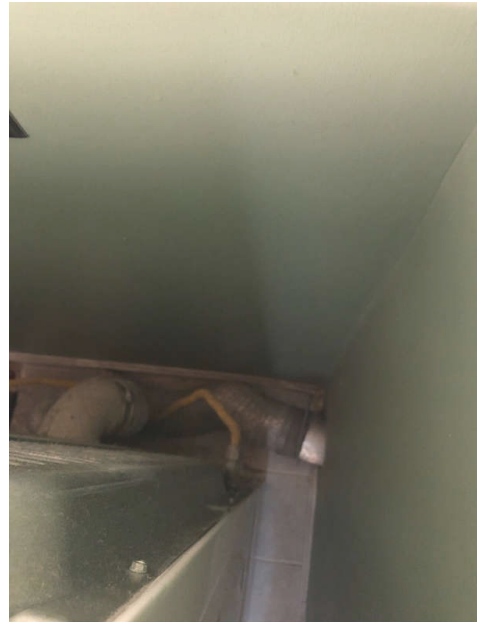
### 12.1.1 Washer/Dryer **RIBBED FOIL VENT**

The dryer was vented using a flexible, ribbed, foil-like vent that is not approved by the Underwriter's Laboratory (UL). This type of dryer exhaust vent is more likely to accumulate lint than a smooth metal vent, creating a potential fire hazard. Excessive lint accumulation can also increase drying time and shorten the dryer's lifespan. The Inspector recommends replacing this plastic vent with a properly-installed, UL-approved dryer vent. All work should be performed by a qualified contractor.

Recommendation  
Contact a handyman or DIY project

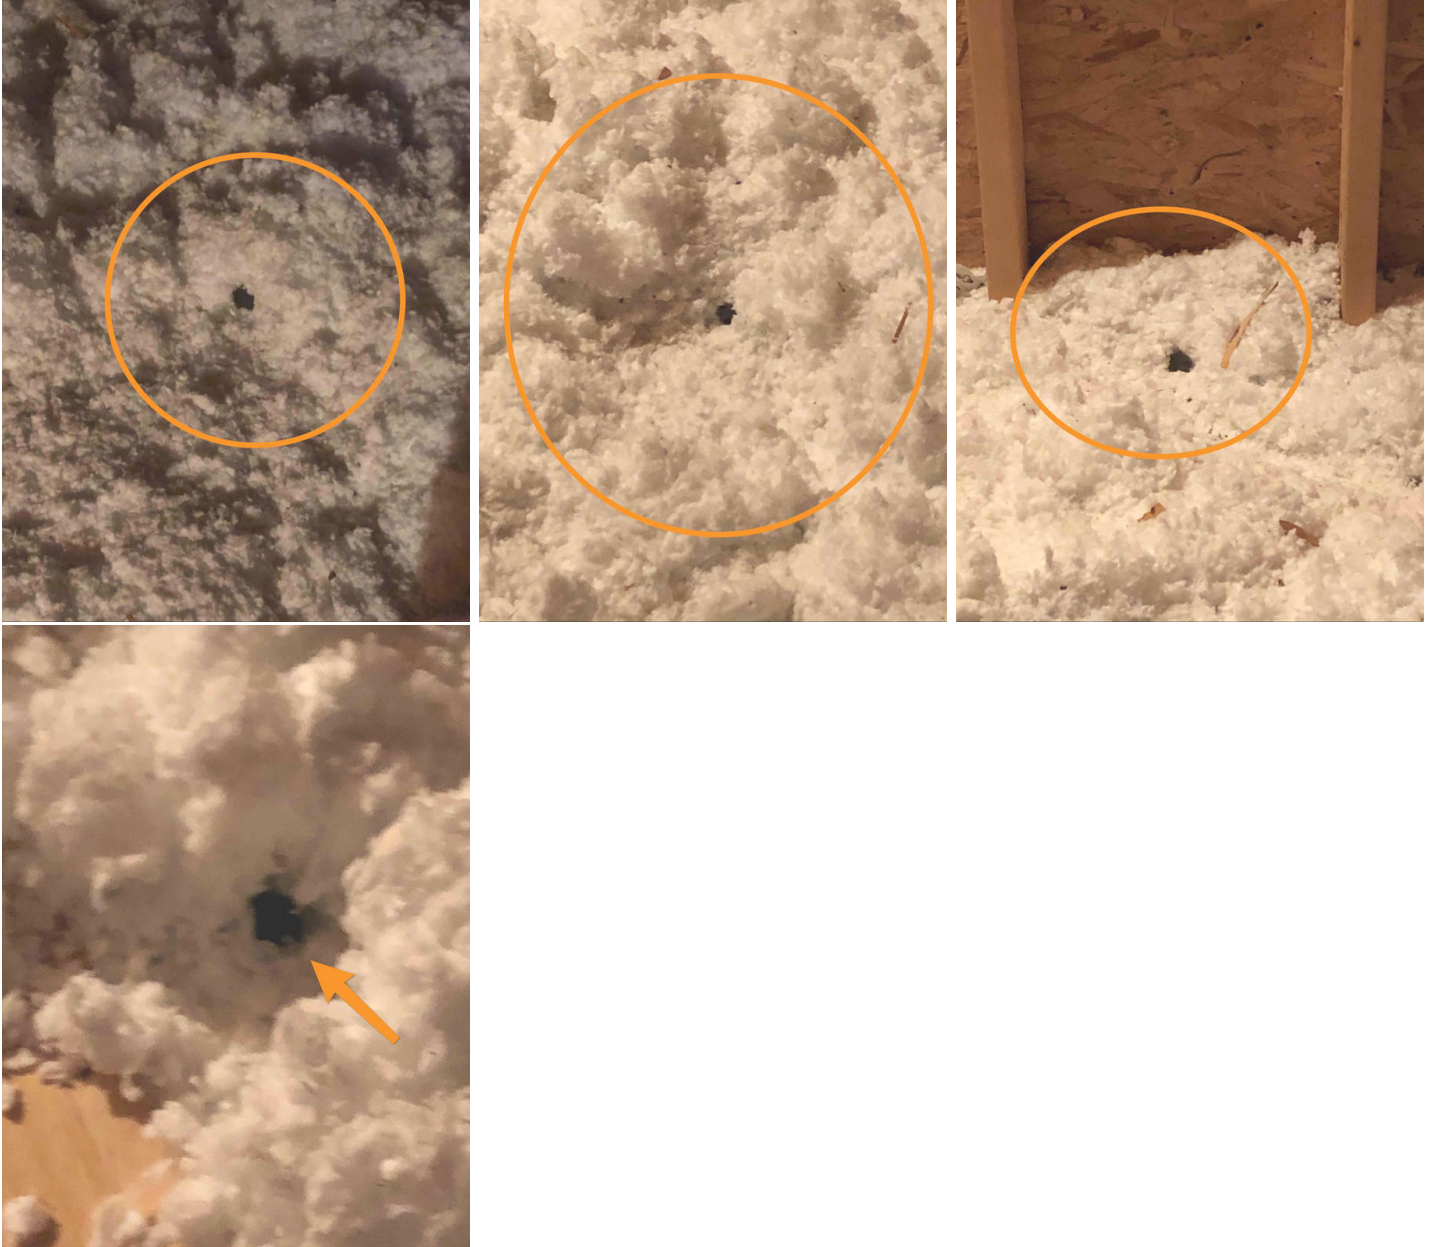
### 16.2.1 Attic Insulation

#### PEST

Evidence of pest and or rodent nesting was observed in attic area, recommend licensed pest control contractor to evaluate and repair as needed.

Contact a qualified pest control specialist.

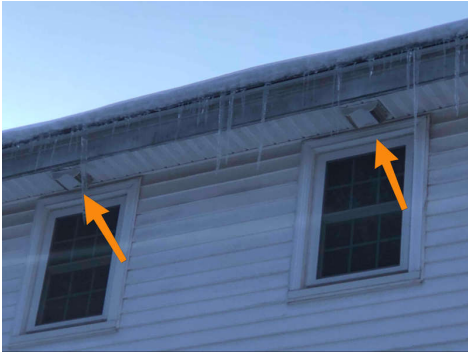
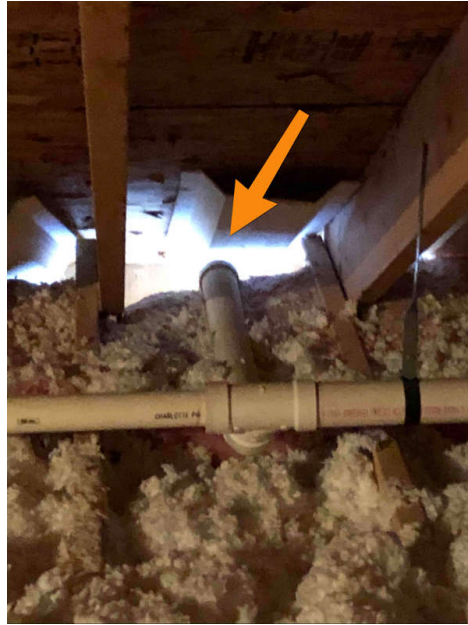
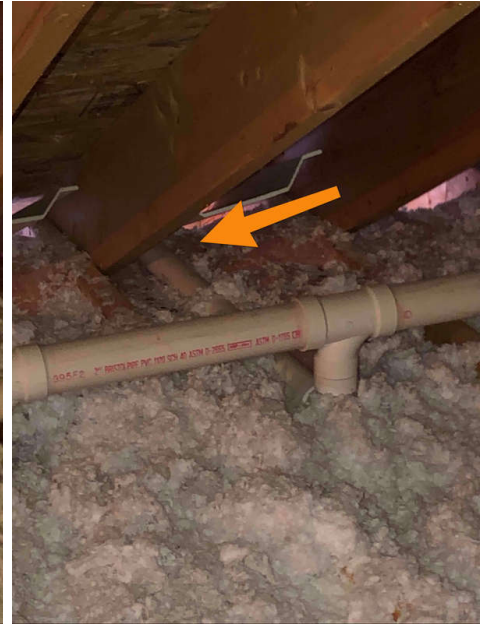
### 16.3.1 Ventilation

#### EXHAUST DUCTS TO SOFFIT

One or more exhaust fan ducts terminated at a soffit vent rather than at a dedicated hood or cap. Soffit vents are designed to allow cool air to be drawn into the attic, and to prevent excess moisture from accumulating in the attic. When such ducts are routed to terminate at soffit vents, the moist exhaust air may flow back into the attic and the soffit venting will be reduced. Recommend that a qualified contractor repair per standard building practices. For example, by installing approved hoods or caps at the roof surface or exterior wall(s), and permanently securing exhaust ducts to them.

Contact a qualified professional.

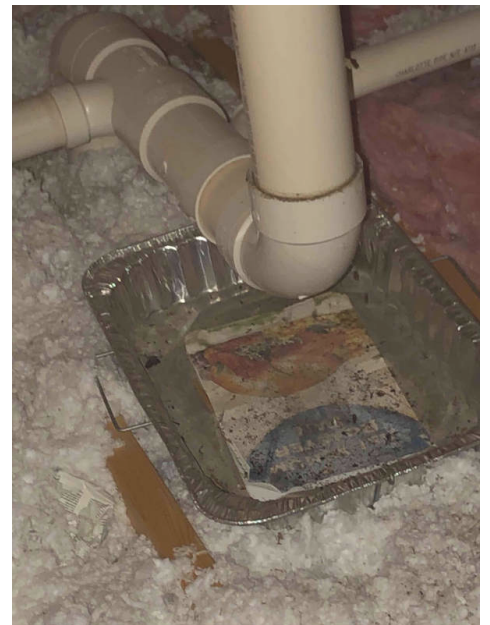
16.3.2 Ventilation

**PAN PRESENT UNDER EXHAUST**

Observed a foil pan present underneath the exhaust for the kitchen sink. The pan is dry and no moisture is present. Recommend asking the home owner what this may have been for??
