**SUMMARY**  
1234 Main St. Jenison Michigan 49428  
Buyer Name  
11/08/2018 9:00AM

Michael Moores  
InterNACHI Certified Home Inspector  
Veteran Inspections & Services  
(616) 379-9388  
michael@veteraninspection.com

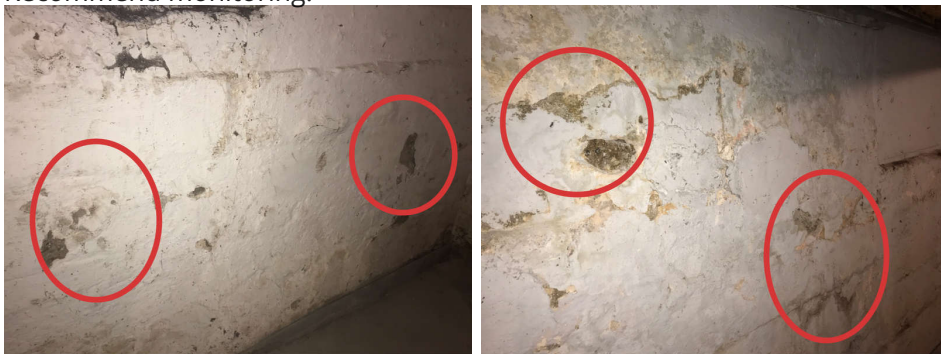
### INTERIOR CRUMBLING/SPALLING

Some interior foundation walls are crumbling/spalling due to moisture intrusion. Some possible fixes are ensuring proper gutter drainage as well as ensuring landscaping near the home is sloped in such a way as to direct water away from the foundation will help prevent excessive water from penetrating into the bricks/blocks. The placement of one or more dehumidifiers to assist in removing moisture in the air is also recommended.

If the concrete continues to deteriorate further evaluation and/or repair by a foundation specialist is recommended.

Recommendation  
Recommend monitoring.

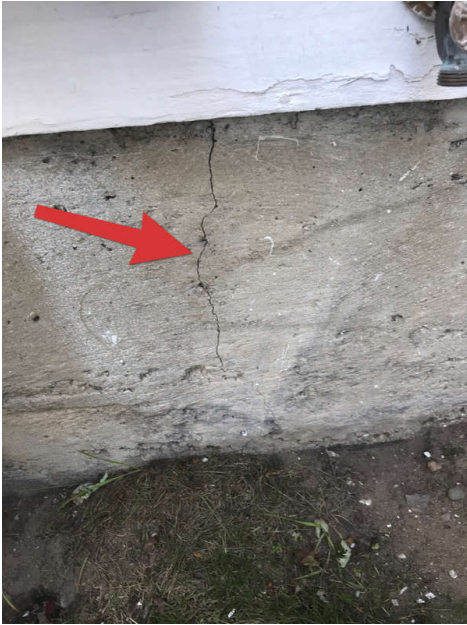
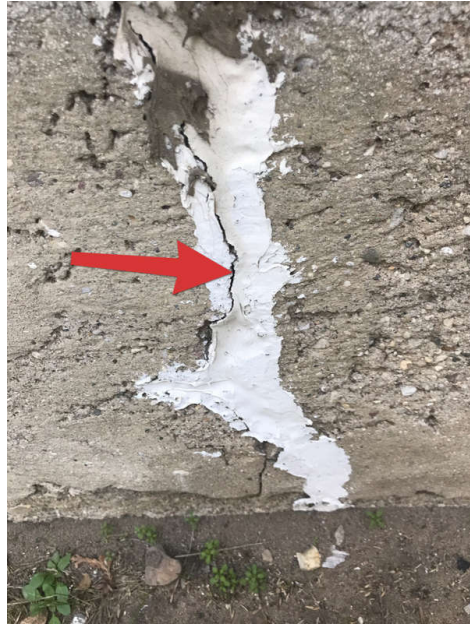
Rear

### EXTERIOR SETTLING CRACK(S)

Settling cracks on the foundation exterior are present. Most settling cracks are common and do not pose a concern with the structural integrity of the foundation. However, cracks in the foundation wall can lead to leaks. Sealing and monitoring these areas is recommended.

Recommendation  
Recommended DIY Project

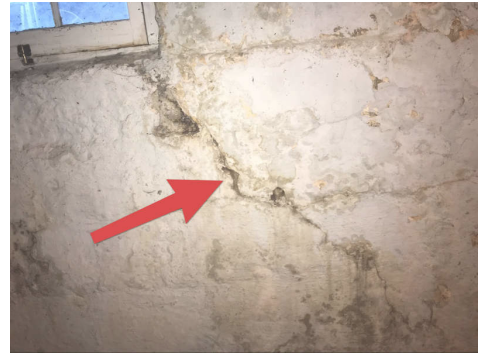
**CRACKS/GAPS AT INTERIOR FOUNDATION**

Settling cracks and/or gaps were observed on the interior foundation wall of the home. Proper sealing and monitoring is recommended to prevent future cracking and water intrusion into the basement/crawlspace. If cracking or gaps worsen, further evaluation by a foundation specialist is advised.

Recommendation  
Recommended DIY Project

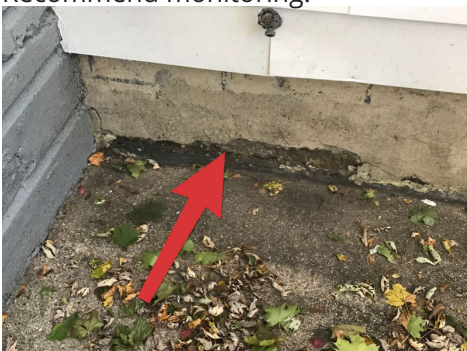
Left Side

**FOUNDATION WALL-CRUMBLING/SPALLING**

The foundation wall is crumbling/spalling in this area which is most likely caused by excessive moisture. Ensuring proper gutter drainage as well as ensuring landscaping near the home is sloped in such a way as to direct water away from the foundation will help prevent excessive water from penetrating into the bricks/blocks. Patching this area should be performed.

If this area continues to degrade, further evaluation and/or repair by a foundation specialist is recommended.

Recommendation  
Recommend monitoring.

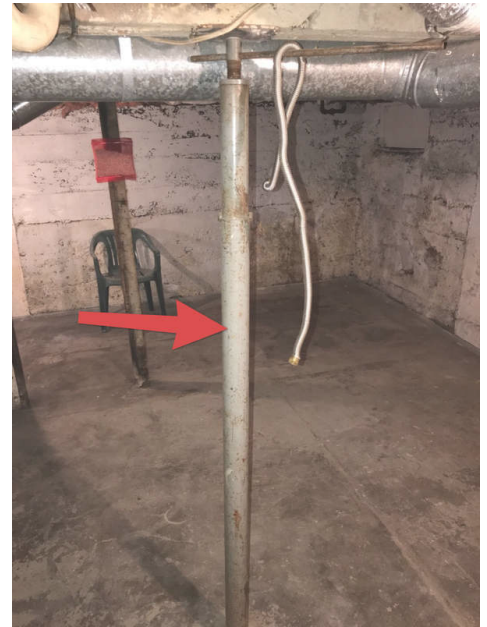
**ADJUSTABLE JACKPOSTS PRESENT**

Split-pinned or telescopic jack post(s) /column(s) are being utilized in a permanent use application. All split type jack posts or telescopic posts/columns are designed for temporary use only. I recommend the improperly used split-pinned or telescopic adjustable post(s) /column(s) being utilized as permanent supports, be replaced with proper cement filled lally columns or approved adjustable solid steel columns designed for permanent use.

Additionally it should be ensured that the new columns have appropriately sized footings under each column.

Recommendation  
Contact a qualified professional.

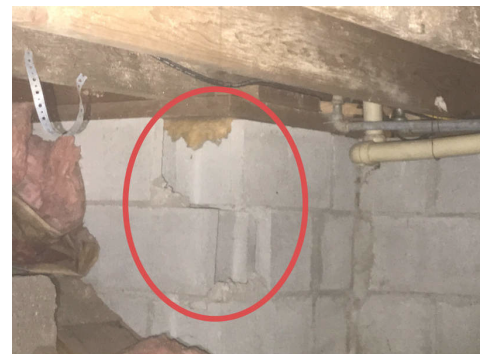
Crawlspace

**DAMAGED FOUNDATION BLOCK**

One or more foundation blocks are damaged and are in need of repair by a licensed foundation specialist.

Recommendation  
Contact a foundation contractor.

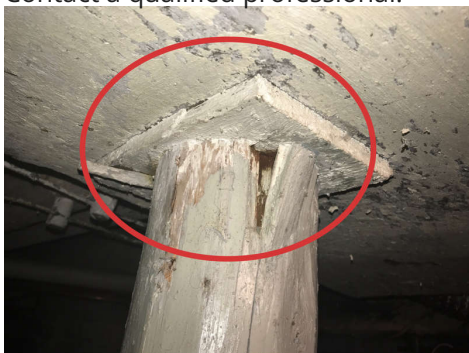
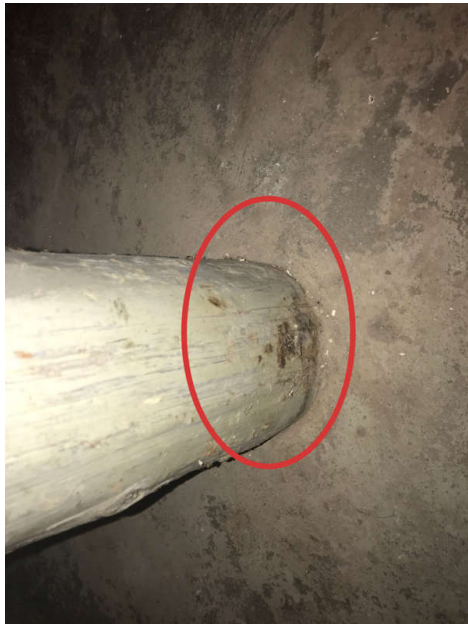
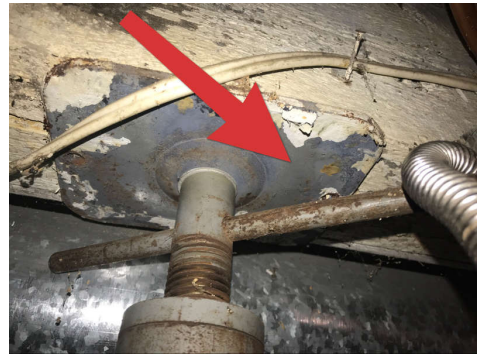
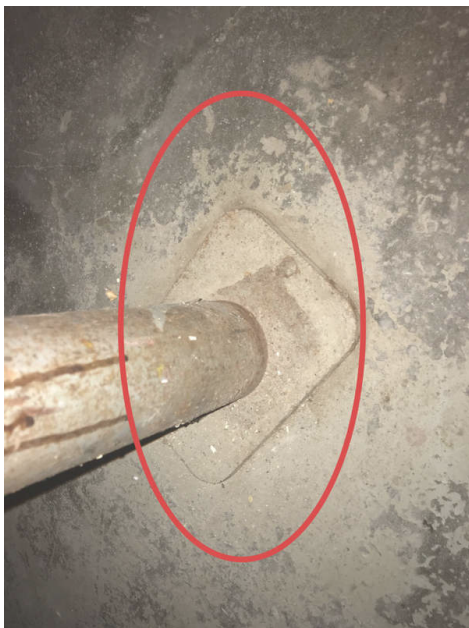
All

**COLUMNS-POSITIVE CONNECTION NEEDED**

Where posts and beam or girder construction is used to support floor framing, positive connections, such as bolts and nails for wood columns, or bolts or welds for metal columns, should be used to ensure against uplift & lateral displacement. Correction is recommended.

Recommendation  
Contact a qualified professional.

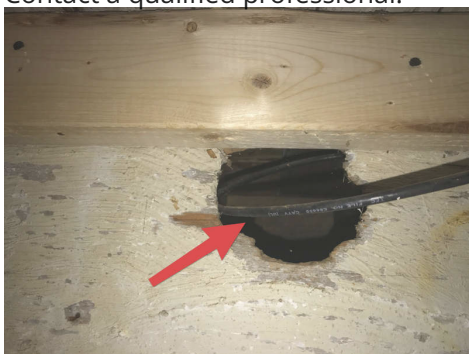
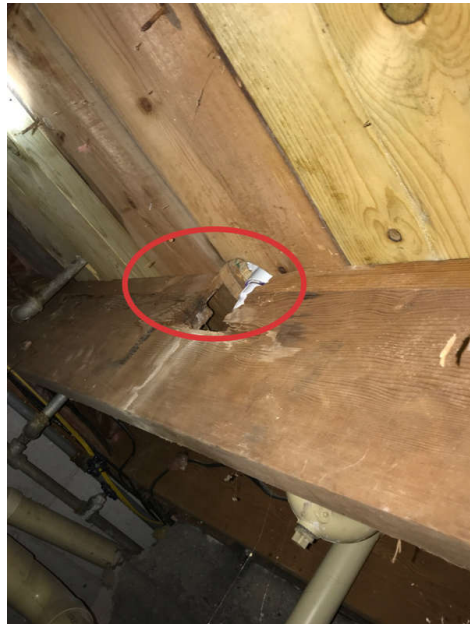
Crawlspace

### IMPROPERLY NOTCHED FLOOR JOIST(S)

One or more joists are improperly notched or bored which reduces the load-bearing capacity to support the floor above.

Adding additional support in this area by a licensed contractor is recommended.

Contact a qualified professional.

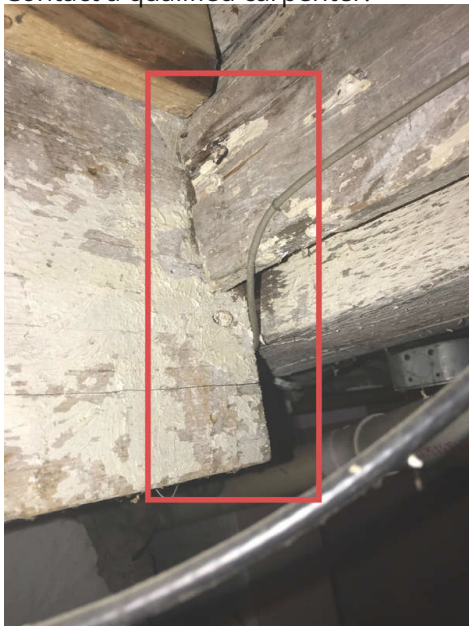
Joist Hanger

**MISSING JOIST HANGER(S)**

The floor joists should be secured to the band joist with appropriately sized joist hangers for proper support. Correction is recommended.

Contact a qualified carpenter.

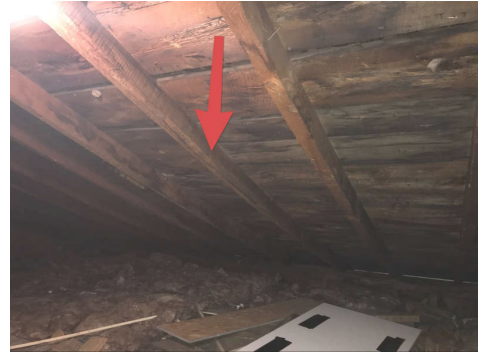
**SAGGING ROOF**

Undersized rafters, inadequate internal bracing and other construction or design issues sometimes fail to provide adequate support.

Snow and ice loads can also cause weight issues for homes in northern climate zones, as well as prolonged stress over the years due to the age of the home may result in sagging. Additional bracing by a licensed roofing contractor may be needed if sagging continues.

Contact a qualified roofing professional.

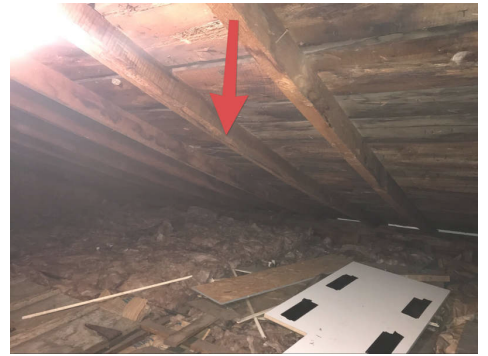
**SAGGING ROOF**

This area of the roof is sagging. There are several reasons why a roof can sag over time to include the age of the home and seasonal snow load as examples. Additional bracing could be installed in these areas to prevent future sagging. Further evaluation by a licensed roofer is recommended.

Contact a qualified roofing professional.

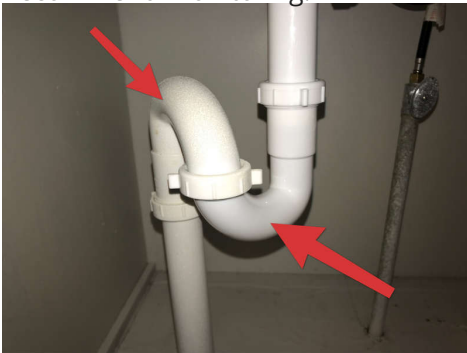
Kitchen

**S-TRAP INSTALLED**

An S-trap has been installed which is and should be changed to a P-trap and vented to the exterior.

S-traps have the potential to suck, or siphon, water out of the trap as the water flows down the drain which can allow sewer gasses and foul odors to enter the home. If an odor is noticed, correction by a licensed plumber is recommended.

Recommend monitoring.

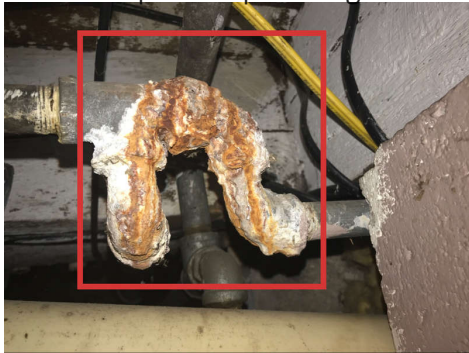
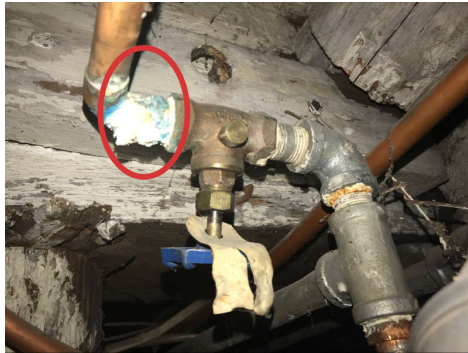
Above Water Heater

### CORROSION ON PIPING

Water pipe corrosion is present at one or more connections and is in need of replacement by a licensed plumber.

Contact a qualified plumbing contractor.

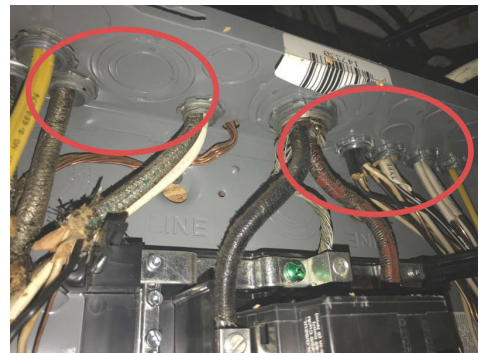
### BUSHINGS RECOMMENDED

Wiring that enters the panel should be solidly anchored and protected where it enters the panel by a bushing to prevent the sharp edges of the panel box from damaging the wiring and creating an equipment/safety hazard. Recommend installation of the proper connectors by a licensed electrical contractor.

Contact a qualified electrical contractor.

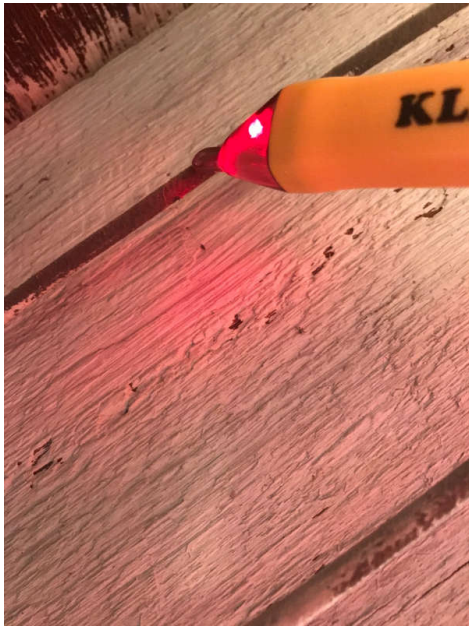
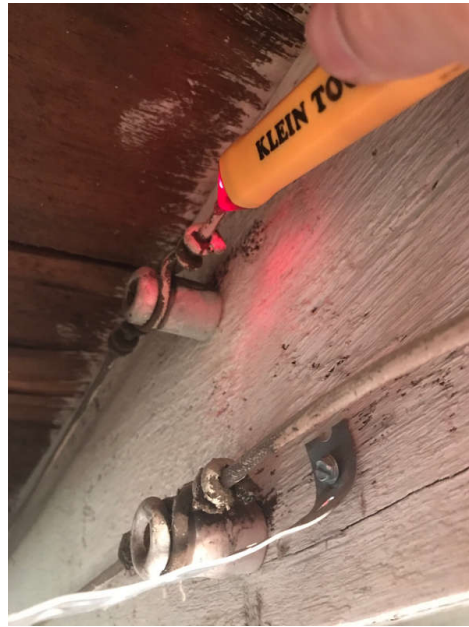
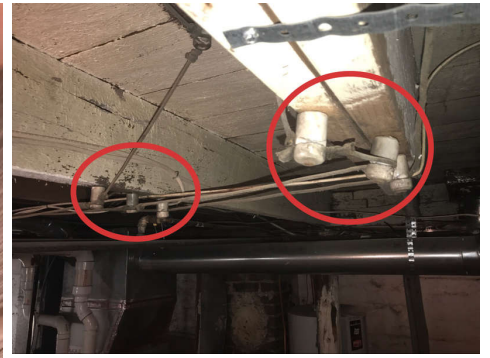
### KNOB & TUBE PRESENT

This property has knob and tube wiring which was commonly installed prior to 1950. It is ungrounded, and considered unsafe by today's standards. Over time, the wire's insulation becomes brittle and falls apart, resulting in exposed conductors and a risk of shock and/or fire. This wiring is also easily damaged by covering it with insulation (a common practice), and incorrectly tapping new wiring into it.

Some energized knob and tube wiring was found during the inspection. It is not within the scope of this inspection to determine what percentage of this property's wiring is of the knob and tube type or to determine what percentage of the knob and tube wiring is energized vs. abandoned. A qualified electrician should evaluate this wiring and make repairs or replace wiring as necessary.

Contact a qualified electrical contractor.

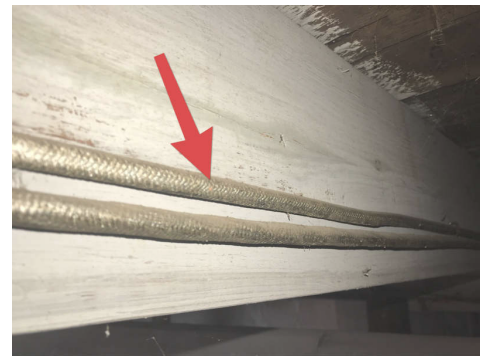
### OLD NON-METALLIC WIRING PRESENT

Old non metallic (NM) wiring is present in the home. Common concerns with older NM wires are that the cloth sheathing and the wire insulation deteriorates and becomes brittle with age. The other concern, shared by most old wiring methods, is lack of a grounding conductor. Upgrading to current standards by a licensed electrician is recommended.

Recommendation  
Contact a qualified electrical contractor.

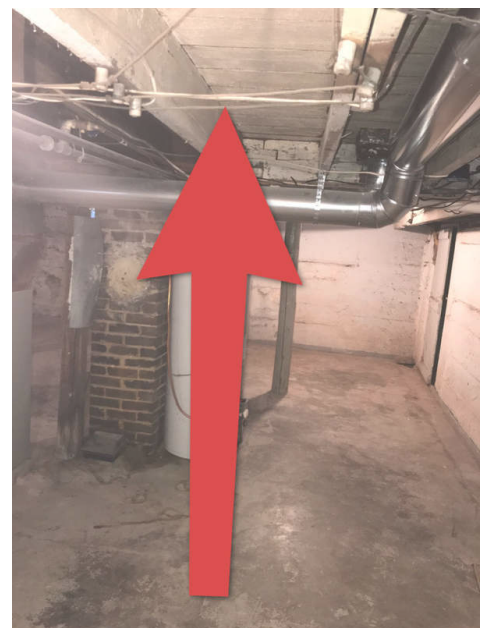
### WIRES-LOW CLEARANCE-SAFETY CONCERN

Current standards require all electrical wiring to be placed through floor joists if run perpendicular to the joists. Additionally, the low clearance of the floor structure places these wires in a position to be snagged or walked into/touched and is a safety hazard. Correction by a licensed electrician is recommended.

Recommendation  
Contact a qualified electrical contractor.

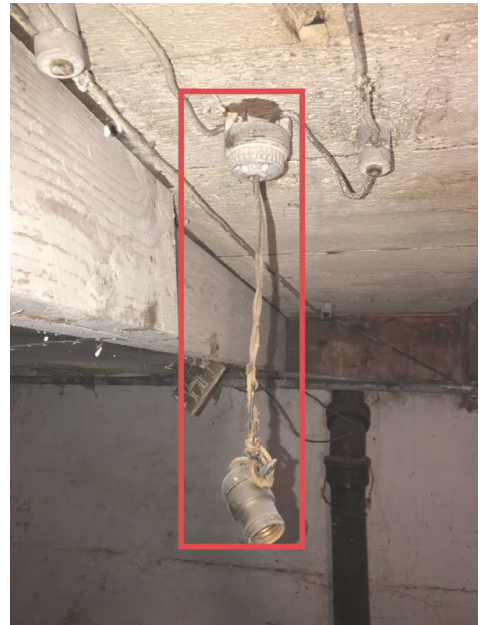
Basement

### OUTDATED LIGHT FIXTURE

The home has an antiquated knob & tube light fixture. This should be upgraded to a modern light fixture by a licensed electrician.

Contact a qualified electrical contractor.

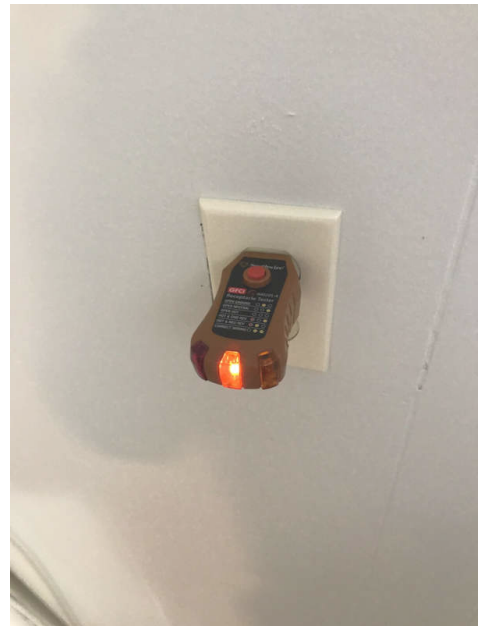
Kitchen-all

### UNGROUND 3-PRONG OUTLET(S)

One or more 3-prong outlets were determined to be ungrounded when tested. This can be corrected by installing a grounded GFCI receptacle or upgrading to a grounded 3-prong receptacle by a licensed electrician.

Contact a qualified electrical contractor.

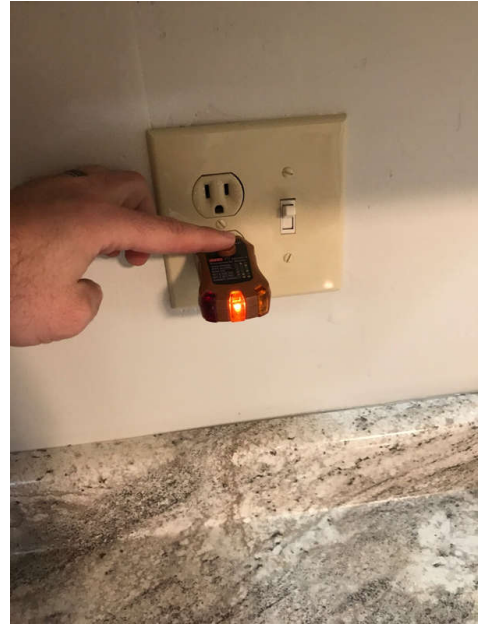
### KITCHEN OUTLET(S) - NOT GFCI PROTECTED

All outlets within 6' of a water or moisture source should be GFCI protected in accordance with today's standards. Updating to current standards by a licensed electrician is recommended.

Contact a qualified electrical contractor.

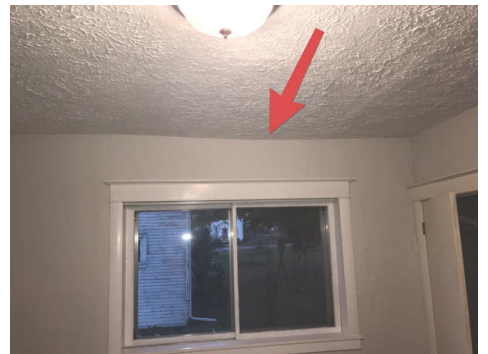
### **SAGGING CEILING-MOISTURE**

The ceiling is sagging in this area. Water leaks, moisture, poor installation, and even the age of a home can cause a ceiling to sag over time. Monitoring this area is recommended. If sagging worsens a qualified professional should be consulted.

Recommendation  
Recommend monitoring.

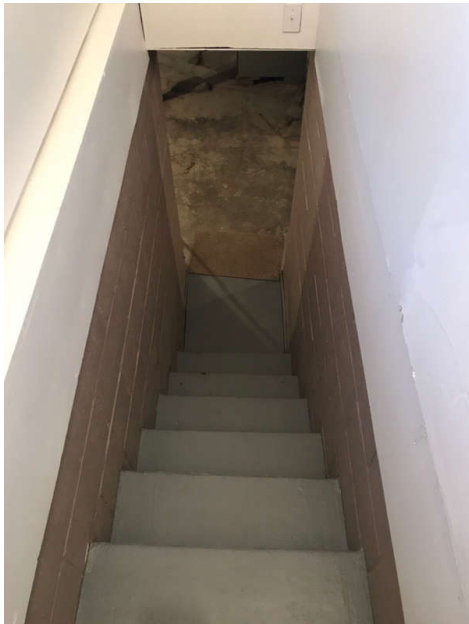
Basement

### **STAIRWAY NEEDS CONTINUOUS, GRASPABLE RAILING**

The stairs are in need of a continuous graspable railing spanning the full length of the staircase to prevent a falling injury.

Recommendation  
Recommended DIY Project

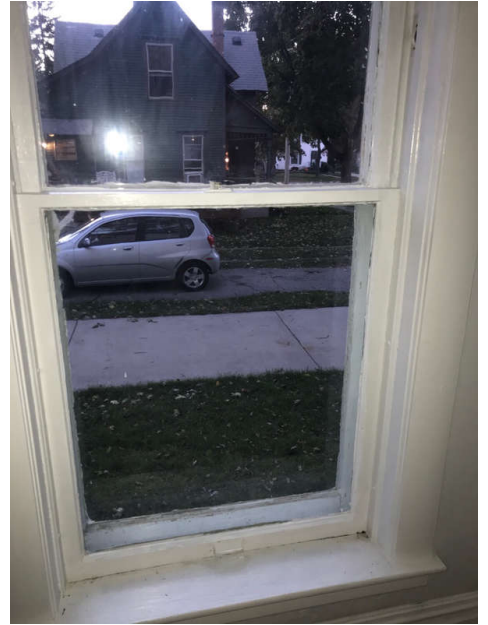
### DOES NOT OPEN

One or more windows do not open, or are difficult to open. This can be due to the expansion of the wood frame due to humidity or can be sealed shut by paint. Replacement may be needed.

Contact a qualified window repair/installation contractor.

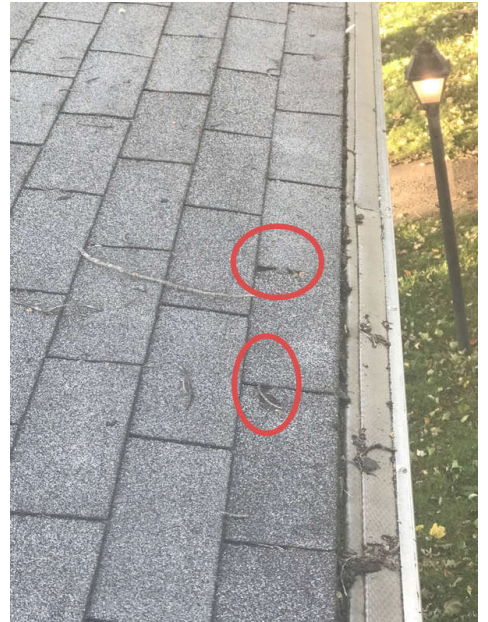
#### **DAMAGED SHINGLE(S)**

One or more shingles are damaged and in need of replacement to prevent water penetration into the attic structure.

Contact a qualified roofing professional.

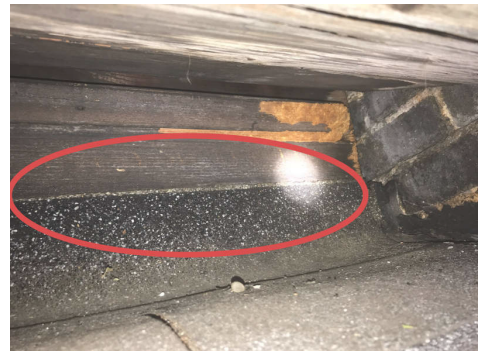
#### **MISSING FLASHING**

It does not appear flashing was installed at the roof and wall juncture. Flashing is critical in preventing water from entering the roof structure which can cause rot and leaks. Correction by a licensed roofing contractor is recommended.

Contact a qualified roofing professional.

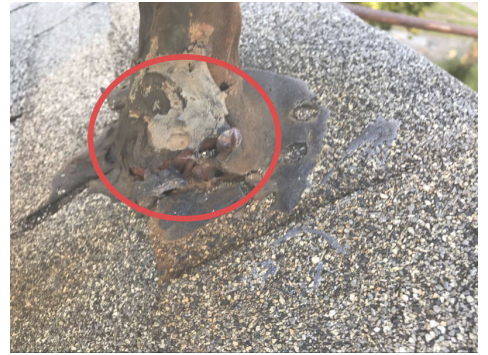
Antennae

**FAILING CAULK/PATCHING**

The patching around this roof penetration has shrunk or cracked creating gaps for water to penetrate. Sealant will eventually dry, shrink and crack. Replacement with proper flashing, or annual inspection and re-application of an appropriate sealant as necessary is recommended

Contact a handyman or DIY project

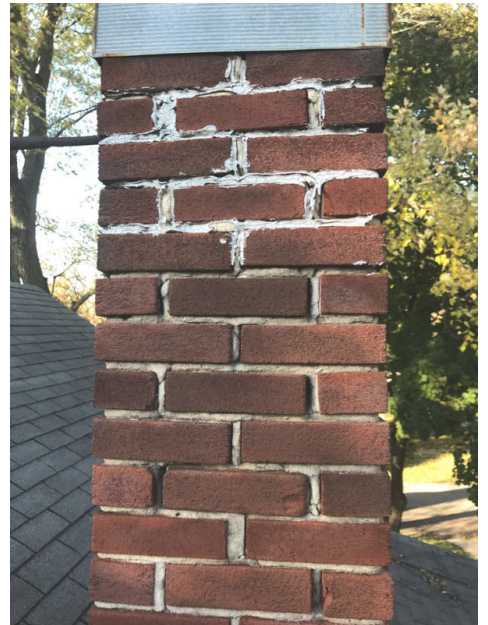
**CHIMNEY - DETERIORATED MORTAR**

Chimney mortar has deteriorated in areas to prevent water intrusion which can cause future brick spalling and cracking. Repair is recommended by a licensed chimney contractor.

Contact a qualified chimney contractor.

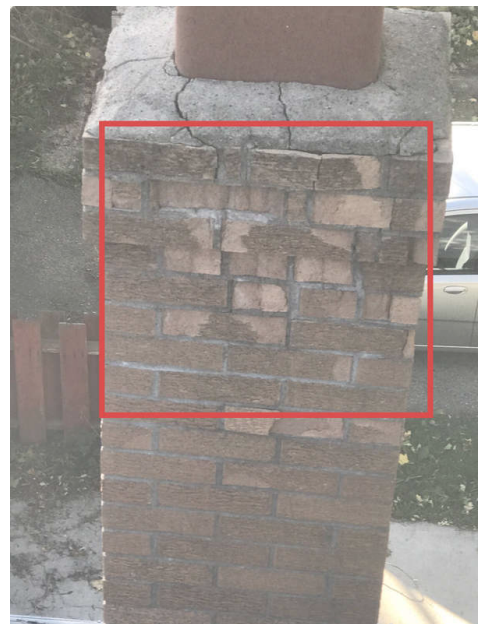
**SPALLING/DAMAGED BRICKS**

Chimney bricks are damaged/spalling due to moisture and are in need of repair by a licensed chimney repair contractor.

Contact a qualified chimney contractor.

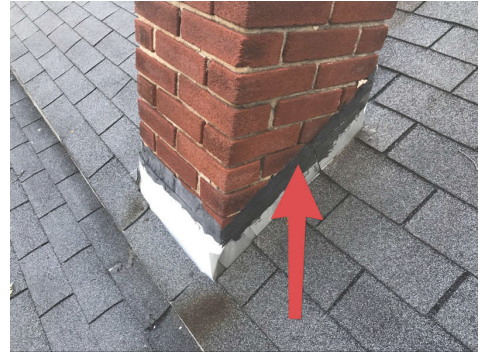
**HEAVILY PATCHED CHIMNEY FLASHING**

The chimney flashing has been heavily patched. The patching will fail over time and should not be relied upon to prevent water intrusion. Re-flashing the chimney is recommended.

Recommendation  
Contact a qualified roofing professional.

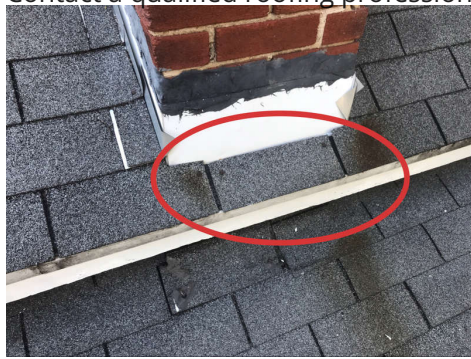
**CHIMNEY-IMPROPER SHINGLE PLACEMENT**

Shingles have been installed on top of the chimney flashing which can channel water under the shingles. Correction by a licensed roofing contractor is recommended.

Recommendation  
Contact a qualified roofing professional.

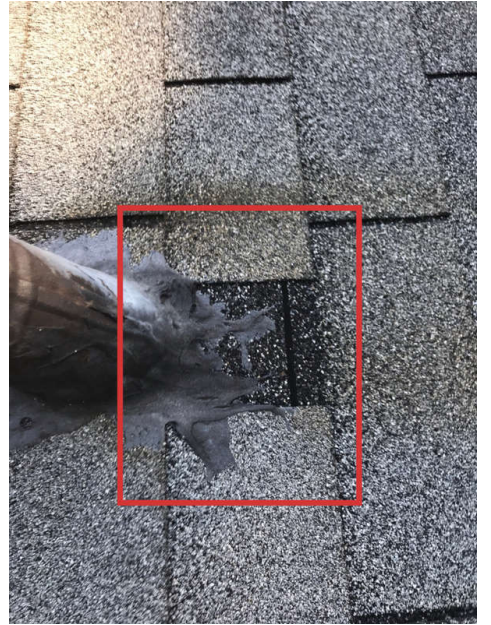
**MISSING FLASHING**

Flashing does not appear to have been installed for this roof penetration risking water intrusion. Correction by a licensed roofing contractor is recommended.

Recommendation  
Contact a qualified professional.
