**SUMMARY**  
 1234 Main St. Virginia Beach VIRGINIA  
 23453  
 Buyer Name  
 01/07/2019 9:00AM

Clay Somers  
 VA HI# 3380001331, NRS Specialty...  
 A Premier Home Inspection, LLC  
 989.413.6905  
[clay@premierinspects.com](mailto:clay@premierinspects.com)

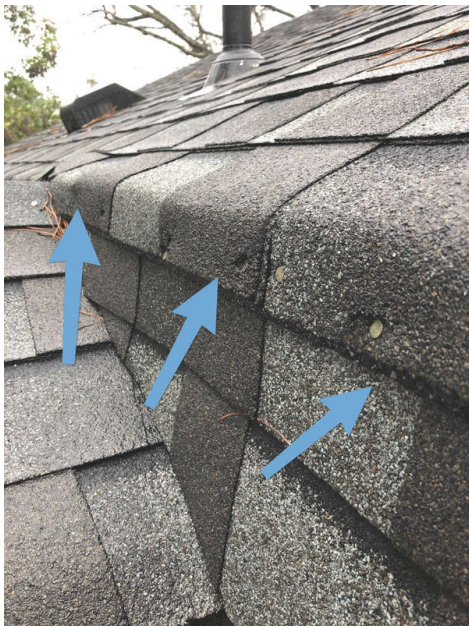
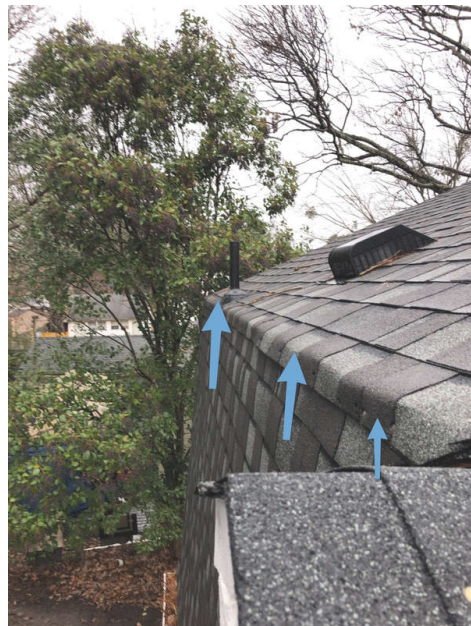
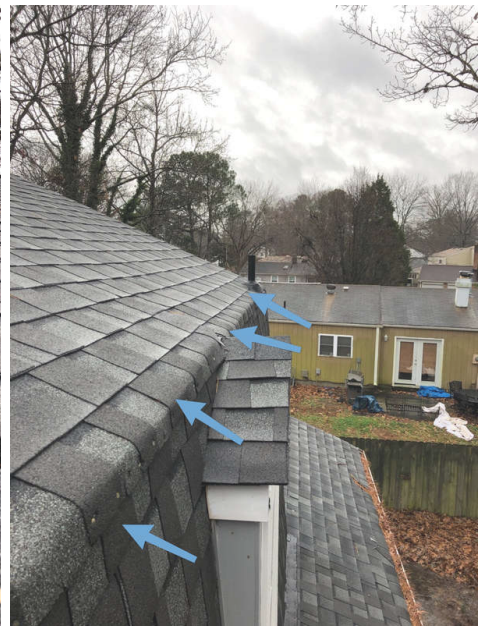
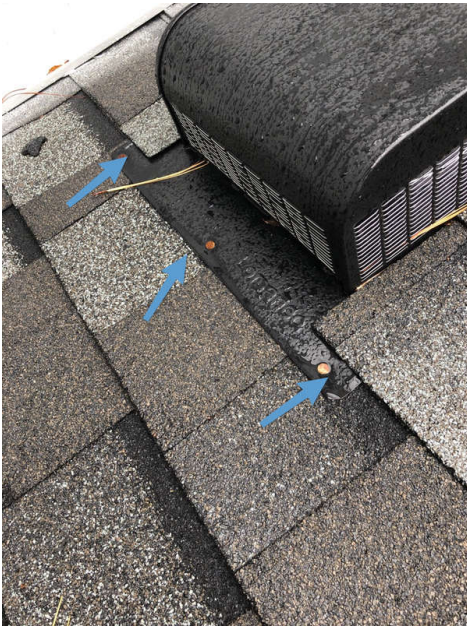
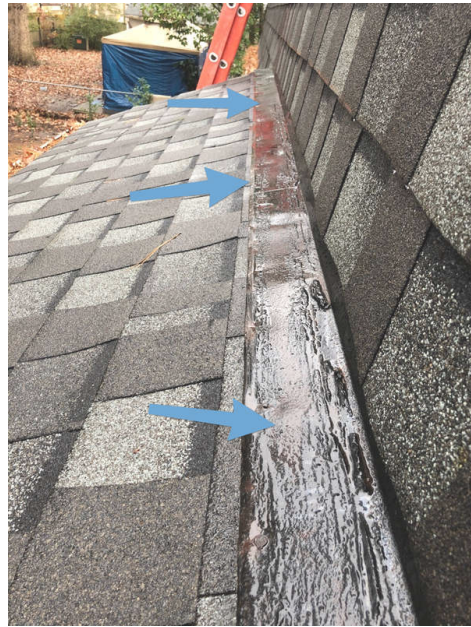
**DETERIORATED ROOFING CEMENT**

One or more area of the roof has roofing cement that is beginning to deteriorate. The roofing cement should be properly repaired to help prevent future leaks due to deterioration.

Recommendation  
 Contact a qualified roofing professional.

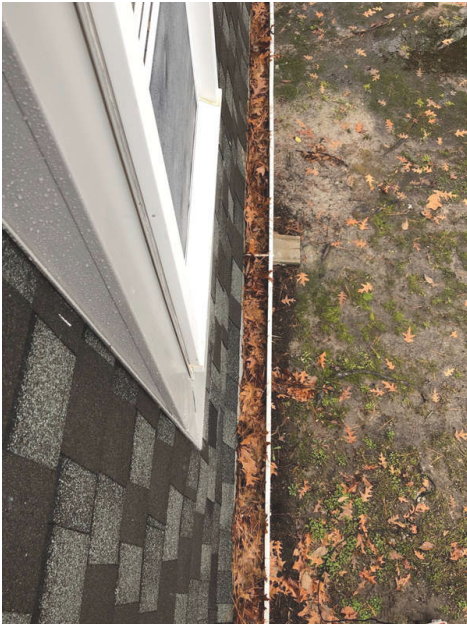
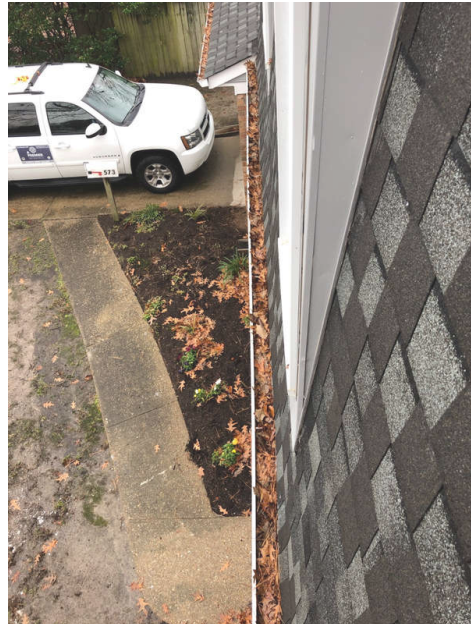
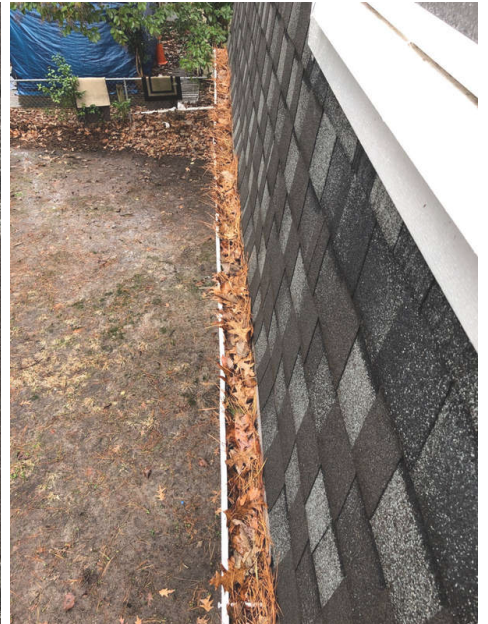
## CLOGGED GUTTERS/DOWNSPOUTS

Significant amounts of debris have accumulated in one or more gutters or downspouts. Gutters can overflow and cause water to come in contact with the building exterior, or water can accumulate around the foundation. This is a conducive condition for wood-destroying organisms. Recommend cleaning gutters and downspouts now and as necessary in the future.

Recommended DIY Project

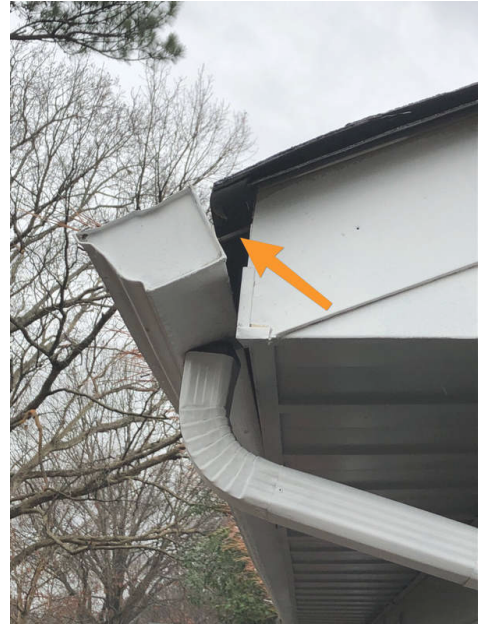
Rear Garage

## DAMAGED/MISSING

One or more gutters or downspouts were damaged or missing. Rainwater can come in contact with the building exterior or accumulate around the building foundation as a result. Recommend that a qualified person repair as necessary.

Contact a qualified professional.

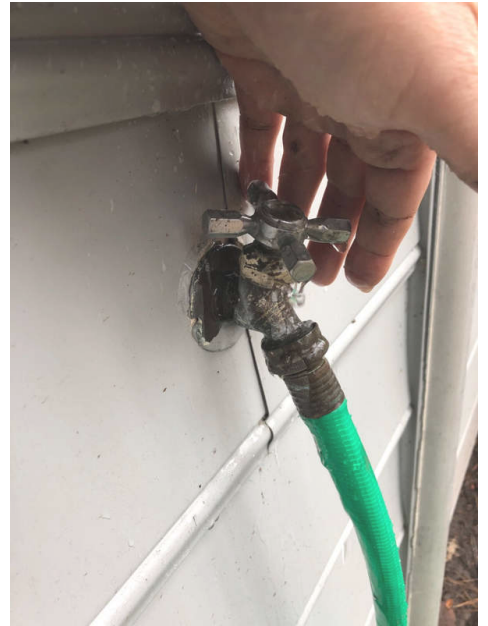
Rear

#### HOSE BIBB LEAK

One or more hose bibs leaked *when tested / while off*. When hose bibs leak while turned off, it's often caused by a worn valve seat or a loose bonnet. When hose bibs leak while turned on, it may be due to worn "packing" around the stem or a defective backflow prevention device. Recommend that a qualified plumber repair as necessary.

Contact a qualified plumbing contractor.

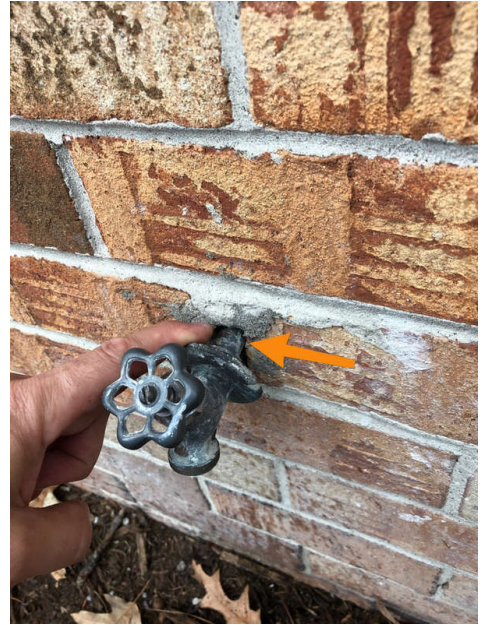
Front

#### LOOSE HOSE BIBB

One or more hose bibs weren't anchored securely to the structure's exterior. Water supply pipes can be stressed when hose bibs are turned on and off and when hoses are pulled. Leaks may occur as a result. Recommend that a qualified person install fasteners per standard building practices.

Contact a qualified professional.

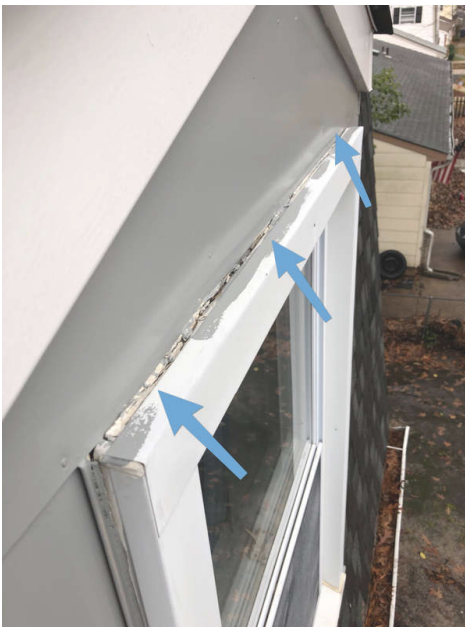
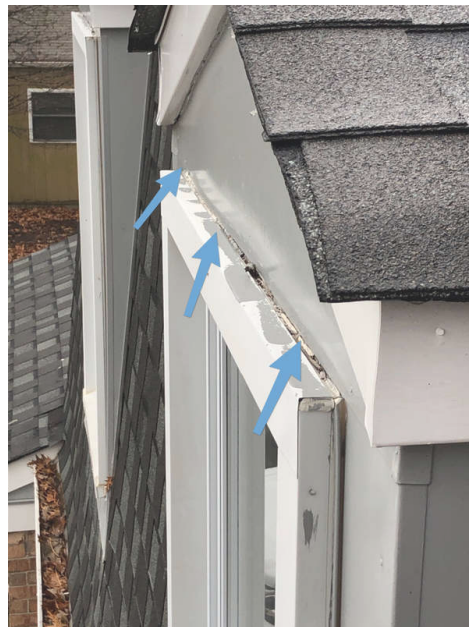
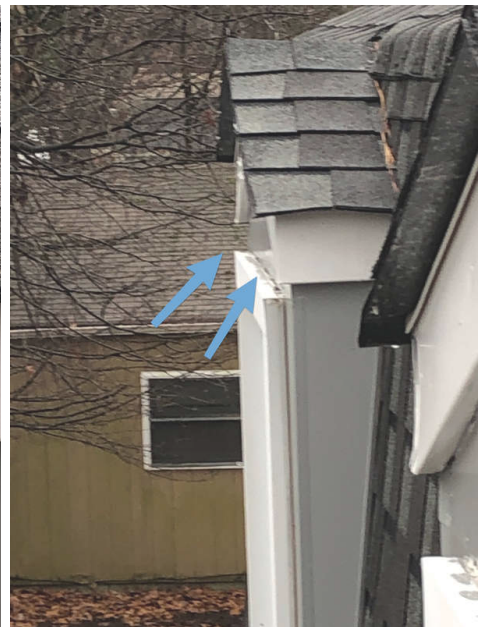
#### CAULKING

Caulk was *missing / deteriorated / substandard* in some areas. For example, *around windows / around doors / at siding butt joints / at siding-trim junctions / at wall penetrations*. Recommend that a qualified person renew or install caulk as necessary. Where gaps are wider than 1/4 inch, an appropriate material other than caulk should be used.

Recommendation  
Contact a qualified handyman.

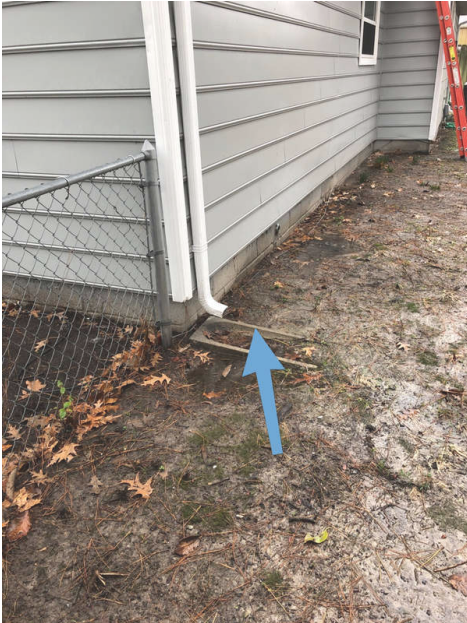
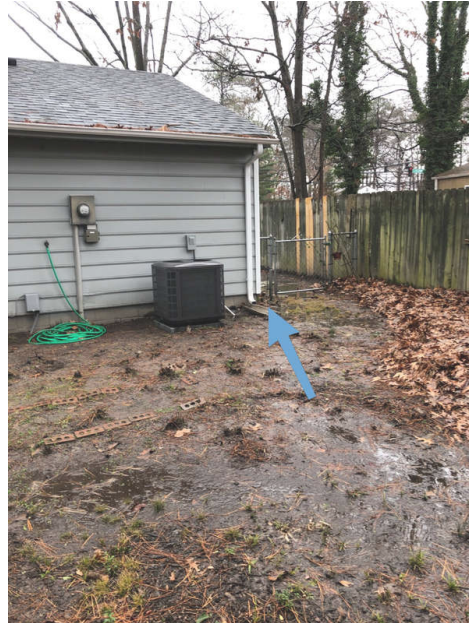
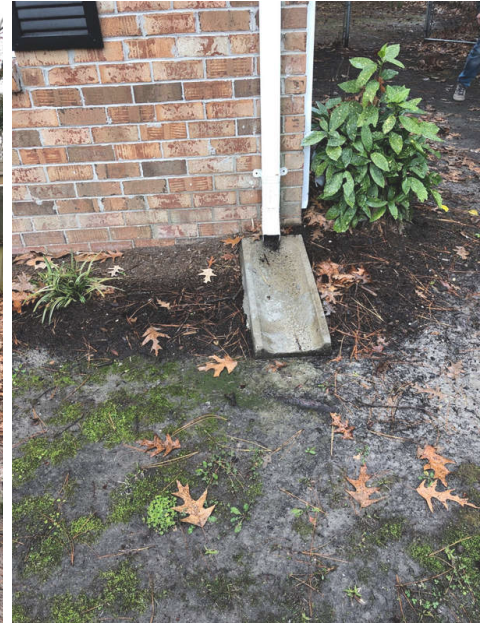
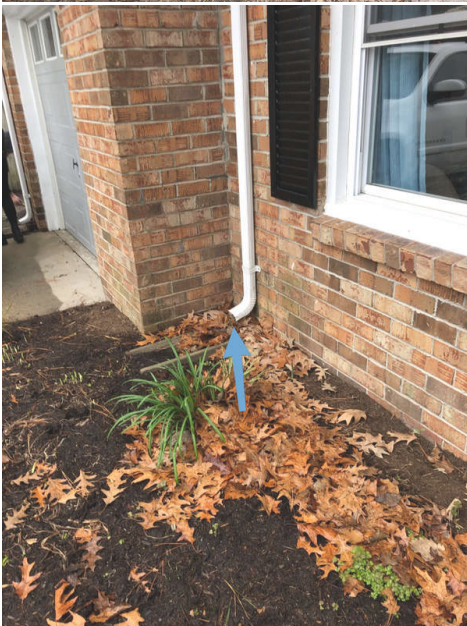
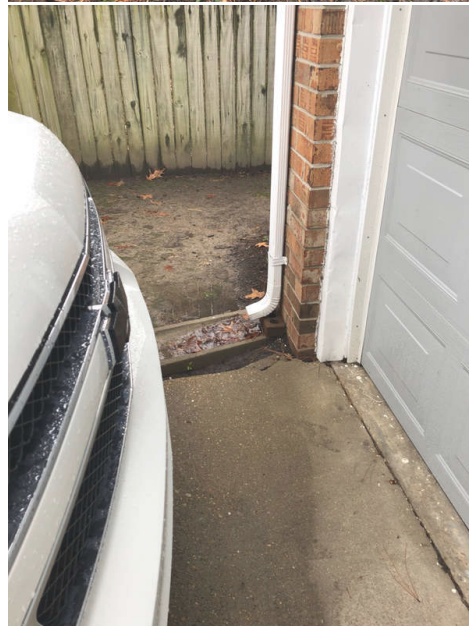
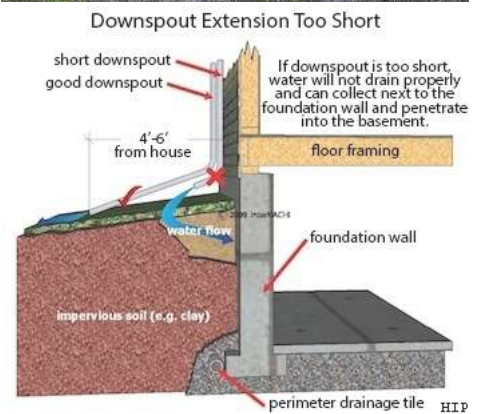
#### DOWNSPOUT EXTENSIONS

Extensions such as splash blocks or drain pipes for one or more downspouts were *missing / poorly sloped / misaligned / clogged / substandard / damaged*. Water can accumulate around the building foundation or inside crawl spaces or basements as a result. Recommend that a qualified person install, replace or repair extensions as necessary so rainwater drains away from the structure.

Contact a qualified professional.

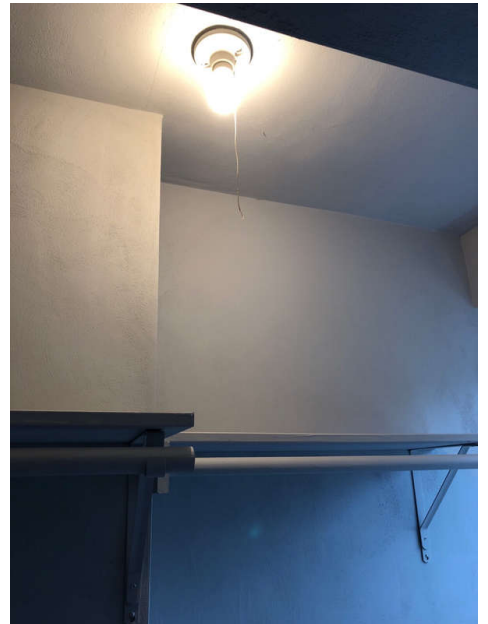
2nd floor Bedroom Left Front

### LIGHT FIXTURE-OPEN LAMP

Lamp holders or light fixtures with fully or partially exposed bulbs are installed in one or more closets. This is a safety hazard due to the risk of fire. Flammable stored items may come into contact with hot bulbs, and hot fragments from broken bulbs may fall on combustible materials. Standard building practices require closet lighting to use fluorescent light fixtures, or to use fully enclosed incandescent fixtures. Installing a compact fluorescent lamp in a lamp holder is not an acceptable practice. A qualified electrician should replace closet lights as necessary and as per standard building practices.

Contact a qualified electrical contractor.

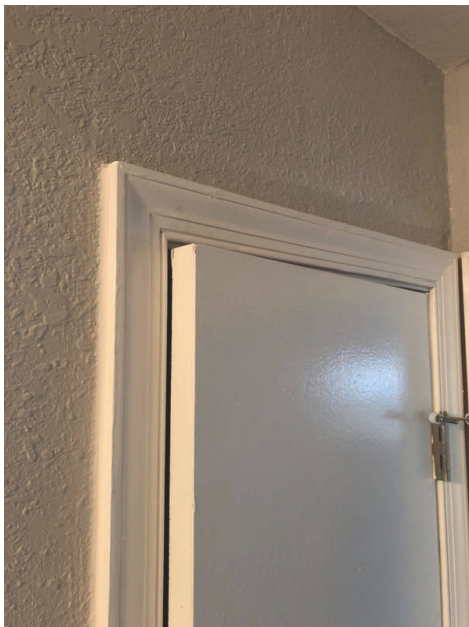
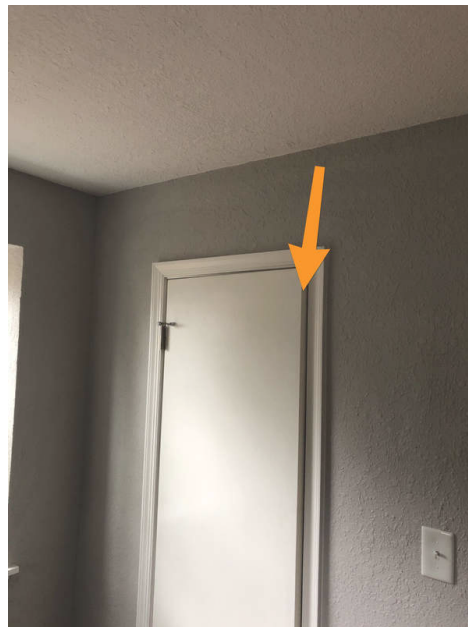
### DOOR-BINDS IN JAMB

One or more doors bind in their jamb and cannot be closed and latched, or are difficult to open and close. A qualified contractor should evaluate and repair as necessary. For example, adjusting jambs or trimming doors.

Contact a qualified door repair/installation contractor.

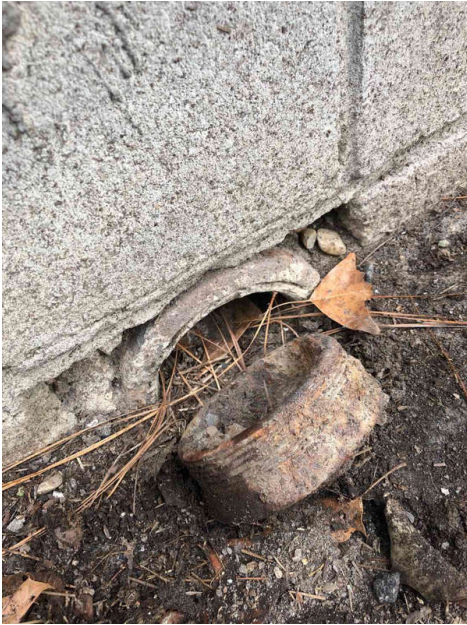
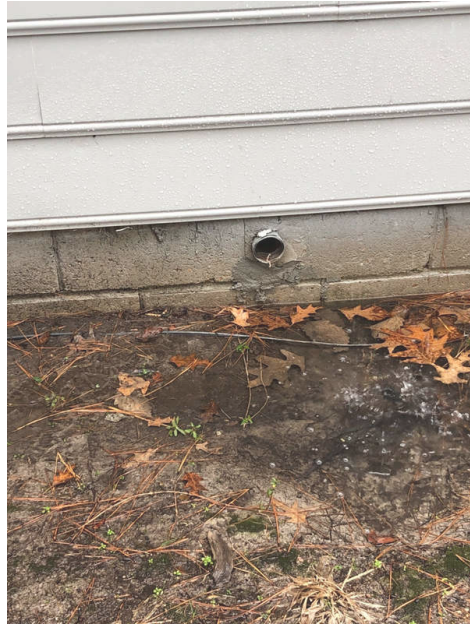
### WASTE CAP MISSING

One or more waste pipe cleanouts have no cap installed. This is a safety hazard because sewer gases may vent into the structure. A qualified plumber should install a caps where missing.

Contact a qualified plumbing contractor.

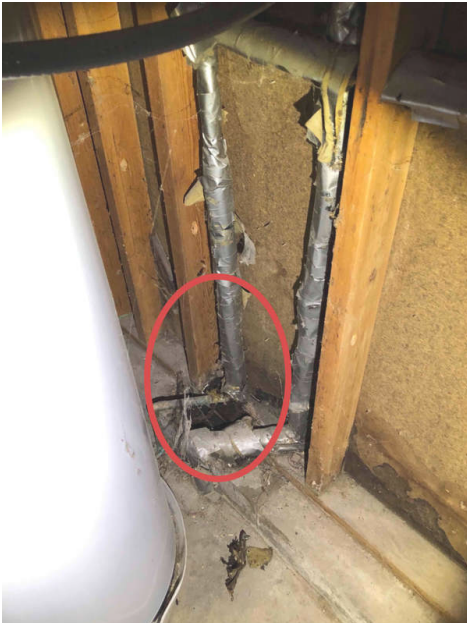
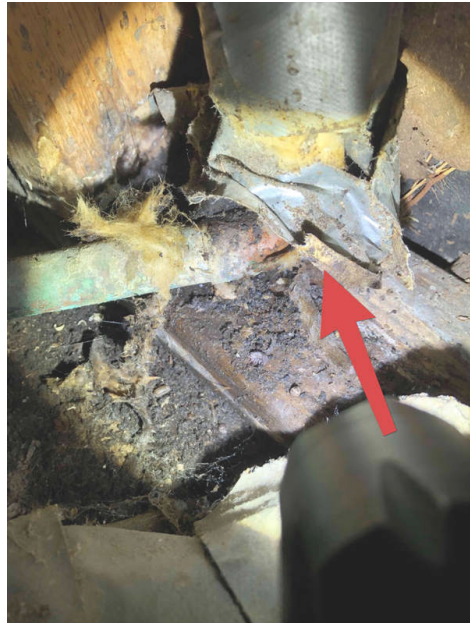
### LEAK SUPPLY PIPE/FITTING

One or more active leaks were found at the water heater's supply pipes, valves, or fittings. A qualified plumber should evaluate and repair as necessary.

Wet/leaking hot water pipe Garage

Contact a qualified plumbing contractor.

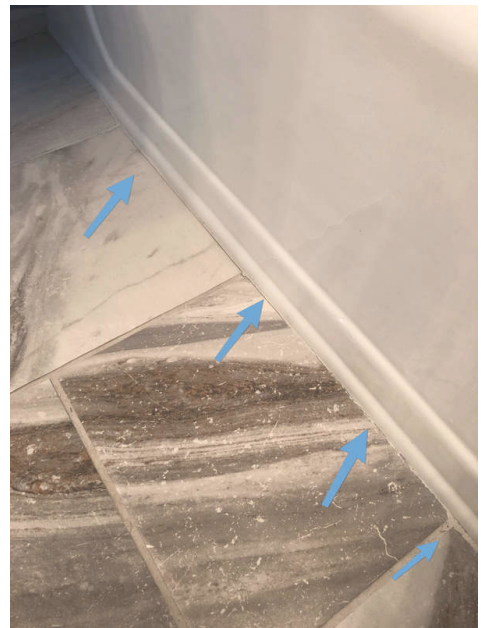
2nd floor Hall Bathroom

### CAULK AT FLOOR

Caulk is missing or deteriorated along the base of one or more bathtubs, where flooring meets the tub. It should be replaced where deteriorated and/or applied where missing to prevent water intrusion and damage to the floor structure.

Recommendation  
Recommended DIY Project

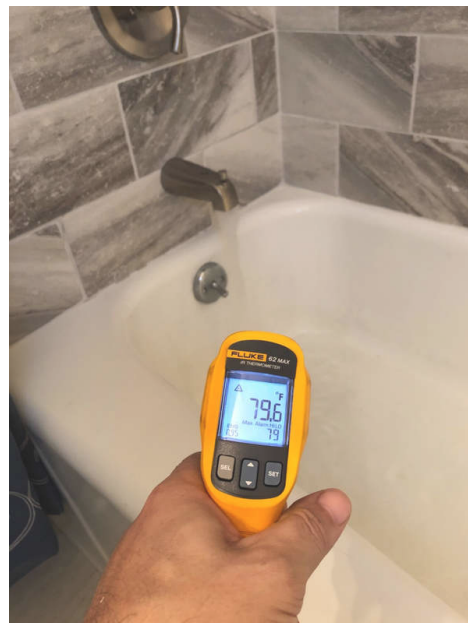
2nd floor Hall Bathroom

### MIXING VALVE

The mixing valve in one or bathrooms is not properly operating. The mixing valve allows the hot and cold water to mix so the temperature can be controlled by any person. The mixing valve is not properly mixing hot and cold water at the valve. There is only hot or cold water coming out of the mixing valve. It is recommended to have a Certified Plumbing Contractor make the necessary repairs.

Contact a qualified plumbing contractor.

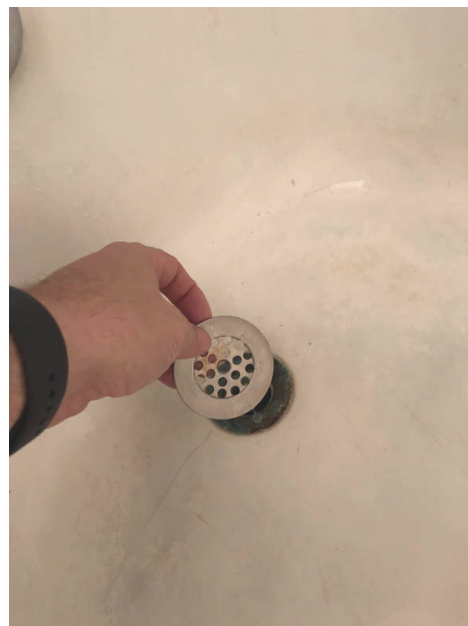
2nd floor Hall Bathroom

### STOPPER ISSUE

The bath tub stopper mechanisms are missing, or need adjustment or repair. Stopper mechanisms should be installed where missing and/or repairs should be made so sink stoppers open and close easily.

Contact a qualified plumbing contractor.

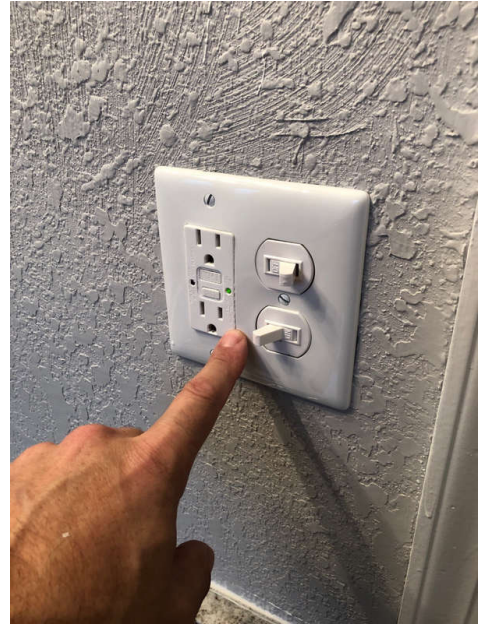
2nd floor Hall Bathroom

### LIGHT GFCI CIRCUIT

The light fixture is on the same circuit as the GFCI plug. This is not a normal building practice. If the GFCI trips the light will go out. Recommend having a dedicated circuit for the light fixture.

Contact a qualified electrical contractor.

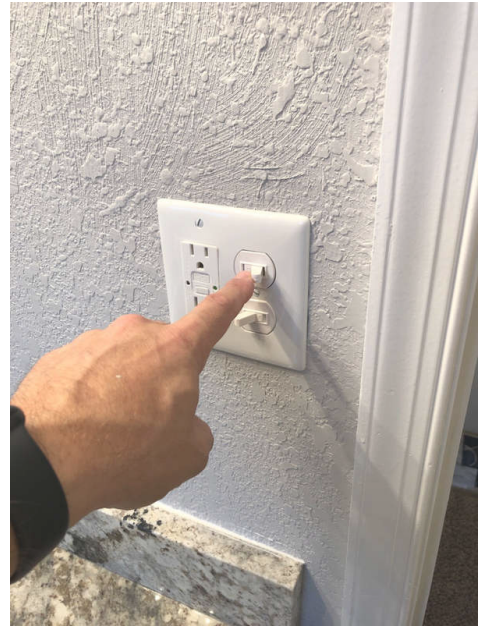
2nd floor Hall Bathroom

### **INOPERABLE**

One or more exhaust fans is inoperable or provides inadequate air flow. Moisture may accumulate as a result. A qualified contractor should evaluate and replace the fan or make repairs as necessary.

Contact a qualified electrical contractor.

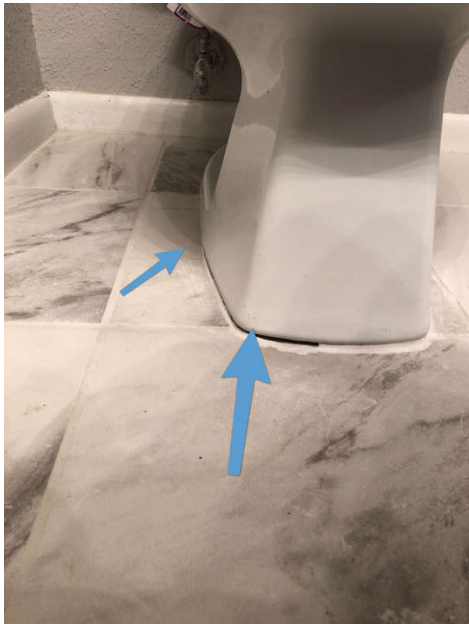
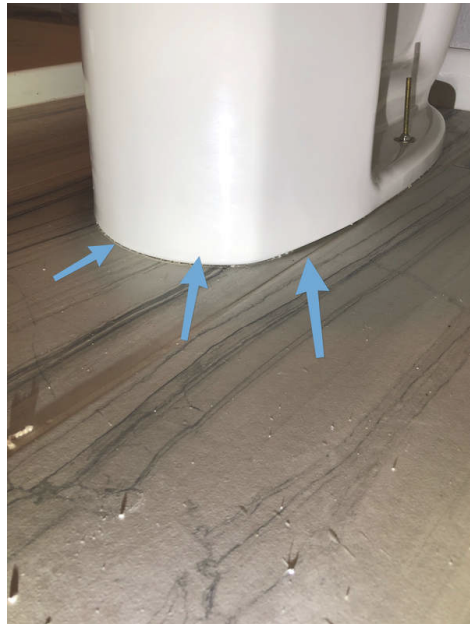
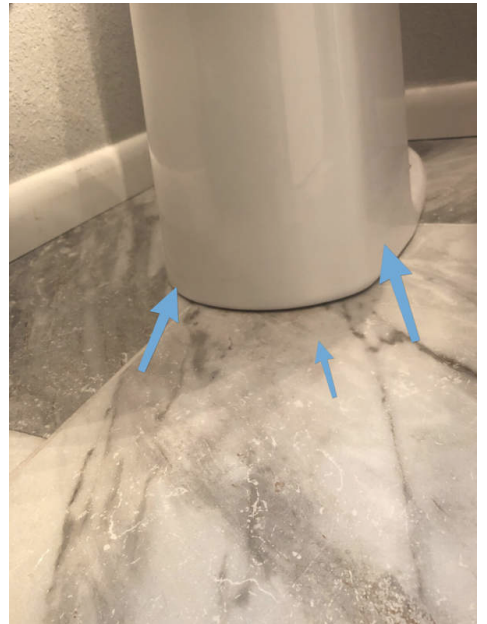
### **NO OR BAD CAULK BASE**

Caulk around the base of the toilet was missing, substandard and/or deteriorated. Modern standards require caulk to be installed around the entire toilet base where it meets the floor for sanitary reasons. Without it, soiled water can soak into flooring and sub-floor materials if the toilet overflows. Condensation from the toilet can also soak into the flooring. Recommend that a qualified person caulk around toilet bases per standard building practices.

Recommended DIY Project

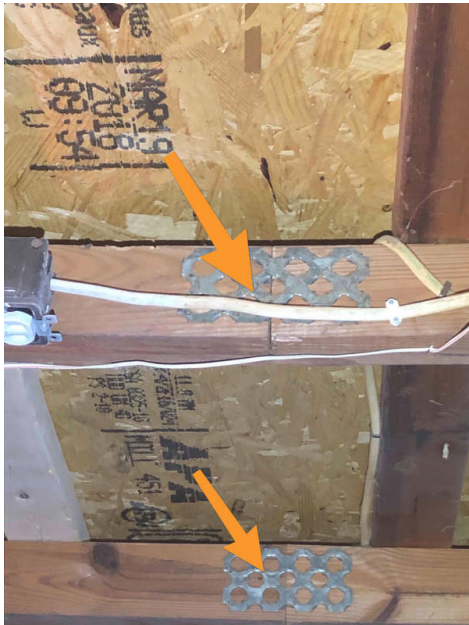
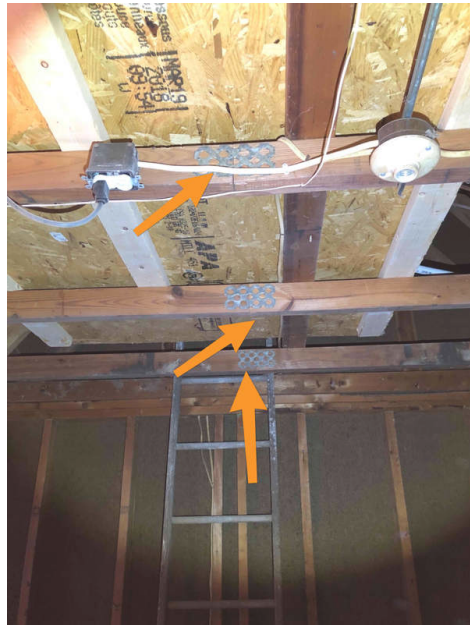
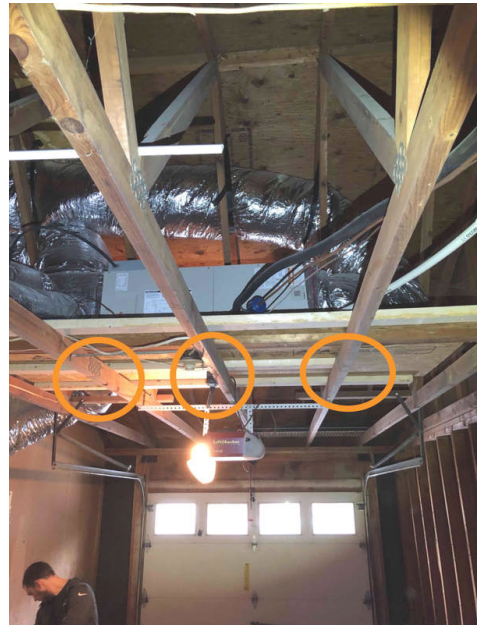
## INSUFFICIENT STRUCTURAL SUPPORT

The air handler is placed in the attic space of the garage. The position of the air handler in the rafters has insufficient structural support since its placed directly above the split in the rafter. I recommend adding more support under the air handler to prevent structural damage or personal injury.

Contact a qualified carpenter.

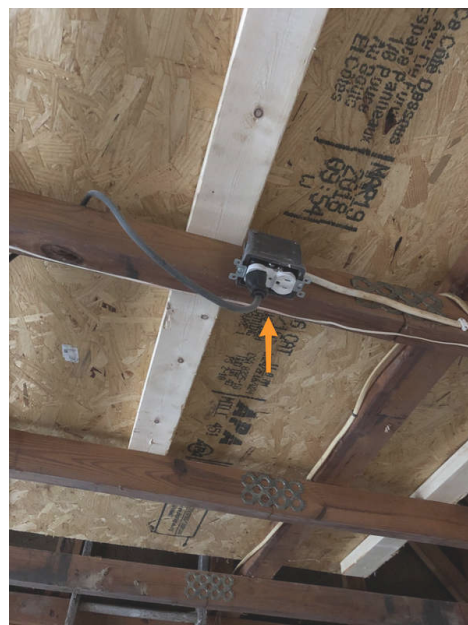
## COVER PLATE MISSING

Cover plate(s) are missing from one or more electric boxes, such as for receptacles, switches and/or junction boxes. They are intended to contain fire and prevent electric shock from exposed wires. This is a safety hazard due to the risk of fire and shock. Cover plates should be installed where missing.

Contact a qualified electrical contractor.

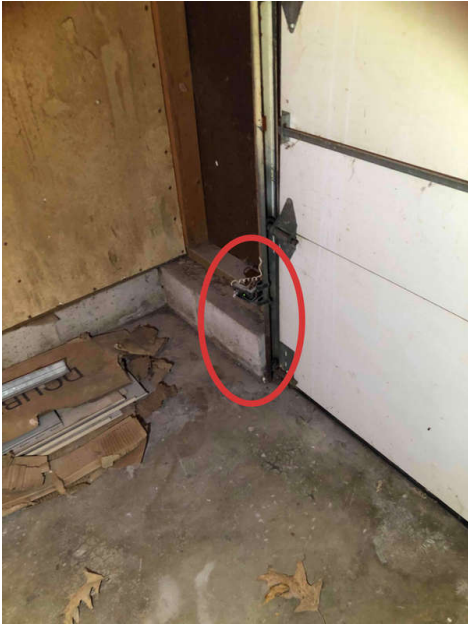
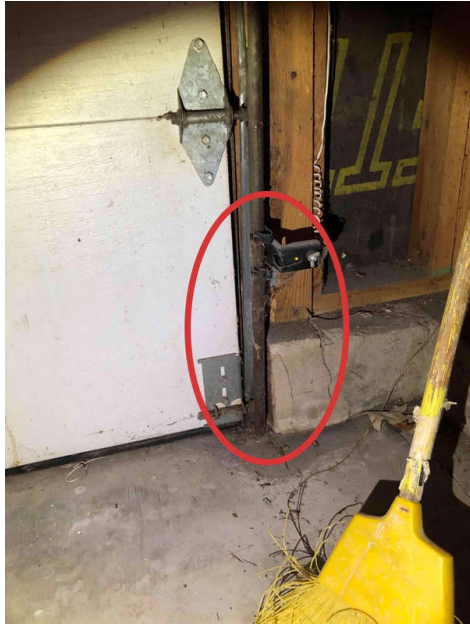
### **PHOTO-EYES TOO HIGH**

The infrared "photo eye" devices that trigger the vehicle door opener's auto-reverse feature are located higher than 4 to 6 inches from the floor. This is a potential safety hazard. A qualified contractor should relocate these devices so they're 4 to 6 inches from the floor.

Contact a qualified garage door contractor.
