SUMMARY

1234 Main St. Oreana IL 62554

Buyer Name
06/28/2018 9:00AM

Michael Bell
License #450.011879
Titan Home Inspections
217-329-4126

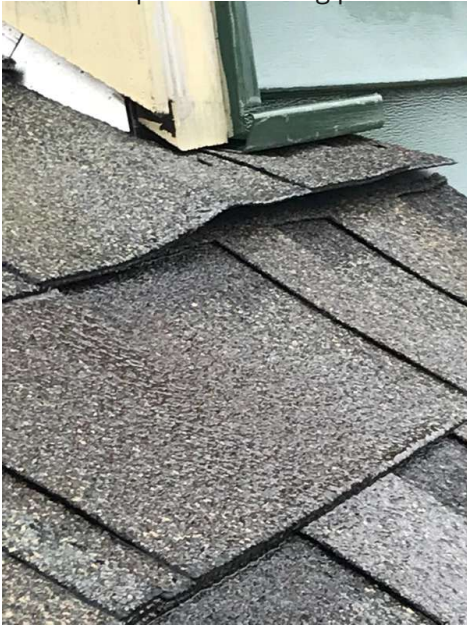
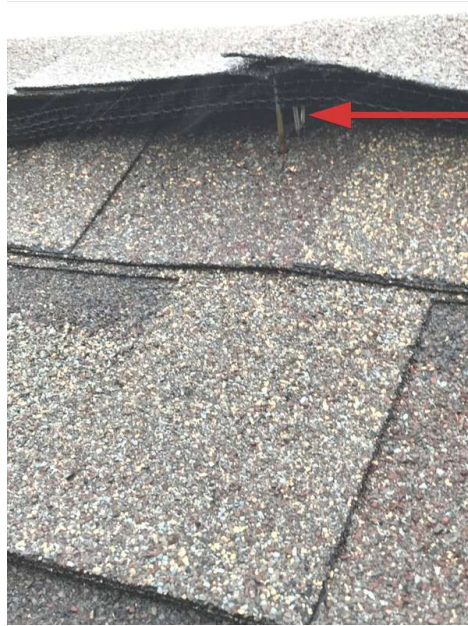
2.1.1 Coverings

IMPROPER/INCOMPLETE NAILING

Roof coverings showed signs of improper installation and fastening. Recommend a qualified roofing contractor evaluate and repair.

Contact a qualified roofing professional.

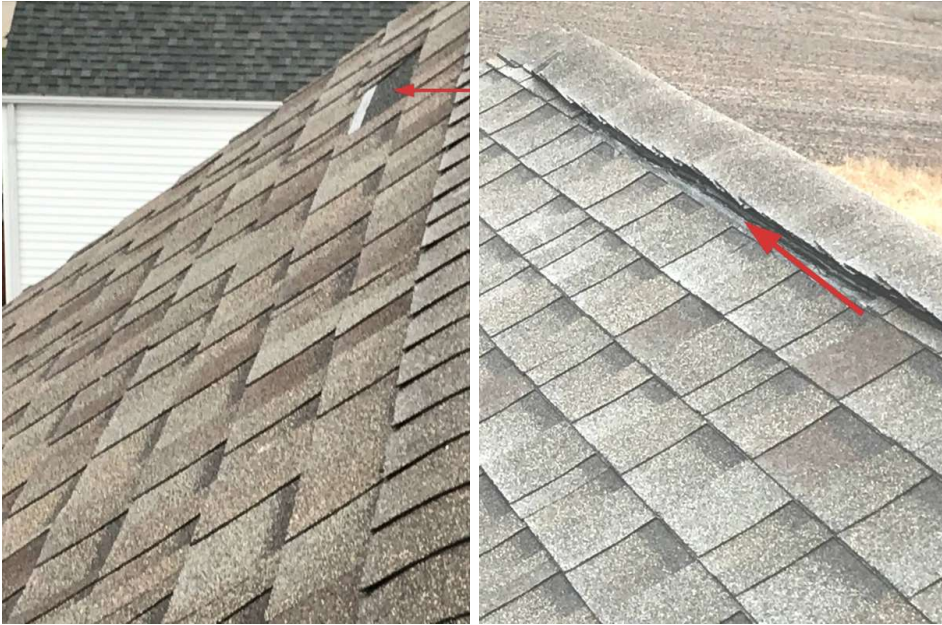
2.1.2 Coverings

SHINGLES MISSING

Observed areas that appeared to be missing sufficient coverings. Recommend qualified roofing contractor evaluate & repair.

Contact a qualified roofing professional.

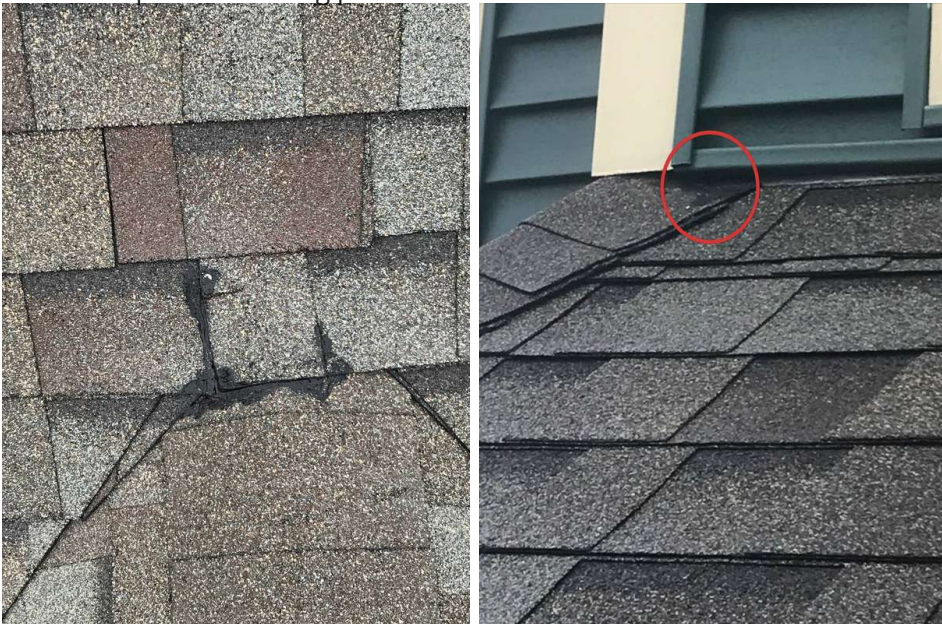
2.1.3 Coverings

EVIDENCE OF PATCHING

During the inspection, I observed areas of patching. This could indicate preventative patching or could indicate corrective repairs to prior leaking. Recommend further evaluation or monitoring.

Contact a qualified roofing professional.

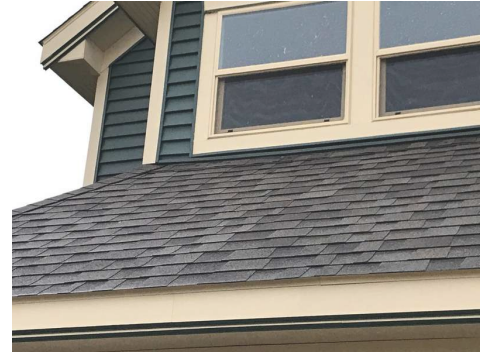
2.2.1 Roof Drainage Systems

DOWNSPOUTS MISSING

Home was missing downspouts in one or more areas. This can result in excessive moisture in the soil at the foundation, which can lead to foundation/structural movement. Recommend a qualified contractor install downspout extensions that drain at least 6 feet from the foundation.

Recommendation
Contact a qualified roofing professional.

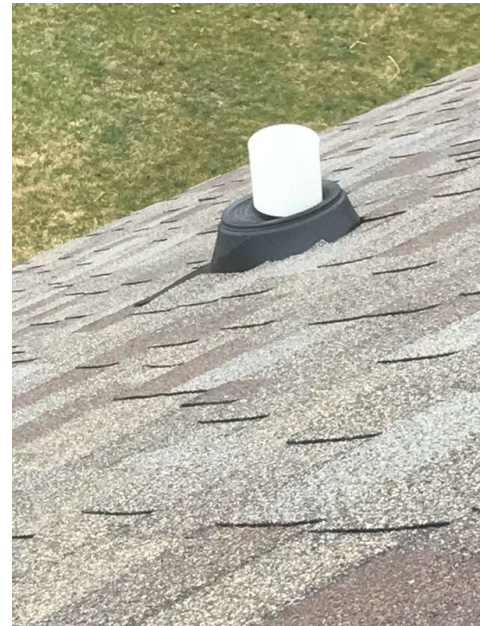
2.3.1 Flashings

PIPE BOOT

The rubber pipe boot appears to be inverted at the collar. This can lead to leaking and premature failure due to ponding water and or snow/ice.

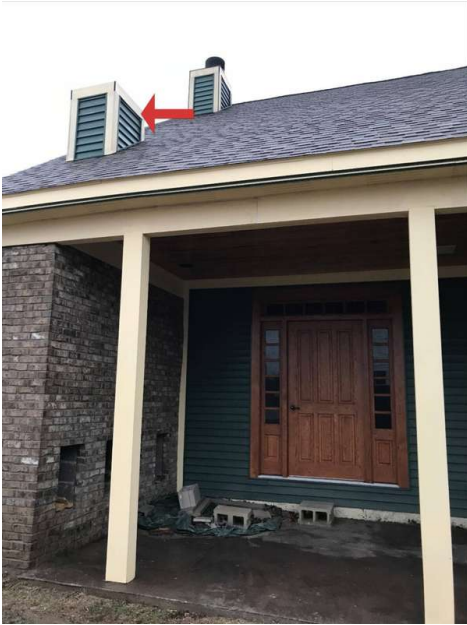
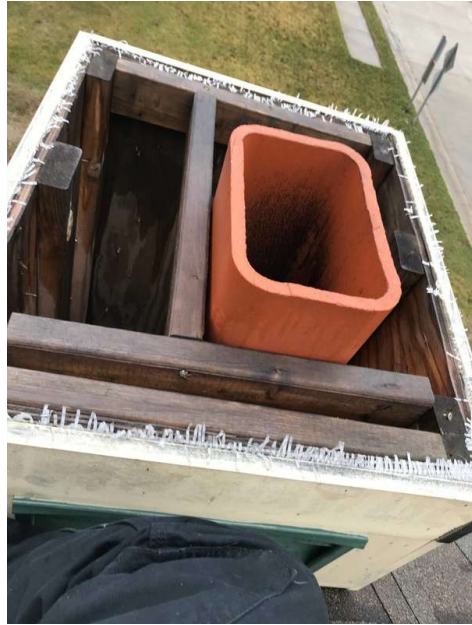
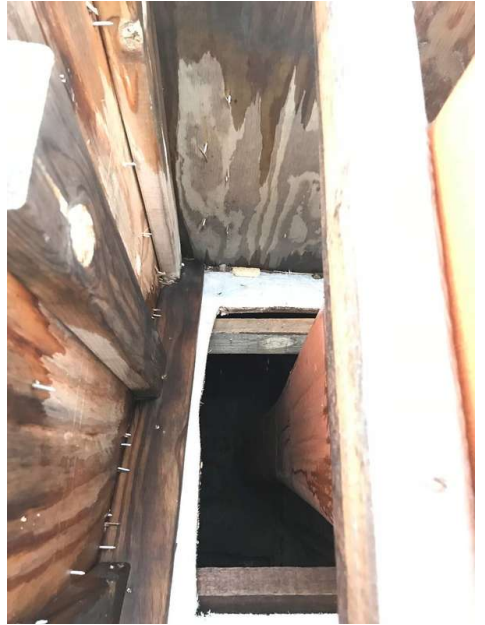
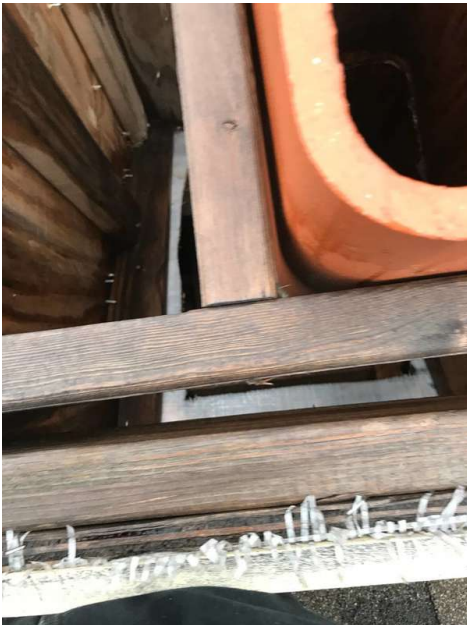
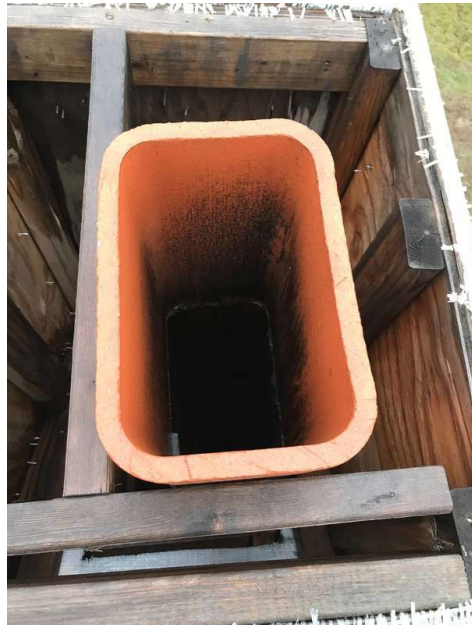
2.4.1 Skylights, Chimneys & Other Roof Penetrations

CHIMNEY CAP MISSING

No chimney cap was observed. This is important to protect from moisture intrusion, weathering and wildlife nesting. Recommend a qualified roofer or chimney expert install.

Recommendation
Contact a qualified roofing professional.

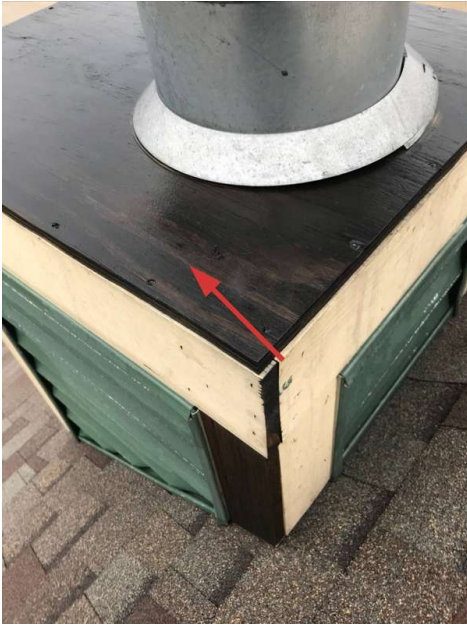
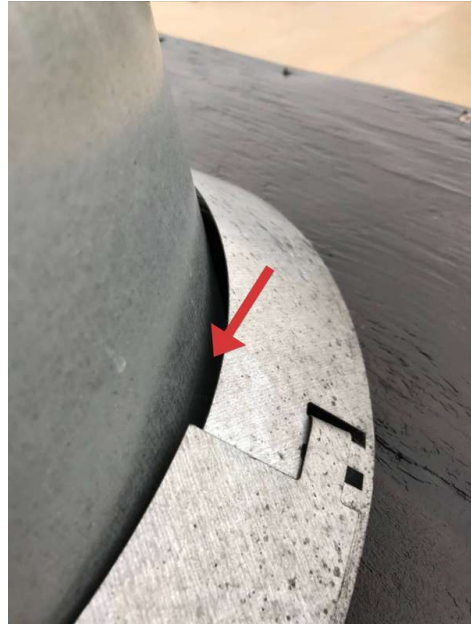
2.4.2 Skylights, Chimneys & Other Roof Penetrations

CHIMNEY CAP IMPROPERLY INSTALLED

CHIMNEY TO INDOOR WOOD BURNING FIREPLACE

Chimney cap was installed using flat plywood rather than recommended materials. This will potentially result in wood rot and water intrusion. Recommend chimney repair contractor install proper cap.

Contact a qualified chimney contractor.

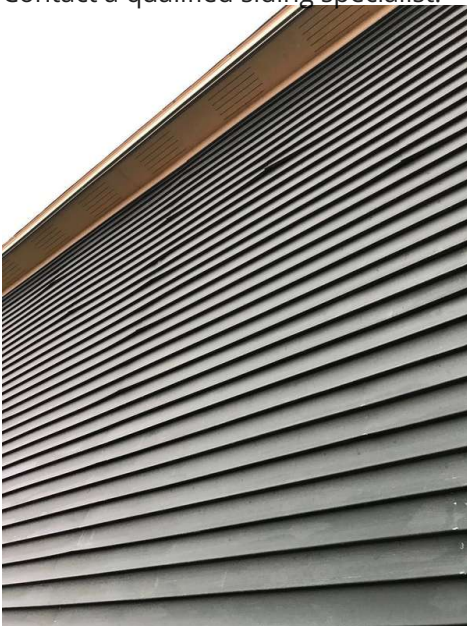
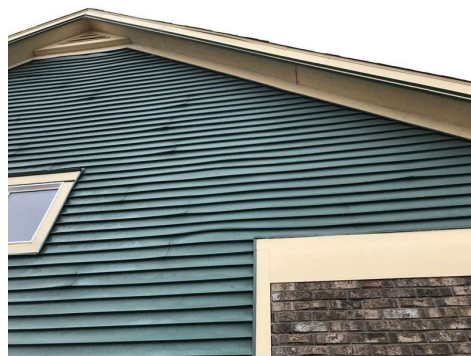
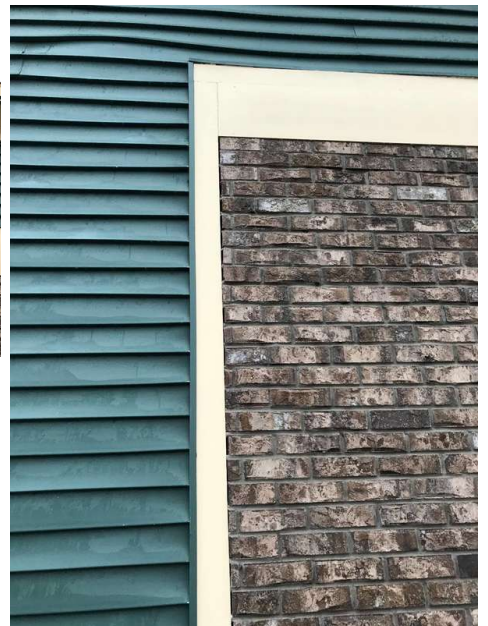
3.1.1 Siding, Flashing & Trim

WARPING/BUCKLING

MULTIPLE LOCATIONS

Vinyl siding was warping or buckling in areas. This is often as a result of nailing siding boards too tight to the home, preventing expansion/contraction. Recommend a qualified siding contractor evaluate and repair.

Contact a qualified siding specialist.

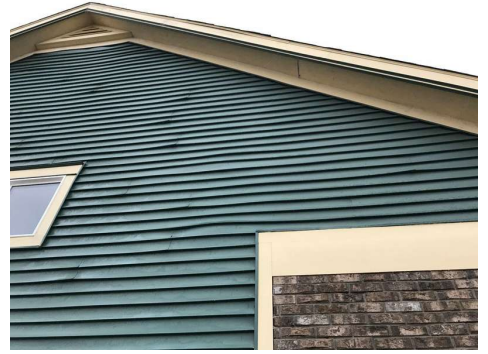
3.1.2 Siding, Flashing & Trim

TRIM IMPROPERLY SEALED

TRIM BETWEEN THE SIDING AND EXTERIOR BRICK FIREPLACE

Trim is improperly sealed which could cause moisture intrusion.
Recommend proper sealing.

Contact a handyman or DIY project

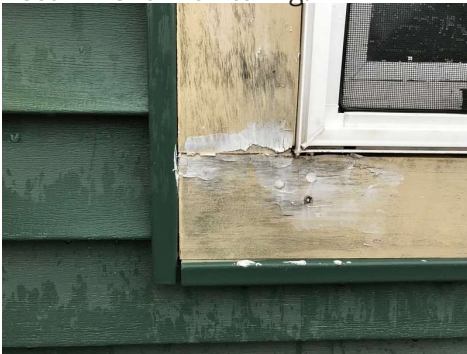
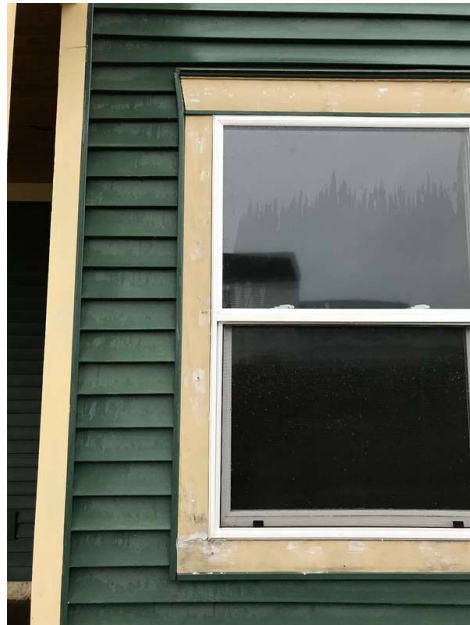
3.1.3 Siding, Flashing & Trim

WOOD TRIM EXPOSED TO ELEMENTS

Trim around exterior windows is wood material. Does not seem to be treated or painted and is exposed to the elements. Recommend treating and monitoring to prevent future wood rot and water intrusion.

Recommend monitoring.

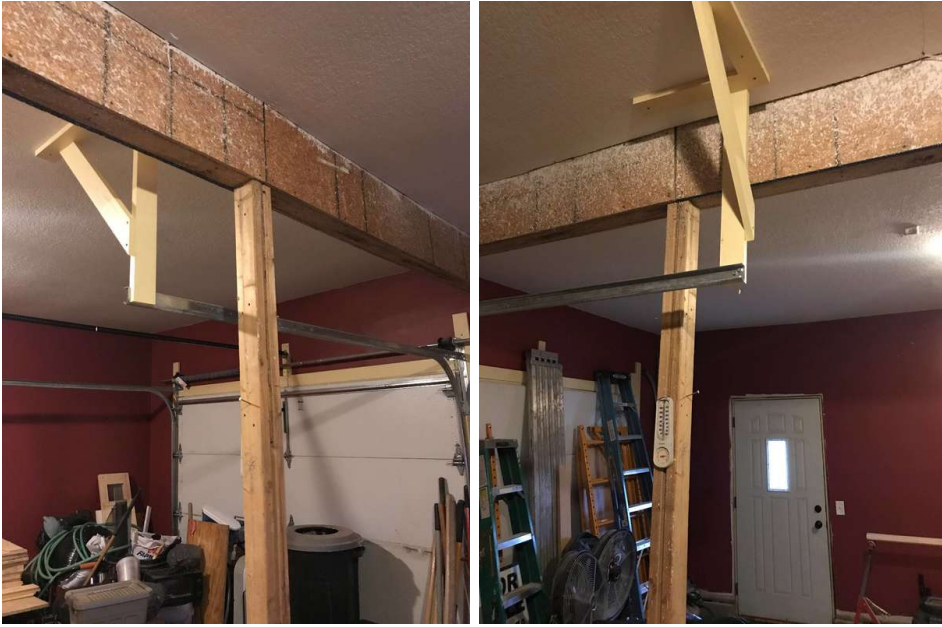
3.2.1 Exterior Doors

GARAGE DOORS

I was unable to test garage overhead doors due to ongoing construction and homeowners belongings.

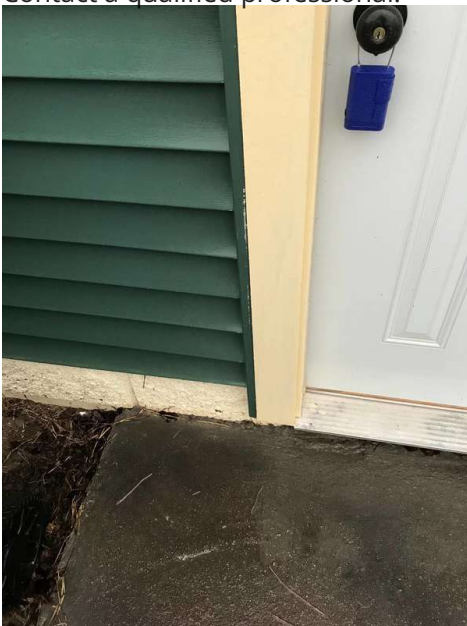
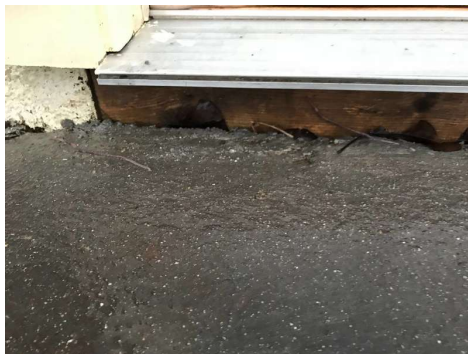
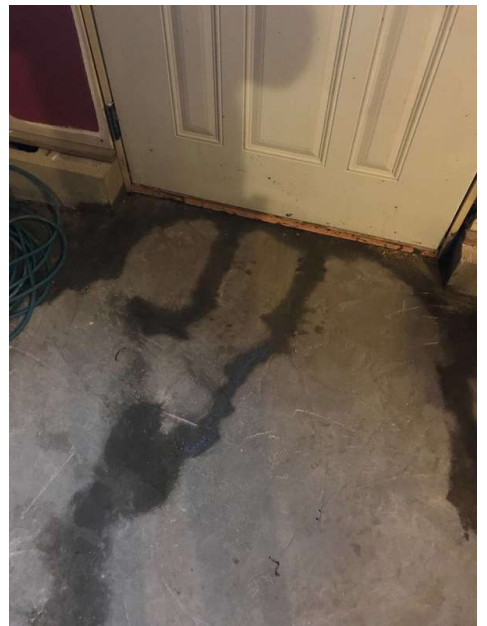
3.2.2 Exterior Doors

LEAKING

GARAGE

Water intrusion most likely due to improper installation or missing trim. Recommend DIY or Qualified Professional to correct.

Contact a qualified professional.

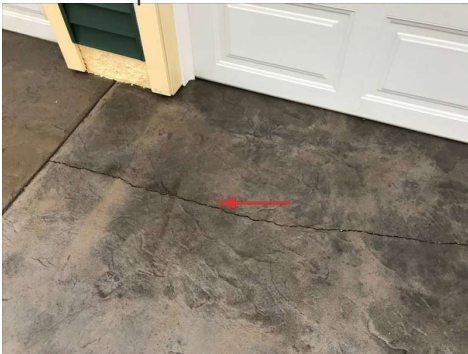
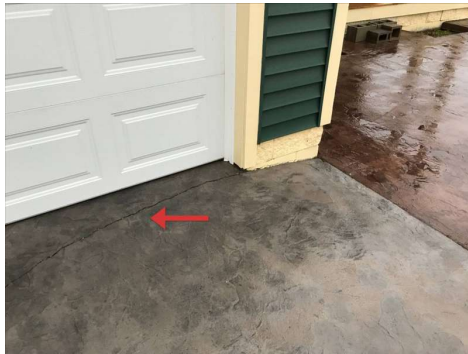
3.3.1 Walkways, Patios & Driveways

DRIVEWAY CRACKING - MINOR

Minor cosmetic cracks observed, which may indicate movement in the soil. Recommend monitor and/or have concrete contractor patch/seal.

Contact a qualified concrete contractor.

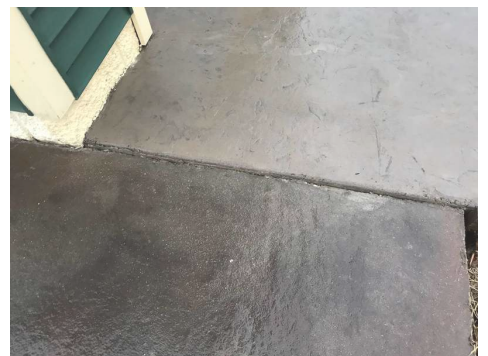
3.3.2 Walkways, Patios & Driveways

DRIVEWAY TRIP HAZARD

WHERE THE DRIVEWAY MEETS THE GARAGE FLOOR

Trip hazards observed. Patch or repair recommended.

Safety Hazard

Recommended DIY Project

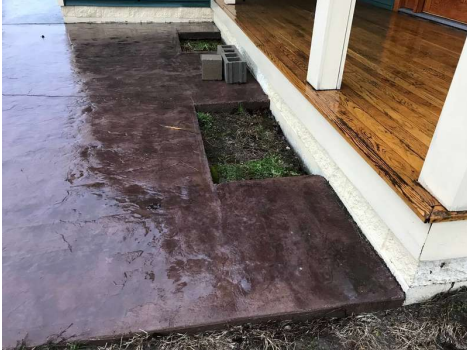
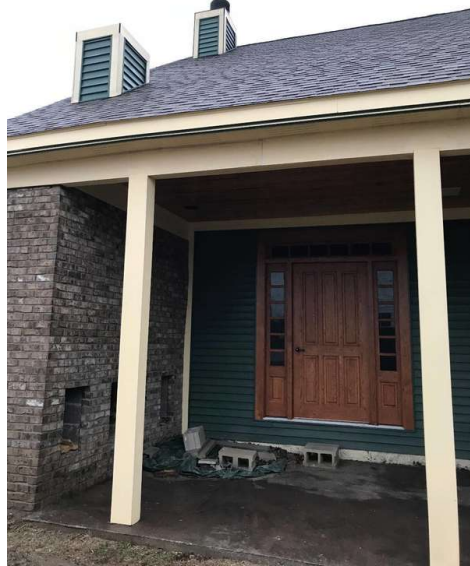
3.4.1 Decks, Balconies, Porches & Steps

MISSING STAIRS

Construction is ongoing so there are no steps leading to the front porch. There are cutouts that may be foundation supports for future steps. The rear patio has no steps leading up to the door for entry to the home. Recommend stairs in both locations.

Contact a qualified professional.

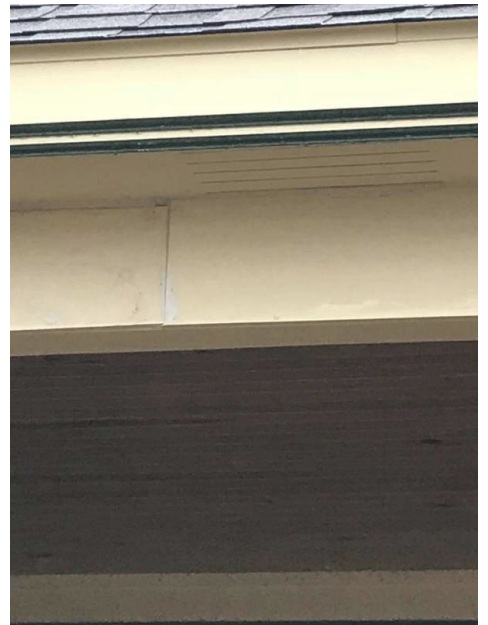
3.5.1 Eaves, Soffits & Fascia

WOOD FINISH

Eaves, Soffits & Fascia are all wood material. Recommend monitoring and maintenance as needed to prevent wood rot and water intrusion.

Contact a qualified professional.

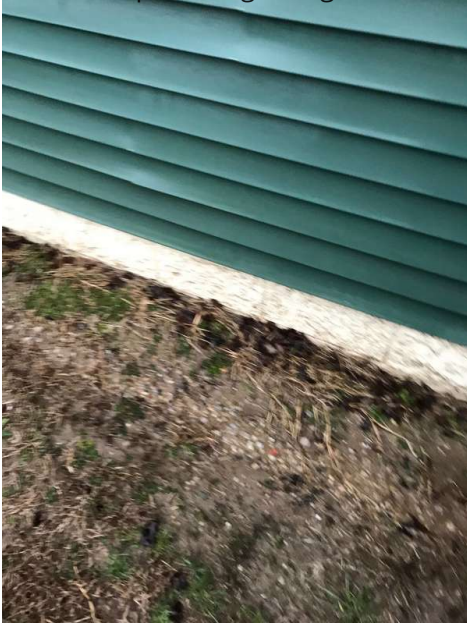
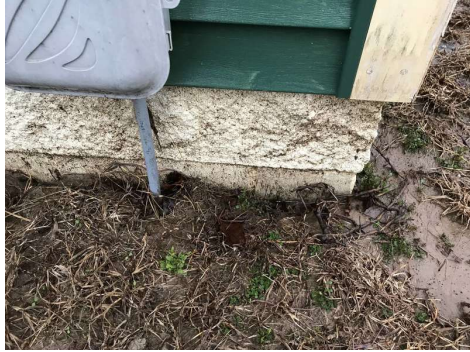
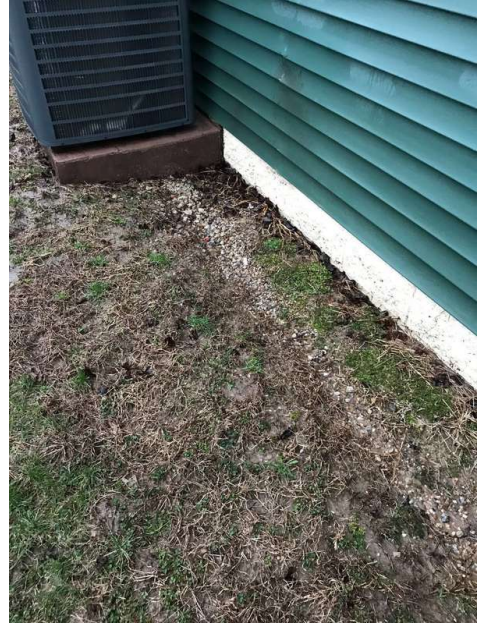
3.6.2 Vegetation, Grading, Drainage & Retaining Walls

INCOMPLETE GRADING

Construction still in progress, gutters have not been installed causing improper drainage. This is creating a trench that is pushing water towards the foundation. Recommend gutter installation and proper grading to prevent future water intrusion.

Recommendation
Contact a qualified grading contractor.

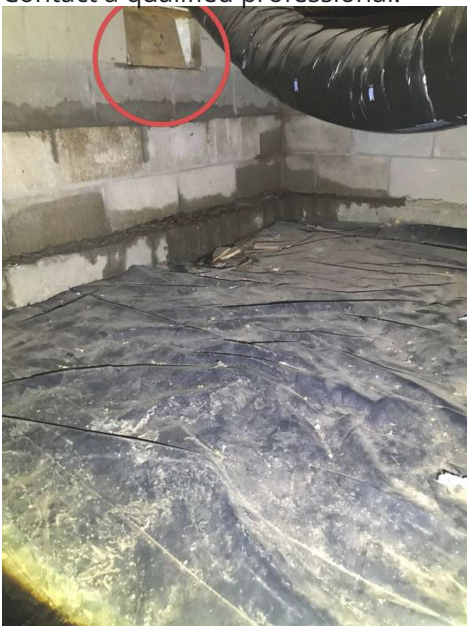
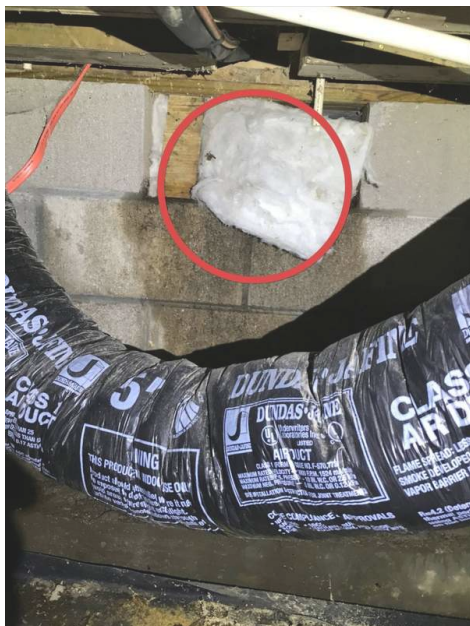
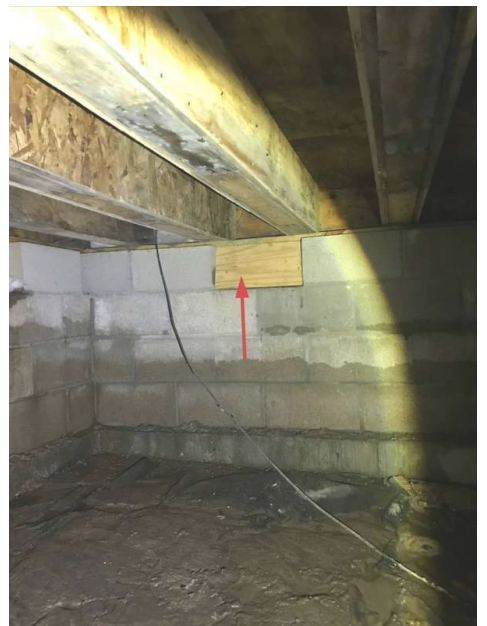
4.1.1 Foundation

POOR VENTILATION OF FOUNDATION AREA

The foundation is poorly ventilated. Increased ventilation (introduction and movement of fresh air) is recommended. This can be accomplished by partially opening basement windows, doors and/or vents on opposite sides of the foundation on a regular basis (when weather is suitable). And by installing a dehumidifier to decrease moisture.

Recommendation
Contact a qualified professional.

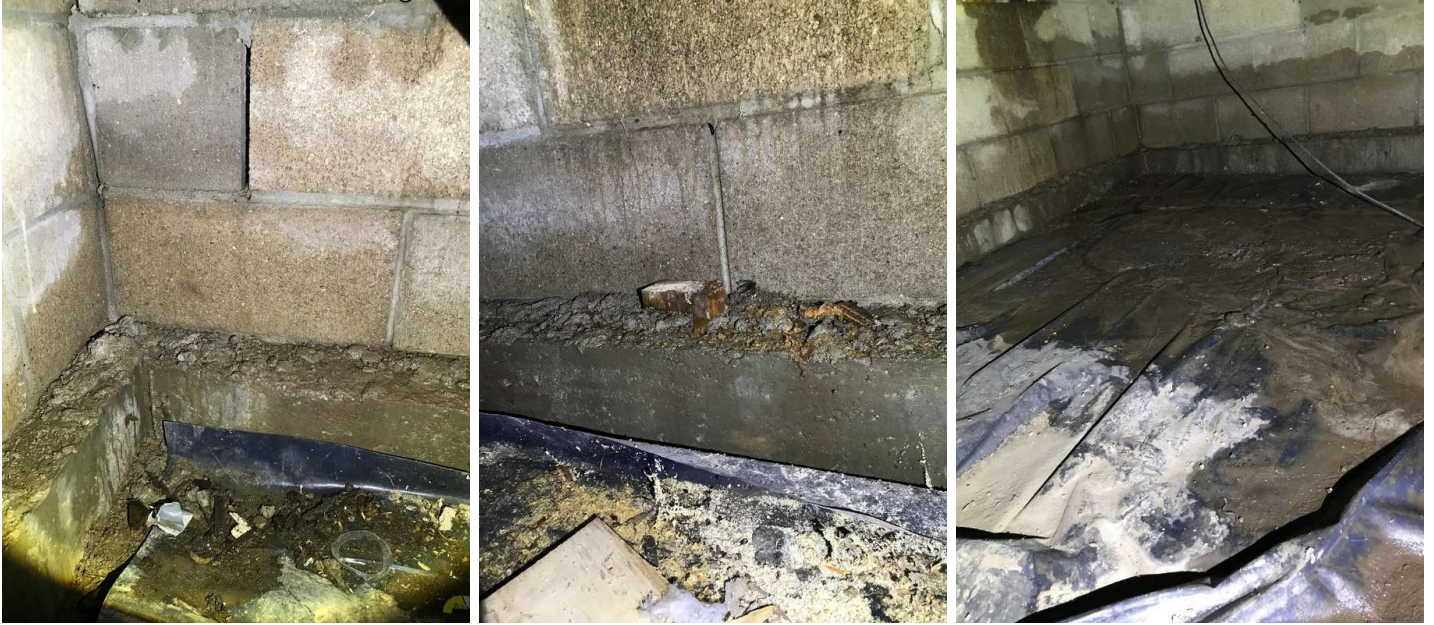
4.1.2 Foundation

WATER INTRUSION

Water intrusion was evident on the surface of the floor slab or in the basement/crawlspace. This can compromise the soil's ability to stabilize the structure and could cause damage. Recommend a qualified contractor identify the source of moisture and remedy.

Contact a qualified structural engineer.

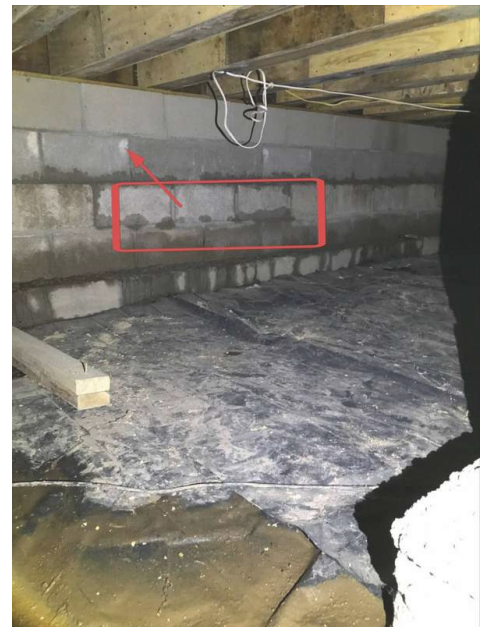
4.2.1 Basements & Crawlspaces

EFFLORESCENCE

Efflorescence noted on the crawlspace surface. This a white, powdery deposit that is consistent with moisture intrusion. This can compromise the soil's ability to support the home structure and/or lead to mold growth. Recommend a qualified contractor identify source or moisture and correct.

Contact a qualified professional.

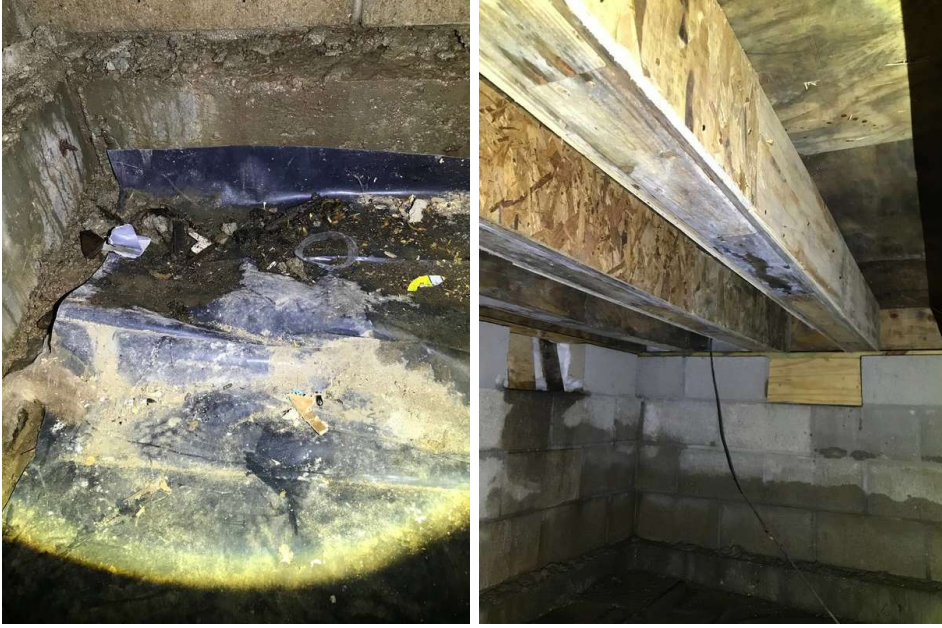
4.2.2 Basements & Crawlspaces

HIGH MOISTURE LEVELS

High levels of moisture were noted in areas of the basement. Recommend monitoring and finding source of moisture intrusion to prevent damage to structure.

Recommendation
Contact a qualified professional.

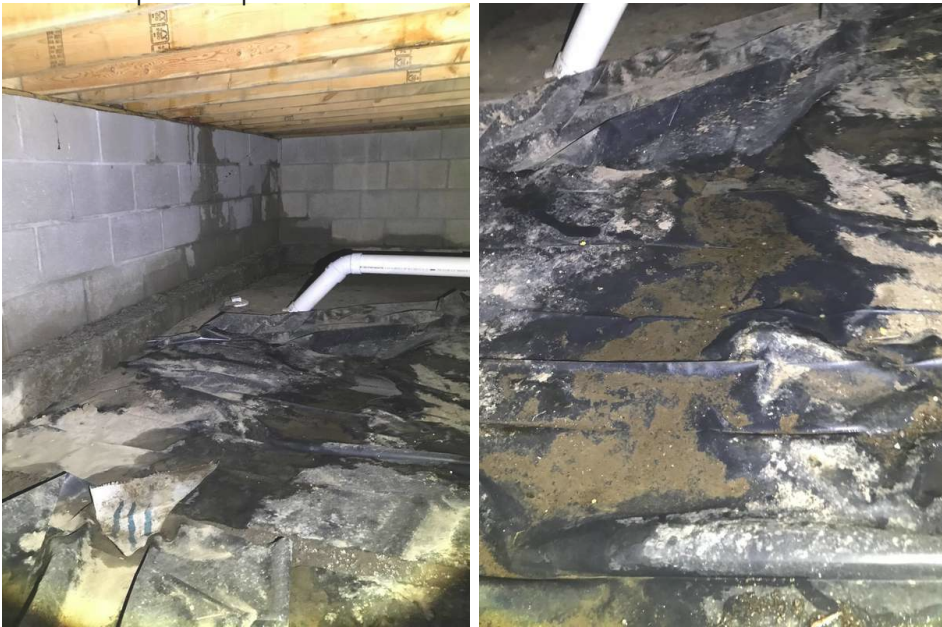
4.2.3 Basements & Crawlspace

STANDING WATER

CRAWLSPACE

Observed signs that standing water may have been present on basement floor. Recommend a qualified contractor evaluate and find potential source of moisture.

Recommendation
Contact a qualified professional.

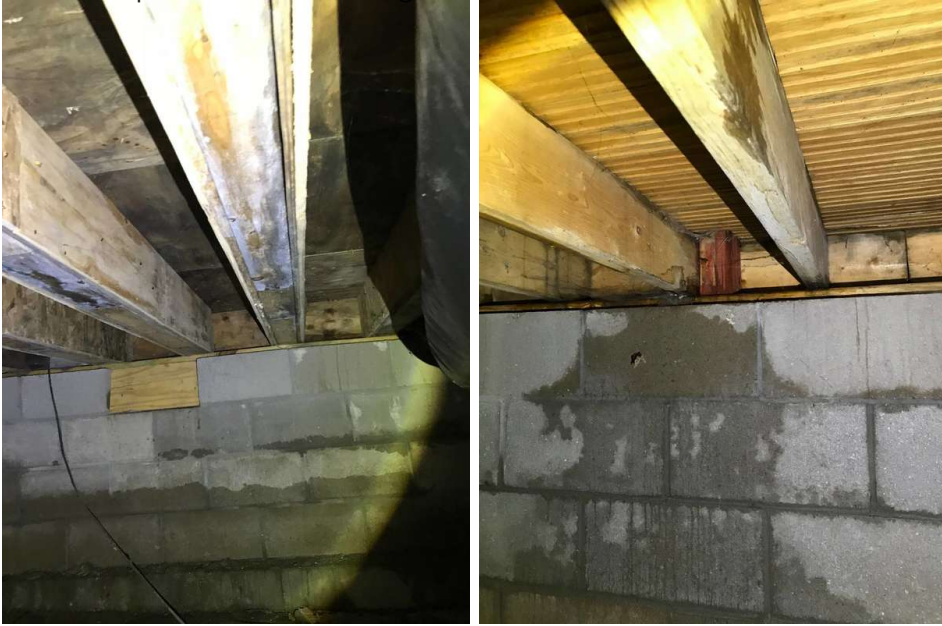
4.3.1 Floor Structure

EVIDENCE OF WATER INTRUSION

CRAWLSPACE

There were signs of water intrusion in the underlying floor structure. Recommend identifying source of moisture and repairing.

Recommendation
Contact a qualified structural engineer.

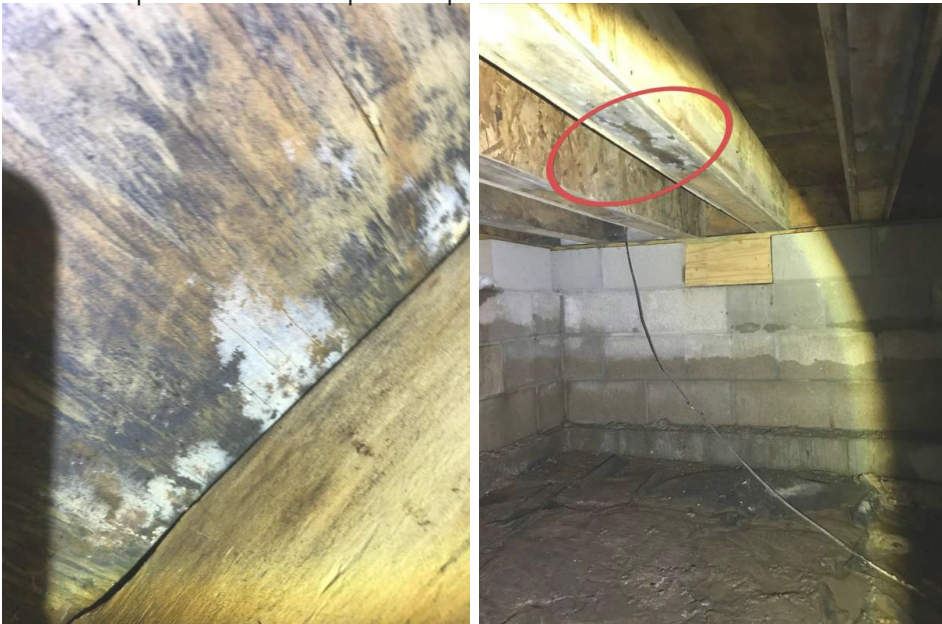
4.3.2 Floor Structure

MOLD

CRAWLSPACE

Observed signs of mold in one or more areas in the flooring structure. Recommend identifying source or moisture intrusion and sending samples to a lab for testing.

Recommendation
Contact a qualified mold inspection professional.

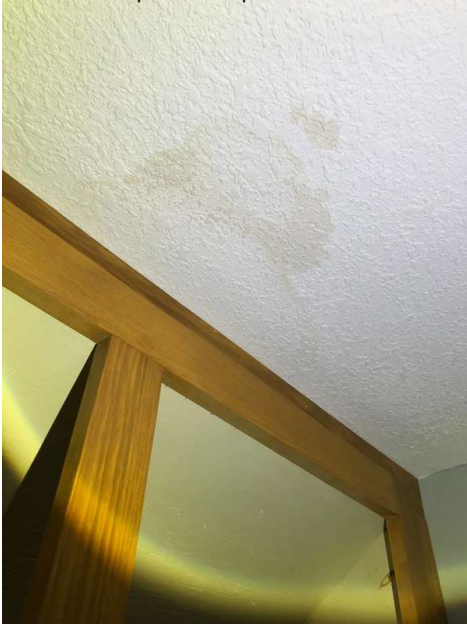
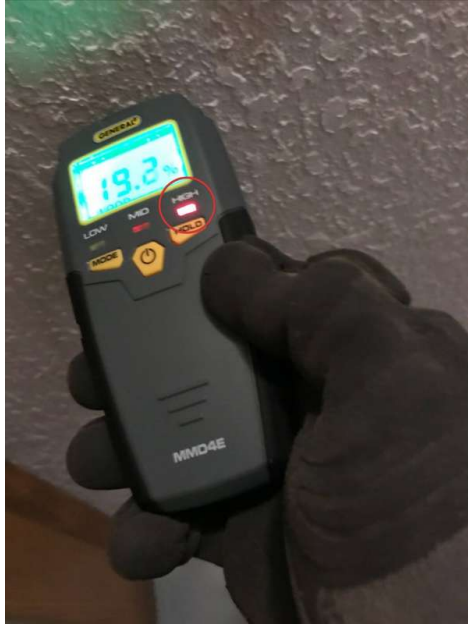
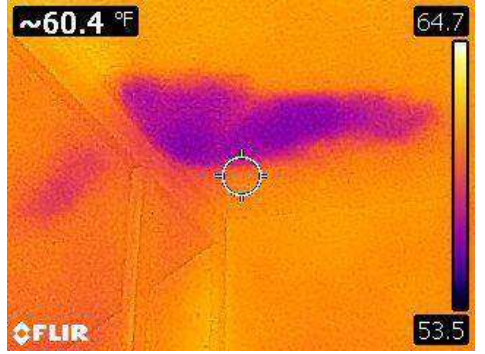
4.5.1 Ceiling Structure

EVIDENCE OF WATER INTRUSION

BEDROOM 2ND FLOOR CLOSET

Ceiling structure showed signs of water intrusion, which could lead to more serious structural damage. Recommend a qualified contractor identify source or moisture and remedy.

Recommendation
Contact a qualified professional.

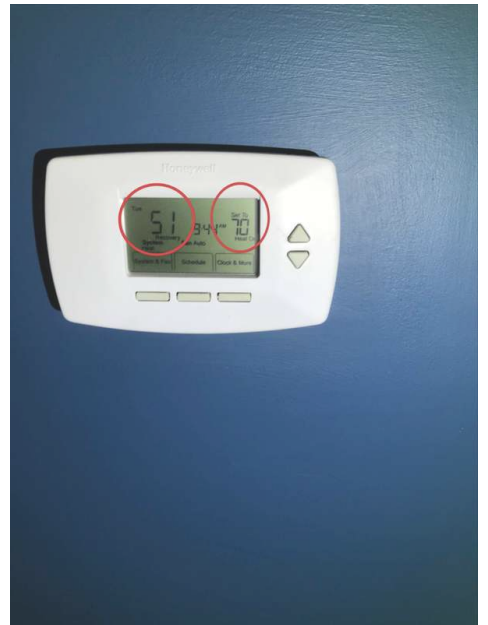
5.1.1 Equipment
INOPERABLE

Heating element was inoperable at time of inspection. Recommend qualified HVAC professional evaluate & ensure functionality.

Recommendation
Contact a qualified HVAC professional.

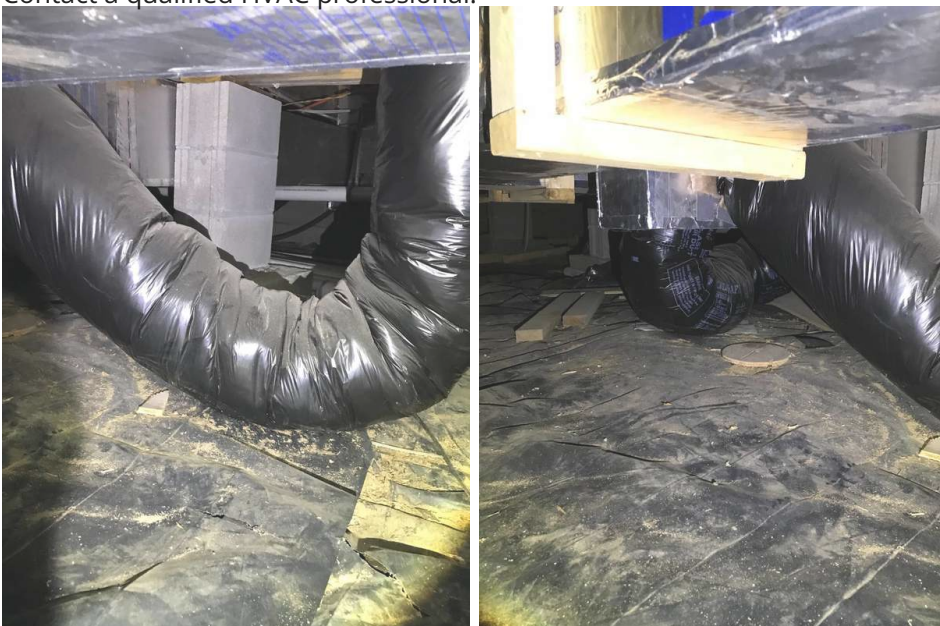
5.3.1 Distribution Systems

DUCT IMPROPERLY SECURED

CRAWLSPACE

Ducts were not properly secured causing them to hang in areas. This can make it more difficult for heat system to push air through. Recommend HVAC technician evaluate and repair.

Contact a qualified HVAC professional.

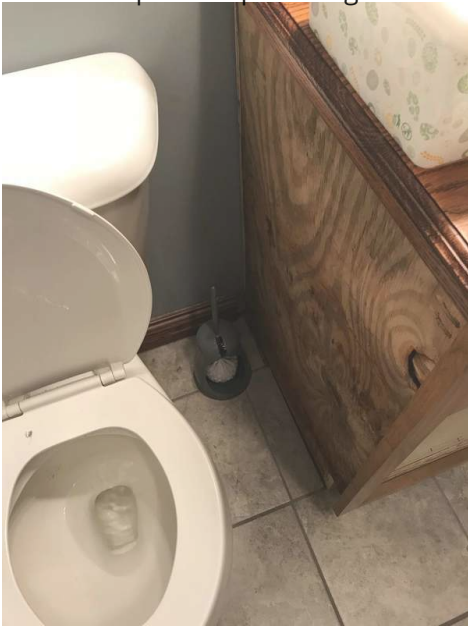
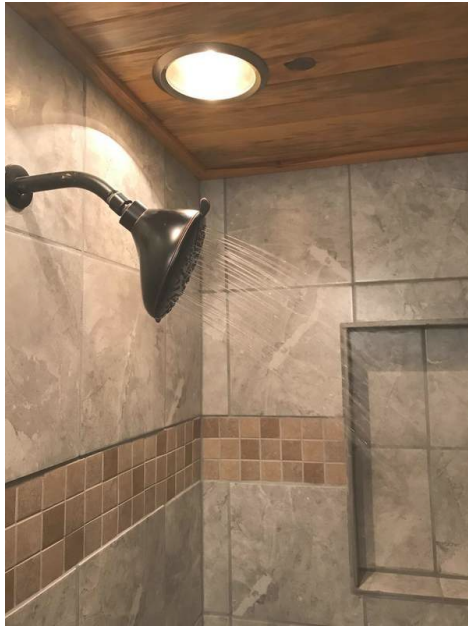
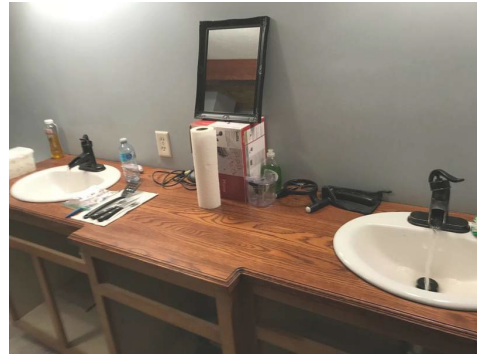
7.3.1 Water Supply, Distribution Systems & Fixtures

INCOMPLETE PLUMBING

Construction is ongoing. Plumbing incomplete. I was unable to properly test functional flow and pressure of water. However, the plumbing I was able to observe was functioning properly at time of inspection. If you would like me to come back and check once complete, please call.

Contact a qualified plumbing contractor.

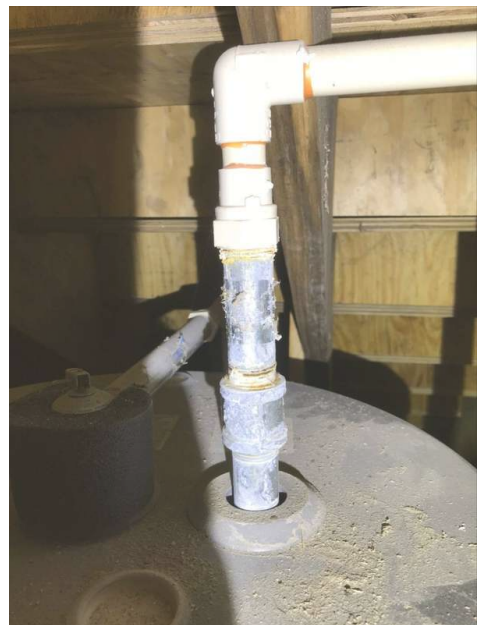
7.4.1 Hot Water Systems, Controls, Flues & Vents

CORROSION

Corrosion was noted at the burn chamber or pipe fittings. Recommend a qualified plumber evaluate for repair/replacement.

Contact a qualified plumbing contractor.

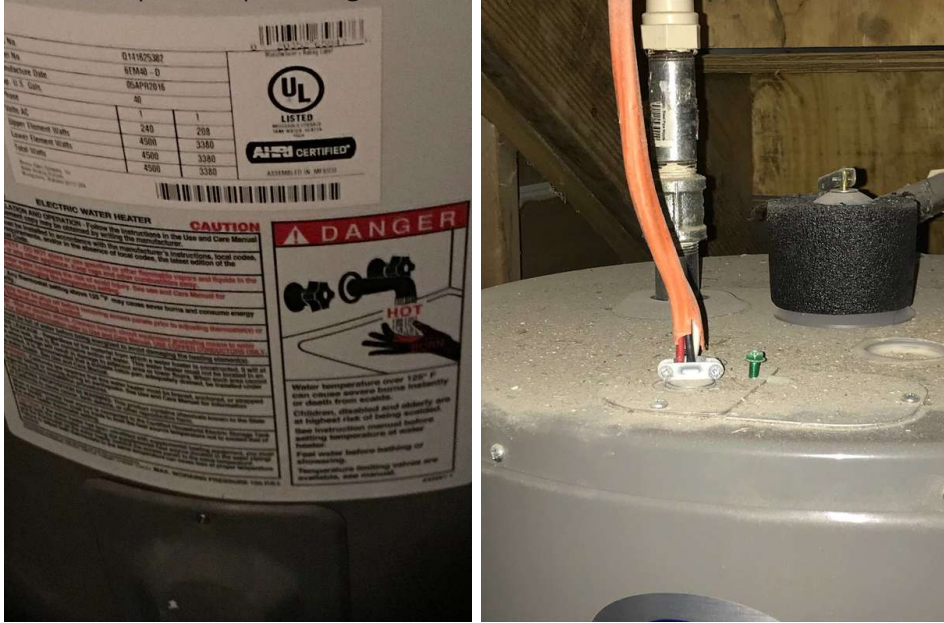
7.4.2 Hot Water Systems, Controls, Flues & Vents

NO DRIP PAN

No drip pan was present. Recommend installation by a qualified plumber.

Contact a qualified plumbing contractor.

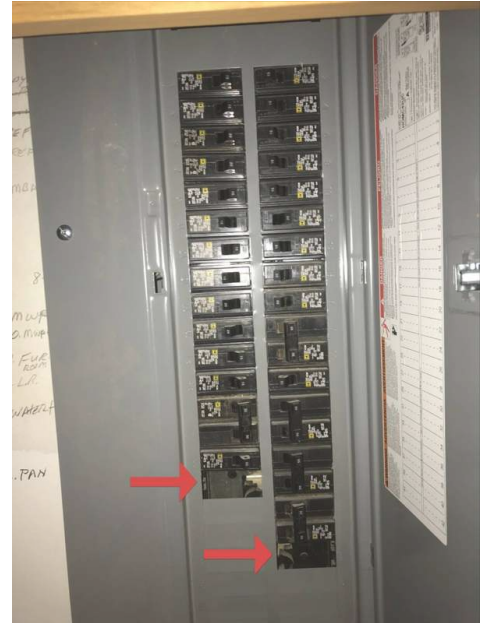
8.2.1 Main & Subpanels, Service & Grounding, Main Overcurrent Device
KNOCKOUTS MISSING

"Knockouts" are missing on the electric panel. This poses a safety hazard and it is recommended that the opening in the panel caused by the missing knockout(s) be properly sealed by a licensed electrician.

Recommendation
Contact a qualified electrical contractor.

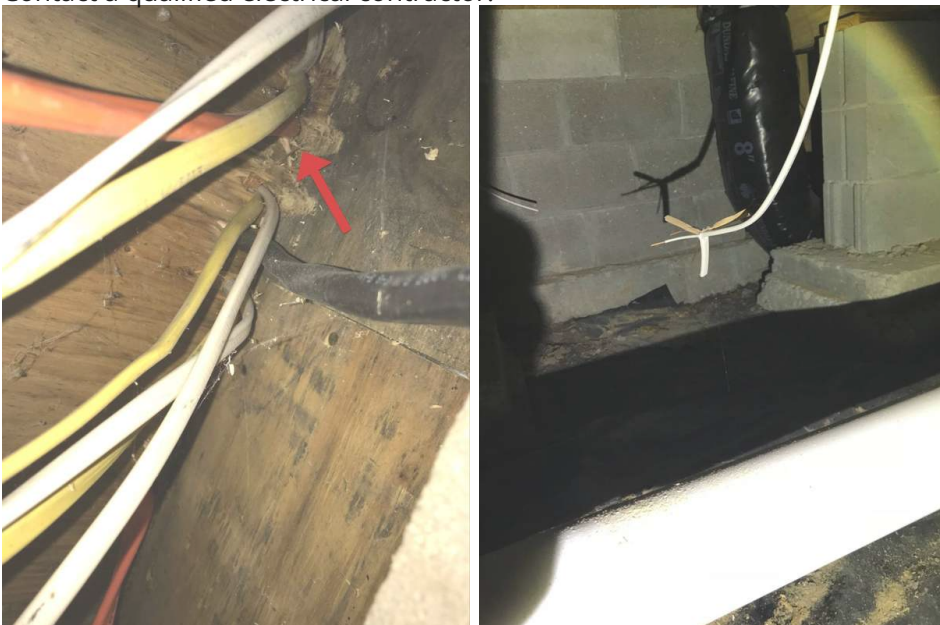
8.3.1 Branch Wiring Circuits, Breakers & Fuses
IMPROPER WIRING

CRAWLSPACE

Wiring is run through flooring into the crawlspace. The hole is jagged which may cause future fraying of the wire. Recommend a qualified electrician further evaluate the wiring and electrical system.

Unknown exposed wire

Recommendation
Contact a qualified electrical contractor.

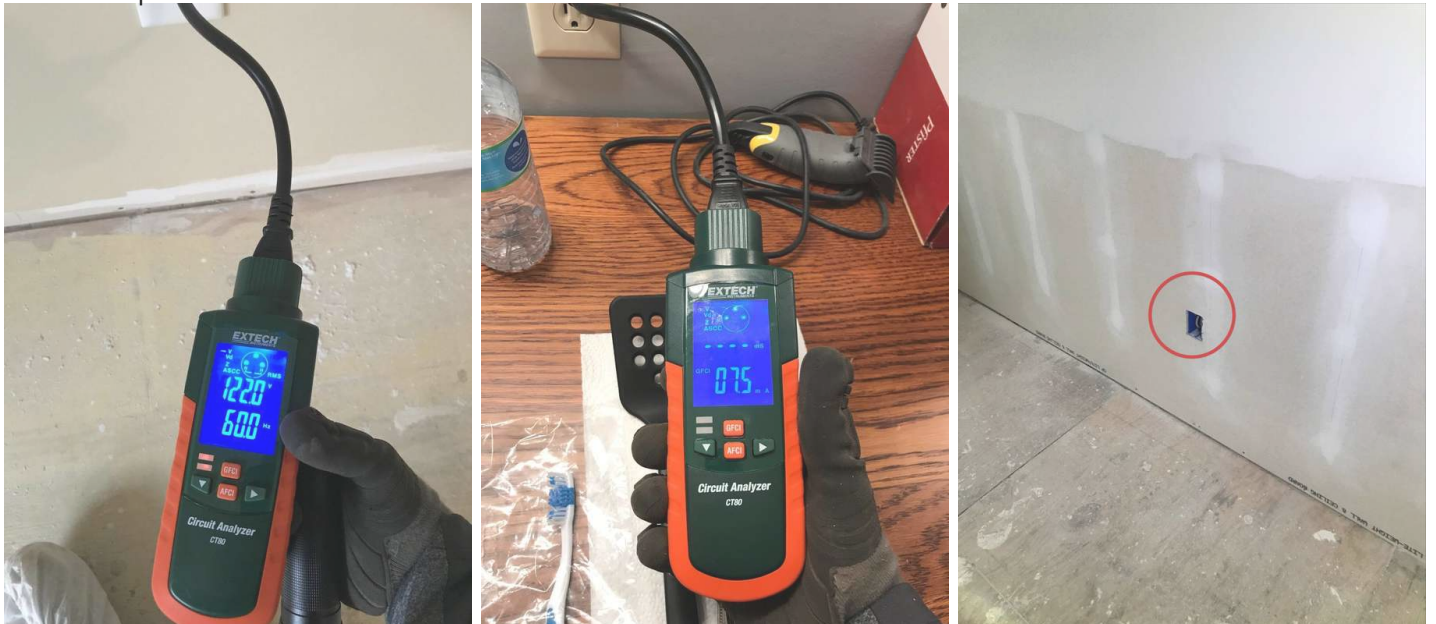
8.4.2 Lighting Fixtures, Switches & Receptacles

INCOMPLETE

Due to ongoing construction, several plate covers were missing. There were outlets yet to be installed. All receptacles did not have power or light fixtures were missing. I did test a representative number of outlets and switches. The ones that were tested seemed to be in working order.

Contact a qualified electrical contractor.

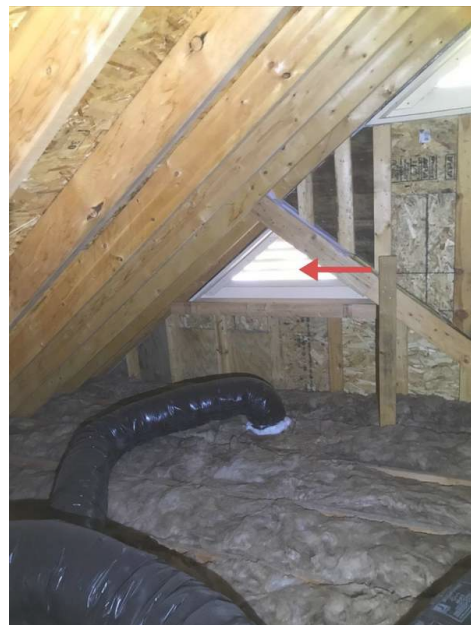
9.3.1 Ventilation

MISSING VENTILATION

I was not able to observe all ventilation systems at the time of this inspection. It is a possibility that the soffit vents were covered by insulation. Recommend evaluate further. Also observed no screen on the attic vent. Recommend screen to prevent vermin from entering residence.

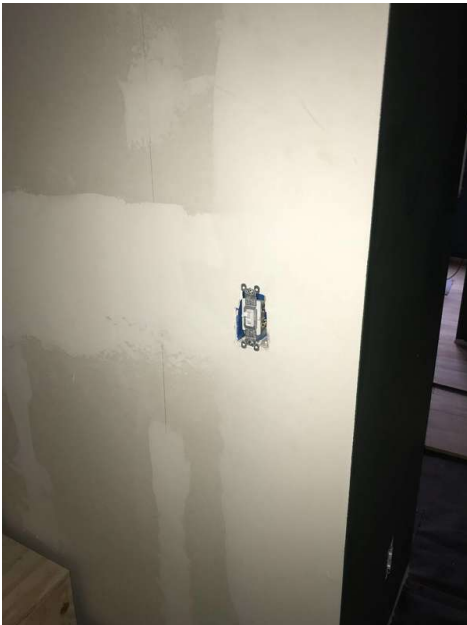
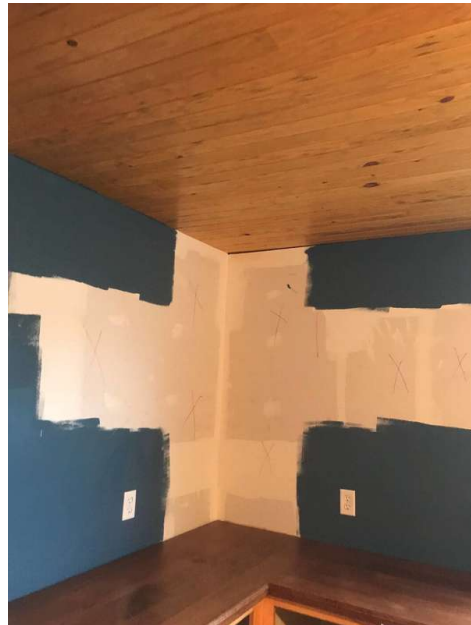
10.4.1 Walls

INCOMPLETE

Due to ongoing construction in the home, many areas of drywall were not complete.

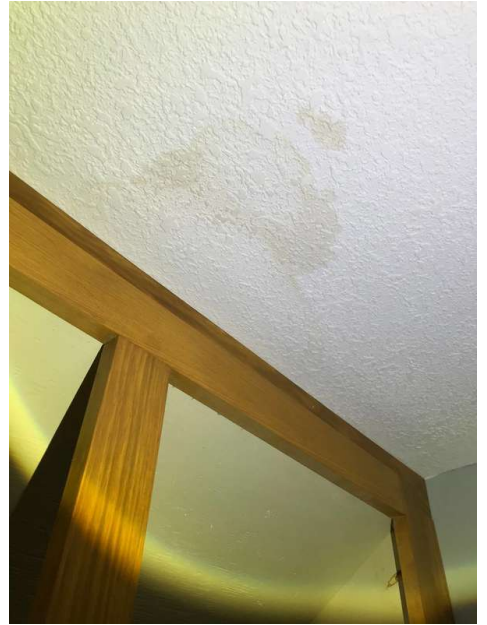
10.5.1 Ceilings

STAIN(S) ON CEILING

MASTER CLOSET

There is a stain on ceiling/wall that requires repair and paint. Source of staining should be determined.

Contact a qualified professional.

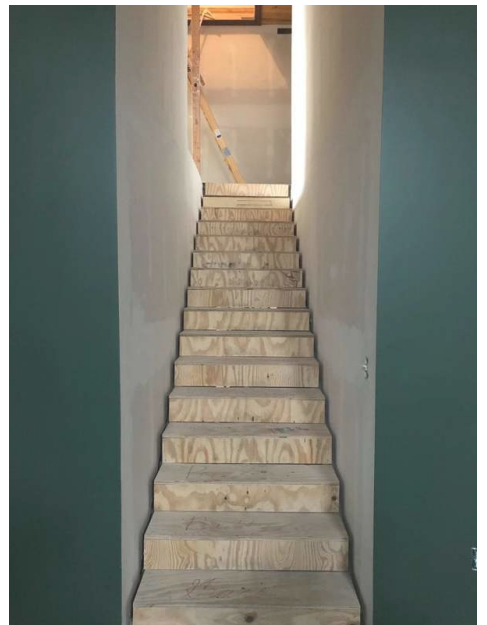
10.6.1 Steps, Stairways & Railings

NO HANDRAIL

STAIRCASE

Staircase had no handrails. This is a safety hazard. Recommend a qualified handyman install a handrail.

Contact a qualified handyman.
