SUMMARY

1234 Main St. Oreana IL 62554

Buyer Name
06/28/2018 9:00AM

Michael Bell
License #450.011879
Titan Home Inspections
217-329-4126

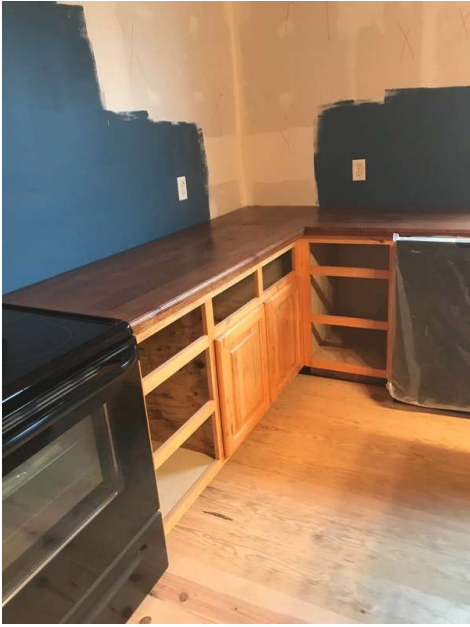
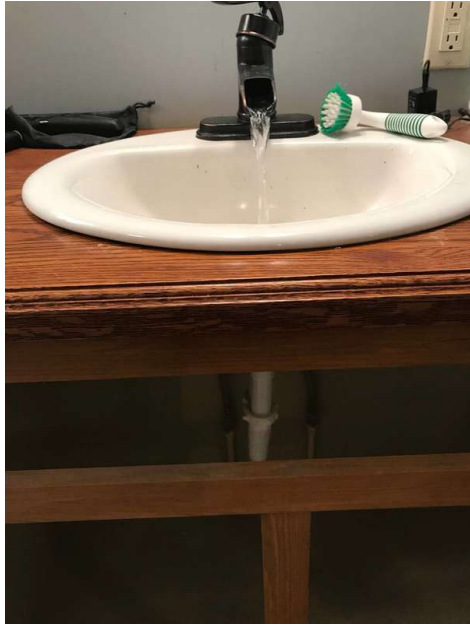
10.7.1 Countertops & Cabinets

CABINET DOOR MISSING

One or more cabinet doors were missing.

Contact a qualified cabinet contractor.
