SUMMARY

1234 Main St. Wheeling WV 26003

Mark Bonar
Certified Master Inspector®
Mountain State Inspections LLC
304-830-3354
wheelinghomeinspector@gmail.com

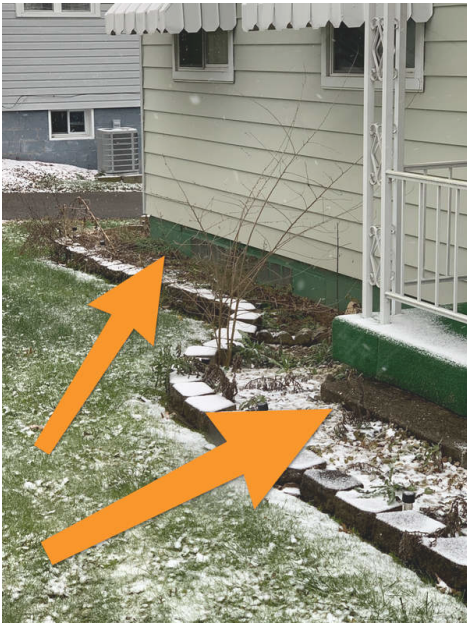
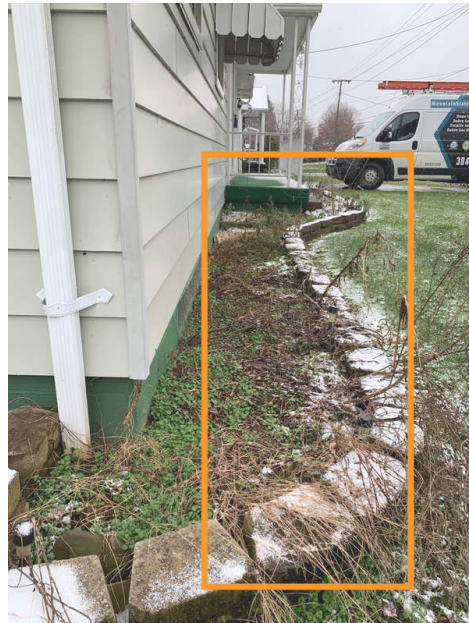
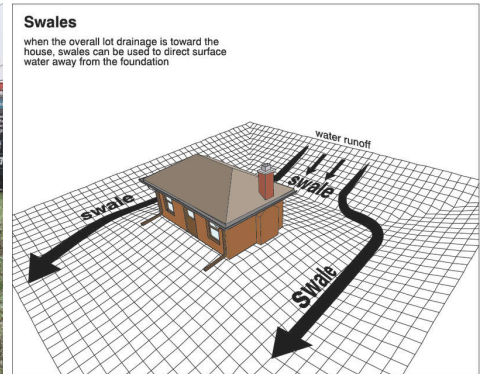
Swale

NEGATIVE GRADING

— Marginal

The grade adjacent to the foundation has settled & needs to be improved. Recommend continual landscaping to ensure positive grade with sloping away from the house to prevent water runoff & seepage into the foundation. The standard is 1 inch of slope per foot up to 6 feet. [Here is a helpful article](#) discussing negative grading. Interior drain tile installed with sump pump to help address any water entry.

Recommendation

Contact a qualified professional.

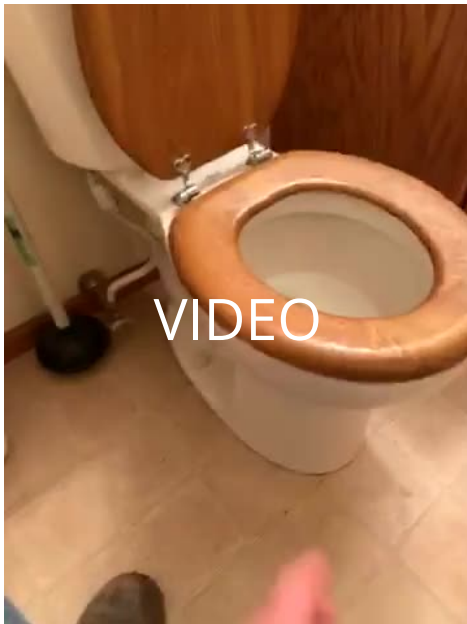
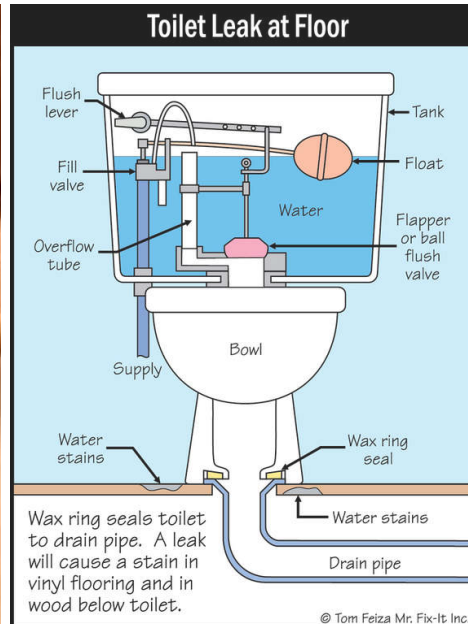
P027C

TOILET LOOSE/LEAKING

Toilet is loose at the base. Recommend a qualified professional evaluate and repair to prevent water damage.

Contact a qualified professional.

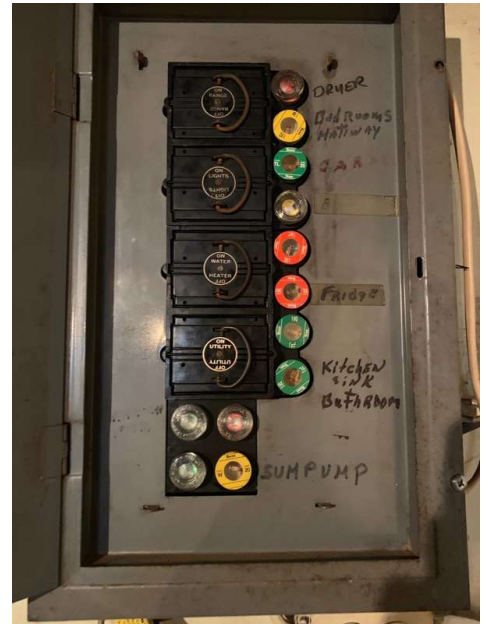
PANEL/BREAKERS OLDER 50+

The main distribution panel is obsolete and should be replaced. It was crowded with over fusing. The service panel and/or its fuses appear to be over 55 years old. We recommend you consult with a qualified electrical contractor concerning this aging fused service panel and its ability to service the home. Information about aging electrical panels and their breakers is available on the internet. [Web source information.](#)

Contact a qualified electrical contractor.

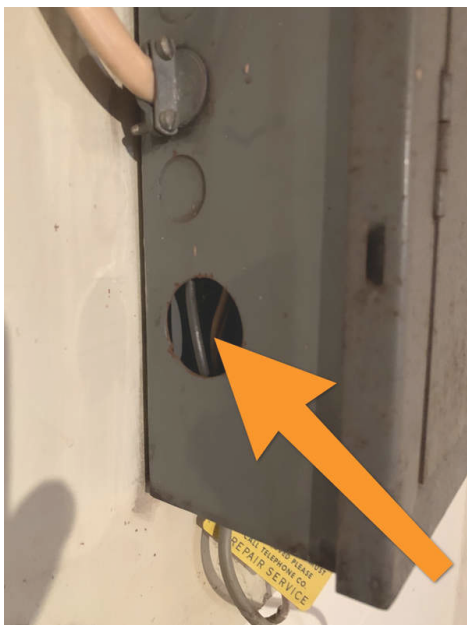
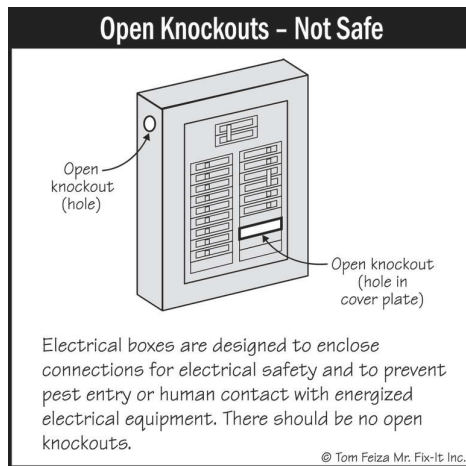
E134

9.2.2 Main & Subpanels, Service & Grounding, Main Overcurrent Device
KNOCKOUTS COVERS MISSING

"Knockouts" covers are missing on the electric panel. This poses a safety hazard and it is recommended that the opening in the panel caused by the missing knockout(s) be properly sealed by a licensed electrician.

Recommendation
 Contact a qualified electrical contractor.

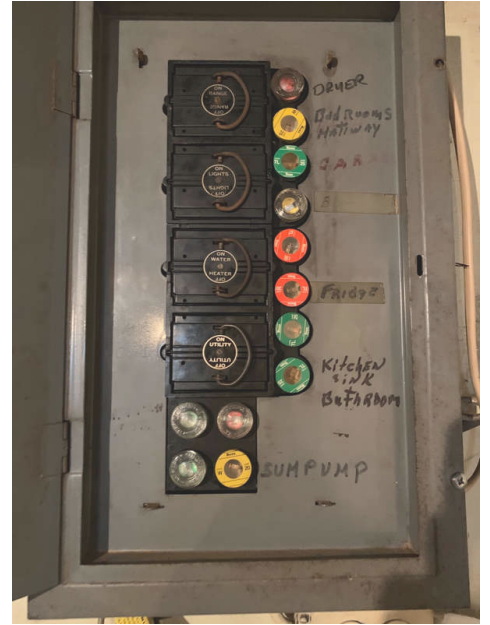
Oversized fuses within the main distribution panel should be replaced. All fuses serving household branch circuits should be sized at no larger that 20 amps.

Recommendation
Contact a qualified professional.

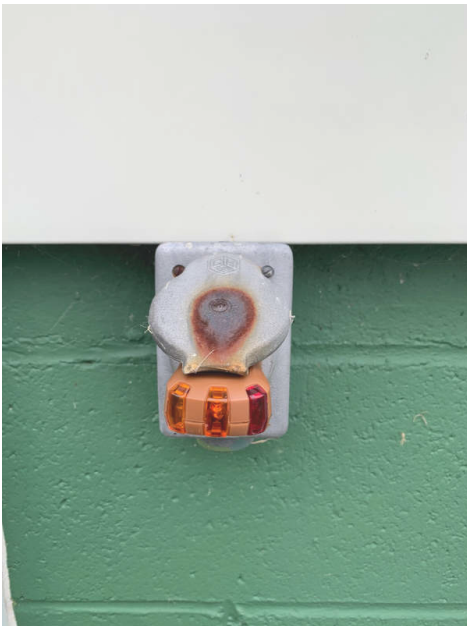
Exterior Rear

OUTLET UNGROUNDED

One or more receptacles have been wired with an open ground (no ground wire connected). The receptacle(s) needs to be repaired by qualified electrical contractor.

Recommendation
Contact a qualified electrical contractor.

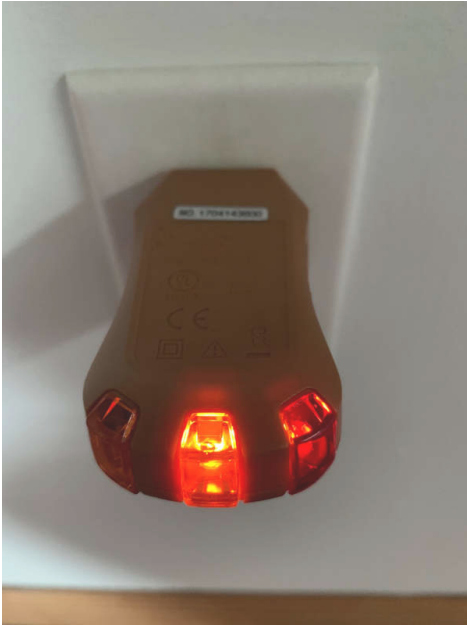
Basement Middle

OUTLET REVERSE POLARITY

One or more receptacles have been wired with reverse polarity. This condition should be corrected by a qualified electrical contractor.

Contact a qualified electrical contractor.

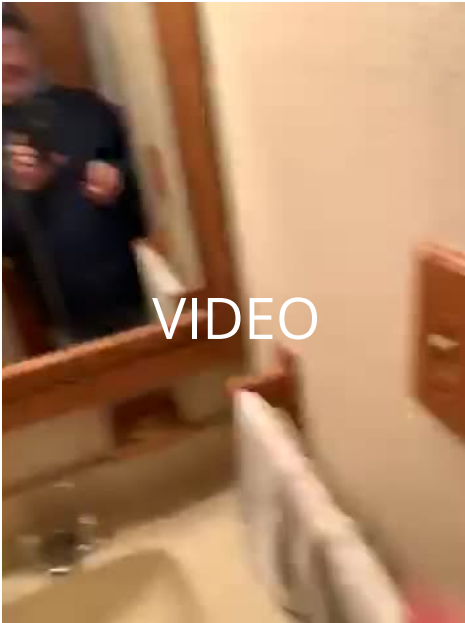
EXHAUST FAN NOISY

Exhaust fan was noisy and his near the end of it useful life, recommend replacing exhaust fan.

Contact a qualified professional.

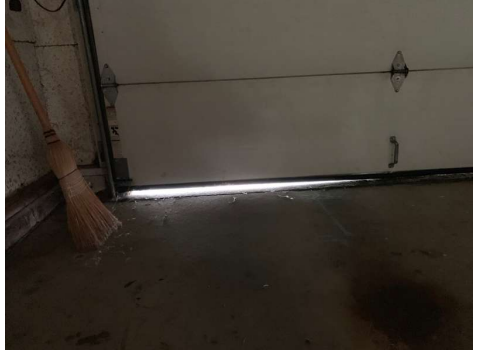
GARAGE DOOR NOT SEALED

Garage door has a gap allowing cold air into area where there is plumbing. Recommend a skirt be installed on the store to slow down cold air movement and then he passed that may want to come in.

Contact a qualified professional.
