SUMMARY 1234 Main St.Ewa Beach Hawii 96706 **Buyer Name** 02/01/2019 9:00AM

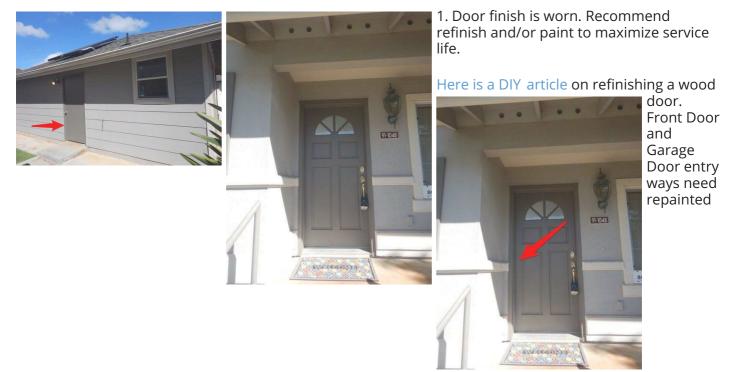
3.1.1 Exterior Doors **PAINT/REFINISH NEEDED** FRONT DOOR AND GARAGE DOOR

Recommendation Contact a qualified painter.

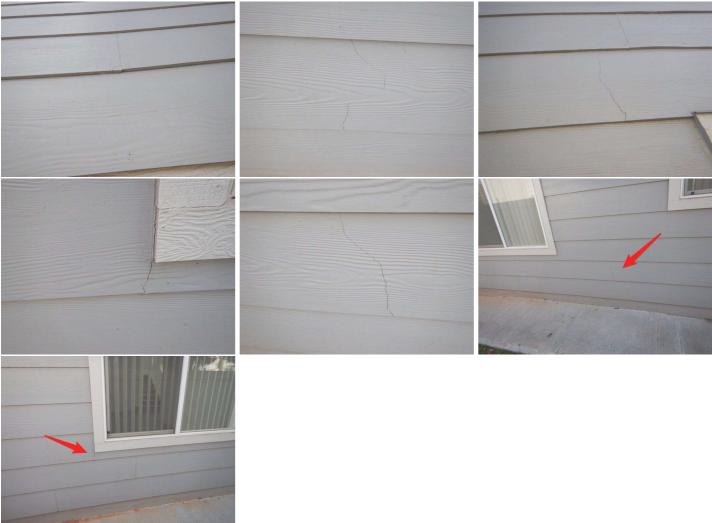
CRACKING - MINOR

Siding showed cracking in one or more places. This is a result of temperature changes, and typical as homes with stucco age. Recommend monitoring.

Recommendation

Contact a qualified siding specialist.

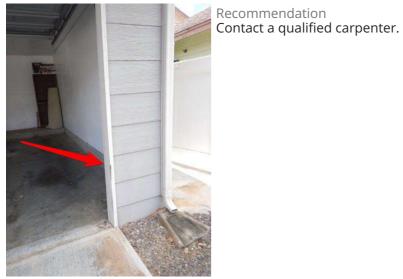
3.3.2 Siding, Flashing & Trim **GARAGE DOOD TRIM**

Trim around overhead Garage Door, seems to have been damaged. Recommend repair by a carpenter.

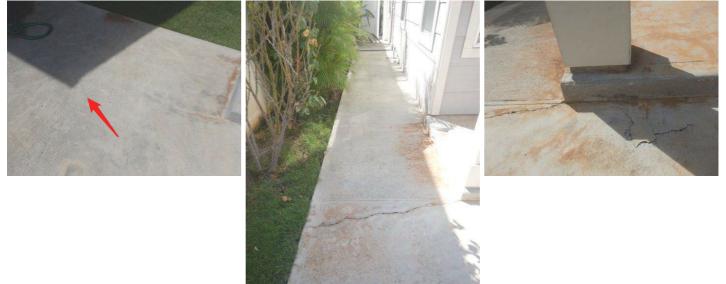
3.4.1 Walkways, Patios & Driveways PATIO CRACKING - MINOR

Normal settling & cracking observed. Recommend monitor and/or patch/seal.

Recommendation Contact a qualified concrete contractor.

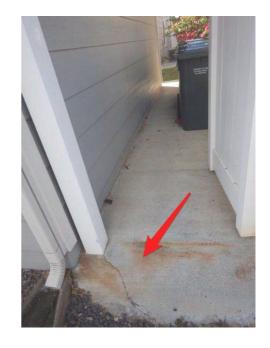
WALKWAY CRACKING - MINOR

Minor cosmetic cracks observed. Recommend monitor and/or patch/seal. Recommendation

Contact a qualified concrete contractor.

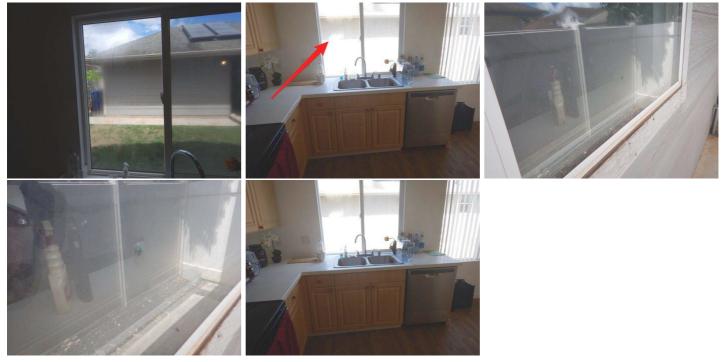
There is condensation between the panes of glass of one double pane window. This indicates a failed seal. We recommend the lens assembly be replaced, which is the only method for correcting this deficiency.

Contact a qualified window repair/installation contractor.

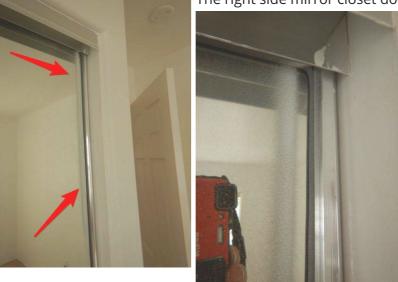
12.2.2 Door **CLOSET DOORS**

The right side mirror closet door has paint over-spray at one side.Repair is needed.

Recommendation Contact a qualified professional.

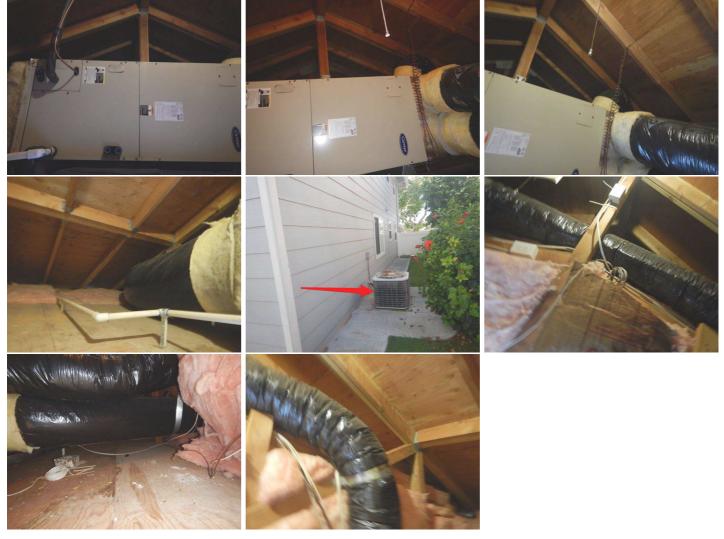
17.1.1 AC AC HAS SIGNS OF WEAR

HVAC system is moderately worn

Recommendation Contact a qualified HVAC professional.
