## SUMMARY

1234 Main St. Rancho Mirage CA 92270

Jerry Campbell  
Certified Inspector / General...  
CAL-SPEC INC.  
760.770.7060  
calspec111@gmail.com

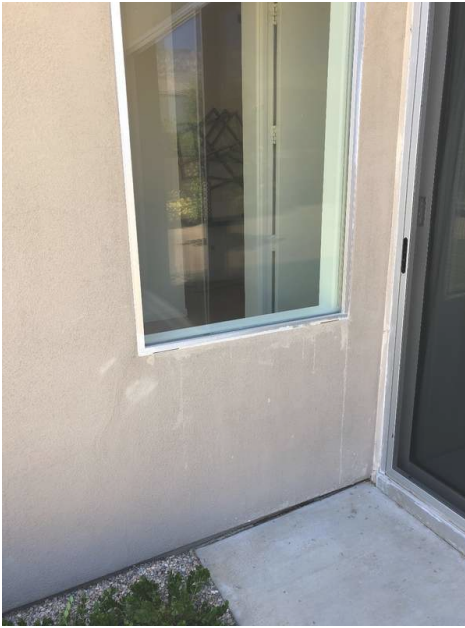
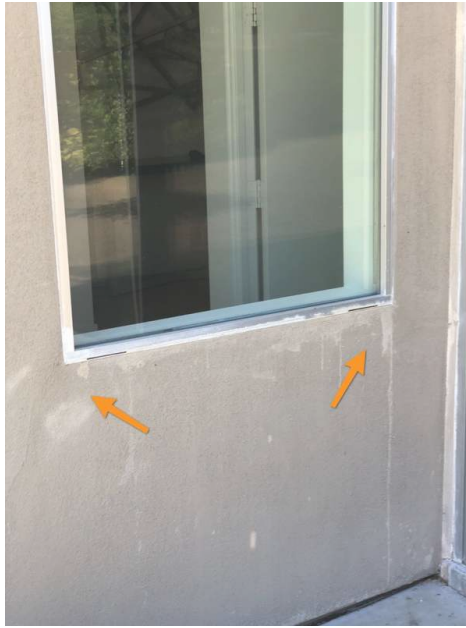
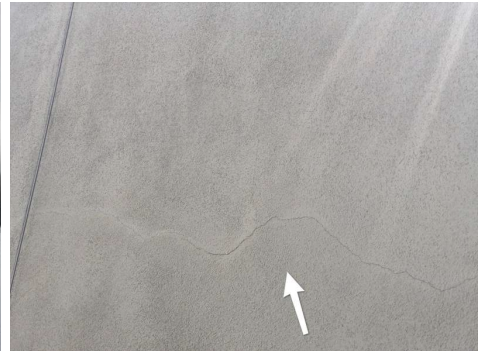
### 2.2.1 Siding, Flashing & Trim

#### CRACKING - MINOR

Siding showed cracking in one or more places. This is a result of temperature changes, and typical as homes with stucco age. Recommend monitoring.

Contact a stucco repair contractor

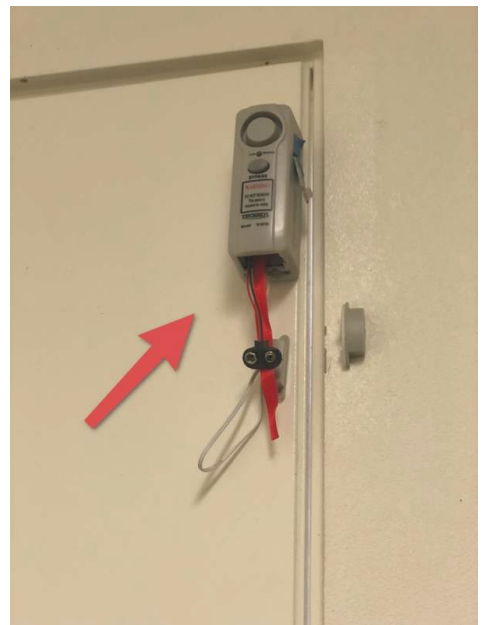
### 3.1.1 Access Door

#### ACCESS DOOR

The access door to the garage is equipped with a swimming pool alarm.

This alarm has been disconnected and must be operational for safety protocols.

Contact a qualified professional.

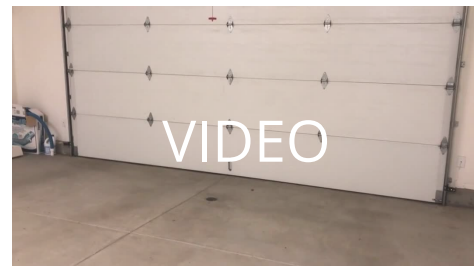
### 3.8.1 Garage Door Opener

#### **GARAGE DOR OPERATOR**

The operator is under strain and starts ver rough upon opening.  
Please see video and contact professional for further evaluation.

Contact a qualified garage door contractor.

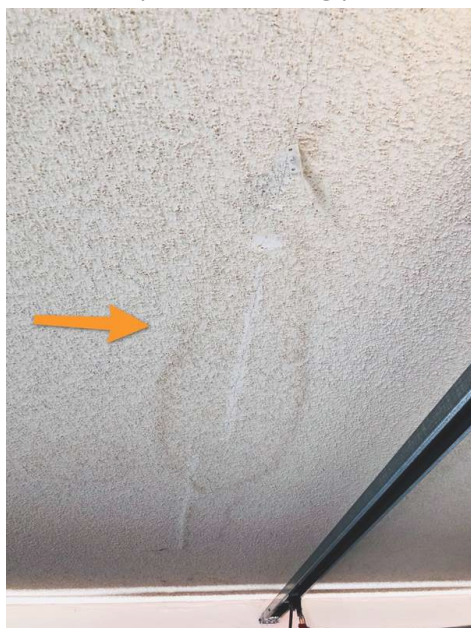
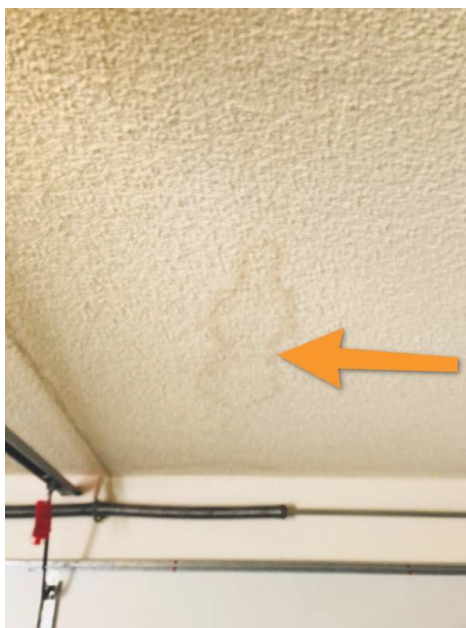
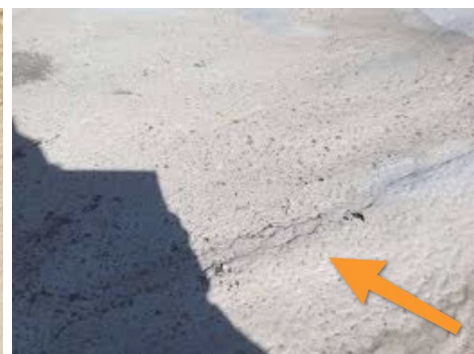
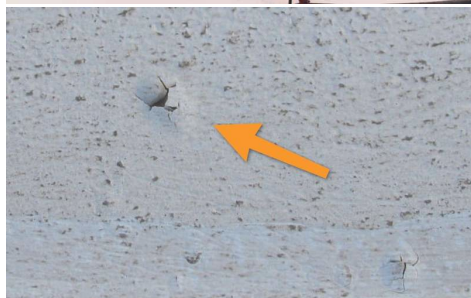
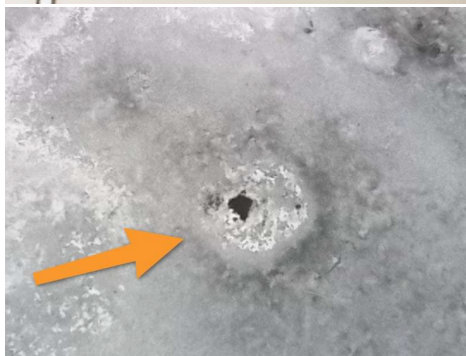
### 4.1.1 Coverings

#### **MODERATE DETERIORATION**

We observed several areas of moderate deterioration and blisters/cracks.

Water intrusion noted.

Contact a qualified roofing professional.

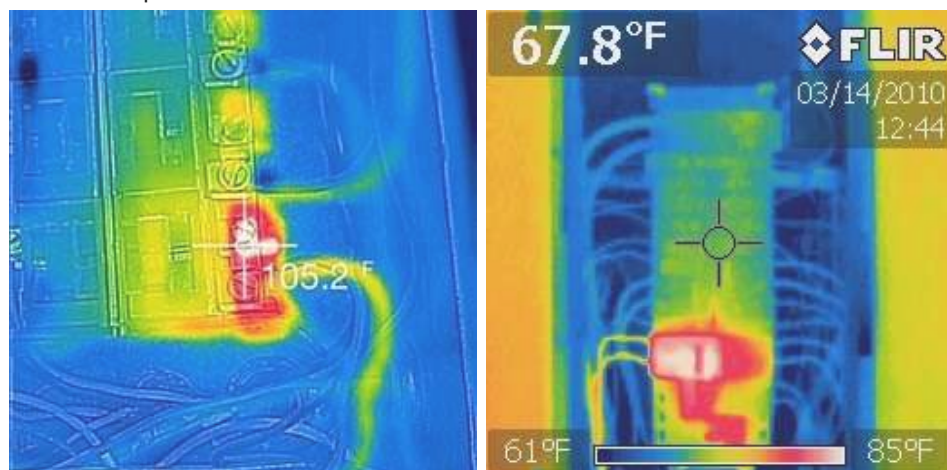
### 5.2.1 Main & Subpanels, Service & Grounding, Main Overcurrent Device

#### **BREAKER INCORRECTLY WIRED**

Circuit breaker was incorrectly wired / installed. This indicates that work was probably not performed by a licensed electrician and poses a safety hazard. Recommend that a licensed electrician check the entire panel and repair and replace as need.

Please noted the over headed circuits in the infrared photos.

Recommendation  
Contact a qualified electrical contractor.

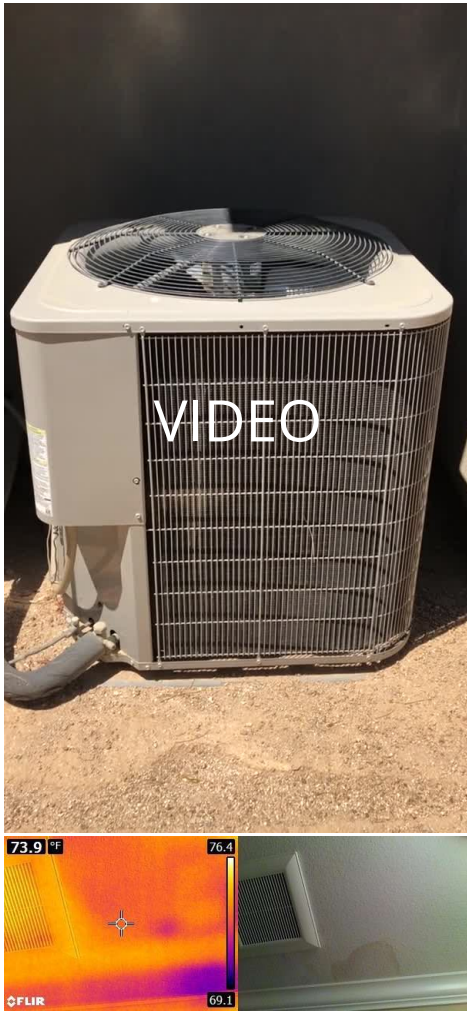
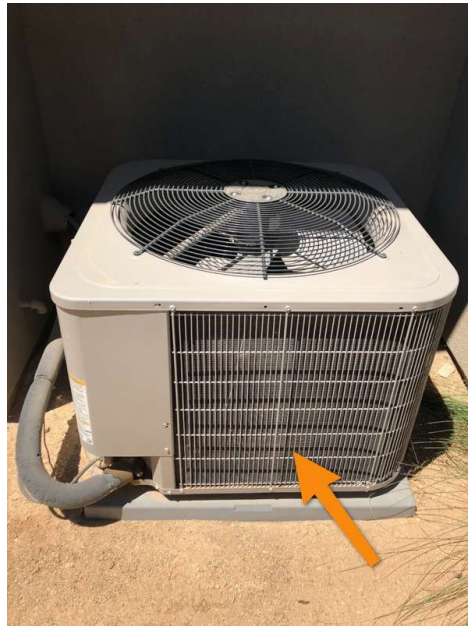
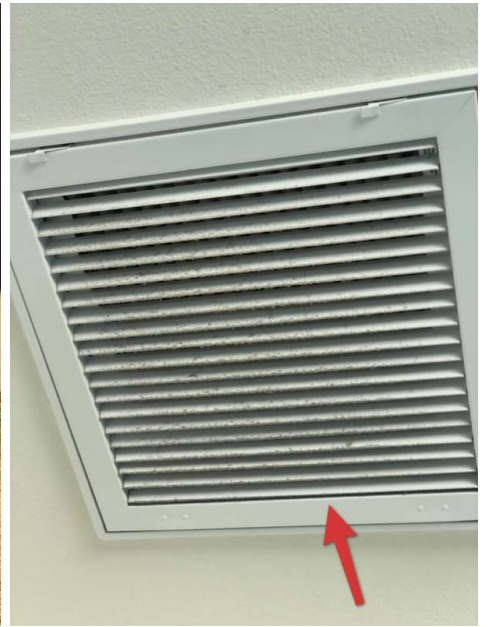
#### 7.1.1 Central Air Conditioning System(s)

##### **SERVICE NEEDED**

\*HVAC units are operational at time of inspection. However, due to age, variable conditions & use of these units, we recommend service and verification by an HVAC specialist

Recommendation  
Contact a qualified HVAC professional.

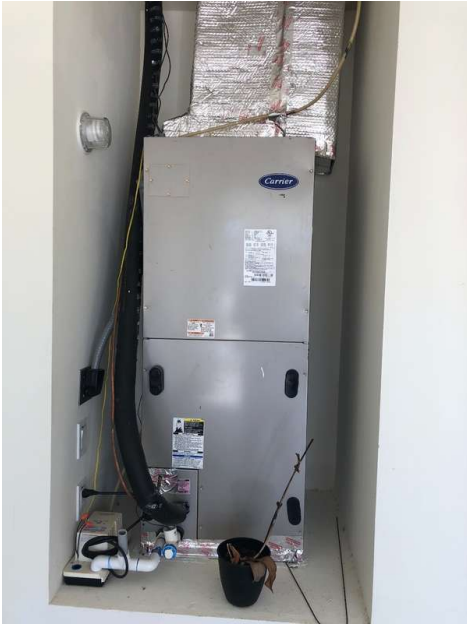
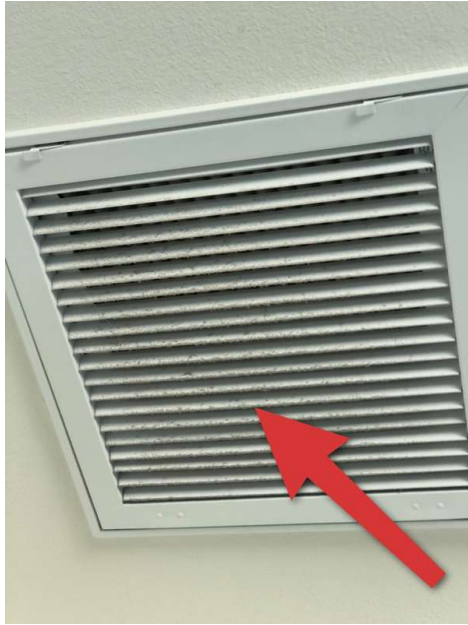
### 7.2.1 Forced Air Heating Equipment **NEEDS SERVICING/CLEANING**

Furnace should be cleaned and serviced annually. Recommend a qualified HVAC contractor clean, service and certify furnace.

Contact a qualified HVAC professional.

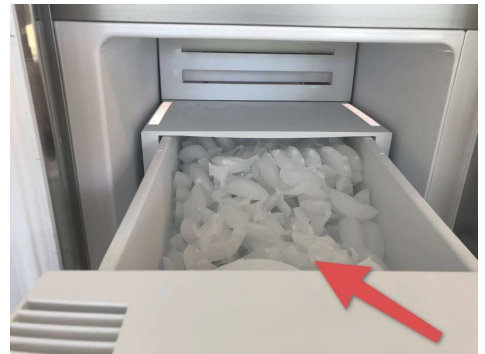
#### 8.13.1 Refrigerator

### ICE MAKER

Ice Maker had not been used for a long period and the ice was frozen so much that the unit was under strain.

Because of the length of time it would take to make ice, we recommend verification before closing.

Contact a qualified appliance repair professional.

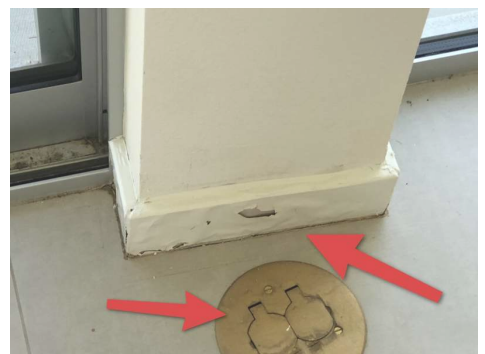
#### 10.4.1 Walls

### WATER DAMAGE

We observed water damage to the center posterior wall.

Since there is no plumbing in this wall, more than likely the source was from the exterior i.e broken sprinkler head.

This water intrusion was also very close to a floor receptacle, and we recommend verification that no corrosion has affected this circuit.

Contact a qualified professional.

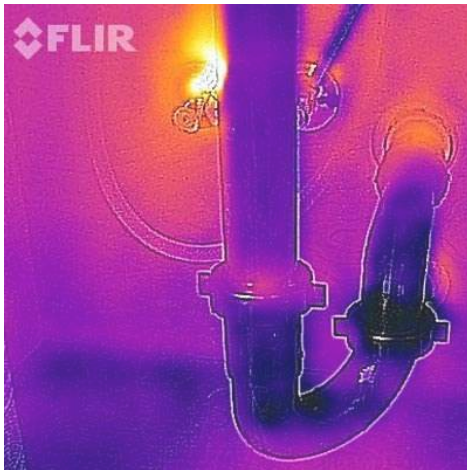
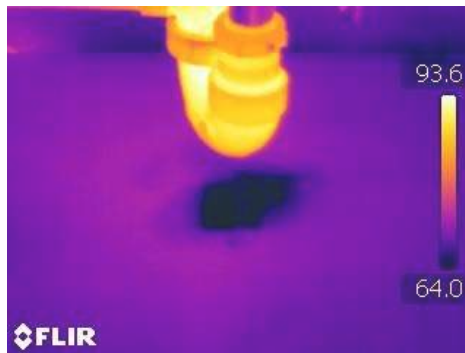
### 13.13.1 Counter/Cabinets

## LEAK UNDER MAIN VANITY

Moisture present under main vanity sink. Please note infrared photos.

Contact a qualified professional.

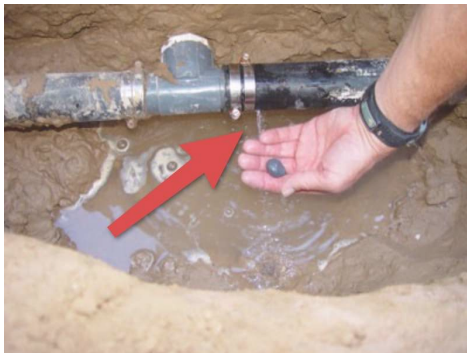
#### 19.9.1 Plumbing

### PVC EFFULENT LINES

WE detected underground plumbing leaks that when the system is activated could flood the equipment area and cause electrical safety hazards.

We strongly recommend a licensed professional do these repairs!

Contact a qualified Swimming Pool Contractor
