SUMMARY

1234 Main St. Hilmar CA 95324

David Alvares
InterNACHI NACHI08050707
Peace Of Mind Home Inspections
866-757-8480
info@pomteam.com

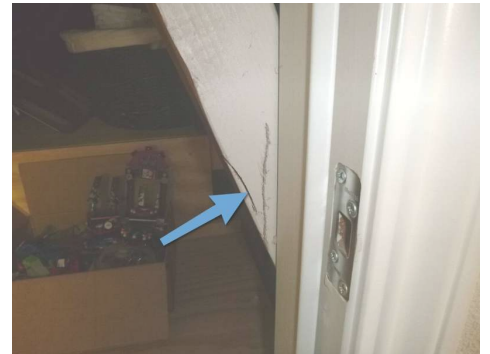
2ND FLOOR HATCH

TRUSS CUT/ALTERED

Roof truss has been slightly cut/altered, truss(es) should not be modified without special engineering of additional support.

Contact a qualified general contractor.

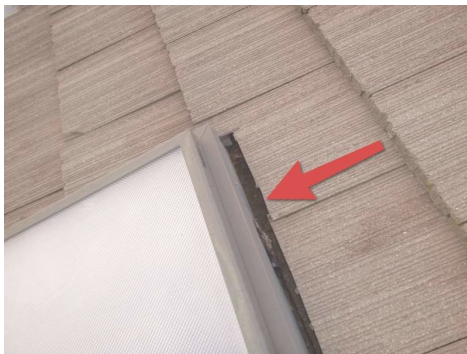
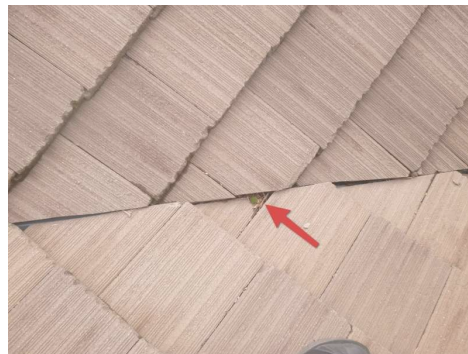
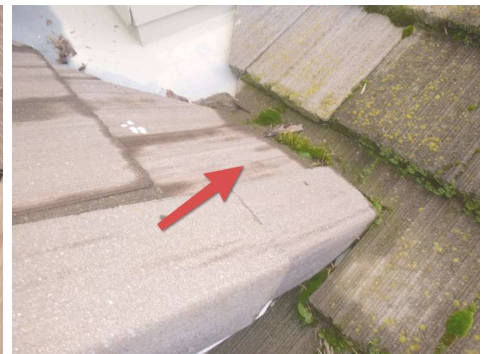
SKYLIGHT, VALLEYS

DEBRIS/VEGETATION - TILE ROOF

Leaves, vegetation or other debris were noted on the roof and should be removed to reduce the risk of leaking or damage to the roofing material. On a tile roof, this may entail the removal of roof tiles should be done by a roofing contractor.

Contact a qualified roofing professional.

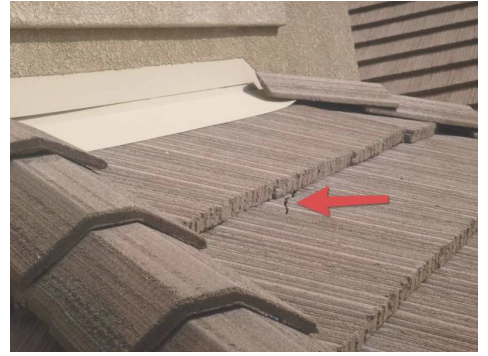
GARAGE

TILE CRACKED/BROKEN

The roof tile(s) are cracked or broken. Recommend a qualified roof contractor to repair or replace roof tile(s).

Recommendation
Contact a qualified roofing professional.

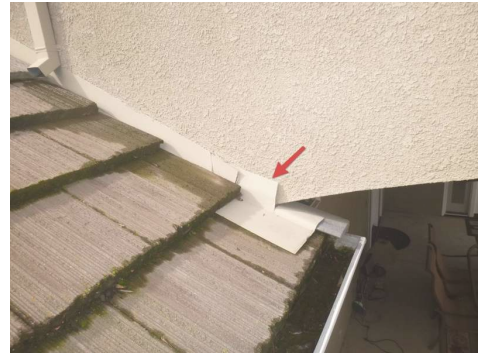
DINING ROOM ROOF TO WALL

3.2.1 Flashings
HOLES/GAPS/OPENING

The roof flashing was observed to have holes, gaps or openings.

Recommendation
Contact a qualified roofing professional.

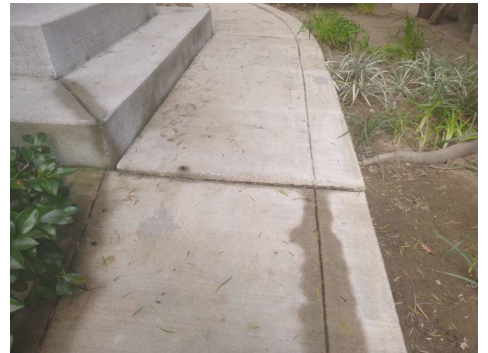
NORTH MASTER BEDROOM

4.4.2 Walkways & Driveways
WALKWAY TRIP HAZARD

The walkway presents a trip hazard. A tripping hazard is considered to be an uneven surface or sudden or unexpected lip.

Recommendation
Contact a handyman or DIY project

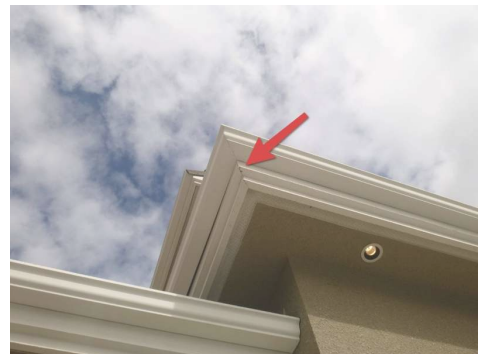
4.5.1 Eaves, Soffits & Fascia
EAVES - WATER DAMAGE TERMITE REPORT

The eaves, (fascia, sheathing and/or rafters) shows evidence of water damage/wood deterioration. The client should refer to the wood destroying pest and organism report (termite report) for all locations of wood deteriorations. The client should also contact a licensed roofing contractor further evaluate.

Recommendation
Contact a qualified pest control specialist.

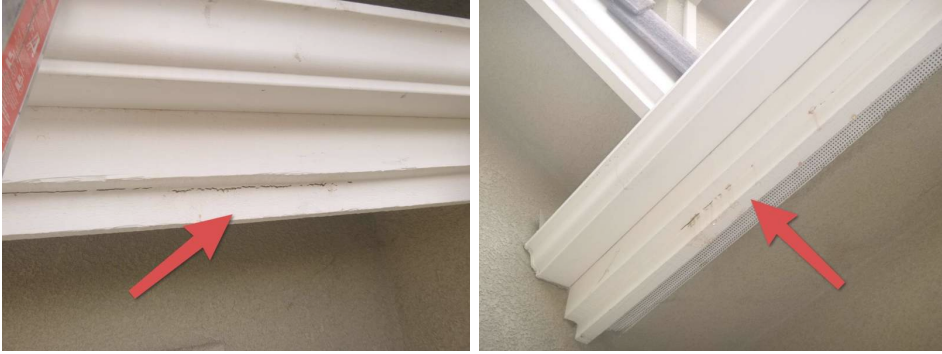
1ST FLOOR SOUTH BEDROOM, NORTH GARAGE, DINING ROOM

4.5.2 Eaves, Soffits & Fascia
EAVES - WATER STAIN ROOFER RECOMMENDED

Water staining was observed on the eave(s). This suggests that the roof may be leaking, the client should contact a licensed roofing contractor for further evaluation of the roofing material and repairs should be made as found needed.

Contact a qualified roofing professional.

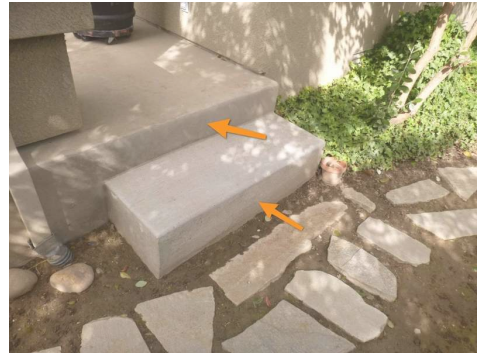
PORCH

STAIRS/STEPS - NOT THE SAME SIZE

The stairs/steps height or depth are not the same sizes which may pose a tripping hazard.

Contact a qualified general contractor.

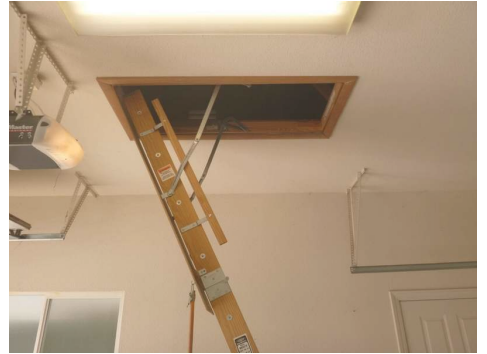
FIREWALL BREACH LADDER

Fire separation between the garage and the residence has been breached with the installation of a non-fire rated pull-down ladder.

Contact a qualified drywall contractor.

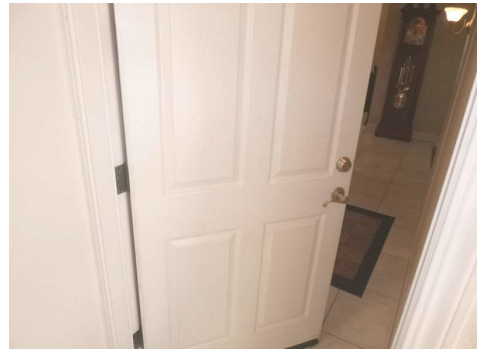
FIRE DOOR SELF CLOSER

The fire door between the garage and the interior of the house should be equipped with a functioning self-closer to prevent automobile fumes from entering the house and for the door to function as a fire rated door.

Contact a qualified door repair/installation contractor.

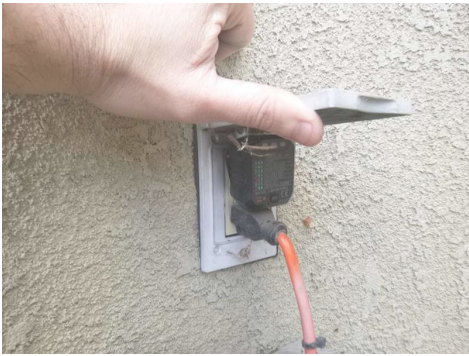
NORTH MASTER BEDROOM

GFCI INOPERATIVE

Ground fault circuit interrupter (GFCI) outlet is inoperative. The outlet(s) and circuit(s) should be investigated.

Contact a qualified electrical contractor.

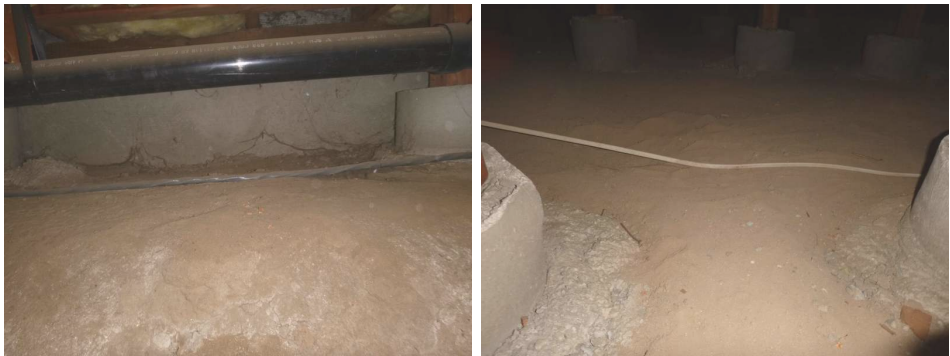
CRAWLSPACE

WIRE SOIL CONTACT

The distribution wiring is in contact with the earth and should be properly secured to avoid any contact with the earth.

Contact a qualified electrical contractor.

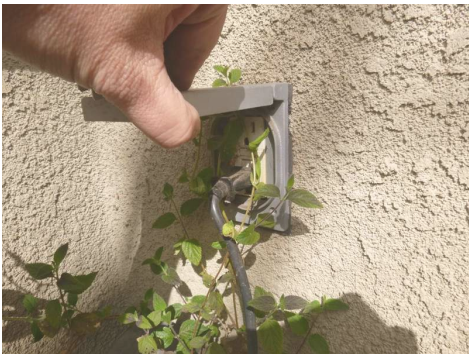
VARIOUS LOCATIONS

COVER EXTERIOR PERMANENT

The exterior outlet should have a dome cover installed which allows permanent use. Covers should be installed to protect the outlet from the elements.

Contact a qualified electrical contractor.

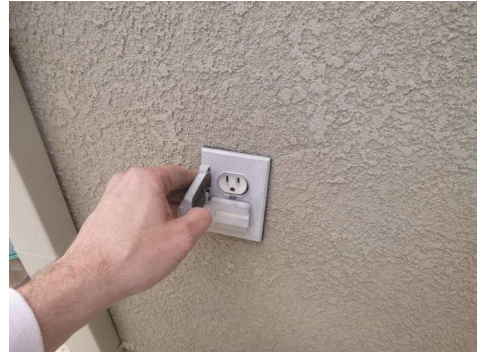
DINING ROOM

COVER FOR EXTERIOR USAGE

The exterior outlet or switch cover is missing or damaged. An exterior cover should be installed to protect the outlet or switch from the elements.

Contact a qualified electrical contractor.

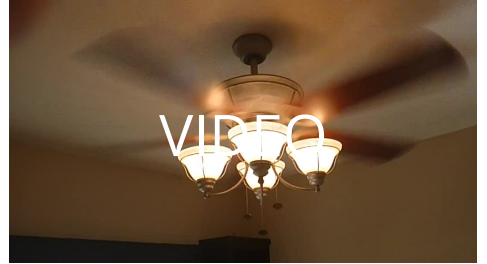
1ST FLOOR SOUTH BEDROOM

FAN NOISY

The ceiling fan is excessively noisy.

Recommend monitoring.

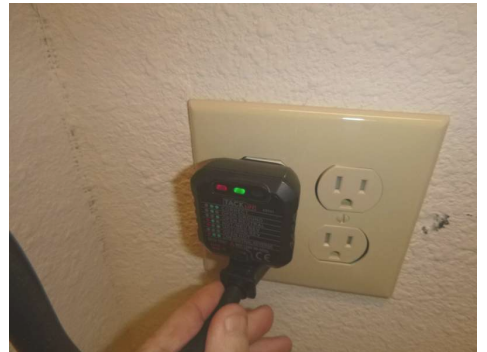
UTILITY ROOM

OUTLET REVERSED POLARITY

The outlet has reversed polarity (i.e. it is wired backward). This outlet(s) and the circuit(s) should be investigated and repaired by a licensed electrician.

Contact a qualified electrical contractor.

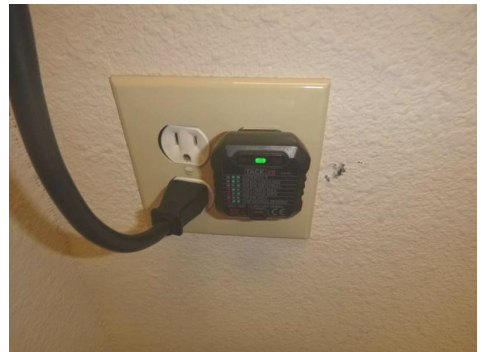
UTILITY ROOM

OUTLET UNGROUNDED

The outlet is ungrounded. The outlet(s) and circuit(s) should be investigated.

Contact a qualified electrical contractor.

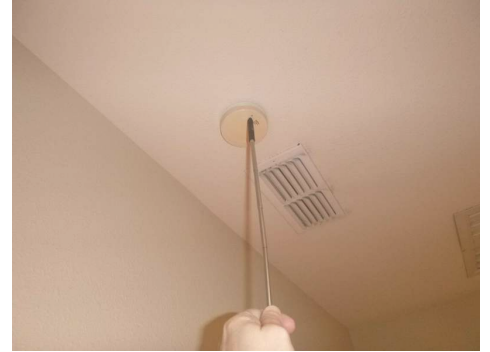
1ST & 2ND HALLWAY, 1ST FLOOR BEDROOM, MASTER BEDROOM

SMOKE DETECTOR INOPERABLE

The smoke detector is inoperative or did not make a loud audible noise.

Recommendation
Contact a handyman or DIY project

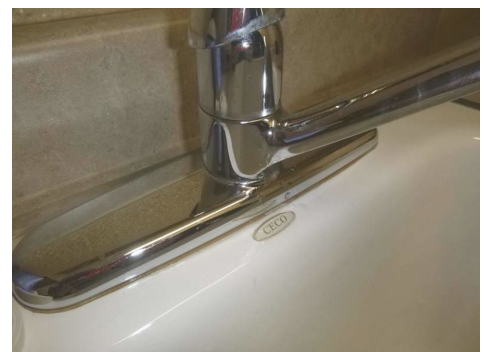
LAUNDRY

SINK FAUCET LEAK SPOUT

The sink faucet spout is leaking.

Recommendation
Contact a qualified plumbing contractor.

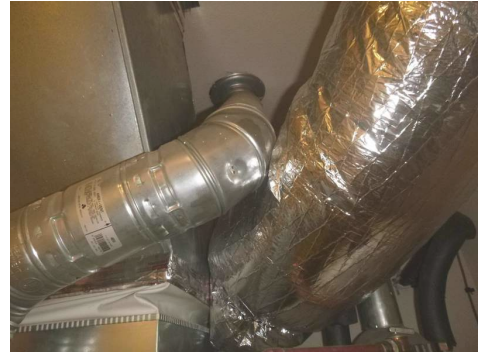
UTILITY ROOM

DUCT CLEARANCE FROM EXHAUST FLUES

The flexible ductwork has improper clearance from the furnace and exhaust flues which should melt the duct.

Contact a qualified heating and cooling contractor

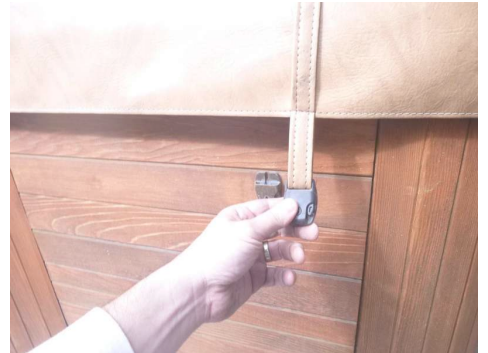
DOES NOT MEET POOL/SPA/HOT TUB SAFETY ACT

Effective January 1, 2018. Sacramento, CA Senate Bill SB442 requires a home inspector to specify if a residential pool/spa/hot tub does not have two of the seven safety devices specified in the bill installed, therefore not meeting the minimum requirement. The space cover locking cover is not properly installed.

Contact a qualified Swimming Pool Contractor
