SUMMARY

1234 Main St. Yreka CA 96097

Michael Colombo
CMI, CPI, CCI

Shacks & Shanties Inspection Services
530-598-7856
mike@shacksandshanties.com

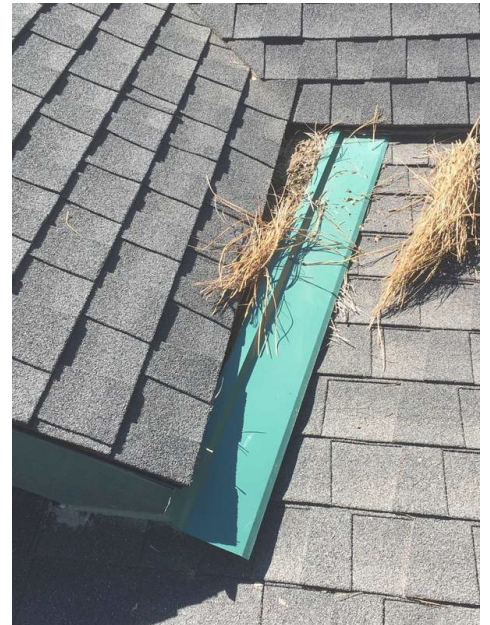
2.2.1 Flashing

LOOSE/SEPARATED

Flashings observed to be loose or separated, which can lead to water penetration. Recommend repair.

Contact a qualified roofing professional.

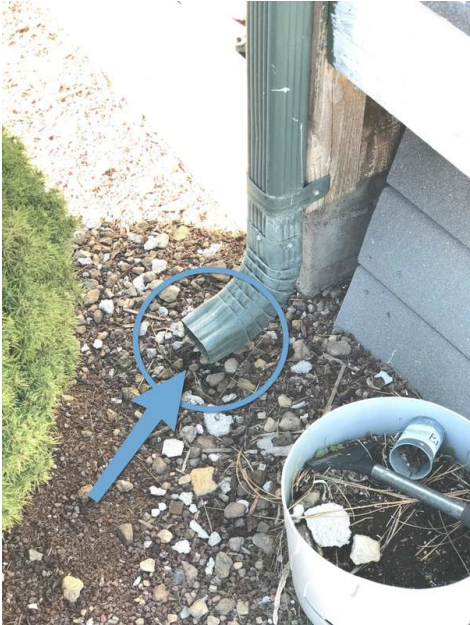
South

DOWNSPOUT TERMINATION

One or more downspouts were observed to terminate (discharge or drain) too close to the foundation. This can result in excessive saturation of the soil around the foundation, which can lead to foundation deterioration, damage and structural movement. Recommend installing downspout extensions to direct water at least four feet from the foundation.

Contact a handyman or DIY project

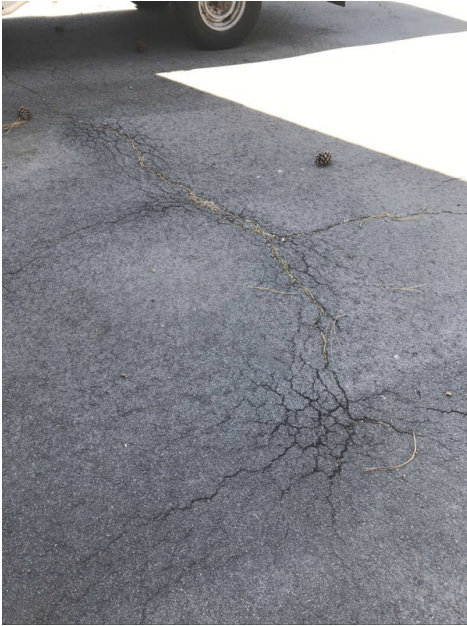
North

3.3.1 Driveway

ASPHALT DAMAGE

Cracks were observed in asphalt driveway apron that appeared to be caused by tree roots. Repair will entail removing the tree and repaving driveway apron.

Recommendation
Contact a qualified professional.

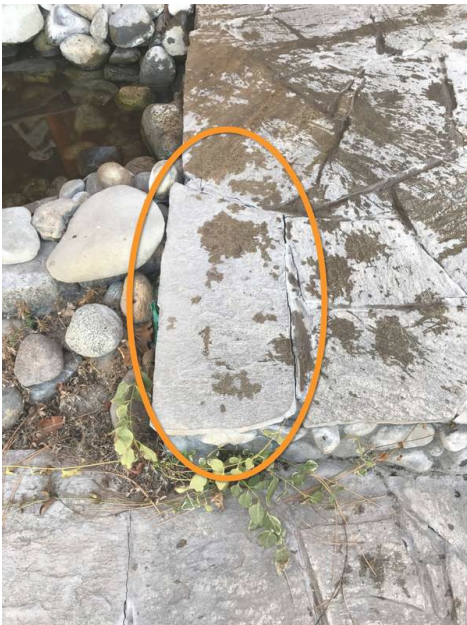
North

3.4.1 Walkways

DAMAGED

Damaged areas of the walkway were observed. These areas may be a tripping/injury hazard and should be repaired.

Recommendation
Contact a qualified professional.

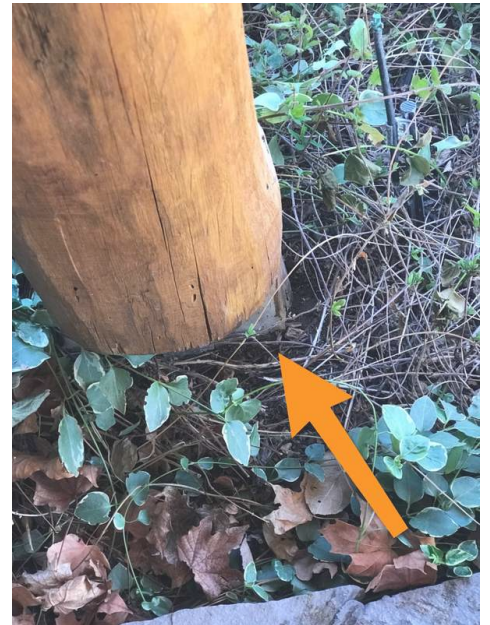
North

3.5.1 Porch & Covered Entryway

DETERIORATED - WOOD ROT

The structural post was observed to have a small area of moisture damage with wood rot (dry rot.) Recommend repair.

Treating and preventing dry rot is a three-step process. Step 1 is to locate and stop the source of the moisture. Step 2 is to remove and replace any damaged wood that has become structurally weakened. Step 3 is to treat new and existing wood with borate wood preservative to prevent growth of the dry rot fungus and kill any fungus already in the wood.

Contact a handyman or DIY project

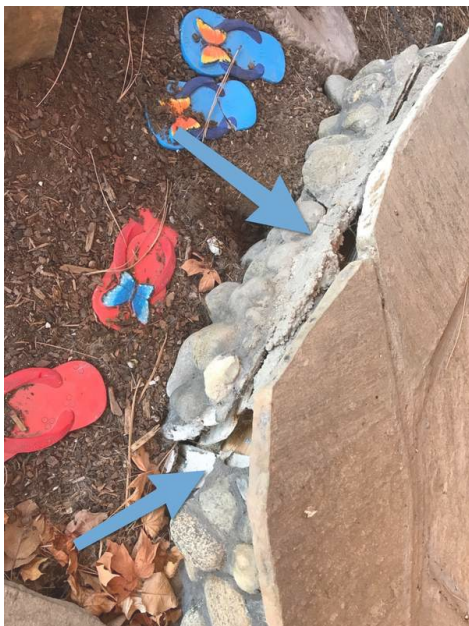
North

3.5.2 Porch & Covered Entryway

DETERIORATION OR DAMAGE

One or more areas of damage or deterioration was observed in the veneer treatment. Recommend repair.

Contact a qualified professional.

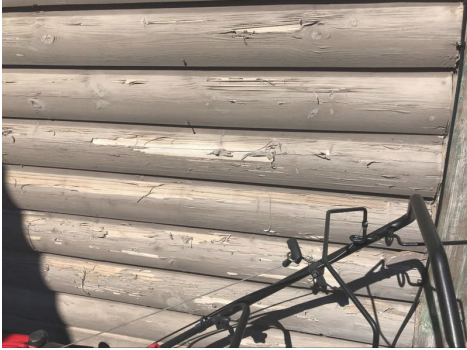
South

3.6.1 Siding

PAINT OR SEAL

The wood log veneer siding was observed to be have one or more areas of deteriorated, missing, peeling paint, or seal. This will allow moisture penetration that will further deteriorate siding. Additionally, all areas where cracking (or checking) is present should be sealed before painting. Recommend re-painting or sealing house siding.

Contact a qualified painting contractor.

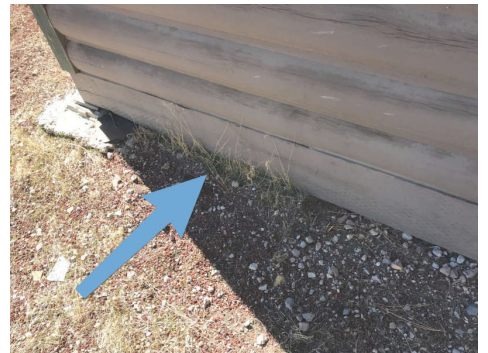
East

3.6.2 Siding

GROUND CONTACT

Inadequate clearance between siding and/or trim and ground was observed, with deterioration and/or damage present. Recommend a minimum ground clearance between bottom of siding and ground of 6" to 8". Siding was observed to be in contact with ground, with evidence of wood rot (dry rot). Wood that touches the ground/soil will wick moisture and and start to deteriorate. This also sets up ideal conditions for dry rot to damage wood, and invites wood destroying pests. Recommend soil be pulled away from all trim for a minimum ground clearance between bottom of trim and ground of 6" to 8" and replace and treat areas of dry rot, as necessary.

Contact a handyman or DIY project

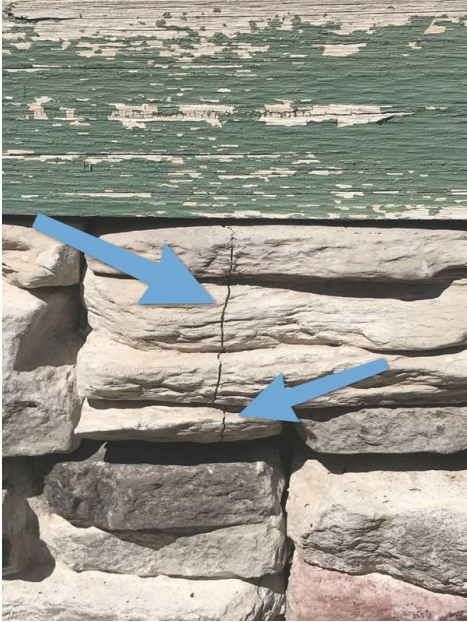
Small stress cracks were observed in masonry siding. This type of crack can occur due to stress, age, damage, settling over time and other causes. These were not, at the time of inspection, observed to be compromising the integrity of the siding; however, due to water penetration, which will contribute to and hasten deterioration, it is recommended that these cracks be sealed.

South (Stress Crack)

Contact a qualified professional.

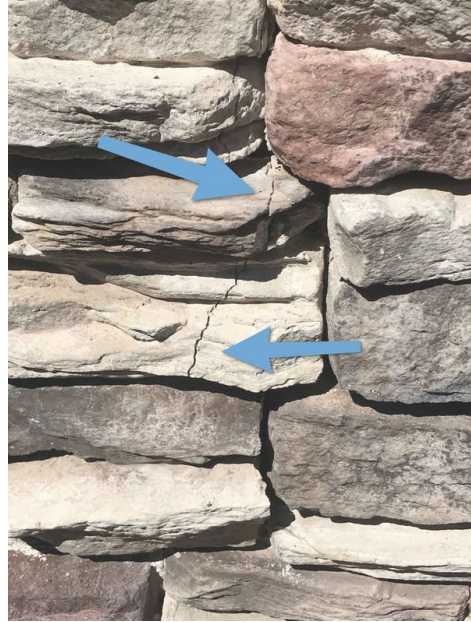
South (Stress Crack)

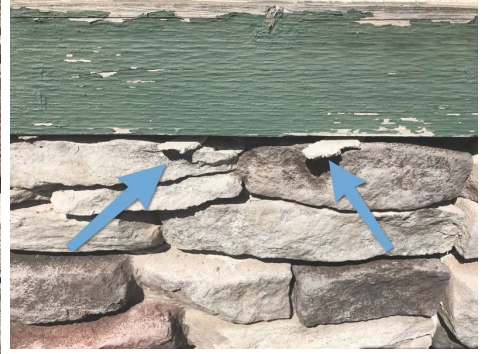
Additionally, the mortar in some areas was observed to be deteriorating and falling away. This can happen with normal shrinkage and the quality of the mortar. Recommend these areas be repaired, as necessary.

South (Mortar Deterioration)

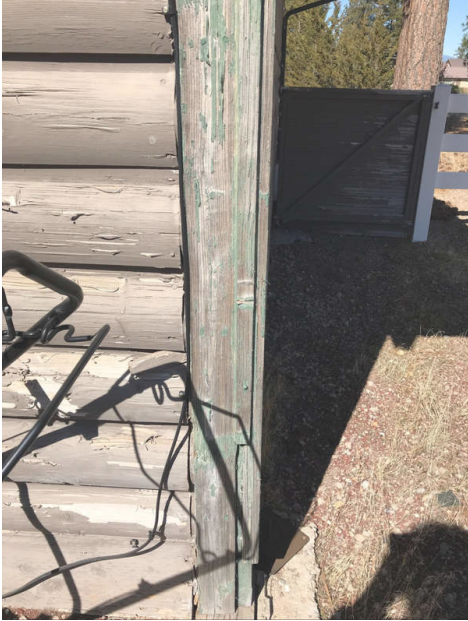
Southeast

3.7.1 Trim

PAINT OR SEAL

Trim was observed to have deteriorated, peeling, missing paint, or seal. Trim that is unsealed and open to weathering will deteriorate and be vulnerable to wood rot (dry rot) conditions. Trim functions as more than an aesthetic accoutrement to the house structure. Trim is an important part of protecting the house structure from water and pest infiltration. Recommend painting or sealing all trim.

Contact a handyman or DIY project

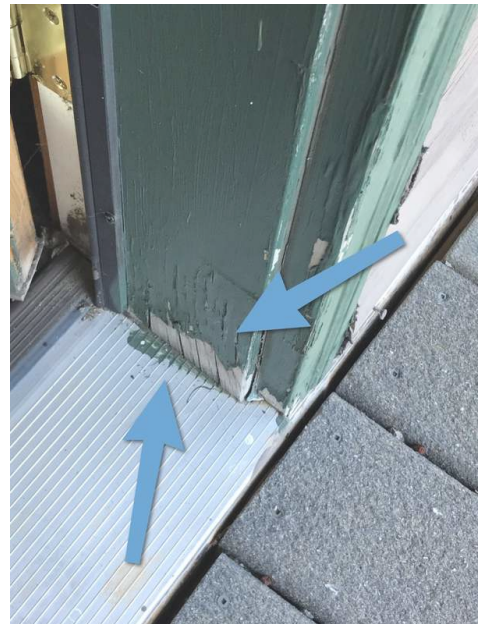
South

3.8.1 Doors

DOOR SILL, FRAMING, OR TRIM

Paint or seal around door sill, framing, and/or trim was observed to be damaged, deteriorated or worn. Recommend repainting.

Contact a qualified painting contractor.

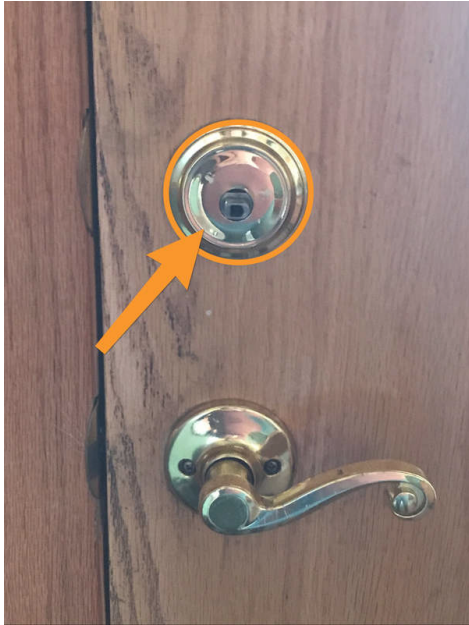
Front Door

3.8.2 Doors

HARDWARE DAMAGED

One or more pieces of door hardware are damaged. Recommend repair or replace.

Contact a handyman or DIY project

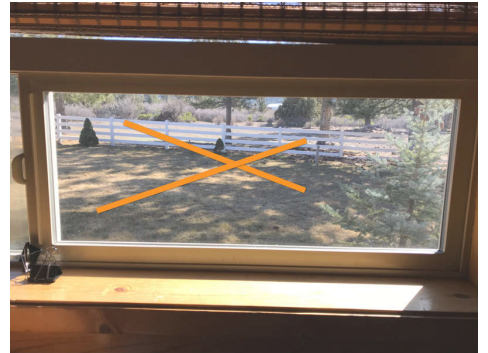
Living Room South

3.9.1 Windows

SCREENS

One or more screens were observed to be missing or damaged. Recommend repair or replacement.

Contact a handyman or DIY project

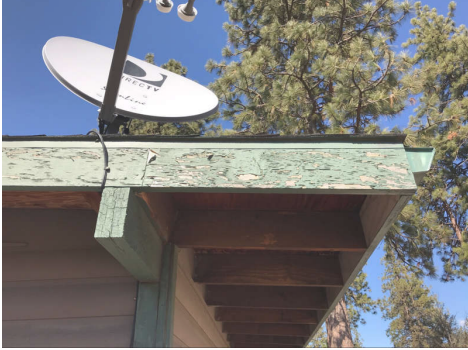
South

PAIN T OR SEAL

The fascia were observed to have deteriorated, peeling, or missing paint. Wood exposed to moisture and weather becomes vulnerable to deterioration and dry rot conditions. Fascia board functions as more than just an aesthetic accoutrement to the house. Fascia serves to keep water away from the rafter tails and prevents or discourages water damage. Recommend painting, as necessary.

Contact a qualified painting contractor.

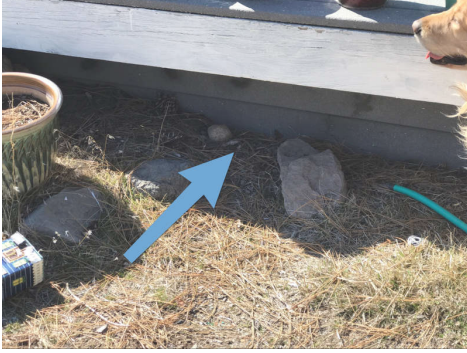
South

3.12.1 Deck

GROUND CLEARANCE

Deck support members were observed to be in contact with ground. Wood that touches the ground/soil will wick moisture and start to deteriorate. This also sets up ideal conditions for dry rot to damage wood, and invites wood destroying pests. Composite Trex-type of material should also not be in contact with the ground as it will become moisture damaged and deteriorate. Recommend all soil be pulled away from all wood structures.

Contact a handyman or DIY project

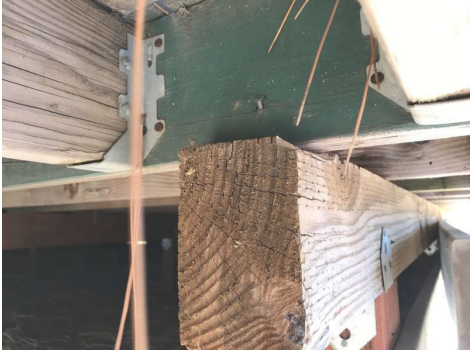
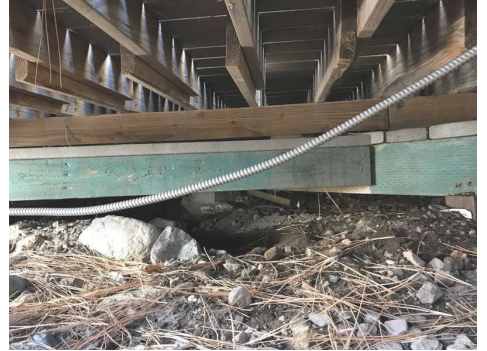
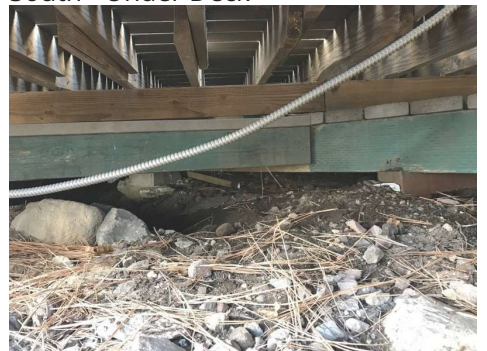
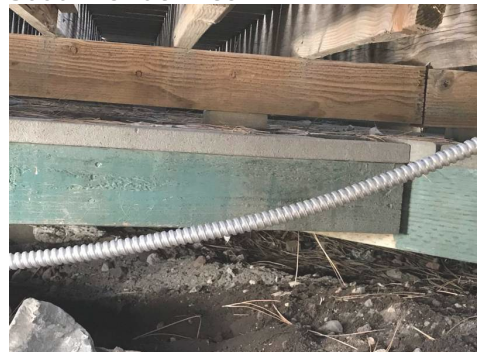
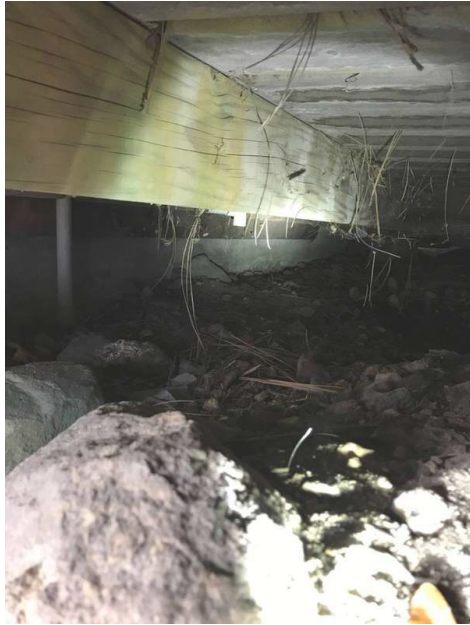
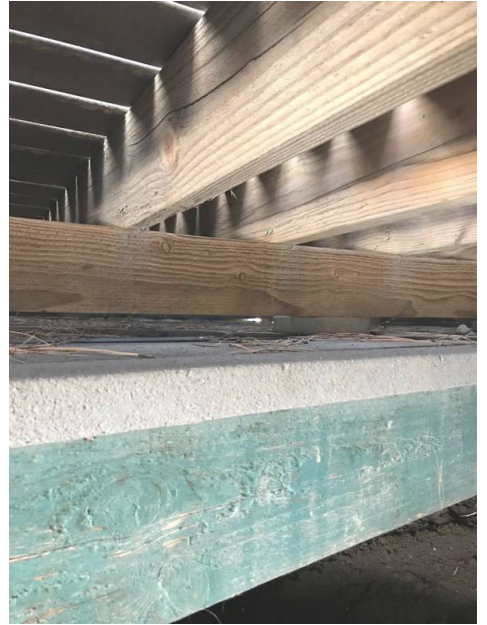
3.12.2 Deck

MULTIPLE OBSERVATIONS

Deck failures account for thousands of injuries each year in the US. Most of these injuries are caused by deficient construction methods and unsafe guardrails and handrails. Deck failures can happen in an instant when loads become more than the structure can bear. Multiple observations regarding potential deck safety were made.

1. Ledger Board: The ledger board is not properly attached to the building. This can cause the deck to pull away from the building and possibly collapse.

2. Missing Flashing: Flashing was observed to be missing at ledger/siding.
3. Construction Method: It appeared that the visible deck was constructed over an existing, older deck structure. Support structures were not observed to be constructed in a professional manner and the extra load of the new deck on top of the older deck may be more than the original deck was designed for.

4. Hot Tub Deck: The deck the hot tub is sitting on was observed to not be constructed in a professional manner. Connections and support structures may not be adequate to handle the load safely.

5. Ground Contact: Many structural members were observed to be in direct contact with the ground. This will allow moisture damage, dry rot, and encourage wood destroying organisms to infiltrate wood and compromise the structure.

1. Ideally, a licensed contractor experienced in safe deck construction should evaluate the entire structure.
2. At least, the deck structure should be closely monitored for structural integrity, stability and safety. Especially prior to exerting a heavy load (such as a party with numerous people.)

Recommendation
Contact a qualified general contractor.

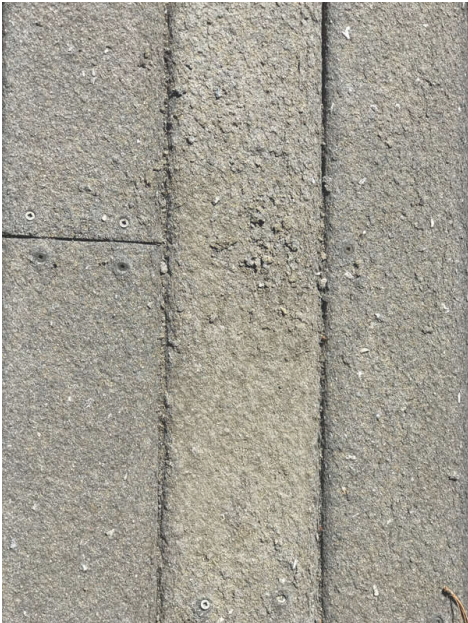
South

3.12.3 Deck

TREX DETERIORATION

Trex, or Trex-type decking was observed to be deteriorated and may eventually lose its load-bearing ability. Deteriorated boards were observed to be deflecting (soft, bending) when walked. As the Trex company warns of possible step-through injuries, it is recommended to replace deck boards for safety.

Contact a qualified professional.

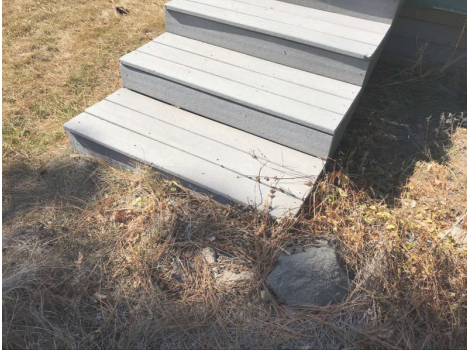
South

3.15.1 Stairways, Steps, Stoops, & Ramps

GROUND CLEARANCE

Deck support members were observed to be in contact with ground. Wood that touches the ground/soil will wick moisture and start to deteriorate. This also sets up ideal conditions for dry rot to damage wood, and invites wood destroying pests. Recommend all soil be pulled away from all wood structures.

Contact a handyman or DIY project

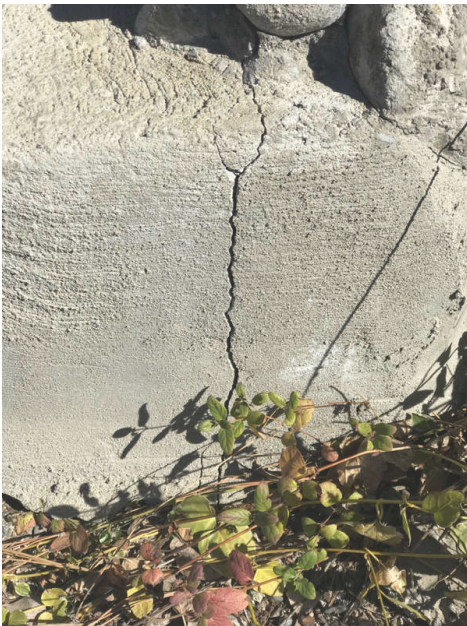
North

3.15.2 Stairways, Steps, Stoops, & Ramps

CONCRETE CRACKS

One or more cracks were observed in cement stairs. These do not impact your foundation, nor do they represent failure of the concrete patio slab. Shrinkage and minor settling cracks can make the cement vulnerable to further deterioration when water penetrates and the freeze/thaw cycle starts to damage the concrete. Sealing cracks with the proper sealant can help prevent weathering deterioration at these cracks. Also, using a cement stain, or paint will help prevent spalling. Otherwise, monitor for further, or widening of the cracks and repair as necessary.

Contact a handyman or DIY project

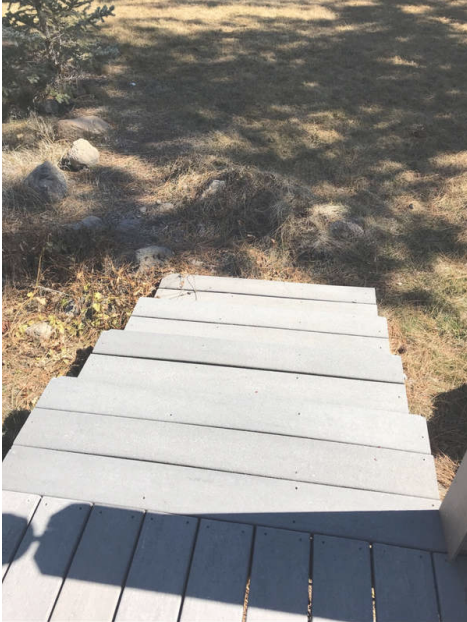
South

3.16.1 Railing & Handrails

MISSING RAILING

Handrail and/or guardrail was observed to be missing at time of inspection. Requirements vary among states and municipalities; however, generally where the surface of the deck is thirty inches (30") above grade (from the ground) a guardrail is required. Consider installing a guardrail.

Recommendation
Contact a qualified carpenter.

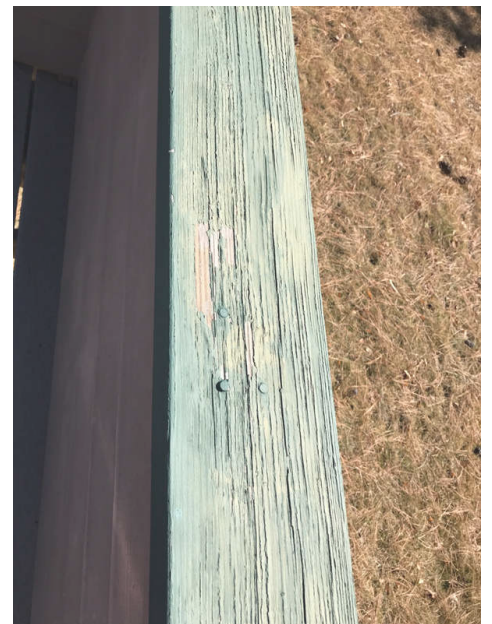
South

3.16.2 Railing & Handrails

WATER SEAL

One or more areas was observed have deteriorated, missing, peeling paint or water seal; allowing for deterioration from weathering. Recommend water sealant/weatherproofing be applied.

Recommendation
Contact a handyman or DIY project

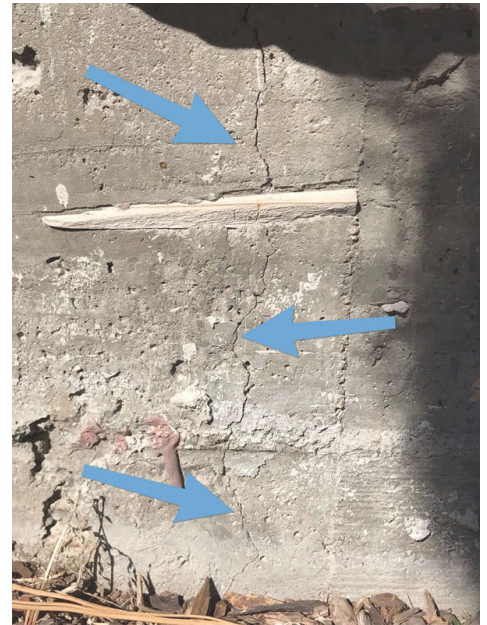
South

4.5.1 Foundation - Crawlspace & Exterior

FOUNDATION CRACKS - COMMON

One or more cracks were observed in the perimeter foundation that are consistent with normal concrete shrinkage, age, or some settling; however, this does not necessarily mean the foundation is failing, or compromised. Shrinkage and some other types of cracks in concrete are typical, and are usually characterized as being less than three millimeters in width and are not offset. These types of cracks may also appear when the soil supporting the foundation becomes too wet. Recommend sealing with appropriate sealant to prevent moisture penetration and prolong service life, and continued monitoring.

Contact a handyman or DIY project

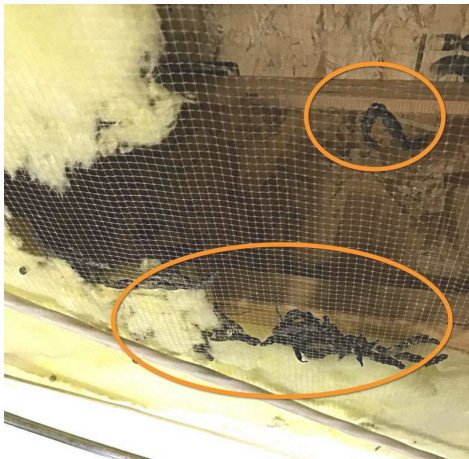
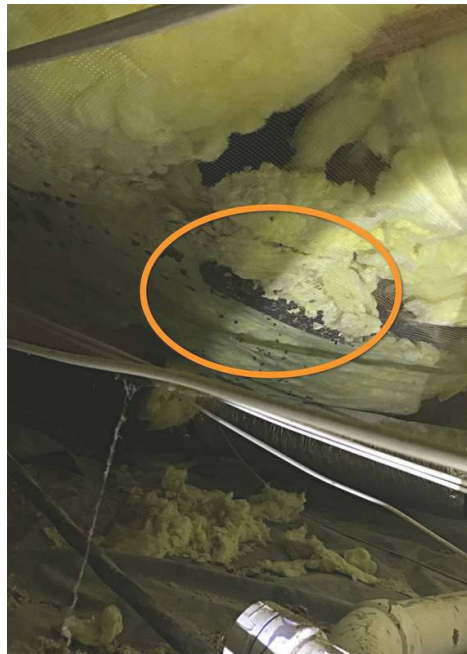
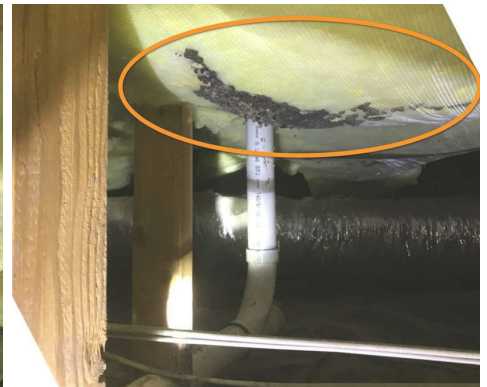
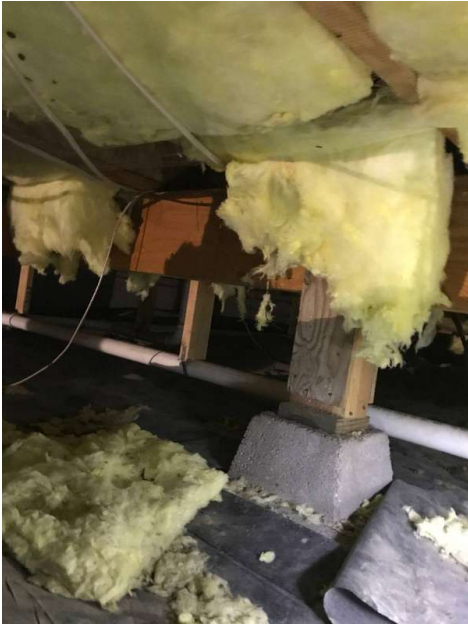
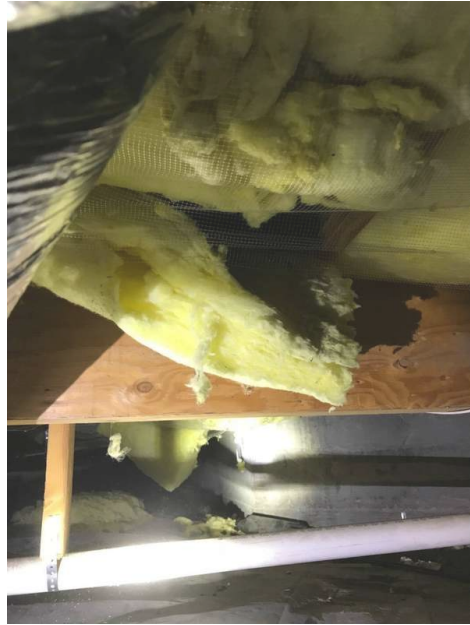
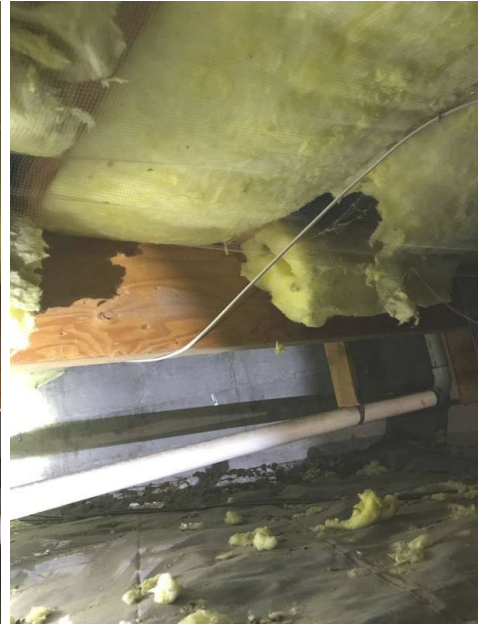
4.5.2 Foundation - Crawlspace & Exterior

EVIDENCE OF VERMIN

Evidence of moderate to heavy infestation of rodents and/or other vermin was observed in the crawlspace as evidenced by large amounts of fecal matter and damage to the insulation. This was observed throughout the entire crawlspace. Rodents and their droppings can carry disease that can become airborne and pose a health risk. Recommend extermination and remediation.

Contact a qualified professional.

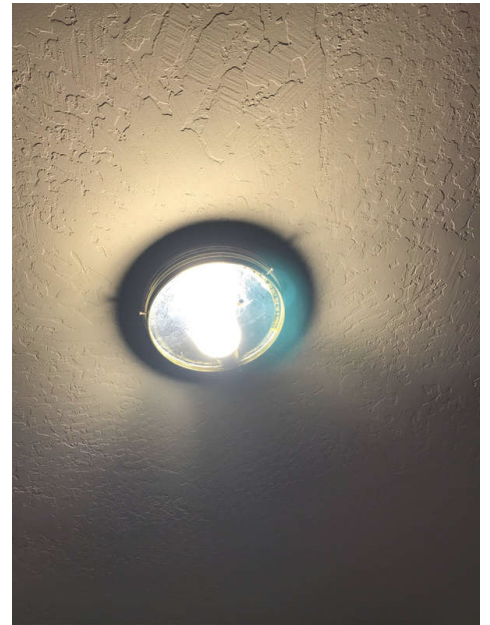
Office/Den

5.8.1 Lighting Fixtures (Including Ceiling Fans)

COVER MISSING

One or more lighting fixtures were observed to be missing a protective cover (aka: shade.) This allows for short and shock risk. Recommend installation of cover.

Contact a handyman or DIY project

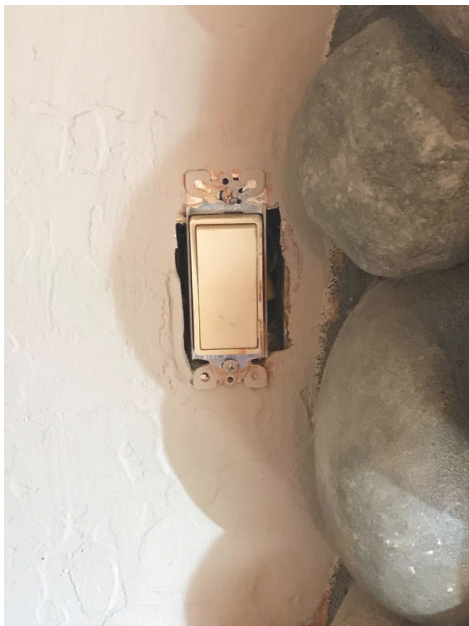
Master Bedroom

5.9.1 Switches & Receptacles

INTERIOR COVER PLATE

One or more receptacles were observed have missing or damaged cover plate. This allows for short and shock risk. Recommend installation of plates.

Contact a handyman or DIY project

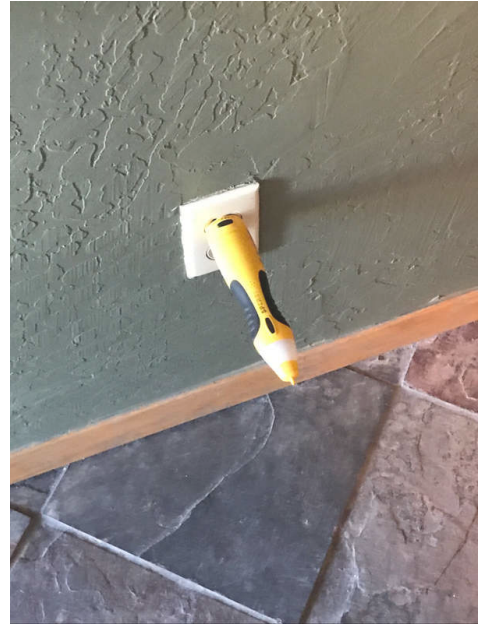
Utility/Laundry Room

5.9.2 Switches & Receptacles

NO POWER

The receptacles and switches servicing one/or more rooms in the house were observed to be without power, or current, when tested. If circuit breaker(s) in electrical panel(s) are tripped or in the off position, it is recommended that an electrician evaluate before to ensure there are no faults in the circuit. Recommend evaluation and repair, as necessary.

Recommendation
Contact a qualified electrical contractor.

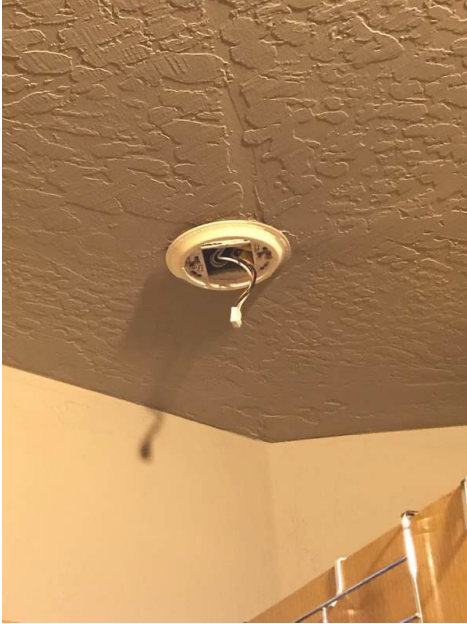
Office/Den

NON-FUNCTIONING AND/OR MISSING

One or more smoke detectors were observed to be installed, but not functioning properly; or, smoke detector units were observed to be missing. Recommend replacement or installation.

Contact a handyman or DIY project

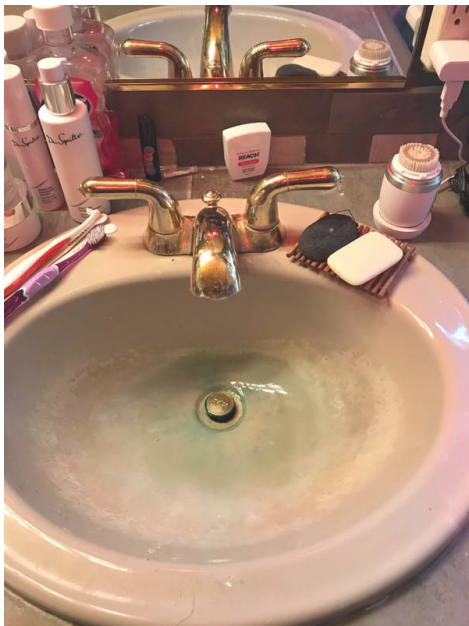
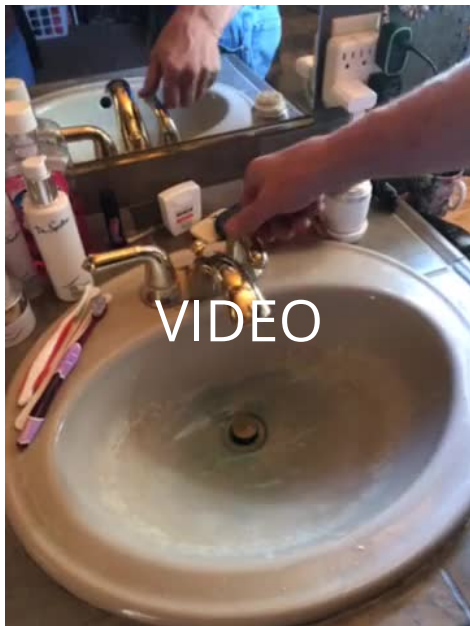
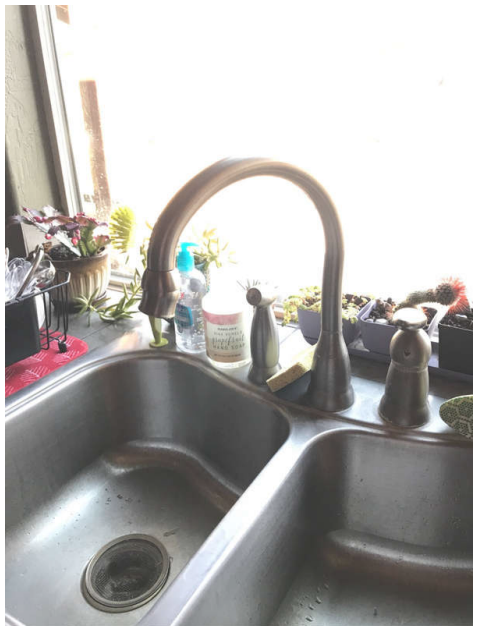
6.3.1 Plumbing Fixtures (Faucets, Sinks, Toilets, etc.)

FIXTURE IN DISREPAIR

One or more fixtures were observed to be in disrepair or not functioning correctly. Recommend repair or replacement, as necessary.

Contact a handyman or DIY project

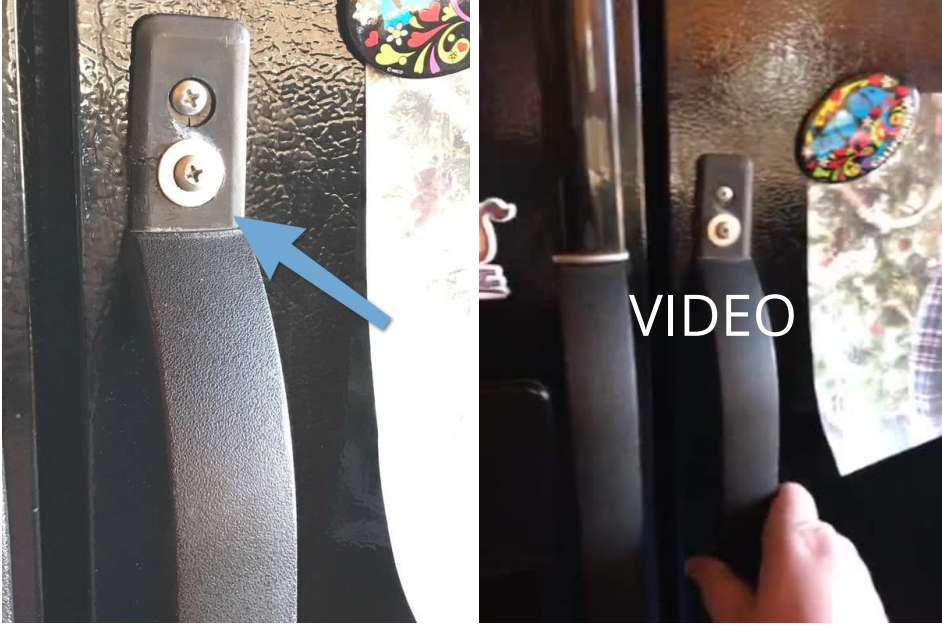
Kitchen

14.1.1 Refrigerator

MINOR DAMAGE

The door handle was observed to be damaged. Recommend repair.

Contact a handyman or DIY project

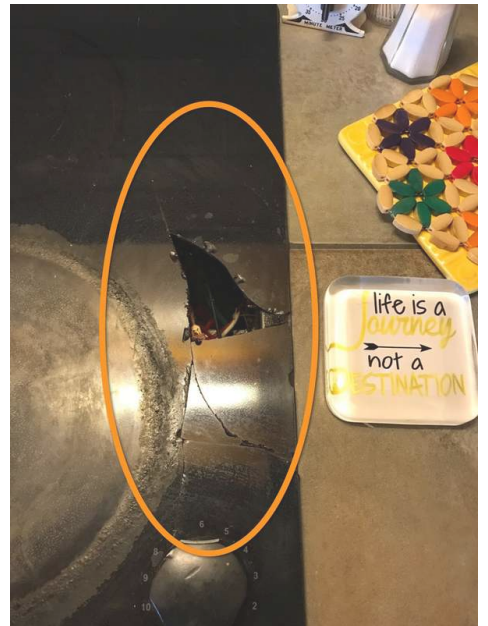
Kitchen

14.3.1 Cooktop (No Oven)

CRACKED GLASSTOP

Glass cooktop was observed to be damaged. Recommend repair.

Contact a qualified appliance repair professional.

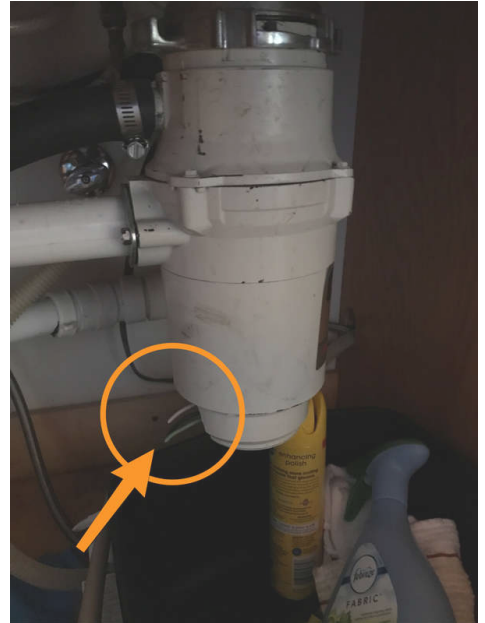
Kitchen

14.8.1 Garbage Disposal

INOPERABLE

Garbage disposal was inoperable at the time of inspection. Recommend repair or replacement.

Recommendation
Contact a qualified appliance repair professional.

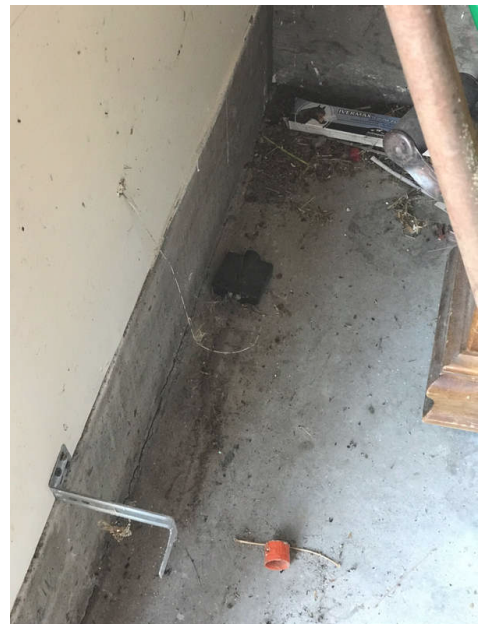
17.1.1 Garage Door

AUTO REVERSE

The auto reverse was missing or the sensor was not responding at time of inspection. This is a safety concern for children and pets. Recommend checking alignment of sensors and repair/replace, if necessary.

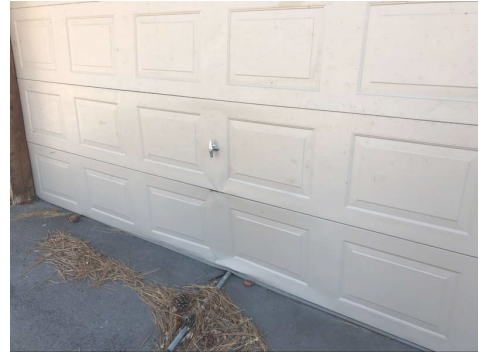
18.1.1 Garage Door

PANEL DAMAGE

Garage door was observed to be damaged and was not operable at the time of inspection. Recommend repair

Contact a qualified garage door contractor.
