SUMMARY

1234 Main St. Grayslake Illinois 60030

Buyer Name
10/07/2018 9:00AM

John Reim
InterNACHI, CMI
Bee Sure Home Inspection Svcs.
773-425-8275
jrinspect1@comcast.net

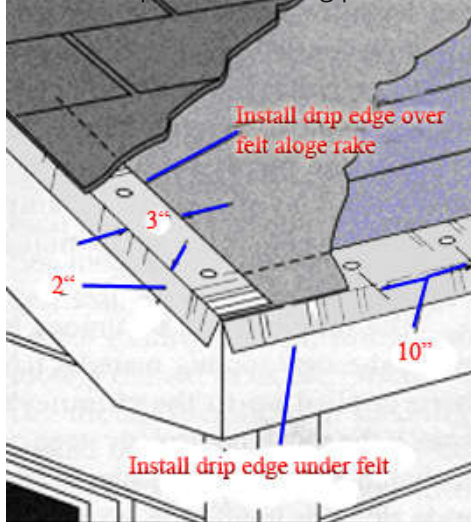
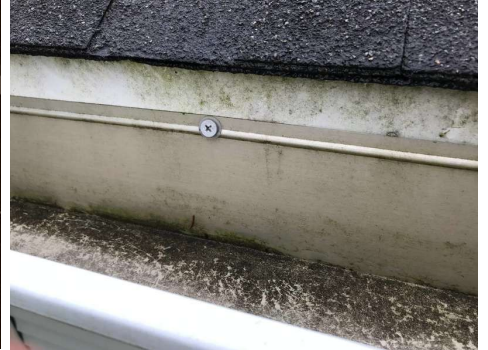
3.4.3 Flashings

ROOF EDGE FLASHING- IMPROPER OVERLAP

Roof edge flashing was improperly installed in places. When asphalt-saturated felt paper underlayment is used, it should overlap roof edge flashing at the eaves, and be overlapped by the flashing at the rakes. This condition may cause moisture damage to roof sheathing in the affected areas from wood decay and/or delamination. Any corrections should be made by a qualified contractor.

Contact a qualified roofing professional.

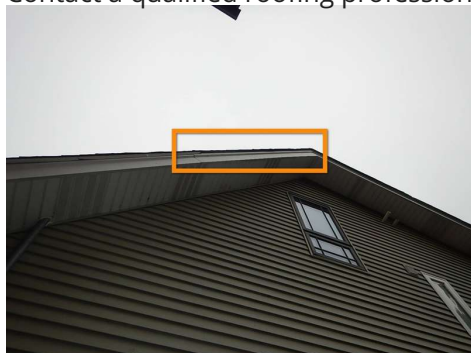
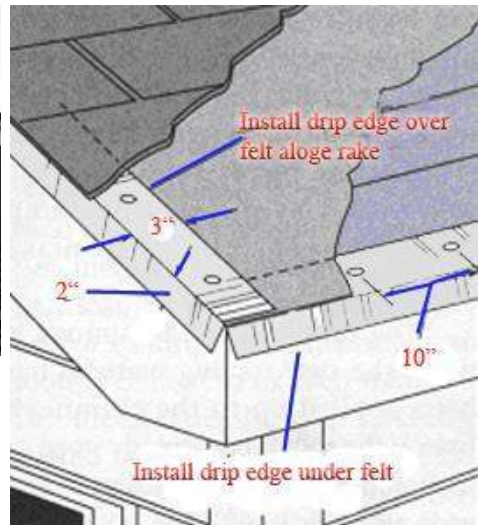
3.4.4 Flashings

ROOF EDGE FLASHING MISSING

NORTH RAKE EDGE

Areas of the roof were missing roof edge flashing. Lack of roof edge flashing leaves the edges of roof sheathing and underlayment exposed to potential moisture damage from wood decay and/or delamination. Water is capable of running behind the gutter systems if no drip edge flashings are installed, which can lead to water damage / rot / decay of the soffit and fascia boards. The inspector recommends replacement of roof edge flashing in areas where it is missing. All work should be performed by a qualified contractor.

missing section of rake edge flashing

Contact a qualified roofing professional.

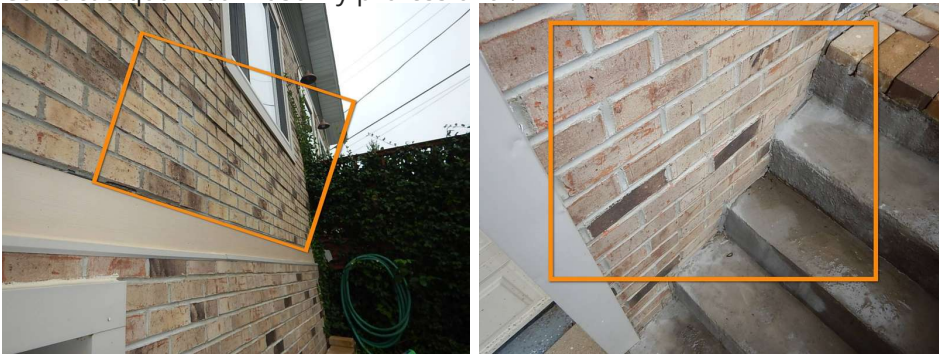
SOUTH

Areas of the brick veneer siding were showing signs of minor bowing. There appear to be no weep systems in place to allow for drainage of moisture from behind the veneer siding components. The masonry is porous, and may absorb water or moisture. It is recommended that this be evaluated by a qualified masonry professional and monitored closely. It is possible that the bowing may become more severe with time, and brick work could eventually start to become loose and experience mortar deterioration.

Contact a qualified masonry professional.

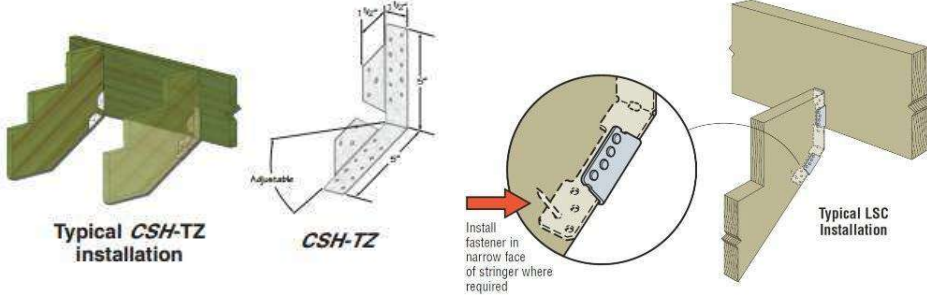
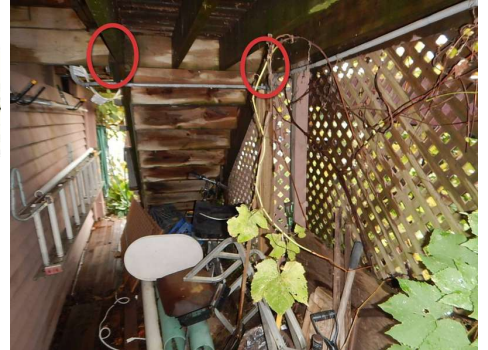
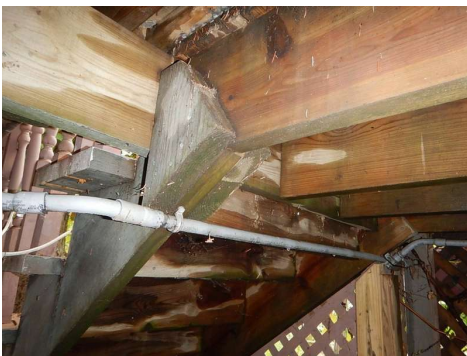
The connections between the supporting beams and supporting posts for the deck system do not conform with modern standards for safe deck construction. It is recommended that the connections be evaluated and upgraded by a qualified deck repair specialist to comply with modern and current deck building standards. To prevent beam rotation and resist lateral forces it is recommended that the beam or girder be connected to the supporting deck posts with approved metal connectors and hardware. Though this deck may have been built according to accepted standards at the time of its construction, any recommendations for upgrades or compliance with current standards are ultimately made with your safety in mind, and are recommended for repair.

Contact a qualified deck contractor.

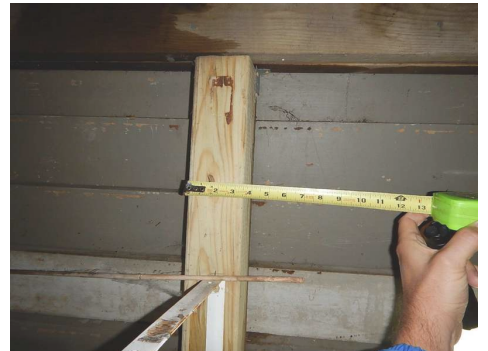
4.7.4 Decks, Balconies, Porches & Steps

DECK - SUPPORT POSTS UNDERSIZED

It appears that the elevated deck structure is being supported by posts or columns which may be undersized according to modern accepted deck construction standards. It is recommended that the support posts be upgraded to a larger dimensional lumber size for added safety and support of the deck structure. Though these sized columns or posts may have been widely accepted during the era of construction for this deck, current modern accepted building and safety standards call for larger dimensional lumber (minimum 6"x6") to be used in this application. Consult with a qualified deck repair professional for further evaluation / repair / or replacement.

Contact a qualified deck contractor.

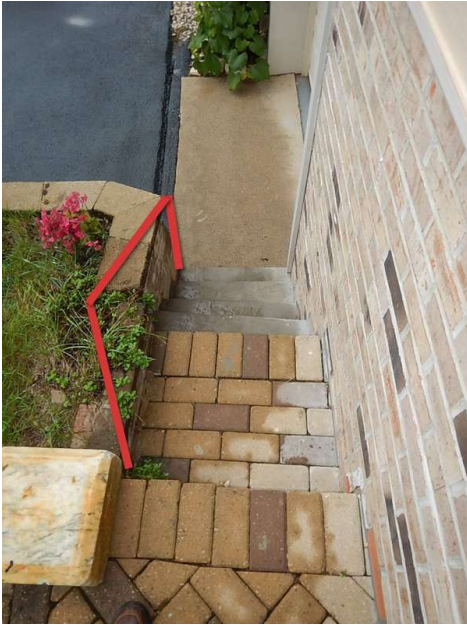
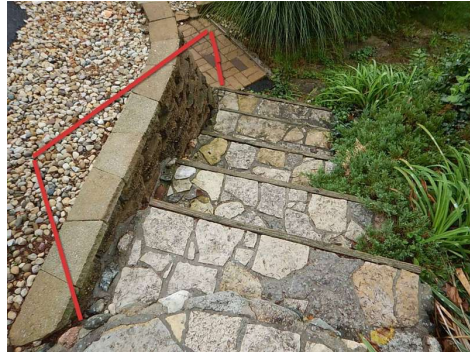
4.7.5 Decks, Balconies, Porches & Steps

HAND RAILING RECOMMENDED

Steps are recommended to have a hand railing installed for safety. Lack of guard rail / hand rail may result in potential for trip or fall hazards.

Contact a qualified general contractor.

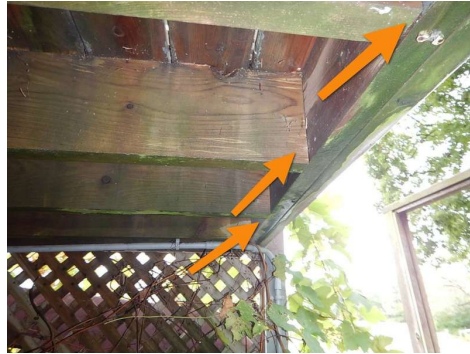
4.7.6 Decks, Balconies, Porches & Steps

JOIST HANGERS

Joist hanger(s) are missing or improperly installed. This could cause the deck structure to fail. Recommend that joist hangers be properly installed by qualified contractor. End nailing or toe nailing may not provide adequate attachment.

Contact a qualified deck contractor.

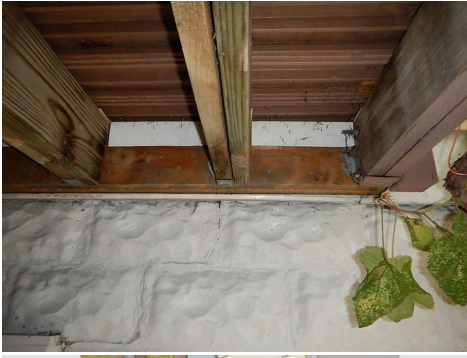
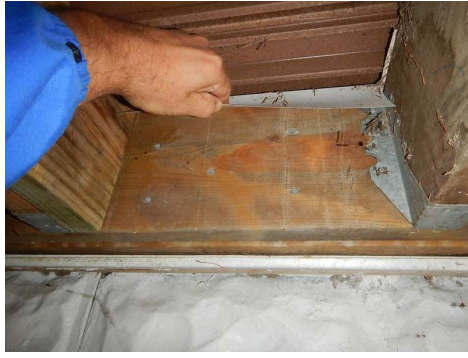
4.7.7 Decks, Balconies, Porches & Steps

LEDGER BOARD IMPROPERLY INSTALLED

The ledger board is not properly attached to the building. This can cause the deck to pull away from the building and possibly collapse. Recommend that the deck and/or ledger board be properly attached by qualified contractor. Fasteners should be properly spaced and staggered across the length of the ledger board. Flashing is required per current building standards at the ledger to protect from rot / decay and should be strongly considered for older deck systems. Further information on deck construction can be found at: [DCA 6 Prescriptive Residential Wood Deck Construction Guide](#)

Contact a qualified deck contractor.

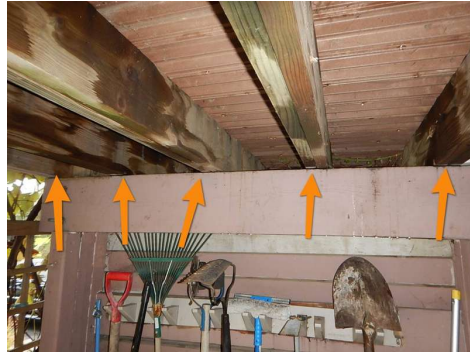
The method of attachment observed between the deck joists and the supporting cross beam appears to be inadequate and / or possibly insufficient. Each joist is recommended to be attached to the supporting beam by either toe nailing the joists to the beam AND providing blocking between each joist above the beam to prevent rotation - or - by using approved mechanical fasteners between the joist and beam. Joists may also be installed to the side of the beam with approved hangers, with the tops of the joist being flush with the top of the beam.

Recommendation
 Contact a qualified deck contractor.

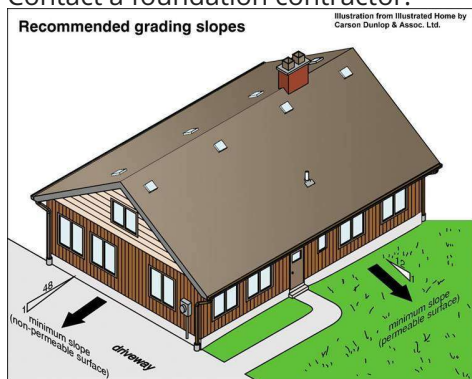
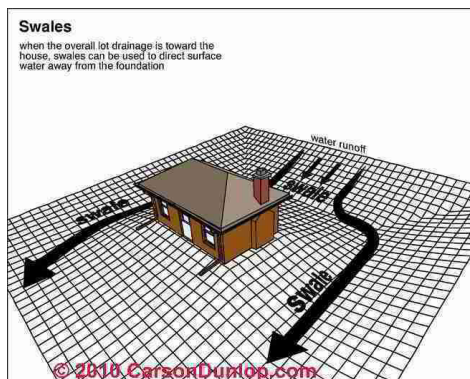
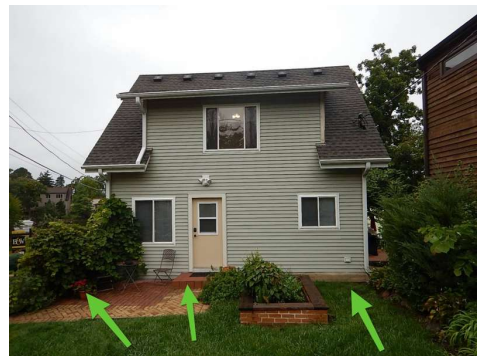
4.9.1 Vegetation, Grading, Drainage & Retaining Walls

NEGATIVE GRADING

Grading is sloping towards the home in some areas. This could lead to water intrusion and foundation issues. Recommend qualified landscaper or foundation contractor regrade so water flows away from home. Where regrading is not possible, measures should be considered for controlling surface drainage to direct it away from the home, such as installation of drainage swales, or in-ground french drains / collection systems.

negative grading @ East side of home

Contact a foundation contractor.

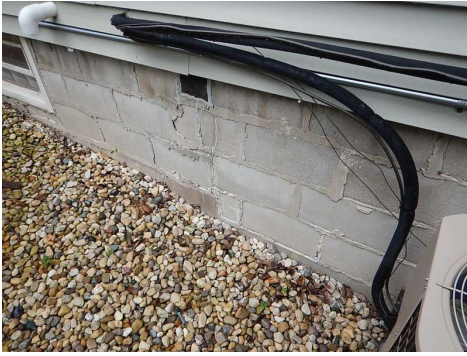
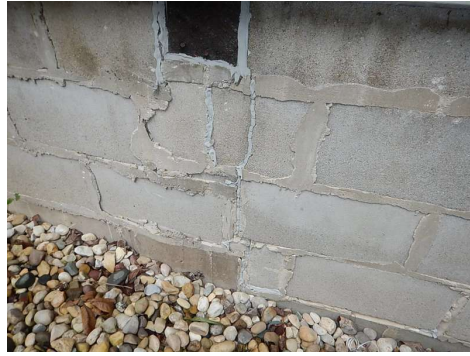
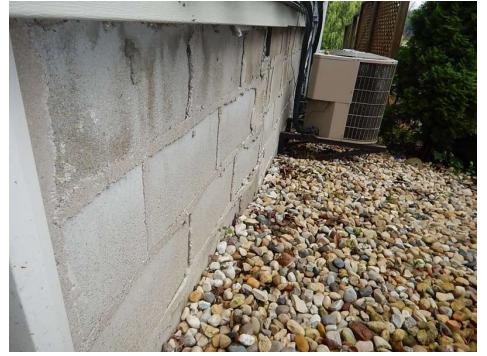
5.1.1 Foundation

Foundation wall observed to be bowing and/or leaning. Further evaluation is recommended from a qualified foundation specialist or structural engineer. Amateur repairs are evident using caulks or sealants in an attempt to seal cracks in the block wall foundation.

Contact a qualified structural engineer.

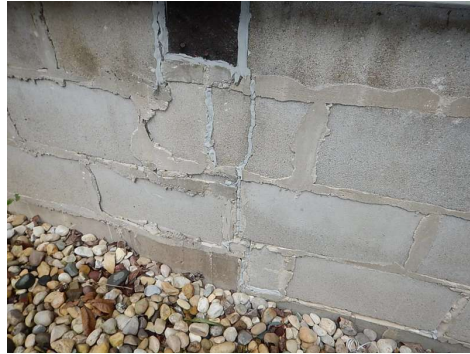
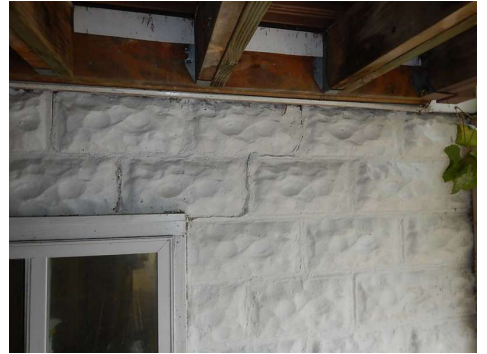
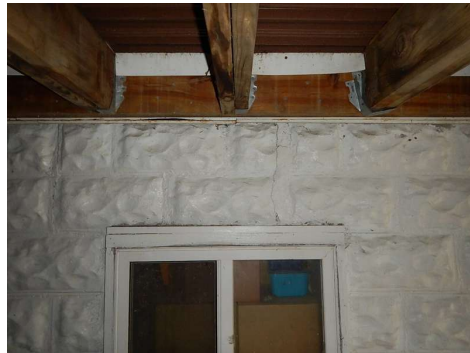
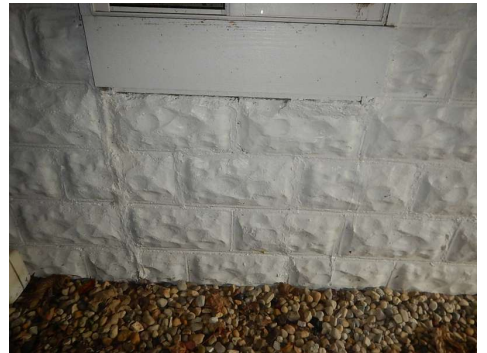
5.1.2 Foundation

CMU'S - MODERATE CRACKING

Concrete Masonry Unit (CMU) foundation walls had moderate cracking and stepped cracking visible in mortar joints. Cracking should be patched properly to avoid freeze damage and the cause of the cracking should be determined and corrected. It is recommended that you consult with a qualified foundation repair professional or structural engineer before the expiration of your Inspection Objection Deadline to discuss options and costs for stabilization, correction, or needed repairs.

Contact a foundation contractor.

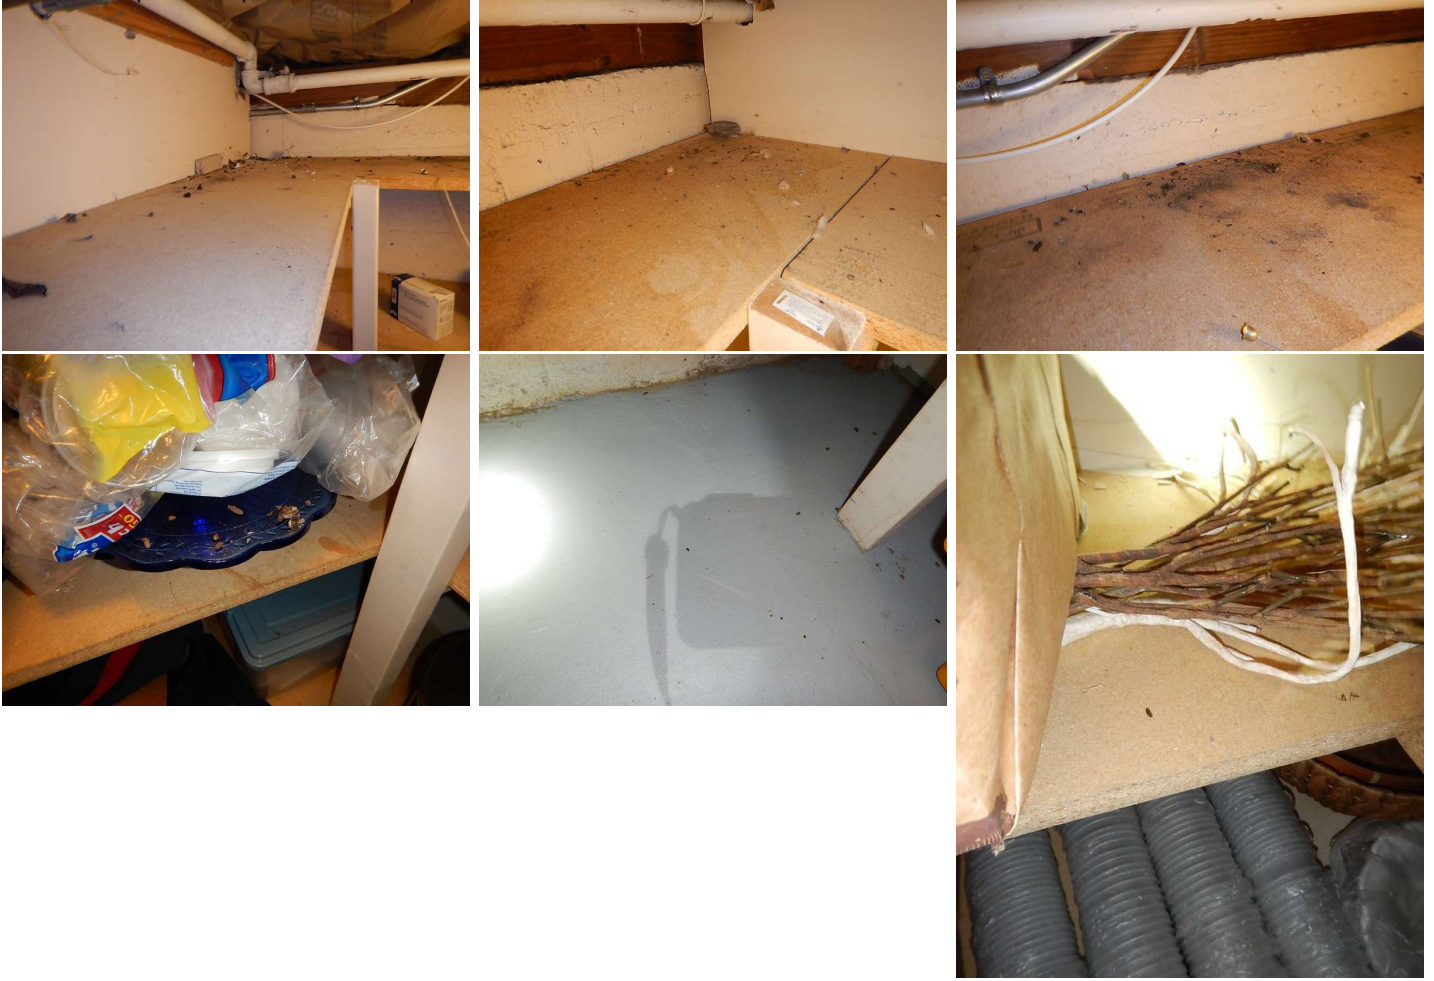
5.2.1 Basements & Crawlspaces

EVIDENCE OF PEST / RODENT ACTIVITY

Rodent droppings or bait stations were observed in areas of the home, along with strong odor of ammonia (urine). This may suggest there have been prior issues with pest control, and it is recommended that you consult with a qualified pest control professional for an evaluation. Pest control contractors can assess the home to determine if infestations are active, and identify / correct possible entry points.

Recommendation
Contact a qualified pest control specialist.

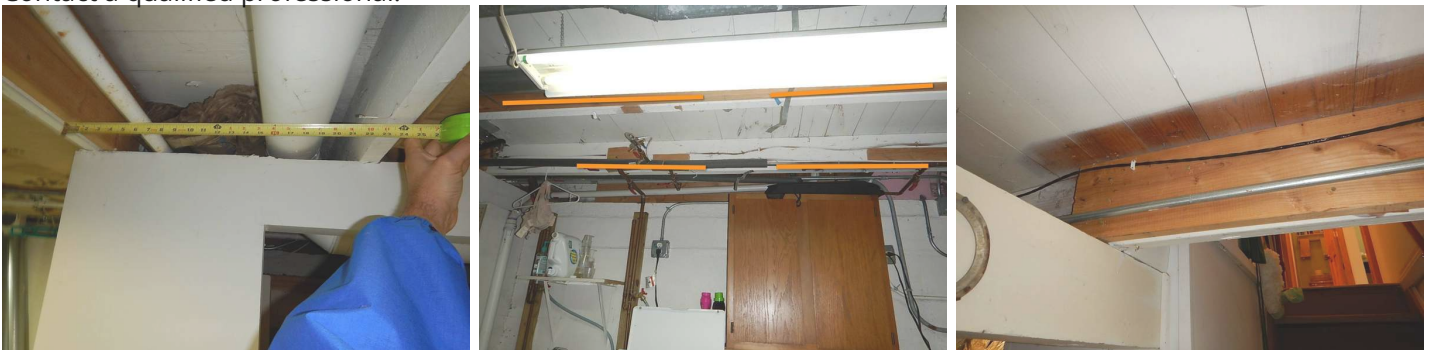
5.3.1 Floor Structure

SAGGING JOISTS - OVERSPANNING / UNDERSIZED

Visible sagging of floor joists in the basement appeared to be the result of inadequate engineering design (overspanning or undersizing of the joists). You may wish to consult a qualified contractor / framing professional to determine the cost of any needed corrections. This condition is not uncommon in older / historic homes as building practices were not on par with modern construction and engineering designs.

joists span 24" O.C. - modern dimensional lumber floor framing typically will span 16" O.C., by today's standards, 24" O.C. spacing is considered "overspanned"

one area where minor sagging was observed at North end of basement

a "sistered" joist repair to solidify the floor structure

Recommendation
Contact a qualified professional.

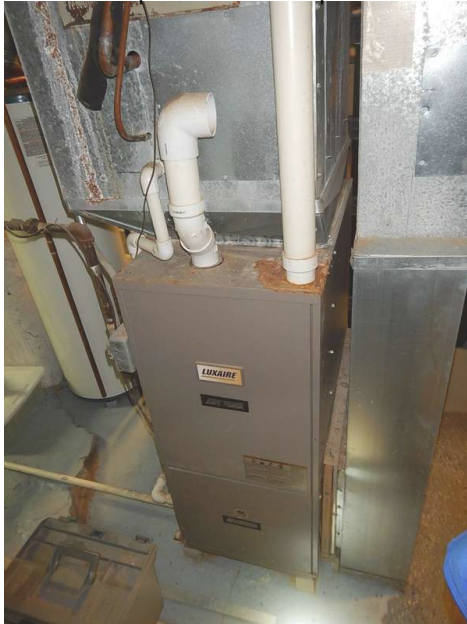
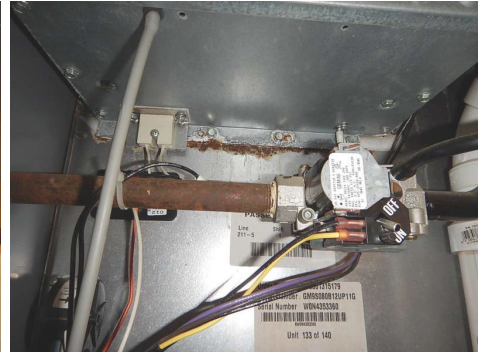
RUST - SIGNS OF LEAKING

There was rusting and corrosion visible inside the furnace cabinet which suggests leakage may be occurring or has occurred in the past from condensate drainage systems.

Recommendation
Contact a qualified HVAC professional.

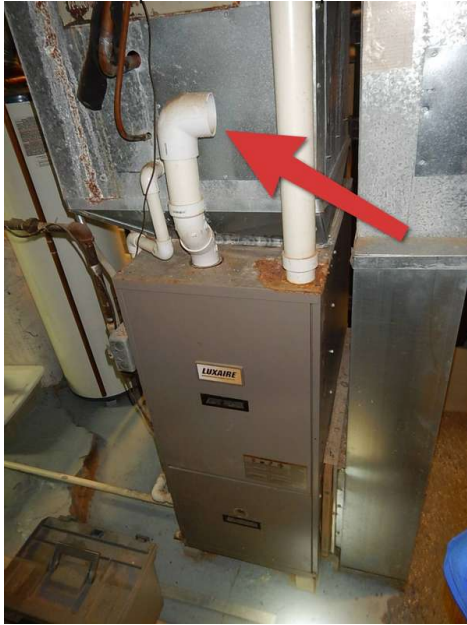
6.1.2 Equipment 1- Basement

HIGH EFFICIENCY FURNACE - OBTAINING COMBUSTION AIR FROM INDOORS

Obtaining combustion air from indoors may be causing some negligible negative pressure inside the home, and may be a contributing factor to the water heater showing signs of back drafting. It is recommended that you consider installing proper piping to obtain combustion air from the exterior of the home to aid in proper venting of flue gases from the water heater.

melted and scorched plastic bushing near water heater draft hood, indicative of back drafting condition

combustion air inlet for high efficiency furnace - recommend obtaining all combustion air from the exterior of the home

Recommendation
Contact a qualified HVAC professional.

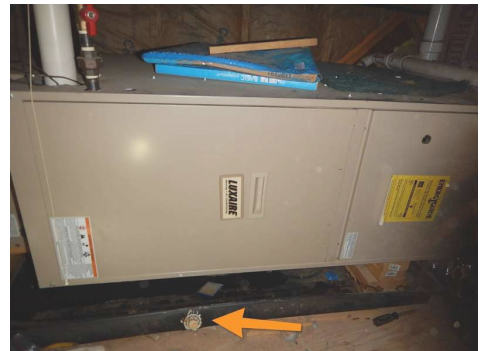
ATTIC FURNACE - IMPROPER OR MISSING CATCH PAN

drain for the catch pan has not been plumbed into the household drain

The catch pan installed beneath this furnace does not appear to have been plumbed to the household drain system. This leaves the home at risk for possible water damage due to a leaking furnace or air conditioning system. Recommend correction from a qualified HVAC professional.

Recommendation
Contact a qualified HVAC professional.

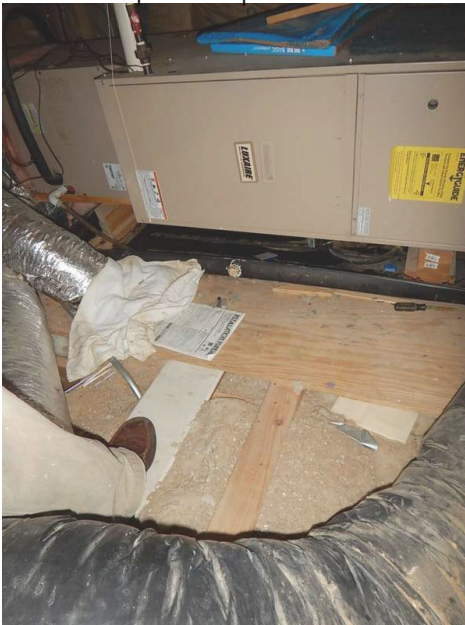
ATTIC FURNACE - INADEQUATE PATHWAY / PLATFORM

The furnace unit installed in the attic space does not meet modern building and safety standards in regards to a provided pathway and or working platform for servicing or maintaining the unit. It is recommended that a continuous solid pathway be constructed a minimum of 24" wide, and a platform to be installed in front of the furnace for servicing which should be a minimum of 30"x30". The pathway should begin at the entrance to the attic space and be no longer than 20 feet. Lack of adequate pathway and or service platform may create a safety hazard for those who need to access the furnace for service or maintenance, and could result in injury or ceiling damage.

installed pathway and service platform are inadequate and pose a hazard

Recommendation
Contact a qualified professional.

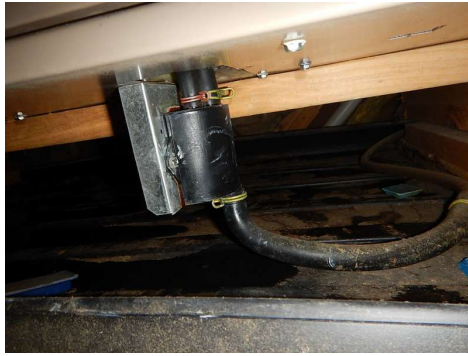
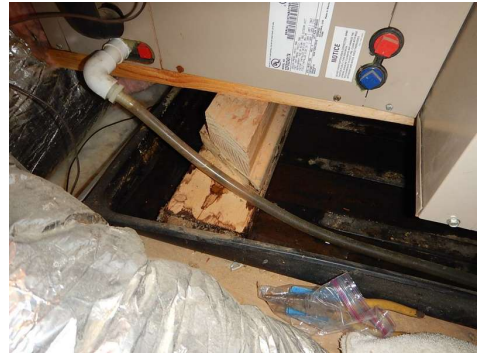
6.2.6 Equipment 2 - Attic

FURNACE - ACTIVE LEAKING

The furnace unit was observed to have an active leak from the condensate drainage systems and is in need of repair from a qualified HVAC professional.

Recommendation
Contact a qualified HVAC professional.

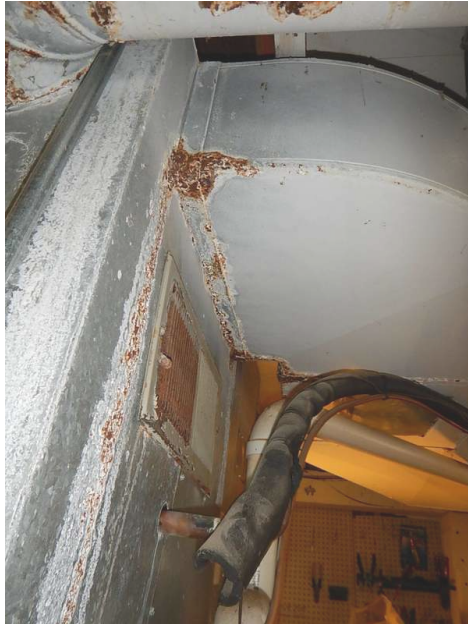
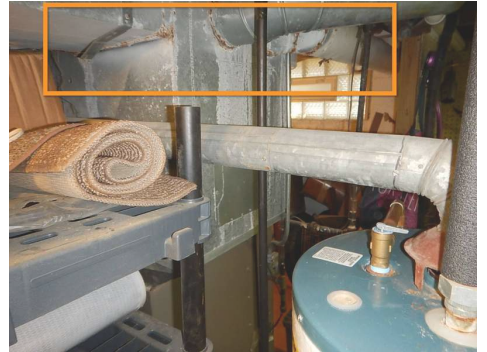
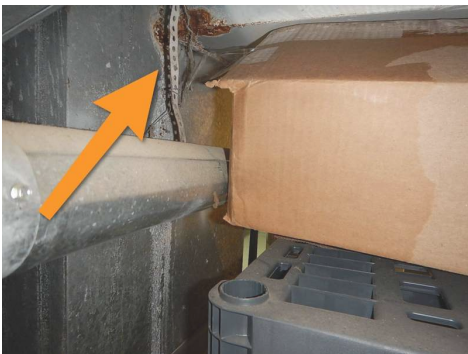
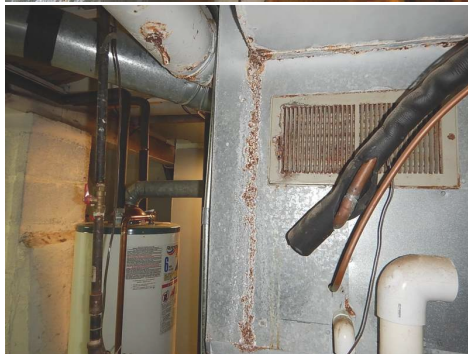
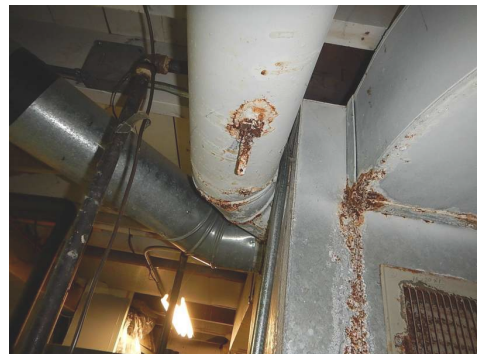
6.4.1 Distribution Systems

DUCT WORK - CORROSION / RUST

Some of the duct work for the HVAC system was observed to have moderate corrosion and rust present. This may indicate that the duct work is at or nearing the end of its useful lifespan. It is recommended that you have the duct work evaluated by a qualified HVAC professional to determine the extent of any damage or needed repairs / replacements at this time.

Recommendation
Contact a qualified HVAC professional.

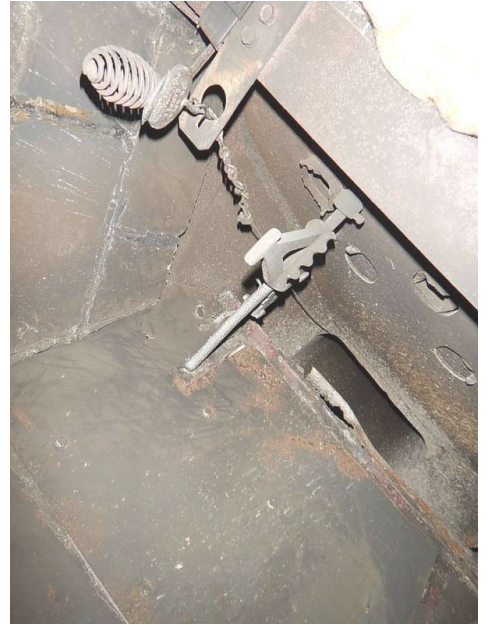
6.6.1 NG/LP Firelogs & Fireplaces

FLUE CLEANING / INSPECTION

It is recommended that prior to your closing, a certified professional chimney sweep perform a level 2 inspection and cleaning of the fireplace and flue systems.

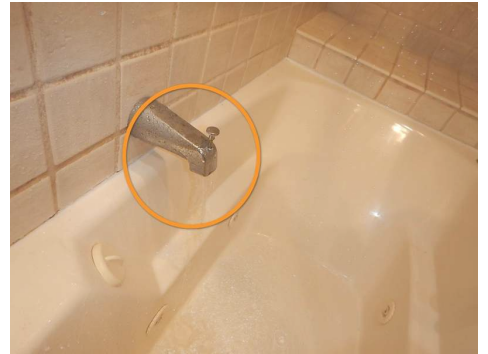
8.2.2 Water Supply, Distribution Systems & Fixtures

POOR SHOWER DIVERTOR

The shower was observed to have a poor divertor mechanism. The divertor should direct all water flow from the faucet to the shower head, with minimal or no leakage from the tub spigot. Recommend repair / replacement of worn shower divertor device.

Contact a qualified plumbing contractor.

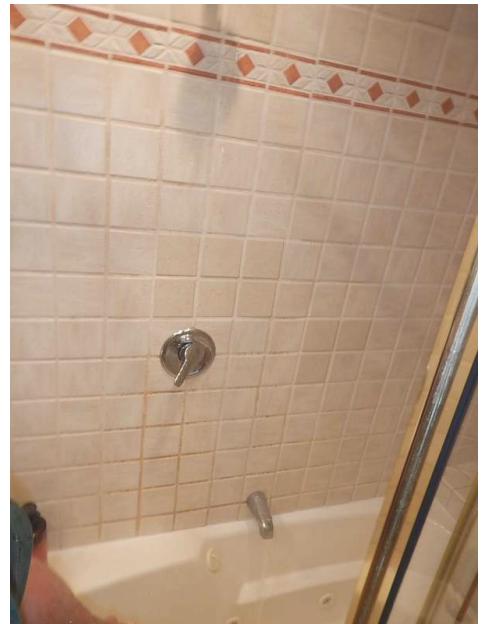
8.2.3 Water Supply, Distribution Systems & Fixtures

INADEQUATE FLOW

Plumbing fixture exhibited insufficient flow. The Inspector recommends that before the expiration of your Inspection Objection Deadline you consult with a qualified contractor to discuss options and costs for correction.

Contact a qualified plumbing contractor.

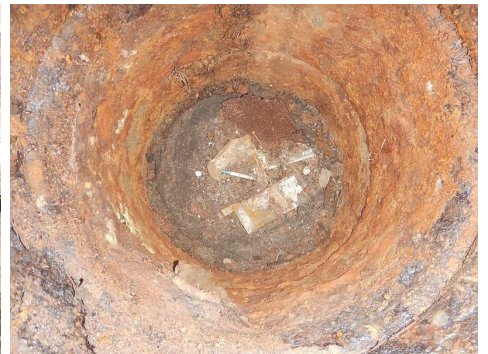
CATCH BASIN OBSERVED

A catch basin was observed in the home which should be evaluated further by a qualified plumbing and sewer professional. Catch basins are considered outdated, and may pose concerns with proper drainage or conforming with current plumbing / sanitary standards.

floor drain is actively discharging into a catch basin

basin is heavily corroded, full of debris, and inspector unable to verify if there is a drain at bottom of basin, or where it may be plumbed to - further evaluation is recommended

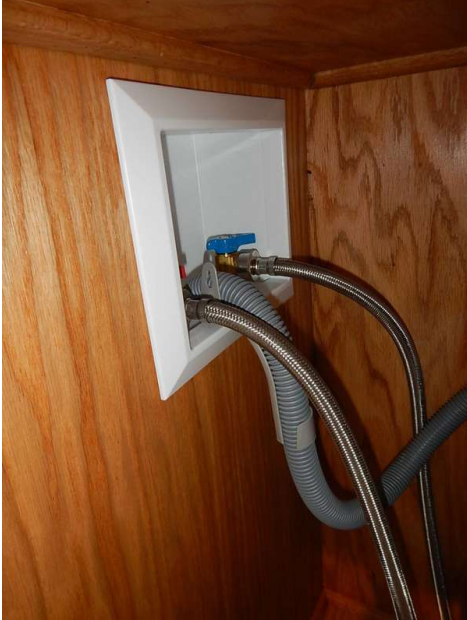
IMPROPER DRAIN

2nd Floor laundry unit observed to be draining into the bathtub. This is poor practice and could cause drain clogging in the tub. Recommend consulting with qualified plumbing professional to discuss alternative drainage options and costs.

Contact a qualified plumbing contractor.

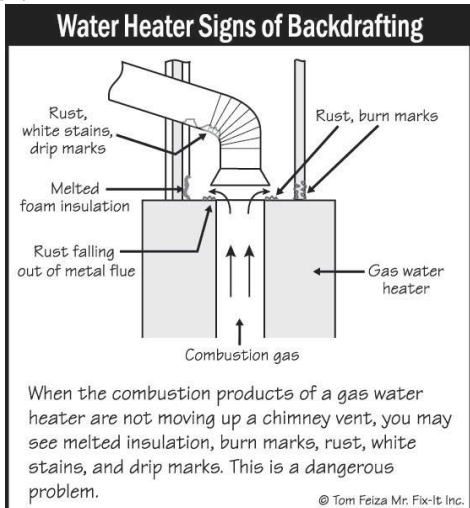
BASEMENT

BACKDRAFTING

This gas-fired water heater showed evidence of prior backdrafting at the time of the inspection. "Backdrafting" is a condition in which the invisible, odorless, tasteless, toxic products of combustion from the water heater flue leak into the living space. Excessive exposure to these products of combustion can result in injury or death (carbon monoxide hazard). The Inspector recommends that an evaluation and corrections be performed by a qualified plumbing contractor.

scorching / melting of plastic bushing adjacent to draft collar

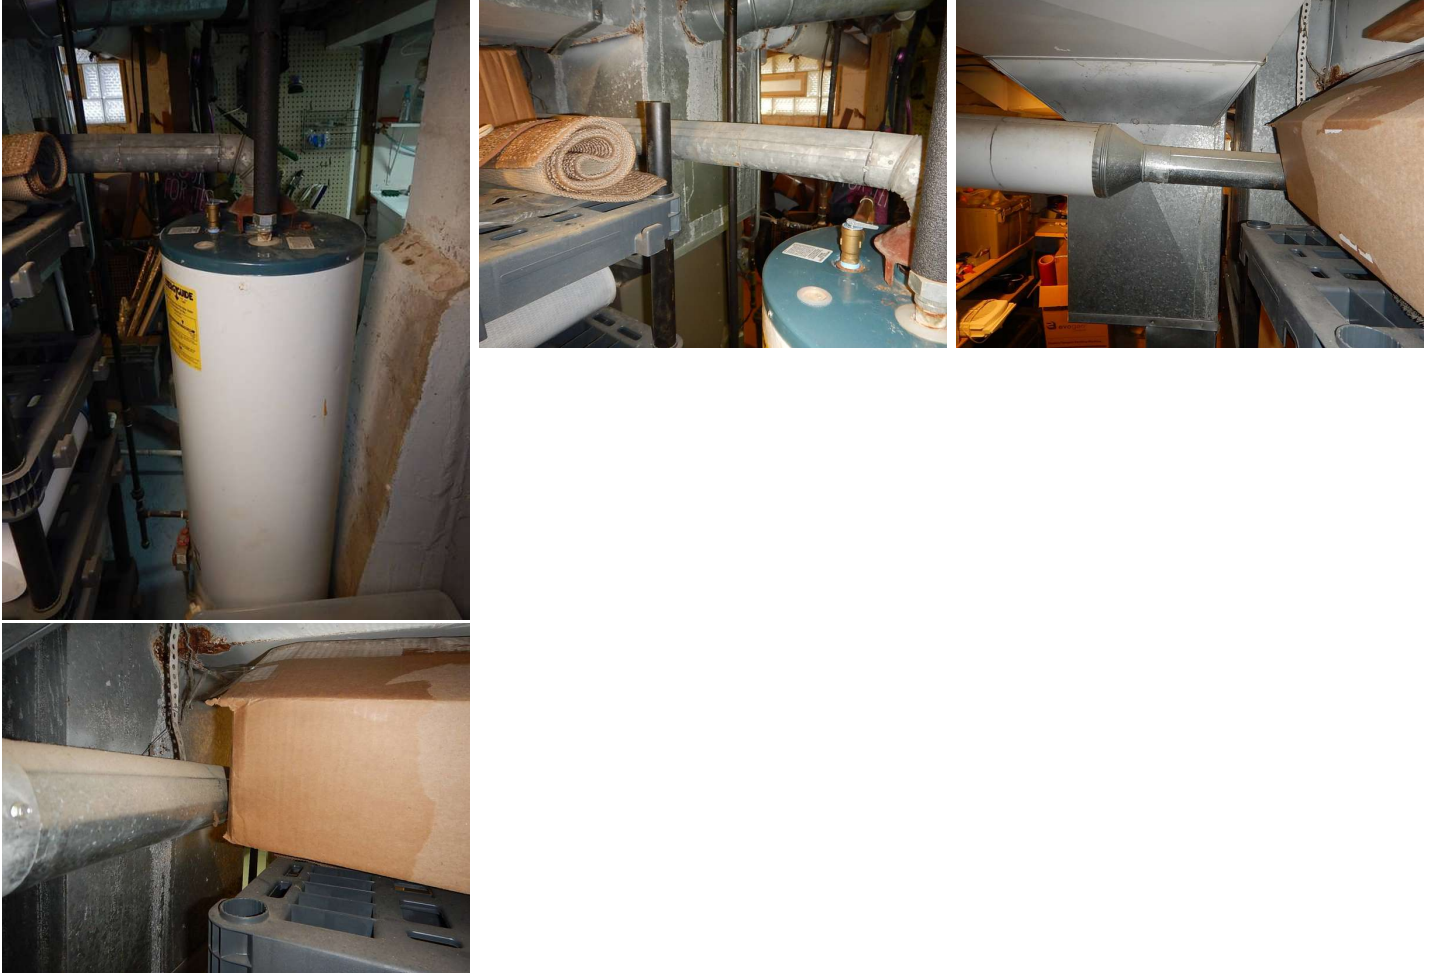
F018

FLUE- INADEQUATE CLEARANCE FROM COMBUSTIBLES

The exhaust flue for this gas-fired water heater had inadequate clearance from combustibles. This single wall flue requires 6-inch clearance from combustible materials. This condition is a potential fire hazard and all stored items should be moved away from the flue piping.

Contact a qualified plumbing contractor.

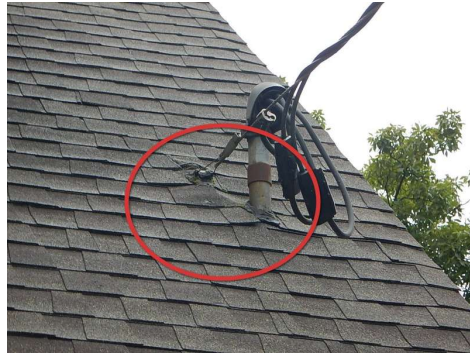
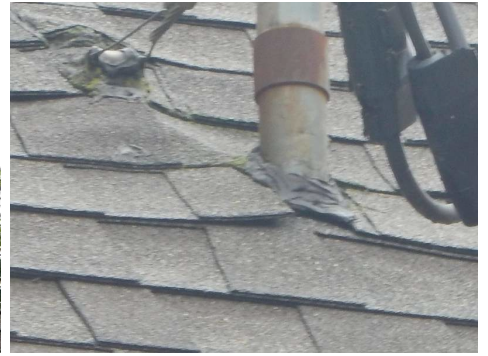
ATTACHMENT AND CLEARANCES - EVALUATE

The overhead service-drop conductors were attached directly to the home exterior at the roof. Components anchoring the conductors to the roof appear that they may be inadequate or loose (bulging observed in roofing shingles near anchor point) at the time of the inspection. This could be due to a failing connection, or it could also simply be the way the shingles were installed around the attachment. The Inspector recommends that before the expiration of your Inspection Objection Deadline, you consult with an electrical professional to evaluate the connection and discuss options and costs for any needed correction. Any work on the service conductors should be performed by a qualified personnel only.

It appears the shingles may be lifting around the electrical attachment. Further evaluation is recommended. This may just be how the shingles were installed, or could be an underlying problem with the connection coming loose.

Recommendation
Contact a qualified professional.

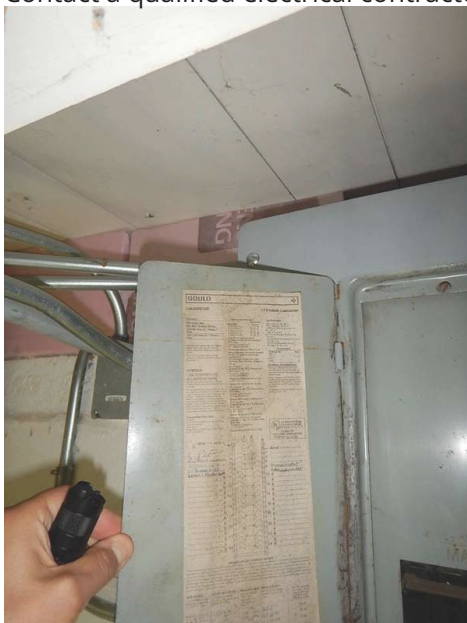
9.2.1 Main & Subpanels, Service & Grounding, Main Overcurrent Device

Electrical panel manufacturers stipulate that only their brand of service equipment should be utilized in the electrical panel. For example, General Electric service panels call for use of General Electric brand circuit breakers. The use of other manufacturers equipment in the electrical panel is poor practice, may result in poor connections and fire risks, and will void most panel manufacturers warranties. There were circuit breakers observed to be in use inside the electrical panel(s) which may not be conforming to the panel manufacturer specifications, and further evaluation / replacement is recommended from a qualified electrical professional.

Panel manufactured by Gould

Recommendation
Contact a qualified electrical contractor.

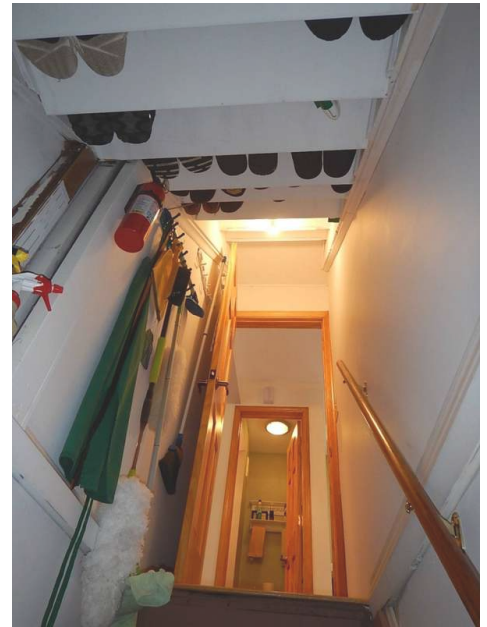
One or more stairwells in the home were observed to be lacking recommended two-way or three-way switches. This results in the lighting for the stairwell to only be operational from either the top or bottom of the stairwell and may present a safety hazard for potential trips or falls. Modern accepted building standards require a means of operating the stairwell lighting from both the top and bottom of the stairwell. It is recommended that a qualified electrical professional install a proper two-way switch system for stairwell illumination.

stairwell illumination is only operable from the top of the stairwell - installation of two way switch recommended at bottom of stairs so that light can be operated from both the top and bottom of the stairwell

Contact a qualified electrical contractor.

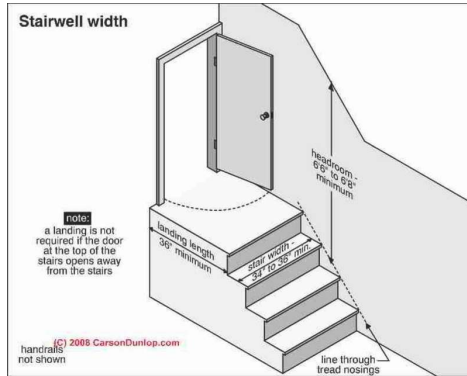
DOOR OPENS INTO STAIRWELL - SAFETY HAZARD

36" minimum landing size, door opening into too small of a landing may pose a hazard

Contact a qualified carpenter.

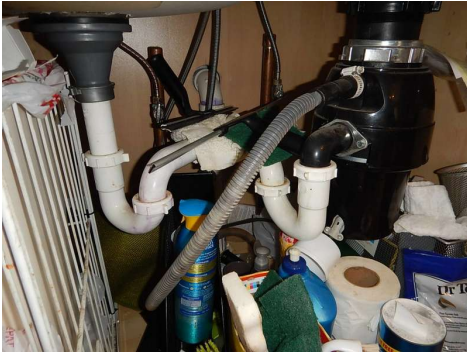
KITCHEN

NO HIGH LOOP

High Loop installation - IL prohibits connections to disposers

Contact a qualified plumbing contractor.

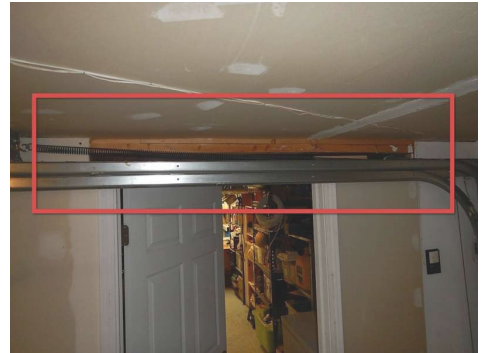
13.3.1 Walls & Firewalls

FIREWALL SEPARATION - INCOMPLETE

Firewall separating the home and garage is not compliant with modern building standards. Firewalls should be built with materials to prevent the spreading of a fire into the home living space. Though these requirements may have not been in place at the time of construction, it is recommended for safety that you consider repairing these systems and bringing into compliance with modern standards to reduce risks of fire / spreading.

Recommend a qualified contractor evaluate and bring firewall up to standards.
