SUMMARY

1234 Main St. Upper Darby PA 19082

Bill Strehse
Certified Property Inspector -
YOUR Home Inspection Company
(484) 420-7210
bstrehse@gmail.com

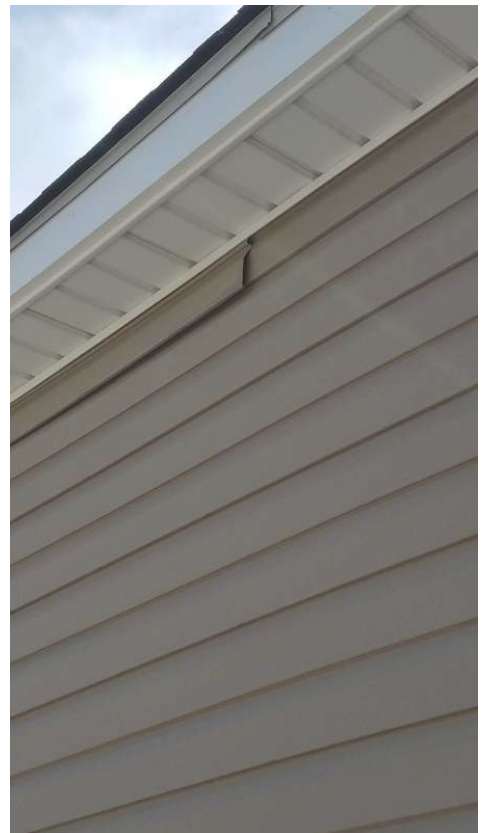
WEST ELEVATION - UNIT A

LOOSE SIDING

Secure loose siding.

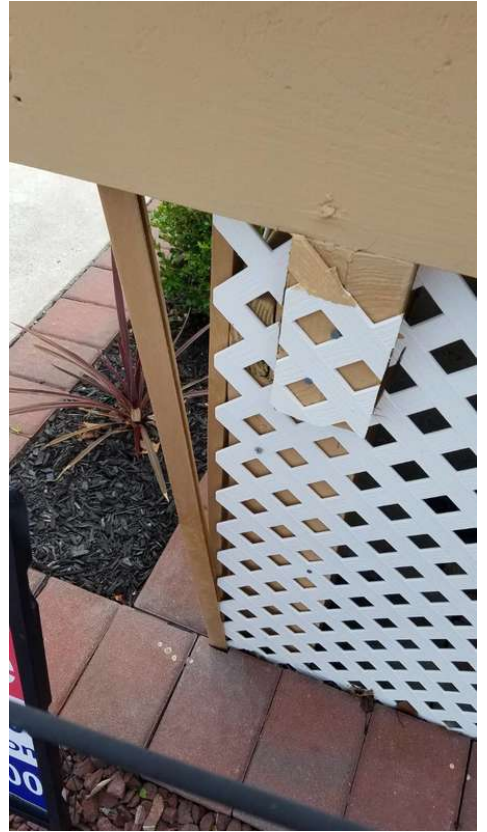
UNIT A - UNDER PORCH

LOOSE LATTICE SUPPORT

Resecure channel at corner of front porch

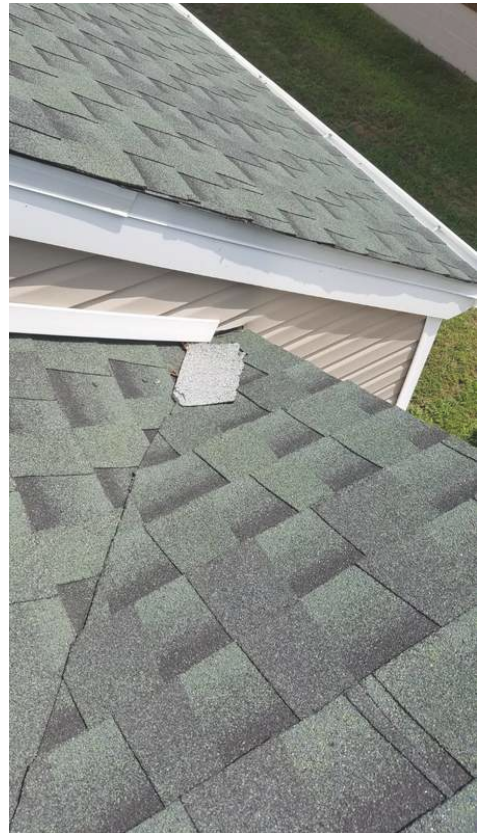
UNIT B - REAR VALLEY

KICKOUT FLASHING

Kickout flashing was missing at one or more locations. Kickout flashing directs water away from the dwelling as it exits the roof to prevent moisture intrusion inside. Recommend roofer install kickout flashing. Please note any areas concealed behind walls are not able to be evaluated for damage inside.

Contact a qualified siding specialist.

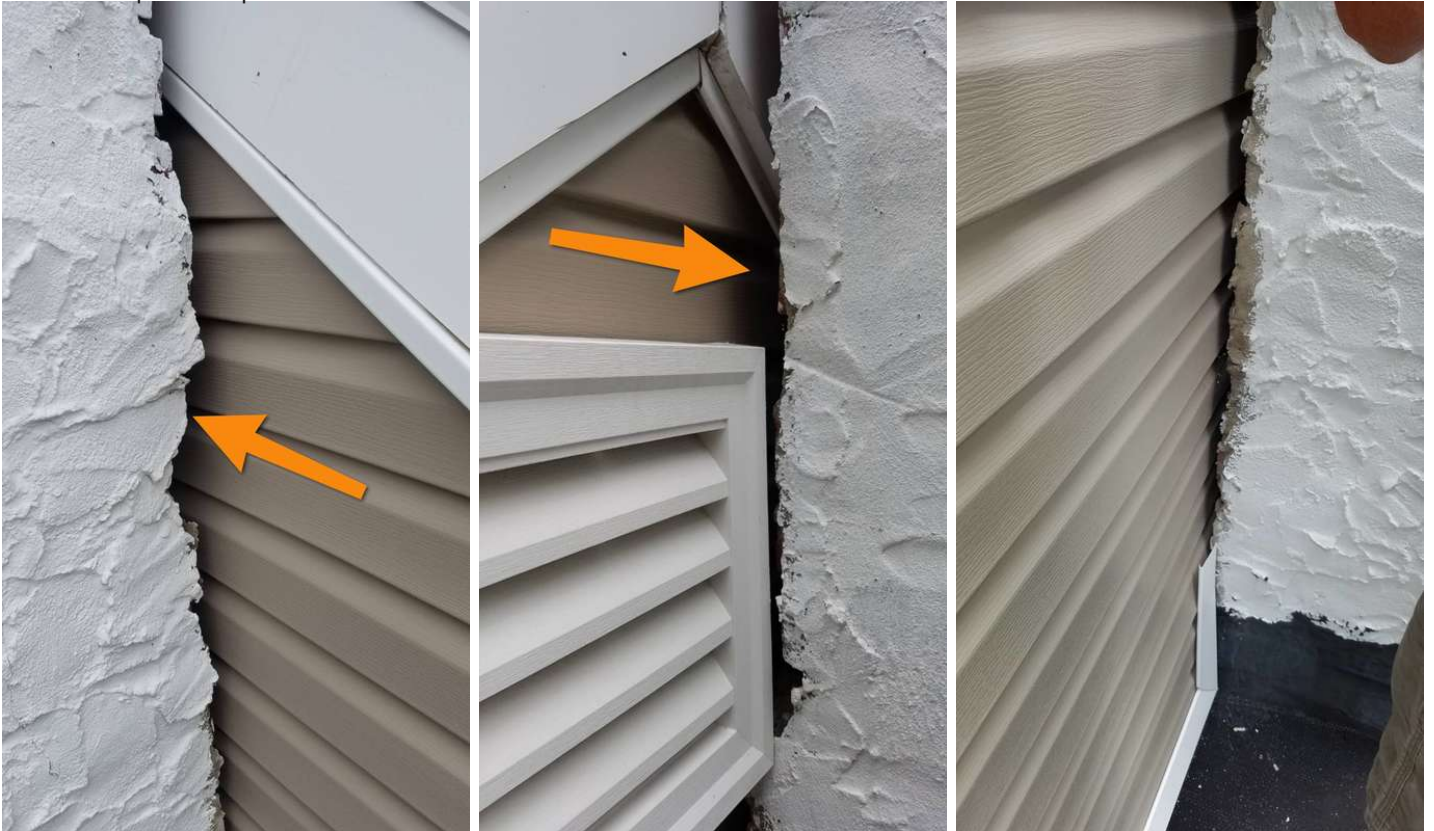
SIDING AT CHIMNEY - UNIT A

There is a gap between the siding and chimney over the flat roof - see additional comments for repair in Roof section.

Contact a qualified professional.

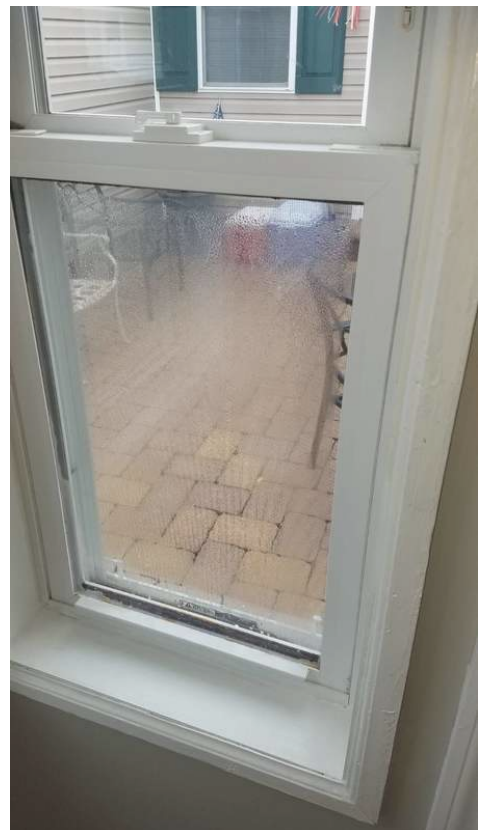
UNIT A WINDOW SEALS BROKEN

@ of the smaller windows in the rear Mud room of Unit A were fogging - seals have been broken. Recommend replacement of window sash if possible to find replacement.

Contact a qualified window repair/installation contractor.

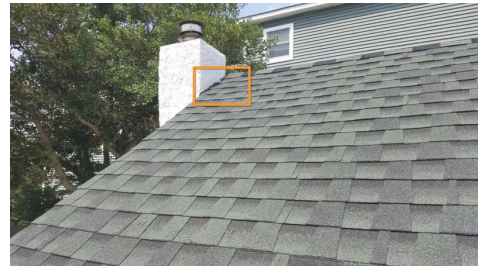
UNIT A ROOF AT CHIMNEY

INSTALL STEP FLASHING

Water intrusion at connection of main roof to Chimney - Step flashing should be installed where roof meets chimney. Also, a counter flashing shall be installed over the step flashing and secured to chimney. Additional comments on Siding section.

Install step flashing with counter flashing

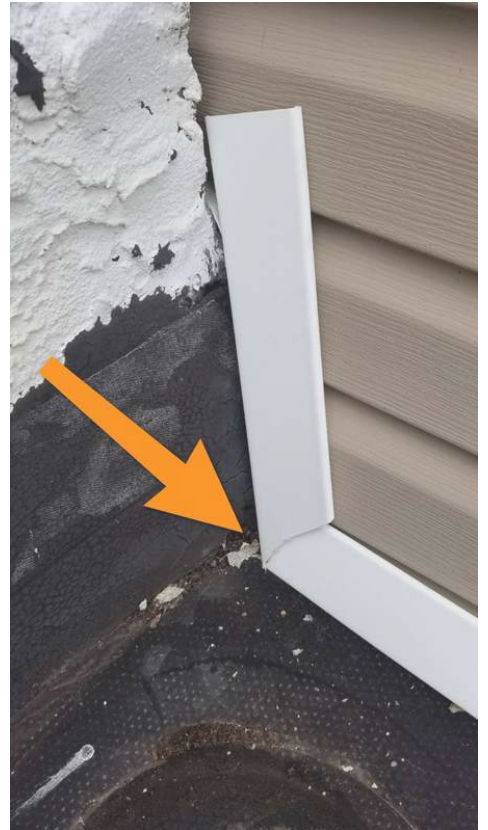
UNIT A - LOWER FLAT ROOF - CHIMNEY

PATCHED/SEALED

One or more areas were patched or sealed where the flat roof meets the Chimney. These areas may have been leaking previously - signs of moisture were detected in the closet below this connection. Recommend consulting with seller or property disclosures. These areas should be repaired. If leaks are observed, a licensed roofing contractor may need to evaluate and repair.

Contact a qualified roofing professional.

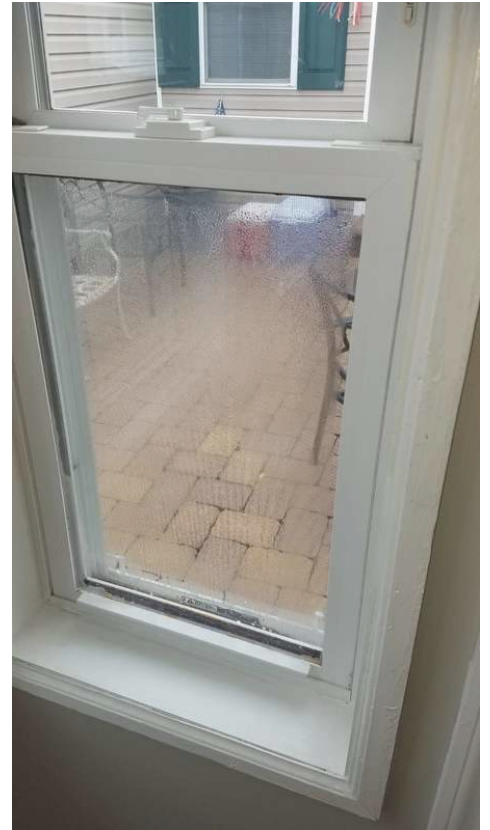
UNIT A - REAR MUD ROOM

WINDOW SEAL BROKEN

2 Windows in Unit A rear mud room had seals broken and the window was fogging.

Recommendation
Contact a qualified professional.

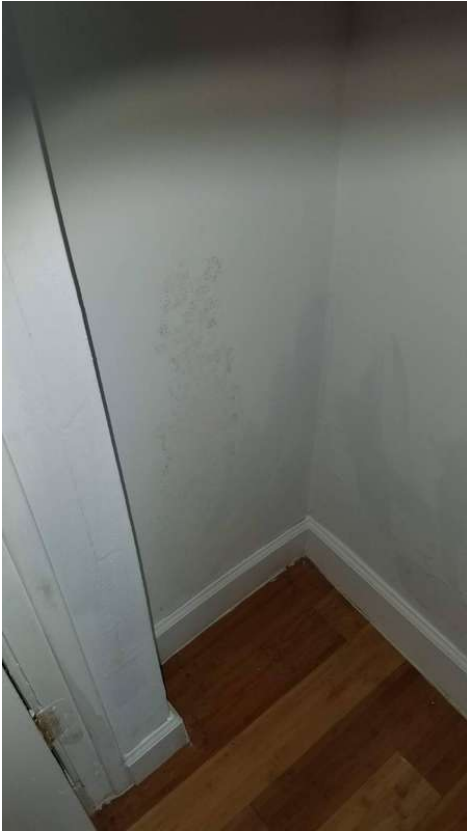
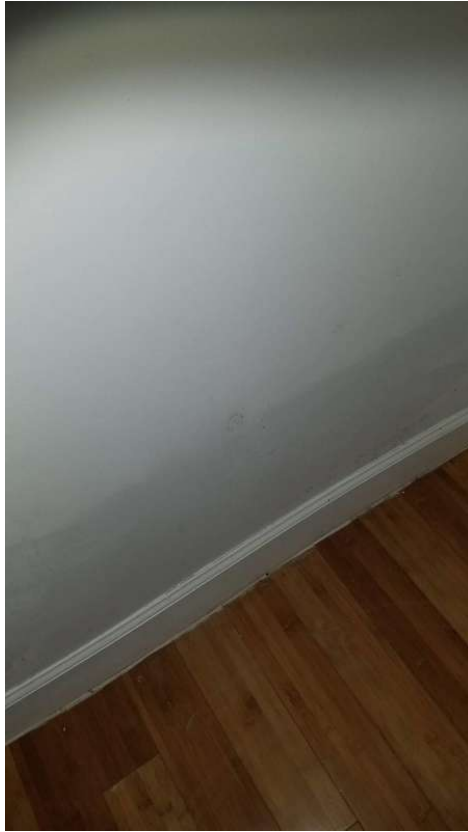
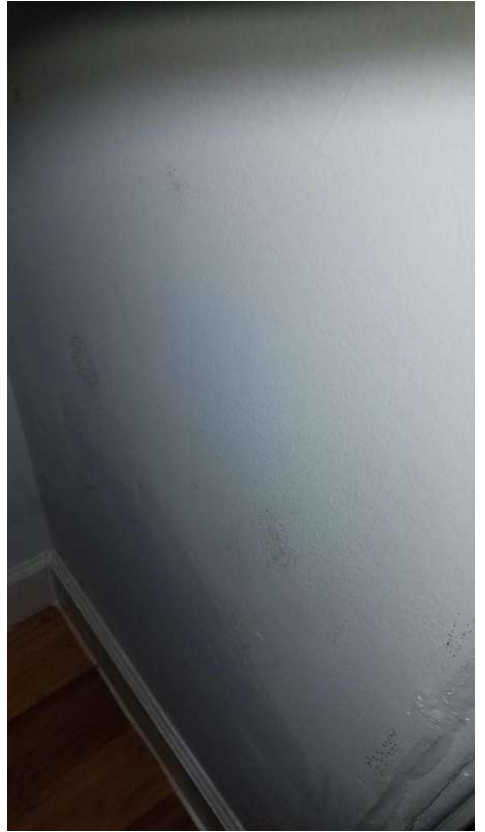
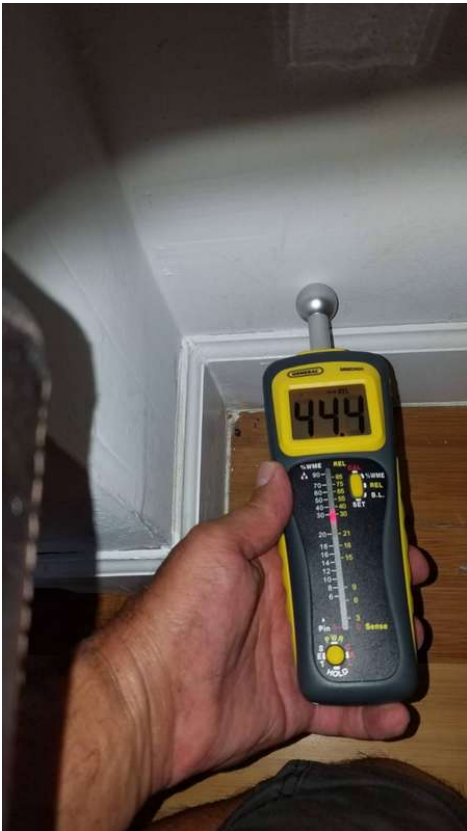
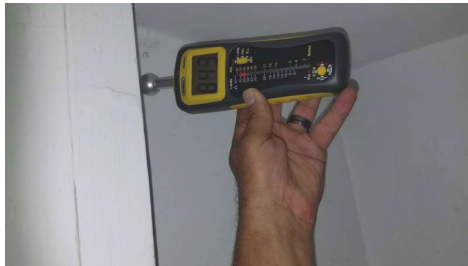
UNIT A REAR BEDROOM CLOSET

Observed signs of mold in one or more areas in the wall structure. Recommend identifying source or moisture intrusion and sending samples to a lab for testing. Expected caused is the connection of the Chimney at the flat roof. Siding does not go behind the chimney allowing water intrusion at base of chimney.

POSSIBLE MICROBIAL GROWTH

There was evidence of possible microbial growth on the wall(s). Recommend sample collection and further testing by a qualified lab. Wall covering should be removed in order to determine any possible mold growth inside the wall cavity. Clearance from a Certified Mold inspector should be given before closing any work.

High moisture level at top of closet

Moisture reading of 44% - should be below 10%.

Siding should have a backer rod and Joint sealer installed between the Chimney and siding. Closet drywall should be replaced and tested while open by a Mold inspector.

Recommendation
Contact a qualified mold inspection professional.

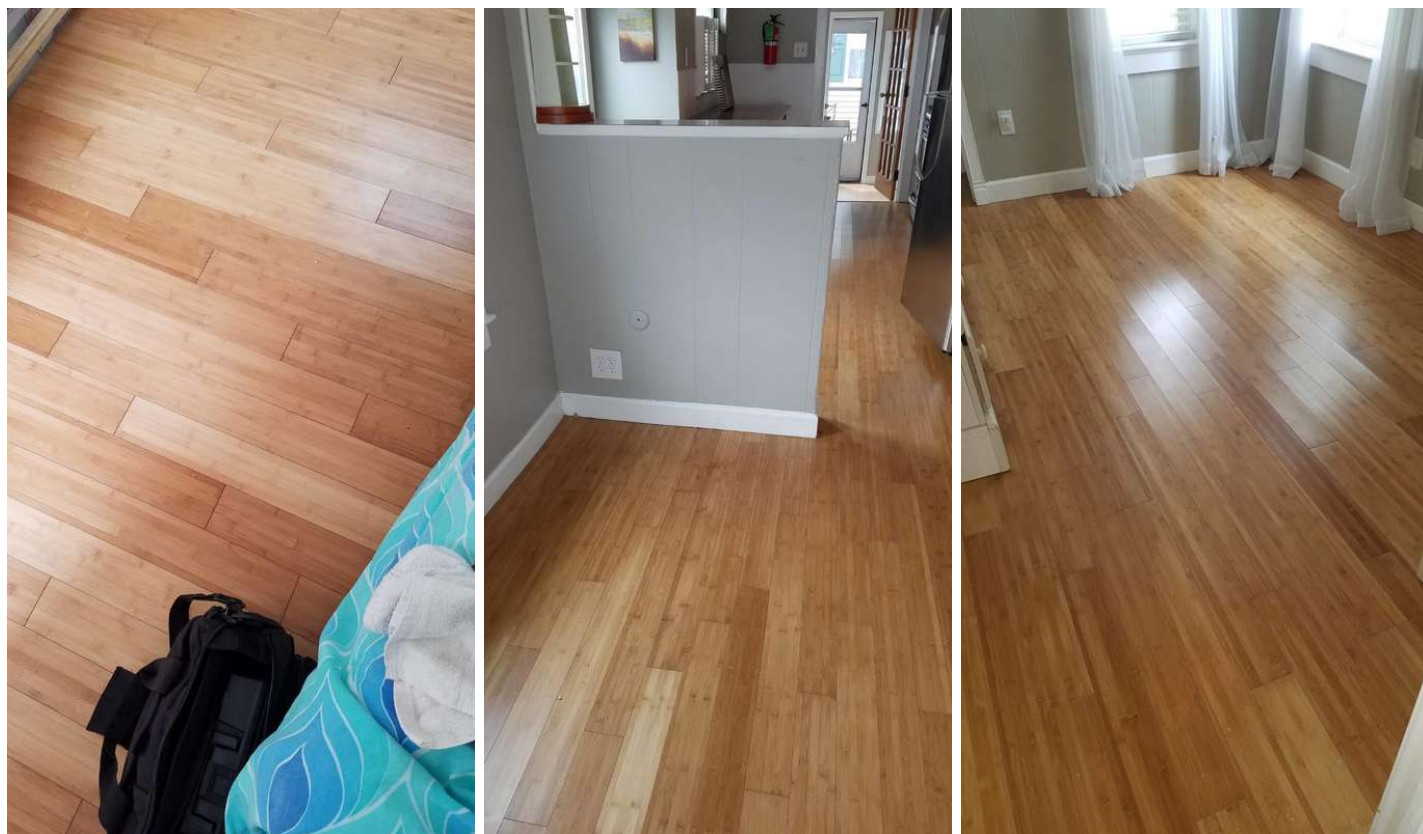
5.4.1 Floors
MODERATE WEAR
THROUGHOUT

Floors had moderate surface wear along major paths of travel.

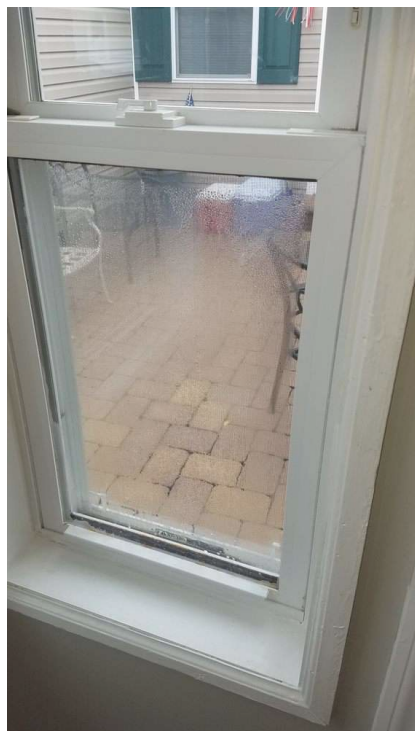
UNIT A - REAR MUDROOM

FAILED SEAL

Observed condensation between the window panes, which indicates a failed seal. Recommend qualified window contractor evaluate and repair or replace.

Contact a qualified window repair/installation contractor.

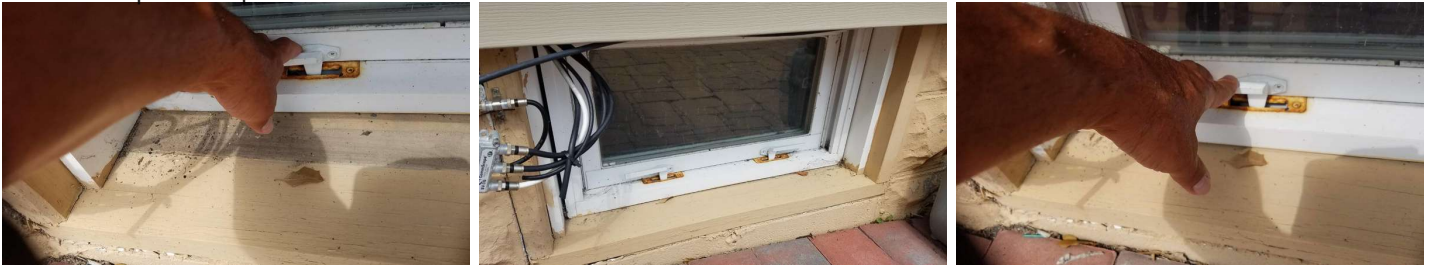
LOOSE WINDOW FRAME

Unit A - East elevation - casement window to Crawl space was not secure. Window pulled away from frame when attempting to open window.

Recommendation
Contact a qualified professional.

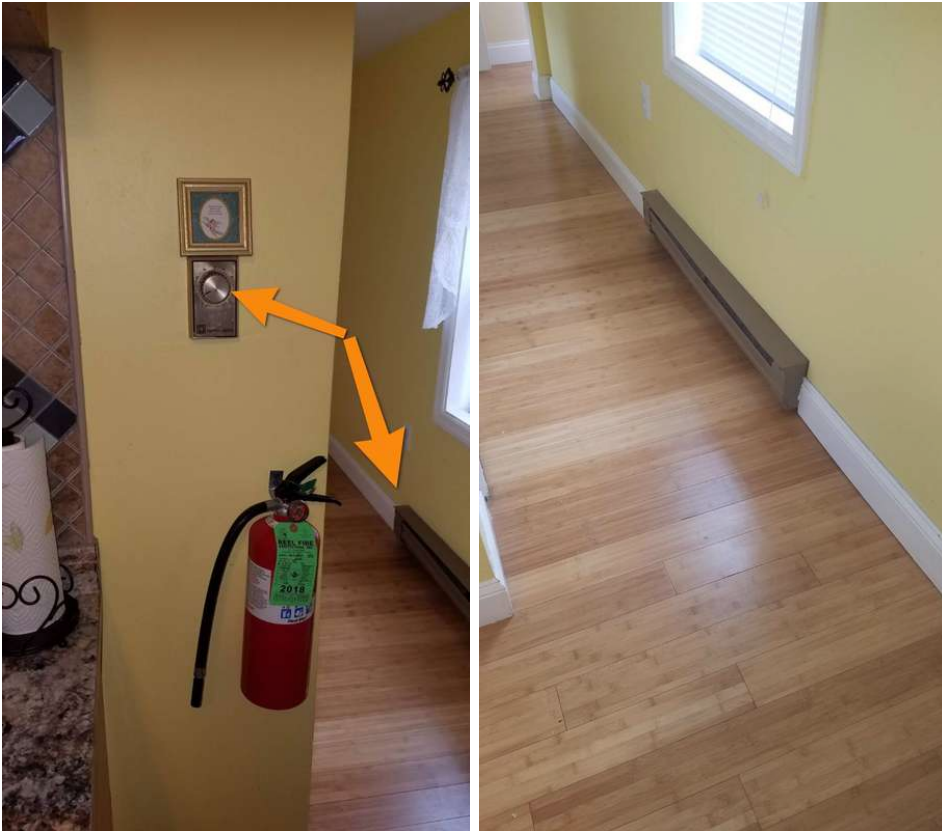
Unit B had baseboard electric heat as heat source. Unit were tested by turning on Thermostat (wall mounted at each location) and activated. Living room had couch pushed up against the baseboard heat which should be relocated away from Heat source.

Typical - wall thermostats that operate base heating system.

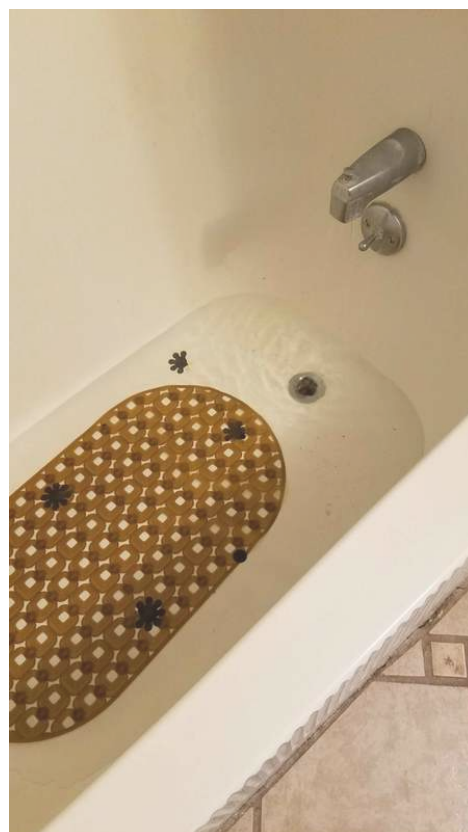
UNIT B

DRAINED SLOWLY SHOWER

The bathtub or shower drained slowly. Recommend clearing drain and/or that a qualified plumber repair if necessary.

Contact a qualified plumbing contractor.

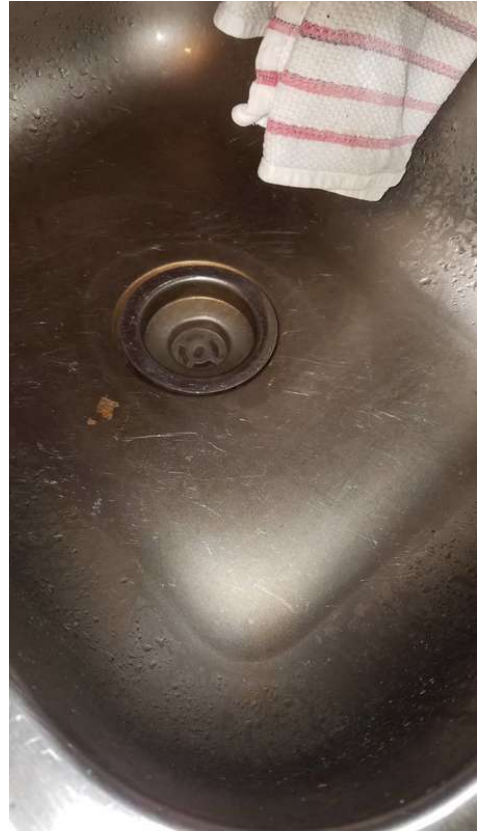
UNIT B SLOW DRAINS

Both the tub/shower and Kitchen sinks drained slowly. The drains should be cleared and retested prior to closing.

Contact a qualified plumbing contractor.

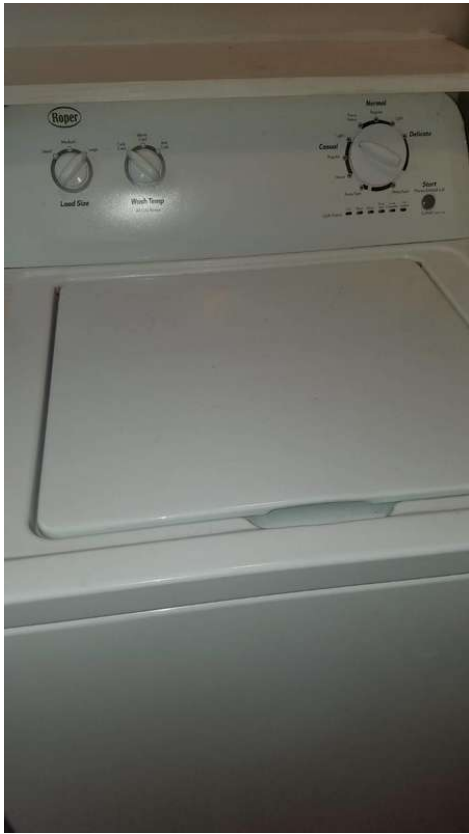
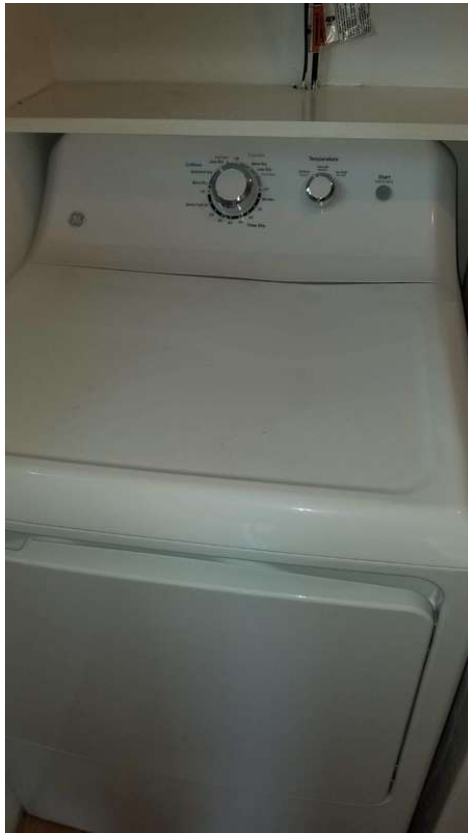
UNIT A

Unit A had side by side GE Washer & Dryers - Gas was not on so hot water could not be tested. After gas service is restored test dryer for proper operation.

Dryer was a relatively new GE unit.

Contact a qualified professional.

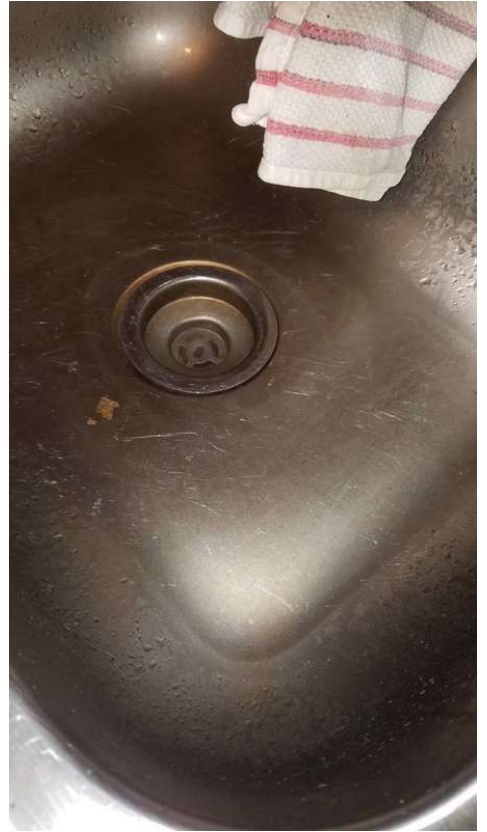
UNIT B - KITCHEN SINK

SINK DRAINED SLOWLY

One or more sinks drained slowly. Recommend clearing drain and/or having a qualified plumber repair if necessary.

Contact a qualified plumbing contractor.

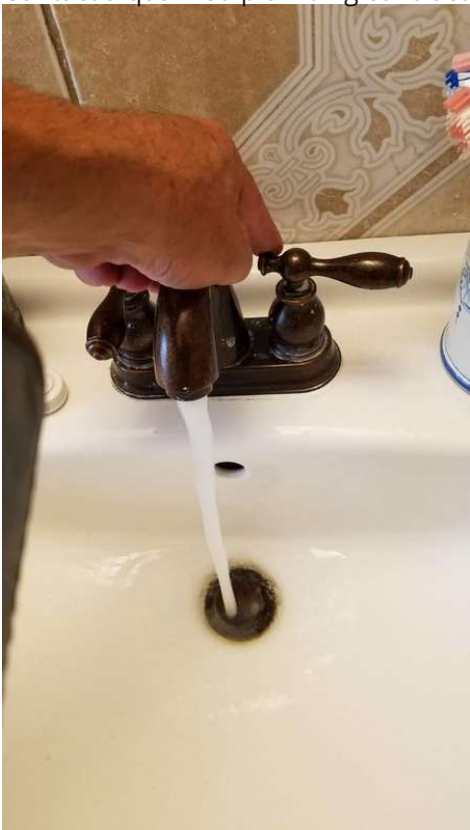
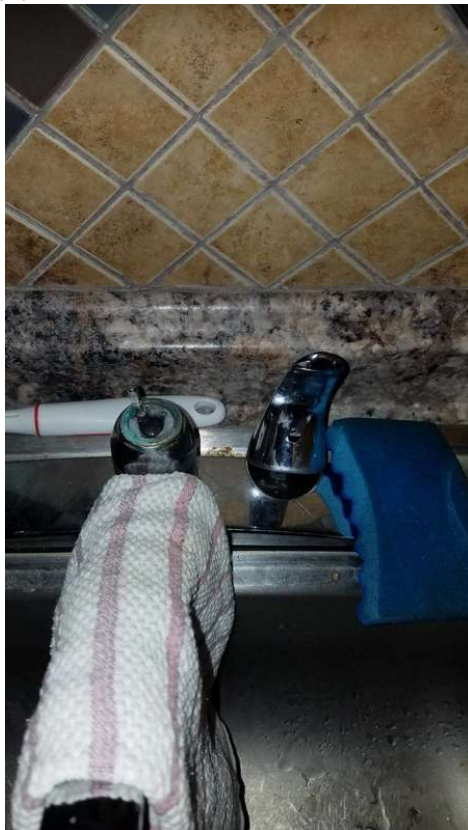
UNIT B - KITCHEN & BATHROOM VANITY SINK FAUCET

FAUCET DAMAGED

One or more faucets were loose and/or damaged. Recommend repair or replacement.

Contact a qualified plumbing contractor.

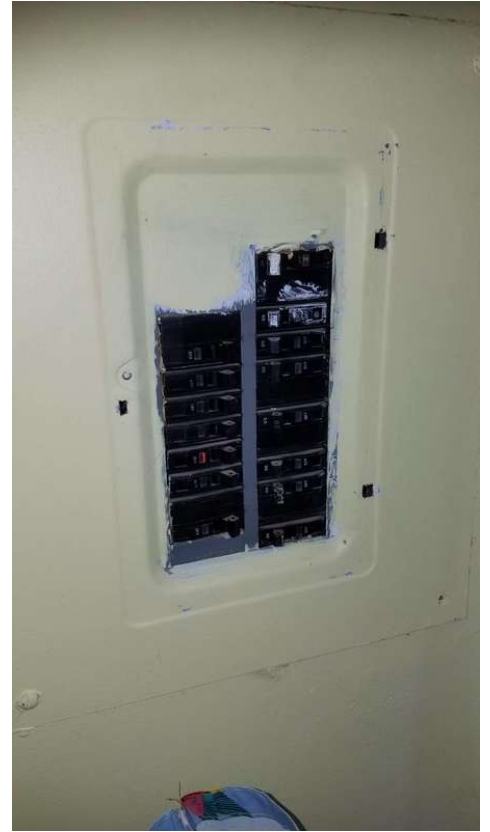
BOTH UNITS

PANEL/COVER DAMAGED

Panel Cover missing or damaged at one or more locations.

Recommend repair

Contact a qualified electrical contractor.

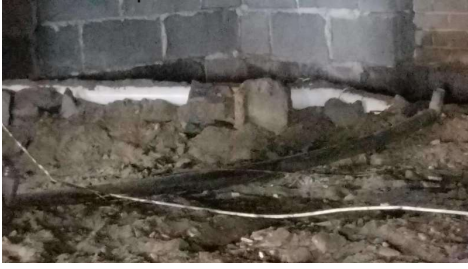
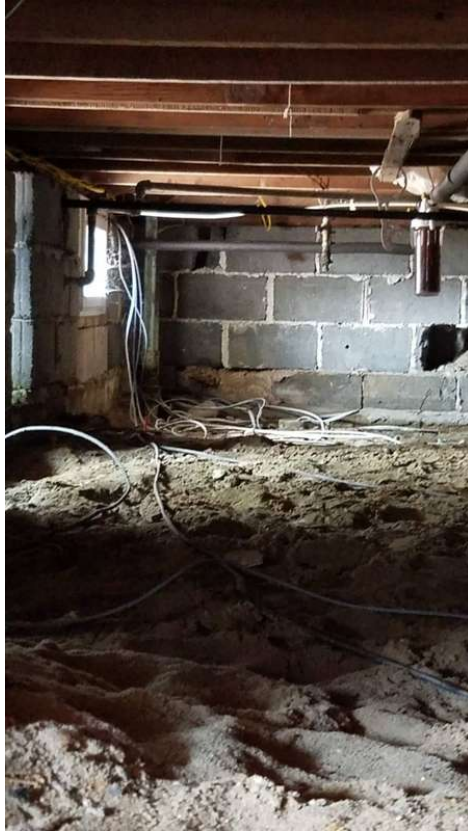
UNIT A CRAWL SPACE

CRAWLSPACE NOT SECURED

Crawlspace wiring was not secured to joists and was laying on the ground. This is a safety hazard. Recommend a qualified electrician properly secure all loose wiring to floor joists per standard building practices.

Recommendation
Contact a qualified electrical contractor.

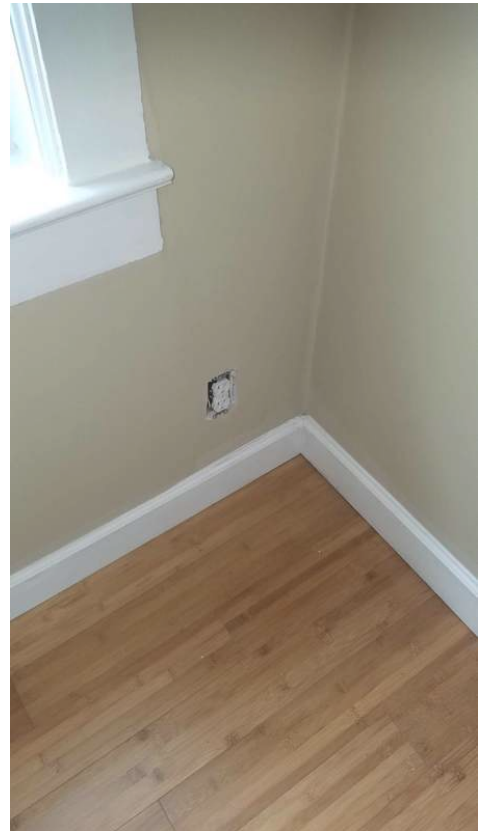
UNIT A - FRONT BEDROOM

COVER PLATE

One or more cover plates for switches, receptacles (outlets) or junction boxes were missing or broken. These plates are intended to contain fire and prevent electric shock from occurring due to exposed wires. Recommend that a qualified person install cover plates where necessary.

Recommendation
Recommended DIY Project

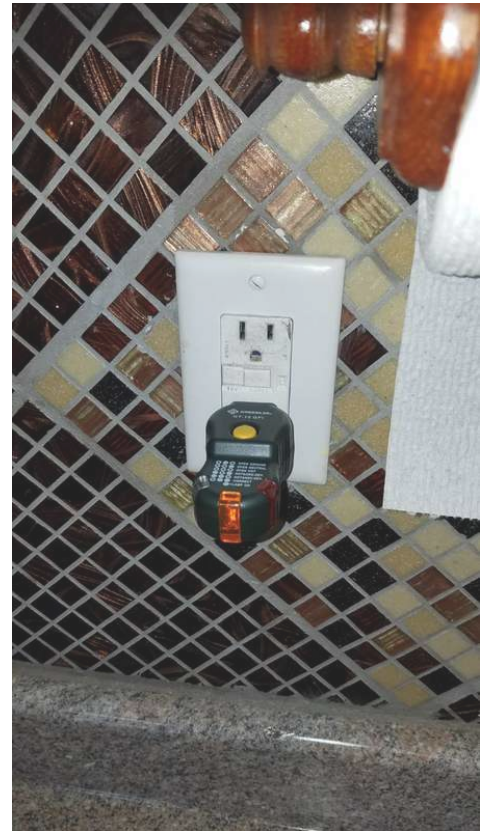
UNIT A - KITCHEN

GFCI ISSUES

One or more ground fault circuit interrupter (GFCI) receptacles (outlets) were not functioning properly (would not trip/would not reset). Recommend replacing with new gfc outlet.

Contact a qualified electrical contractor.

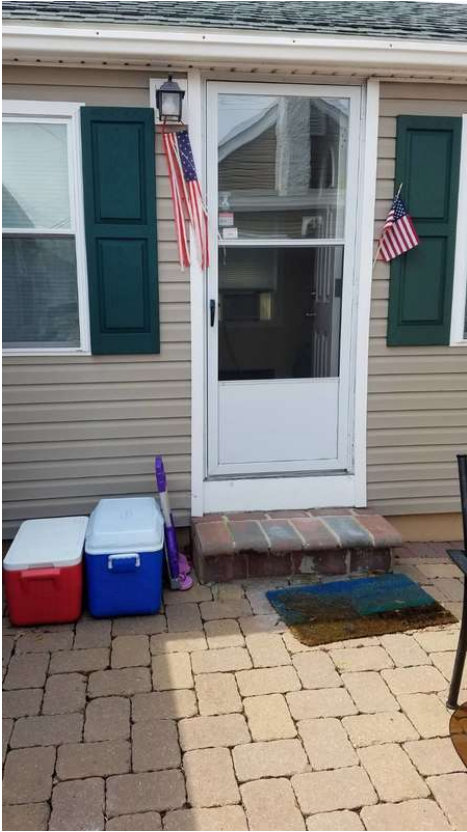
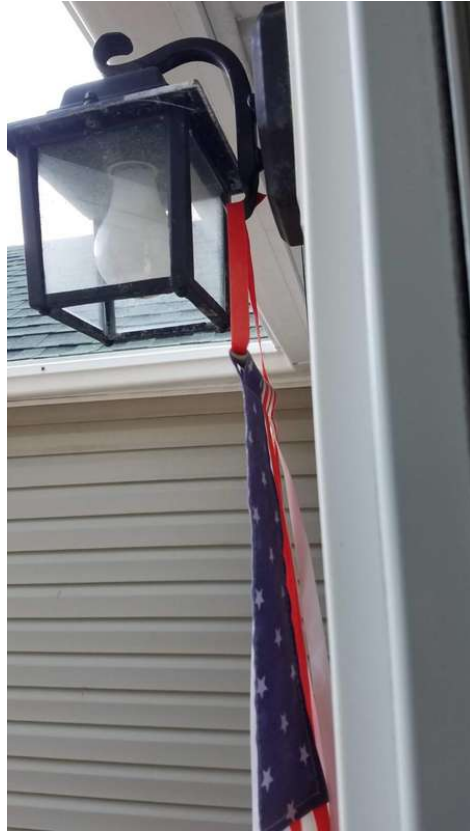
Unit A attic - Unit B entry

BULBS MISSING/BROKEN

Bulbs in one or more light fixtures were missing or not functioning. These light fixtures couldn't be fully evaluated. If replacement bulbs are inoperable, then recommend that a qualified electrician evaluate and repair or replace light fixtures as necessary.

Contact a qualified electrical contractor.

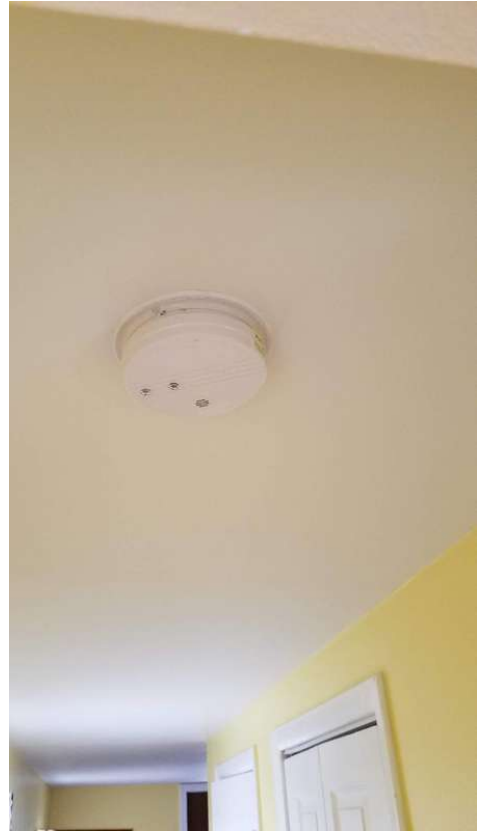
SEVERAL

LOW BATTERY

Smoke detector failed to respond when tested. Recommend battery be replaced or units to be relaced. Since this was installed prior to current codes smoke detectors were not interconnected or hard wired. Only battery operated units were installed.

Recommended DIY Project
