SUMMARY
1234 Main St. Wellington 6022
Buyer Name
10/27/2018 9:00AM

Adam Collins
LBP; NZQA in Carpentry
(advanced), Roofing level 4, Asbestos
Identification
inquest.co.nz
+64 210372132
inquest.kiwi@gmail.com

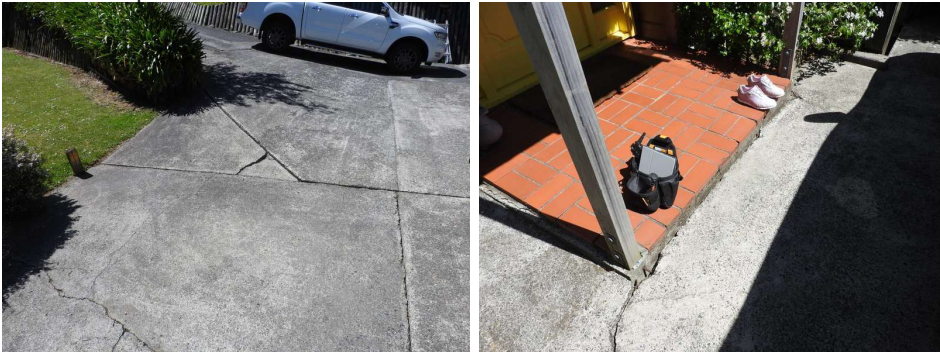
5.3.1 Driveway

DRIVEWAY CRACKING - MINOR

Minor cosmetic cracks observed which may indicate movement in the soil. Recommend monitor and/or have concrete contractor patch/seal.

Recommendation
Contact a qualified concrete contractor.

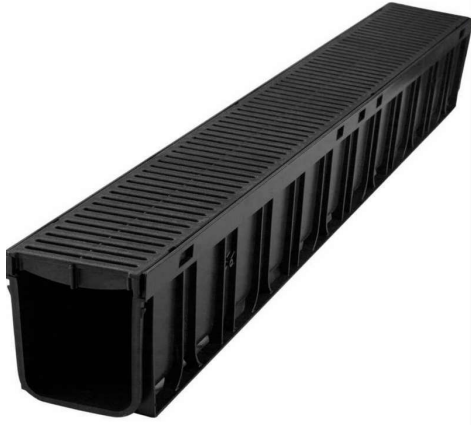
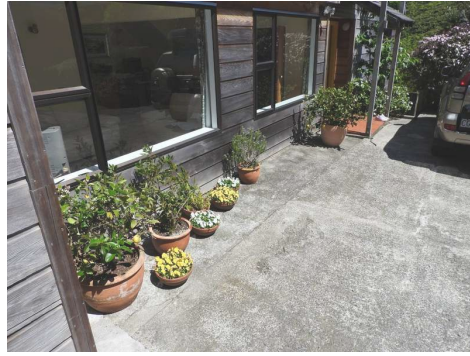
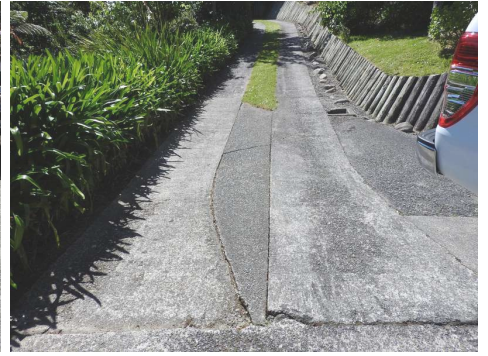
5.3.2 Driveway

DRIVEWAY DRAINING TOWARDS HOME

The driveway has a negative slope and drains towards the structure. Recommend a driveway contractor to install a threshold drain.

Recommendation
Contact a qualified handyman.
Estimated Cost
\$850 - \$1,450

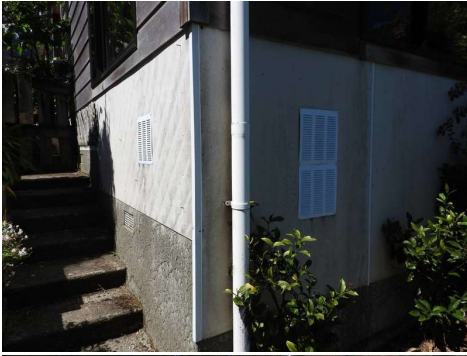
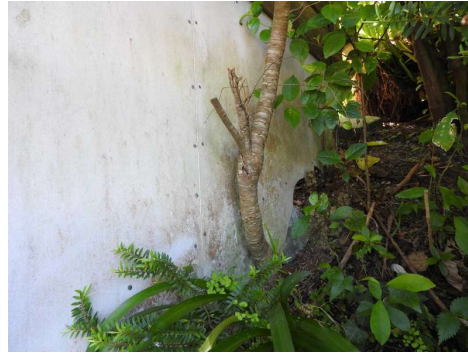
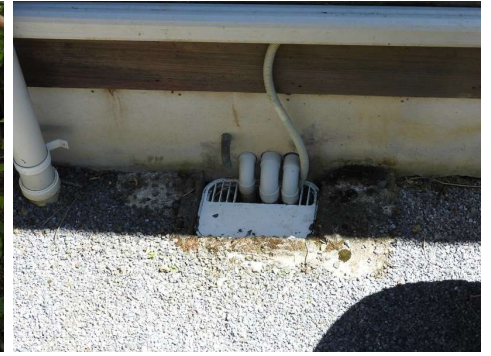
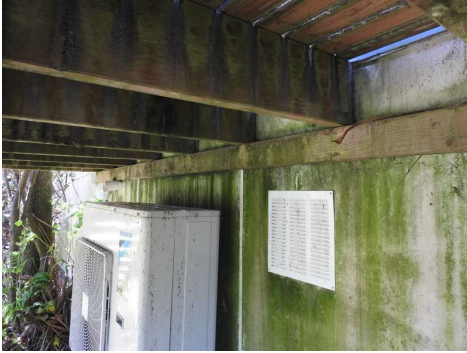
6.2.1 Fibre cement sheet product

ASBESTOS PRODUCT SUSPECTED (ACM)

ASBESTOS PRODUCT SUSPECTED. (ACM) These fibre cement sheet products are quite likely to be ACM. There is some damage and cracking in isolated areas, not considered to be living areas, however, wind can carry these fibres. We recommend encapsulate/sealing these products with flexible paint on a product.

Primarily for a lab to verify the presence of Asbestos used in any building material, an invasive test sample is required. This will involve removing a small portion of the product (an invasive inspection).

Contact a qualified professional.

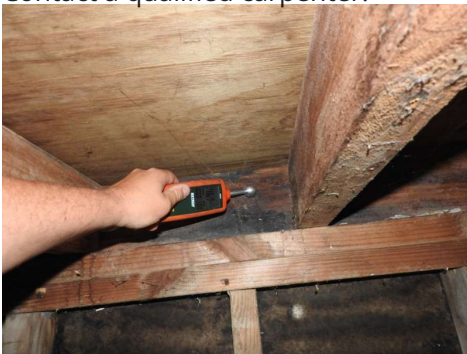
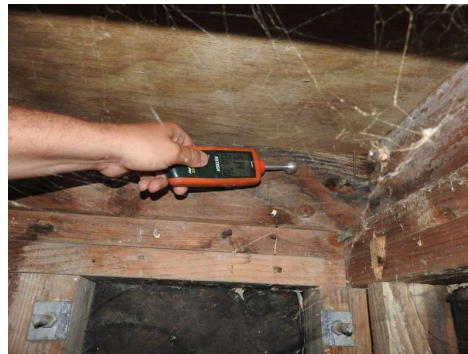
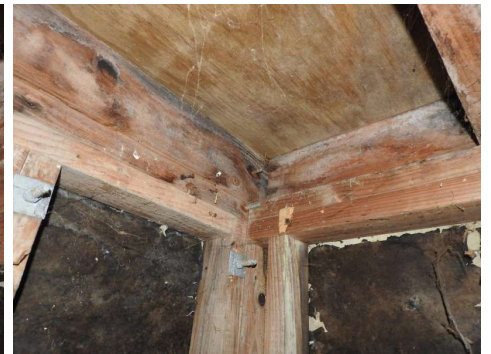
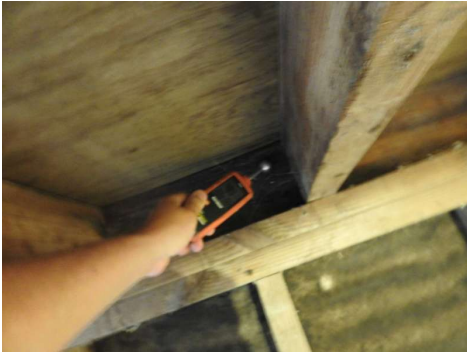
8.3.1 Jack frame

ROTTING

There are some elevated moisture readings in the area under the waterproofed deck substrate, located at the back door. This is a fairly well-protected area and may cause future problems if left unchecked - check under here during the next storm for a good indication on whether or not the waterproofing membrane is performing as it should. The owner mentioned that this has been installed fairly recently, recommend checking if there is a still warranty from the builder.

Rot is conditional to the environment surrounding the timber, there are many types of rot with many different causes. Change the environment and you will fix the issue, replace the timber like for like but use H4 treated timber this time.

Contact a qualified carpenter.

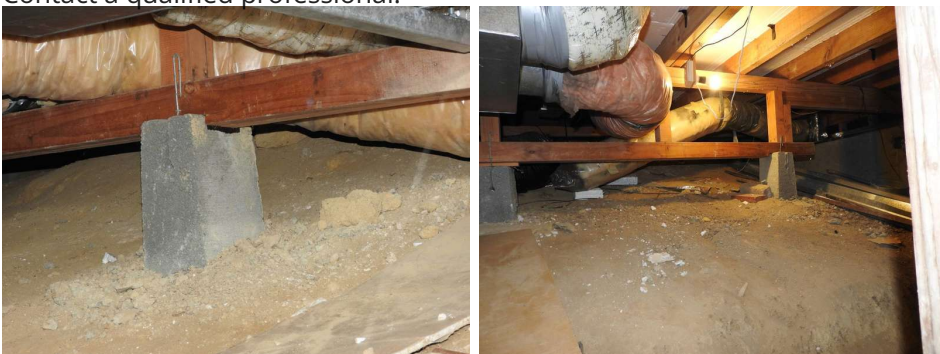
9.1.1 Subfloor Space

CLEARANCES - FLOOR LEVEL

Ground levels are too close to floor.

NZ building code standards 3604 states the minimum floor height in relation to ground level. The standards were different at the time of this build.

Suspended timber floor construction underside of joists (i.e. crawlspace) 450mm.

This is very important to maintain these minimum clearances, neglecting this will result in rotting of structural framing members.

The addition of ground vapor barrier and adequate ventilation is about the only solution for this age-old problem as mentioned elsewhere in this report.

Contact a qualified professional.

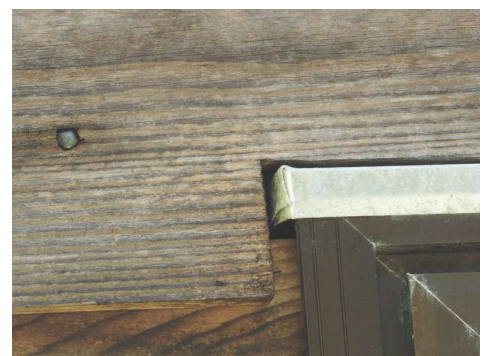
10.1.1 Weatherboard - Timber

FLASHING

Some of the cutouts around the window head flashings have not been done properly and may be leaking during times of stormy weather.

The raking windows should have kick out flashings, this in a modern building requirement because these have been known to leak.

Contact a qualified carpenter.

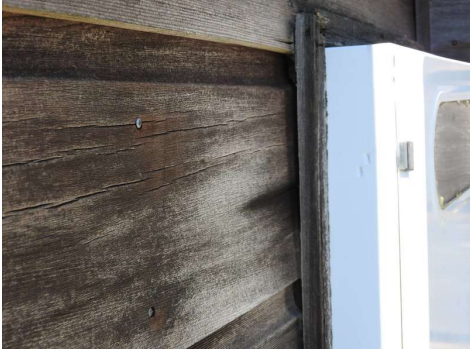
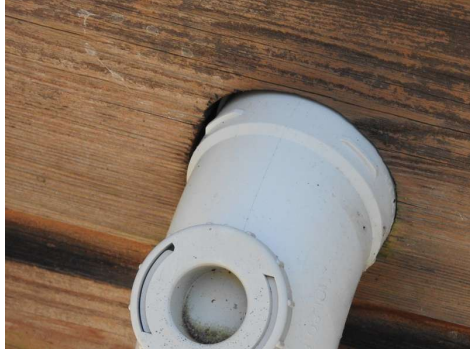
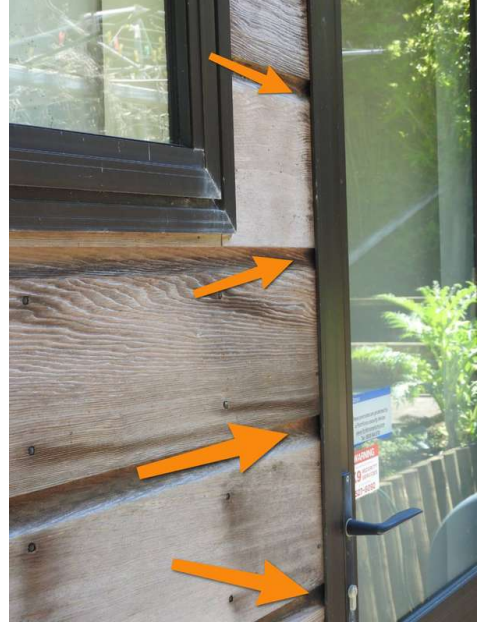
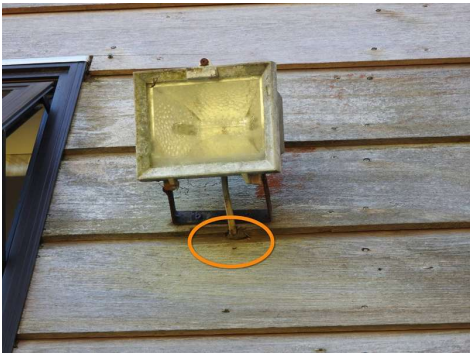
10.1.2 Weatherboard - Timber

WALL PENETRATIONS

Some attention required around the pipe penetrations.

The electrical meter box should have a head flashing and side scribes

The windows on the back wall (master bedroom an ensuite) have no scribe plugs, this is poor workmanship and may be leaking during times of stormy weather

The floodlight by the kitchen has an exposed cable that is a high risk of rainwater ingress. these should be monitored.

Contact a qualified handyman.

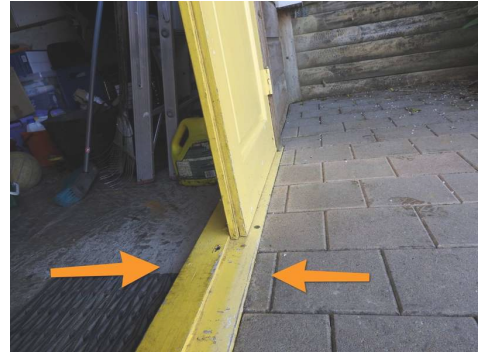
14.2.1 Back porch

THRESHOLD - TO PERMANENT PATH

Water may splash onto absorbent cladding or track inside.

NZS 3604, gives a minimum threshold height of 150 mm at an opening onto a permanent path.

Contact a qualified concrete contractor.

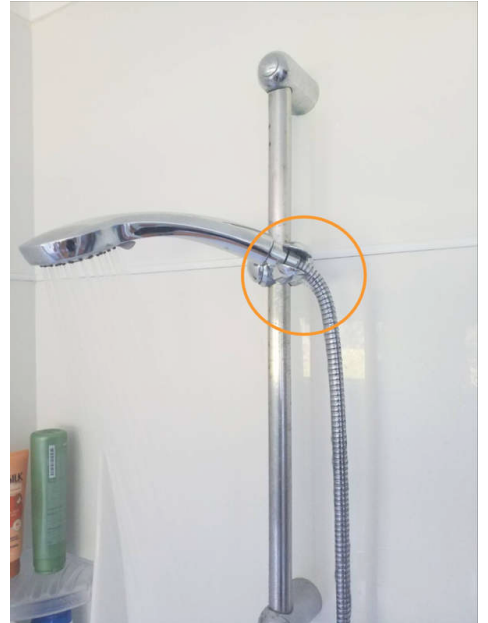
19.11.1 Shower

FAULTY TAPWARE

There are some issues with the fittings in this location.

Contact a qualified plumbing contractor.

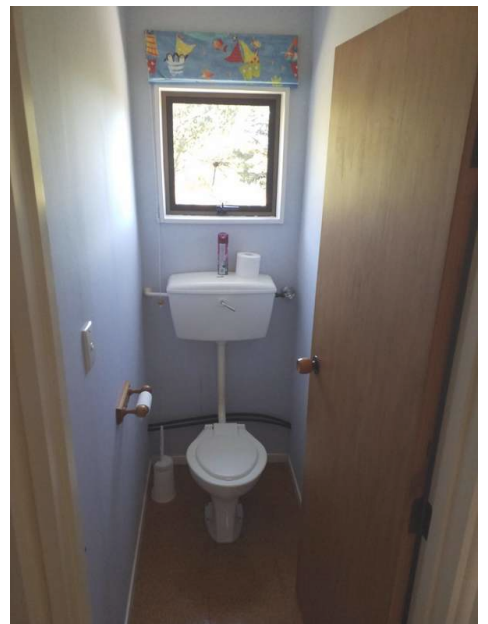
20.1.1 General

DUX QUEST PIPES

Dux Quest pipes and connections identified - owner has advised verbally he plans to have it removed.

Dux Quest was withdrawn from the market about 30 years ago. It pre-dates the current Building Code and the Building Act.

This product has been causing serious problems for home owners throughout NZ.

Often insurance companies wont cover damage done by Dux Quest piping, especially if it has leaked before.

Contact a qualified professional.
