1234 Main St. Dandridge TN 37725

Buyer Name
02/13/2019 9:00AMSteven Motruk
License #1791, EIT
Eagle Engineering LLC
865-250-8983

smotruk.eagleengineering@gmail.com

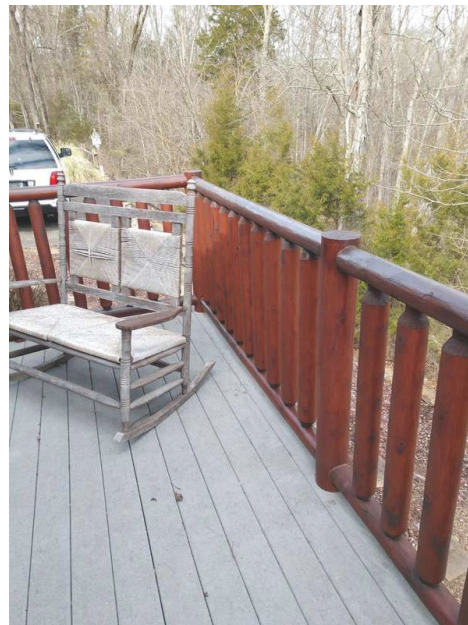
LEFT SIDE SECOND POST FROM FRONT

RAILING UNSAFE

The post and rail are loose.

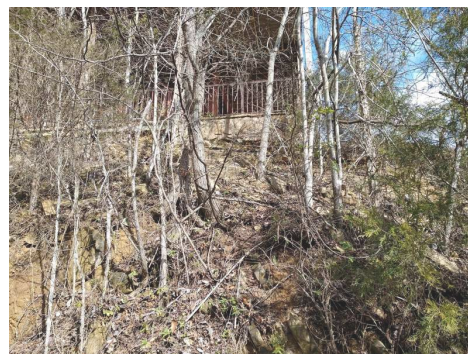
BACK PORCHThe rock is falling out from beneath the porch on the right rear side.
Recommend placing a type of retaining system to hold stone in.Recommendation
Recommended DIY Project

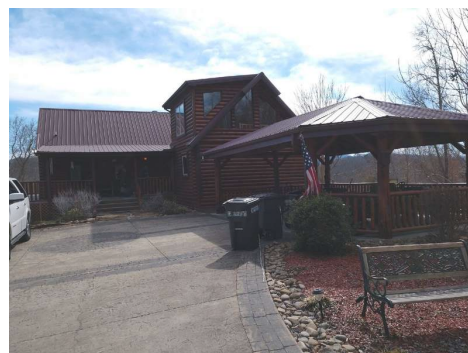
FRONT PORCH

GUTTER IMPROPERLY SLOPED

Gutter are improperly sloped in areas, which could result in runoff drainage around the foundation and possible structural shifting.
Recommend qualified roofing or gutters contractor repair.

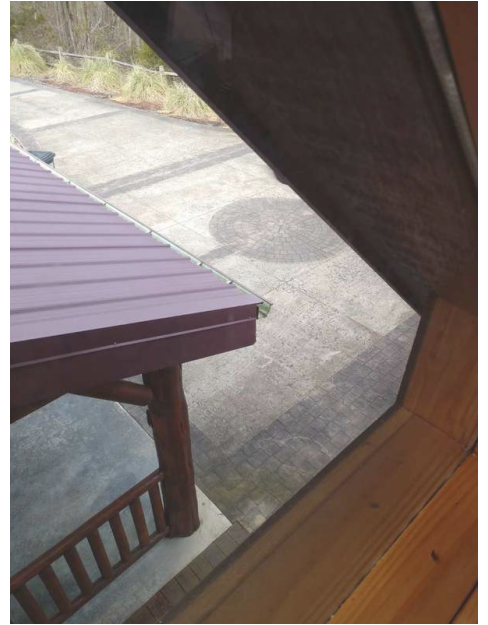
END CAP MISSING

End cap of gutter was missing allowing water to run out the back towards the house off the carport. Recommend a gutter installer replace and cap.

Recommendation
Contact a qualified professional.

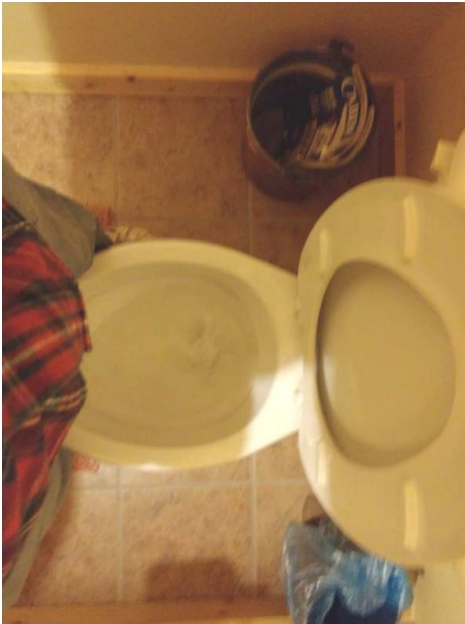
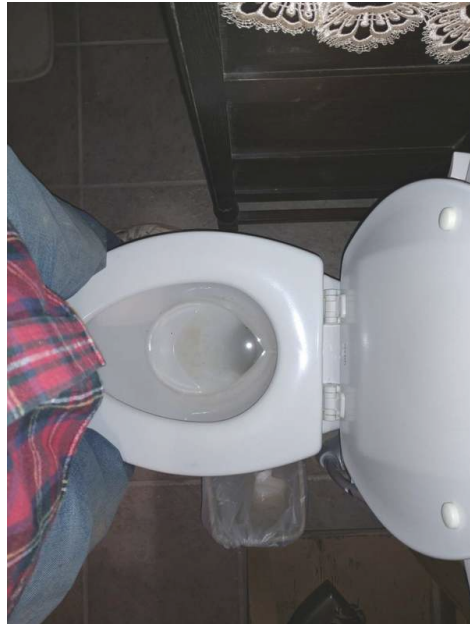
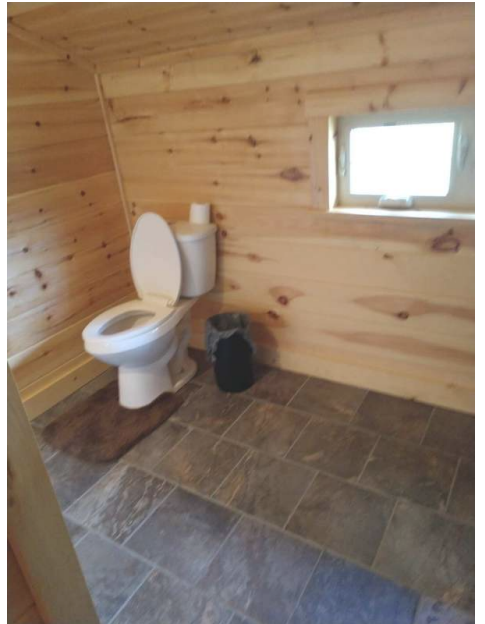
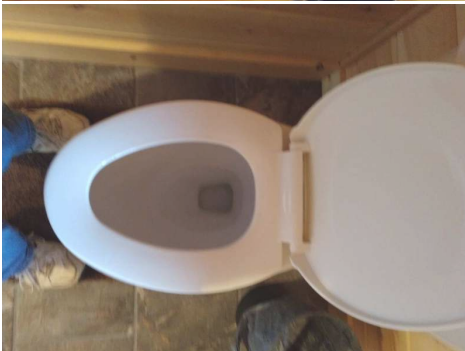
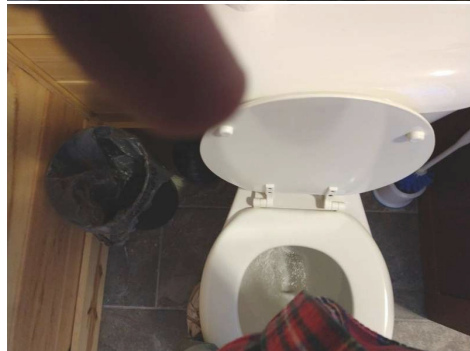
TOILETS WOBBLE

Check toilets, several if not most have a slight wobble and need to be tightened up.

Recommendation
Recommended DIY Project

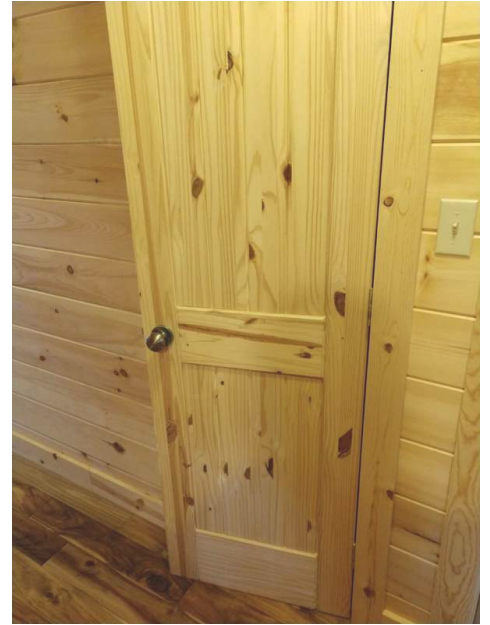
GUEST HOUSE 2ND FLOOR

DOOR SCRAPES FLOOR

Door scrapes floor. Recommend sanding or cutting to resolve the problem.

Contact a qualified carpenter.

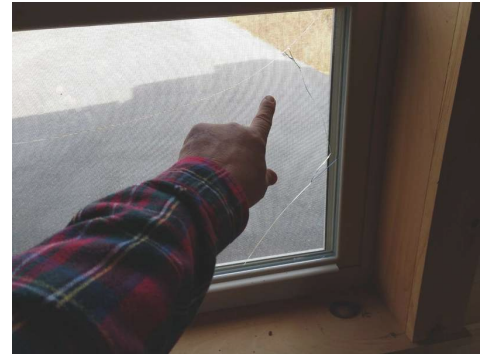
TO THE RIGHT OF ENTRY DOOR IN THE GUEST HOUSE

DAMAGED

One of the Windows has broken glass. Recommend a professional installer replace broken window
