2.1.1 Wood Shake Roof

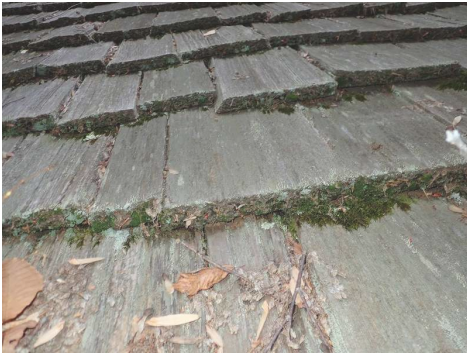
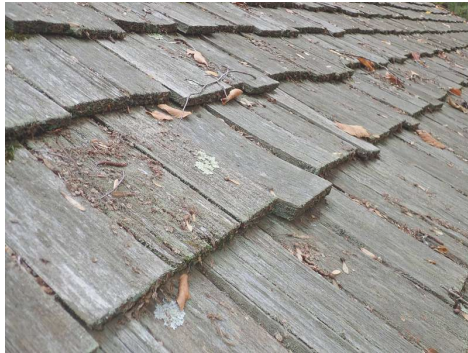
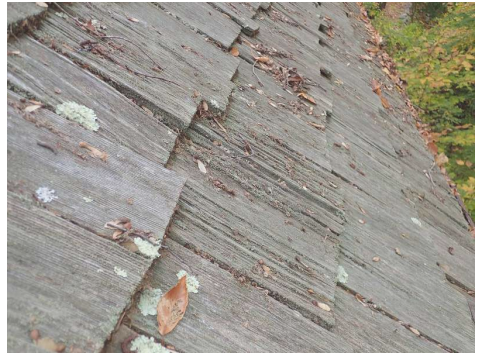
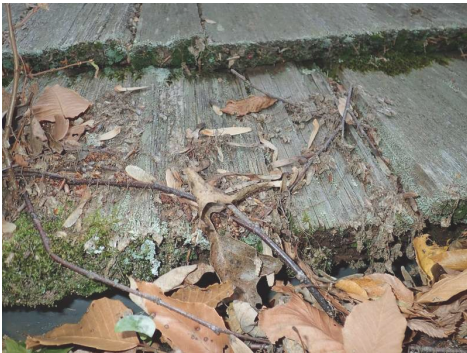
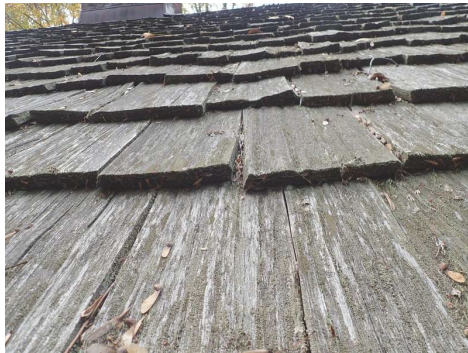
END OF LIFE

The wood shake roof covering appeared to be at the end of its long term service life and was in need of replacement. The wood shakes exhibited widespread splitting, decay and rot with interlayment exposed in several areas. A general rule of thumb is complete replacement is warranted when the percentage of cracked, damaged or missing shingles exceeds approximately 30 percent of the roof-covering material. I recommend you consult with a qualified roofing contractor to discuss options and costs for roof replacement.

Contact a qualified roofing professional.

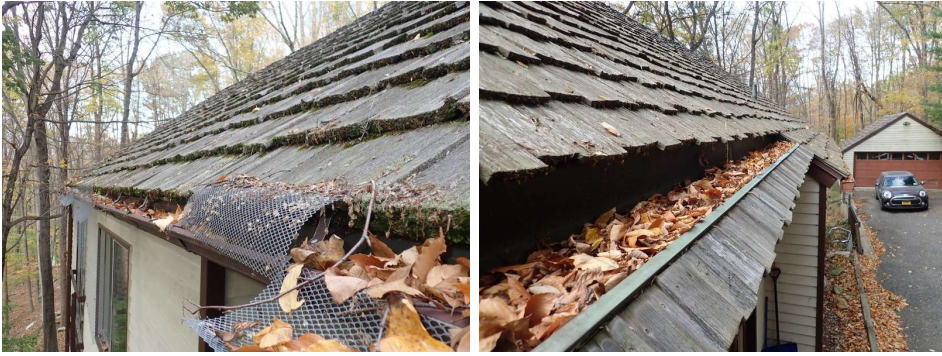
2.4.1 Roof Drainage System

GUTTERS FULL

The roof gutters and downspouts were completely filled with leaf debris and no performing their intended functions. Recommend having gutters replaced when roof is replaced, installing larger gutters to better capture the rain water at the roof thereby diverting water away from the foundation and sidewalls

Contact a qualified professional.

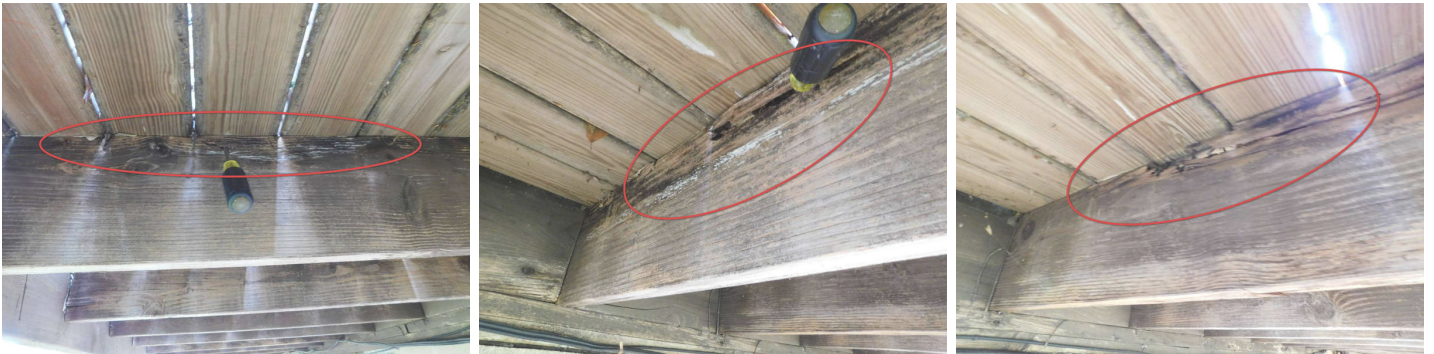
3.2.1 Deck, Porch & Patio **ROT AT DECK JOISTS**

The cantilevered wood supports for the deck at the rear of the home were showing signs of heavy wood rot. A cantilevered deck relies on the integrity of the wood supports as the deck's only means of support. When wood rot is found in the supports, the deck is no longer safe for use. Recommend having a qualified person remove and rebuild the deck as a conventional deck with an attached ledger board and support posts at the outer end of the deck.

Recommendation
Contact a qualified professional.

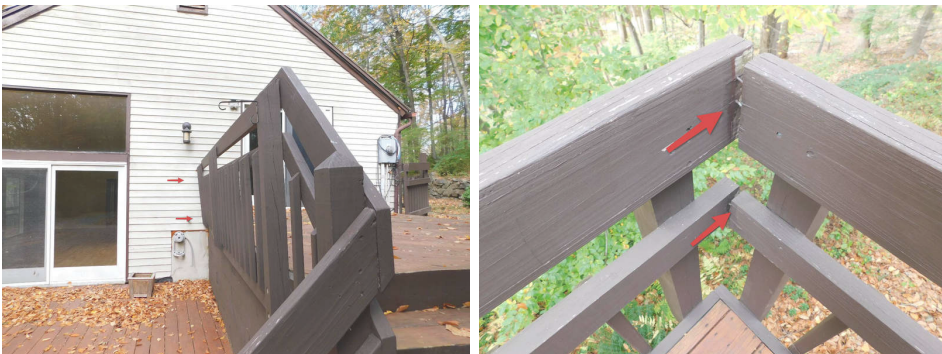
3.2.2 Deck, Porch & Patio **LOOSE RAILINGS**

The railings at the deck are not safely attached to the deck and can easily be pushed off of the deck. Recommend having the railings replaced with new railings that conform to current building and safety standards. This is a fall hazard that needs to be corrected.

Railings Separated

Recommendation
Contact a qualified professional.

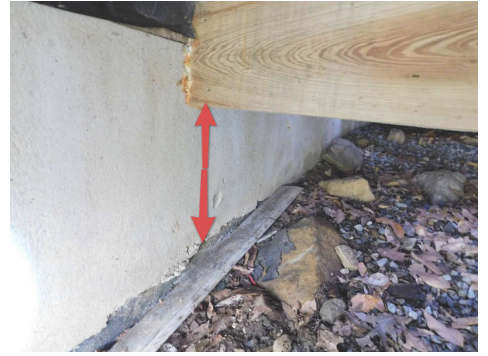
3.2.3 Deck, Porch & Patio

The deck main beams at the new section of the deck are missing support posts where they meet the house. Recommend having posts installed under the beams as needed for proper support.

Missing Post Under Support Beam on Deck

Recommendation
Contact a qualified professional.

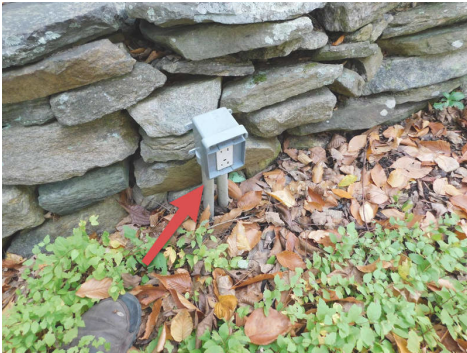
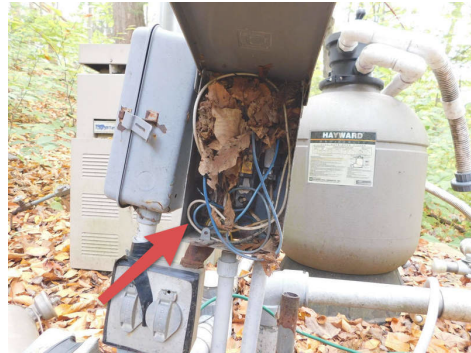
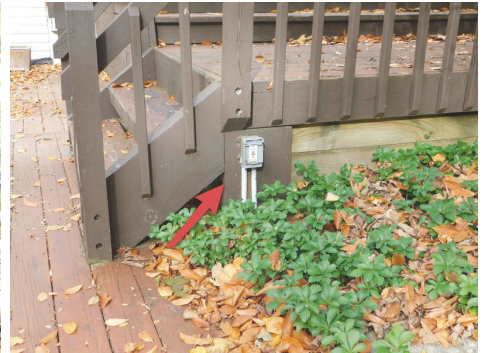
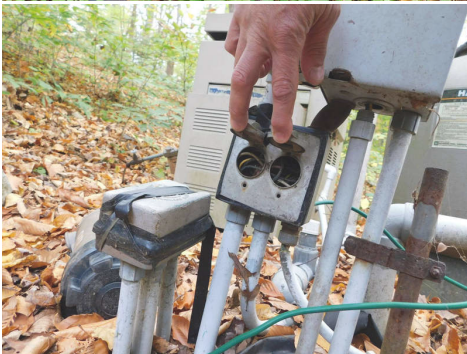
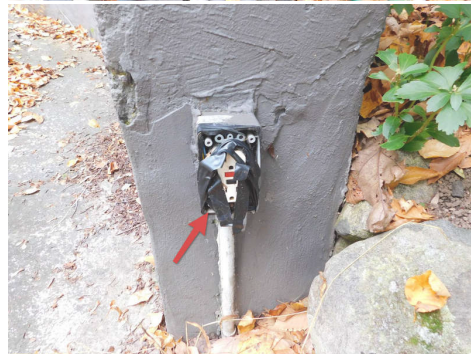
3.6.1 Exterior Electrical

There were damaged outlet boxes, open/uncovered boxes and open pull boxes around the exterior of the home.

Recommend having all repaired with new waterproof covers as needed for safety

Recommendation
Contact a qualified electrical contractor.

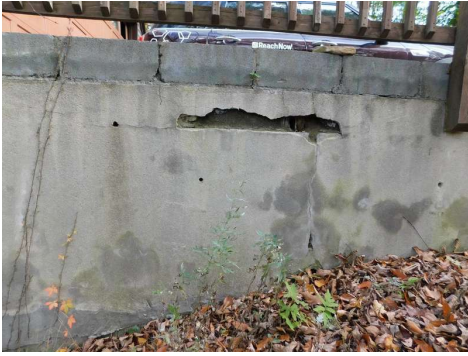
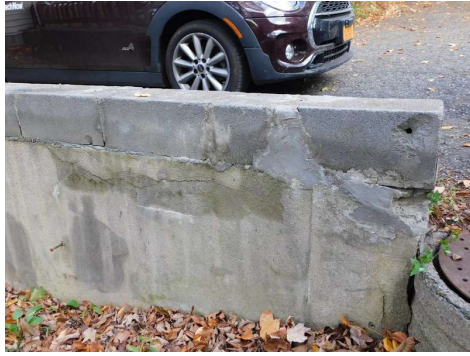
3.9.1 Retaining walls (with respect to their effect on the condition of the building)

The retaining wall at the bottom of the driveway was deteriorated and in need of repair or replacement. Recommend having further evaluated by a qualified person to identify if patching is possible or if replacement is needed.

Recommendation
Contact a qualified professional.

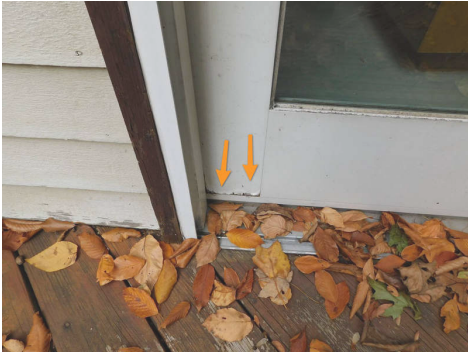
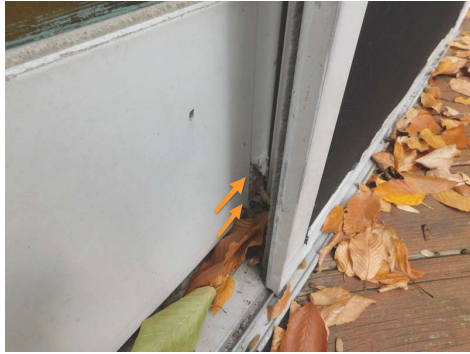
4.1.1 Door & Window Exteriors

The kitchen sliding doors were showing signs of wood rot along their bottom edges. Recommend having repaired as needed.

Recommendation
Contact a qualified carpenter.

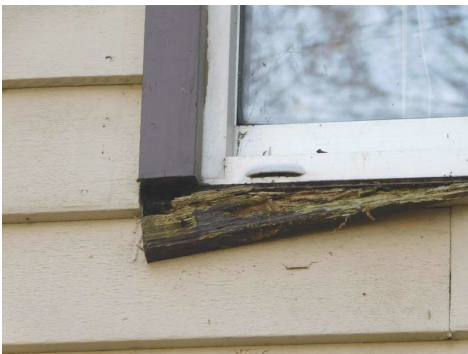
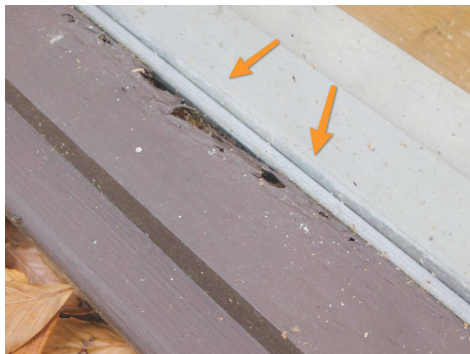
4.1.2 Door & Window Exteriors

Rot was found on a window along the right side of the home and along the deck doors. Repair as needed

Recommendation
Contact a qualified professional.

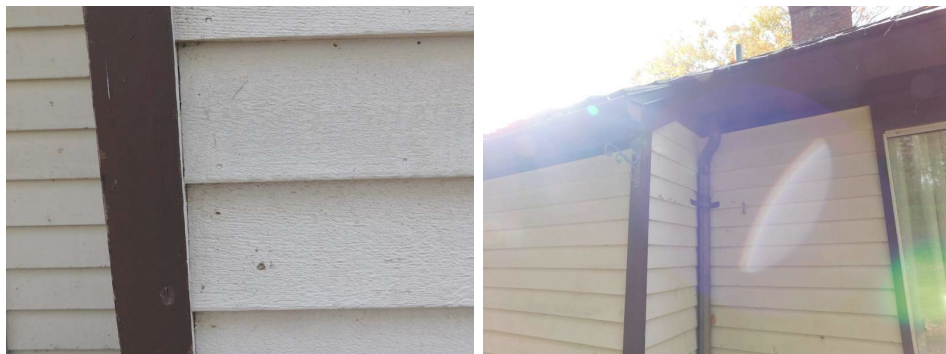
4.5.1 Exterior Trim

The paint or stain finish in some areas was failing (e.g. peeling, faded, worn, thinning) Exterior Trim with a failing finish can be damaged by moisture. Recommend that a qualified contractor prep (e.g. clean, scrape, sand, prime, caulk) and repaint or restain the building exterior where necessary and per standard building practices. Any repairs needed to the trim should be made prior to this.

Contact a qualified painter.

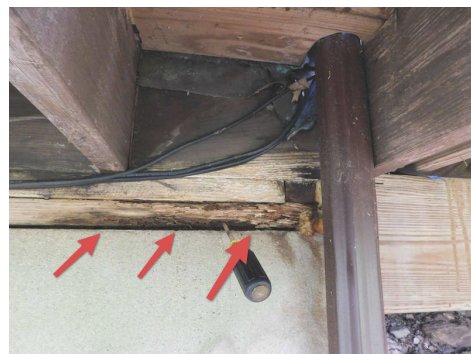
6.3.1 Floor Structure

Sill plates along the rear of the building have some rot at different location. Recommend having the damaged wood framing members replaced as needed

Contact a qualified professional.

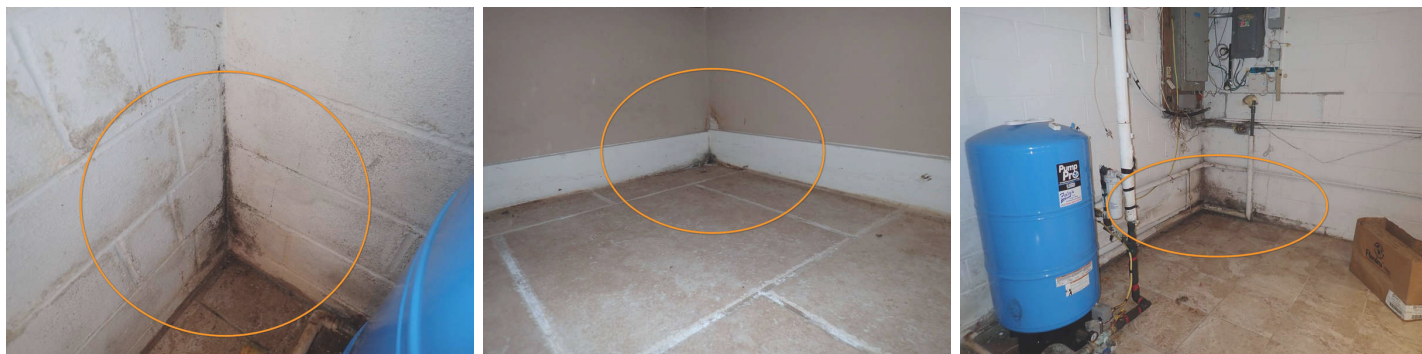
6.7.1 Report Any Signs of Water Intrusion or Unusually Damp Areas

There were signs of moisture along the foundation walls at the front of the building. Recommend having a qualified person repair the problem as needed.

Contact a qualified professional.

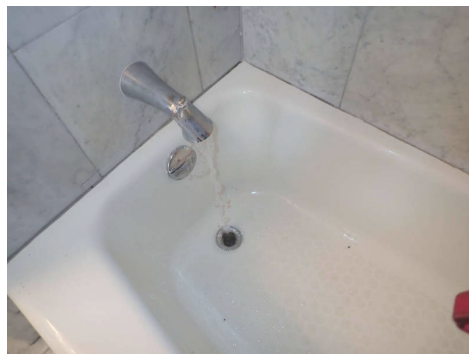
7.1.1 Main Water Supply

The water pressure in the home was not good. Water only ran from a faucet for a few seconds before the pressure disappeared. I recommend having a qualified well company further evaluate to determine the cause of low/ no pressure and the costs to fix or repair.

Very Low Flow at Fixtures

Recommendation
Contact a qualified well service contractor.

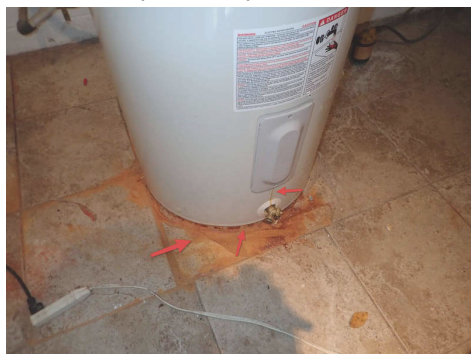
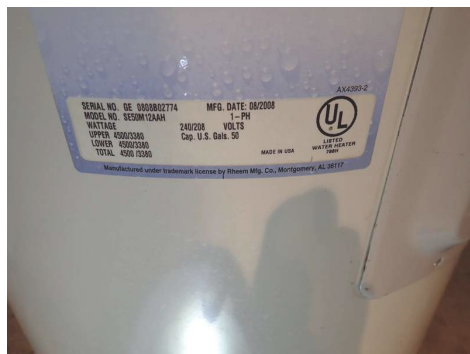
7.5.1 Electric Water Heater

The water to the water heater was turned off as was the power to the water heater. The water heater showed signs of leaking (rust stains on floor around water heater) and will need to be replaced. The installed heater is no longer any good.

Recommendation
Contact a qualified professional.

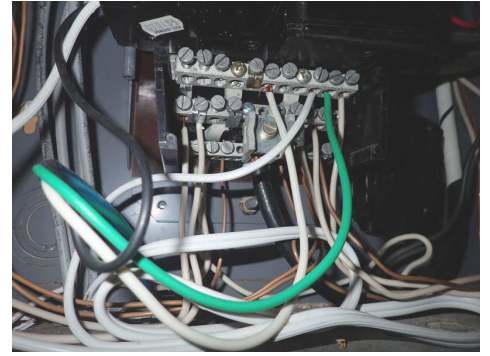
8.2.1 Main & Distribution Panels

Neutral and equipment ground wires were bonded (connected) at the electrical sub-panel. This should only occur in the main service panel, not sub-panels, and is a shock hazard. Neutral wires should be attached to "floating" neutral bar and not bonded to the panel, and grounding wires should be attached to a separate grounding bar bonded to the sub-panel. Recommend having a licensed electrician repair as per standard building practices.

Recommendation
Contact a qualified electrical contractor.

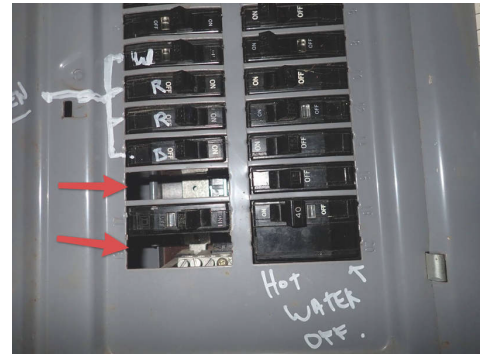
8.2.2 Main & Distribution Panels

One or more slots where circuit breakers are normally installed were open in the front of the electrical panel. Energized equipment was exposed and is a shock hazard. Recommend that a licensed electrician install closure covers where missing.

Recommendation
Contact a qualified electrical contractor.

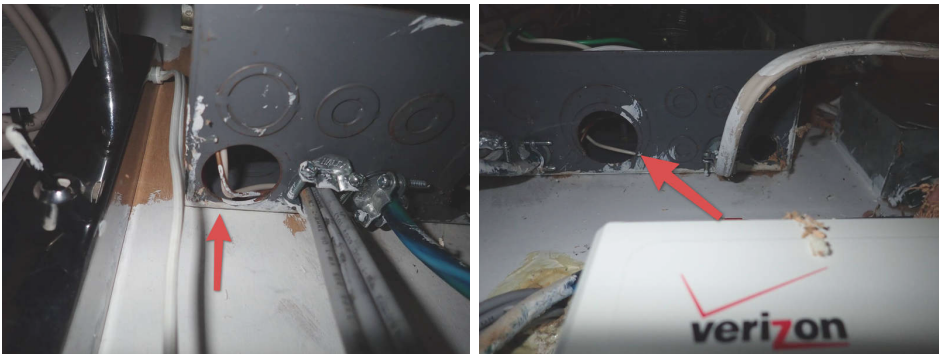
8.2.3 Main & Distribution Panels

One or more knockouts were missing from the electrical panel. Holes in the panel enclosures are a potential fire hazard if a malfunction ever occurs inside the panel. Recommend that a licensed electrician install knockout covers where missing as per standard building practices.

Recommendation
Contact a qualified electrical contractor.

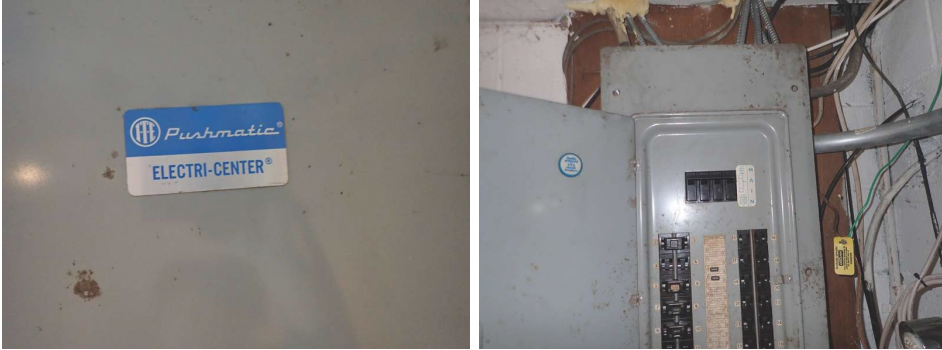
8.2.4 Main & Distribution Panels

Suggested Improvement - The main electrical panel was a "Pushmatic" brand panel. These panels are found in older electrical systems. Their circuit breakers are known to become very stiff and difficult to operate or reset over time. Breakers may remain on after attempts to trip or turn them off have been made. They also have an indicator flag that falsely indicated the on/off tripped state. The breakers rely on thermal tripping only, whereas modern breakers have both thermal and magnetic trip mechanism. These conditions pose shock and fire hazards. Recommend that a qualified electrician replace pushmatic brand panels with more modern panels that offer more flexibility for new, safer protective technologies like GFCIs (ground fault circuit interrupts) and AFCIs (arc fault circuit interrupts).

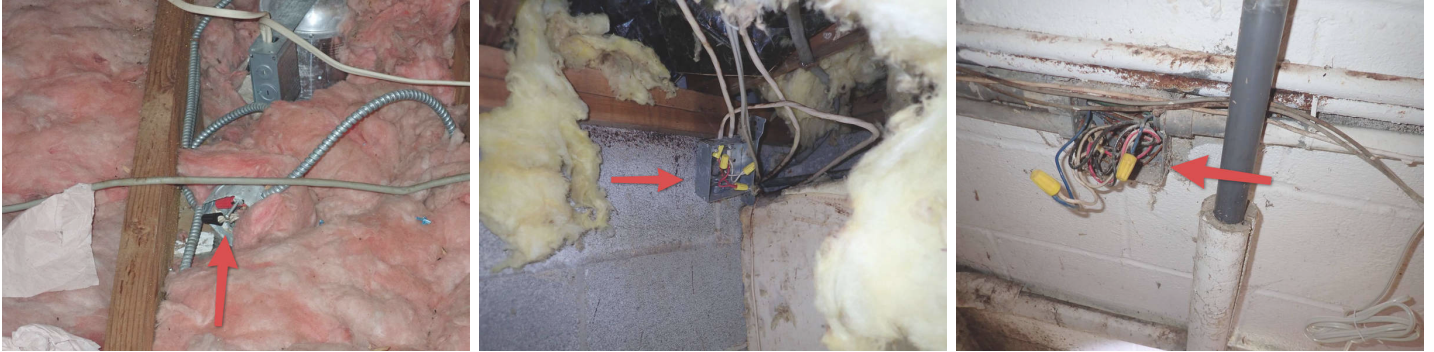
8.4.1 Connected Devices, Fixtures & Outlets

One or more cover plates for switches, receptacles (outlets) or junction boxes were missing or broken. These plates are intended to contain fire and prevent electric shock from occurring due to exposed wires. Recommend that a qualified person install cover plates where necessary.

Contact a qualified electrical contractor.

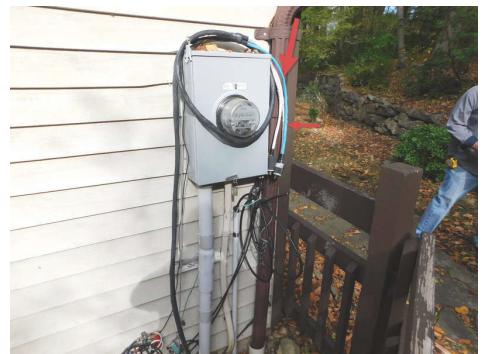
8.4.2 Connected Devices, Fixtures & Outlets

The generator wiring was done improperly and is unsafe to use. This was not done by an electrician and was not inspected by the electrical inspector. Recommend immediate removal by a qualified person.

Contact a qualified electrical contractor.

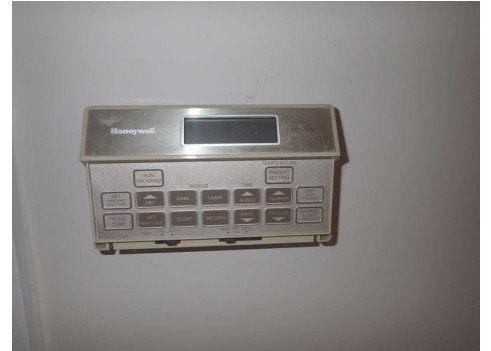
9.5.1 Thermostat

The basement thermostat was not operating. Recommend having replaced as needed. The basement level heat was not tested as a result.

Contact a qualified professional.

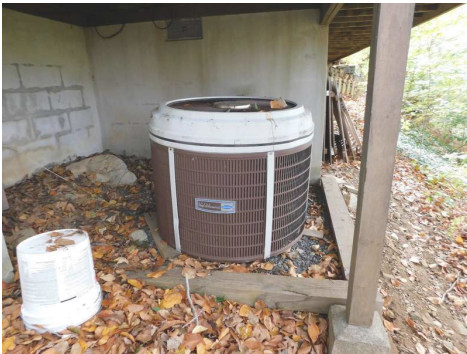
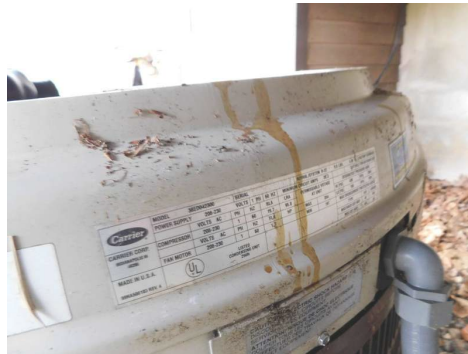
10.1.1 Central Air Conditioner

The estimated useful life for most air conditioning equipment is 15-20 years. This equipment appeared to be near, at, or beyond this age and/or its useful lifespan and may need replacing or significant repairs at any time. Recommend budgeting for a replacement in the near future.

Contact a qualified heating and cooling contractor

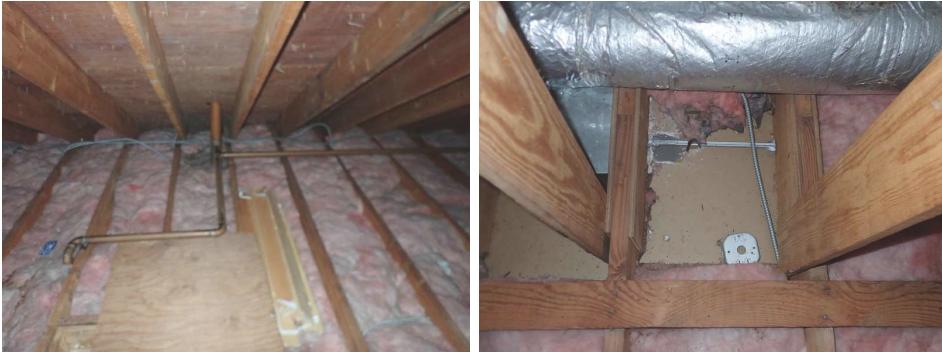
11.1.1 Insulation in Attic

Suggested Improvement - Ceiling insulation installed in the attic was less than the amount recommended by today's building standards. Recommend that a qualified contractor install insulation for better energy efficiency and per current standard building practices (typically 12" with an R rating of R-38).

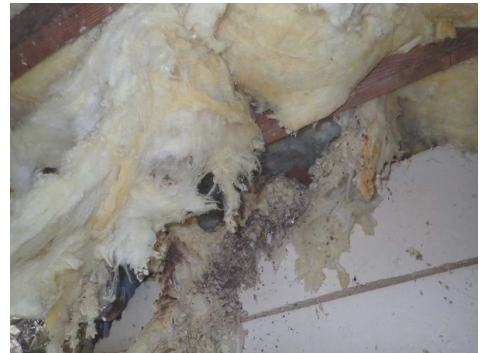
11.2.1 Insulation Under Floor System

The insulation in the crawlspace was fouled by heavy rodent activity. I recommend having the insulation removed and replaced by a qualified person.

Recommendation
Contact a qualified professional.

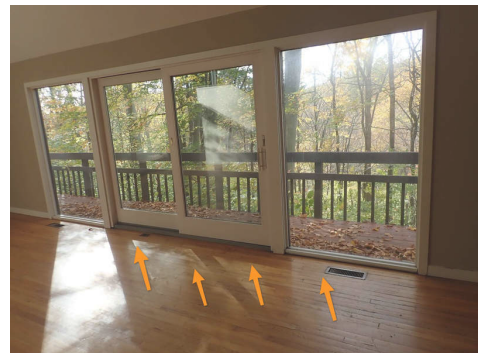
12.1.1 Ceilings, Walls & Floors

The floor along the rear wall of the building in the living room was spongy and slightly sunken. The framing under the floor may be damaged by wood rot and termite activity that could not be seen from below due to insulation and ductwork. Recommend further evaluation when insulation is removed from crawlspace.

Recommendation
Contact a qualified professional.

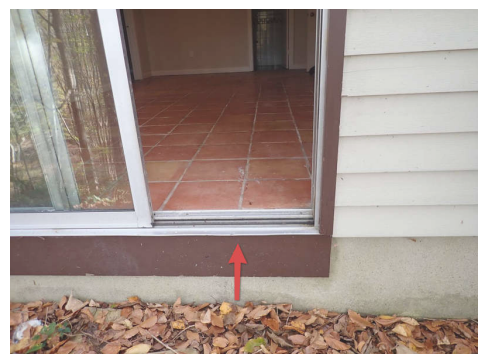
12.2.1 Doors (representative number)

The basement sliding door was dangerous. The step to the exterior was far in excess of a typical seven inch step. Anyone unfamiliar with the door could fall and become injured. Recommend correcting as needed by adding steps or sealing up the door.

Recommendation
Contact a qualified professional.

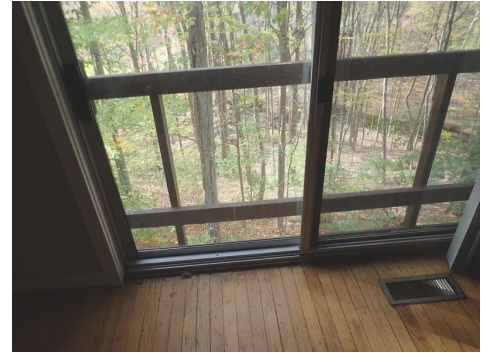
12.2.2 Doors (representative number)

The 2nd floor doors in the master bedroom do not have adequate fall protection and what is installed has been damaged by wood rot. Recommend installing railing as per current building standards for safety

Recommendation
Contact a qualified carpenter.

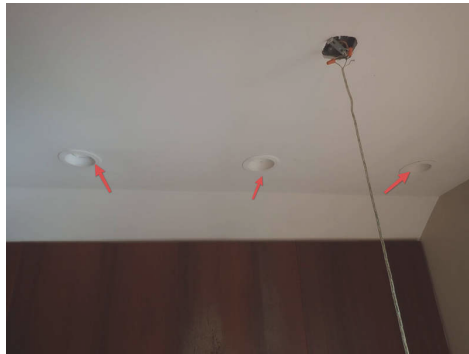
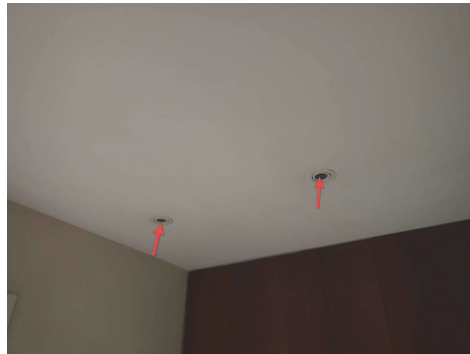
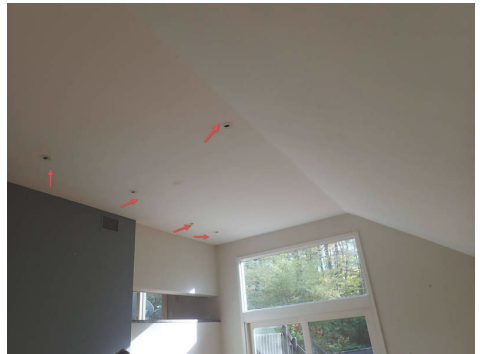
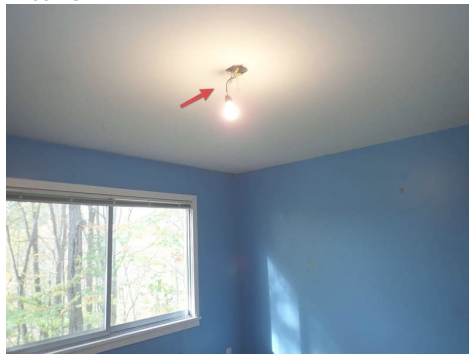
12.4.1 Lighting & Outlets

The lighting in the kitchen and the lighting in the living room did not work. Recommend having repaired as needed by a qualified person.

Recommendation
Contact a qualified electrical contractor.

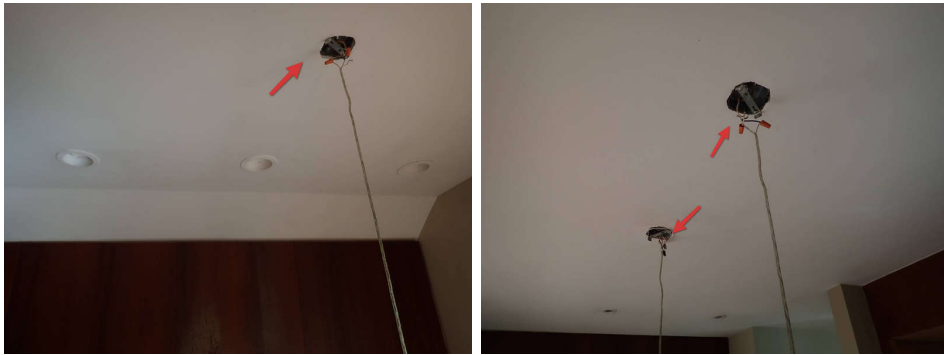
12.4.2 Lighting & Outlets

Light fixtures throughout the house were missing, improperly/unsafely hung. Recommend having repaired as needed for safety

Recommendation
Contact a qualified professional.

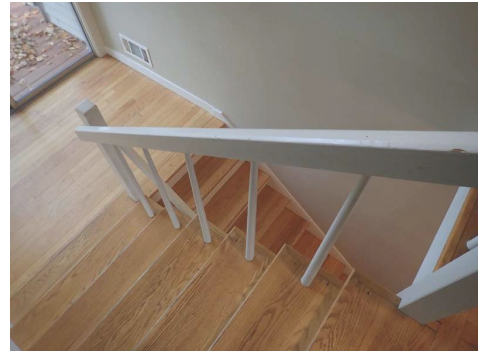
12.5.1 Stairs, Balconys & Railings

A handrail assembly at this staircase had spaces between balusters that allowed the passage of a 4 3/8-inch sphere. To improve child safety, the Inspector recommends altering the handrail assembly in a manner which will prevent the passage of a 4 3/8-inch sphere. All work should be performed by a qualified contractor.

Recommendation
Contact a qualified professional.

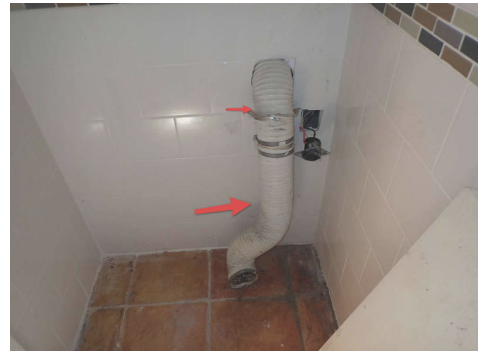
13.15.1 Dryer Venting

The dryer was vented using a flexible, ribbed plastic vent that is not approved by the Underwriter's Laboratory (UL). This type of dryer exhaust vent is more likely to accumulate lint than a smooth metal vent, creating a potential fire hazard. Excessive lint accumulation can also increase drying time and shorten the dryer's lifespan. Recommend replacing this plastic vent with a properly-installed, UL-approved dryer vent. All work should be performed by a qualified contractor.

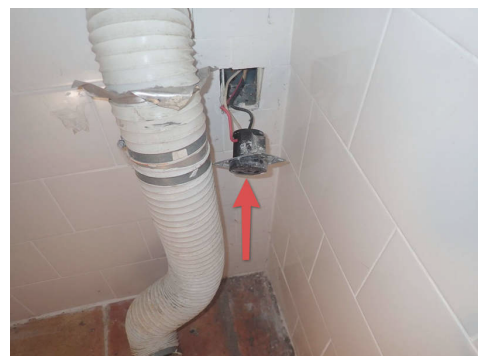
13.16.1 Washer and Dryer

The 240-volt dryer electrical receptacle in the laundry area was loose. The Inspector recommends that it be securely re-attached by a qualified electrical contractor.

Recommendation
Contact a qualified professional.

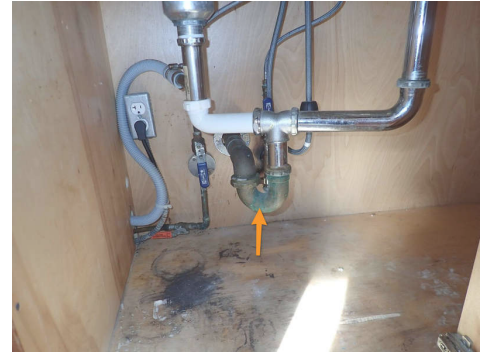
14.5.1 Condition of Plumbing Under the Sink

Leaking connections at the trap assembly beneath the kitchen sink should be repaired to avoid future/additional damage to the cabinet floor and possibly the wall/floor structures below. The Inspector recommends repair by a qualified plumbing contractor.

Contact a qualified plumbing contractor.

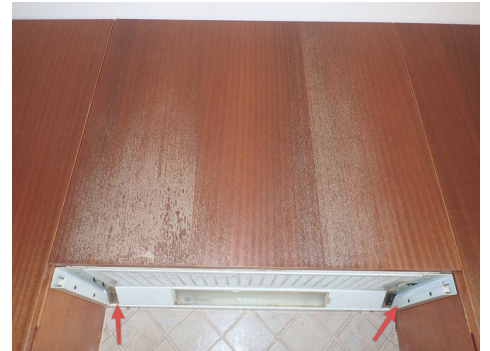
14.7.1 Range Hood

The range hood was broken and missing pieces. Recommend having repaired or replaced as needed for proper operation.

Contact a qualified professional.

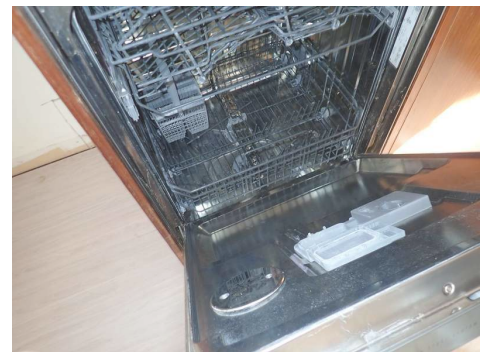
14.8.1 Dishwasher

Due to low water pressure the dishwasher could not be tested for proper operation. I recommend having tested prior to the closing when the water pressure issue has been corrected.

Contact a qualified professional.

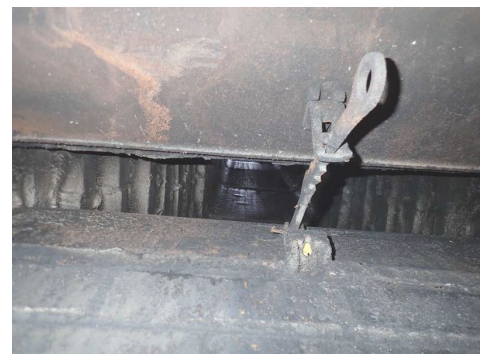
16.2.1 Damper Condition and Function

The damper for the fireplace was rusted tight or "seized" (non-operational). Repairs should be made so unit works properly. I recommend a qualified contractor inspect and repair as needed.

Contact a qualified chimney contractor.

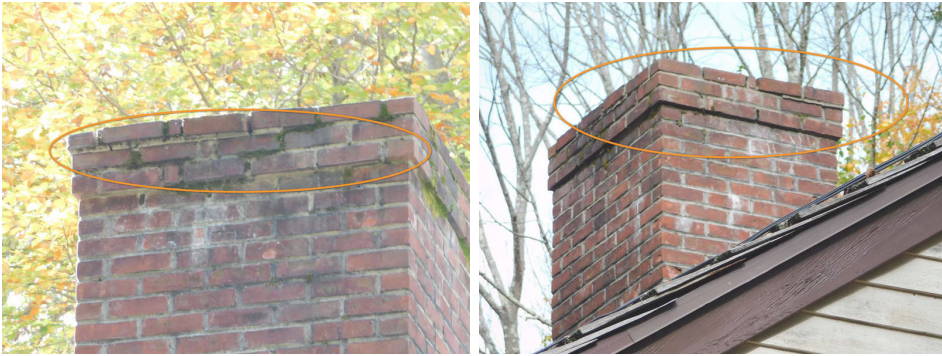
16.6.1 Chimney Structure/Exterior

Mortar at the top or sides of the brick chimney was deteriorated (e.g. loose, missing, cracked). As a result, water is likely to infiltrate the chimney structure and cause further damage. Recommend that a qualified contractor evaluate and repair as necessary. For example, by repointing the mortar or replacing damaged bricks.

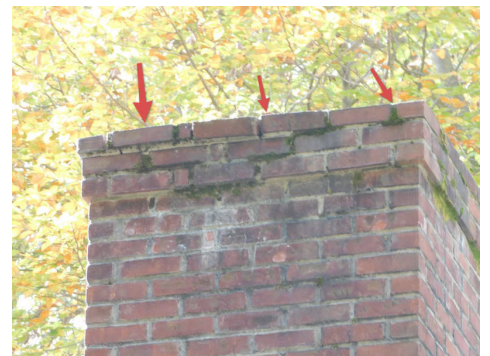
16.6.2 Chimney Structure/Exterior

The chimney crown (concrete) at the top of the chimney was cracked/damaged and in need of repair or replacement. The chimney crown keeps water from entering the chimney and causing damage to the chimney structure. Recommend having a qualified person repair/replace as needed.

Contact a qualified chimney contractor.

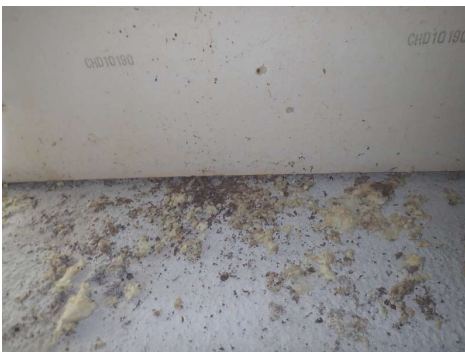
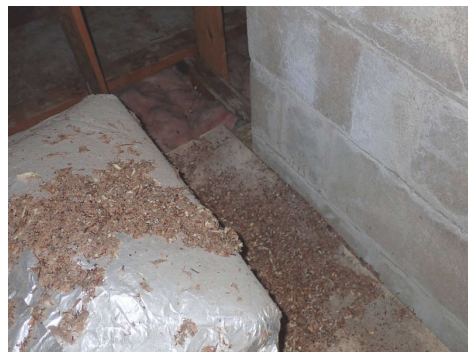
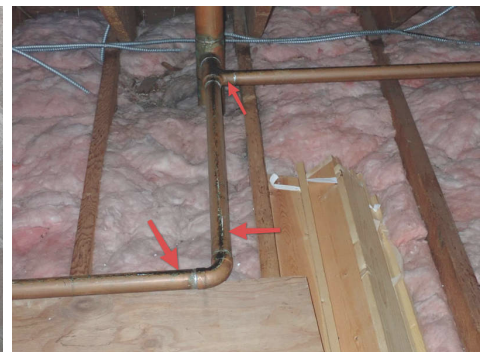
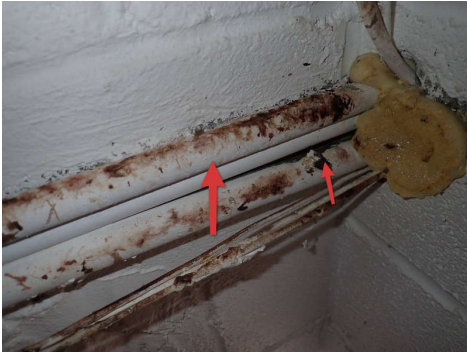
17.1.1 Rodents

Evidence of rodent infestation was found in the form of urine stains, traps, poison, dead rodents, rodent droppings, and damaged insulation. Consult with the property owners about this. A qualified person should make repairs to seal openings in the structure, set traps, and clean rodent waste as necessary. For additional information, visit: <http://www.sterlinghomeinspections.com/index/#/mice/>

Mouse Trails Attic

Contact a qualified pest control specialist.

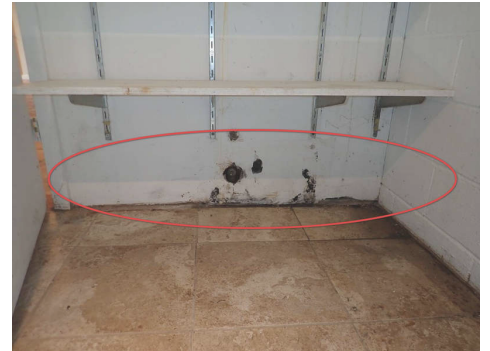
17.2.1 Possible Microbial Growth

Possible microbial growths were found at one or more locations. It is beyond the scope of this inspection to identify what organism or substance this staining is. However, such staining is normally caused by excessively moist conditions, which in turn can be caused by plumbing or building envelope leaks and/or substandard ventilation.

These conducive conditions should be corrected before making any attempts to remove or correct the staining. Normally, affected material such as drywall are removed, enclosed spaces are allowed to dry thoroughly, a mildewcide may be applied, and only then is drywall reinstalled. For evaluation and possible mitigation, consult with a qualified or NYS Licensed industrial hygienist or mold/moisture assessment specialist. For more information, visit: <http://www.sterlinghomeinspections.com/index/#/mold/>

Contact a qualified environmental contractor

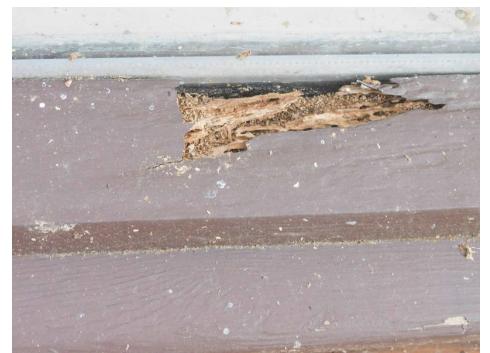
17.4.1 Insect Damage

Visible insect damage was observed at the time of the inspection. In many houses where the basement is finished, like this one, it is not possible to observe for activity in a majority of the house. I recommend having an qualified pest control company install termite bait stations proactively in the ground at the building's exterior to make sure there is no activity in the ground around the house. If no activity is found the bait stations can be removed.

Rear of Home along Deck at Windows

Contact a qualified pest control specialist.

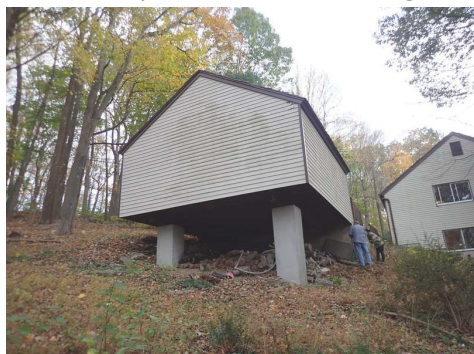
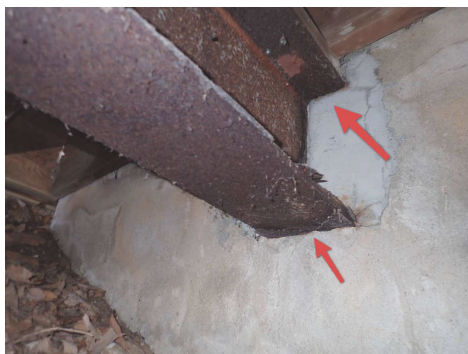
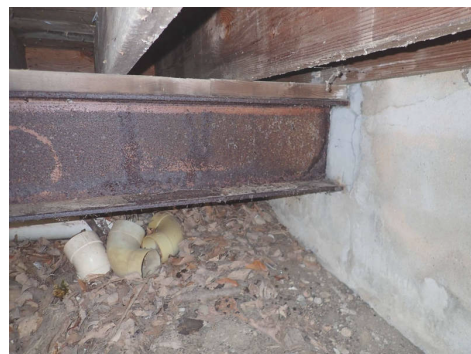
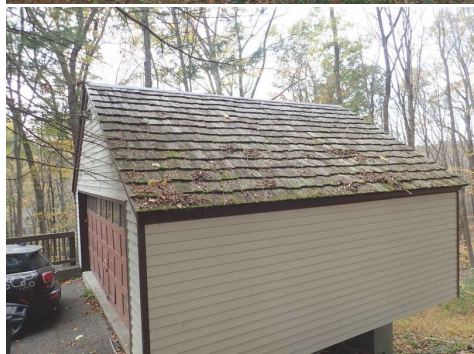
18.1.1 Foundations (If all crawlspace areas are not inspected, provide an explanation. An opinion on performance is necessary)

The garage floor was a floating or elevated floor, being supported by two steel beams exposed to the elements. The steel beams were heavily rusted and may no longer be able to support the intended loads. I recommend having a structural engineer further evaluate and recommend if repairs are needed such as replacing the steel beams.

Recommendation
Contact a qualified structural engineer.

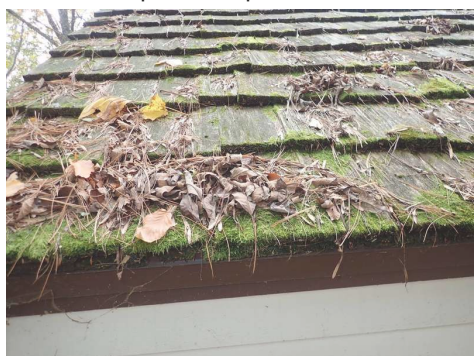
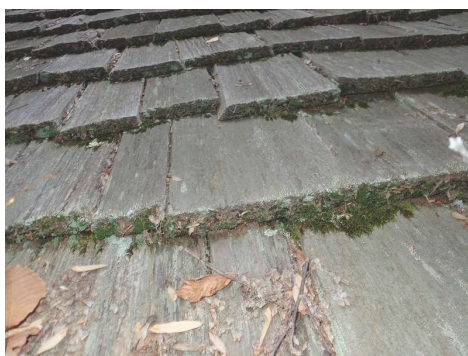
18.5.1 Roof Covering (If the roof is inaccessible, report the method used to inspect)

The roof was well worn and in need of replacement same as the main house.

Recommendation
Contact a qualified professional.

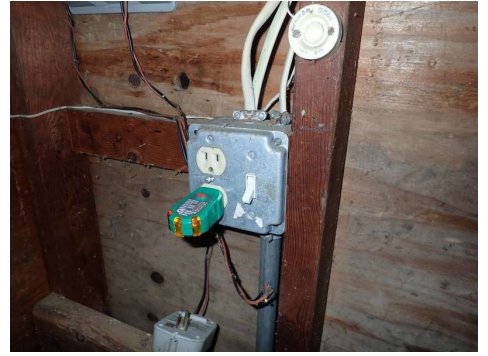
18.16.1 Polarity and Grounding of Receptacles within 6 feet of interior plumbing fixtures, all receptacles in garage, carport and exterior walls of inspected structure

One or more electrical receptacles (outlets) at the *LOCATION (GFCI)* had no visible ground fault circuit interrupter (GFCI) protection, or the inspector was unable to determine if GFCI protection was present. If not GFCI-protected, receptacles in wet areas pose a shock hazard. Recommend that a qualified electrician evaluate and install GFCI protection if necessary and per standard building practices/ General guidelines for GFCI-protected receptacles include the following locations:
