DEFICIENCY SUMMARY

1234 Main St.Oklahoma City OK 73134

Buyer Name 08/28/2017 9:00AM

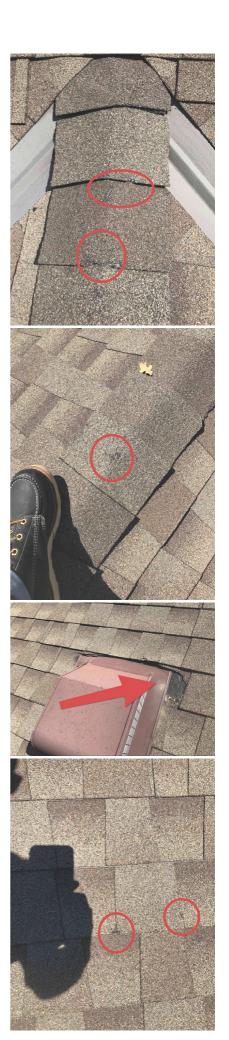
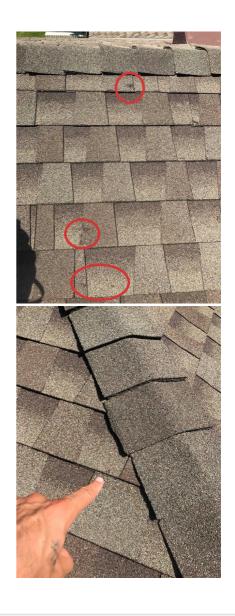
2.1.3 Coverings

DAMAGED (MODERATE)

Roof coverings showed moderate damage. Recommend a qualified roofing professional evaluate and repair. Contacting your insurance company to verify insurability is always recommended as well.

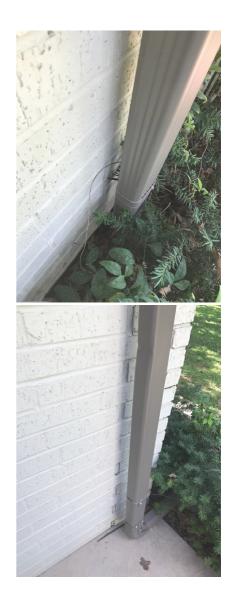
2.2.3 Gutters & Downspouts

DETACHED GUTTER

The gutter(s) is loose and needs to be re-fastened. Recommend correction by qualified professional.

Contact a qualified professional.

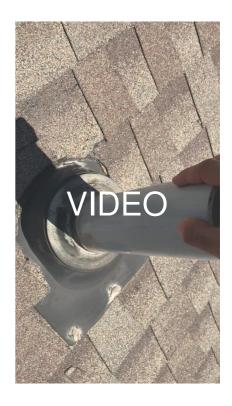
2.4.2 Roof Penetrations

LOOSE BOOT / POOR INSTALLATION

One or more roof jacks or plumbing boots were loose. This could lead to water intrusion if not properly installed. Recommend correction by a qualified professional.

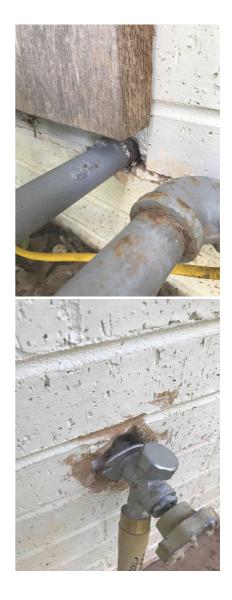
3.1.1 Exterior Wall

SEAL WALL PENETRATION(S)

Exterior wall penetrations or pipes had gaps that should to be sealed with an appropriate sealant to prevent moisture and insect entry. All work should be performed by a qualified contractor.

Contact a qualified professional.

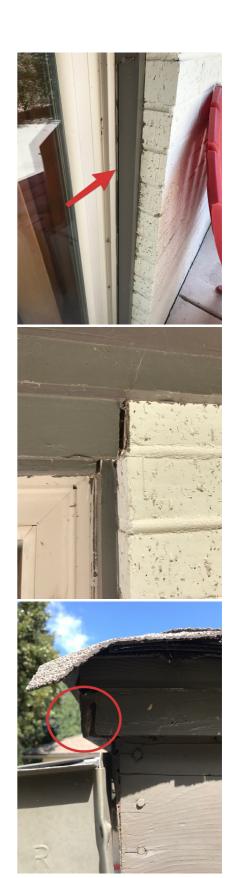
3.2.4 Trim

SEPARATED TRIM

Gaps were observed at one or more locations of trim junctions. Recommend correction by a qualified professional to prevent moisture or insect intrusion.

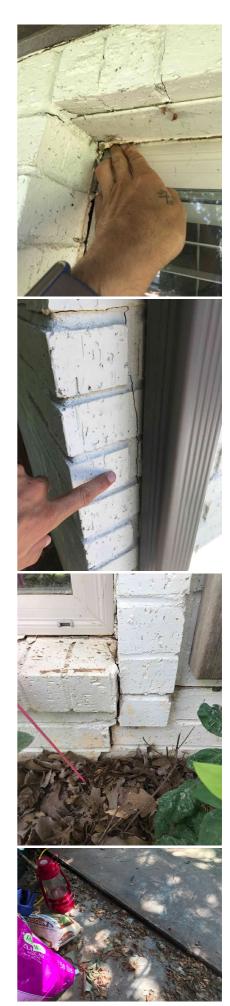
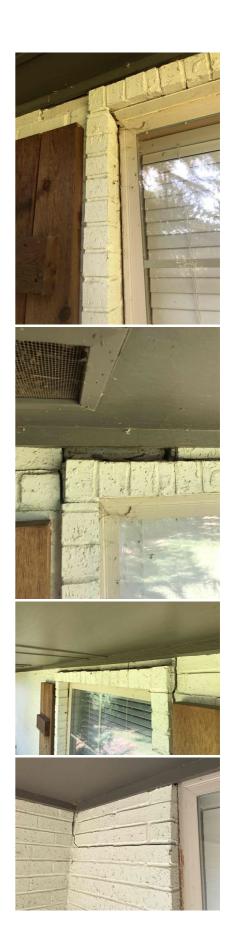
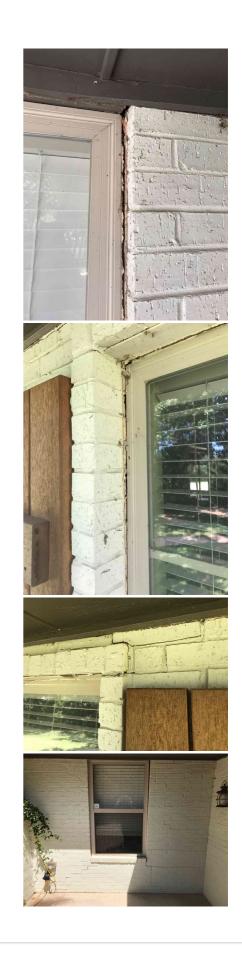
4.1.1 Foundation

EVIDENCE OF STRUCTURAL DAMAGE

Evidence of structural damage was found in the wall structure. Recommend a structural engineer evaluate and advise on how to repair.

Settling garage slab

Contact a qualified structural engineer.

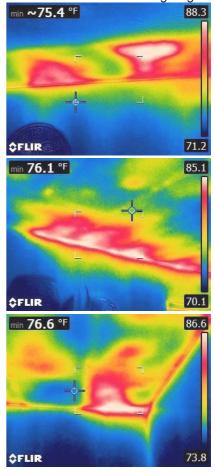
This thermal image was taken in the bathroom next to the garage.

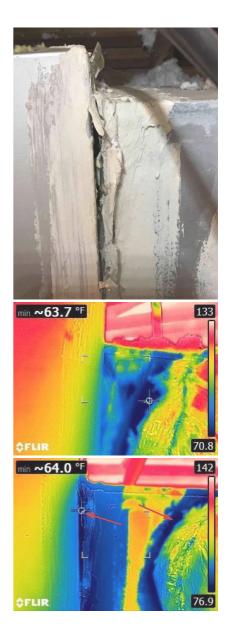
6.2.3 Cooling Equipment

AIR LEAK

The Inspector observed an air leak at the plenum and ductwork connection in the attic. Recommend correction by a qualified professional.

Contact a qualified professional.

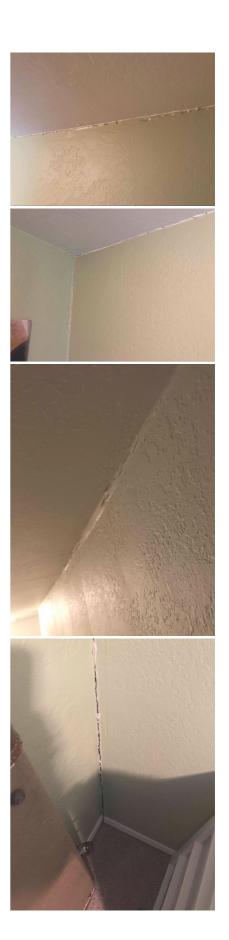
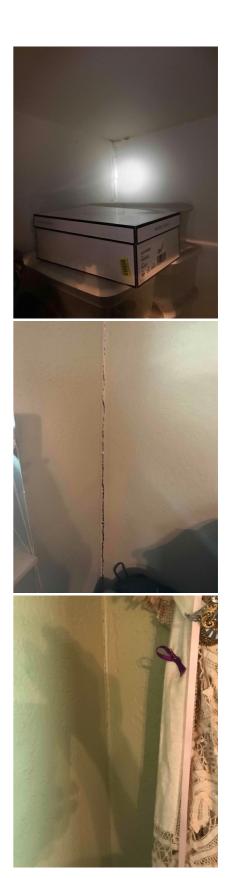
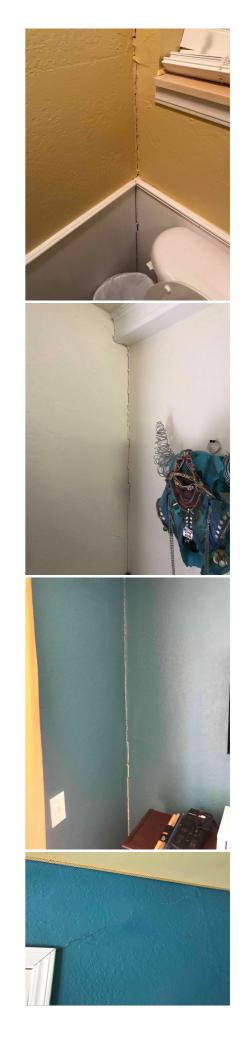
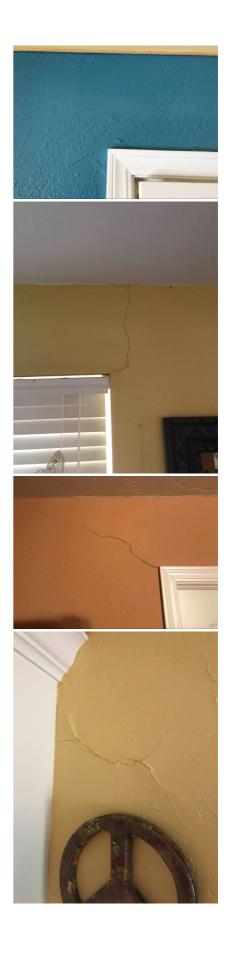
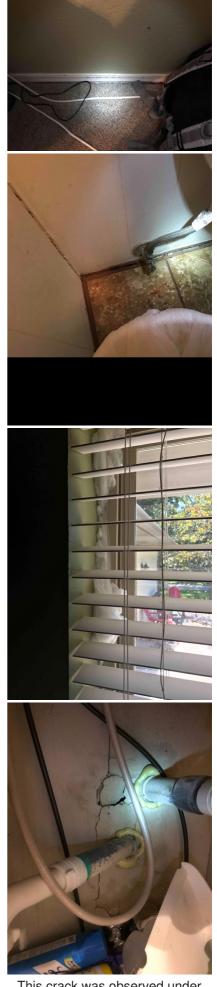
9.4.1 Walls

MAJOR CORNER CRACKS

Cracking visible at the corners of doors and windows. Indicate soil movement, which is a structural concern and should be evaluated by a

structural engineer.

This crack was observed under the kitchen sink.

Contact a qualified structural engineer.
