SUMMARY

1234 Main St. Tempe Arizona 85282

Buyer Name
01/03/2019 9:00AM

Scott Alack
AZ License # 67432
The Dwelling Inspector
480-773-5435
scott@thedwellinginspector.com

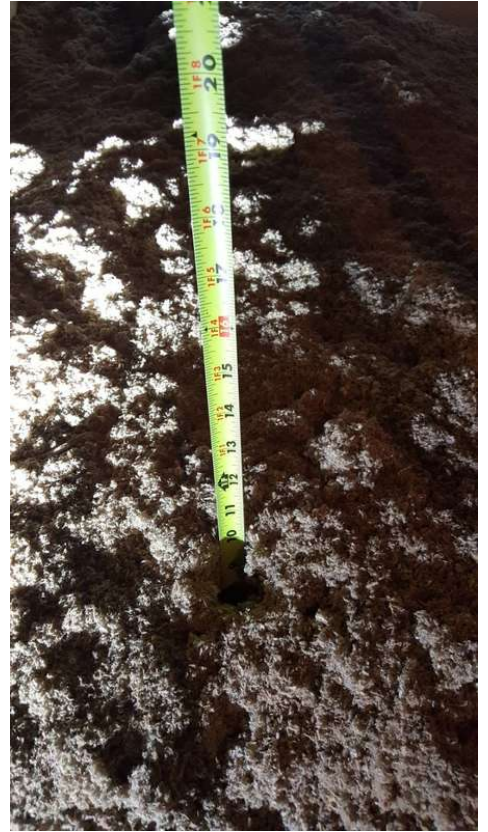
2.8.1 Roof / Ceiling Structure & Attic

ATTIC INSULATION DEPTH WAS INADEQUATE

The attic insulation depth or thickness was inadequate. The recommended depth of attic floor insulation is 12+ inches to achieve an R30 rating. Inadequate attic insulation depth or thickness may allow greater than normal loss of conditioned air.

Contact a qualified insulation contractor.

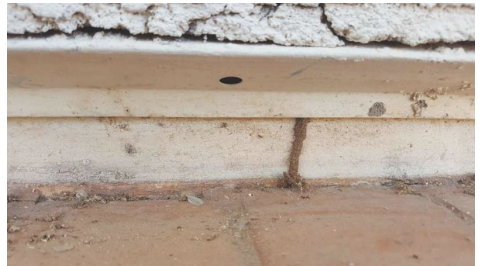
3.1.1 Exterior Wall Cladding

POSSIBLE PRESENCE OF WOOD DESTROYING ORGANISMS

Runner tubes were observed at the foundation perimeter indicating a possible presence of wood destroying organisms. Recommend further evaluation for the presence of any wood destroying pests or organisms by a qualified pest inspector.

Contact a qualified pest control specialist.

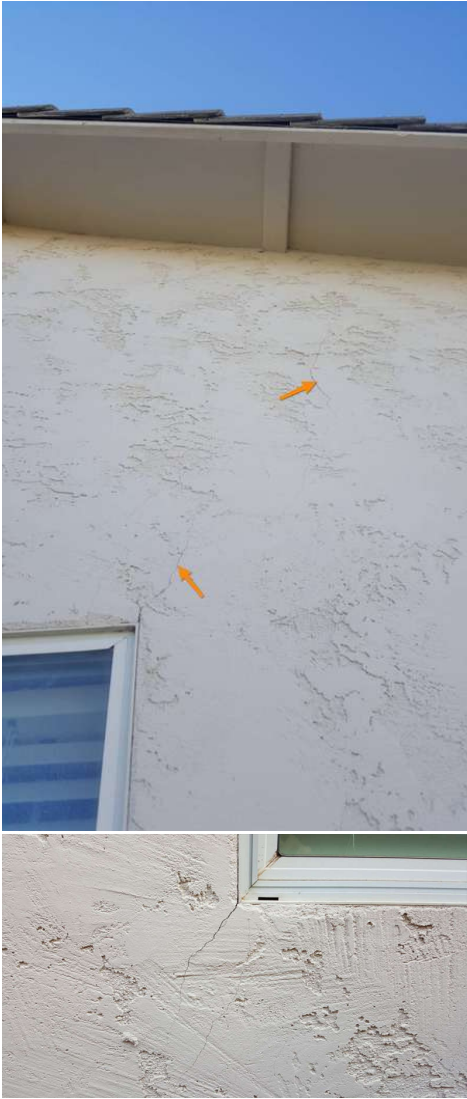
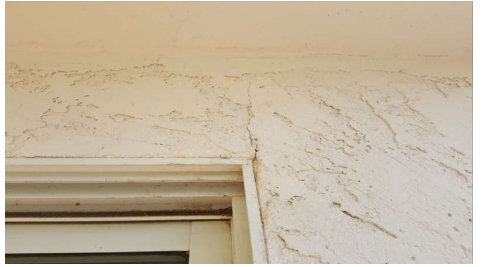
3.1.2 Exterior Wall Cladding

MINOR CRACKS IN STUCCO

Stucco showed cracking in one or more places. This could be a result of temperature changes or building settlement and is typical as homes with stucco age. Recommend a stucco repair contractor to seal and repaint to prevent water penetration.

Contact a stucco repair contractor

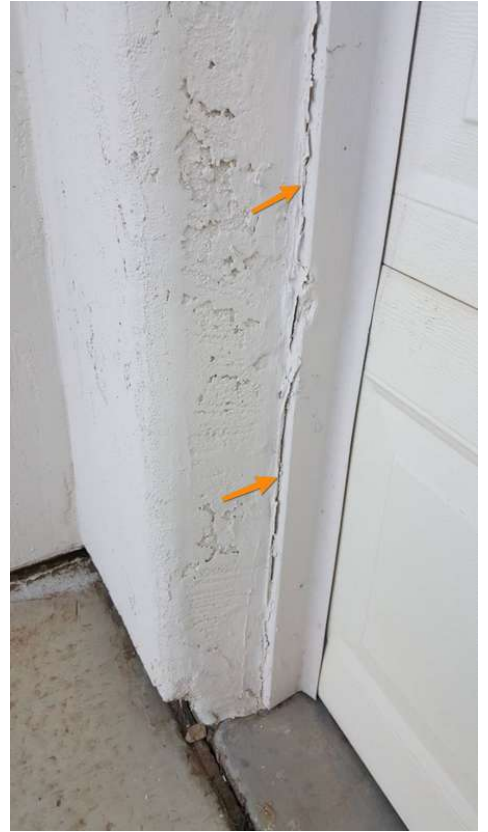
3.2.1 Wall Flashing and Trim

PEELING OR DAMAGED PAINT ON EXTERIOR TRIM

Peeling, damaged or deteriorating paint, stain and/or sealant was observed at the exterior trim. Peeling, damaged and deteriorating paint or sealant should be repaired to prevent moisture penetration and deterioration of materials.

Contact a qualified painter.

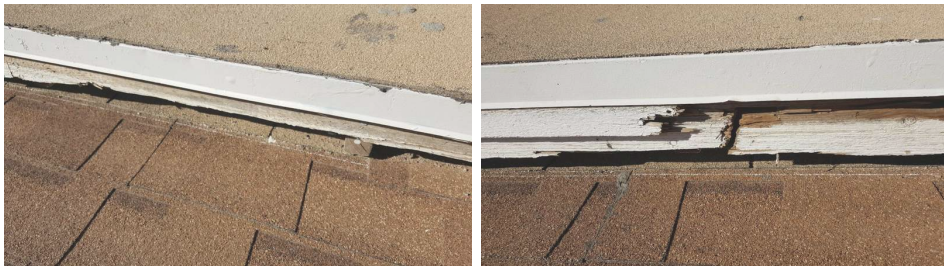
3.3.1 Eaves, Soffits & Fascia

DAMAGED FASCIA

One or more sections of the fascia were damaged. Recommend a qualified roofing professional to further evaluate and repair.

Contact a qualified roofing professional.

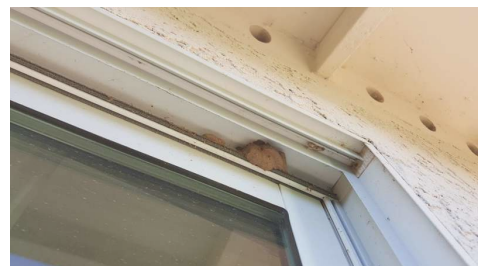
3.3.2 Eaves, Soffits & Fascia

WASPS NEST UNDER THE EAVE

Wasp nests were visible under the eaves. Recommend a qualified exterminator to further evaluate and remove.

Contact a qualified pest control specialist.

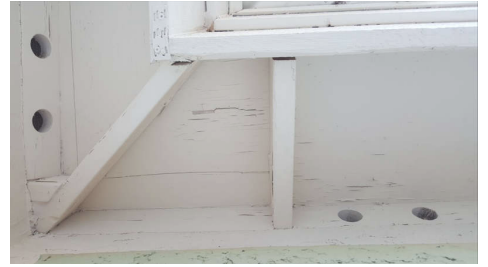
3.3.3 Eaves, Soffits & Fascia

PAINT/SEALANT RECOMMENDED AT THE EAVES

Peeling, damaged or deteriorating paint, stain and/or sealant was observed under the roof eave at the soffit and/or fascia. These conditions should be repaired to prevent moisture penetration and deterioration of materials.

Contact a qualified painter.

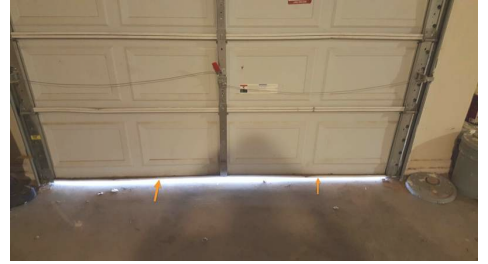
3.5.1 Garage Door

DAMAGED/MISSING GARAGE DOOR WEATHER STRIPPING

Damaged or missing garage door weather stripping should be replaced to prevent water and pest intrusion.

Contact a qualified garage door contractor.

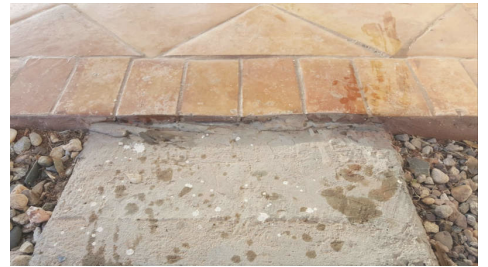
3.7.1 Walkway(s)

TRIPPING HAZARD AT WALKWAY

Differential movement, unevenness and/or cracking in poured concrete was observed to be a TRIPPING SAFETY HAZARD. Differential movement in poured concrete may be an indication of settlement or other defects and should be repaired as needed.

Contact a qualified concrete contractor.

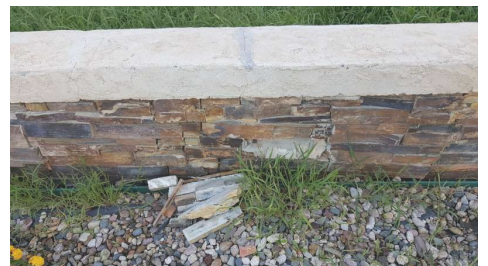
3.8.1 Retaining Wall(s)

DAMAGE TO THE RETAINING WALL(S)

Damage was noted to the retaining wall(s) at the time of inspection and should be repaired. Recommend a qualified landscape contractor to further evaluate and repair as necessary.

Contact a qualified landscaping contractor

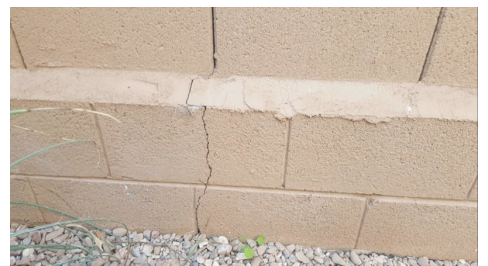
3.12.1 Fences and Gates

COMMON CRACKS FOUND IN CONCRETE/MASONRY WALL

Common cracks were found in the concrete/masonry wall at the time of the inspection.

Recommend monitoring.

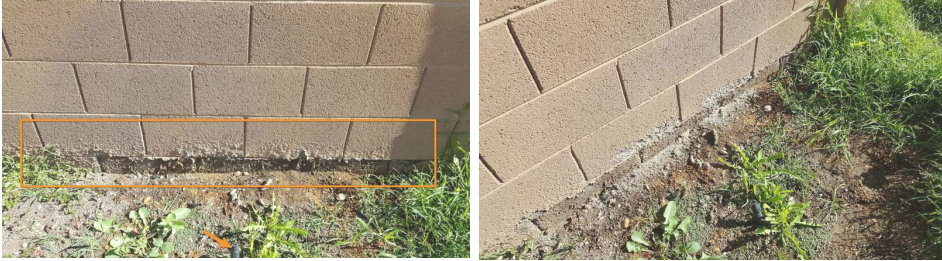
3.12.2 Fences and Gates

SPALLING CONCRETE NEAR SPRINKLER HEADS

The CMU fencing was spalling or flaking in some areas due to the adjacent sprinkler heads spraying water on the lower portions of the fence. Recommend adjusting or re-positioning the sprinkler heads away from the CMU fence to prevent further deterioration.

Contact a qualified landscaping contractor

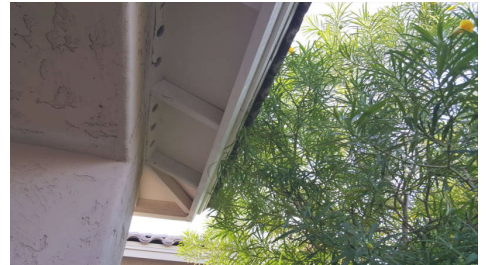
3.13.1 Vegetation, Grading & Drainage

FOLIAGE/VEGETATION IMPACTING THE STRUCTURE.

Heavy foliage growing on, over or around the exterior walls of the structure should be trimmed back at least 18-inches. Heavy foliage limits the Inspectors visual observation of the exterior surfaces. Heavy foliage at exterior walls creates conducive conditions for material damage, wood destroying insects and moisture damage. Heavy foliage may damage the roof and/or exterior wall cladding.

Contact a qualified landscaping contractor

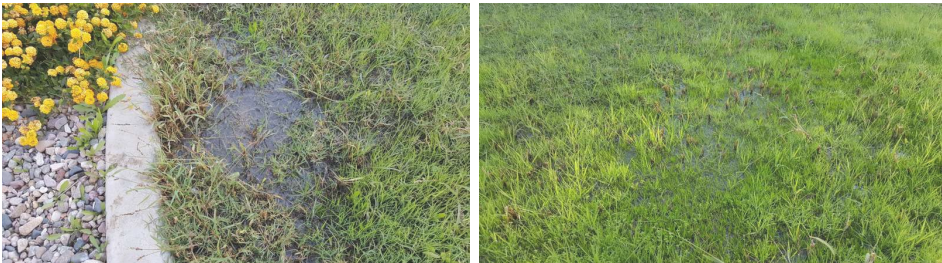
Water was observed to be ponding in the backyard. This is most likely caused by the irrigation sprinkler system. It is recommended that the irrigation sprinkler system be evaluated for proper distribution of water and timing. The system may be on a water timed schedule that is inappropriate for this time of the year or it may be leaking and is in need of repair.

Contact a qualified landscaping contractor

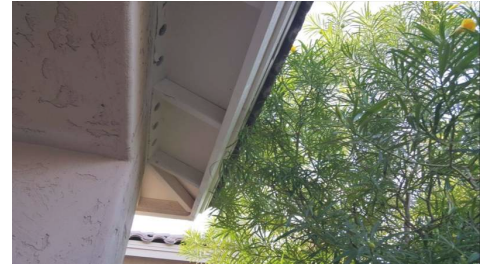
4.1.1 Main Roof

Tree and shrub branches should always be trimmed away from the roofing material. Tree and shrubbery branches may damage the roof covering and exterior wall cladding.

Contact a qualified landscaping contractor

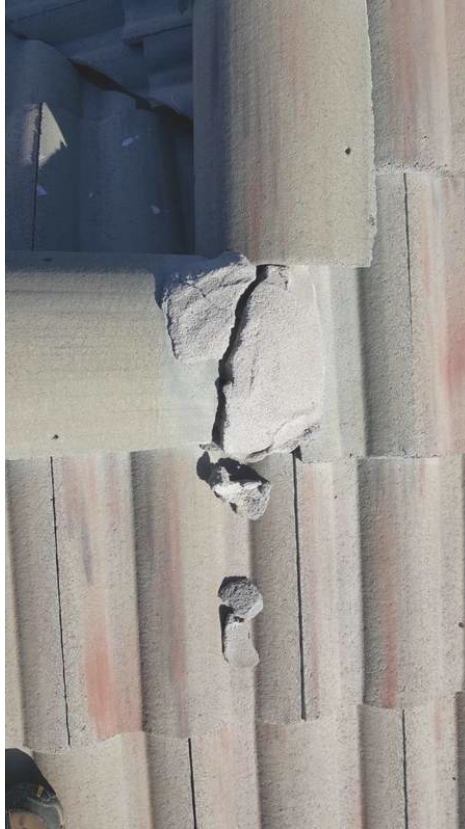
4.1.2 Main Roof

BROKEN CONCRETE MUD BALLS

Several concrete "mud balls" were observed to be broken and in need of repair. Mud balls should be repaired by a qualified roofing contractor to prevent moisture intrusion, leaking, damage and deterioration.

Contact a qualified roofing professional.

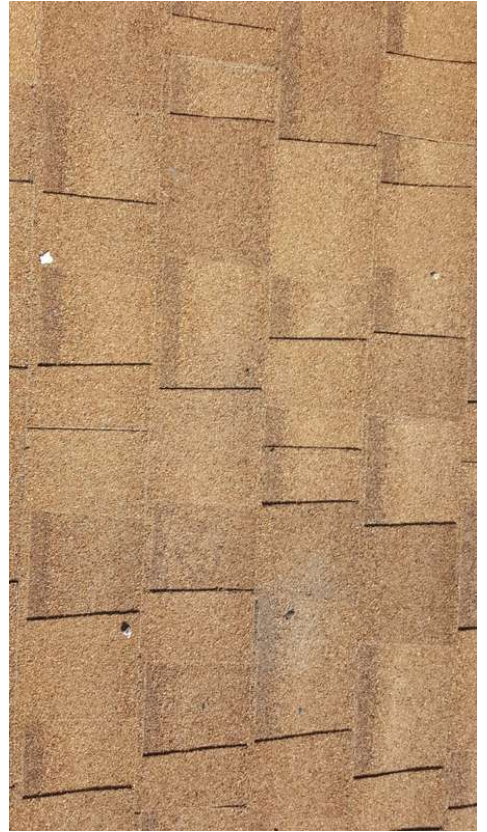
4.3.1 Patio Roof

THINNING GRANULES ON ASPHALT SHINGLES

Composition shingle tab granules were observed to be thinning on the roof covering. This is an indication of weathering and age. You are encouraged to have a licensed roofing contractor to physically inspect the roof to fully evaluate the condition of the roofing materials.

Contact a qualified roofing professional.

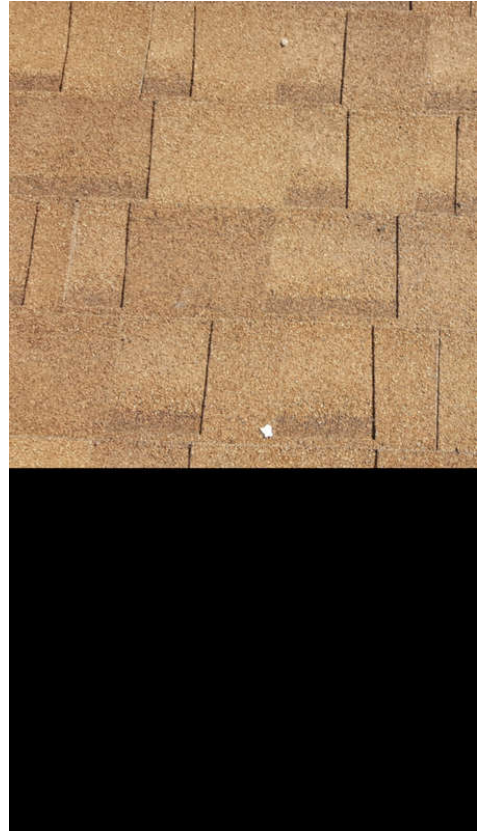
4.3.2 Patio Roof

ROOF COVERING APPEARED TO BE INAPPROPRIATE FOR THE ROOF SLOPE

The roof covering material appeared to be inappropriate for the roof slope and may allow water penetration, premature wear, weather damage and other defects. You are encouraged to have a licensed roofing contractor to physically inspect the roof to fully evaluate the condition of the roofing materials.

Contact a qualified roofing professional.

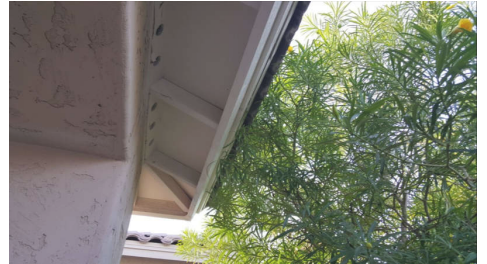
4.3.3 Patio Roof

TREE AND SHRUB BRANCHES WERE IN CONTACT WITH THE ROOF

Tree and shrub branches should always be trimmed away from the roofing material. Tree and shrubbery branches may damage the roof covering and exterior wall cladding.

Contact a qualified landscaping contractor

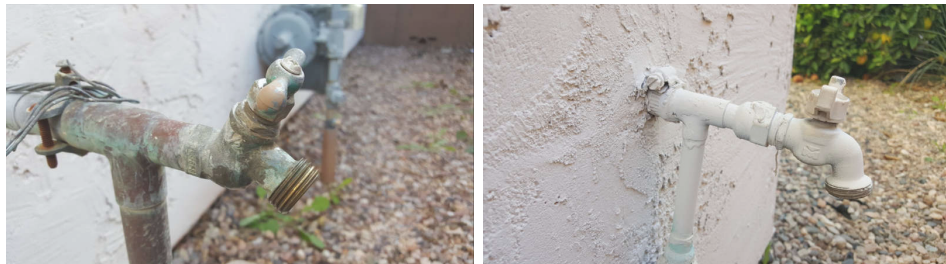
It is recommended to install an anti-siphon device at the exterior hose faucet for safety reasons. An anti-siphon device (or vacuum breaker) prevents unsanitary water from being pulled back through a garden hose and contaminating your water system, otherwise known as a "Cross Connection". These are fairly inexpensive and can be picked up at your local hardware store.

Contact a handyman or DIY project

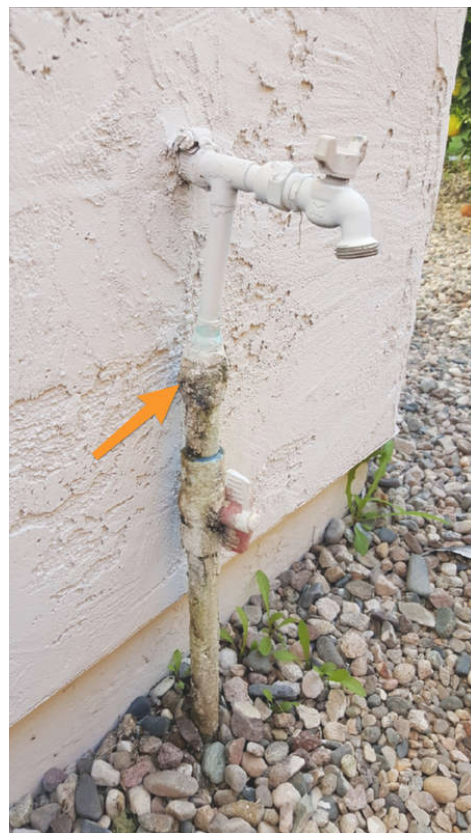
CORRODED - ACTIVE LEAKAGE

Actively leaking, heavily-corroded water distribution pipes were observed and should be repaired by a qualified plumbing contractor to avoid damage to home materials or the development of conditions which encourage the growth of microbes such as mold.

Contact a qualified plumbing contractor.

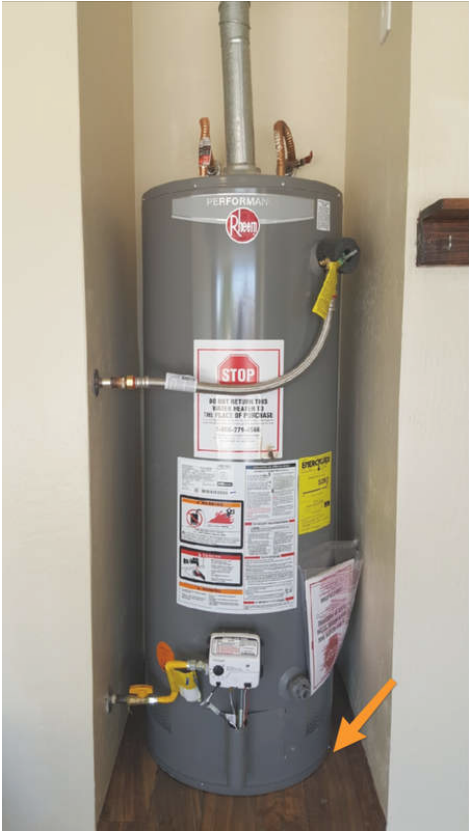
5.6.1 Water Heater

MISSING OVERFLOW PAN

The water heating equipment was installed without an overflow pan. Current building standards state that all water heaters should be equipped with an overflow pan with a drain that drains to the exterior of the structure if leaks would cause damage.

Recommendation
Contact a qualified plumbing contractor.

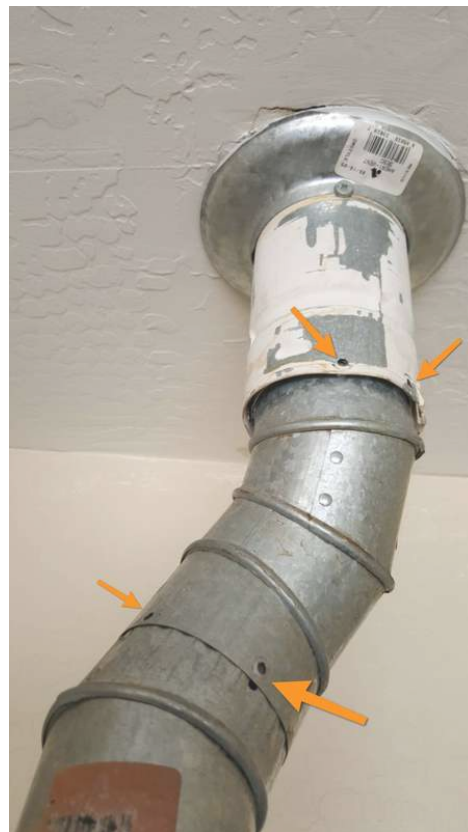
The water heater flue was incorrectly fastened at the connections. Single wall vent pipe should be connected with 3 sheet metal screws at each joint. Recommend a qualified professional to correct.

Contact a qualified professional.

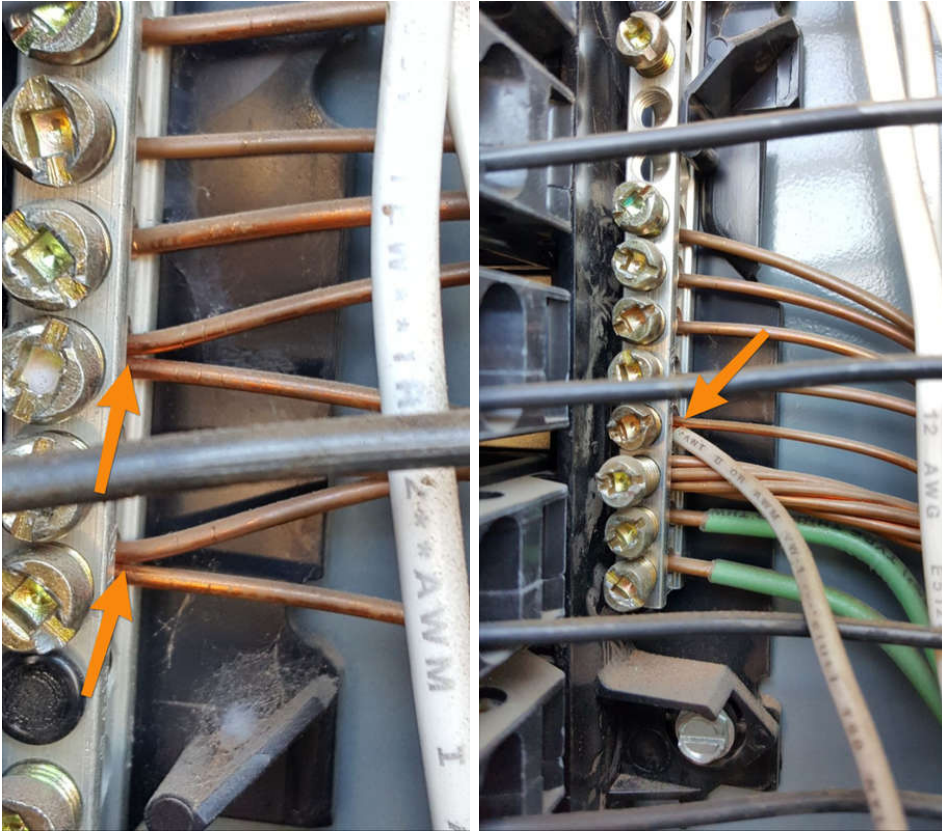
6.4.1 Branch Circuit Conductors

DOUBLE TAPPING AT NEUTRAL BUS BAR

Neutral electrical conductors were observed to be double tapped on the neutral bus bar in the electric service panel. Each neutral electrical conductor in the electric service panel should terminate individually unless the terminals are made for more than one conductor. Double tapped neutral electrical conductors should be further evaluated and repaired as needed by a qualified electrical specialist.

Contact a qualified electrical contractor.

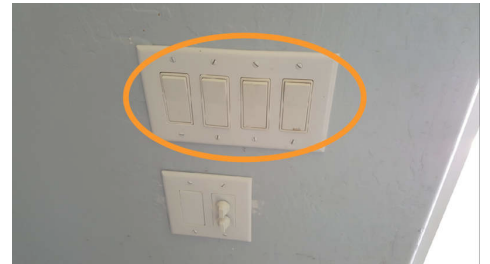
6.6.1 Lights, Switches, Receptacles and Junction Boxes

One or more switches in the home appeared to be inoperable at the time of the inspection. These switches may connect to exterior lights which are controlled by photo sensors and so will operate only at night. They may be improperly wired and represent a potential fire hazard, or they may connect to outlets which were not tested. Switches sometimes control only the upper or lower half of an outlet. Tracing the devices controlled by all switches exceeds the scope of the general home inspection. You should take action to confirm that these switches are safe, either by asking the seller or having them traced by a qualified electrician.

Recommendation
Contact a qualified electrical contractor.

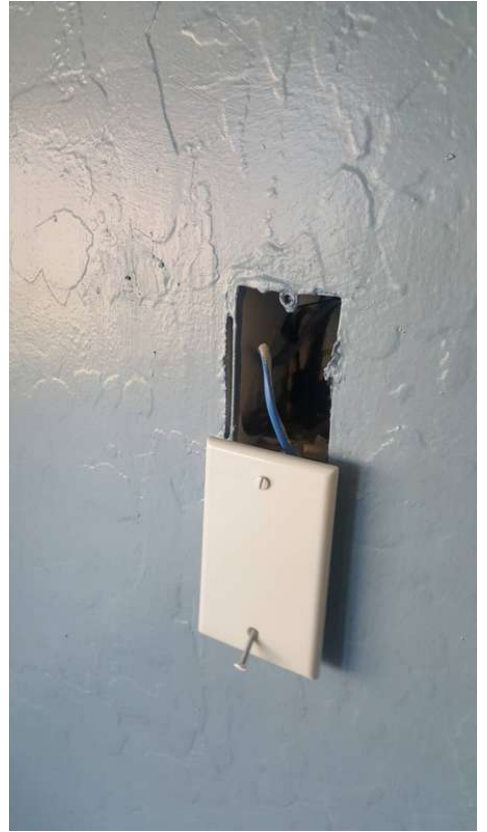
6.6.2 Lights, Switches, Receptacles and Junction Boxes

COVER PLATE MISSING

At the time of the inspection, a cover plate was missing. This condition left energized electrical components exposed to touch, a shock/electrocution hazard. The Inspector recommends that a listed cover plate be installed by a qualified electrical contractor.

Recommendation
Contact a qualified electrical contractor.

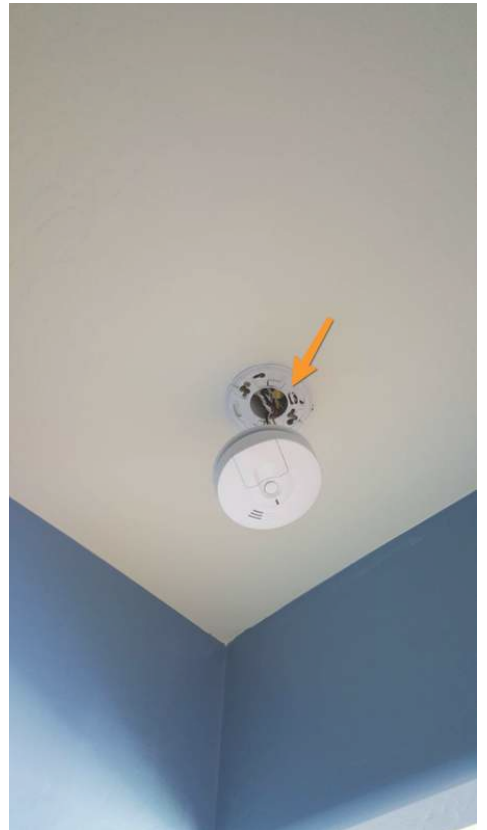
6.8.1 Smoke Detectors

SMOKE DETECTOR WAS NOT MOUNTED

Recommendation
Contact a qualified professional.

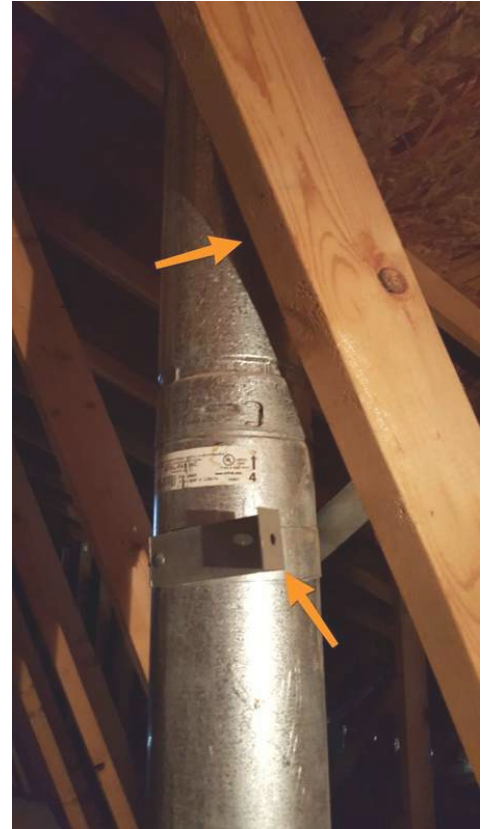
7.3.1 Flues/Venting

FLUE WAS IMPROPERLY SUPPORTED

The furnace flue appeared to be improperly supported at the time of the inspection. It appeared that the installer attached the flue to be hanging off the wood support to achieve a 1" clearance from the combustible wood it is attached to. Recommend a qualified HVAC professional to evaluate and repair.

Contact a qualified professional.

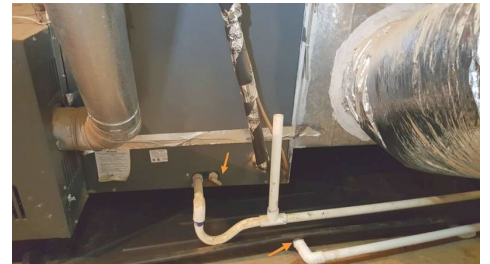
7.6.1 Air Handler Unit

RECOMMEND INSTALLING CONDENSATE DETECTION SAFETY SWITCH

The condensation overflow pan or secondary drain lines installed above ceilings were not equipped with water or moisture sensors/alarms. Cooling equipment condensation drain pans or drain line sensors and alarms should be installed at HVAC equipment installed above ceilings for additional protection against water damage.

Contact a qualified HVAC professional.

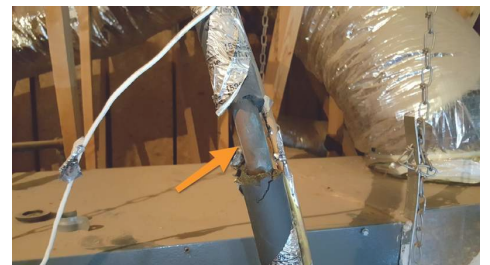
7.6.2 Air Handler Unit

REFRIGERANT LINES WERE NOT PROPERLY INSULATED

The HVAC refrigerant lines were not properly insulated in the attic. Inadequate cooling line insulation at the attic HVAC equipment may result in equipment damage, inadequate performance, reduced equipment life or other defects.

Contact a qualified HVAC professional.

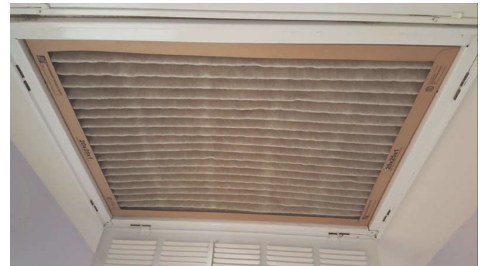
The air filter for this furnace was dirty and should be changed. Filters should be checked every three months and replaced when they reach a condition in which accumulation of particles becomes so thick that particles may be blown loose from the filter and into indoor air. Homes in areas with high indoor levels of airborne pollen or dust may need to have air filters checked and changed more frequently. Failure to change the filter when needed may result in the following problems: - Reduced blower life due to dirt build-up on vanes, which increasing operating costs. - Reduced indoor air quality. - Increased resistance resulting in the filter being sucked into the blower. This condition can be a potential fire hazard. - Frost build-up on air-conditioner evaporator coils, resulting in reduced cooling efficiency and possible damage. - Reduced air flow through the home.

Contact a handyman or DIY project

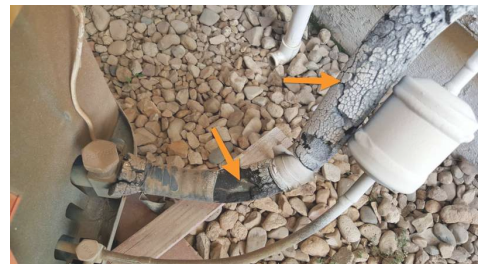
8.1.1 Cooling Unit

INSULATION MISSING OR DAMAGED

The HVAC refrigerant lines were not properly insulated or the insulation was damaged and in need of replacement at the exterior equipment. Inadequate cooling line insulation at the exterior HVAC equipment may result in equipment damage, inadequate performance, reduced equipment life or other defects.

Contact a qualified HVAC professional.

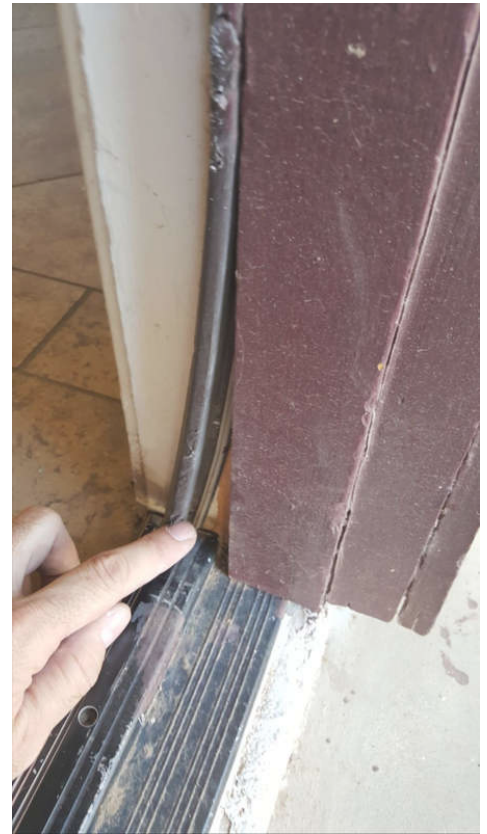
At the time of the inspection, weather-stripping at an exterior door was damaged or deteriorated. The Inspector recommends replacement/installation of effective weather-stripping components as necessary by a qualified contractor.

Contact a qualified door repair/installation contractor.

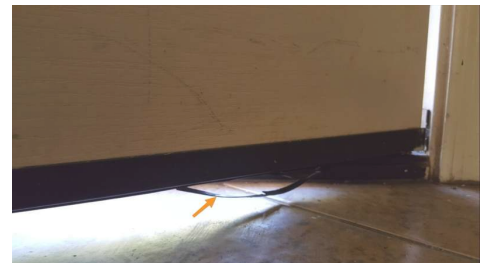
9.2.2 Entry/Exterior Door(s)

SWEEP DAMAGED

At the time of the inspection, the sweep was damaged or deteriorated. A sweep is a rubber strip that attaches to the bottom of a door to seal the gap between the bottom of the door and the threshold. It should be replaced to help prevent moisture and pest intrusion and air/heat leakage that will increase heating/cooling costs and reduce home comfort. All work should be performed by a qualified contractor.

Contact a qualified door repair/installation contractor.

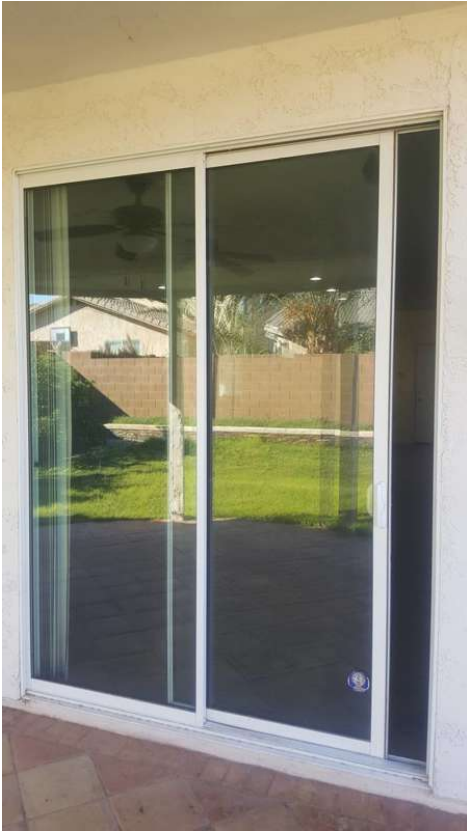
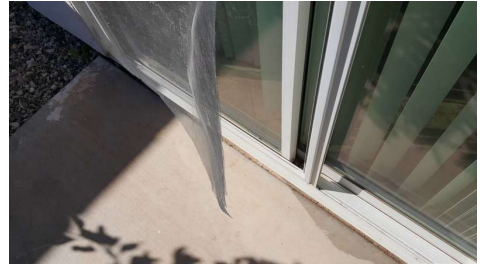
9.2.3 Entry/Exterior Door(s)

SLIDING SCREEN DOOR MISSING OR DAMAGED

The sliding screen doors were missing or damaged at the time of the inspection. Recommend repair or replacement by a qualified contractor.

Contact a qualified door repair/installation contractor.

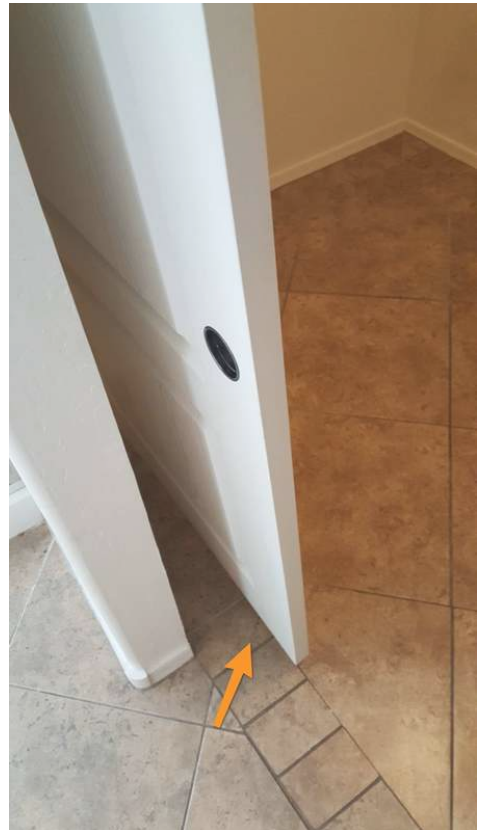
9.3.1 Interior Doors

MISSING BOTTOM TRACK

The sliding closet door in the Master Bathroom did not have a bottom track to hold the door in place when sliding. Recommend installing a door track/guide by a qualified professional.

Contact a qualified professional.

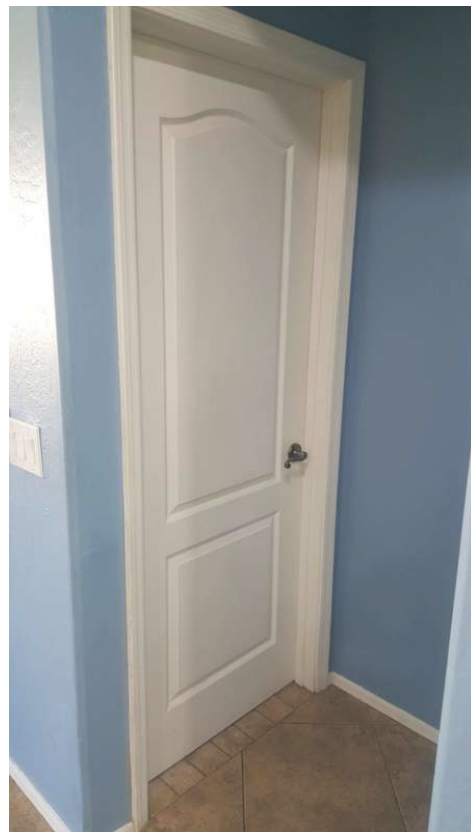
9.3.2 Interior Doors

MASTER BEDROOM DOOR CLOSSES WHEN HVAC IS TURNED ON

Contact a handyman or DIY project

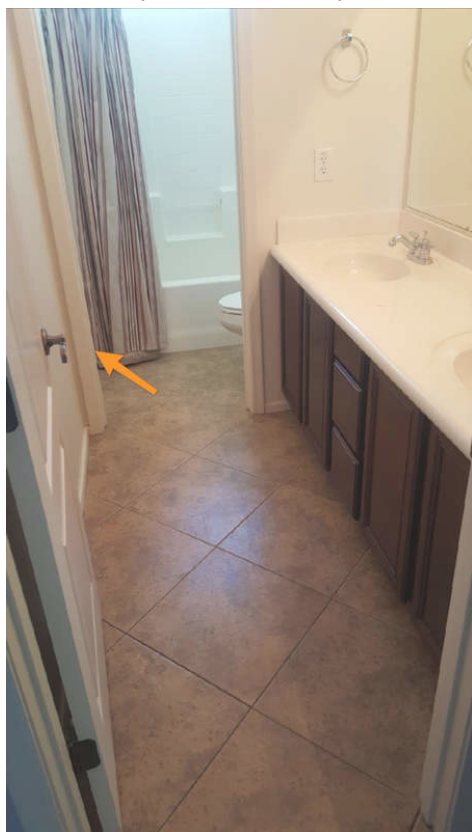
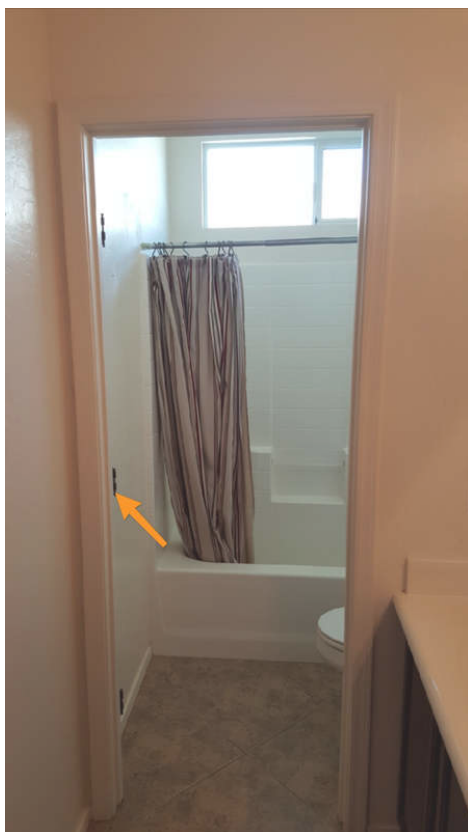
9.3.3 Interior Doors

MISSING DOOR

The door to the guest bathroom toilet room was missing at the time of the inspection. Recommend installing a door by a qualified professional.

Contact a qualified door repair/installation contractor.

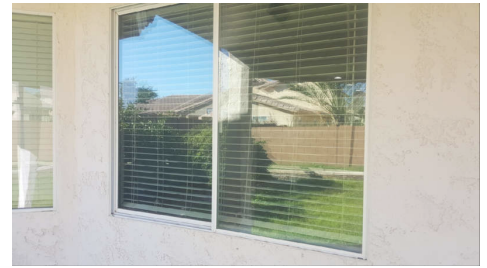
9.4.1 Windows

MISSING SCREEN

Several windows were missing the screen. Recommend replacement.

Contact a qualified window repair/installation contractor.

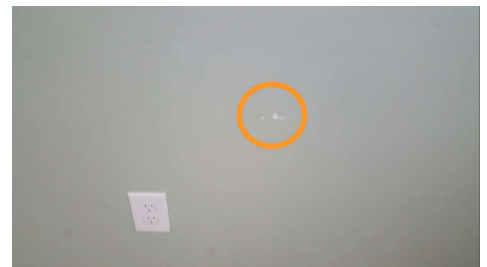
MINOR DAMAGE AND DETERIORATION - GENERAL

Interior walls in the home exhibited general minor damage or deterioration at the time of the inspection. This is typical throughout the home.

Contact a handyman or DIY project

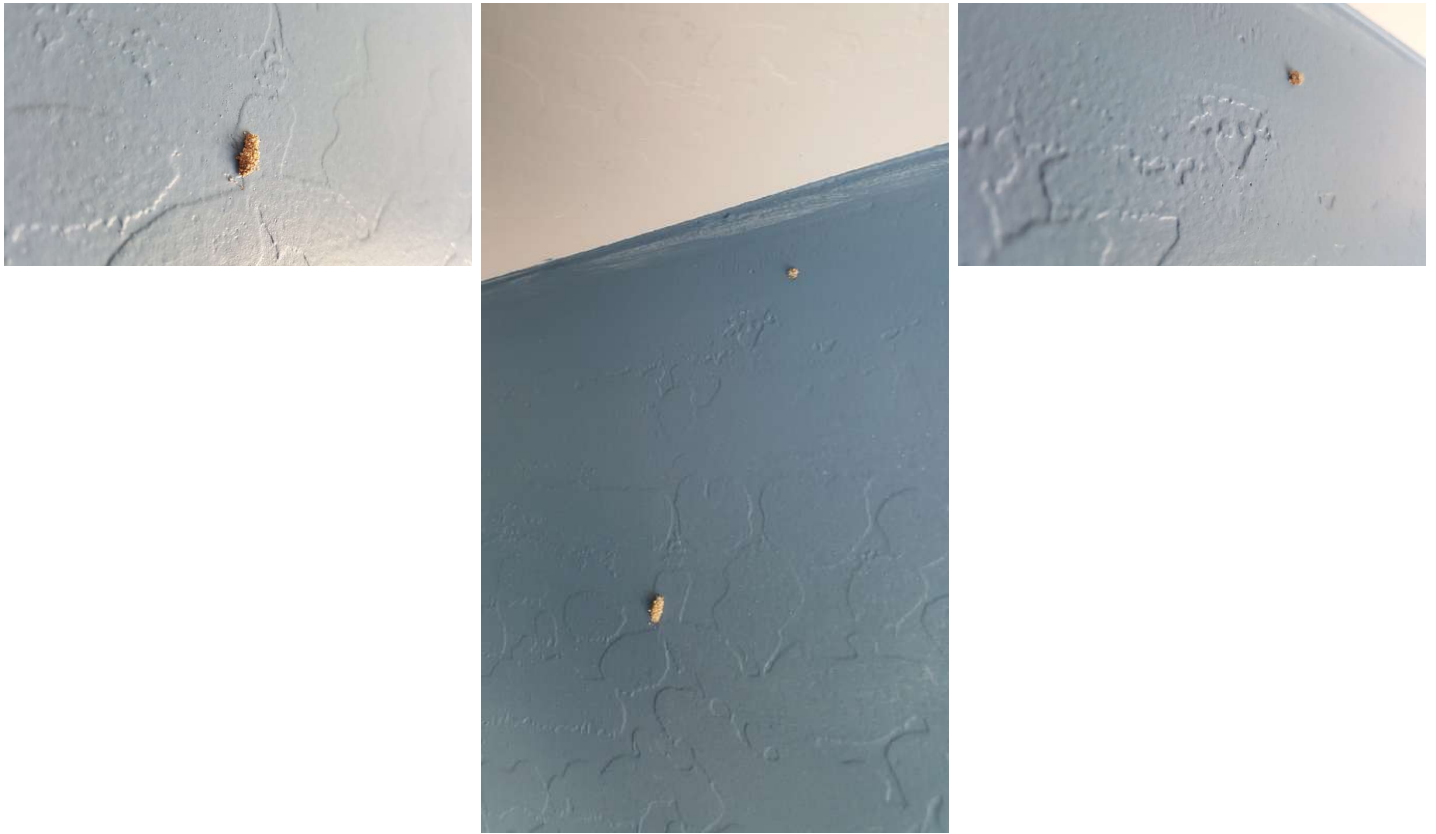
9.6.2 Walls

INDICATIONS OF WOOD DESTROYING ORGANISMS

There are signs of wood destroying organisms. Recommend further evaluation by a pest control professional to determine and perform the proper treatment and removal of the wood destroying organisms.

Contact a qualified pest control specialist.

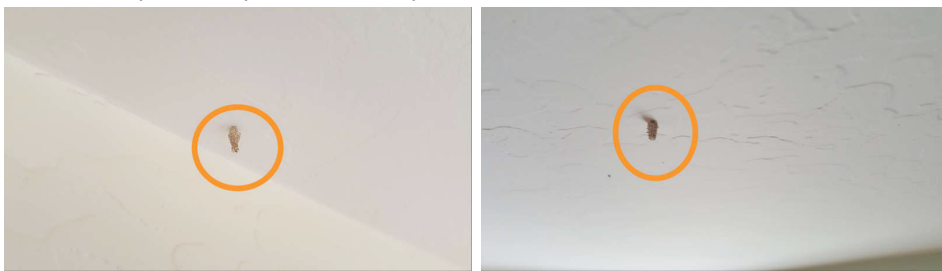
9.7.1 Ceilings

INDICATIONS OF WOOD DESTROYING ORGANISMS

Contact a qualified pest control specialist.

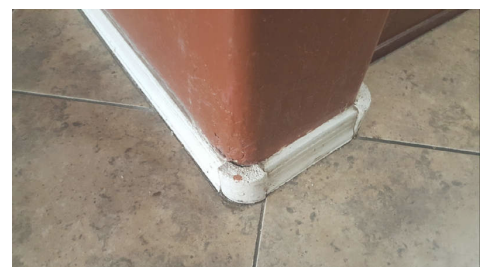
9.8.1 Trim

TRIM DAMAGE/DETERIORATION-MINOR

Trim exhibited minor cosmetic damage/deterioration.

Recommend monitoring.

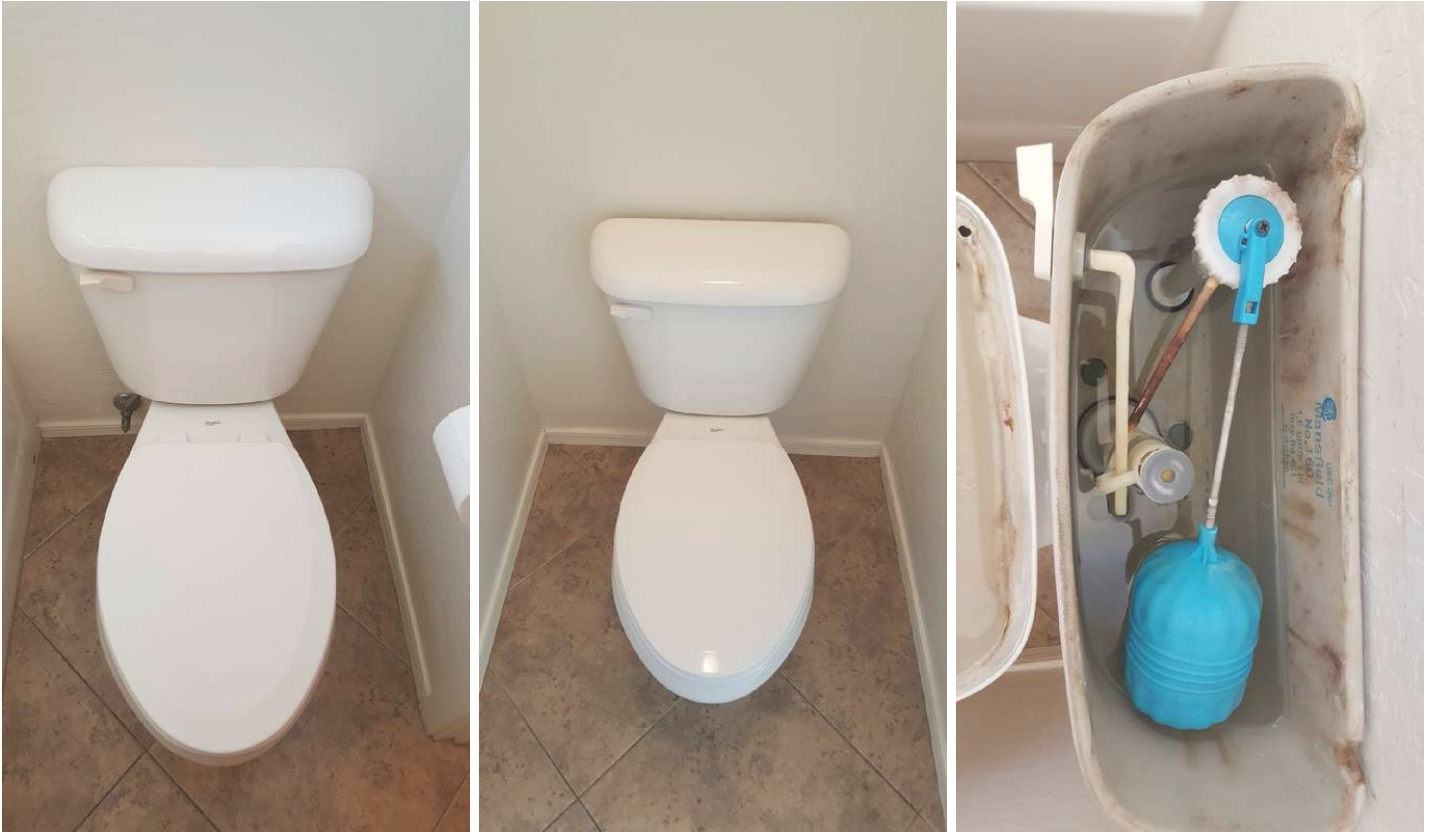
10.1.1 Toilet(s)

OLD AND STAINED

The toilets in the master and guest bathrooms appeared old and stained, but were functional at the time of the inspection.

Recommendation
Recommend monitoring.

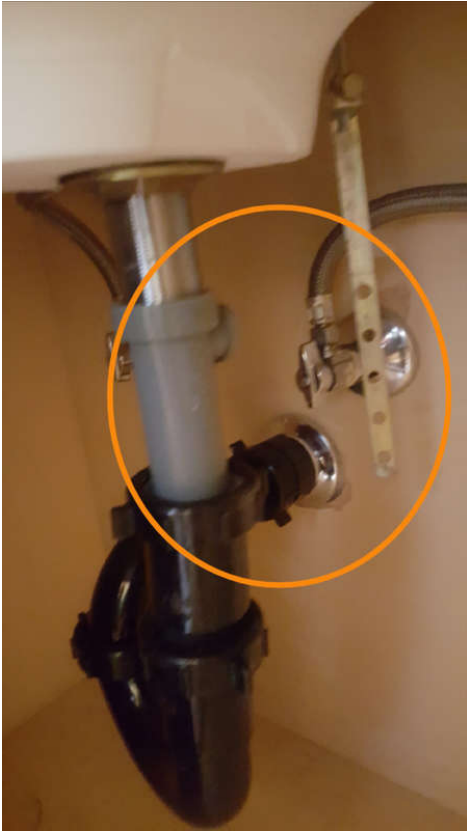
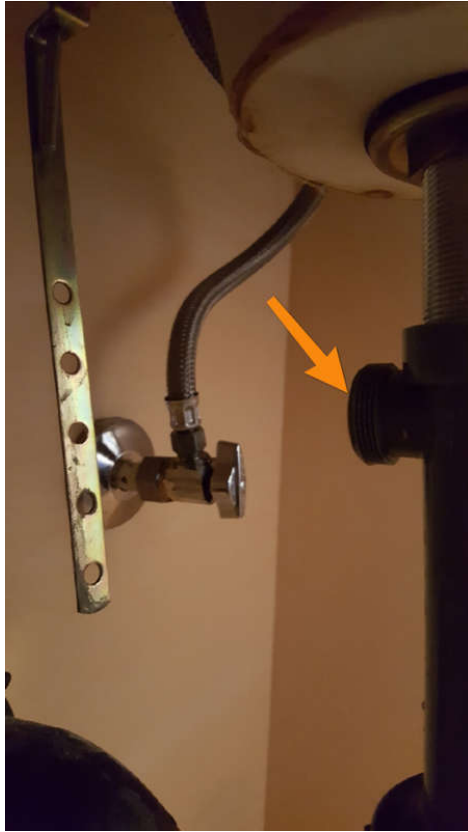
10.2.1 Sink(s)

MISSING STOPPER

The sink in the master and guest bathrooms had a missing stopper and stopper assembly and should be repaired or replaced by a qualified professional. Due to the missing stopper assembly this sink will leak when the water is running.

Recommendation
Contact a handyman or DIY project

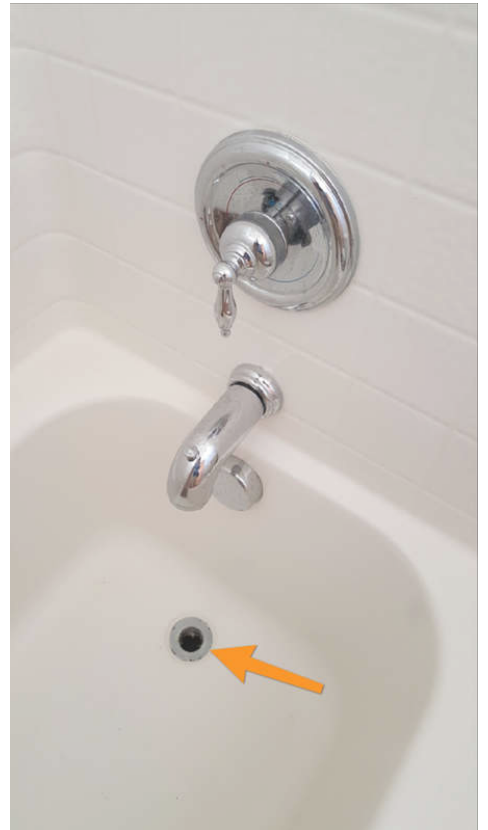
10.3.1 Bathtub(s)

MISSING STOPPER

The tub in this bathroom had a missing stopper and should be repaired or replaced.

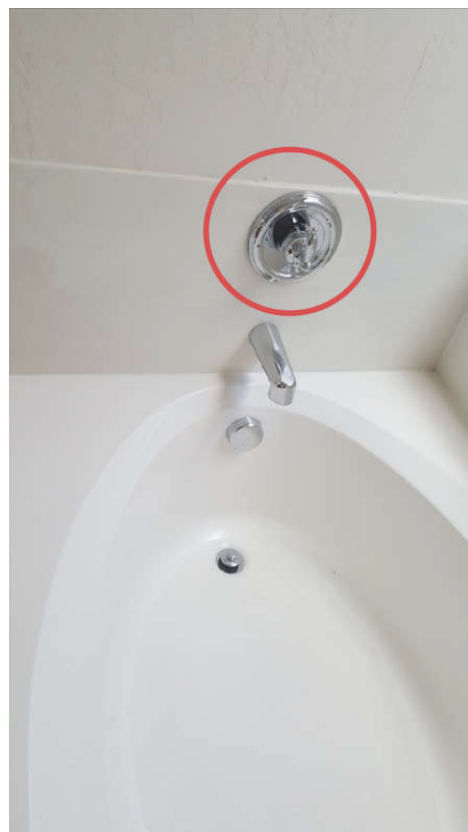
10.3.2 Bathtub(s)

HOT & COLD REVERSED

Contact a qualified plumbing contractor.

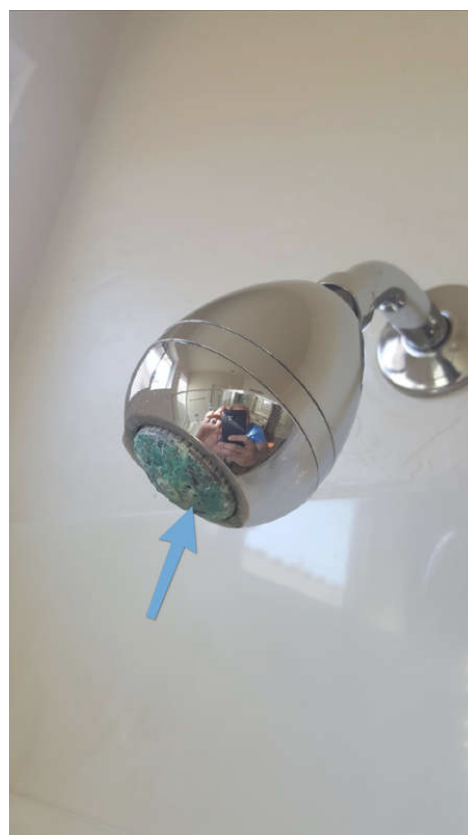
10.4.1 Shower(s)

SHOWER HEAD HAD CORROSION OR BUILD-UP

Contact a handyman or DIY project

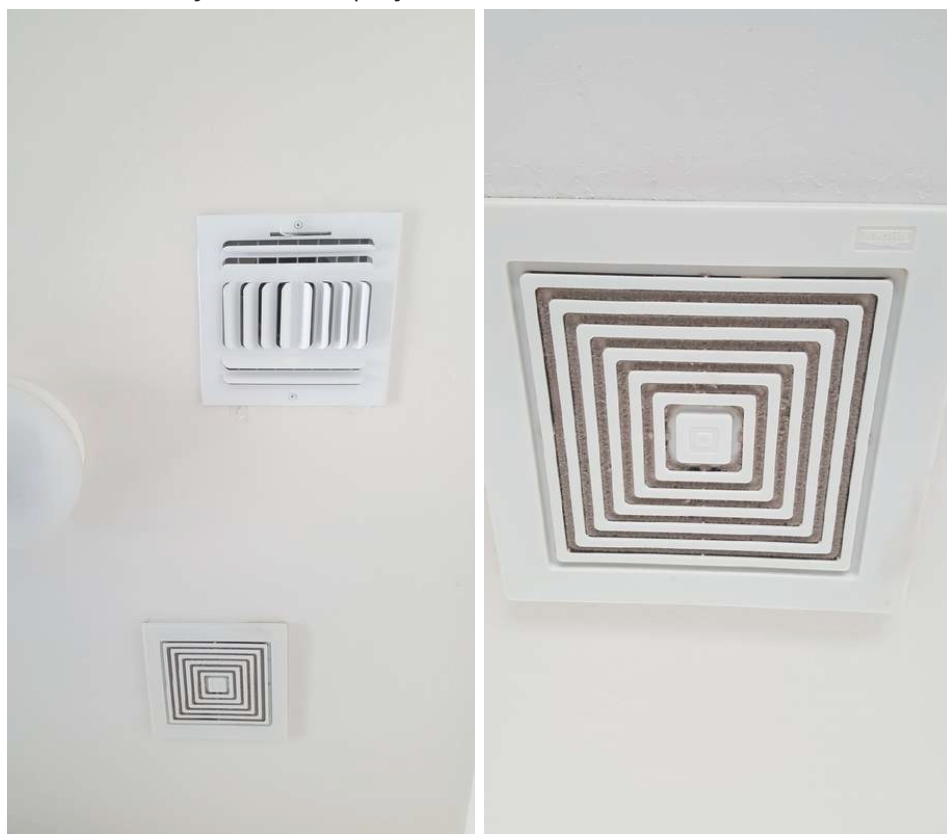
10.5.1 Bathroom Exhaust Fan

DIRTY EXHAUST FAN

Contact a handyman or DIY project

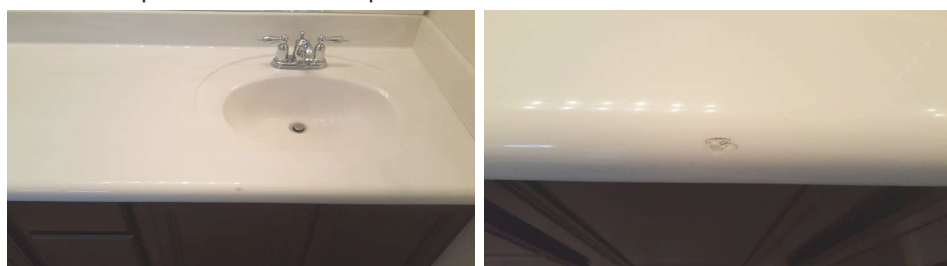
10.6.1 Countertops & Cabinets

COUNTERTOP CRACKED/CHIPPED

Contact a qualified countertop contractor.

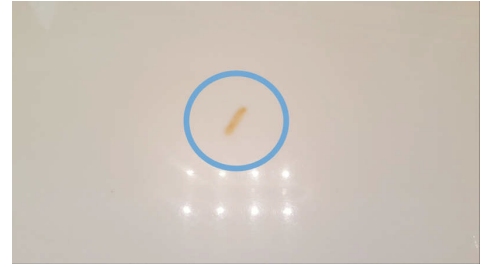
10.6.2 Countertops & Cabinets

COUNTERTOP- MINOR DAMAGE/DETERIORATION

Recommendation
Recommend monitoring.

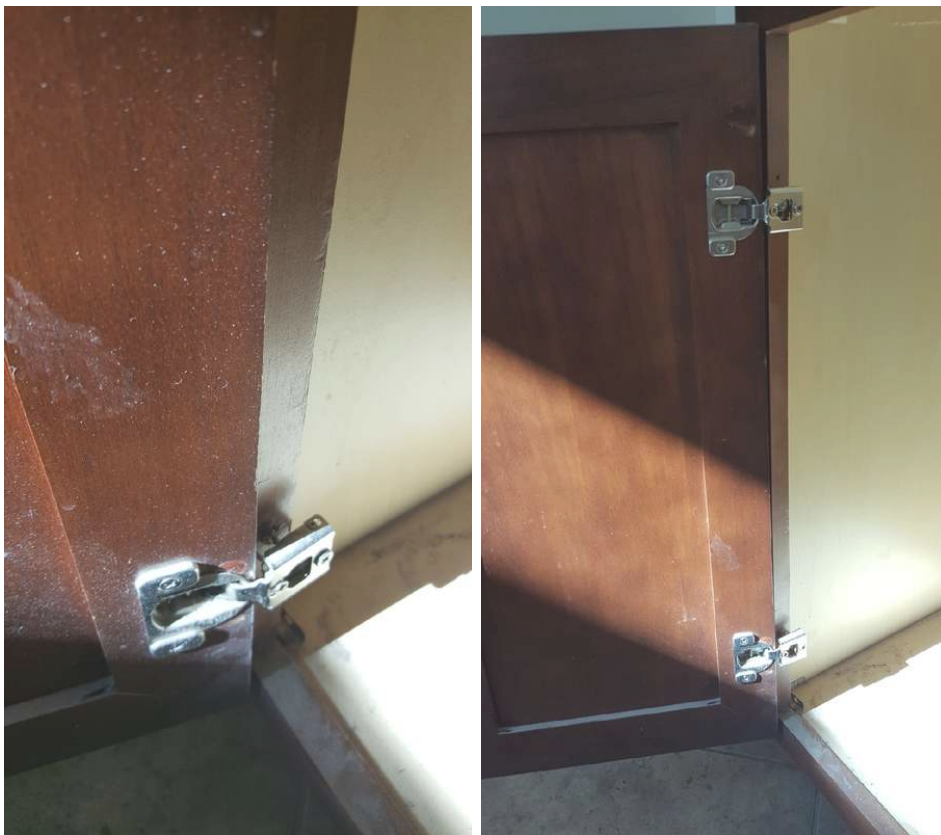
10.6.3 Countertops & Cabinets

CABINET DOOR HINGE LOOSE

A cabinet in this bathroom had a loose door hinge.

Recommendation
Contact a qualified professional.

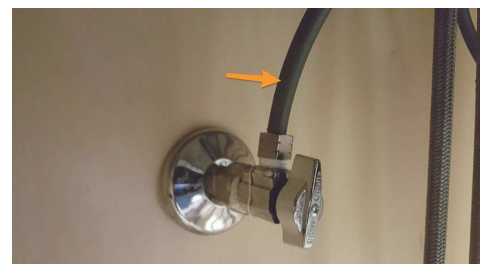
11.1.1 Kitchen Sinks

RECOMMEND UPGRADING WATER SUPPLY LINES

Recommend upgrading the flexible plastic water supply lines to a braided stainless steel water supply line for added protection against leakage and/or breaks.

Recommendation
Contact a qualified professional.
