SUMMARY

1234 Main St. Tempe Arizona 85282

Buyer Name
01/03/2019 9:00AM

Scott Alack
AZ License # 67432
The Dwelling Inspector
480-773-5435
scott@thedwellinginspector.com

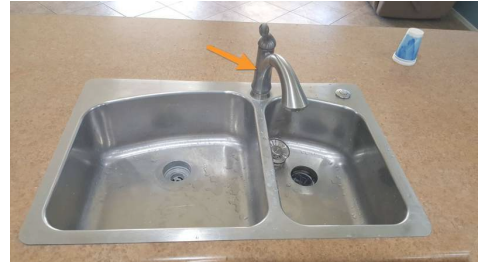
11.1.2 Kitchen Sinks

FAUCET DID NOT SWIVEL

Contact a handyman or DIY project

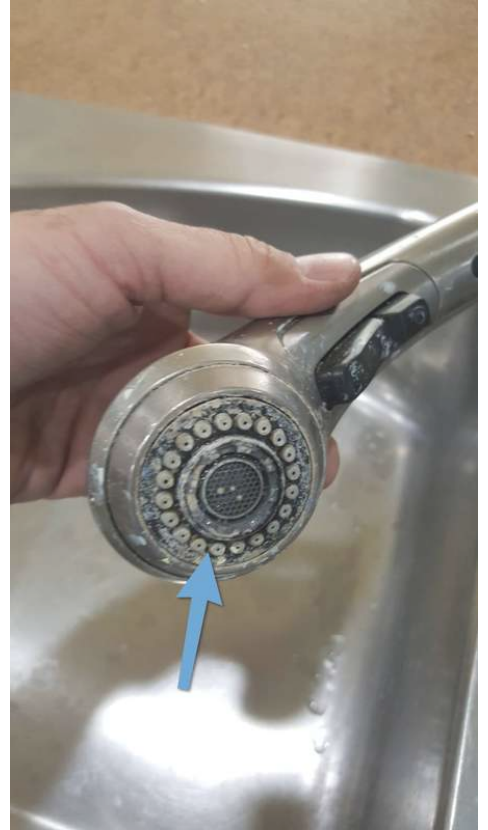
11.1.3 Kitchen Sinks

FAUCET HAD EXCESSIVE CORROSION OR BUILD-UP

Contact a handyman or DIY project

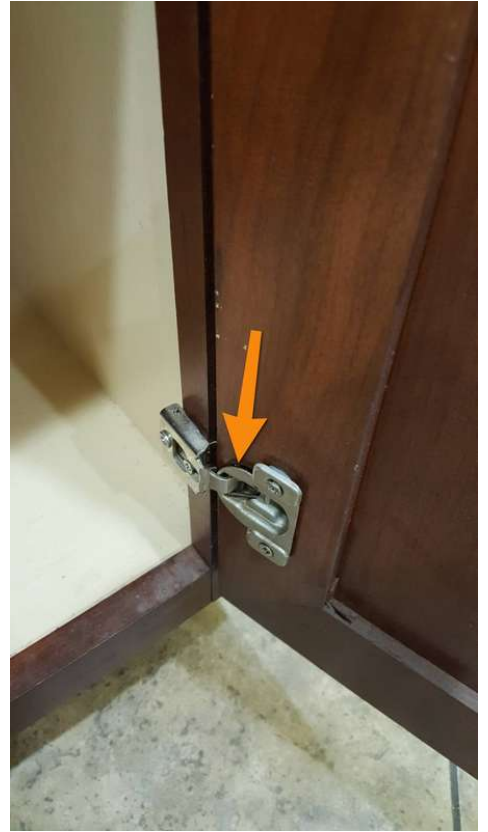
11.2.1 Kitchen Countertops & Cabinets

CABINET HINGE LOOSE

Contact a handyman or DIY project

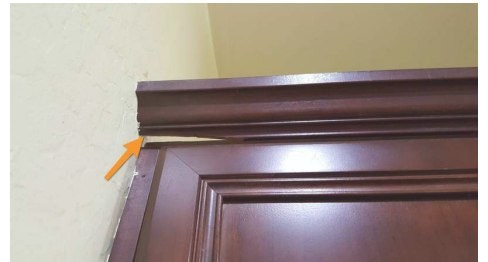
11.2.2 Kitchen Countertops & Cabinets

**CABINET- MINOR
DAMAGE/DETERIORATION**

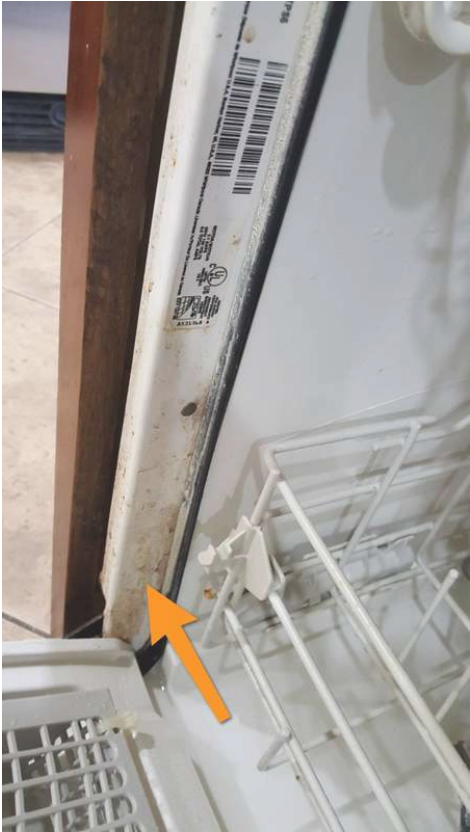
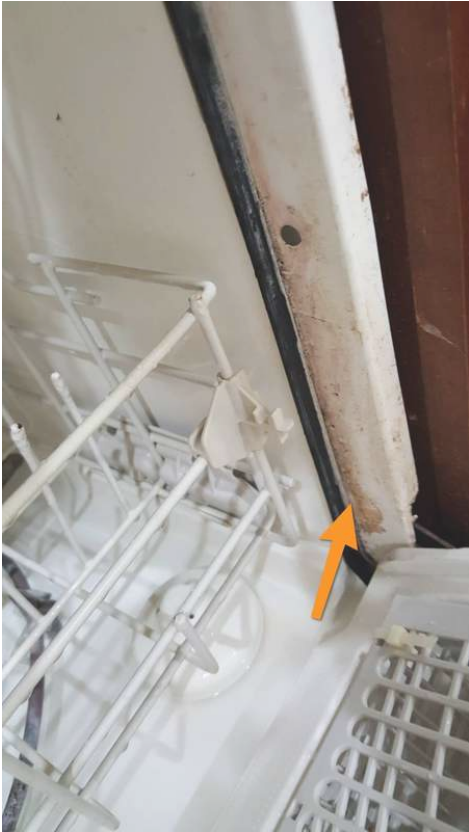
Rust or discoloration was present at the interior of the dishwasher walls and/or racks that are an indication of wear, age or other defects. The dishwasher may be an older component and the future life expectancy cannot be determined. you can continue to use and service this component until replacement is necessary.

Recommendation
Recommend monitoring.

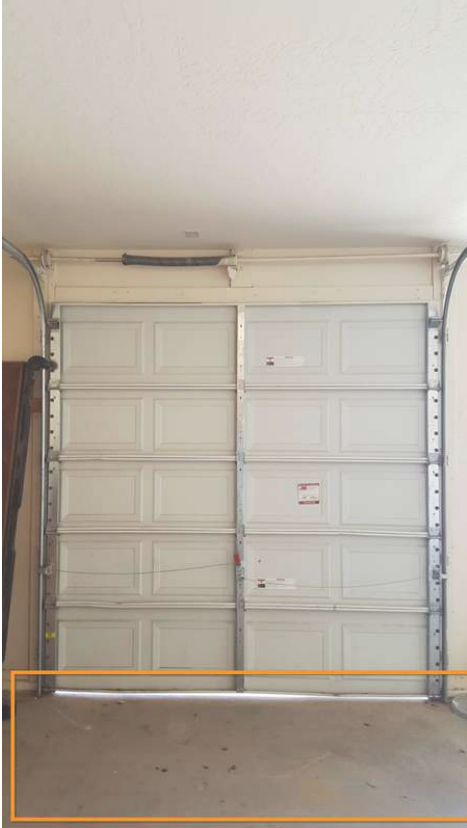
Garage floor shows visible staining from oil/grease and paint. Recommend scrubbing with a degreaser or cleaning solution.

Recommendation
Recommended DIY Project

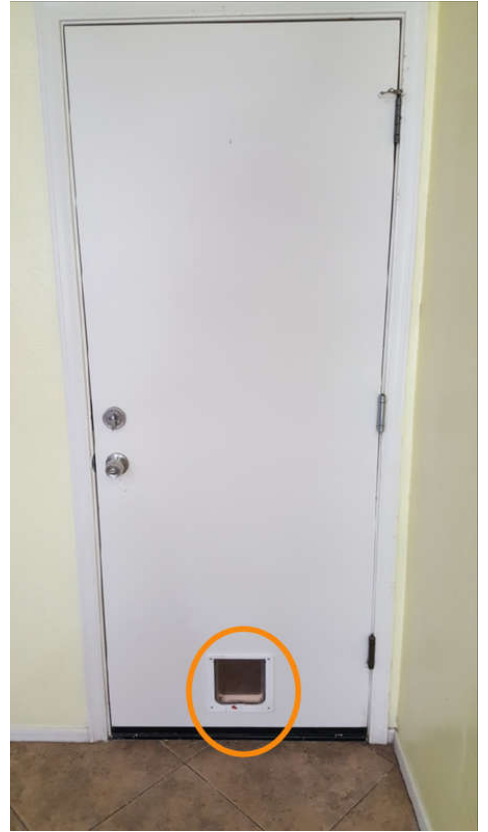
12.5.1 Door to Living Space
DOOR DOES NOT MEET SEPARATION REQUIREMENTS

Door separating garage and home does not meet safety standards. Doors in firewalls must be at least 1 3/8-inch thick, metal/steel, or a 20-minute fire-rated door.

Recommendation
Contact a qualified door repair/installation contractor.

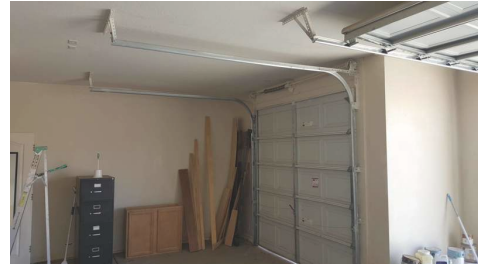
12.7.1 Overhead Garage Door(s)

STICKING

Contact a qualified garage door contractor.

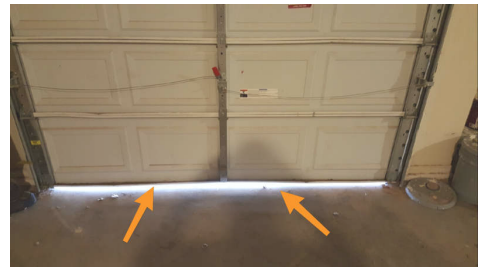
12.7.2 Overhead Garage Door(s)

MISSING WEATHER STRIPPING

Contact a qualified garage door contractor.

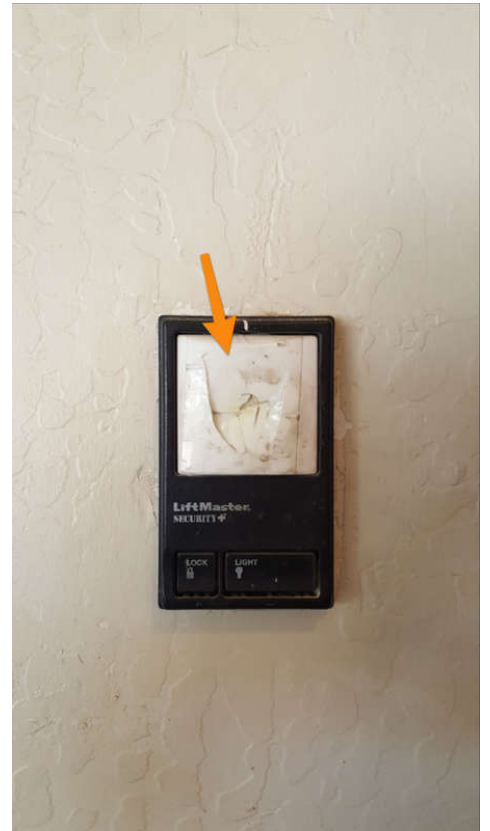
12.8.1 Automatic Opener(s)

AUTOMATIC GARAGE DOOR SWITCH WAS DAMAGED

Contact a qualified garage door contractor.

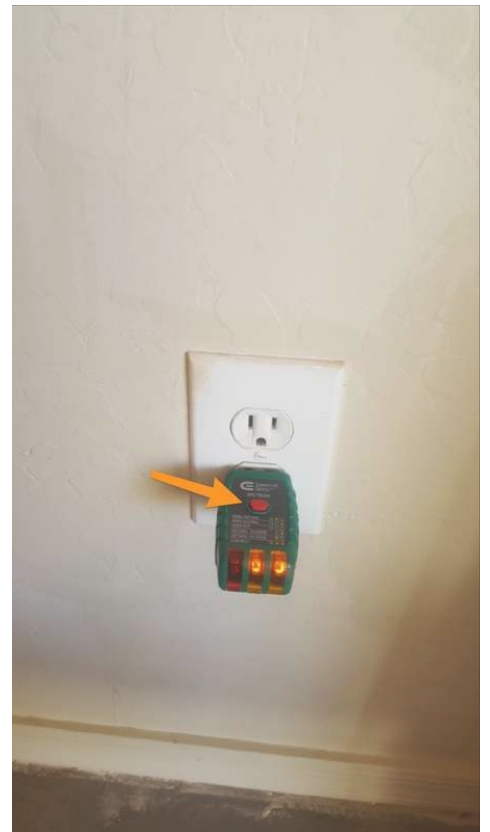
12.10.1 Garage Electrical Notes

GARAGE OUTLET WAS NOT GFCI PROTECTED

This Outlet located in the garage on the South Wall was not GFCI protected as required. Recommended electrical contractor for evaluation and correction.

Recommendation
Contact a qualified electrical contractor.
