SUMMARY 1234 Main St.Palm Beach Gardens **NCO** Florida 33410 INSPECTIONS Buyer Name 07/29/2018 9:00AM

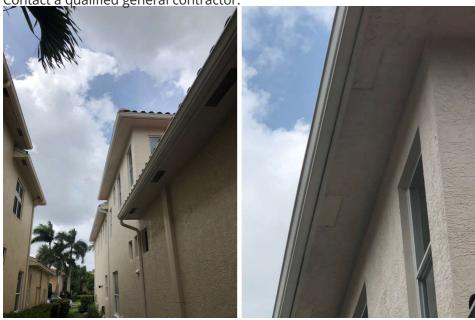
2.3.1 SOFFITS AND FASCIA SOFFIT VENTS (PAINTED)

There are areas of the soffit vents that have been painted/taped over restricting the air flow to the attic as designed. recommend repair/replace the vents to provide appropriate air flow.

Recommendation Contact a qualified general contractor.

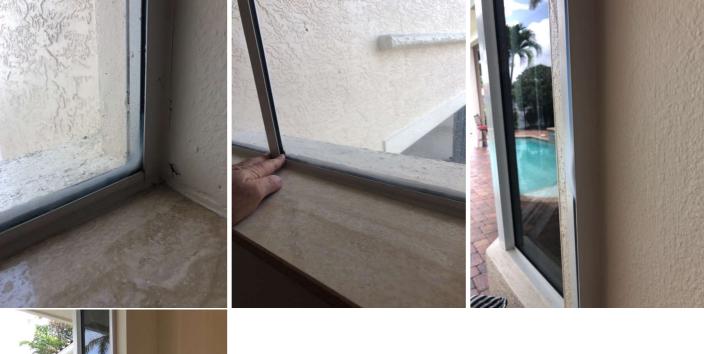
2.6.1 WINDOWS AND SCREENS EXTERIOR WINDOWS (DELAMINATION)

There are windows that show delamination between the panes of glass and will require replacement

Contact a qualified professional.

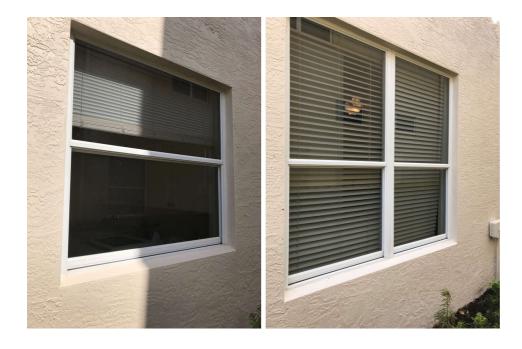
2.6.2 WINDOWS AND SCREENS WINDOW SCREENS (MISSING)

There are missing exterior window screens (not inventoried)

Recommendation Contact a qualified window repair/installation contractor.

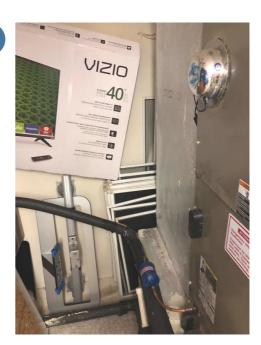
2.6.3 WINDOWS AND SCREENS **EXTERIOR WINDOW SCREENS**

Exterior window screens have been removed and were noted to be stored. The window screens are not inventoried or inspected as part of the inspection if they have been removed.

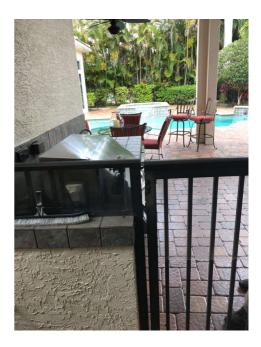
2.9.1 GATES AND FENCING GATE LATCH (BINDING)

The Gate Latch is binding and will need service or repair

Recommendation Contact a qualified fencing contractor

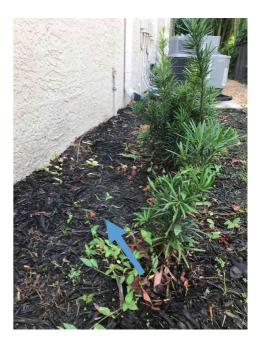
IRRIGATION MAINTENANCE

Recommend verify all irrigation heads are adjusted to prevent contact with the structure and watering areas that are not necessary for conservation.

Recommendation Contact a qualified lawn care professional.

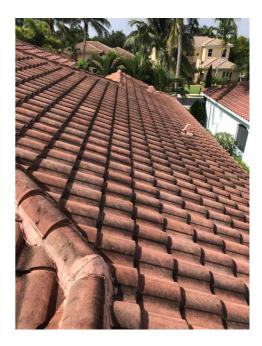
CLEANING (MAINTENANCE)

The roof surface will require a full maintenance cleaning.

Recommendation Contact a qualified roofing professional.

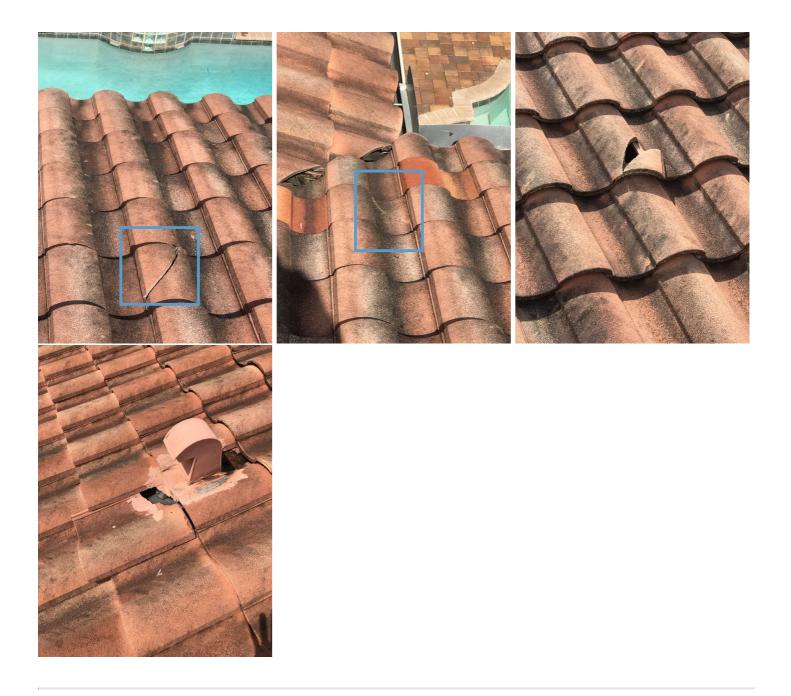
3.1.3 ROOF COVERINGS TILE ROOF (CRACKED)

There are cracked roof tiles in various areas of the surface, these are typically considered cosmetic in nature with no signs of visible leaks as a result

Recommendation Contact a qualified roofing professional.

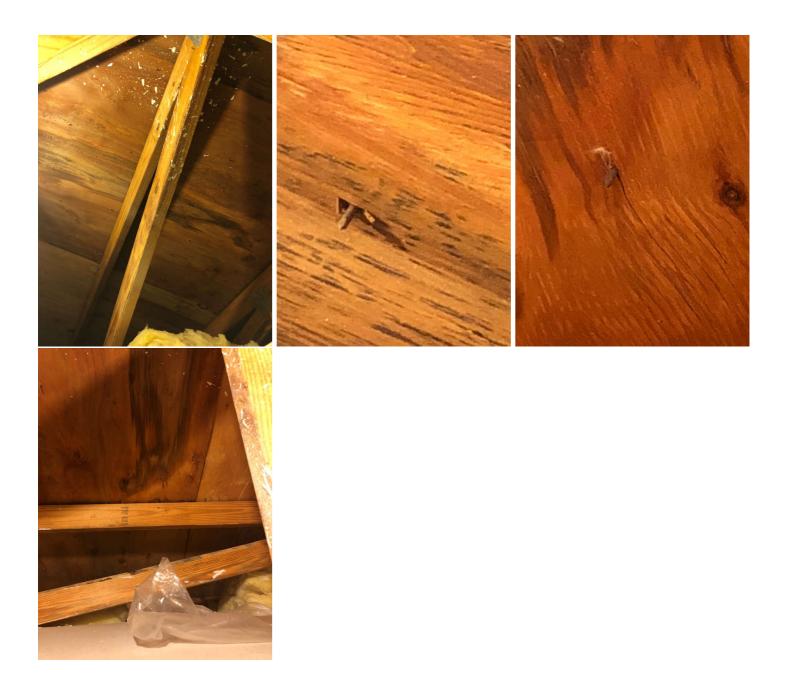
3.3.1 Evidence of Leaks (past or present) **EVIDENCE OF PREVIOUS LEAKS**

There is visible evidence that there have been previous weeks. While no active moisture was detected in these areas at the time of inspection and all areas were not fully visible. This is typically an indication that repairs have either been performed or me need performance in the future

Recommendation Contact a qualified professional.

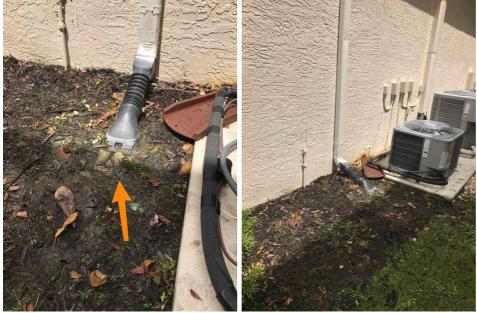
4.1.2 Gutters, Leaders and Downspouts **RESTRICTED LEADER**

The gutter leader is restricted by grading and vegetation

Recommendation Contact a qualified professional.

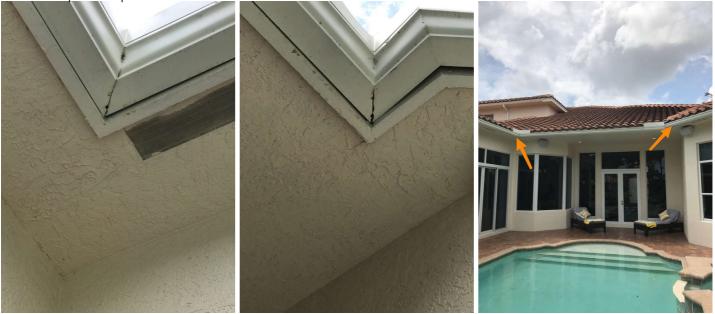
4.1.3 Gutters, Leaders and Downspouts **GUTTERS (SEAM LEAKS)**

There are multiple areas of the gutter seems that are leaking and require maintenance re-sealing

Recommendation Contact a qualified professional.

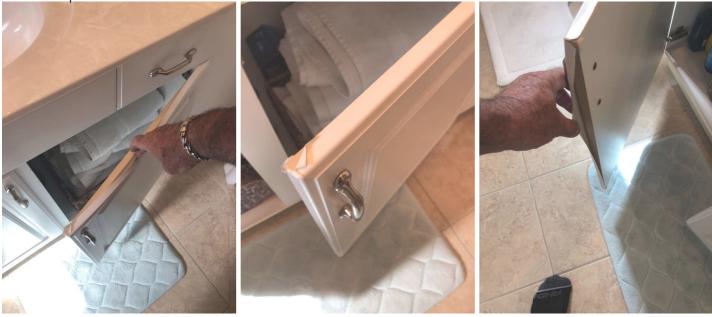
GUEST BATHROOM

6.2.1 COUNTERS AND CABINETS THERMOFOIL CABINETS (MAJOR DELAMINATION)

There are areas of the thermofoil cabinets that have major areas of delamination that will likely require replacement

Recommendation Contact a qualified cabinet contractor.

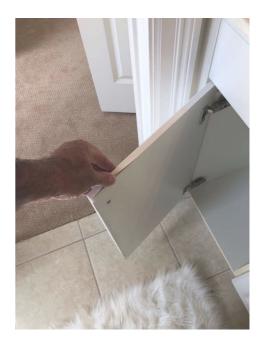
6.2.2 COUNTERS AND CABINETS **THERMOFOIL CABINETS (MINOR DELAMINATION)** GUEST BATHROOM

There are areas of the thermofoil cabinets that are delaminating at the edges. These areas should be repaired to prevent further damage.

Recommendation Contact a qualified cabinet contractor.

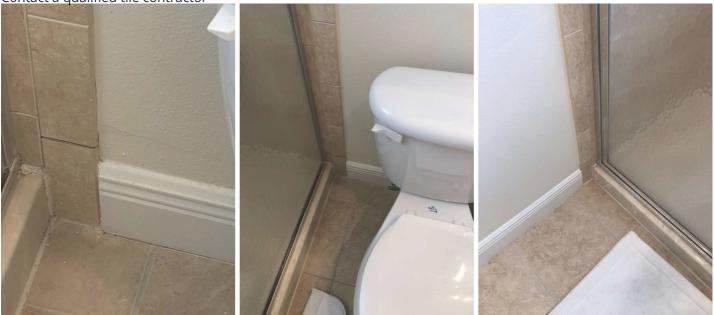
RIGHT SIDE REAR UPSTAIRS GUEST BATHROOM

6.3.1 SHOWERS AND BATHS SHOWER WALL (LOOSE TILE)

Multiple areas of the bathroom shower have loose tiles, this indicates the tiles have lost the bond to the substrate likely due to water intrusion, possible hidden damage behind the tiles is likely.

Recommendation Contact a qualified tile contractor

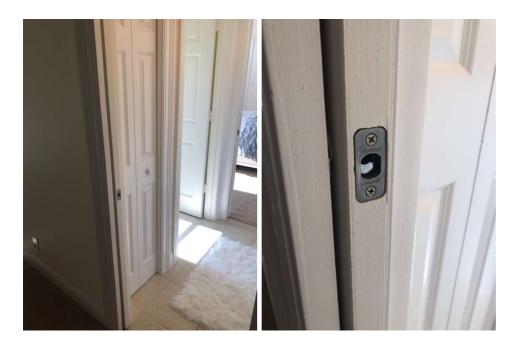
UPSTAIRS GUEST BATHROOM RIGHT SIDE

6.4.1 DOORS and HARDWARE POCKET DOOR (BROKEN LATCH)

The pocket door latch is physically damaged and does not operate

Recommendation Contact a qualified professional.

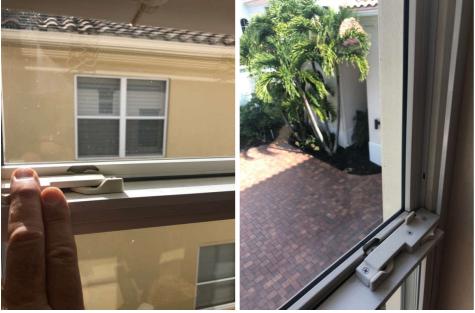
6.5.1 WINDOWS INTERIOR WINDOW TRIM

The plastic trim on the interior windows is deteriorating in several areas. While this may not effect performance it is a cosmetic failure

Recommendation Contact a qualified professional.

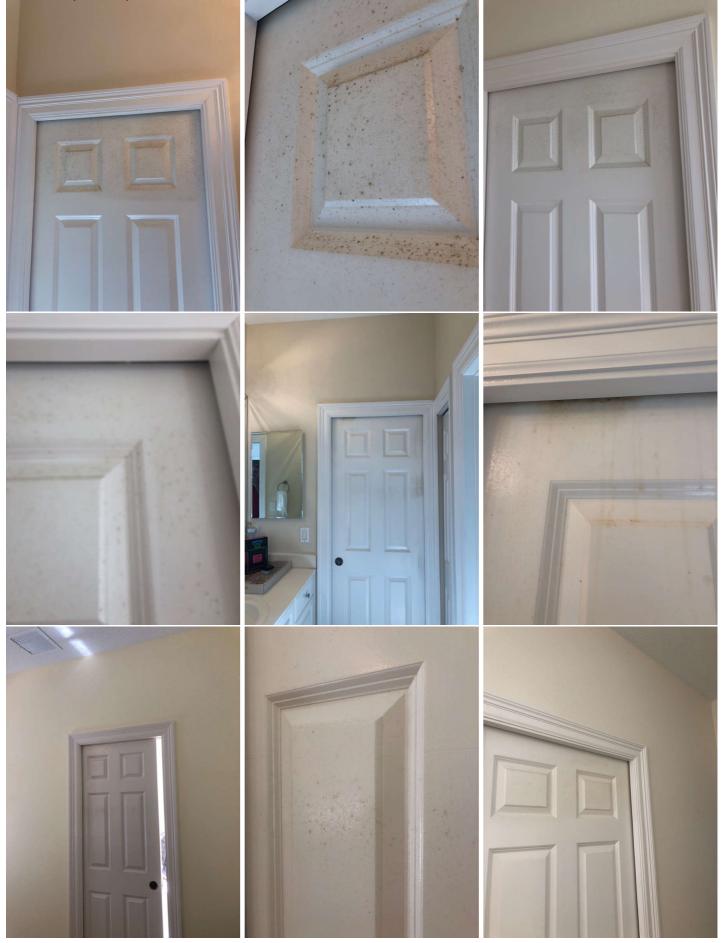
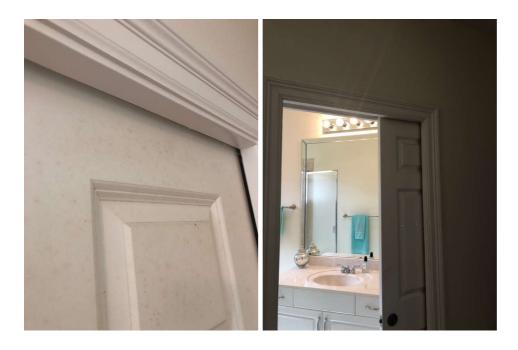
GUEST BEDROOM GUEST BATHROOM UPSTAIRS RIGHT SIDE

6.6.1 EVIDENCE OF MOISTURE OR MOLD VISIBLE MOLD (NO ACTIVE MOISTURE)

There is visible mold or indications of mold on the interior of the home. There is no active moisture in the area at the time of inspection. However this does indicate either a previous moisture event, or excessive humidity in the area has occurred. It is highly recommended that a fall mold assessment be performed, to determine the extent of damage in the proper course of repair

Recommendation Contact a qualified professional.

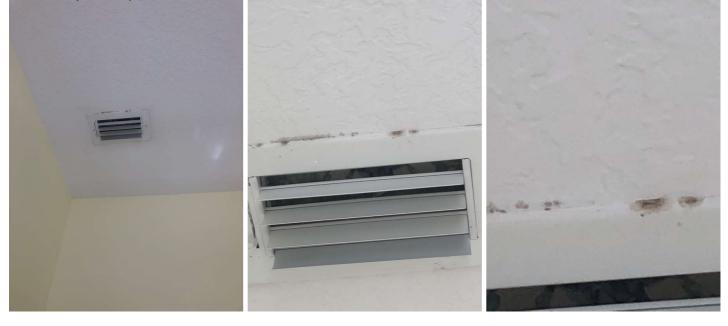
GUEST BATHROOM UPSTAIRS RIGHT SIDE

6.6.2 EVIDENCE OF MOISTURE OR MOLD **VISIBLE MOLD (AC REGISTERS)**

There is visible mold around the AC registers. While no active moisture was detected in these areas at the time of inspection, this indicates a previous moisture event. This could be as a result of condensation forming on the metal registers, however the specific cause could not be determined. Recommend further evaluation to determine the specific cause and course of repairs

Recommendation Contact a qualified professional.

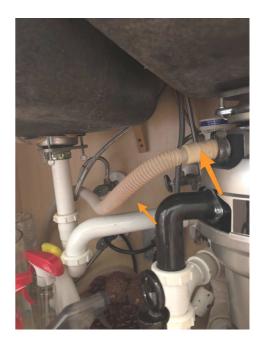
7.1.1 DISHWASHER DISHWASHER DRAIN (HIGH LOOP)

The dishwasher drain line should be routed with a high loop to the drain connection to prevent potential odor

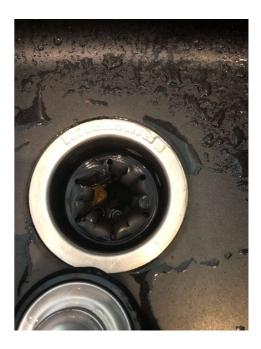
7.3.1 FOOD WASTE DISPOSER DISPOSAL (SPLASH GUARD)

The garbage disposal splash guard is missing/damaged and will require replacment.

Recommendation Contact a qualified appliance repair professional.

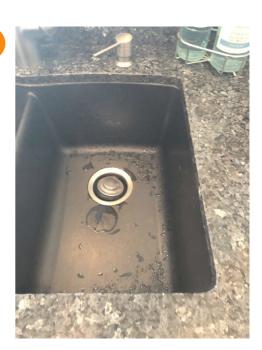
7.3.2 FOOD WASTE DISPOSER DISPOSAL (NOISY OPERATION)

The disposal is noisy during operation and will require service/repair or replacement

Recommendation Contact a qualified appliance repair professional.

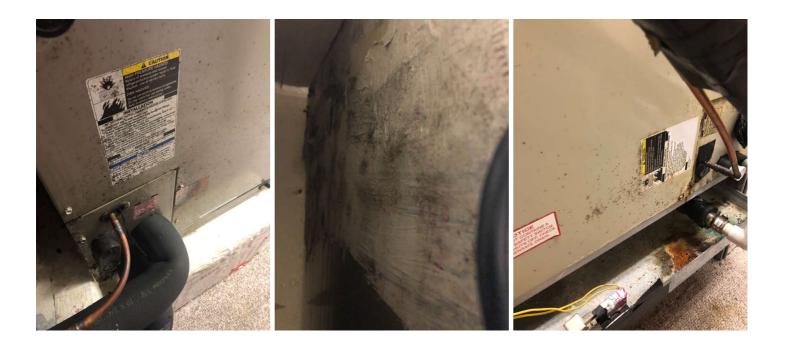
MOLD

There is visible mold around the plenum and the air handler in the garage. Recommend for maintenance service, cleaning and evaluation

Recommendation Contact a qualified professional.

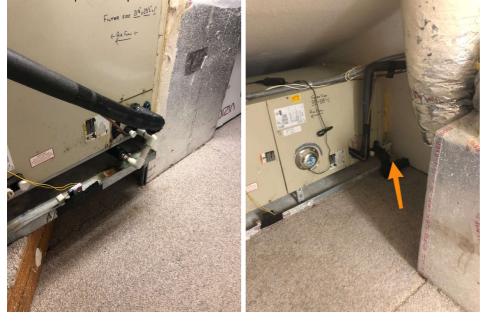
INSTALL OVERFLOW

Recommend installation of an inline condensate overflow switch. This is a safety device that helps to prevent damage due to an overflow of the condensate drain pan. Recommendation

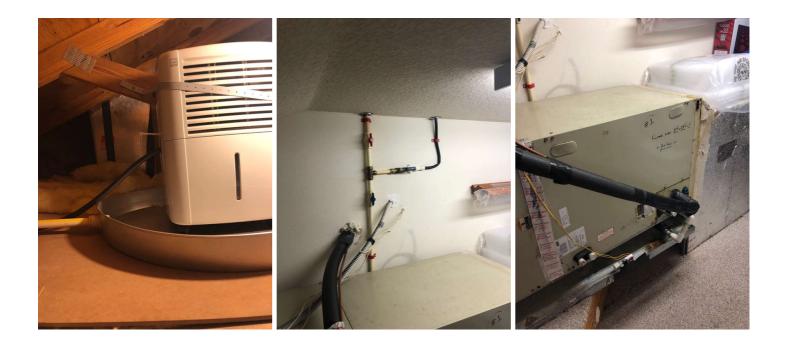
10.6.1 CONDENSATION/DRAINAGE SYSTEMS CONDENSATE DRAIN (MODIFIED)

The AC condensate drain has been modified to tie in with a drain for the attic mounted aftermarket installed dehumidifier. It was noted there was audible noise from the drain pan in the attic unit while the AC system that it is connected to was operating.

Recommendation Contact a qualified professional.

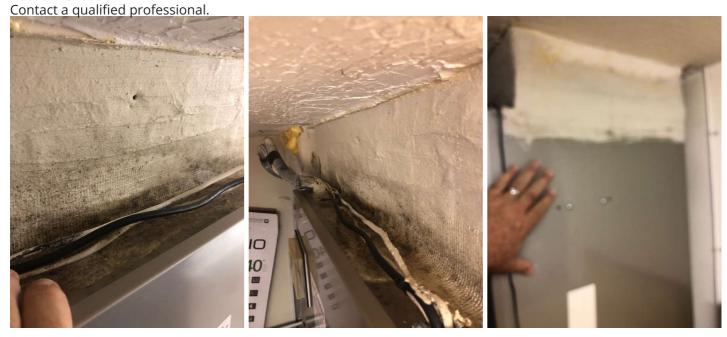
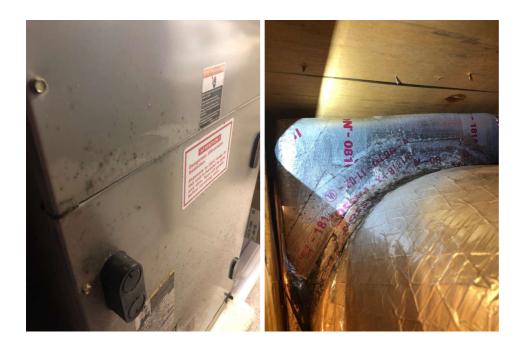
10.7.1 DISTRIBUTION SYSTEMS AC PLENUM/AIR HANDLER (CONDENSATION BUILDUP)

There is notable condensation buildup on the AC Plenum and air handler. This may indicate improper Insulation, These areas have notable visible organic growth and active moisture. The system will require maintenance service, cleaning, and periodic maintenance. The notable air leaks should be resolved and the Plenum properly insulated to prevent further damage

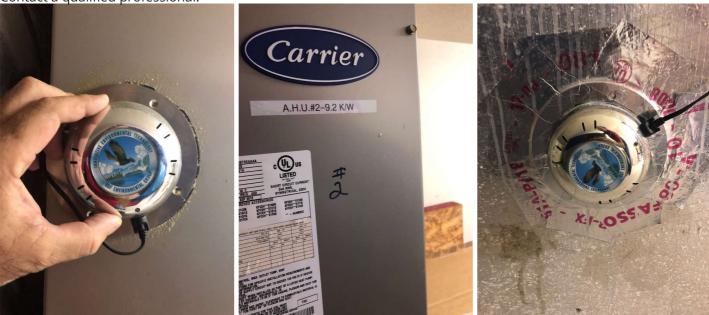
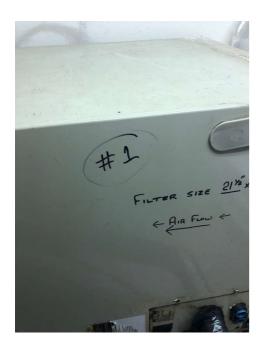
10.9.1 OPTIONAL COMPONENTS UV LIGHT NUMBER ONE AND NUMBER TWO UNIT

The UV light system is apparently inoperative And will require repair/replacement for further diagnosis

Recommendation Contact a qualified professional.

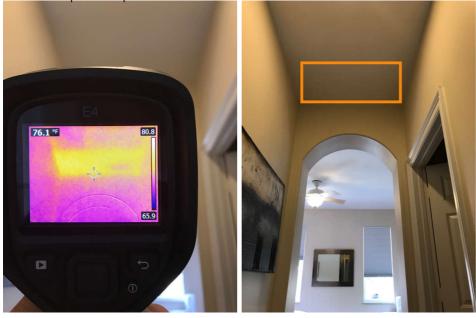
RIGHT FRONT GUEST BEDRM

11.1.1 INSULATION AND THERMAL SCANS **MISSING**

The majority of the attic insulation is missing, is damaged or improperly installed. Recommend full evaluation to properly insulate the attic.

Recommendation Contact a qualified professional.

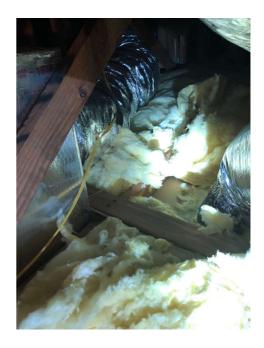
11.1.2 INSULATION AND THERMAL SCANS INSULATION (OUT OF POSITION)

There are areas of the insulation in the attic that are out of position and will need to be properly re-applied to provide proper coverage

Contact a qualified professional.

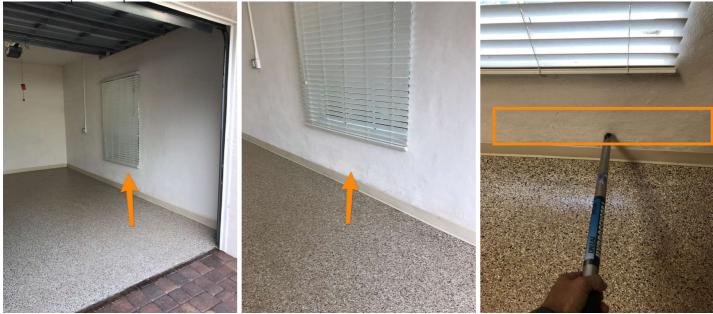
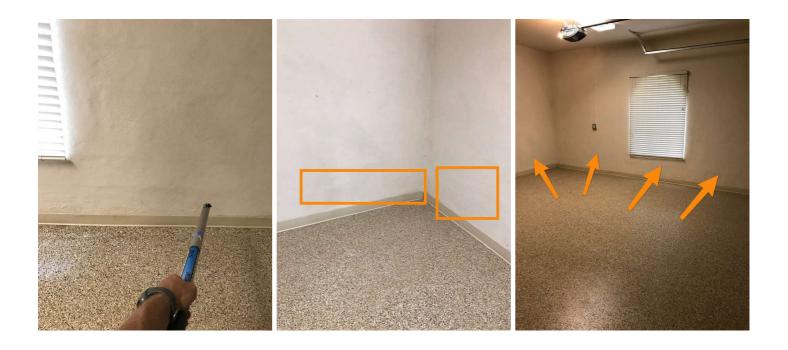
13.2.1 GARAGE WALLS **MOISTURE DAMAGE**

There is visible moisture damage at the right hand side front of the garage wall. The source of the moisture cannot be determined. There is visible areas of peeling or bubbling paint.

Recommendation <u>Contact a qualified professional.</u>

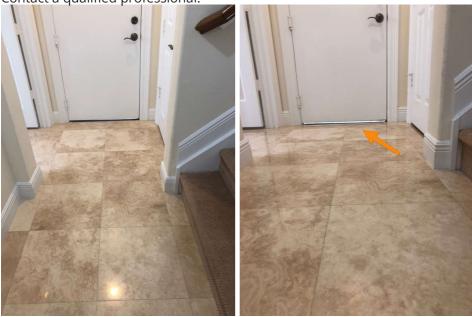
WEATHERSTRIP MISSING

The weatherstrip at the threshold for the garage pedestrian entry door is missing in the door does not properly seal

Recommendation Contact a qualified professional.

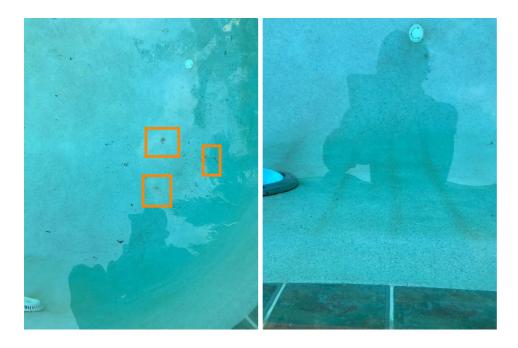
15.1.1 GENERAL CONDITION AND NOTES **STAINING AND DISCOLORATION**

The pool surface shows multiple areas of staining and discoloration.

Recommendation Contact a qualified Swimming Pool Contractor

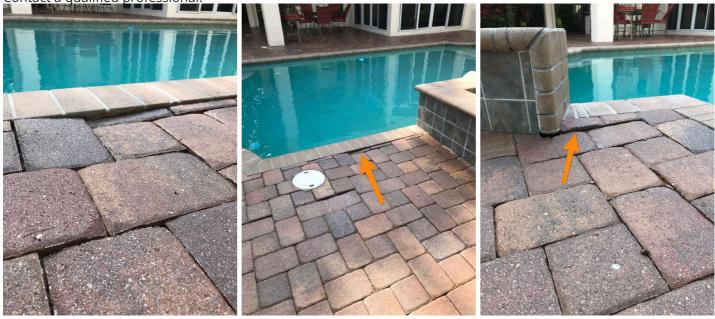
15.4.1 POOL DECK AND COPING BRICK PAVER SETTLEMENT

There are multiple areas of uneven surfaces on the brick pavers around the pool. Specifically around the skimmer, the paver is loose and creates a potential trip hazard. Recommend removal of the pavers identifying the cause and repair

Recommendation Contact a qualified professional.

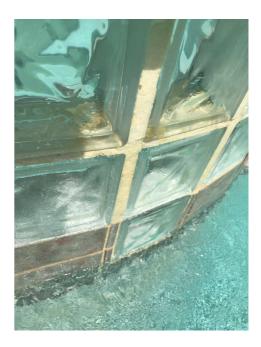
15.4.2 POOL DECK AND COPING GLASS BLOCK (MORTAR) POOL WATERFALL

Moisture penetration and deterioration of grout glass block of waterfall. Recommend replair of grout to prevent further deterioration.

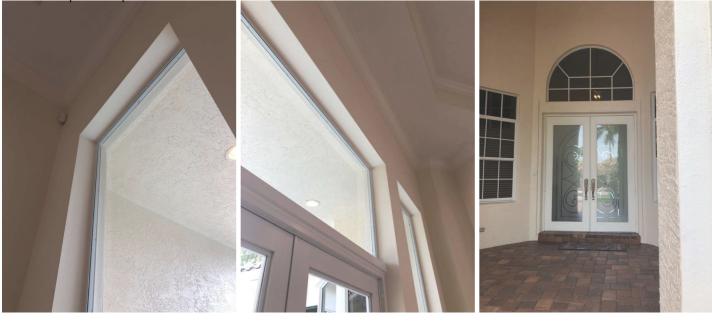
16.1.1 Impact Rating Information IMPACT RATING INFORMATION

There are multiple areas of the impact rating information/stickers that have either been partially removed, or are missing. The stickers are required to verify compliance with large missile impact rating for insurance purposes

Recommendation <u>Contact a qualified professional.</u>
