SUMMARY
1234 Main St. Centralia WA 98531
Buyer Name
05/01/2019 9:00AM

Eric Corder
Licensed Inspector #2231
Cornerstone Northwest Inspections, LLC
(360) 970-4882
cornerstonenwi@gmail.com

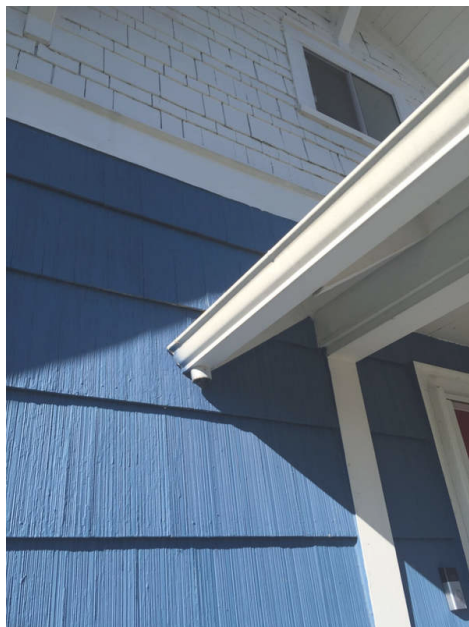
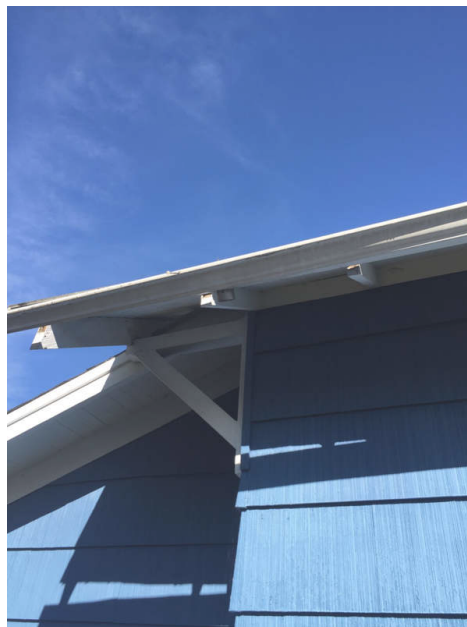
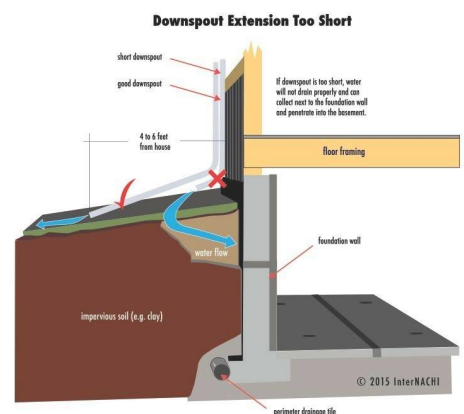
ENTIRE HOME EXCEPT THE VERY REAR

DOWNSPOUTS MISSING

Home was missing downspouts in one or more areas. This can result in excessive moisture in the soil at the foundation, which can lead to foundation/structural movement. Recommend installation of downspouts and extensions that drain at least 6 feet from the foundation.

Contact a handyman or DIY project

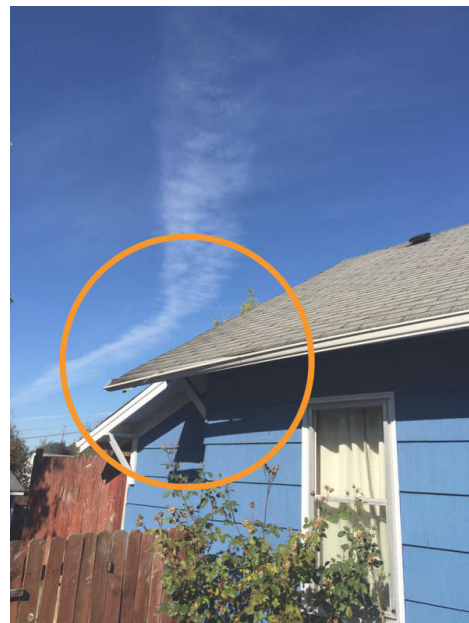
BACK LEFT OF HOME

GUTTER DAMAGED

Gutters were damaged. This can result in excessive moisture in the soil at the foundation, which can lead to foundation/structural movement. Recommend repair.

Contact a handyman or DIY project

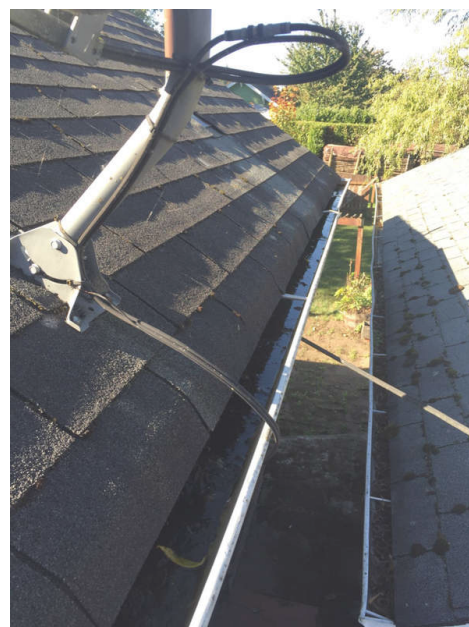
BACK RIGHT SIDE OF HOME

GUTTER IMPROPERLY SLOPED

Gutters are improperly sloped in areas, which could result in runoff drainage over the edge of gutter, placing water next to the home. Recommend adding additional downspout to the rear of home on the right.

Contact a handyman or DIY project

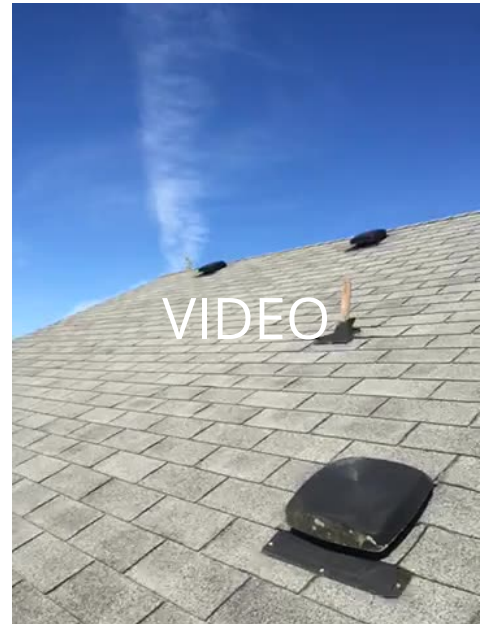
EXPOSED NAIL HEADS

Roof vents have exposed nail heads. This can allow water penetration over time. Recommend a dab of silicone caulk to seal. Most roof vents on the home have this condition.

Contact a handyman or DIY project

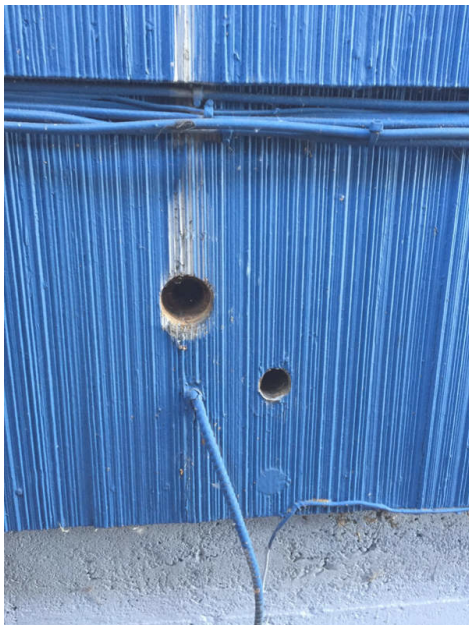
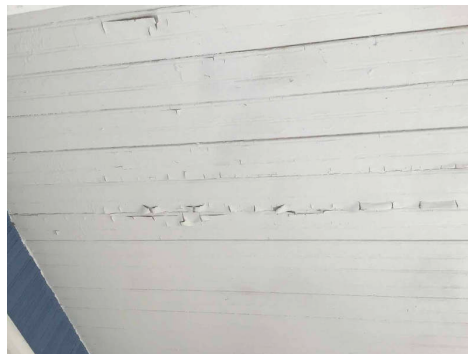
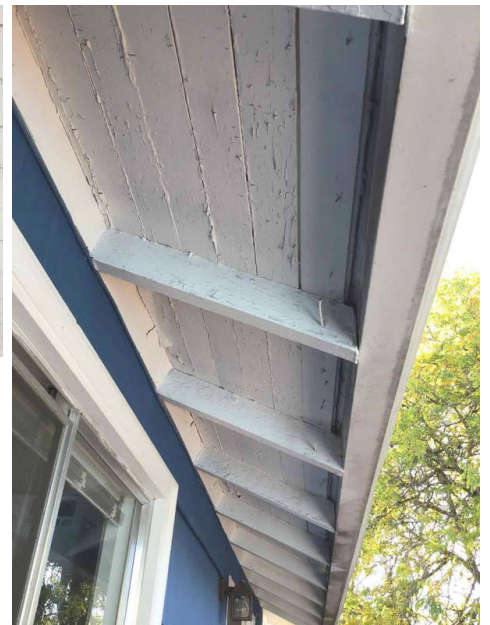
CAULKING NEEDED

Soffit needs scraping, caulking, and painting. Lack of caulking will allow moisture intrusion, which leads to wood rot and other structural moisture issues. Recommend scraping, caulking, and painting. Also recommend filling holes below electric panel. Moisture will get into the wall structure and cause damage. Recommend filling and painting.

Contact a handyman or DIY project

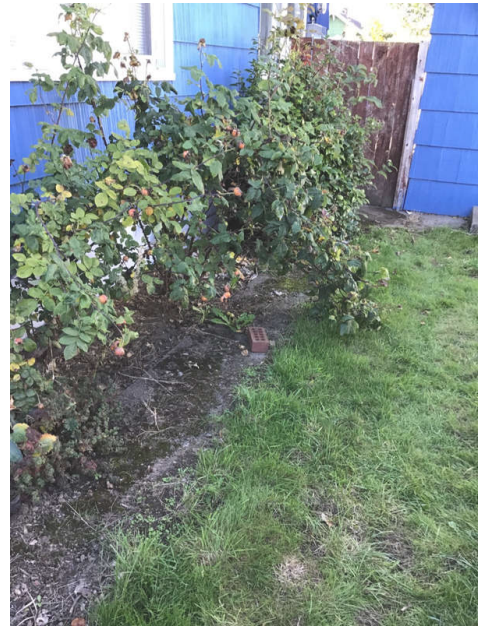
VEGETATION OVERGROWING WALKWAY

Vegetation is over growing walkway. Recommend trimming to prevent tripping.

Recommendation
Recommended DIY Project

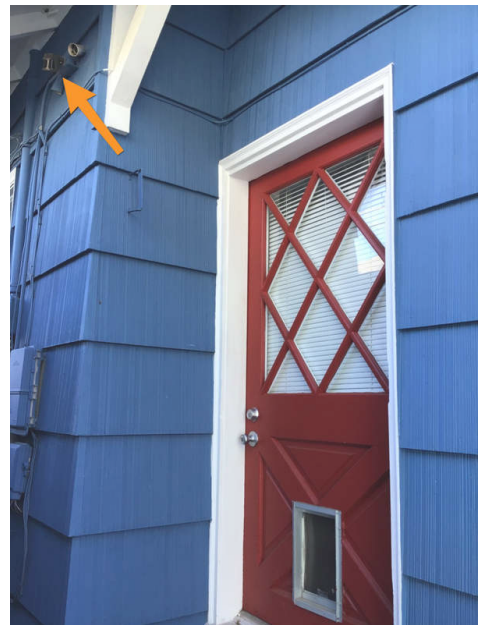
NO EGRESS LIGHTING

No operable egress lighting by side door. All exit doors should have functioning lighting. May need bulbs replaced in fixture.

Contact a handyman or DIY project

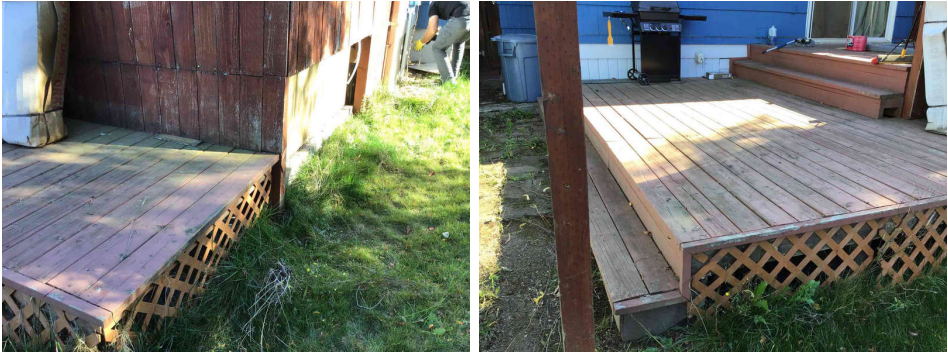
DECK - WATER SEALANT REQUIRED

Deck is showing signs of weathering and/or water damage. Recommend water sealant/ weatherproofing be applied.

Contact a handyman or DIY project

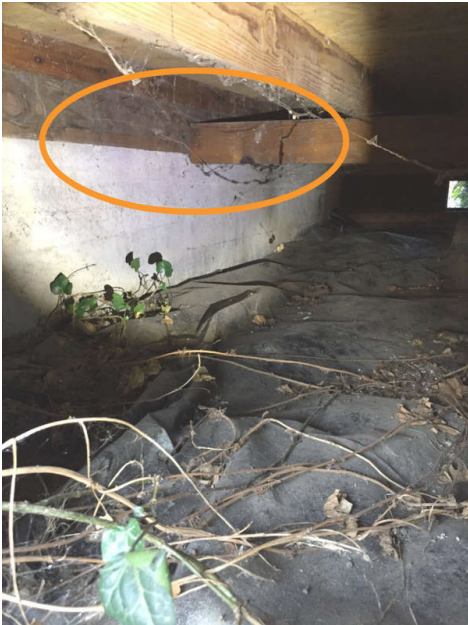
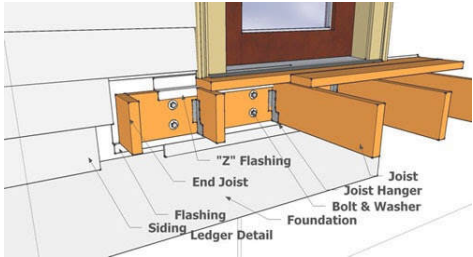
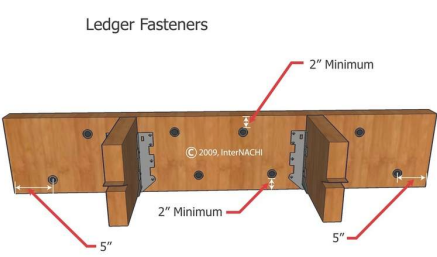
LEDGER BOARD IMPROPERLY INSTALLED

There is no ledger board attaching the front porch to the house. This can cause the deck to pull away from the building and possibly collapse. Recommend ledger board be properly installed and attach deck to it.

Recommendation
Contact a qualified deck contractor.

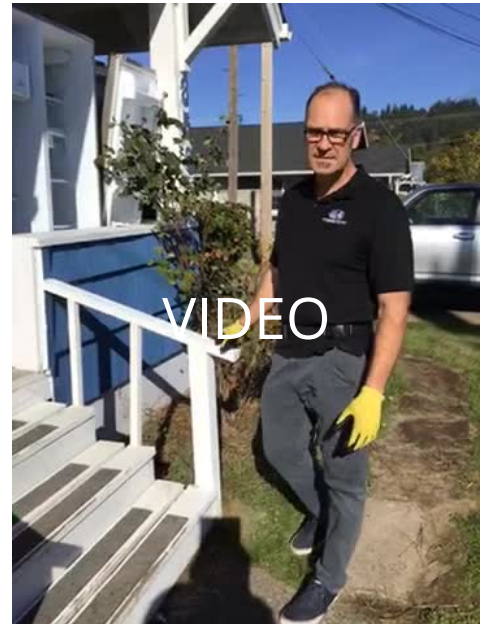
LOOSE HANDRAIL

Front stair handrails loose & too low. Recommend repairing and raising to 36" height.

Recommendation
Contact a qualified professional.

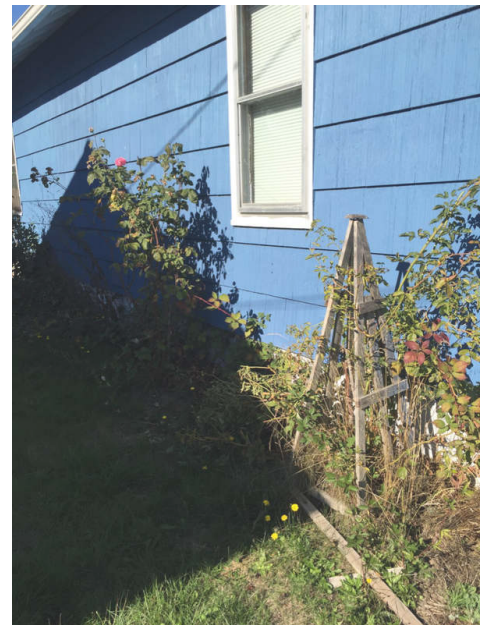
BOTH SIDES OF HOUSE

FOLIAGE TOO CLOSE TO EXTERIOR CLADDING.

This condition promotes moisture introduction to exterior cladding, which may cause material rot and decay. Recommend removal of all foliage within 1 feet of structure.

Contact a handyman or DIY project

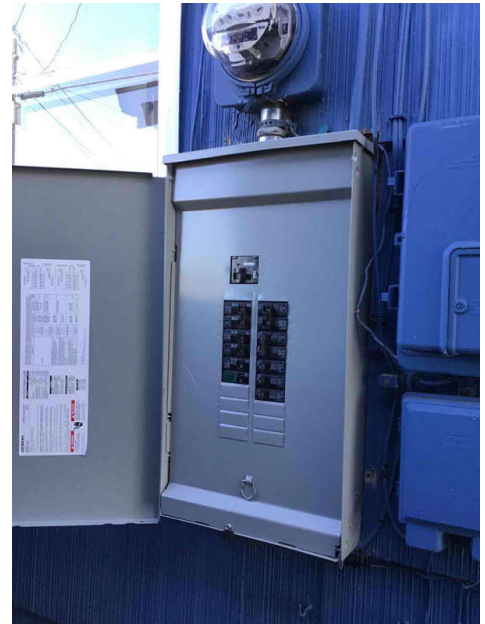
MISSING LABELS ON PANEL

At the time of inspection, panel was missing labeling. Recommend identification and map out locations.

Contact a qualified electrical contractor.

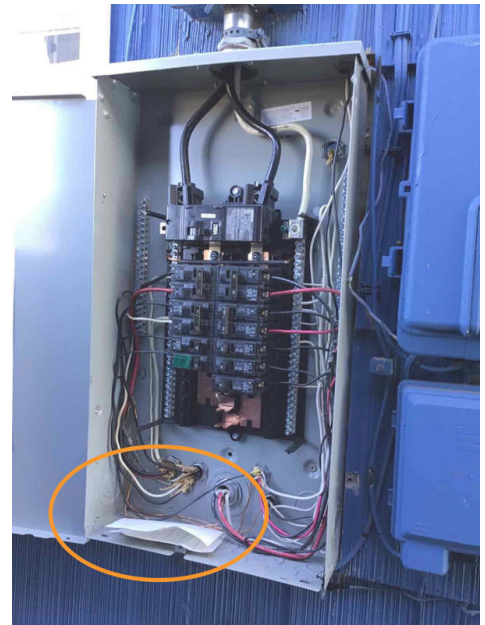
DEBRIS IN PANEL

Debris in panel is a fire hazard. Recommend removing labeling stickers from panel and using to label circuits.

Recommendation
Recommended DIY Project

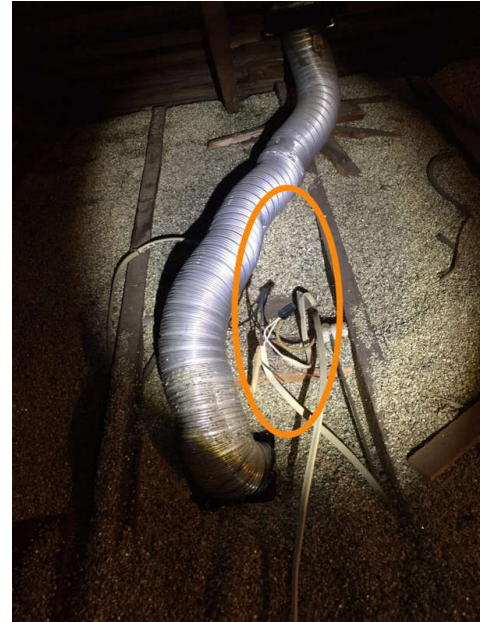
IMPROPER WIRING

These wiring connections should be in an electrical box. Recommend securing connections in a box for safety.

Recommendation
Contact a qualified electrical contractor.

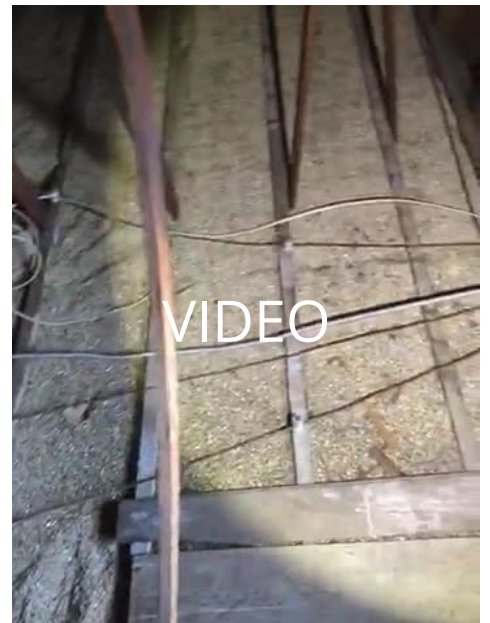
KNOB AND TUBE WIRING

Knob and tube wiring exists in most of the home. This is generally not a problem. The big problem with knob and tube wiring is there is no ground wire that keeps equipment and people safe and keep them from being shocked. I recommend evaluation by an electrician to ensure the home is safely wired.

Contact a qualified professional.

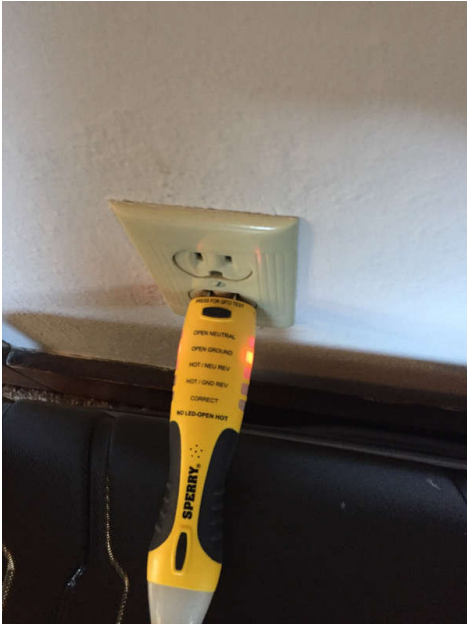
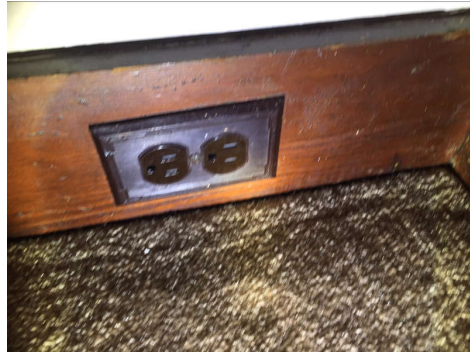
UNGROUND RECEPTACLE

All receptacles in the home are ungrounded. Home has original ungrounded, knob and tube wiring and a mixture of older, two slot and newer, two slot-with-ground receptacles. The electrical receptacles that have been replaced and look modern do not have a ground wire attached. Home has original interior ungrounded wiring and receptacles. To eliminate safety hazards to people and equipment, all receptacles should be grounded. Recommend evaluation and repair by licensed electrician.

Contact a qualified electrical contractor.

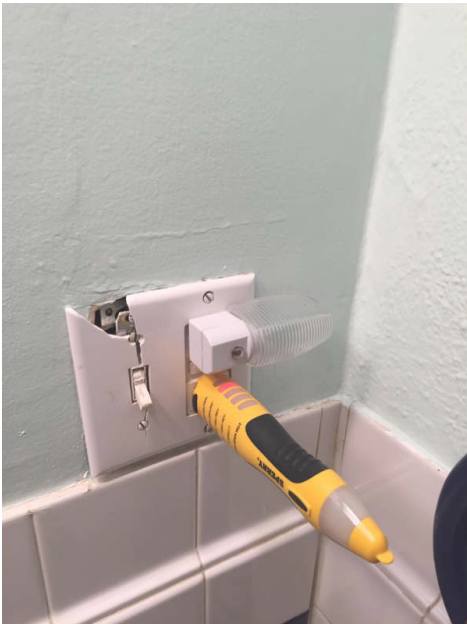
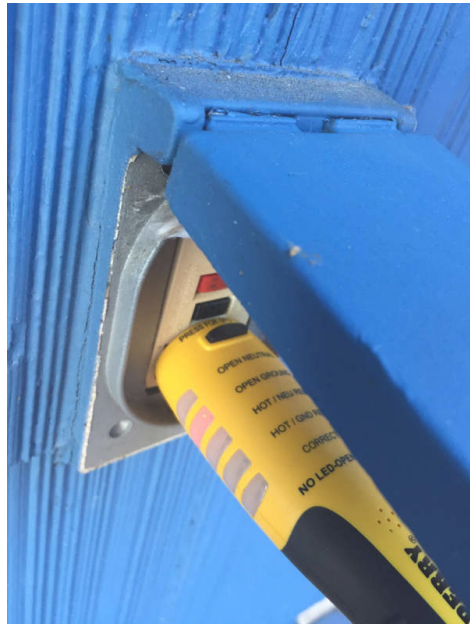
EXTERIOR PLUG NEAR HOT TUB, DOWNSTAIRS BATHROOM,

GFCI IMPROPER FUNCTION

GFCI outlet did not function as designed. It is also displaying an open ground fault, which means it is not grounded back to the panel. Recommend evaluation and repair/replace.

Contact a qualified electrical contractor.

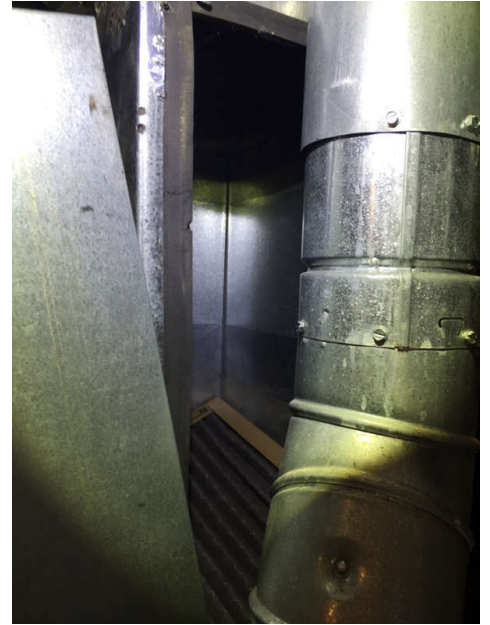
FILTER PLACEMENT

The furnace filter was placed precariously inside unit. Check manufacturers instructions for air filter placement. Recommend replacement.

Recommended DIY Project

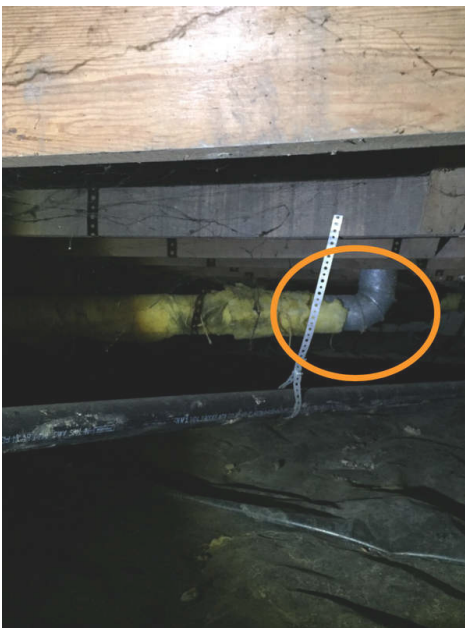
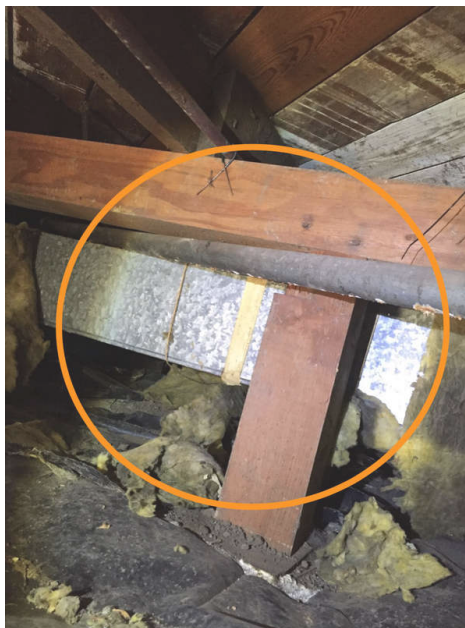
SUPPLY DUCTS NEED INSULATION

Supply ducts need insulation. You are losing heating efficiency...and money. Recommend Insulating all supply ducts.

Contact a handyman or DIY project

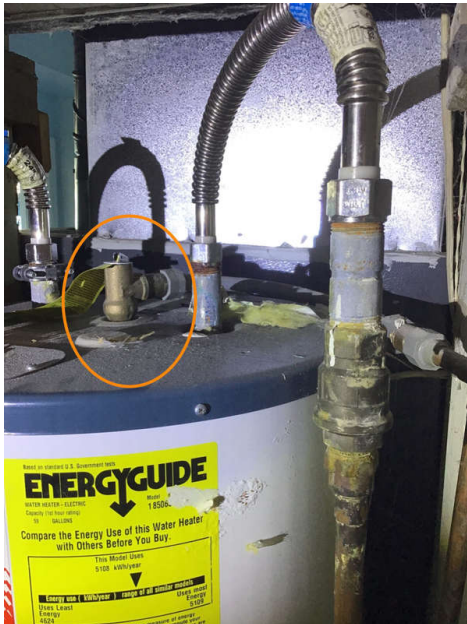
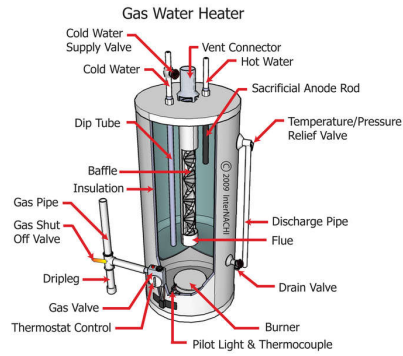
TPR VALVE DISCHARGE PIPE

Temperature Pressure Relief (TPR) valve discharge pipe is improperly installed/routed. Piping is undersized and does not terminate correctly. Recommend repair.

Contact a qualified plumbing contractor.

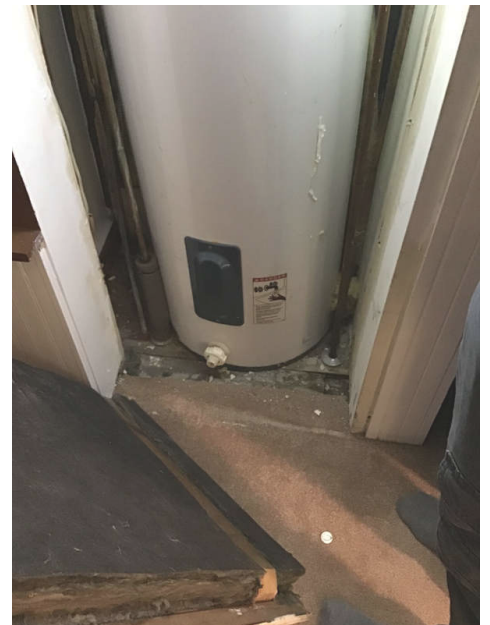
NO DRIP PAN

No drip pan was present. Recommend installation.

Contact a handyman or DIY project

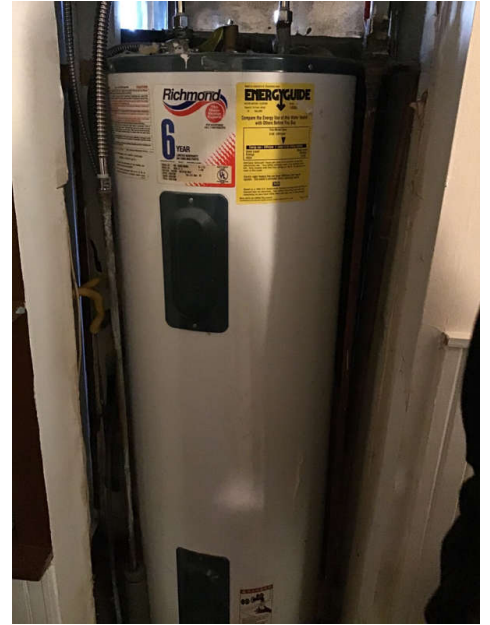
NO SEISMIC STRAPS

No seismic straps present. Recommend installing in accordance with standards.

Contact a handyman or DIY project

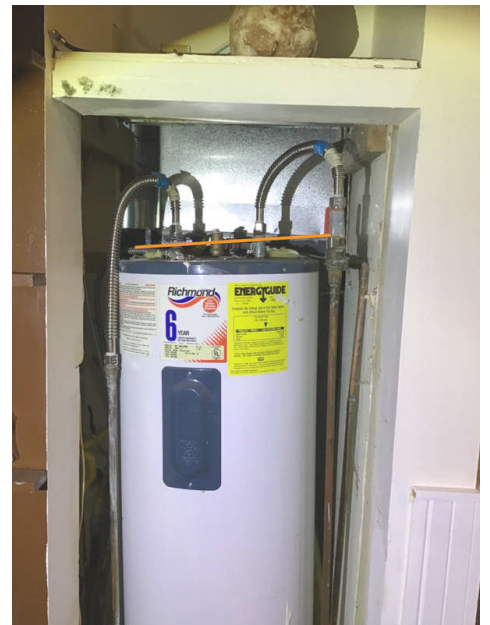
8.3.4 Hot Water Systems, Controls, Flues & Vents **NOT LEVEL**

Water heater is not level. Recommend leveling.

Contact a handyman or DIY project

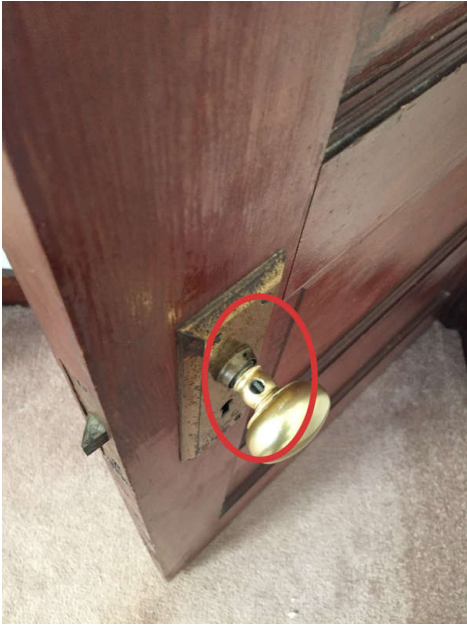
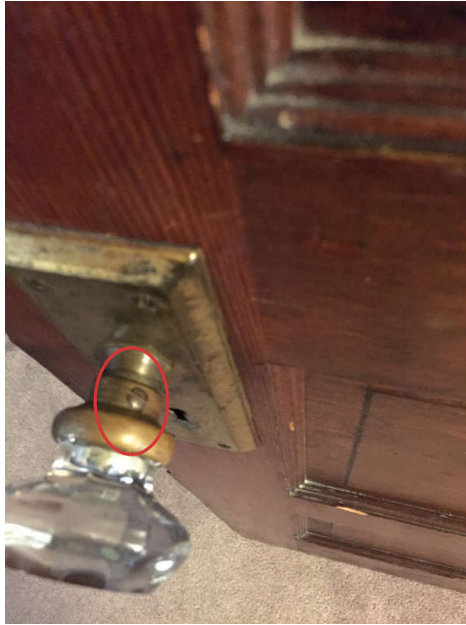
FRONT BEDROOM (INSIDE) AND BACK BEDROOM (OUTSIDE)

DOOR KNOB LOOSE

Door knob is loose. Recommend adding set screw so door knob turns latch for front bedroom. Recommend tightening the screw on the back bedroom. This is a safety issue.

Contact a handyman or DIY project

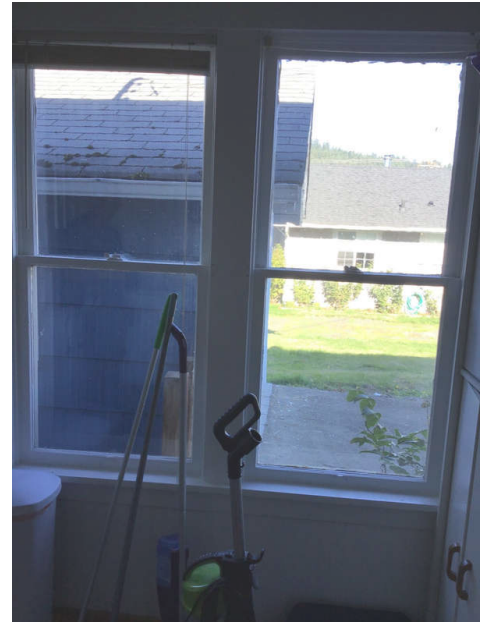
MOST WINDOWS IN HOME

PAINTED SHUT

Most windows are either painted shut or are swollen in place. Recommend windows be restored to functional use. This is a safety egress issue.

Contact a handyman or DIY project

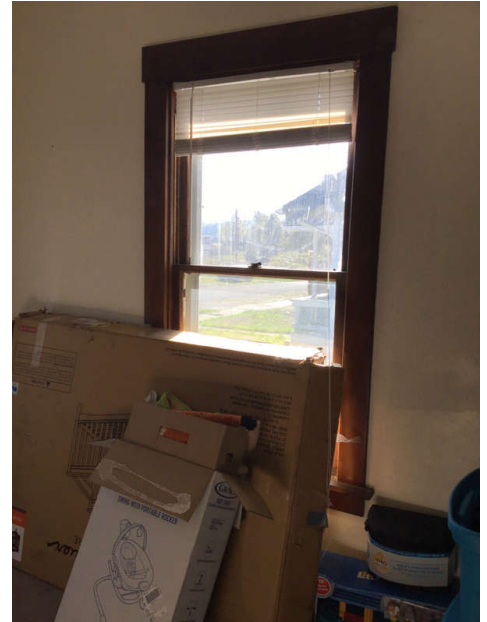
FRONT BEDROOM ON THE WEST SIDE

WINDOW NOT FUNCTIONING PROPERLY

At time of inspection window does not close or lock. It opens, which is unusual for the home...but it does not close or lock properly. Recommend repair.

Contact a qualified window repair/installation contractor.

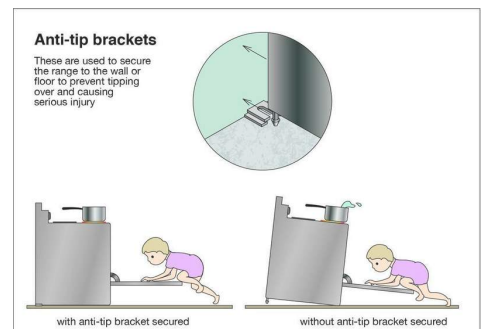
RANGE NOT FASTENED/NO ANTI-TIP BRACKET

Range was not fastened to the floor. This poses a safety hazard to children. Recommend a qualified contractor secure range so it can't tip.

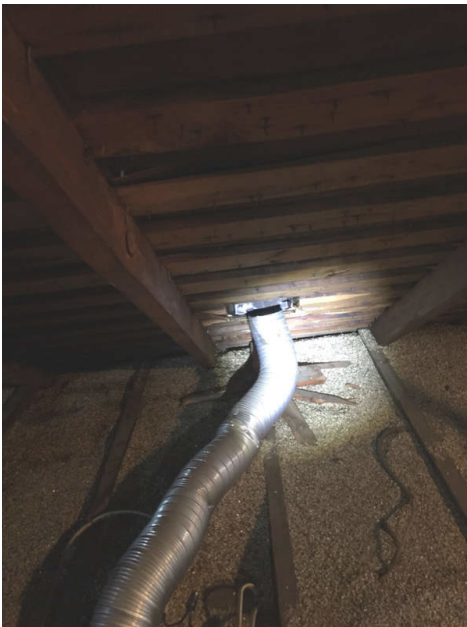
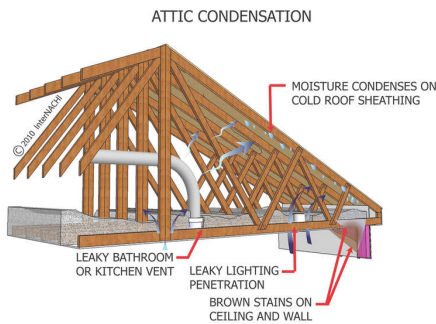
INTERIOR EXHAUST VENTS INTO ATTIC

Interior exhaust fan is venting into attic. This condition promotes moisture in attic and can lead to mold and other material degradation caused by moisture. Recommend vent be routed properly/fixed so warm, moist house air exits the outside of the structure.

Contact a handyman or DIY project

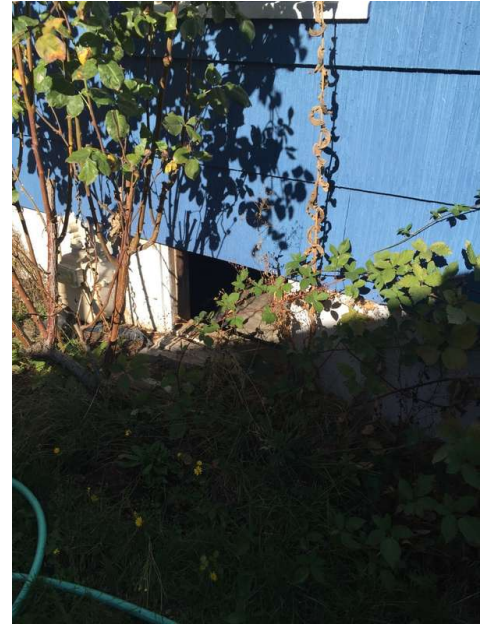
CRAWLSPACE ACCESS OPEN

Crawlspace access open. Recommend keeping these closed to prevent animal intrusion.

Recommended DIY Project

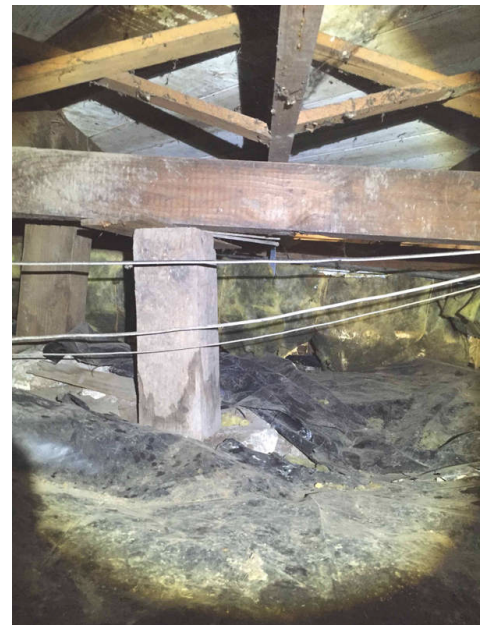
PIERS NEED STRAIGHTENING

Pier needs straightening and proper securing to girder under house. There is a slight sag in the floor in this area in the kitchen. It is probably due to this pier being weakend or replaced in the past. This is also the general location of the chimney that used to exist in the home, so taking out the chimney would have placed other stresses on the floor structure. Recommend repairing pier and leveling floor.

Contact a qualified professional.
