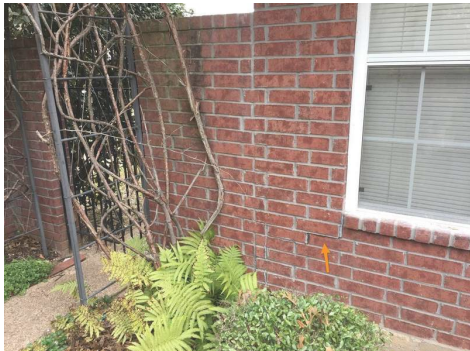
The foundation shows signs of settling around the home, evident mainly by cracks in the slab or brick walls, cracks above doors and windows, gaps around exterior trim or lowered areas of the floor. Further evaluation by a structural engineer is recommended to help determine if corrective action is necessary.

Left rear of house. There appears to be rotation of the brick face just below the corner of the window.

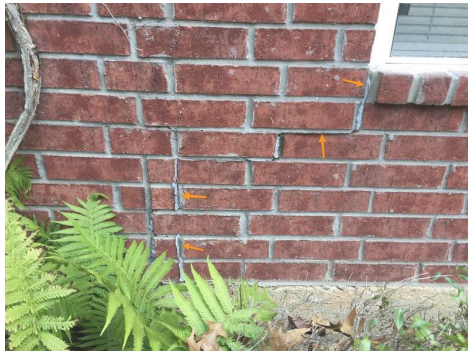
There appears to be rotation of the brick face just below the corner of the window.

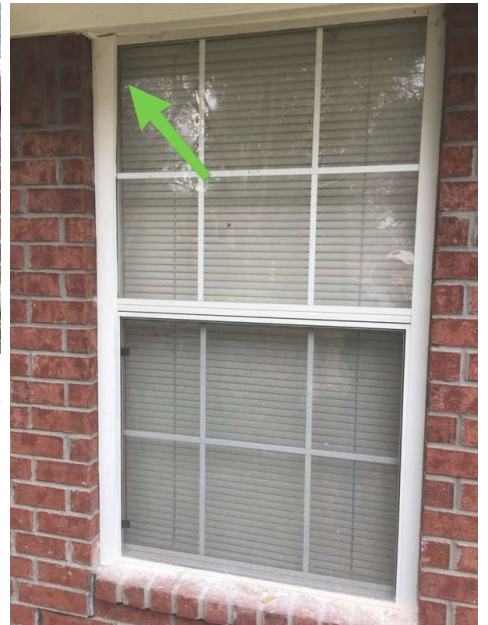
A trim piece has been added, presumably to cover a gap between the window and the brick.

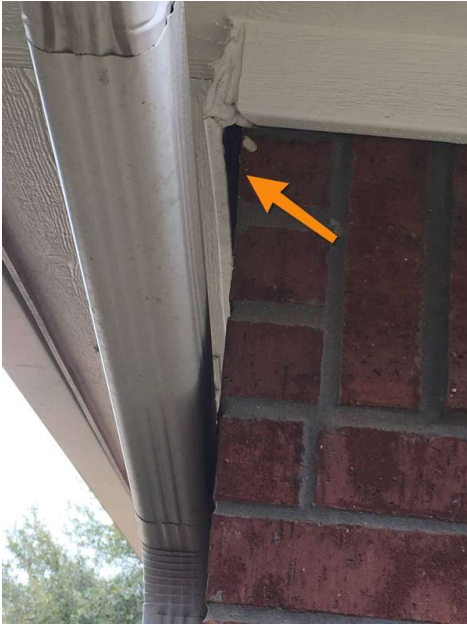
Separation of the brick mold from the wall.

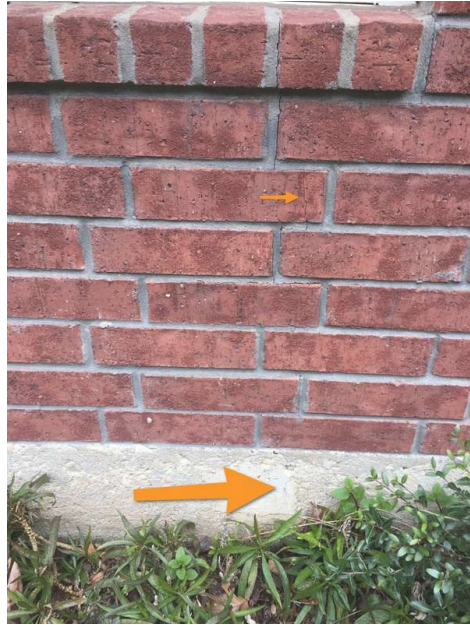
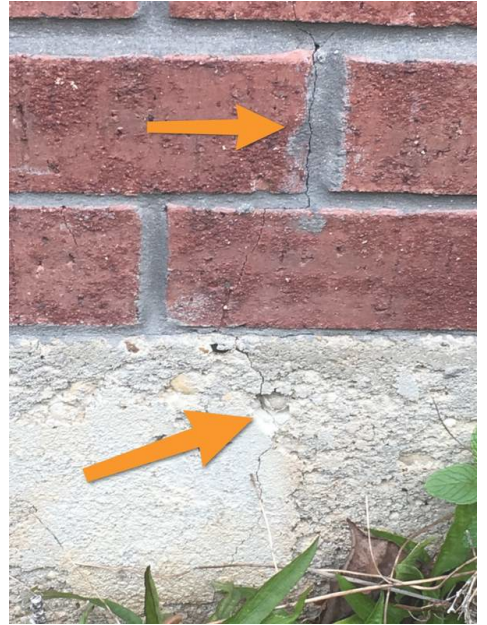
Cracks at the foundation wall and brick wall.

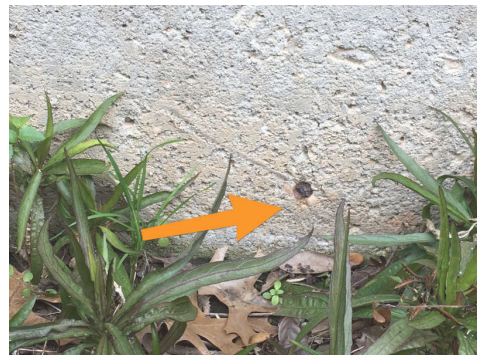
EXPOSED REINFORCEMENT

Post tension cable ends, rebar or nails were found to be exposed at the time of inspection and showing signs of rust. It is recommended to clean the exposed metal of rust and apply a non-shrink grout to help prevent rust which may lead to cracks in the slab.

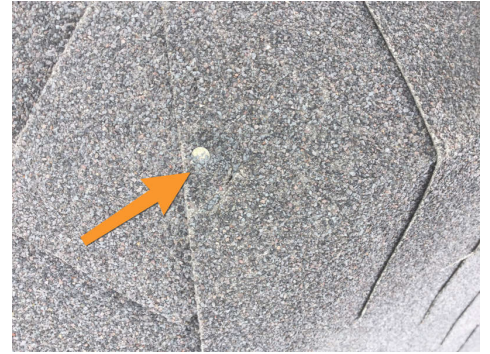
FASTENERS-EXPOSED

Some areas of the roof had fasteners visible. Fasteners have been installed to secure shingles or flashings from being blown loose by wind. Exposed fasteners should be sealed periodically to prevent moisture intrusion into the roof structure.

Contact a qualified roofing professional.

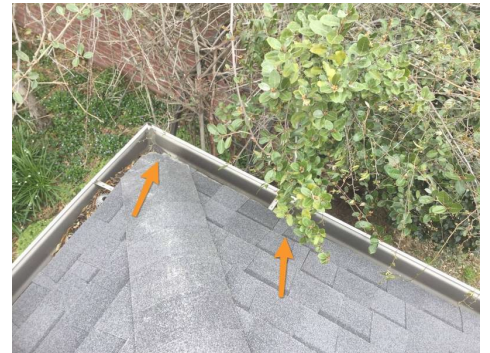
TREE LIMBS

The tree limbs that are in contact with the roof or hanging near roof can cause abnormal wear and moisture penetration at the roof.

Recommend trimming all tree limbs at least 18" away from the edge of the roof.

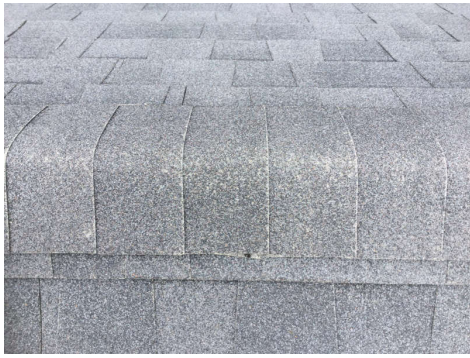
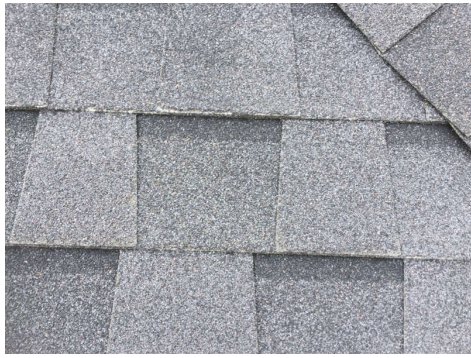
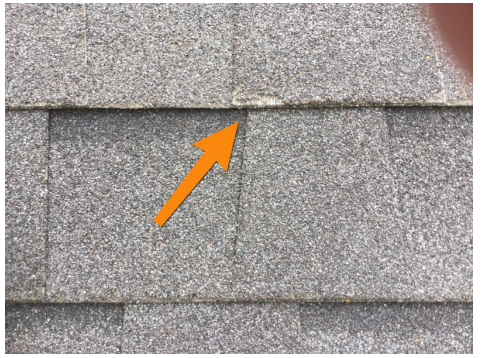
MINOR DETERIORATION

Shingles exhibited signs of minor deterioration commensurate with the age of the roof at the time of inspection. Given the age of the roof (approximately 15 years old), we recommend budgeting to replace the roof within the next few years.

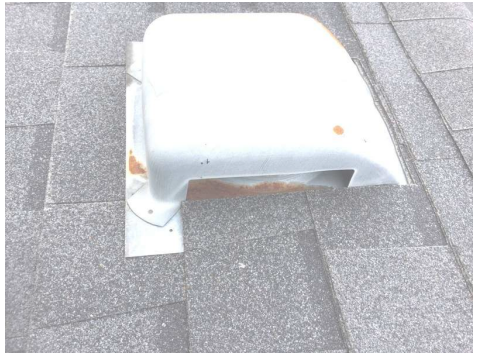
2.3.5 C. Roof Covering Materials **RUSTED FLASHING/VENTS**

At the time of the inspection, flashing, turtle vents, and lead boots were showing signs of rust or corrosion. These may need to be replaced before it begins to leak to help prevent damage from moisture intrusion to the home materials, the roof structure and to help prevent development of microbial growth.

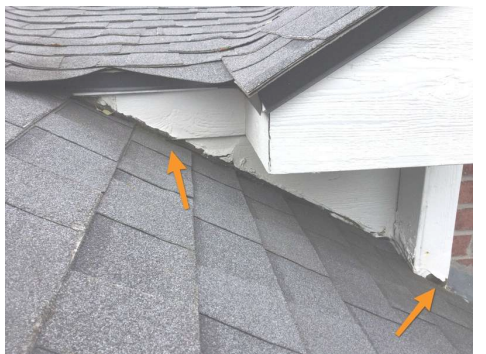
ABOVE AND TO THE LEFT OF FRONT DOOR

2.3.6 C. Roof Covering Materials **FLASHING-IMPROPER/MISSING**

Flashing appeared to be missing or improperly installed and may allow moisture intrusion resulting in damage to home contents or materials. It is recommended to have this corrected to help prevent moisture intrusion into the roof structure.

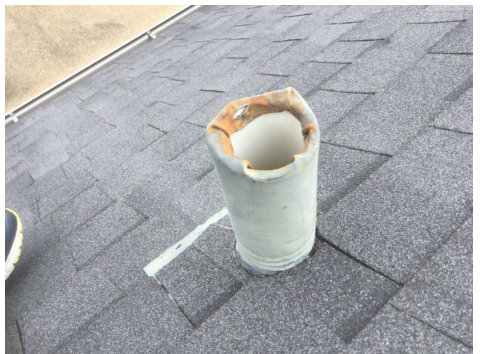
2.3.7 C. Roof Covering Materials **RUSTING LEAD BOOT**

The lead "boots" on a number of vent pipes are beginning to rust. This leads to pitting, and then leaking, which allows moisture penetration down the outside surface of the vent pipe, into the attic, and possibly the ceiling.

Recommendation
Contact a qualified professional.

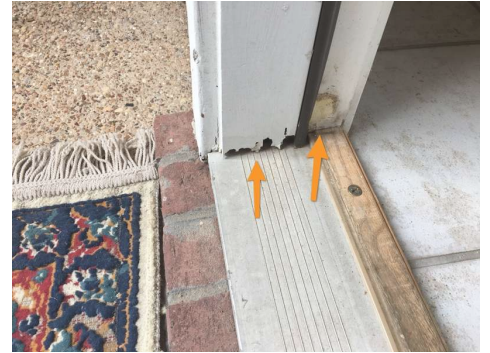
FRONT DOOR

TRIM DECAY

Exterior trim had decay visible in areas. This condition should ideally be corrected to help prevent water penetration into the wall structure and to help prevent further deterioration.

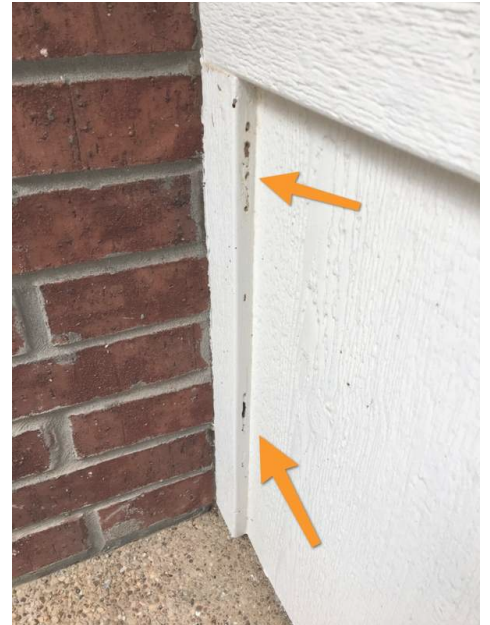
LEFT OF, AND ABOVE, FRONT DOOR

POSSIBLE WOOD-BORING INSECT DAMAGE

There is evidence of activity by possible wood-boring insects. Recommend an inspection by a licensed pest inspector.

Contact a qualified professional.

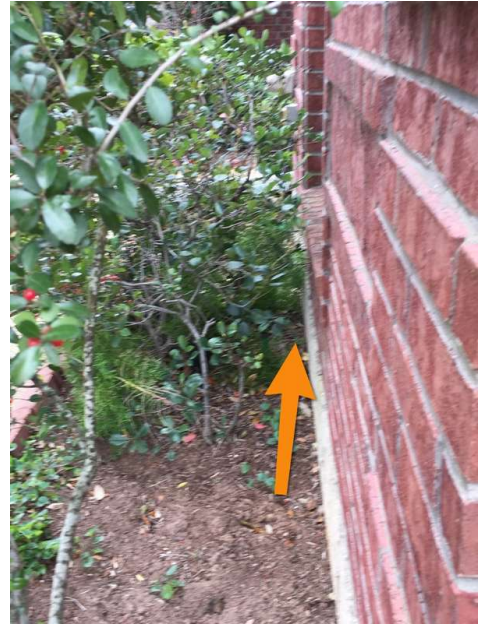
VEGETATION AGAINST HOUSE

Vegetation was observed growing against the house at various locations. This contributes to wear and provides a pathway for insect access, including wood-boring insects. Recommend cutting vegetation away from the house at least 18 inches.

Contact a qualified professional.

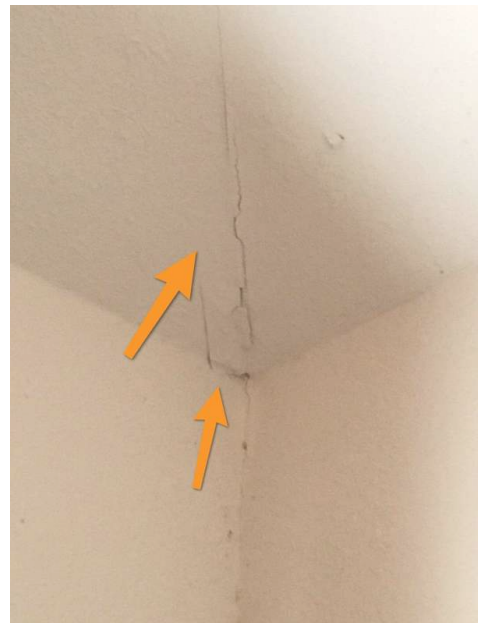
The ceiling has cracks, which may be an indication of settlement.

Master bedroom, at the outside corner. There is a similar crack on the same outside wall in the opposite corner.

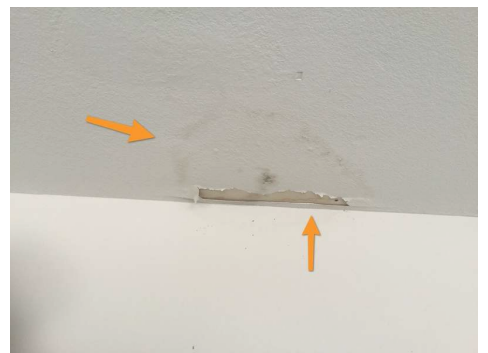
CEILING MOISTURE

A moisture meter indicated the possibility of moisture in the garage ceiling materials. This may be an indication of roof leakage, leaking pipes or condensation in the attic and should ideally be corrected by a qualified professional to help prevent further deterioration.

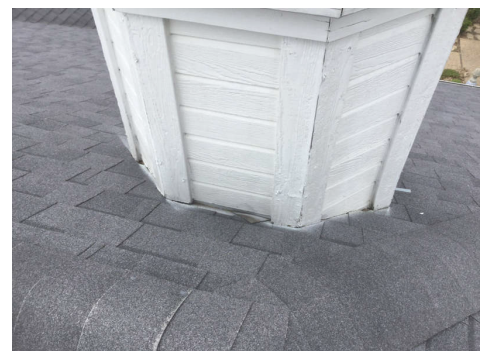
NO CRICKET

The chimney had no cricket. A cricket is a small roof built on the uphill side of the chimney to prevent roof drainage from pooling and causing damage from roof leakage. Crickets are recommended for chimneys measuring 30 inches or more in width (measured parallel to the eaves). This chimney appeared to measure more than 30 inches in width. Further evaluation by a qualified professional is recommended.

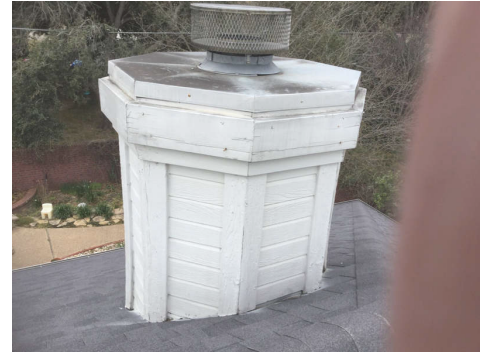
CHIMNEY EXTENSION IN NEED OF REPAIR

The chimney is showing signs of weather deterioration and should be repaired by a qualified professional.

Contact a qualified professional.

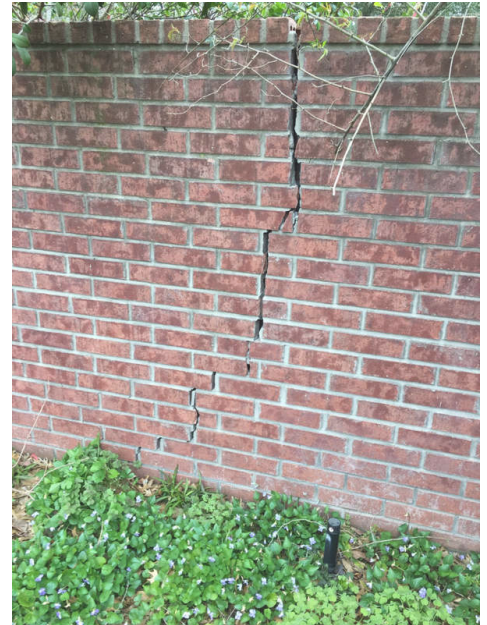
CRACKS IN FENCE

Significant settling cracks exist in the brick fence. Recommend a structural engineer evaluate.

Contact a qualified professional.

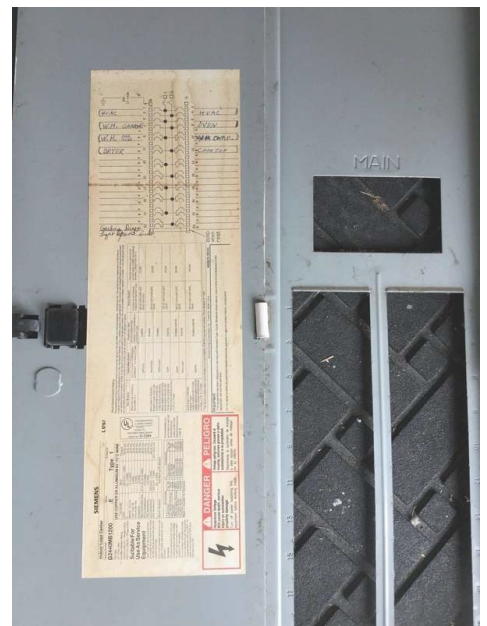
LABEL PANEL

A Circuit Directory identifying individual electrical circuits was missing, illegible or inaccurate at this panel. The panel should contain a clearly-marked label identifying individual circuits so that in an emergency, individual circuits can be quickly shut off.

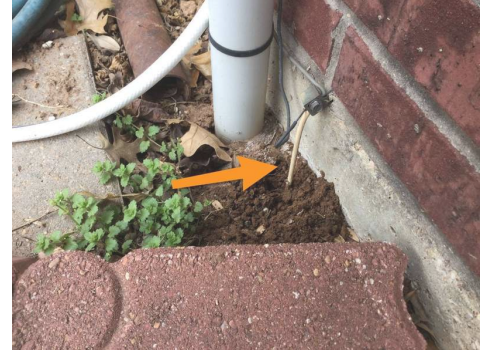
GROUNDING ROD

While there was a grounding cable connected to the panel, the inspector was unable to verify the presence of a grounding rod. Recommend a licensed electrician evaluate and repair if necessary.

Recommendation
Contact a qualified professional.

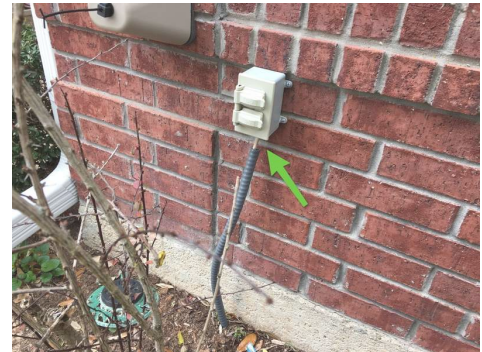
FRONT FLOWER BED, RIGHT OF FRONT DOOR

NO GFCI; EXPOSED WIRING

No ground fault circuit interrupter (GFCI) protection of some of the home electrical receptacles was provided in areas at the time of inspection. Also, wiring was exposed at this location and at the base of the mailbox. These issues should be repaired by a licensed electrician.

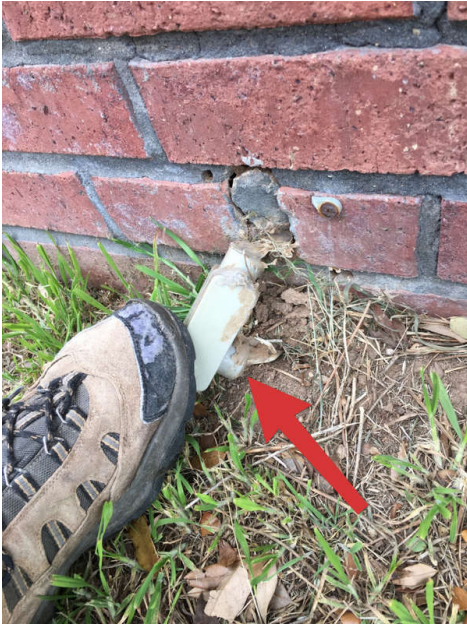
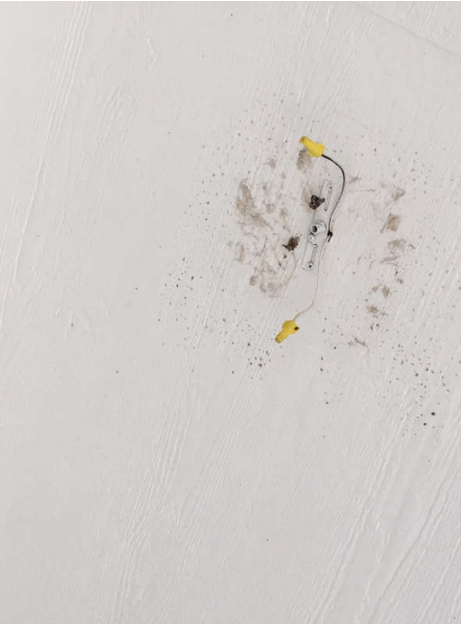
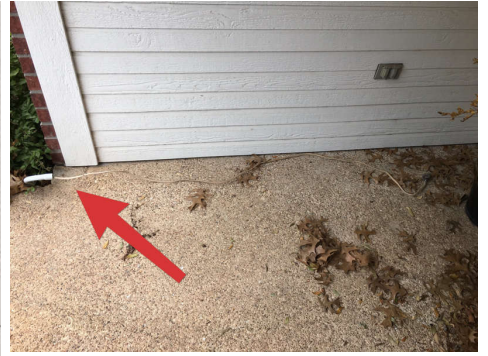
BASE OF MAILBOX, BACK PORCH CEILING, BACK PATIO

EXPOSED WIRING

Exposed wiring was visible and should be protected from physical damage as a safety precaution. This should ideally be performed by a qualified professional.

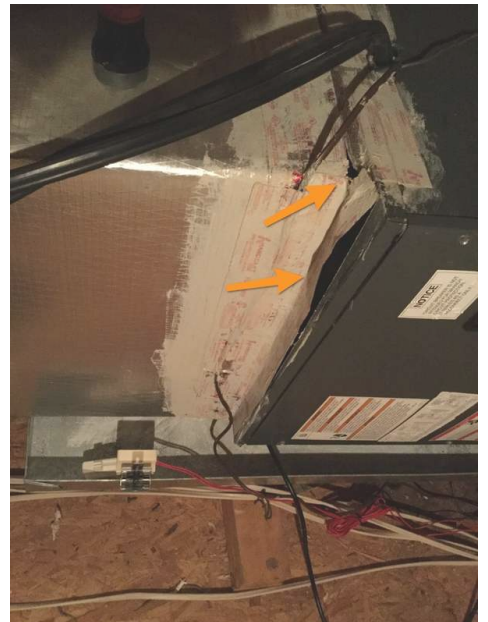
ATIC

AIR LEAKING AT PLENUM

The connection between the plenum and the furnace unit is leaking a significant amount of air. This connection should be retaped and mastic applied to create a strong, airtight seal.

Contact a qualified professional.

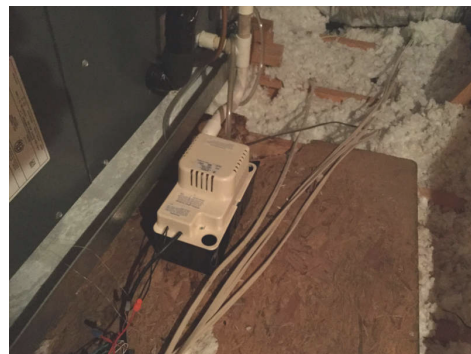
UNABLE TO OPERATE CONDENSATE PUMP

The attic unit uses a condensate pump to remove condensation from the a/c unit. The inspector was unable to test or activate this pump manually. This does not imply that the unit is defective, only that the inspector was not able to observe its function at the time of the inspection.

Recommendation
Contact a qualified professional.

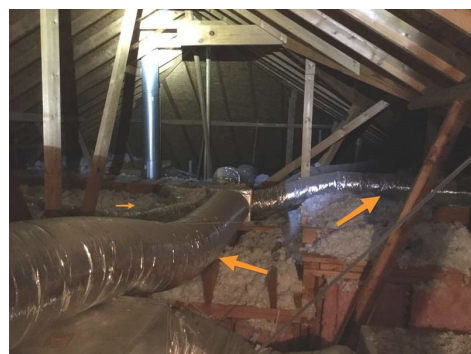
HVAC DUCT(S) NOT SUPPORTED BY STRAPPING

Air conditioning duct work should be suspended by proper strapping material. Allowing ductwork to lay directly on ceiling joists compacts insulation and increases the possibility of condensate buildup.

Recommendation
Contact a qualified professional.

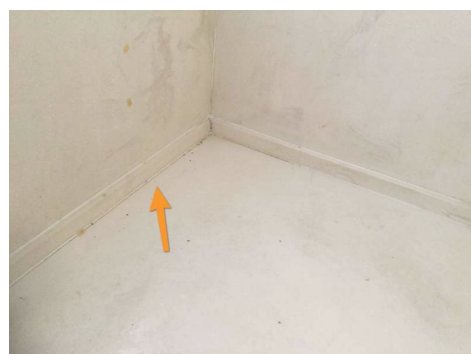
MASTER BATH SHOWER

CAULK LINE FAILED

The sealant where the shower floor meets the wall was old and had sections of sealant missing, which may allow damage from moisture intrusion of the wall assembly.

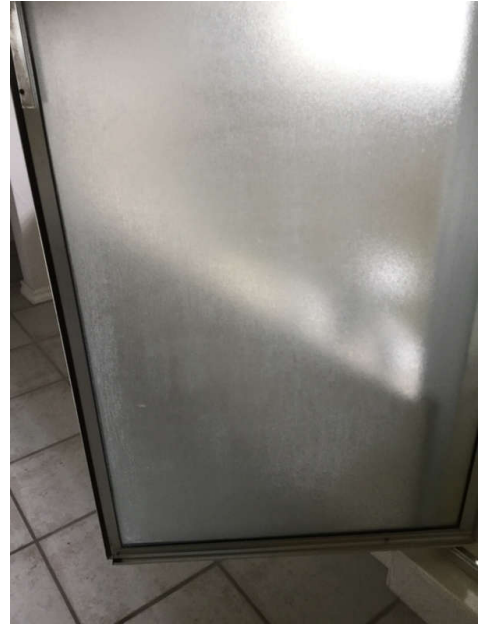
SHOWER GLASS NOT TEMPERED

The glass shower enclosure may not have been made from tempered glass or the label was not visible at the time of inspection. Tempered glass is typically required in this area. Further evaluation by a qualified contractor is recommended if this is an area of concern to you.

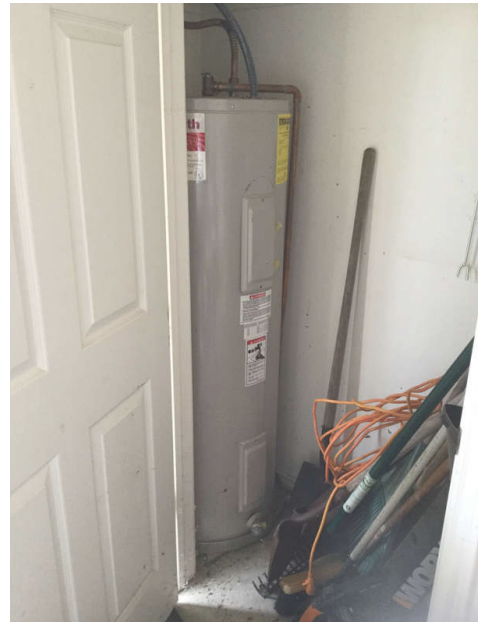
GARAGE, NOT RAISED

Although this gas water heater was installed in the garage, it was not installed on a raised platform a minimum of 18 inches in height as is required by generally-accepted modern safety standards for water heaters that are not a Flammable Vapor Ignition Resistant (FVIR) type. This water heater did not appear to be a FVIR Type. The Inspector recommends correction by a qualified plumbing contractor.

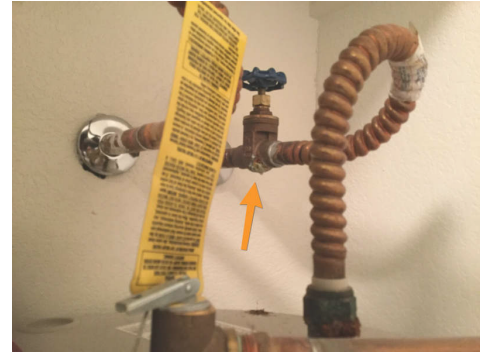
MASTER BATHROOM WATER HEATER CLOSET

**COLD WATER SHUT OFF LEAKS,
APPEARS NOT TO FUNCTION**

The cold water supply shutoff to this water showed visible evidence of long term leaking. This valve appeared to have failed, cutting off the water supply to the water heater, which allowed no hot water function at the attached hot water faucets. Recommend a qualified plumber evaluate and repair as needed.

Contact a qualified professional.
