SUMMARY
1234 Main St. Knoxville TN 37918
Buyer Name
10/23/2018 9:00AM

Patrick Cloninger
TN Lic. 247
Pinpoint Home Inspections
865-705-0260
info@pinpointtn.com

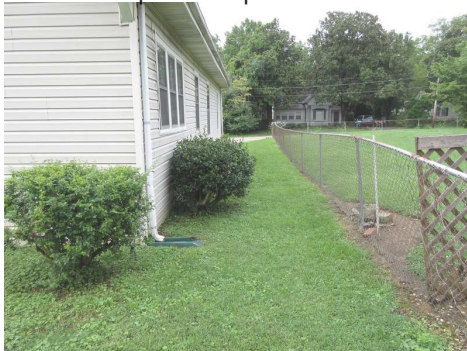
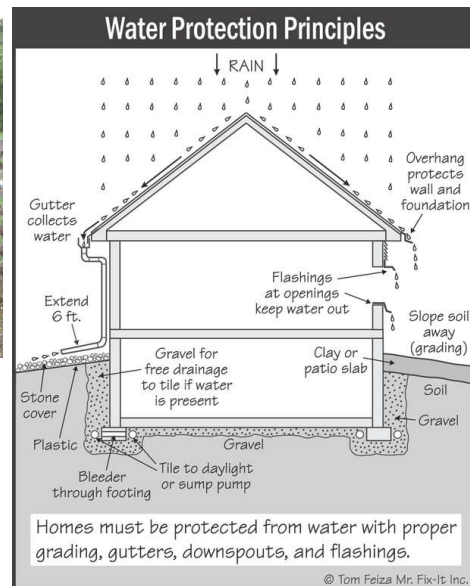
2.1.1 Grading, Vegetation, & Retaining Walls

NEGATIVE GRADE; SOIL, CORRECT

REAR AND LEFT EXTERIOR

The soil or grading sloped down towards building perimeters in one or more areas. This can result in water accumulating around building foundations or underneath buildings. It can be a conducive condition for wood-destroying organisms. Recommend grading soil so it slopes down and away from buildings with a slope of at least 1 inch per horizontal foot for at least 6 feet out from buildings.

Contact a qualified professional.

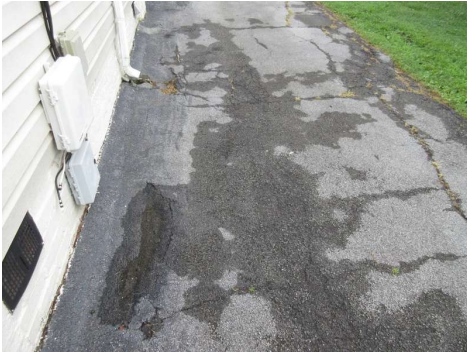
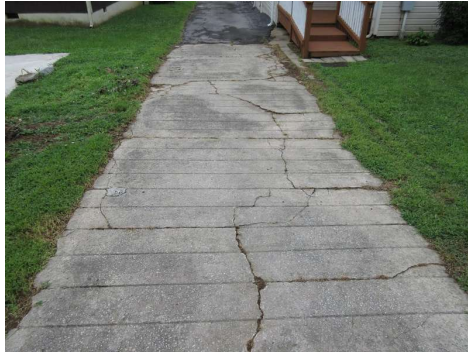
2.2.1 Driveway

DRIVEWAYS - NEED REPAIR

RIGHT SIDE, EXTERIOR

Cracks, holes, settlement, heaving and/or deterioration were found in the driveway. Recommend that qualified contractor repair as necessary. Trip hazards were present.

Contact a qualified professional.

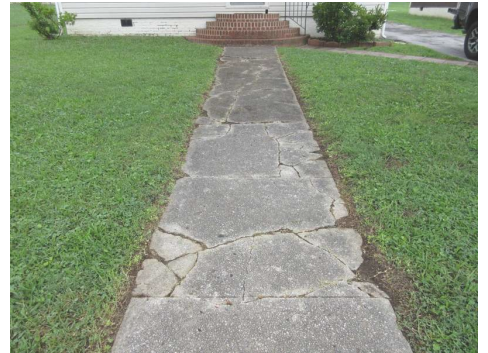
2.3.1 Sidewalks & Patios

SIDEWALK; NEEDS REPAIR

FRONT, EXTERIOR

Cracks, holes, settlement, heaving and/or deterioration were found in sidewalks. Recommend that qualified contractor repair as necessary.

Contact a qualified professional.

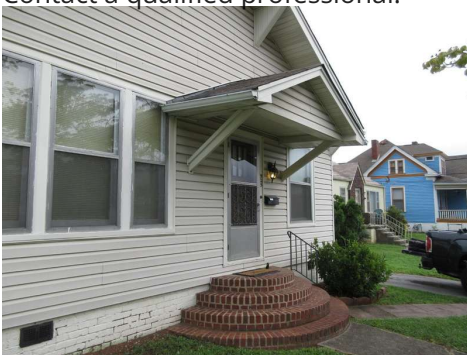
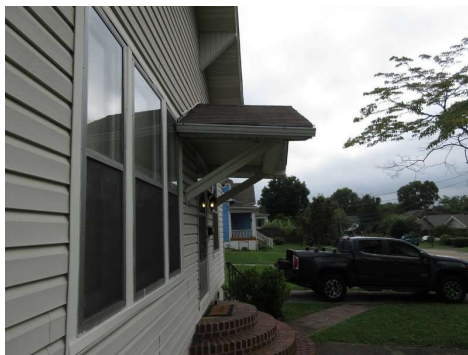
2.5.1 Deck, Patio, Porch Covers

UNSTABLE OR SAGGING; EVALUATE OR REPAIR

FRONT PORCH

The porch roof appeared unstable due to substandard bracing, lack of diagonal bracing, or lack of attachment to the main building. This is a safety hazard since severe movement may cause the cover to collapse. A qualified contractor should repair as necessary.

Contact a qualified professional.

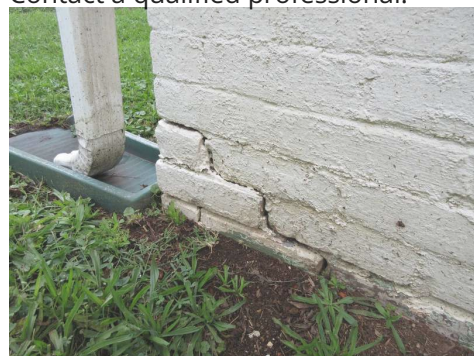
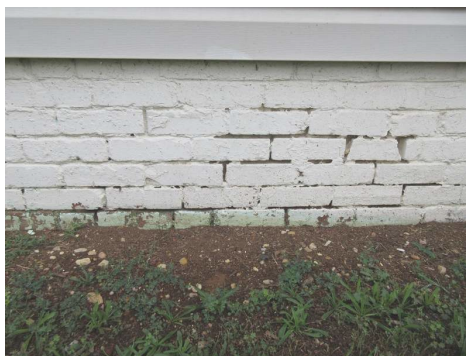
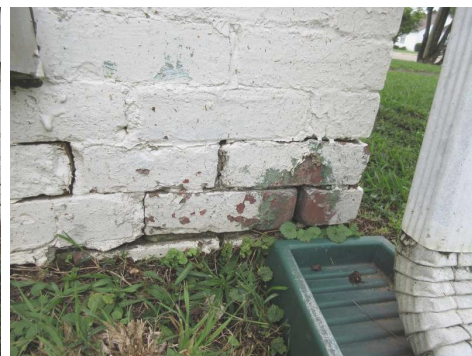
2.8.1 Exterior Walls & Trim

BRICK, STONE VENEER - CRACKS, DETERIORATION

LEFT AND FRONT EXTERIOR WALLS

The masonry (brick) veneer was deteriorated or damaged in some areas. Where cracks or openings are exposed, water can enter the wall structure causing mold, fungal growth and structural damage. This is a conducive condition for wood-destroying organisms. Recommend that a qualified contractor repair as necessary. For example, by repointing mortar or replacing broken or missing masonry.

Contact a qualified professional.

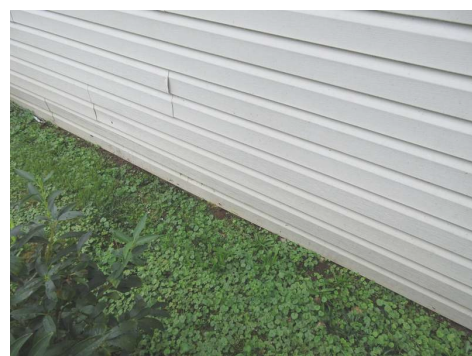
2.8.2 Exterior Walls & Trim

CLEARANCE TO GRADE; OTHER SIDING

REAR EXTERIOR WALL

Soil was in contact with or less than 6 inches from siding or trim. Regardless of what material is used for siding, it should not be in contact with the soil. If made of wood, siding or trim will eventually rot. For other materials, ground or surface water can infiltrate siding or trim and cause damage to the wall structure. Wood-destroying insects are likely to infest and damage the wall structure. This is a conducive condition for wood-destroying organisms. Recommend grading or removing soil as necessary to maintain a 6-inch clearance. Note that damage from fungal rot and/or insects may be found when soil is removed, and repairs may be necessary.

Contact a qualified professional.

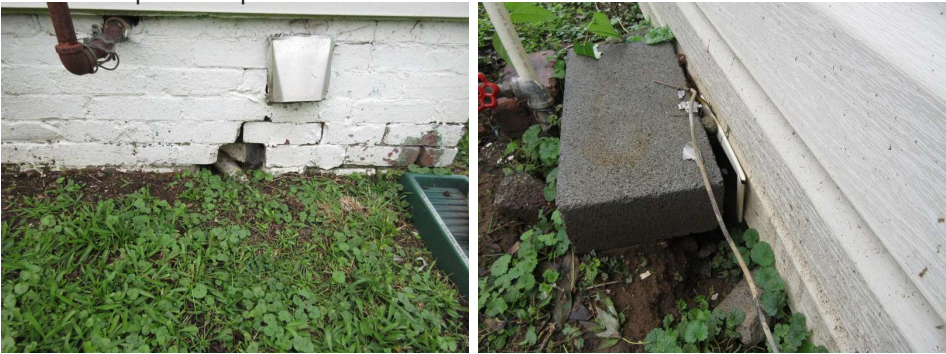
2.8.3 Exterior Walls & Trim

HOLES, GAPS

REAR AND LEFT EXTERIOR WALLS

One or more holes or gaps were found in siding or foundation walls. Vermin, insects or water may enter the structure. Recommend that a qualified person repair as necessary.

Recommendation
Contact a qualified professional.

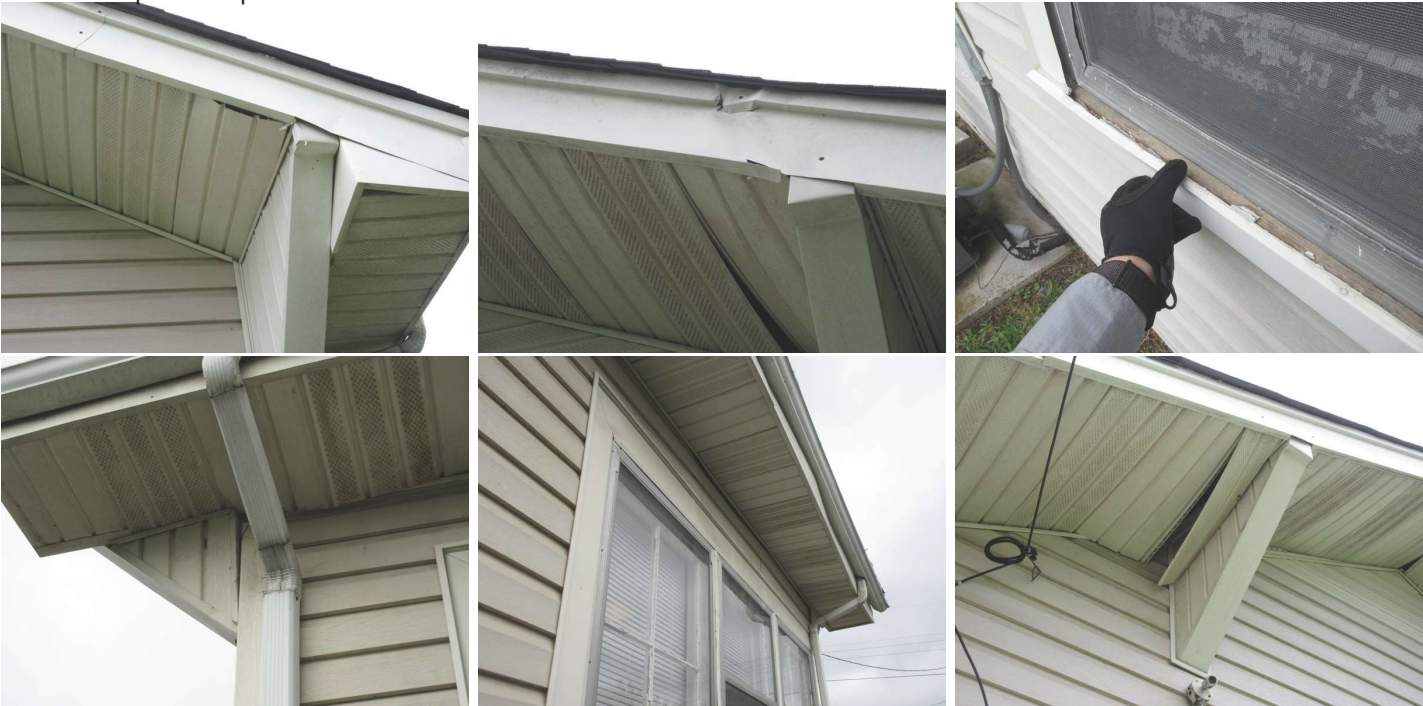
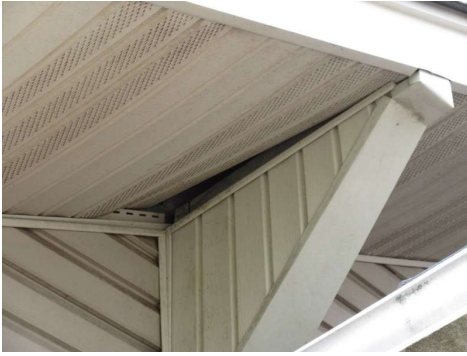
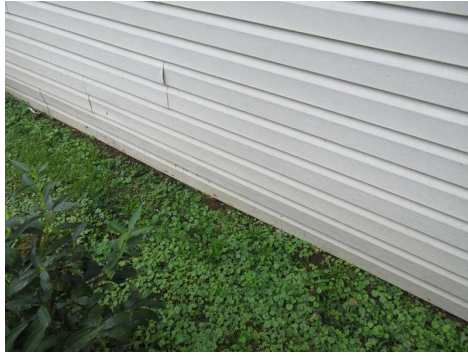
2.8.4 Exterior Walls & Trim
VINYL SIDING, TRIM; DAMAGE OR DEFICIENCIES

THROUGHOUT EXTERIOR WALLS

Vinyl siding, trim, soffits and fascias covering exterior walls contained several deficiencies. Multiple sections of soffit were loose or damaged. Aluminum fascia trim was loose and damaged in several areas. Vinyl siding covering exterior walls was loose, bulged, and contained damage which may allow moisture intrusion. Recommend a qualified contractor evaluate the home's wall cladding and trim and provide options and costs for repair.

Recommendation
Contact a qualified professional.

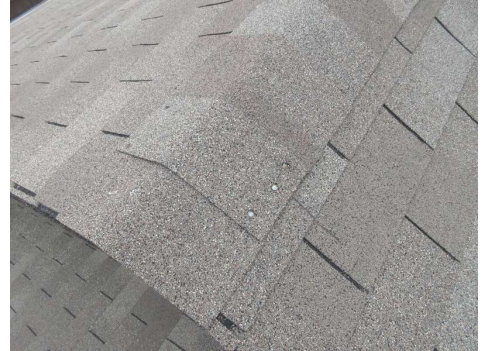
3.1.1 Coverings

COMPOSITION - EXPOSED NAIL HEADS

RIDGE

Nail heads were exposed at one or more shingles. More than just a few exposed nail heads may indicate a substandard roof installation. Recommend applying an approved sealant over exposed nail heads now and as necessary in the future to prevent leaks.

Contact a qualified professional.

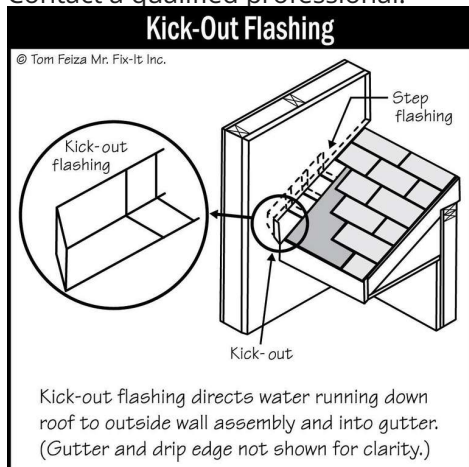
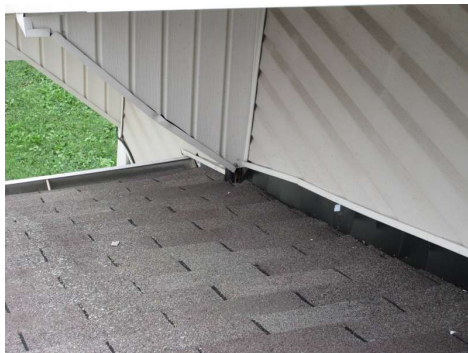
3.2.1 Flashings

ROOF FLASHING

VARIOUS

Kick-out flashing was missing where walls extended past the roof edge. Leaks can occur as a result. This is a conducive condition for wood-destroying organisms. Recommend that a qualified person repair as necessary.

Contact a qualified professional.

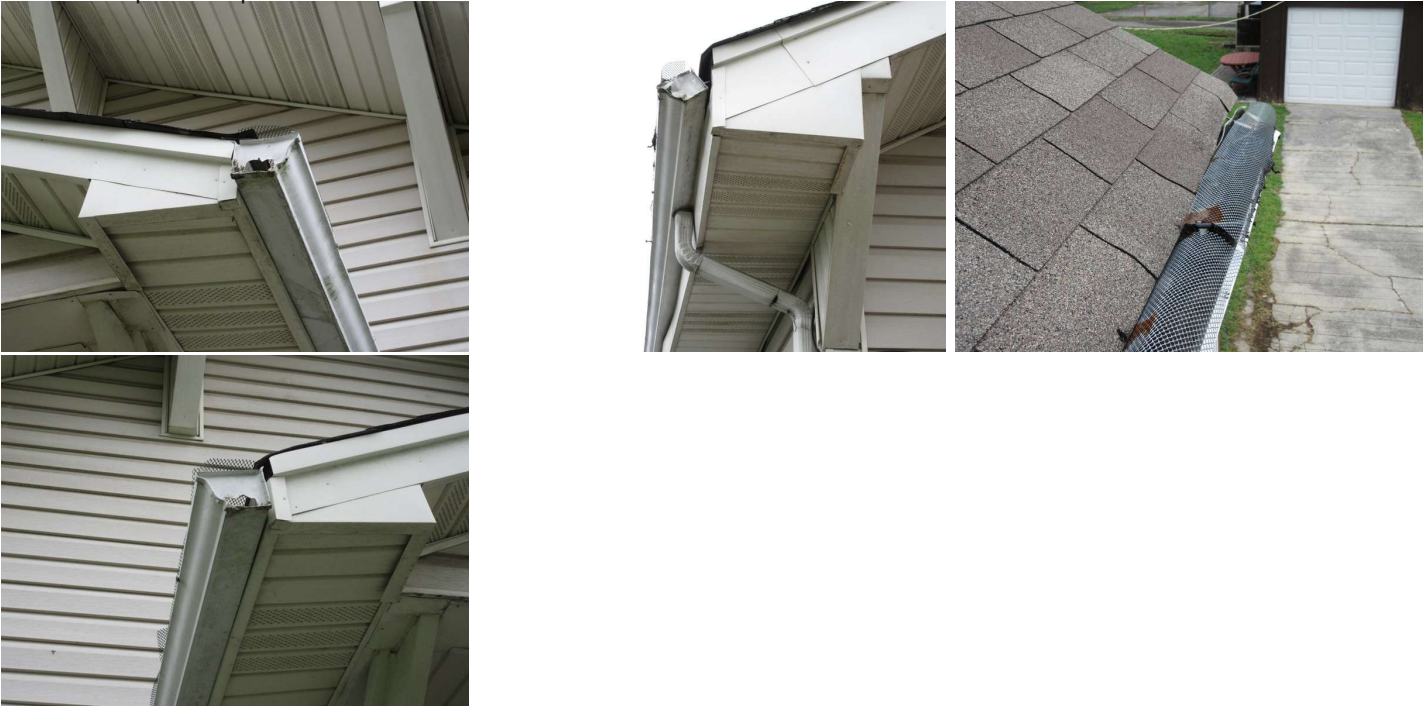
3.3.2 Gutters, Downspouts, & Extensions

DRAINAGE SYSTEM

FRONT, RIGHT, AND LEFT EXTERIOR

Gutters and downspouts were loose and damaged. Rainwater can come in contact with the building exterior or accumulate around the building foundation as a result. This is a conducive condition for wood-destroying organisms. Recommend that a qualified person repair as necessary.

Recommendation
Contact a qualified professional.

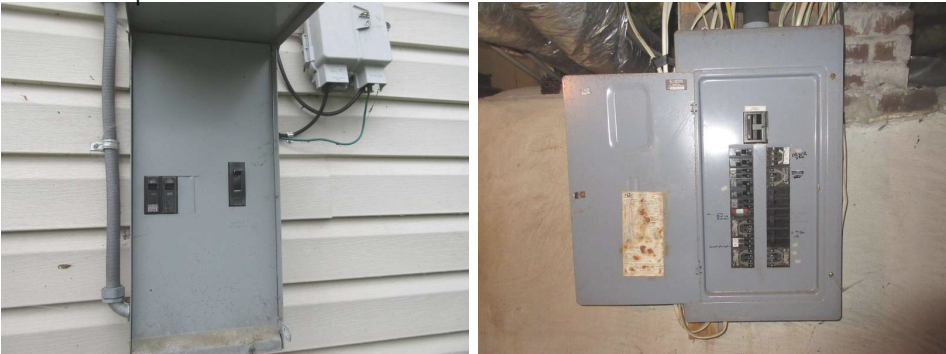
4.2.1 Panels
LEGEND MISSING, SUBSTANDARD

MAIN SERVICE (EXTERIOR) AND SUB-PANEL (BASEMENT)

The legend/directory for circuit breakers was incomplete. This is a potential shock or fire hazard in the event of an emergency when power needs to be turned off. Recommend correcting the legend so it's accurate, complete and legible. Evaluation by a qualified electrician may be necessary.

Recommendation
Contact a qualified electrical contractor.

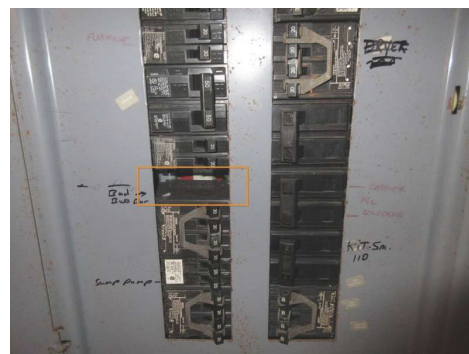
4.2.2 Panels
MISSING KNOCKOUT
BASEMENT

One or more knockouts were missing from the sub-panel. Holes in panels are a potential fire hazard if a malfunction ever occurs inside the panel. Rodents can also enter panels through holes. Recommend that a qualified person install knockout covers where missing and per standard building practices.

Contact a qualified electrical contractor.

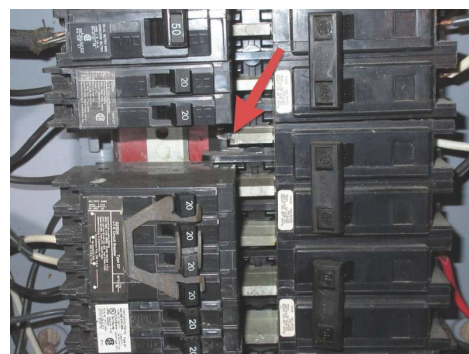
4.2.3 Panels

PANEL; DAMAGE

BASEMENT

The sub-panel contained damage to the bus bar and minor surface rust was present. Recommend consultation with a qualified electrical contractor to determine if repair or replacement is necessary.

Contact a qualified electrical contractor.

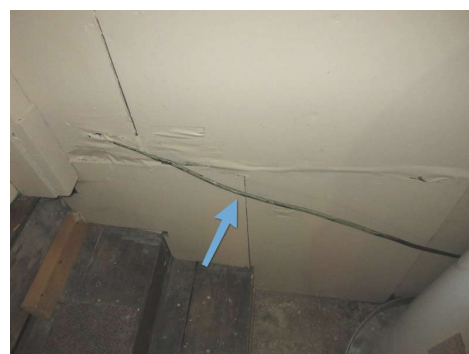
4.3.1 Wiring

EXPOSED

BASEMENT STAIRWAY

Non-metallic sheathed wiring was installed at one or more locations, and was subject to damage such as on easily accessible wall or ceiling surfaces. The insulation can be damaged by objects coming in contact with it, resulting in exposed, energized wires. Also, copper conductors can break after being repeatedly moved or bent. This is a potential shock or fire hazard. Recommend that a qualified electrician repair per standard building practices. For example, by installing protective conduit or re-routing wires through walls or ceilings.

Contact a qualified electrical contractor.

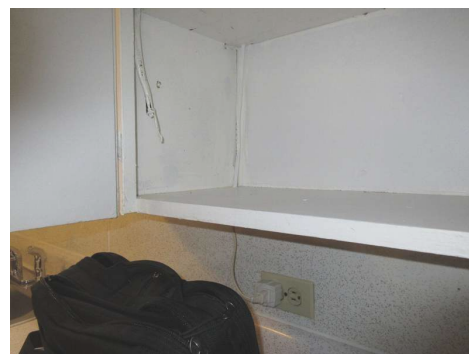
4.3.2 Wiring

EXTENSION CORD

KITCHEN

Extension cords were being used as permanent wiring at one or more locations. They should only be used for portable equipment on a temporary basis. Using extension cords as permanent wiring is a potential fire and shock hazard, and indicates that wiring is inadequate and needs updating. Extension cords may be undersized. Connections may not be secure resulting in power fluctuations, damage to equipment, overheating and sparks that could start a fire. Recommend that a qualified electrician repair per standard building practices and eliminate extension cords for permanently installed equipment.

Contact a qualified electrical contractor.

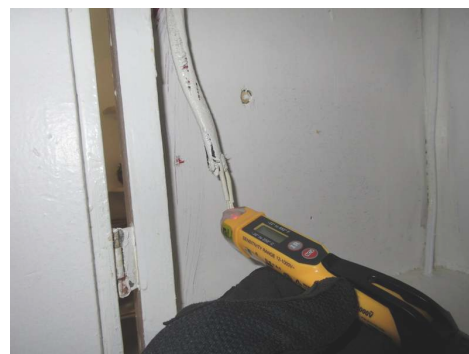
4.3.3 Wiring

EXPOSED SPLICES OR ENERGIZED WIRING

KITCHEN CABINET

Energized wiring was exposed to touch. This is a potential shock or fire hazard. Recommend that a qualified electrician repair per standard building practices. For example, by removal or proper termination of wiring.

Contact a qualified electrical contractor.

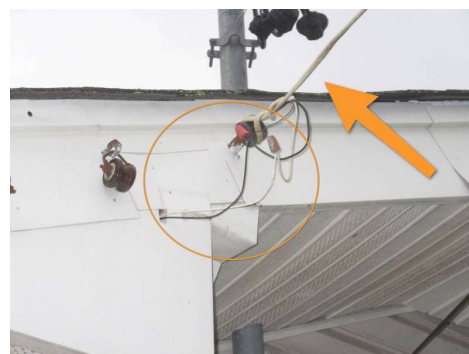
4.3.4 Wiring

WIRING

REAR EXTERIOR

Substandard wiring was found at the building exterior. For example, exposed wiring and wiring not suitable for its use. This is a safety hazard. Recommend that a qualified electrician evaluate and repair as necessary and per standard building practices.

Contact a qualified electrical contractor.

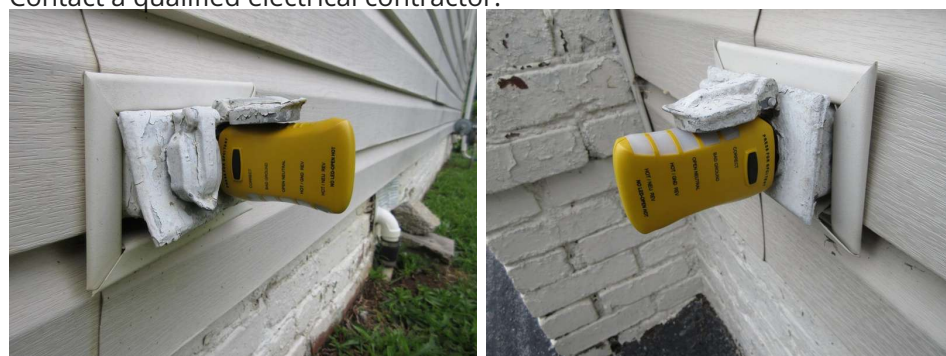
4.4.1 Receptacles

EXTERIOR; COVERS BROKEN

LEFT AND RIGHT EXTERIOR WALLS

One or more exterior receptacle covers were broken, worn, or damaged. This condition may allow moisture intrusion. Recommend that a qualified person replace covers where necessary.

Contact a qualified electrical contractor.

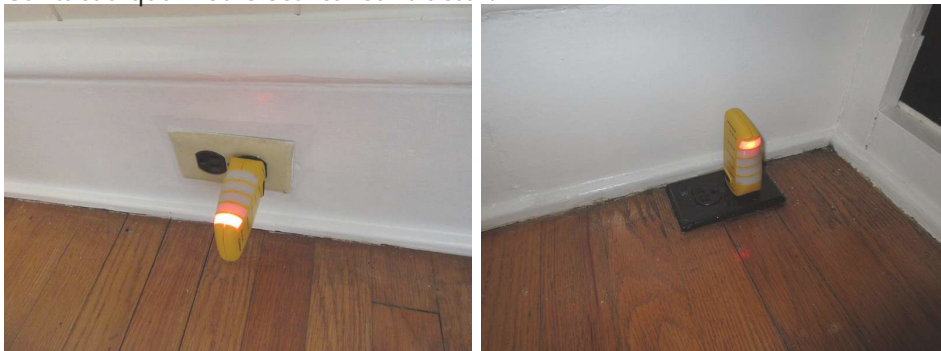
4.4.3 Receptacles

HOT-NEUTRAL REVERSE

DINING ROOM

One or more electric receptacles had reverse-polarity wiring, where the hot and neutral wires were reversed. This is a shock hazard. Recommend that a qualified electrician repair as necessary. For more information, visit:

Contact a qualified electrical contractor.

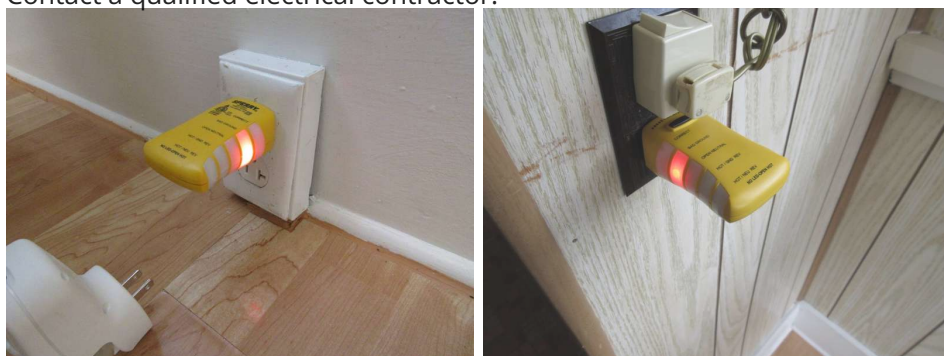
4.4.4 Receptacles

OPEN GROUND - REWIRE OR REPLACE WITH 2-SLOT

THROUGHOUT

One or more modern, 3-slot electric receptacles were found with an open ground. Three-slot receptacles should have a hot, a neutral and a ground wire connected. Homeowners often install new 3-slot receptacles on older, 2-wire circuits that only have hot and neutral wires. This is a shock hazard when appliances that require a ground are used with these receptacles. Examples of such appliances include computers and related hardware, refrigerators, freezers, portable air conditioners, clothes washers, aquarium pumps, and electrically operated gardening tools. Where the electric system was installed prior to when grounded circuits were required (1960s), it is permissible to replace 3-slot receptacles with 2-slot receptacles to prevent appliances that require a ground from being plugged in to an ungrounded circuit. However, the client should be aware of this limitation when planning use for various rooms, such as an office. For newer electric systems, circuits should be repaired so grounded, 3-wire cables provide power to 3-slot receptacles. Recommend that a qualified electrician repair per standard building practices.

Contact a qualified electrical contractor.

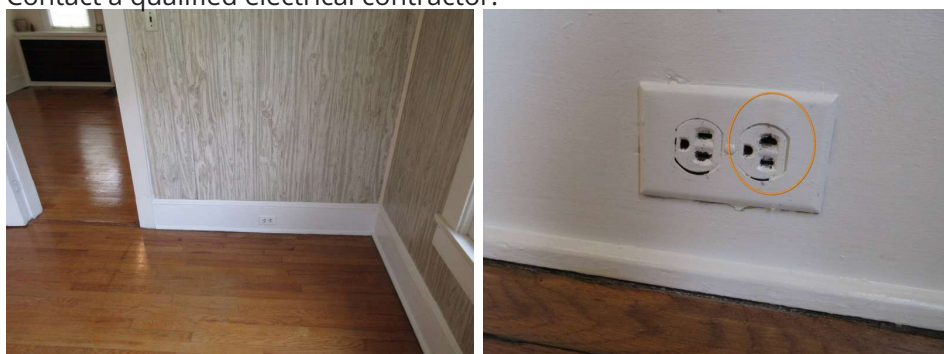
4.4.6 Receptacles

SCORCHED

FRONT BEDROOM; ADJACENT TO LIVING ROOM

One or more receptacles were scorched. The wiring for these receptacles may be damaged due to overheating. Recommend that a qualified electrician replace such receptacles, evaluate related wiring and repair if necessary.

Contact a qualified electrical contractor.

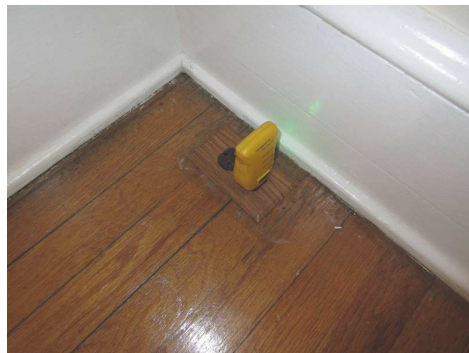
4.4.7 Receptacles

FLOOR RECEPTACLES; IMPROPER COVERS

DINING ROOM AND LIVING ROOM

One or more floor receptacles lacked proper covers. Floor receptacles require specific covers to prevent foot traffic damage and to prevent debris entry in to the receptacle. Recommend a qualified electrical contractor install the necessary covers as needed.

Contact a qualified professional.

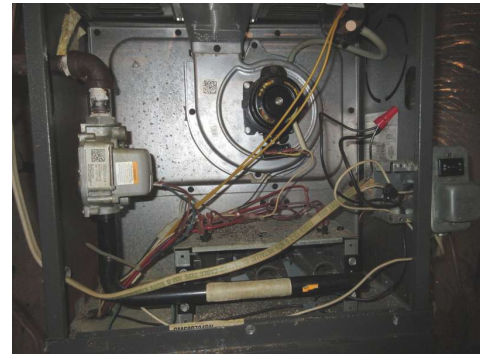
5.1.1 Heating Equipment

BURNERS; CHAMBER DETERIORATION

BASEMENT

The burner chamber had rust, dirt, or deterioration. Recommend that a qualified heating contractor evaluate further.

Recommendation
Contact a qualified heating and cooling contractor

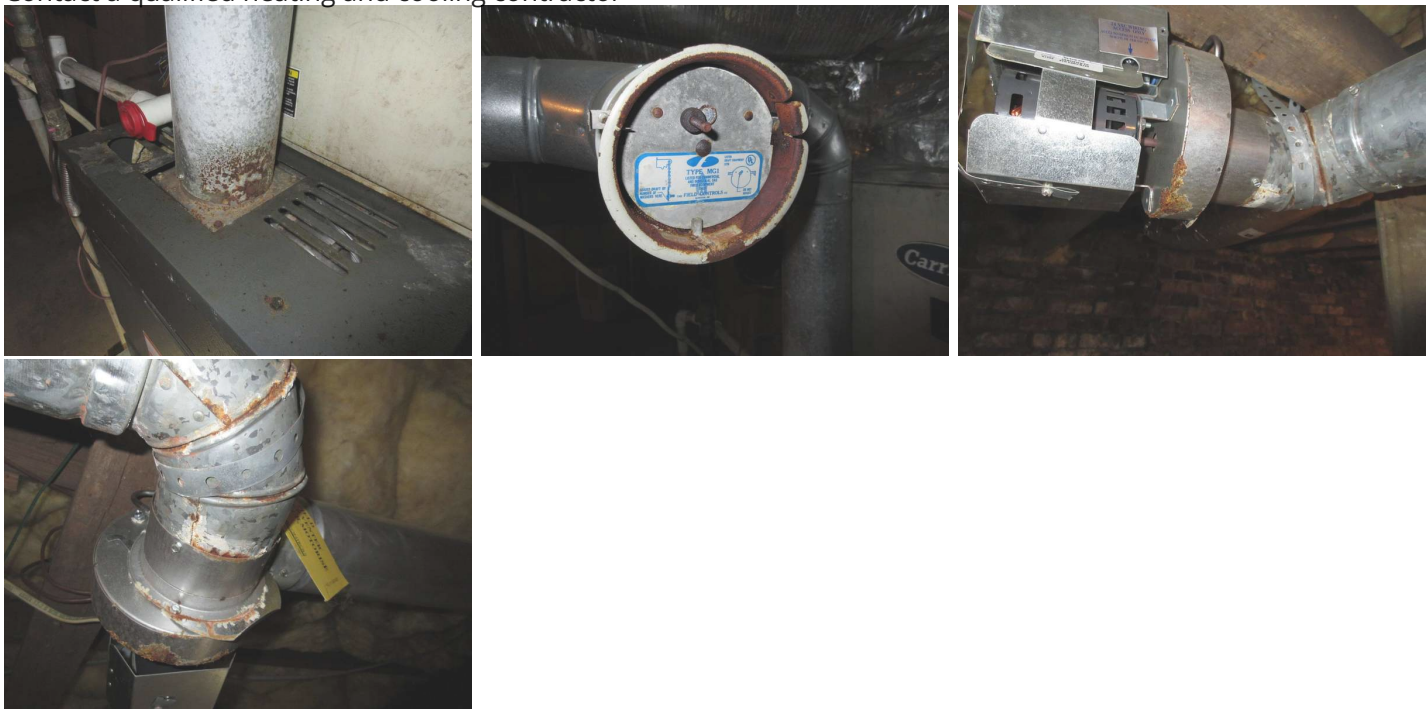
5.2.1 Flue or Vent **FLUE CORROSION** BASEMENT

One or more metal B-vent flues for gas-fired appliances were corroded. Water may enter the building structure or reach the gas-fired appliance. Excessive heat may also be emitted from corroded areas. Recommend that a qualified contractor evaluate and repair or replace corroded flue sections as necessary.

Recommendation
Contact a qualified heating and cooling contractor

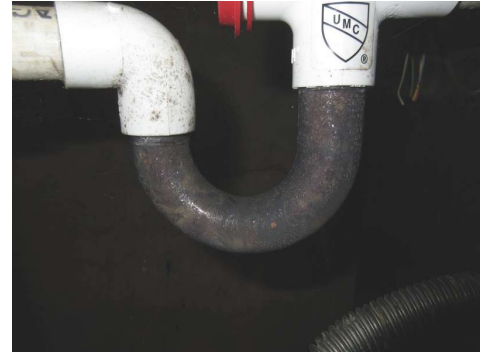
5.3.2 Air-Conditioning or Heat Pump **CONDENSATE TUBE; BLOCKAGE** BASEMENT

The condensation tube or trap designed to safely dispose of condensate produced by the operation of the air-conditioning evaporator coils was blocked or partially blocked and may not properly dispose of condensate. Recommend servicing and repair by a qualified professional.

Recommendation
Contact a qualified professional.

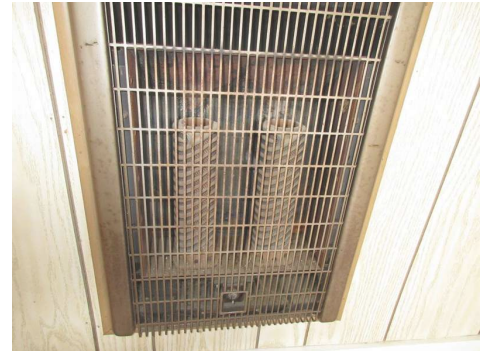
5.5.1 Electric Heat (not forced air)
WALL HEATER; INOPERABLE
KITCHEN

The wall heater was abandoned or inoperable at the time of the inspection. Recommend repair or replacement as desired.

Recommendation
Contact a qualified professional.

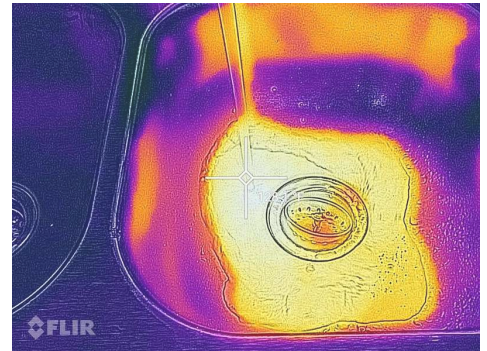
7.1.1 Water Heater
TEMP; > 120

The hot water temperature was greater than 120 degrees Fahrenheit. This is a safety hazard due to the risk of scalding. The thermostat should be adjusted so the water temperature doesn't exceed 120 degrees. If the water heater is powered by electricity, a qualified person should perform the adjustment, since covers that expose energized equipment normally need to be removed. For more information on scalding dangers, visit:

Recommendation
Recommended DIY Project

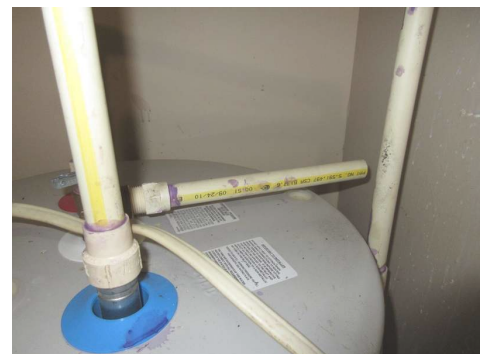
7.1.2 Water Heater
TPRV EXTENSION; TERMINATES >6" ABOVE FLOOR

BASEMENT STAIRWAY

The temperature-pressure relief valve drain line was too short or improperly installed. This is a potential safety hazard due to the risk of scalding if someone is standing next to the water heater when the valve opens. Recommend that a qualified plumber repair per standard building practices. For example, by extending the drain line to within 6 inches of the floor, or routing it to drain outside. For more information, visit:

Recommendation
Contact a qualified professional.

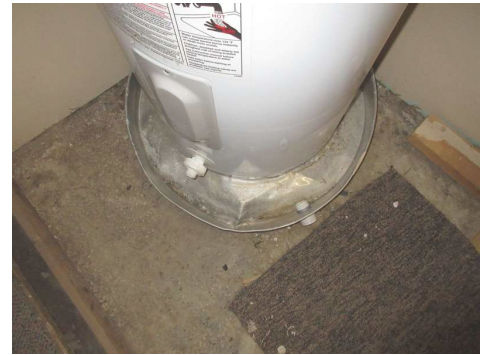
7.1.3 Water Heater

DRIP PAN; INSUFFICIENT OR DAMAGED

BASEMENT

The drip pan installed to prevent water damage in the event leakage of the water heater tank or plumbing connections was damaged. Drip pans should be a minimum of 1 (38mm) inches deep and of sufficient size and shape to receive all leakage and condensate. The pan should be drained by a properly-terminated pipe with a minimum inside diameter of 3/4 inch. Recommend correction by a qualified plumbing contractor.

Contact a qualified professional.

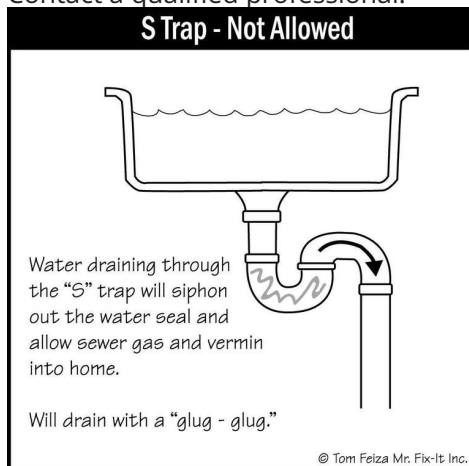
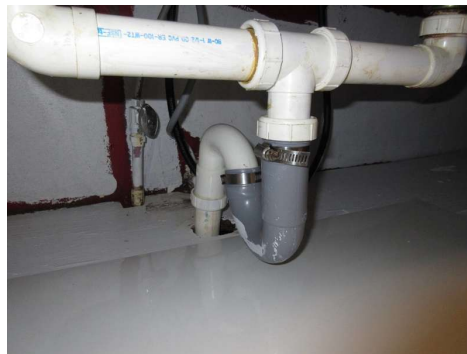
7.5.1 Sinks

S-TRAP

KITCHEN

The sink drain pipe used an S-trap rather than a P-trap, or no P-trap was visible. Siphons and sudden flows of water in S-Traps can drain all the water out of the trap, leaving it dry. Sewer gases can then enter living areas. Recommend that a qualified plumber repair per standard building practices.

Contact a qualified professional.

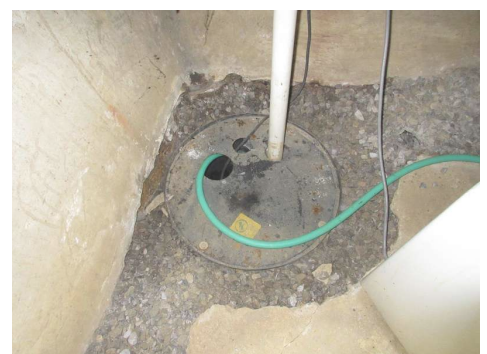
7.10.1 Sump Pump

SUMP COVER; GAPS OR HOLES

CRAWLSPACE

Openings were noted in the sump pit lid. This condition may allow debris to enter the pit, possibly damaging the pump. Recommend repair as necessary.

Contact a qualified professional.

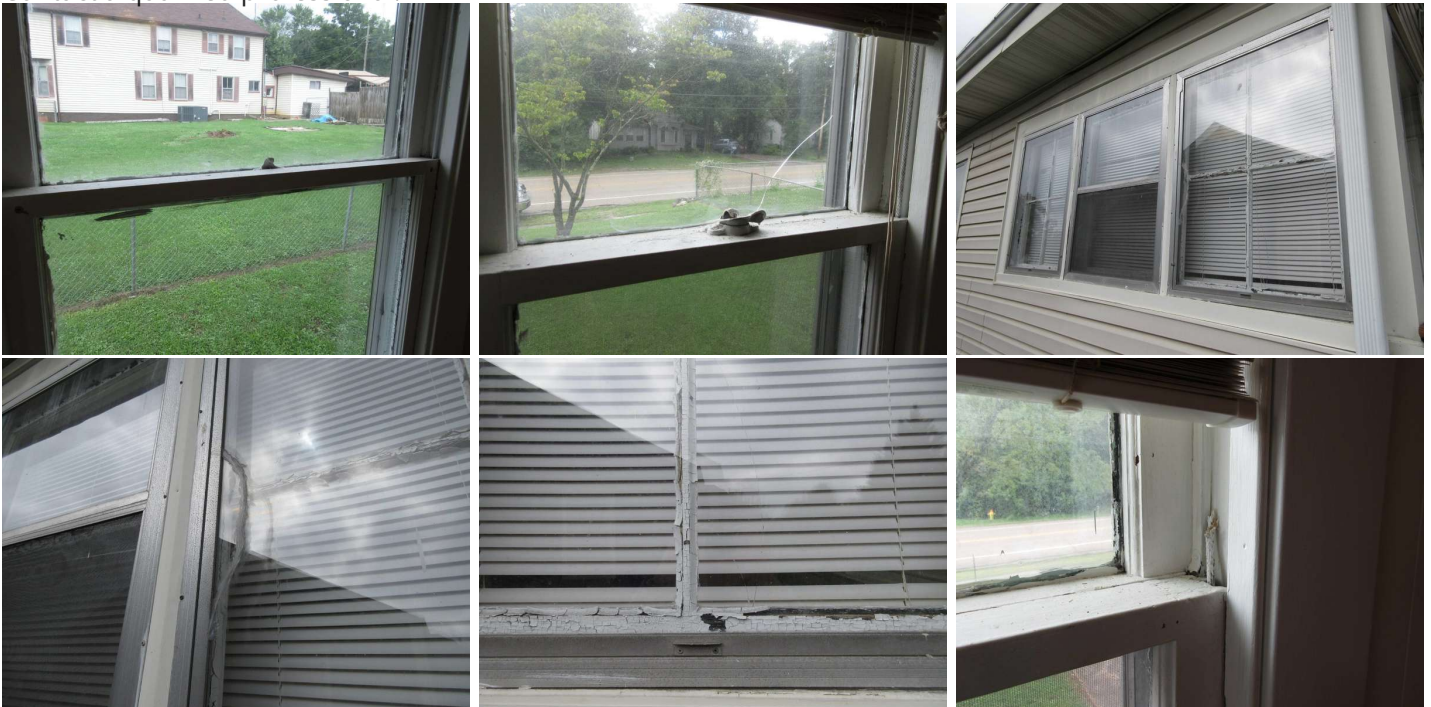
8.5.1 Windows & Skylights

WINDOWS; POOR CONDITION

INTERIOR/EXTERIOR, THROUGHOUT

Original windows throughout the home were in overall poor condition. Peeling paint, wood deterioration, damaged glazing, and cracked panes were present. Operational deficiencies existed in multiple windows. Recommend a qualified contractor evaluate the windows and provide options and costs for repair or replacement.

Contact a qualified professional.

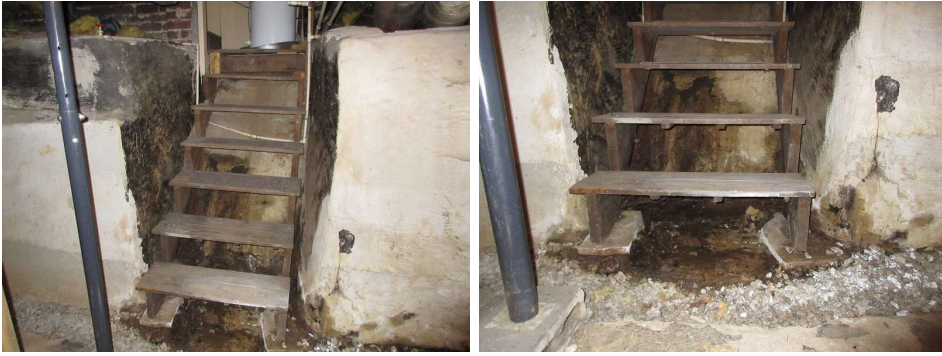
8.8.1 Stairs/Handrails/Gaurdrails

STAIRCASE; OLD UNSTABLE OR DAMAGED

BASEMENT

The staircase was old, contained damages which affected its performance, and lacked generally accepted safety measures such as handrails. Recommend a qualified contractor evaluate the staircase and provide options and costs for repair or replacement.

Contact a qualified professional.

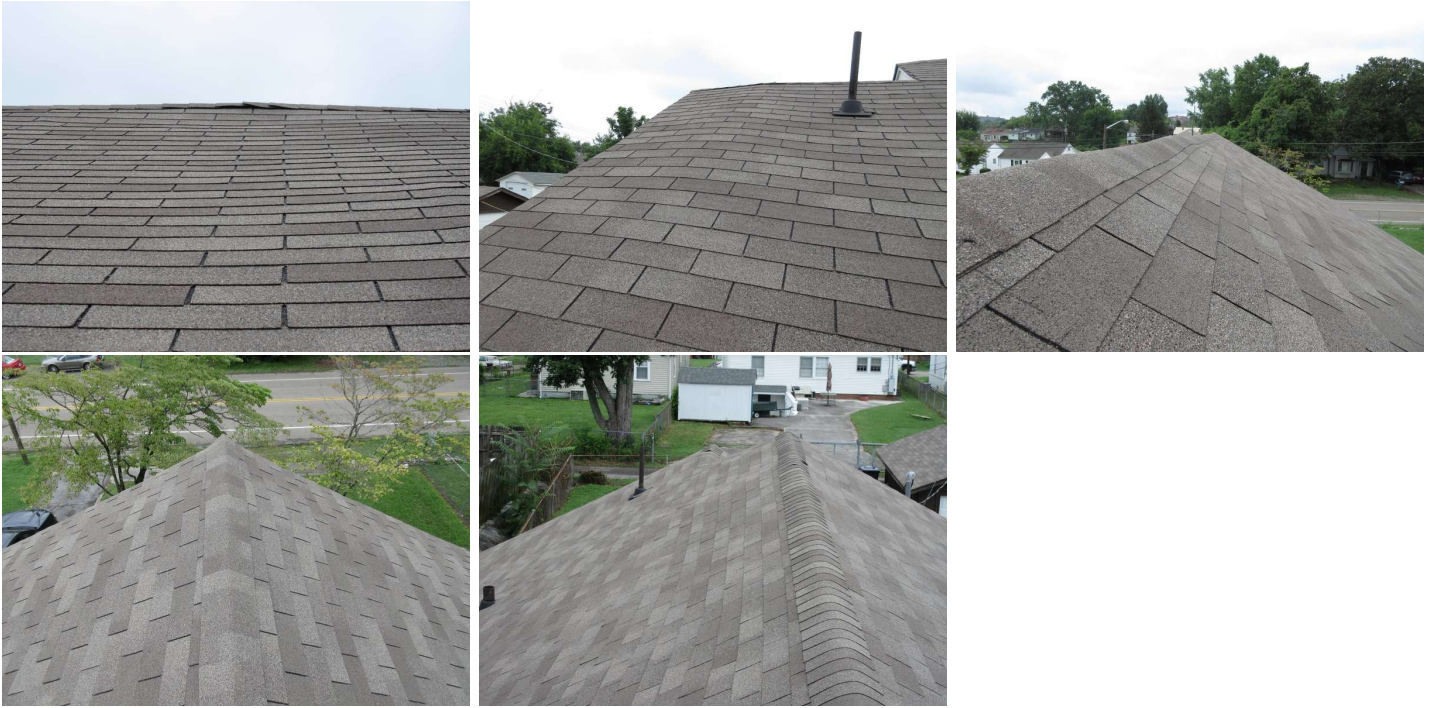
11.4.1 Roof Structure

EXTERIOR STRUCTURE; VISIBLE SAGGING OR RAISED AREAS

ROOF STRUCTURE

Upon visual exterior inspection, the roof structure exhibited raised and sagging areas beyond what would be considered typical of a home of this age. Due to a lack of access to the underside of the structure, it is recommended that further evaluation be performed by a qualified contractor or engineer to determine necessary repairs or stabilization methods.

Contact a qualified structural engineer.

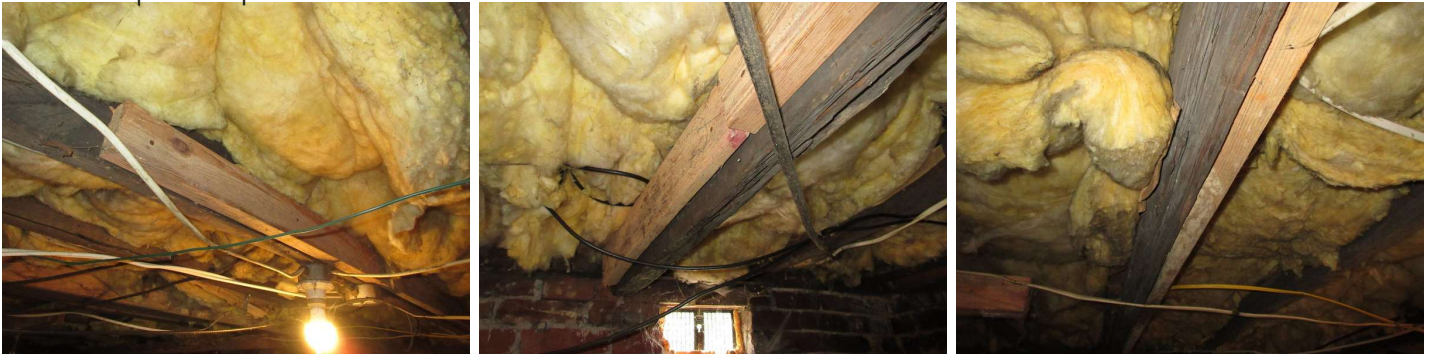
11.5.1 Floor Substructure

FLOOR JOIST; DAMAGE

BASEMENT, CRAWLSPACE

Several floor joists contained damage and were improperly repaired. This can cause damage to the structural integrity of the home, resulting in sagging or failure. Recommend a qualified structural engineer evaluate and advise on how to correct.

Recommendation
Contact a qualified professional.

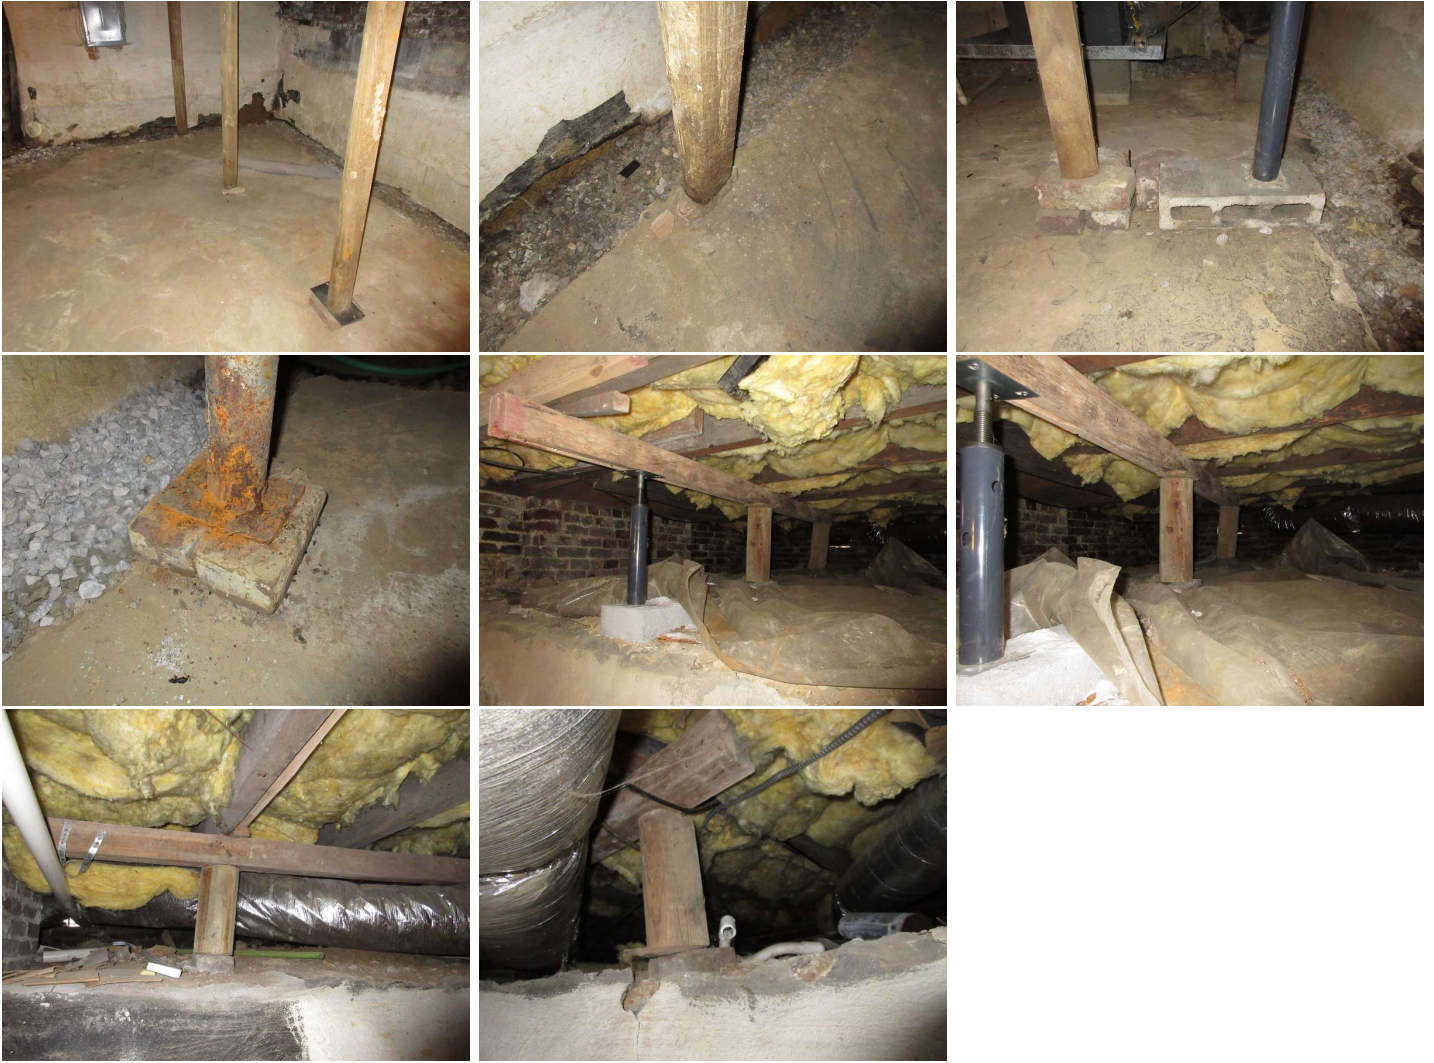
11.5.2 Floor Substructure

FLOOR SUPPORT; DEFICIENCIES

BASEMENT, CRAWLSPACE

Support posts, beams, and additional shoring designed to support or stabilize sagging floors appeared to have been installed in a substandard manner. Additionally, steel support posts which had been exposed to high levels of moisture in the past contained moderate to severe rust or deterioration. Recommend a qualified structural engineer evaluate and advise on how to correct.

Recommendation
Contact a qualified structural engineer.

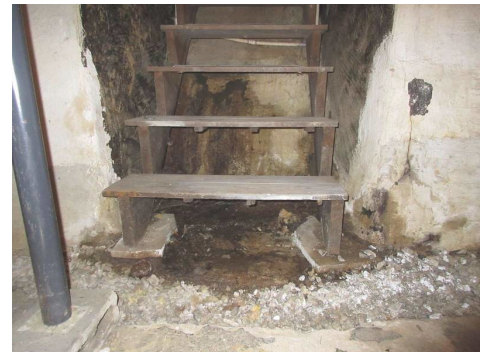
11.6.1 Crawlspace & Basements

WATER INTRUSION; ACTIVE

BASEMENT, BEHIND STAIRCASE

Water intrusion was evident through walls in the basement/crawlspace. This can compromise the soil's ability to stabilize the structure and could cause damage. Recommend a qualified contractor identify the source of moisture and remedy.

Recommendation
Contact a qualified professional.
