SUMMARY

1234 Main St. Hayden ID 83835

Buyer Name
07/03/2018 9:00AM

Joshua McKay
Certified Professional Inspector
Lake City Inspections LLC
(208) 779-1553
hello@lakecityinspections.com

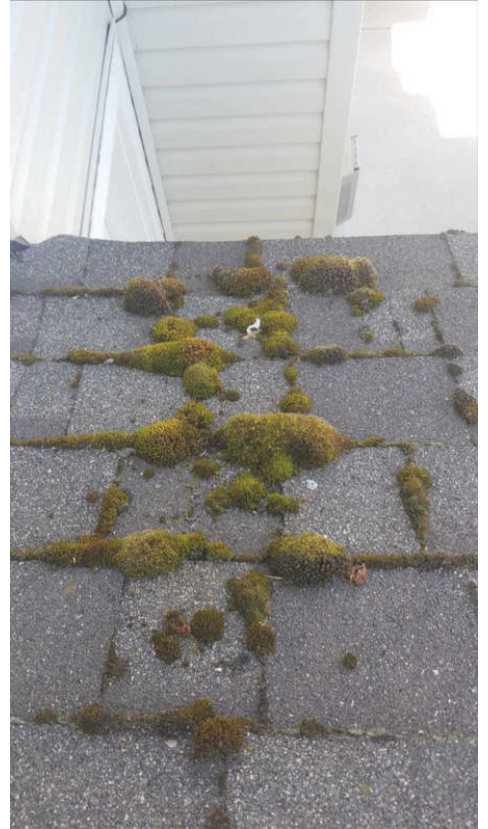
NORTH, ROOF

MOSS

While inspecting the roof I found moss growth in multiple areas on the north side of the roof. If left unaddressed this condition will compromise the integrity of the asphalt shingle covering and lead to moisture intrusion. I recommend that a qualified professional evaluate and clean/repair as necessary.

Contact a qualified roofing professional.

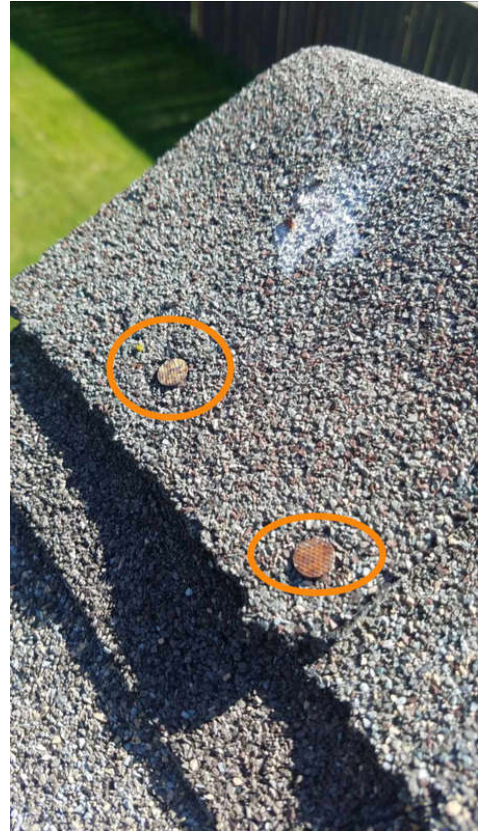
ROOF

FASTENERS - EXPOSED

While inspecting the roof coverings I noticed exposed fasteners in multiple areas along the ridge, specifically at the ends. Best practices call for application of an appropriate sealant over the fasteners to prevent moisture intrusion.

Contact a qualified roofing professional.

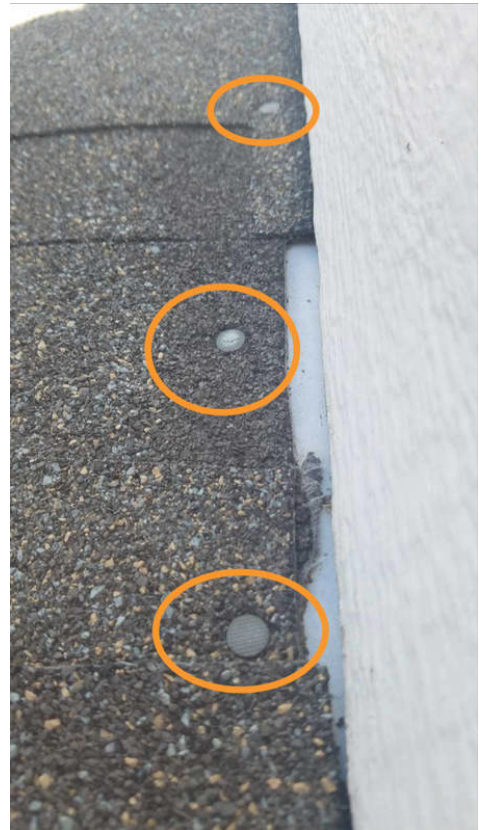
ROOF

FLASHING - EXPOSED FASTENERS

While inspecting the roof I noticed exposed fasteners driven into the flashing. I recommend that a qualified roofing contractor apply sealant over the exposed fastener heads to prevent moisture intrusion.

Contact a qualified roofing professional.

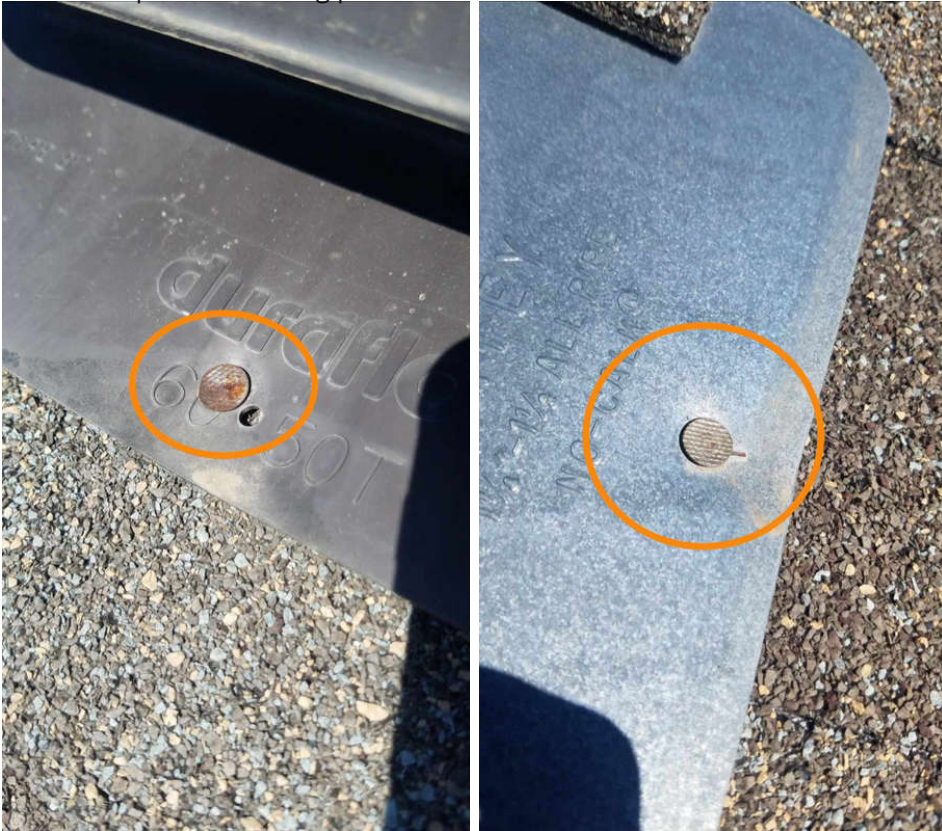
ROOF PENETRATION FLASHING - EXPOSED FASTENERS

While inspecting the penetration flashing I noticed multiple exposed fasteners. Best practices call for application of an appropriate sealant product over the fastener heads to prevent moisture intrusion.

Contact a qualified roofing professional.

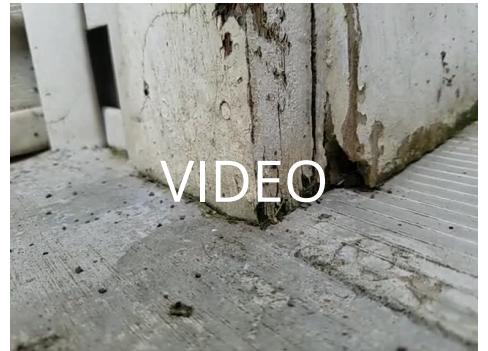
NORTH, EXTERIOR

TRIM - DETERIORATED

While inspecting the patio area I found that the bottom portion of trim around the exterior entry door is deteriorating. This is common due to the amount of moisture (snow) that sits against the trim for long periods of time during the winter months. A handyman can apply new paint to help protect the existing trim or replacement may be considered.

Contact a qualified handyman.

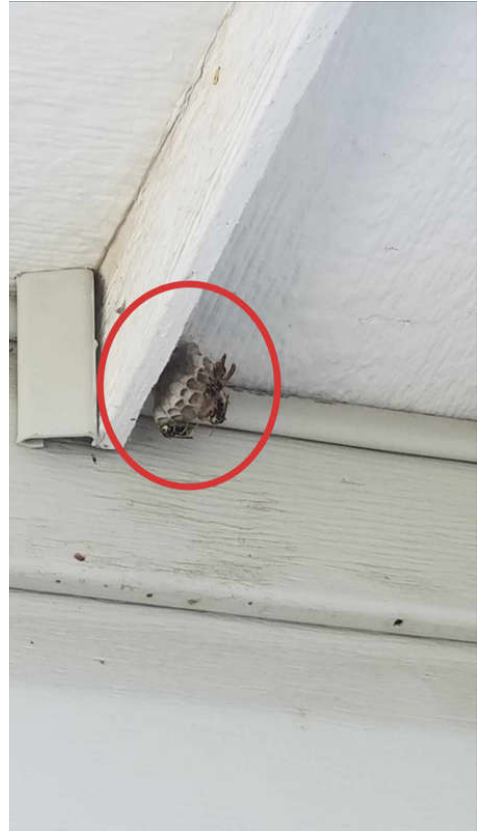
SOUTH

STINGING INSECT NEST

While inspecting the exterior of the home I noticed active wasp nests affixed to the home. This may pose a safety concern depending on the breed of insect and the personal medical vulnerabilities of a given victim. I recommend that a qualified exterminator evaluate and remove.

Contact a qualified pest control specialist.

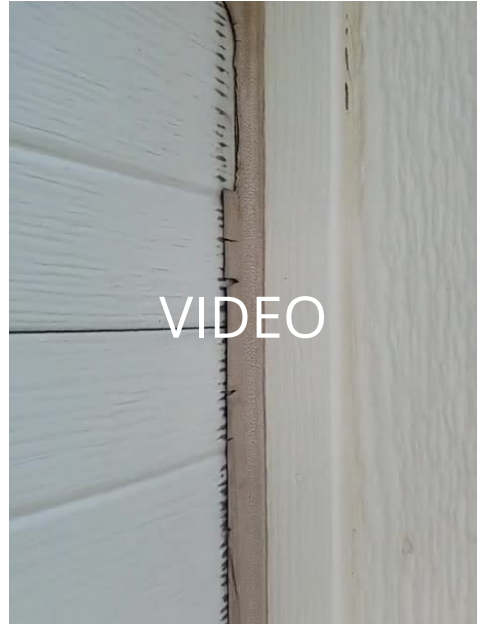
SOUTH, GARAGE

GARAGE DOOR - DETERIORATING THERMOSTOP

While inspecting the garage door I noticed that the thermostop material is deteriorating. This is a common maintenance item as homes age and can be replaced by a garage door contractor.

Contact a qualified garage door contractor.

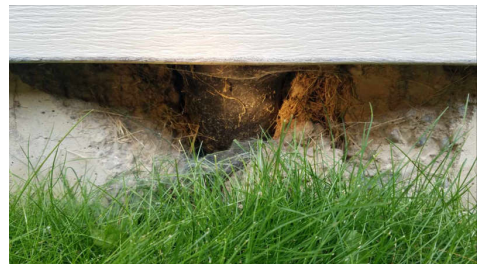
EAST

FOUNDATION - HOLE

While inspecting the foundation I noticed that there is a hole that appears to have been created to make room for an ABS drain pipe. I do not believe this hole is indicative of any major foundation issues, however it is important that moisture is not able to enter this space. I recommend repair by a qualified foundation contractor.

Recommendation
Contact a foundation contractor.

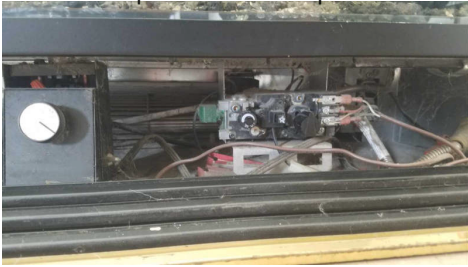
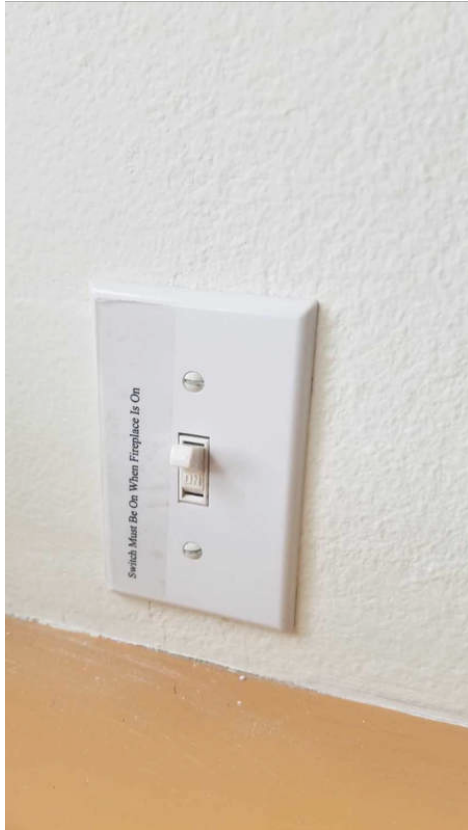
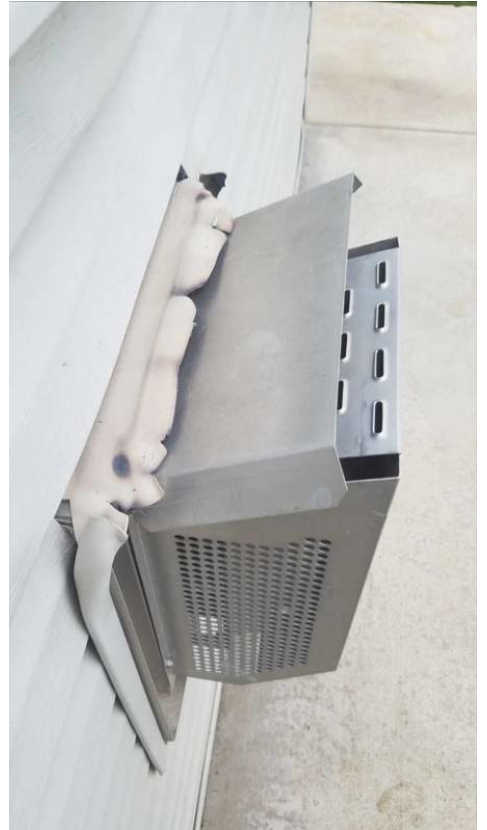
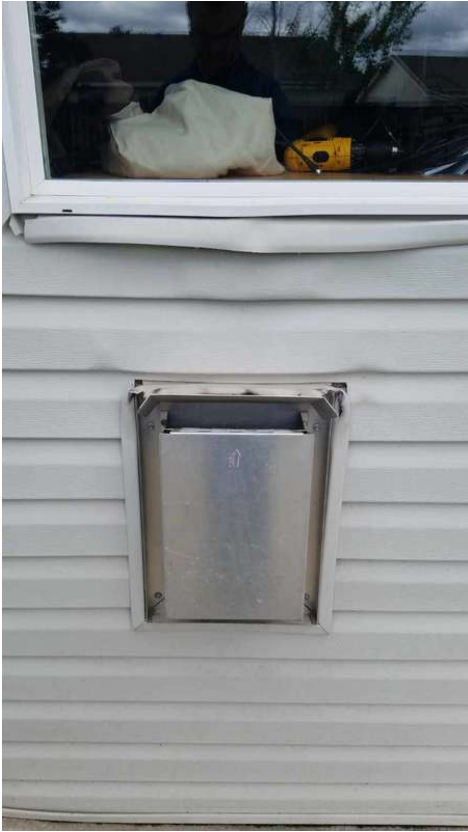
LIVING ROOM

GAS FIREPLACE - INOPERABLE

While inspecting the gas fireplace unit, I found it to be inoperable. The unit was disabled during the inspection and returned to a disabled state following the attempted test. Heat damage was noted to the exterior direct vent exhaust flue trim pieces. Vinyl siding above the vent flue was found to be warped due to heat exposure. I recommend service of the entire unit to restore functionality and ensure safe operation.

Recommendation
Contact a qualified HVAC professional.
