SUMMARY

1234 Main St. Loudon TN 37774

Dusty Jameson
TN Home Inspector License #00123,
TN WDI License #104158
Inspector Cluseau's Home Inspection
Service

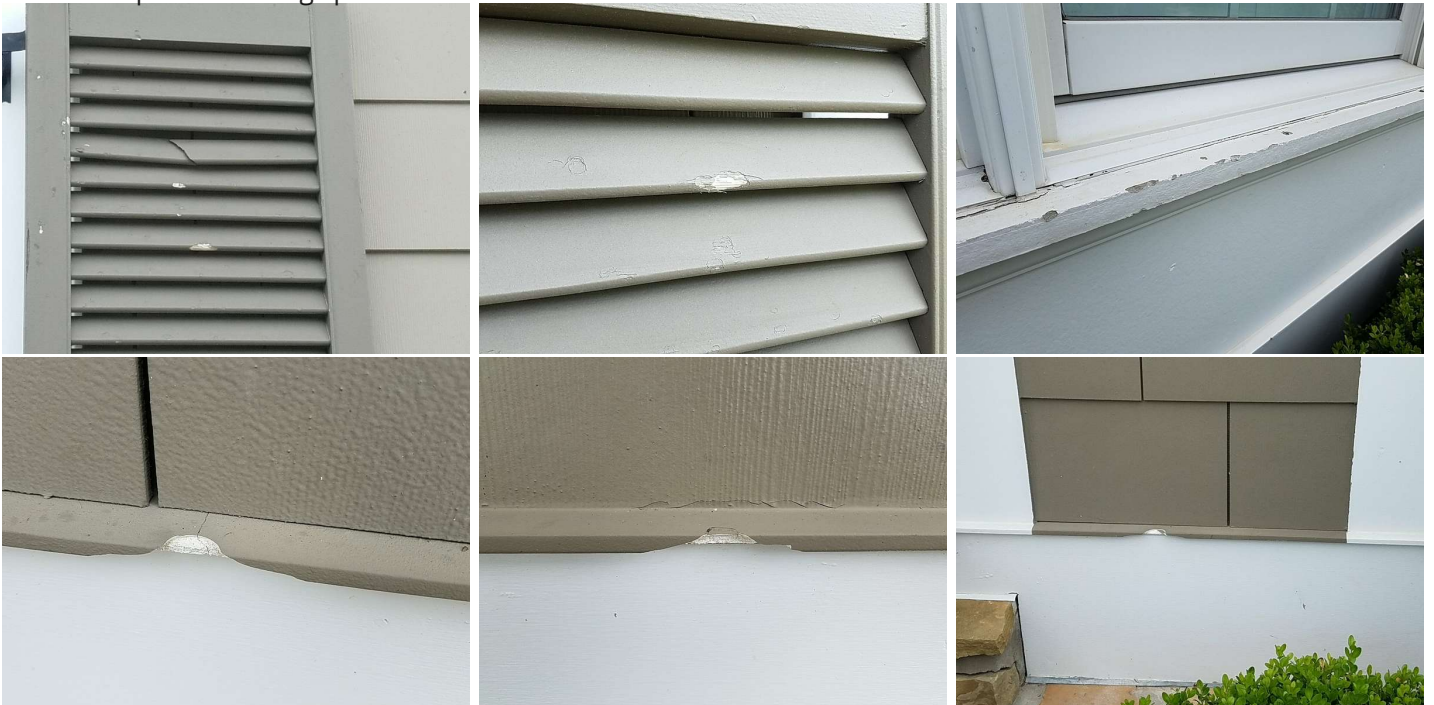
VARIOUS LOCATIONS

SURFACE BLEMISHES

There are blemishes in the surface at several areas around the home (primarily on the front wall - west side facing directional weather). The blemishes are in the surface of the shutters and trim pieces. Wood surfaces should be repaired and painted to discourage deterioration. The blemishes on the trim pieces are mainly aesthetic and can be replaced as desired.

Contact a qualified siding specialist.

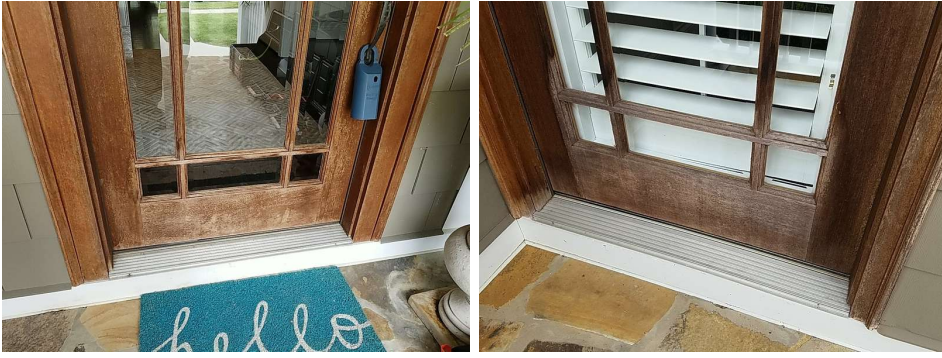
FRONT EXTERIOR DOORS

WEAK STAIN ON DOORS

The stain is weak on the front exterior doors. This is normal to occur, especially for doors facing west and exposed to sunlight. The doors can be re-stained as desired.

Contact a qualified painter.

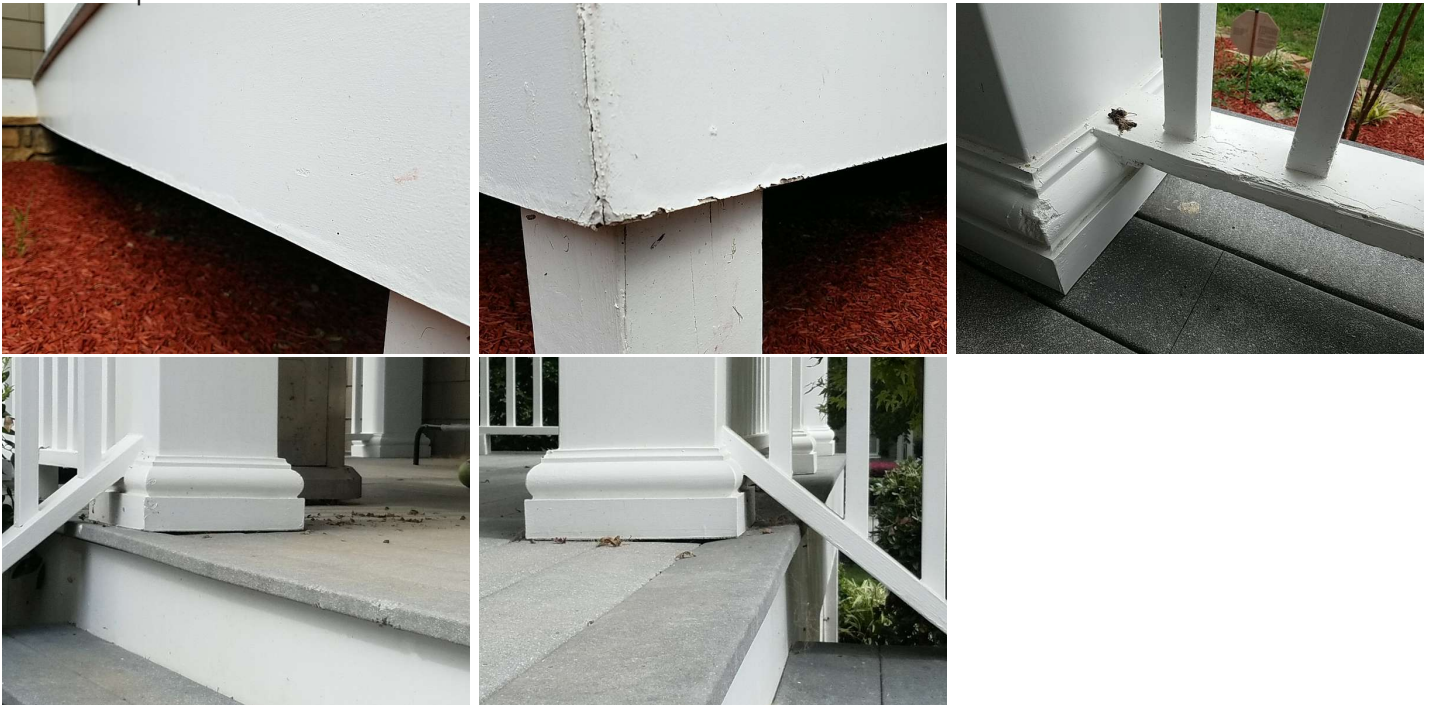
MISCELLANEOUS DECK CONCERNS

There were some concerns with the deck that are primarily aesthetic concerns and do not affect functionality.

- The trim board along the outer perimeter of the deck is weathered. Re-painting the board can help to discourage deterioration.
- Some of the rails are scuffed (caused by pet/s).
- The surface is not level along the outer edge. There were visible issues with the framing below the outer end.

These items do not affect functionality or integrity and can be repaired or addressed as desired.

Contact a qualified deck contractor.

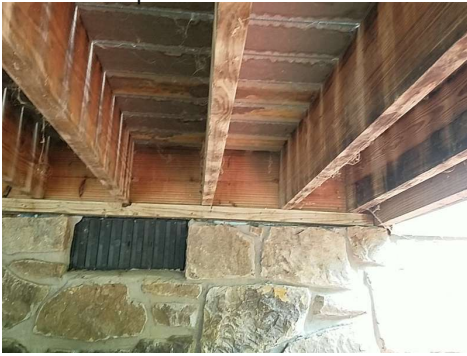
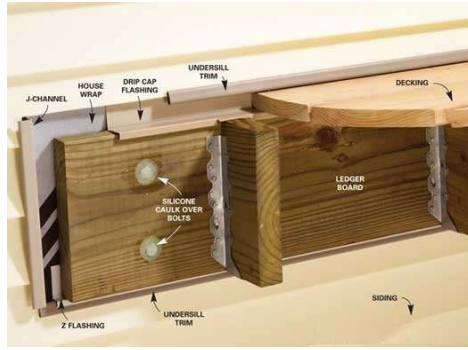
DECK

LEDGER NOT BOLTED

There were no visible bolts attaching the deck ledger to the home. Consult with a reputable deck company to add bolts to the ledger board where attached to the home for best integrity.

Contact a qualified deck contractor.

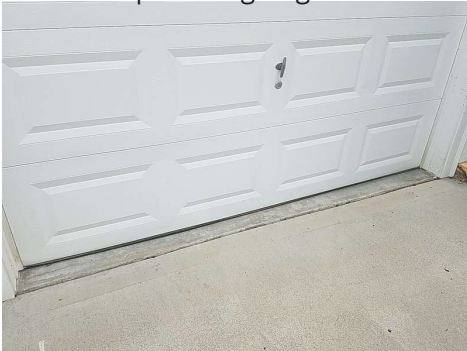
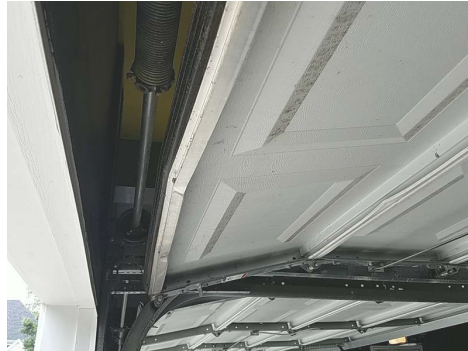
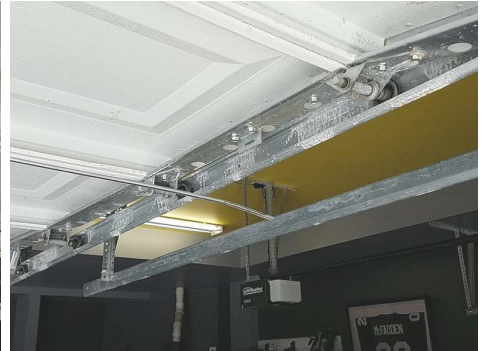
RIGHT HAND GARAGE DOOR

DOOR PANEL BENT AND LOCK ARM IS LOOSE

The right hand garage door is bent (bottom panel). This does not affect functionality of the door. The panel can be replaced as desired.

In addition, the lock bar is disconnected on the left door. The lock mechanism should be adjusted so that the bar is properly secured.

Contact a qualified garage door contractor.

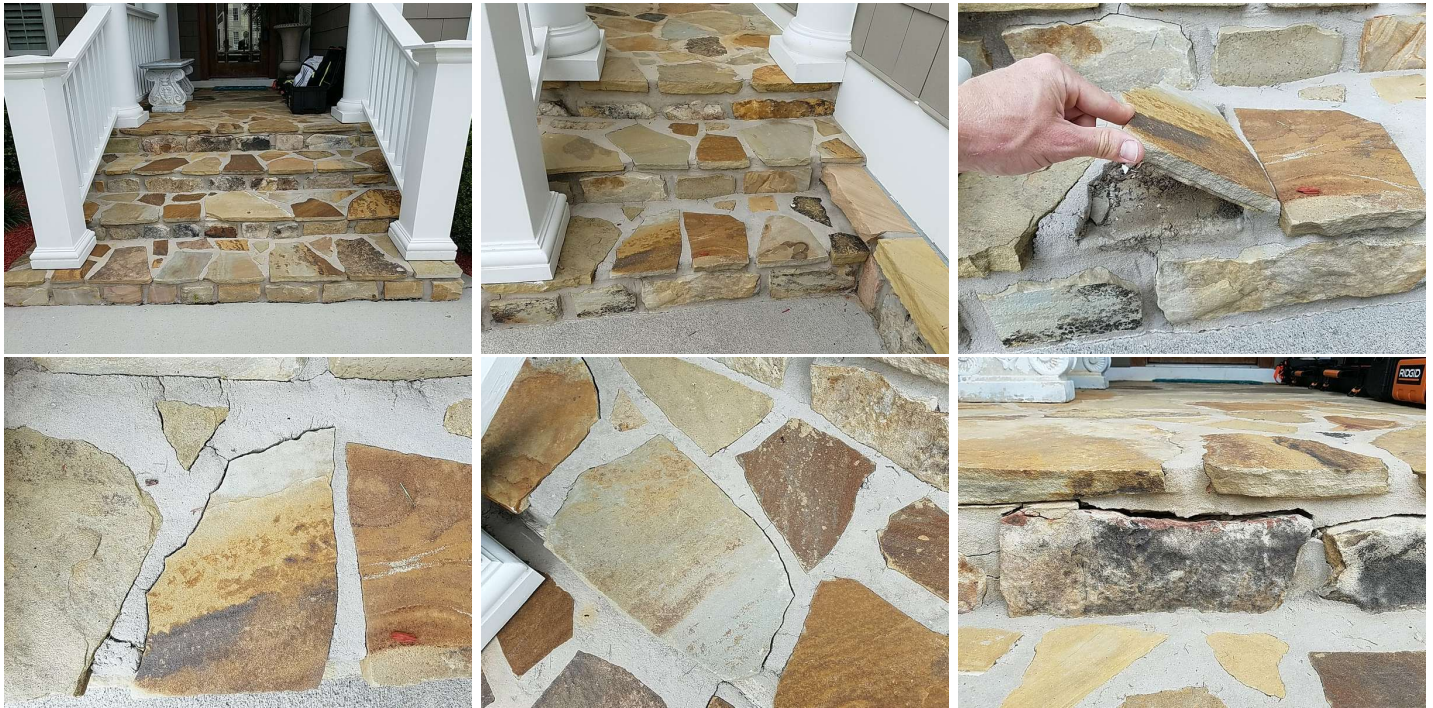
FRONT PORCHES

CONCERNS AT STONE STAIRS

Some of the stones are loose at the porches on the front of the home. In addition, there are cracks in the mortar between the stones at various locations. All loose stones should be properly secured and any open joints in the mortar should be sealed to discourage further deterioration.

Contact a qualified masonry professional.

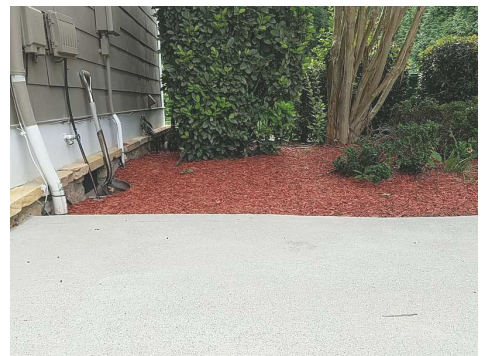
RIGHT SIDE AND FRONT LEFT

NEGATIVE GRADING

Areas of the soil do not maintain proper slope away from the foundation. This could allow surface water to flow towards the foundation. All areas of the soil around the home should slope away from the foundation to encourage proper drainage away from the structure. If proper grading cannot be achieved, alternative means of drainage may be necessary (surface drain, french drain, etc.).

Contact a qualified grading contractor.

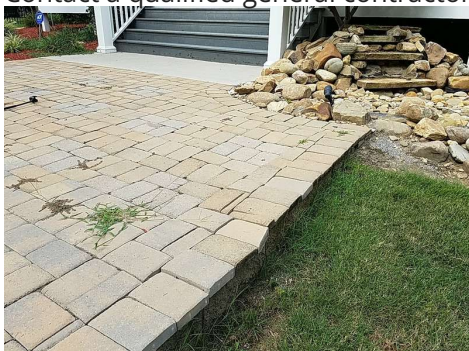
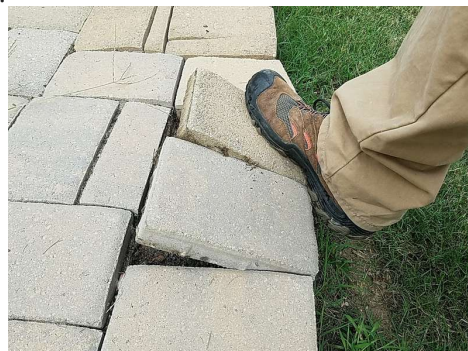
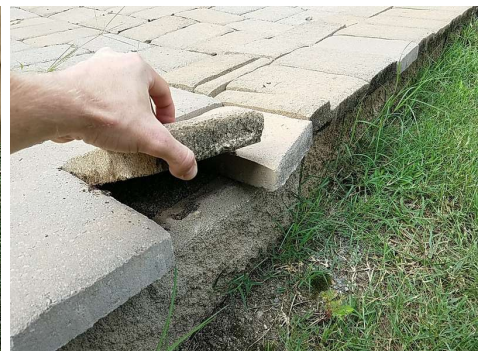
REAR LAWN

LOOSE PAVERS

Some of the pavers are loose along the edge of the patio. This is a potential trip hazard. I recommend all pavers be properly secured.

Contact a qualified general contractor.

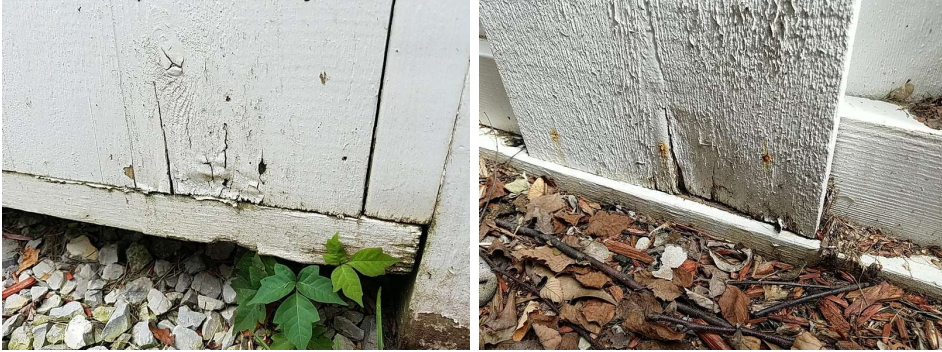
PRIVACY FENCE AROUND HVAC EQUIPMENT

DAMAGE TO FENCE BOARDS

Some of the boards are beginning to rot on the privacy fence around the HVAC equipment. The boards can be repaired or replaced as necessary.

Recommendation
Contact a qualified handyman.

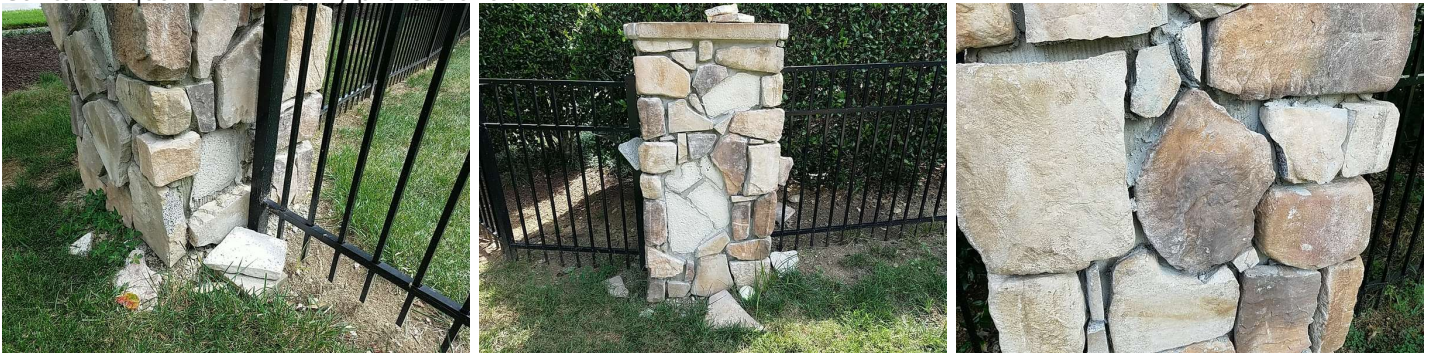
REAR LAWN

LOOSE STONES ON COLUMNS

The stonework is incomplete on the columns for the fence. Some of the stones have come loose and there is no mortar between the stones.

Recommendation
Contact a qualified masonry professional.

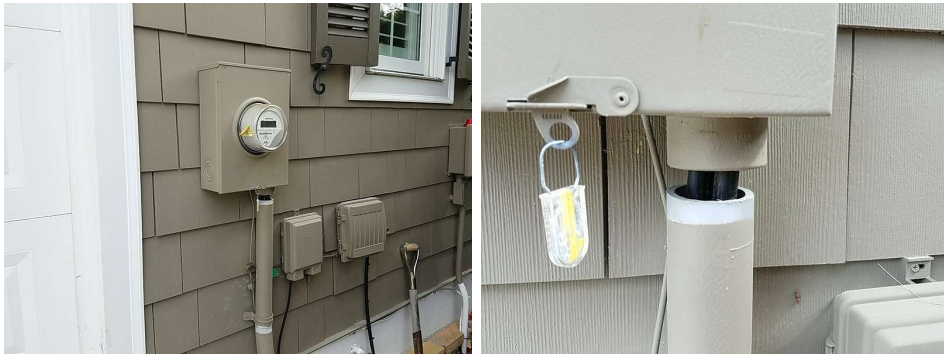
RIGHT SIDE

CONDUIT DISCONNECTED FROM METER

The conduit around the incoming electrical line has come disconnected at the bottom of the meter base.

Recommendation
Contact a qualified electrical contractor.

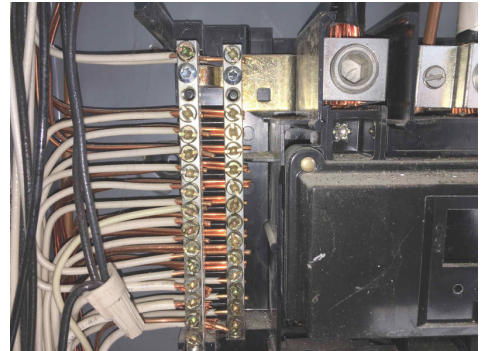
MAIN PANEL BOX IN GARAGE

DOUBLE TAPPED NEUTRAL

The electrical panel has neutral wires present that are sharing a terminal with other wires. Grounded (neutral) conductors are to be isolated (not sharing a terminal with any other conductor).

This item does not affect functionality of the system and can be repaired as necessary (in context with other electrical repairs that may be performed).

Contact a qualified electrical contractor.

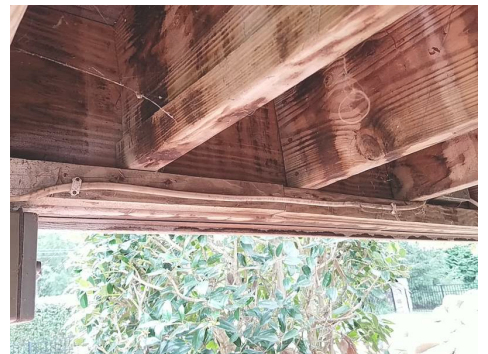
BELOW THE DECK

EXTERIOR WIRE NOT IN CONDUIT

The wire at the listed location is not contained in conduit. This may result in damage to the wire and is a potential shock hazard if the wire is damaged. I recommend all exterior wires be contained in protective conduit.

Contact a qualified electrical contractor.

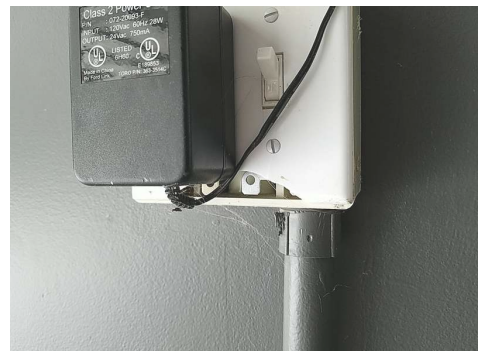
GARAGE

COVER PLATES DAMAGED

Cracked / broken cover plates were observed on the electrical fixtures. NOTE: I recommend replacing damaged covers.

Contact a qualified handyman.

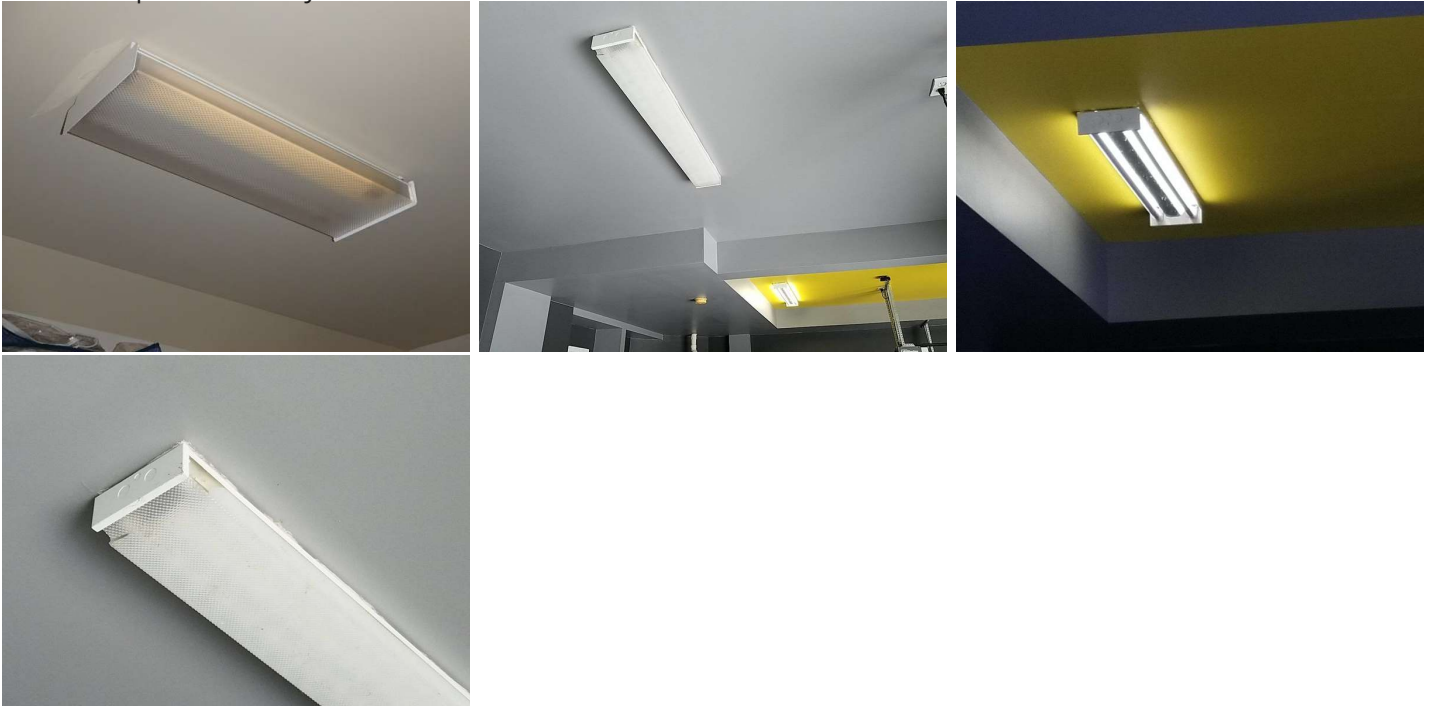
GUEST BEDROOM CLOSET

LIGHT NOT WORKING PROPERLY

The fluorescent lights in the guest bedroom closet and garage are not working. I suspect the bulb or the ballast is bad and should be replaced.

In addition, the cover has been removed from one of the lights in the garage and the cover is broken on the other light in the garage. The covers can be replaced.

Recommendation
Contact a qualified handyman.

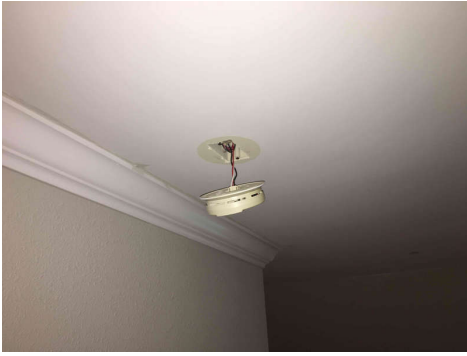
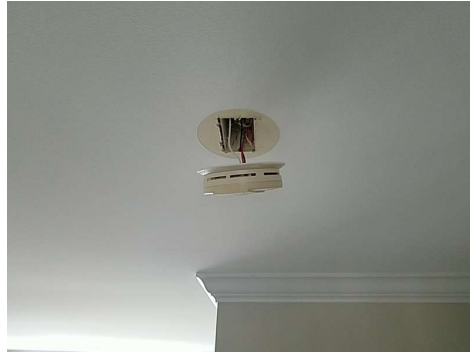
FRONT BEDROOM AND LOFT

NOT SECURED PROPERLY

The smoke detector at the listed location is not properly secured into place. All detectors should be secured to the wall or ceiling and should be functional.

Recommendation
Contact a qualified handyman.

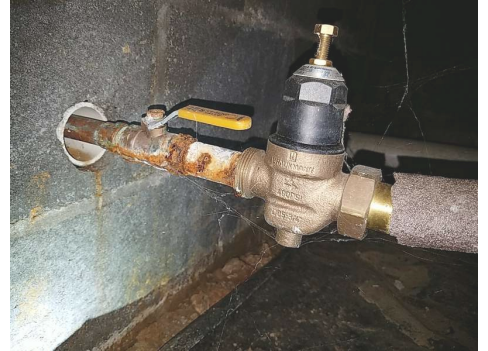
MAIN INCOMING LINE IN THE CRAWLSPACE (BELOW THE POCKET KITCHEN)

CORROSION ON PIPING

There is corrosion on the water piping at the listed location. The affected pipe should be replaced to ensure prevent undetected leaks.

Contact a qualified plumbing contractor.

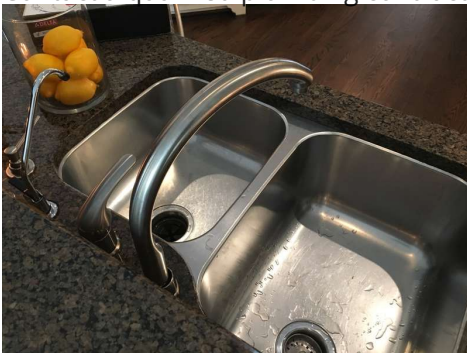
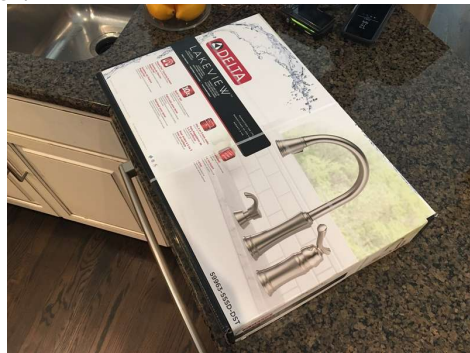
KITCHEN SINK

FAUCET TO BE REPLACED

The kitchen sink faucet is broken. A new faucet is intended to be installed prior to closing.

Contact a qualified plumbing contractor.

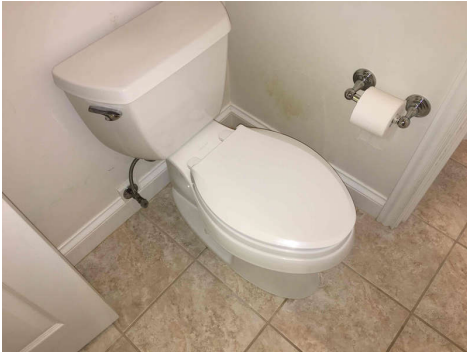
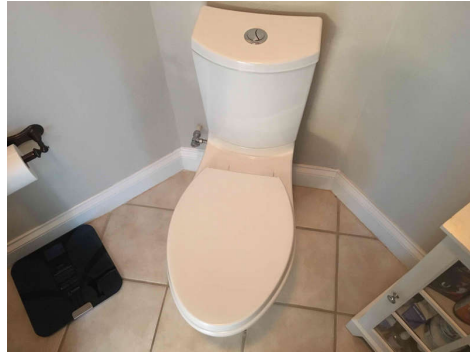
UPPER LEVEL BATHROOMS

TOILET LOOSE / NOT SECURED

The toilet is not secured tightly to the floor at the listed location. This raises potential for leaks at the seal. Necessary repairs should be made to secure the toilet and ensure there are no leaks or underlying concerns.

Contact a qualified plumbing contractor.

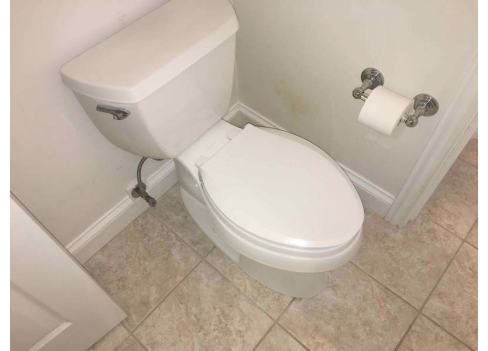
UPPER LEVEL BATHROOM (REAR)

TOILET - WATER RUNS

The water continuously runs at the toilet at the listed location. The internal components will need to be repaired / replaced.

Contact a qualified plumbing contractor.

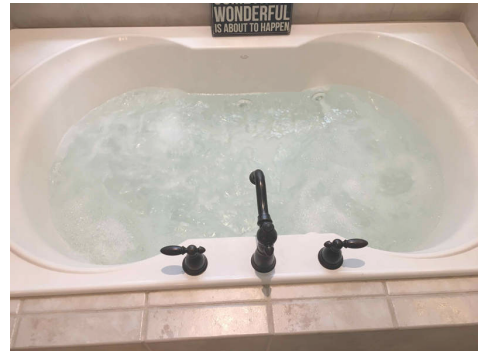
MASTER BATHROOM

NO ACCESS PANEL LOCATED

There was no access panel located for the Jacuzzi tub motor. There should be access to the motor for servicing and maintenance.

Contact a qualified professional.

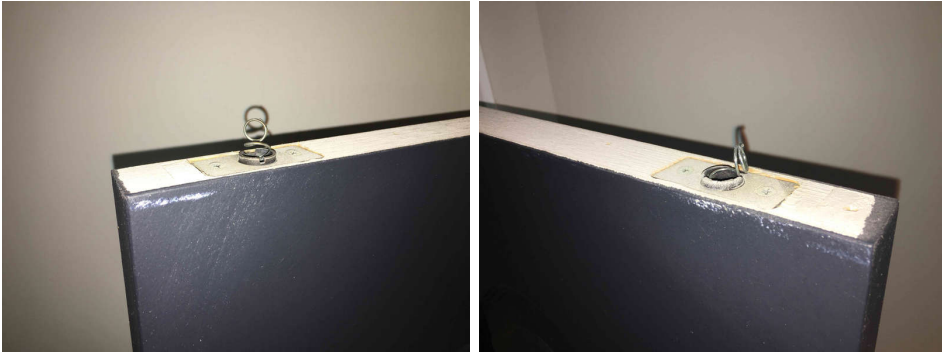
MASTER BATH

BALL CATCH BROKEN

The ball hinge is broken on the door in the master bathroom. The hinge will need to be repaired / replaced.

Contact a qualified door repair/installation contractor.

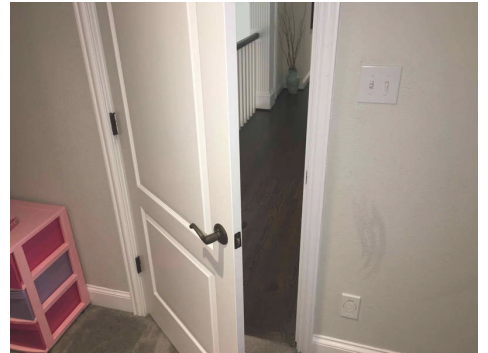
VARIOUS LOCATIONS

DOOR ADJUSTMENTS

There are various doors that need to be adjusted (doors rub casings, do not latch, etc.). This typically requires adjustments with the hinges.

Contact a qualified handyman.

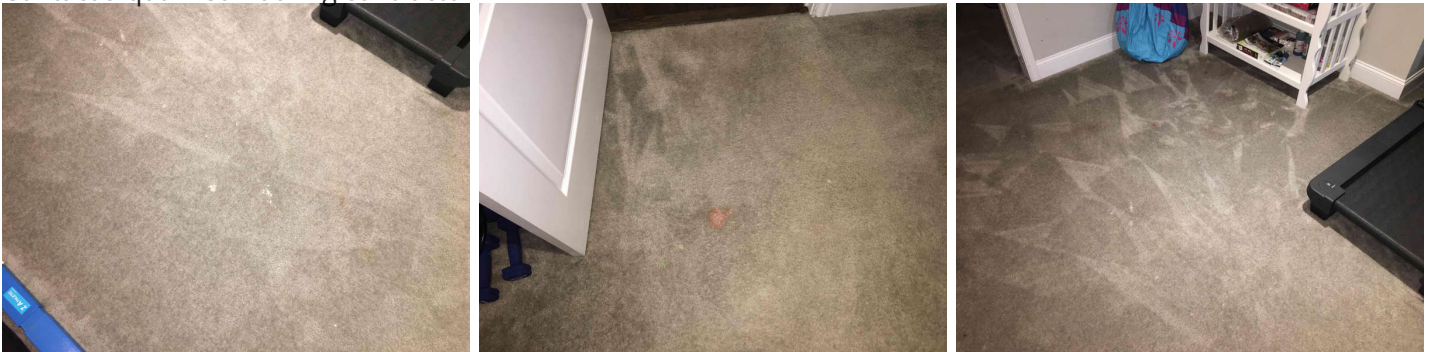
VARIOUS LOCATIONS

CARPET STAINS

The carpet is stained at various locations. The carpet can be cleaned or replaced as desired. NOTE: Some stains may not be able to be removed.

Contact a qualified flooring contractor

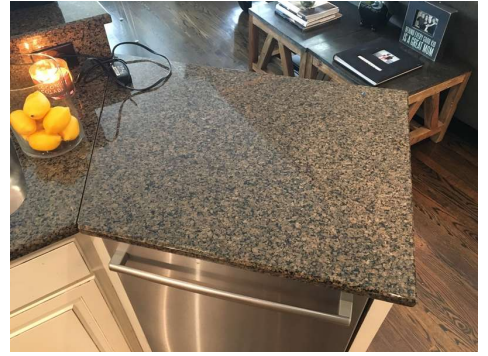
KITCHEN

COUNTER TOP NOT SECURED

The counter top is not secured to the cabinet above the dishwasher. The counter should be properly secured.

Contact a qualified countertop contractor.

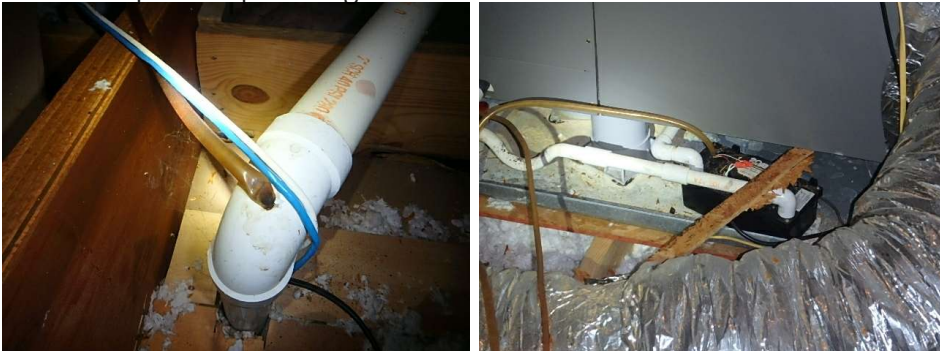
ATTIC

CONDENSATE DRAIN CONCERN

The condensate drain tube is connected to the plumbing vent pipe in the attic. The tube is kinked where connected into the vent pipe, which raises concern for the line to clog and crack. In addition, the drain tube does not have a proper fitting where attached to the vent pipe.

Contact a reputable plumbing company to make necessary repairs to the piping for best functionality and to prevent future concern.

Contact a qualified plumbing contractor.

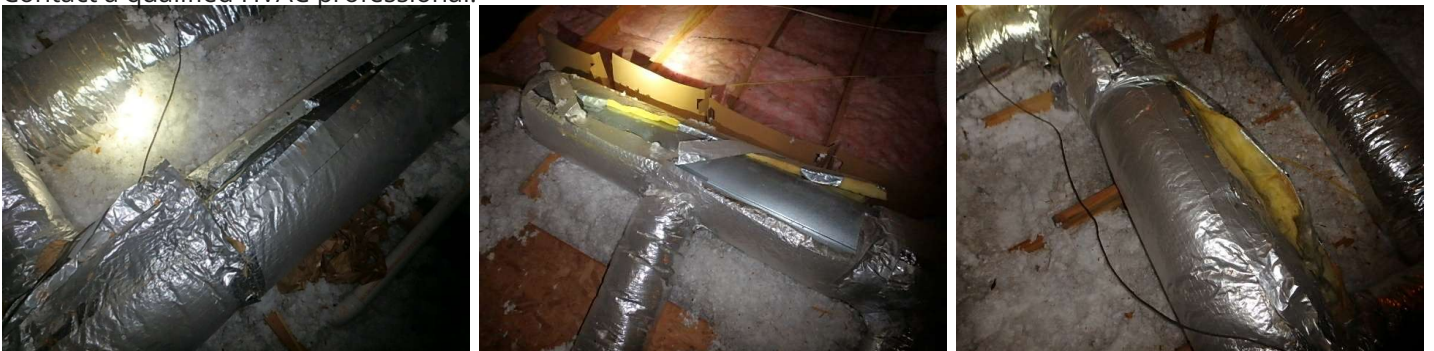
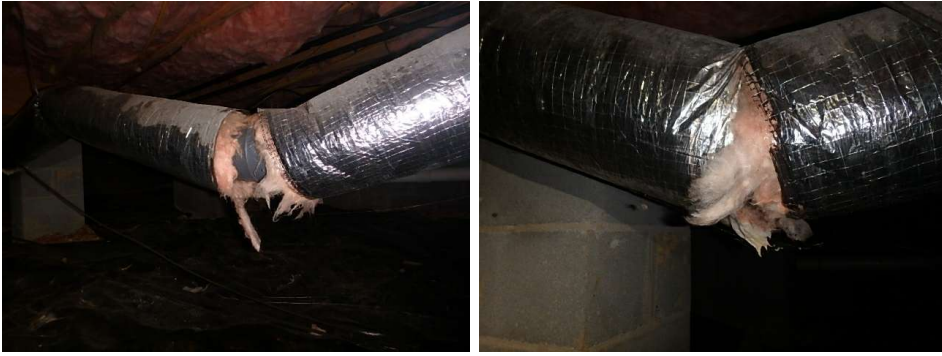
ATTIC AND ONE AREA OF THE CRAWLSPACE

DUCT INSULATION IS LOOSE / TORN

The insulation is loose / torn on sections of the air ducts at the listed locations. The insulation on the ducts should be repaired.

Contact a qualified HVAC professional.

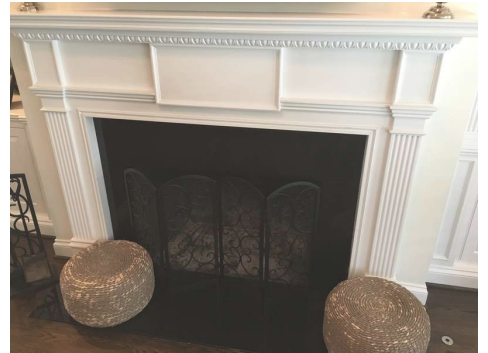
FIREPLACE

RECOMMEND CLEANING

I recommend having the fireplace flue professionally cleaned / swept.

Contact a qualified fireplace contractor.

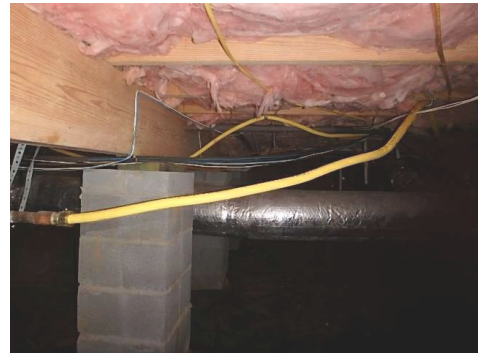
VISIBLE IN CRAWLSPACE

CSST PIPE BONDING

There is CSST gas piping routed in the home. This type of piping is required to be bonded to the main grounding system. You can read more about this type of piping at [this link](#). I recommend contacting a licensed electrician to verify the piping is properly bonded to the main grounding system as suggested by the pipe manufacturer.

NOTE: All electrodes used must be bonded together into one common grounding electrode system. A separate grounding electrode and grounding system cannot be established just for the fuel gas piping system.

Contact a qualified electrical contractor.

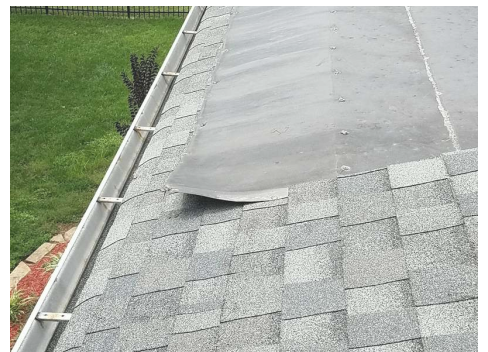
METAL ROOF AT REAR

FLASHING CONCERNS

The bottom edge of the metal is loose at the rear of the home. The metal should be properly repaired to prevent leaks.

Contact a qualified roofing professional.

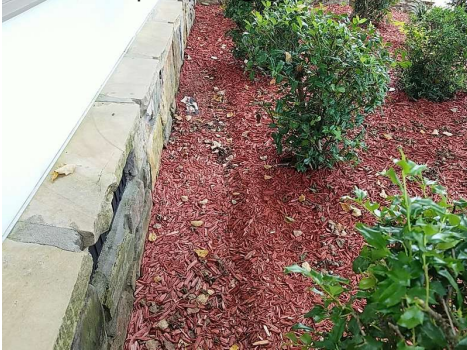
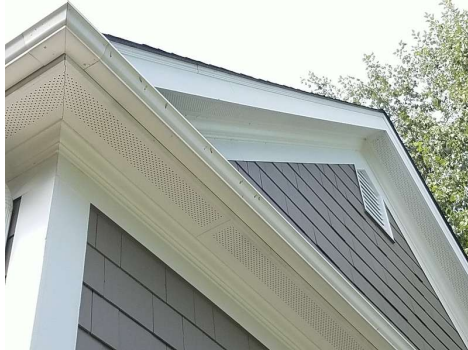
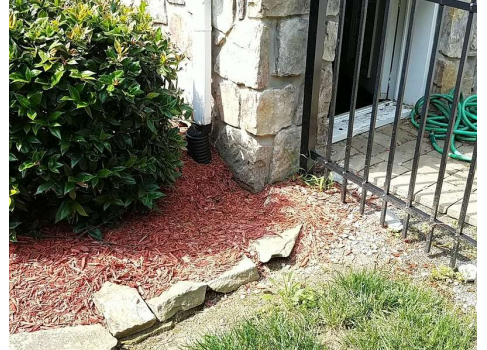
VARIOUS LOCATIONS AROUND HOME

SIGNS OF OVERFLOW

There are signs of gutter overflow. The gutters should be properly cleaned and maintained to ensure water is diverted away from the sides of the home and the foundation.

Contact a qualified gutter contractor

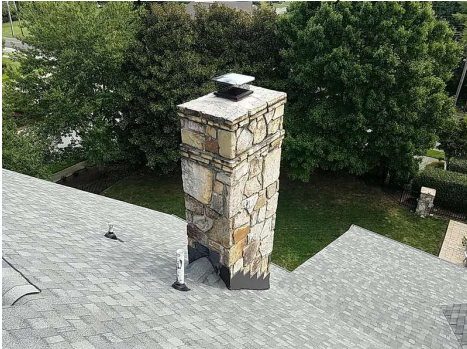
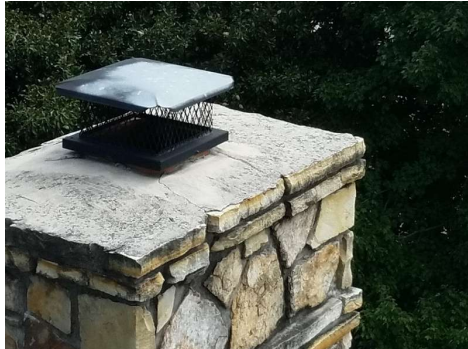
REAR SIDE OF ROOF

SEAL OPEN JOINTS

The open joints in the mortar on the chimney should be sealed to discourage water entry and further deterioration.

Contact a qualified chimney contractor.

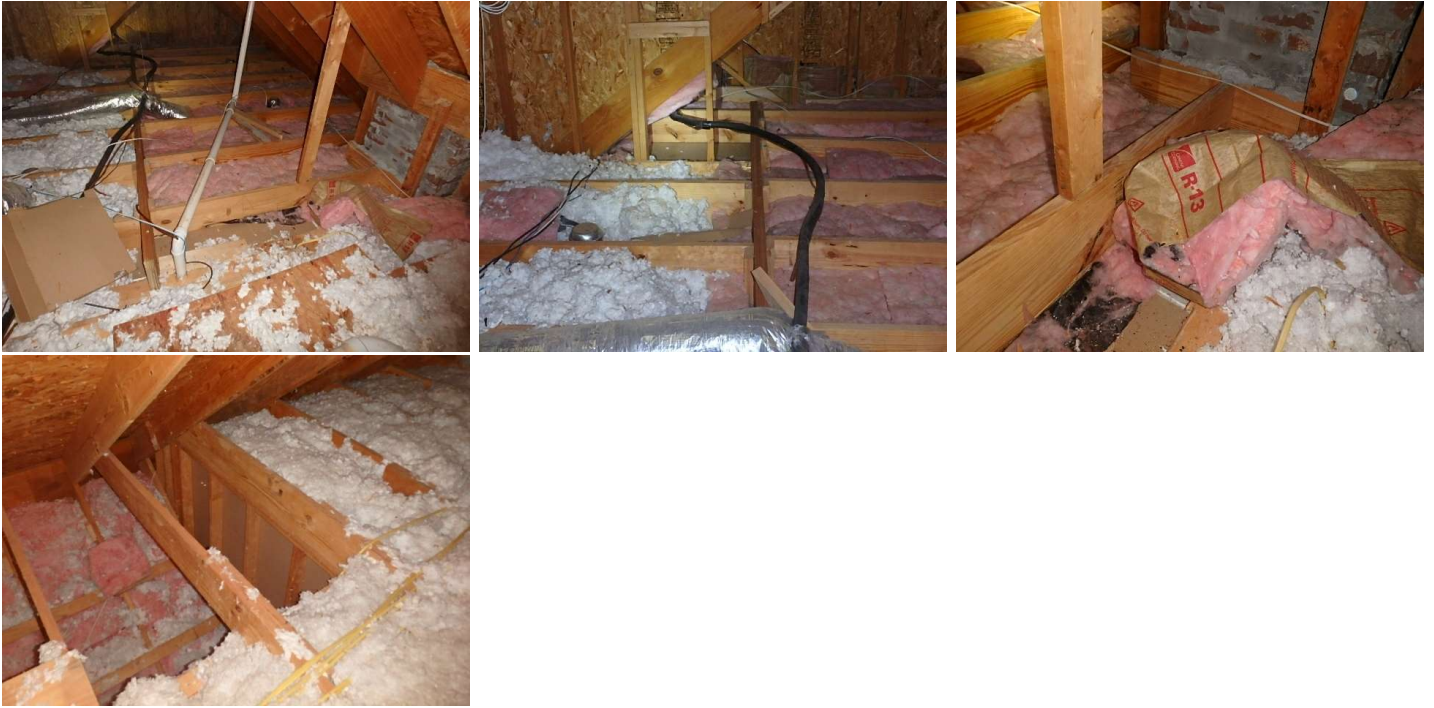
VARIOUS LOCATIONS IN ATTIC

WEAK / NO INSULATION OVER AREA

There are areas in the attic that are not properly insulated. This will reduce energy efficiency. I recommend adding or repairing the missing or weak insulation so that all areas are properly insulated for best efficiency. NOTE: current standard for attic insulation is R38.

Contact a qualified insulation contractor.

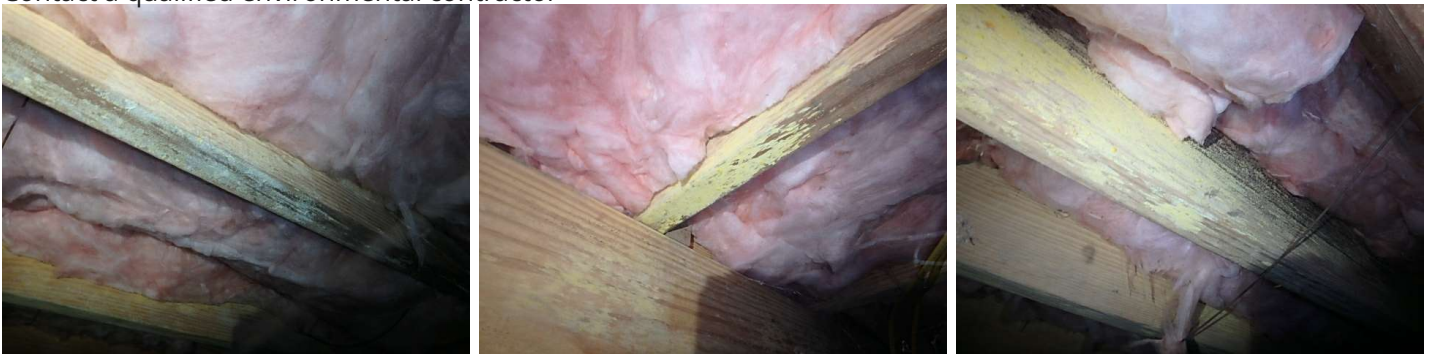
CRAWLSPACE

EVIDENCE OF HUMID CONDITIONS

There is fungus on the framing at various locations in the crawlspace. This is an indication of elevated humidity / moisture levels. I recommend contacting an environmental contractor for further review and for possible methods of correction (removal and treatment of the fungus) and prevention (addressing the cause of elevated humidity levels).

Contact a qualified environmental contractor

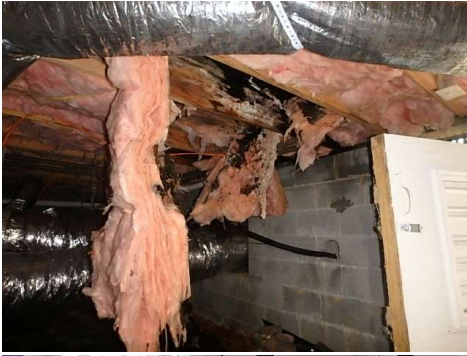
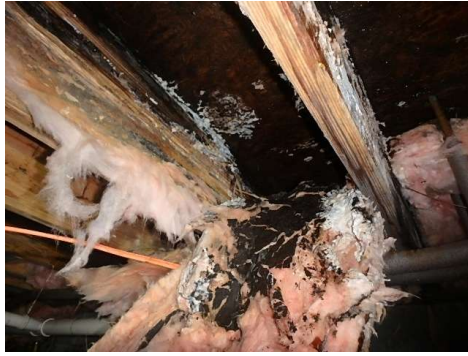
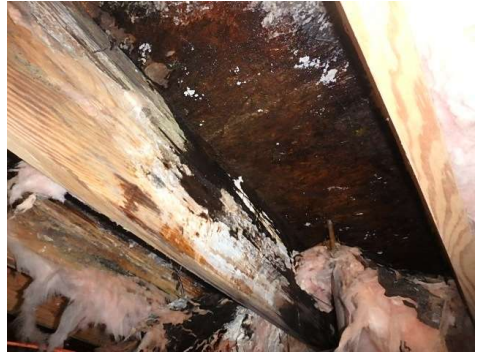
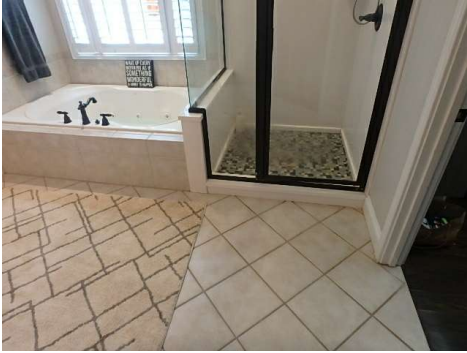
MASTER BATHROOM

DAMAGED FRAMING

There was water leaking from the floor system below the master bathroom shower stall at the time of this inspection. The framing below the shower is saturated and there is deterioration to the wood. I recommend contacting a reputable contractor to make all necessary repairs to the shower and framing.

Contact a qualified general contractor.

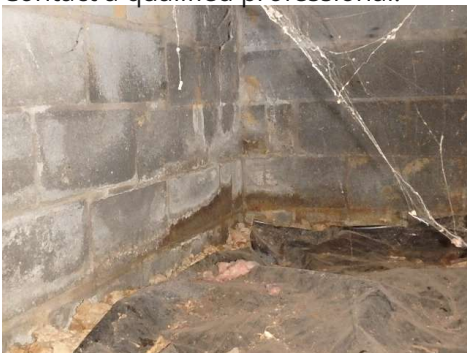
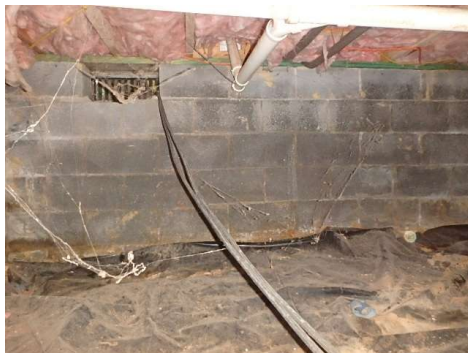
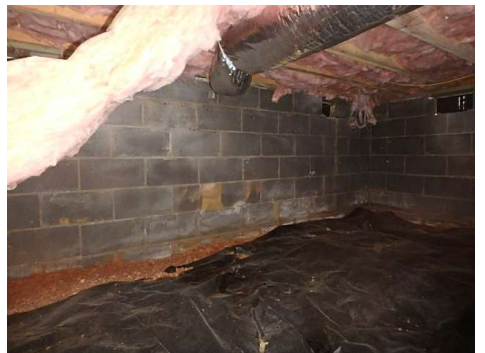
VARIOUS LOCATIONS

MOISTURE ON FOUNDATION WALLS

There were isolated areas in the crawlspace that were stained by moisture (some moisture was present during this inspection).

This appears to be the result of gutter overflow and some areas of the ground not sloping away from the structure. Operation of the irrigation system can also be a culprit.

I recommend making necessary effort to divert water away from the foundation. Keep the gutters maintained so that water from the roof will be diverted away from the structure. Adjusting the soil in the flower beds could help to divert surface water away from the structure.

Contact a qualified professional.
