## Summary Information

### 2.1.1 Roof Coverings

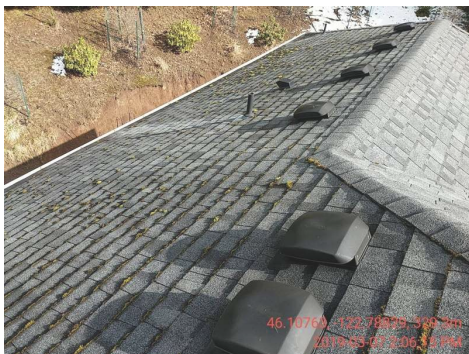
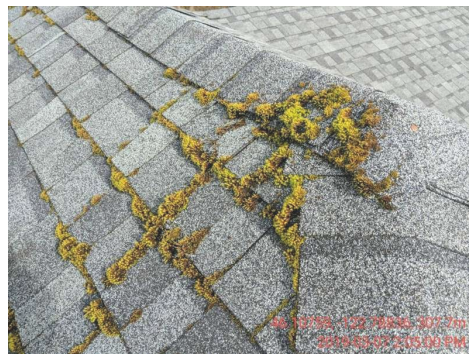
#### MOD - HVY MOSS

There is moderate to heavy moss on the roof covering. Moss can damage the roof covering and potentially promote leaking. I recommend having the moss cleaned off of the roof covering as soon as possible. Never pressure wash shingles as this can damage them and shorten roof cover life.

Contact a qualified professional.

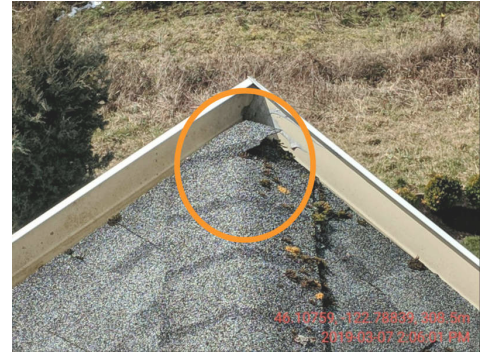
NORTHWEST

There are damaged shingles on the roof which need replacing as necessary by a roofer to prevent potential moisture intrusion and damage to the home's structure. Have a roofer further inspect the roof covering for all necessary repairs.

Contact a qualified roofing professional.

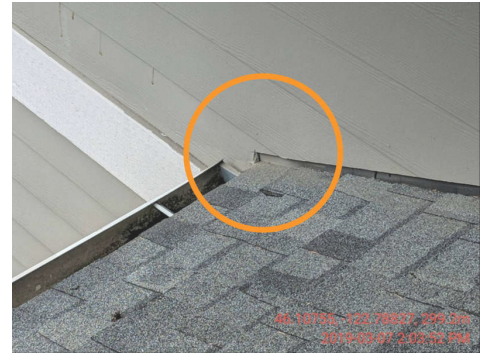
SOUTHWEST

Kickout flashing directs water away from the wall cladding and into the gutter at roof eave / sidewall intersections to prevent water running down and potentially behind the wall cladding causing damage to the structure. While not required on older homes when built, it is a VERY good item to have installed for preventative maintenance if not currently installed and can help prevent leaks and costly repairs. I recommend having a roofer add kickout flashing to areas not having one.

Contact a qualified roofing professional.

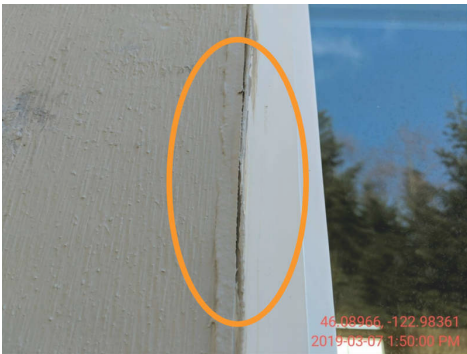
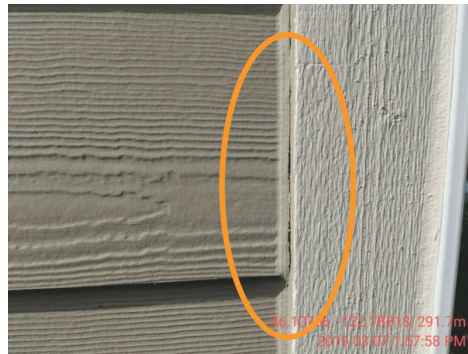
The caulking is cracking or gapping in some areas. Caulking needs to be well maintained at siding / trim, siding / window, and butt joints if the joint is not flashed. This is a maintenance item and should be periodically inspected and repaired as necessary. I recommend re-caulking in these areas to prevent water intrusion and damage to the structure.

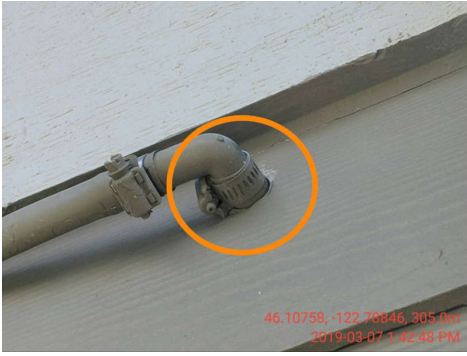
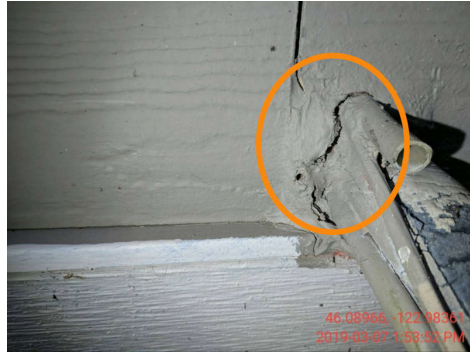
NORTH, SOUTH

There are penetrations in the siding where the hole or gap should be caulked or sealed to prevent water and pest intrusion. Even small holes can allow significant amounts of water into a wall cavity over time and cause damage. Repair as soon as possible.

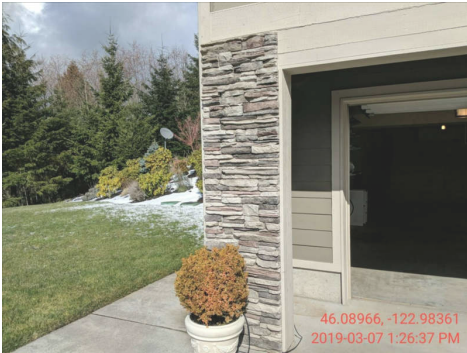
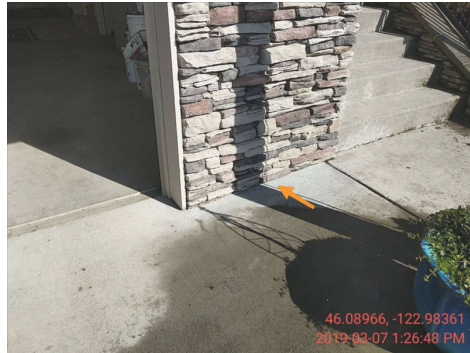
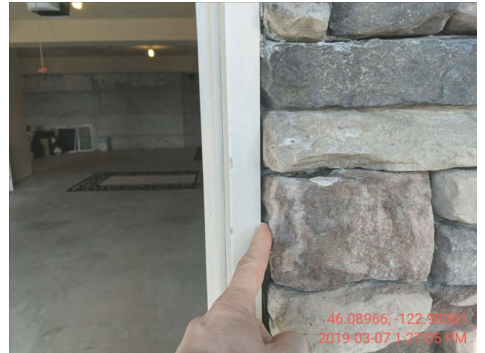
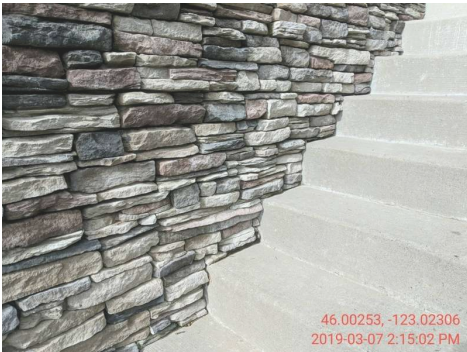
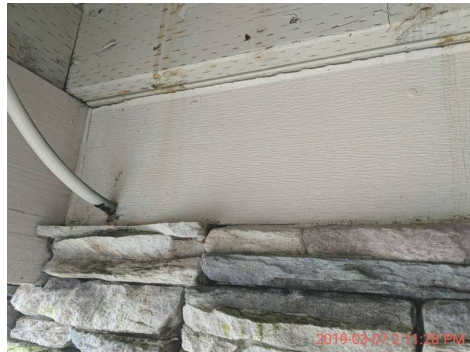
No sealant bead at transitions, Insufficient clearance from stone to grade, No weep screed, No flashing at top of stone assembly

The AMSV (Adhered Manufactured Stone Veneer) or cultured stone as many people call it is not properly installed according to published industry guidelines. The MVMA (Masonry Veneer Manufacturers Association) publishes guidelines for proper installation of manufactured stone veneer. These guidelines help to prevent moisture related issues with the veneer. Not all best practices may be required by a jurisdiction. While I do not see any current moisture issues as a result of the installation, however, it has a higher risk of moisture related issues due to the lack of following best practices. Have it further inspected by a manufactured stone veneer inspector if you would like more information on whether repairs are recommended for this particular installation. Please keep in mind, if this is an older installation, it may have been installed prior to some of the current requirements, however, the best practices still apply to older installations, and they may benefit from being repaired to minimize risk of moisture related issues.

Contact a qualified professional.

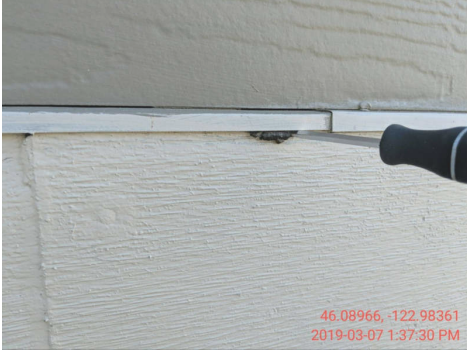
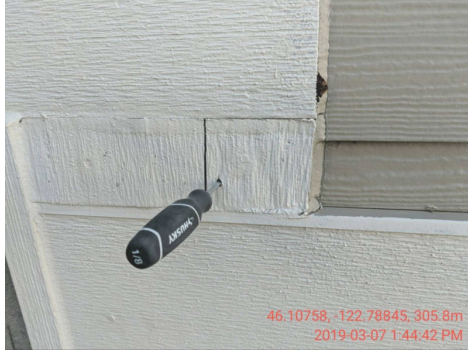
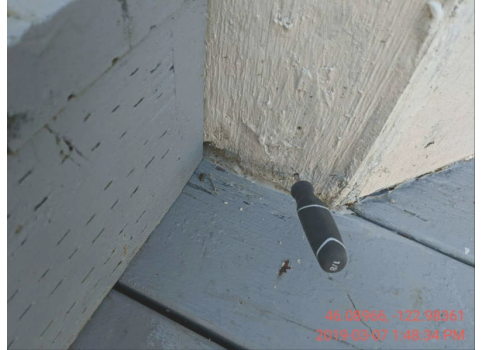
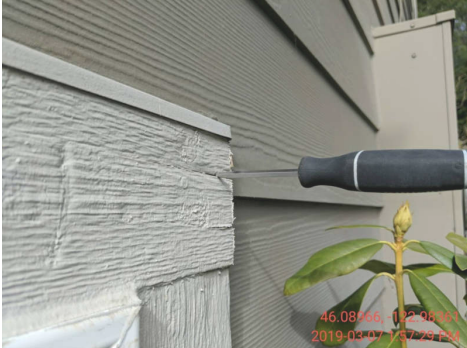
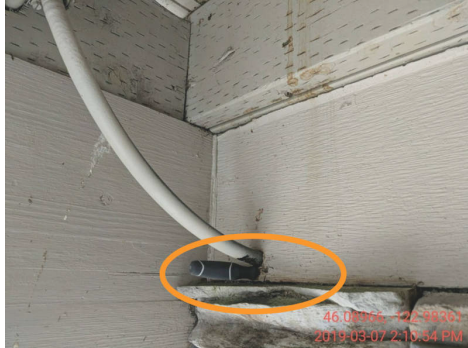
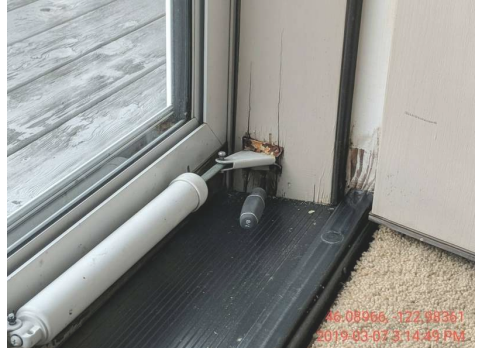
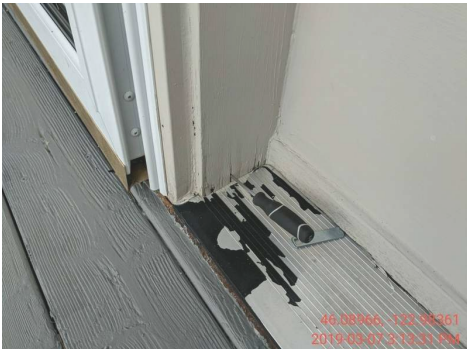
NORTH, EAST, SOUTH, WEST UNDER DECK, AT DECK OFF LIVING ROOM

There is some trim / siding around the home that has some wood decay. Decayed wood can potentially attract pests such as insects. I recommend replacement of any decayed wood. Have a siding contractor further review the siding to find and repair all areas.

Contact a qualified siding specialist.

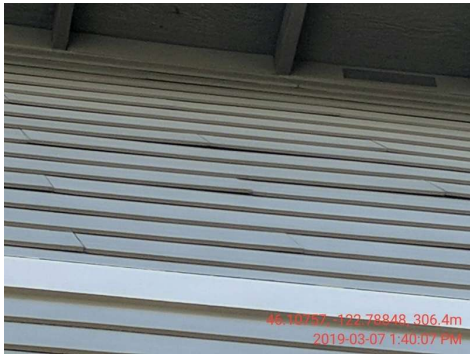
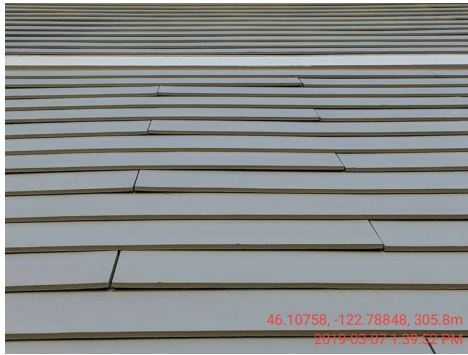
NORTH

Some siding course butt joints have edges curling up away from the home and needs to be pinned back to prevent moisture intrusion behind the siding. Be sure and follow manufacturer directives for placement and fastener specifics. It is usually indicated to use stainless or galvanized finish nails only.

Contact a qualified siding specialist.

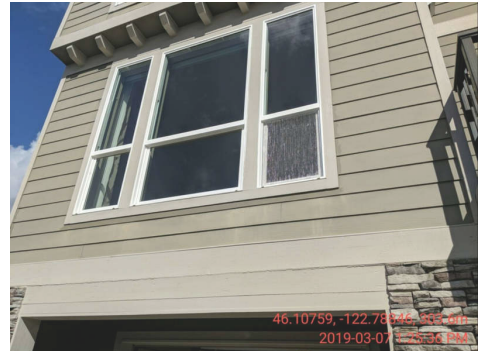
The house is due for paint. Some areas appear thin and there are many areas of peeling or missing paint. I recommend having the entire house painted to help protect the structure.

Recommendation  
Contact a qualified painting contractor.

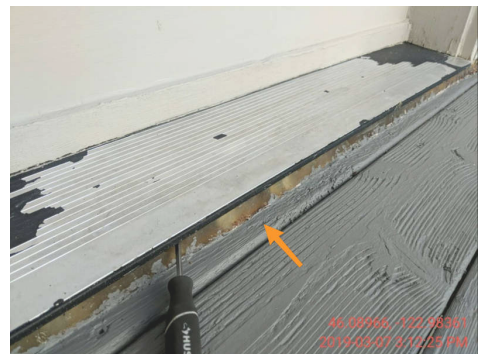
Exterior doors should be wrapped at the bottom sill and properly flashed to prevent water intrusion. This door does not appear to be properly flashed to prevent water intrusion. There is a lot of sealant at the bottom of the door in the attempt to seal this area. There are gaps in the sealant. I recommend having a contractor with knowledge of proper door flashing review this door to make appropriate repairs and prevent potential water damage.

Recommendation  
Contact a qualified door repair/installation contractor.

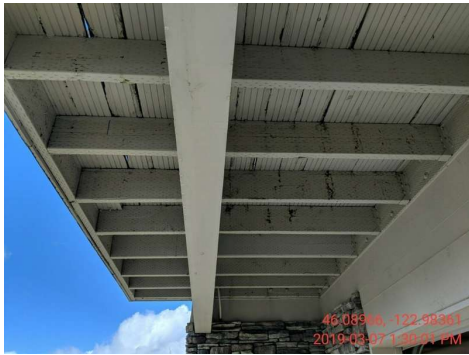
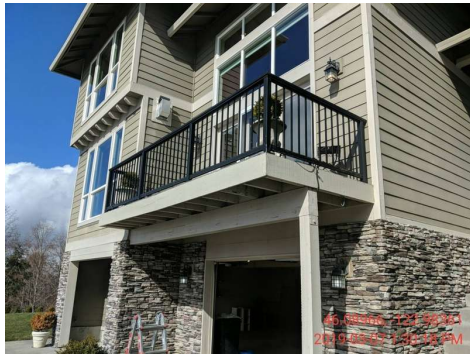
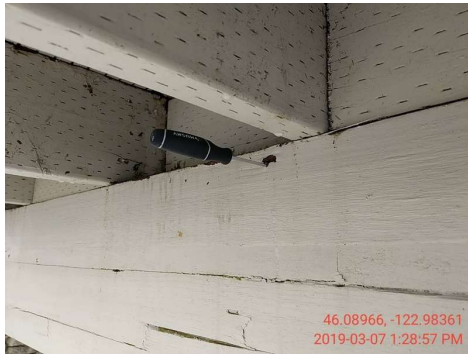
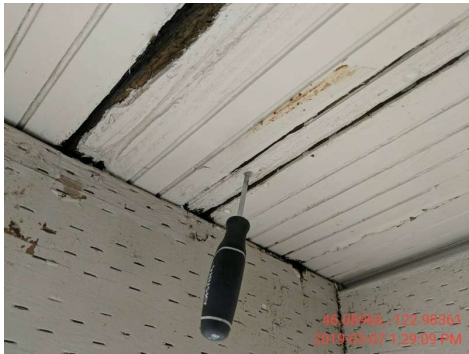
Wood decay in structure, No metal hold downs from rim joist to floor joists, Cantilevered more than 1/4 supported span

Over the years, deck construction standards have changed significantly. A deck built to standards at the time of construction may not meet current standards today. Decks, like other systems, have a lifespan, typically 10-15 years on average. The current deck building standards are outlined in the DCA 6 - Prescriptive Residential Wood Deck Construction Guide. I note multiple issues with the deck and recommend a deck contractor familiar with current standards review and correct the deck as necessary including any additional deficiencies discovered.

Recommendation  
Contact a qualified deck contractor.

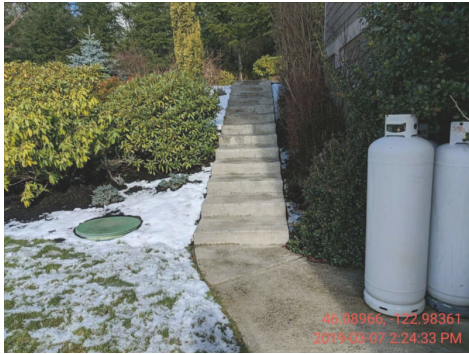
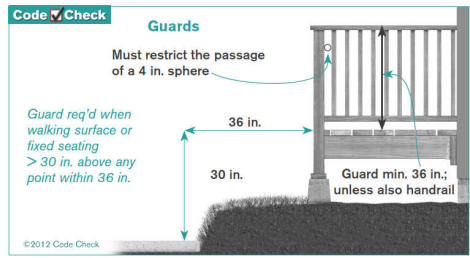
NORTH

There is no railing installed in an area in which current safety standards require a railing or guard. I recommend installation of a railing / guard in this area for safety. Stairways with 4 or more risers should have an approved graspable profile railing and balusters spaced no more than 4 inches apart if the side of the stairs is exposed to falls. Walking surfaces greater than 30 inches above the ground within 3 feet of the walking surface should have a railing installed for safety. Areas noted:

Recommendation  
Contact a qualified deck contractor.

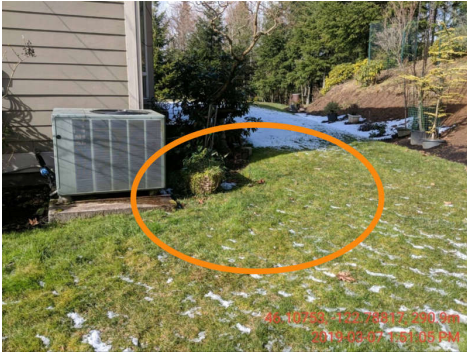
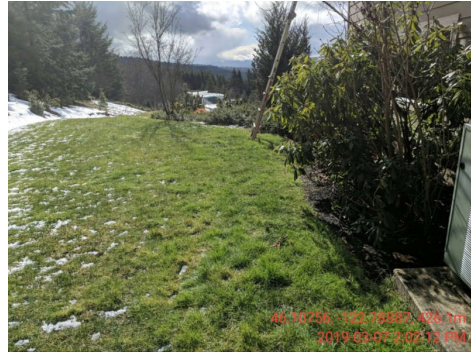
SOUTHEAST, SOUTH

There is a negative slope or drainage towards the home in one or more areas. This area does not drain water away from home and needs landscaping and / or drainage corrected. Recommend any areas that slope toward the home be corrected to maintain positive drainage of water away from the home. Proper slope away from the home is 5% or 6 inches for the first ten feet of ground cover, and 1/4 inch per foot on other surfaces such as patios. If proper drainage cannot be met by landscaping, additional drainage may be necessary, and a drainage contractor should review the premises for further advice.

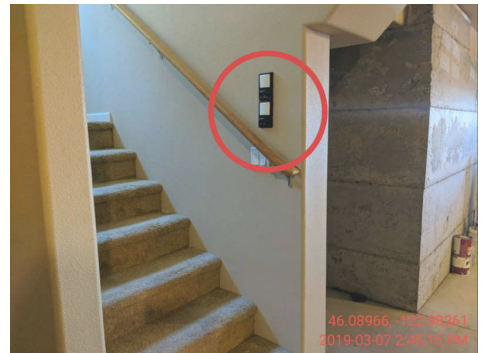
The garage door opener control is installed less than 5 feet tall above the walking surface. Manufacturers recommend installation at least 5 feet above the walking surface to avoid small children from operating the door. Have the controller raised to be at least 5 feet above walking surface.

Contact a qualified garage door contractor.

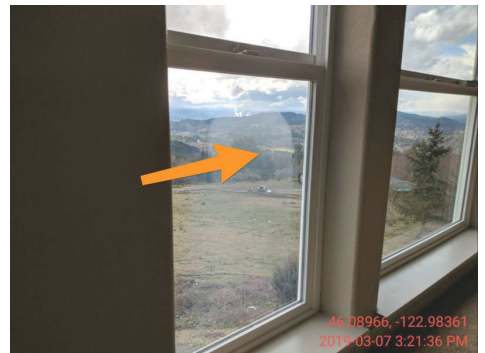
MASTER BEDROOM

Some windows around the home have a broken seal and there is some haziness between the panes. These windows still function fine as insulated windows, however, aesthetically they are not appealing and do not provide a clear view. Have them repaired or replaced by a glass contractor.

Contact a qualified window repair/installation contractor.

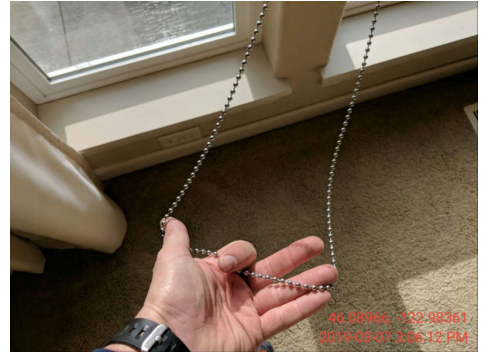
Some window blind cords contain loops. This is a potential strangle hazard for small children. I recommend cords that do not contain loops.

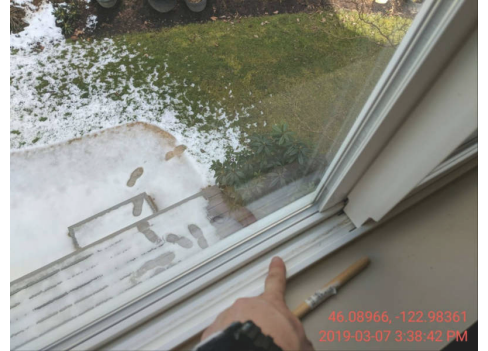
For your information, there are no window guards on some windows in the home on the upper floors which restrict how far the window can be opened. I recommend consider adding window guards on the windows to restrict how far they can be opened for additional child safety if small children will be present in the home.

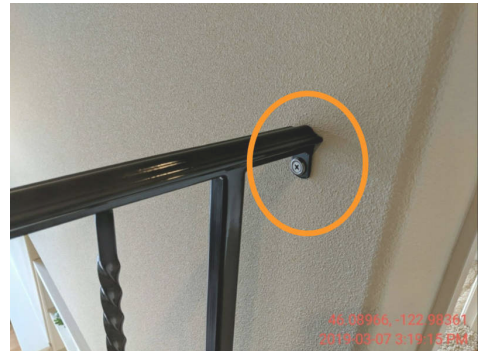
2ND FLOOR

The railing is loose in one or more areas. I recommend repair as necessary.

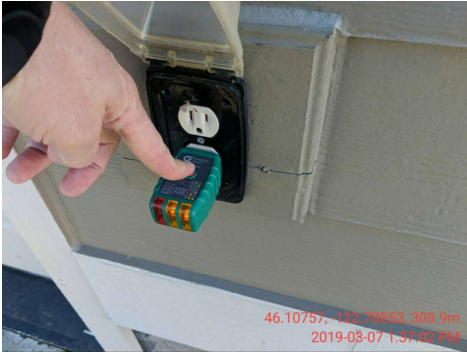
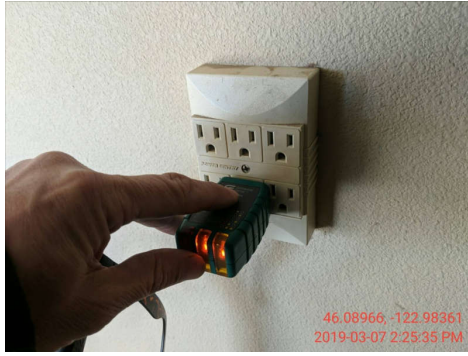
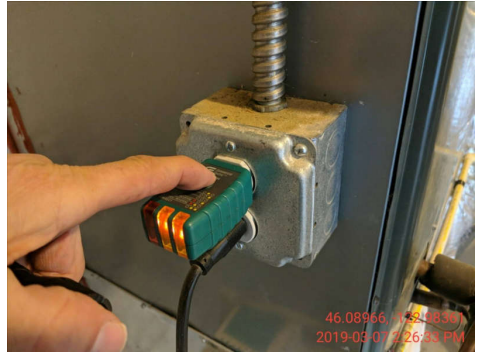
EXTERIOR (ALL), GARAGE (ALL)

There is no GFI (Ground Fault Interrupt) protection at electrical outlets in some areas currently required to prevent shock hazards. Current standards require GFCI protected outlets at kitchen countertops and islands, garages, exterior outlets, bathroom outlets, outlets within 6 feet of a water source or that are in potentially damp areas such as crawlspaces as a safety feature. I recommend adding GFI protection to these areas not having it as a safety upgrade.

Contact a qualified electrical contractor.

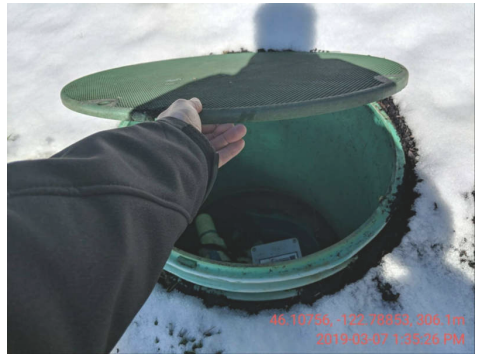
One or more septic tank covers are loose and / or not fastened down. This could allow an animal or child to fall in. Recommend fastening down covers and keeping them fastened at all times. This is a potential safety hazard. Areas noted:

Contact a qualified professional.

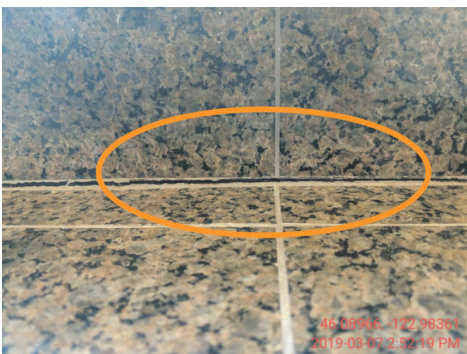
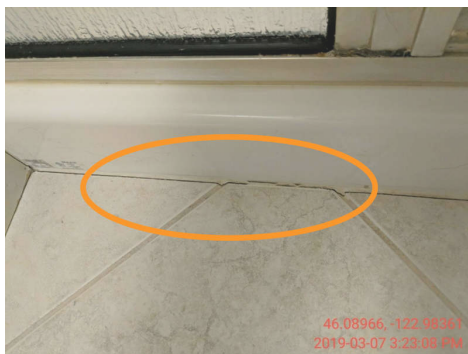
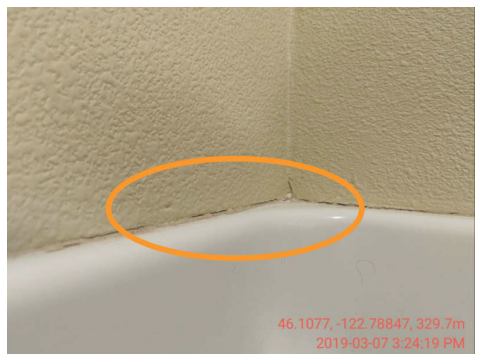
KITCHEN, BATHROOMS 2ND FLOOR

There is some gapping / cracking of the caulk or grout around one or more plumbing fixtures.

Recommend keeping these areas well maintained to prevent potential moisture intrusion and damage to the structure. Recommend caulking/grout maintenance as necessary.

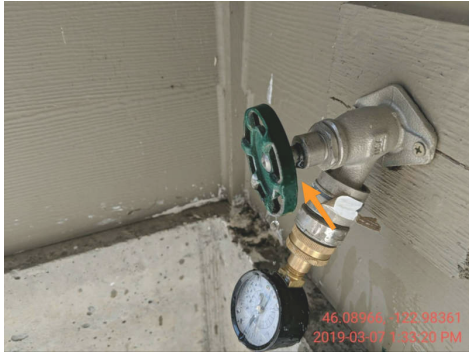
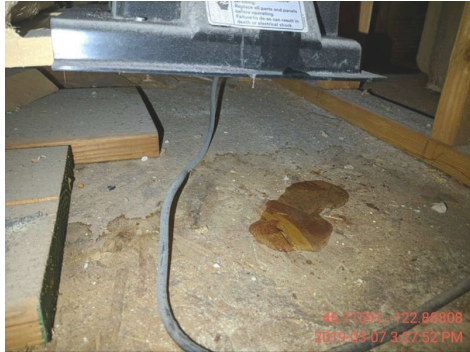
MASTER BATHROOM UNDER JACUZZI, EXTERIOR HOSE BIB WHEN IN USE

There is a leak at one or more plumbing fixtures. I recommend repair by a plumber.

Contact a qualified professional.

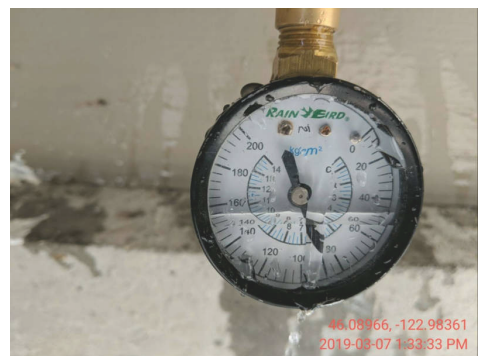
90 PSI P

The water pressure to the home exceeds 80 psi. Recommended maximum pressure is 80 psi to prevent potential damage to internal plumbing and appliances. Recommend a qualified plumber add a pressure regulator for you to maintain water pressure at or below 80 psi. Current pressure approximately:

Contact a qualified plumbing contractor.

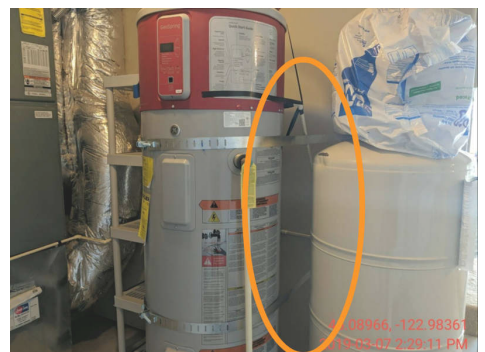
Water heaters should be tightly secured to prevent rocking and breaking straps loose during seismic activity. The heater is not tightly secured. I recommend adding blocking behind the heater to secure it to the wall and prevent rocking.

Contact a qualified professional.

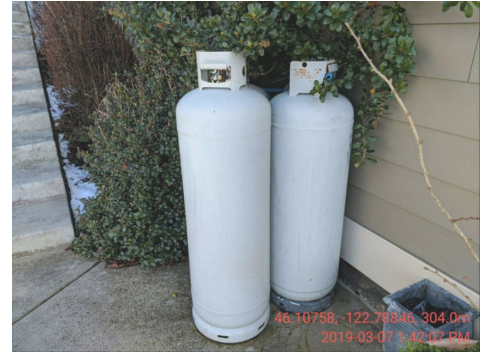
### **MORE THAN 120 GALLONS OF PROPANE NEXT TO HOME**

It is only allowed to store up to 120 gallons of propane next to the home. Do not exceed this amount 4 recommended safety guidelines.

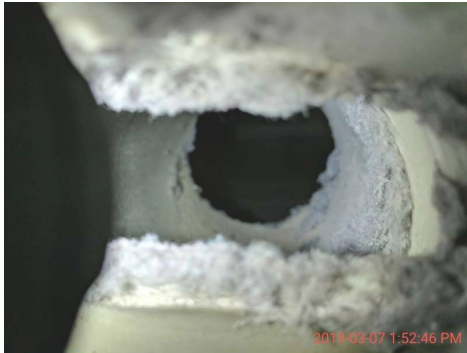
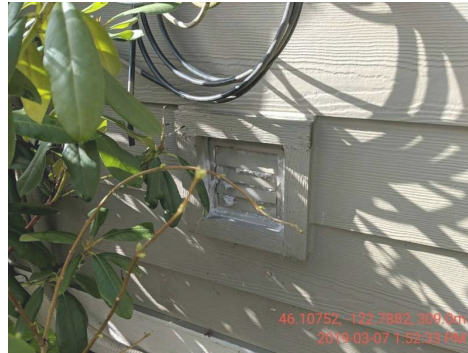
There is lint buildup in the dryer exhaust duct work. I recommend having the dryer duct cleaned. Too much lint buildup is a fire hazard.

Contact a qualified professional.
