SUMMARY

1234 Main St. Annapolis MD 21403

Buyer Name
05/22/2018 9:00AM

Evan Moore
InterNACHI Certified Professional
Inspector
Moore Inspections
810-569-3412
evan@mooreinspects.com

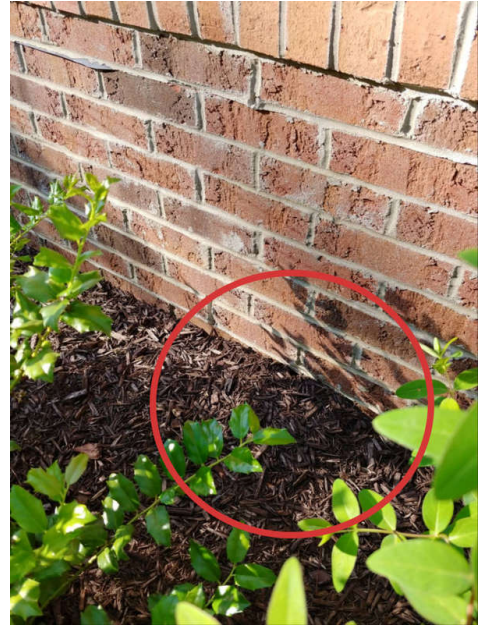
SOUTHWEST

GROUND CLEARANCE

Inadequate clearance between brick veneer and ground. A clearance of at least 4" between the ground and the brick ledge is recommended. Siding in contact with the ground is a serious concern because that condition can provide direct access for wood destroying insects.

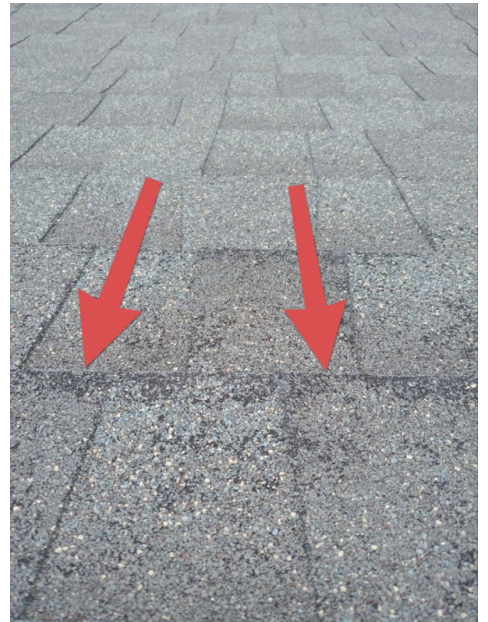
DAMAGED (GENERAL)

Roof coverings showed moderate damage. Recommend a qualified roofing professional evaluate and repair.

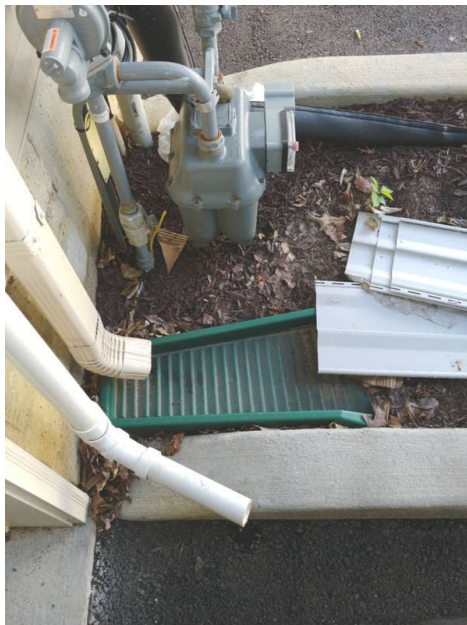
DOWNSPOUTS DRAIN NEAR HOUSE

One or more downspouts drain too close to the home's foundation. This can result in excessive moisture in the soil at the foundation, which can lead to foundation/structural movement. Recommend a qualified contractor adjust downspout extensions to drain at least 6 feet from the foundation.

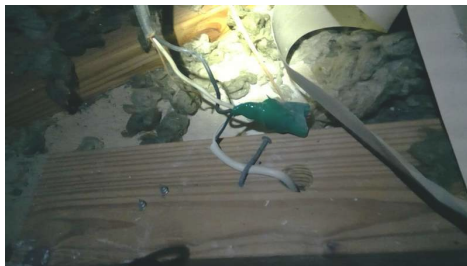
ATTIC

IMPROPER SPLICE

Wires were improperly spliced or terminated. Wire ends and splices should be in properly mounted and covered junction boxes. This condition is a shock/fire hazard and should be serviced by a licensed electrician.

Contact a qualified professional.

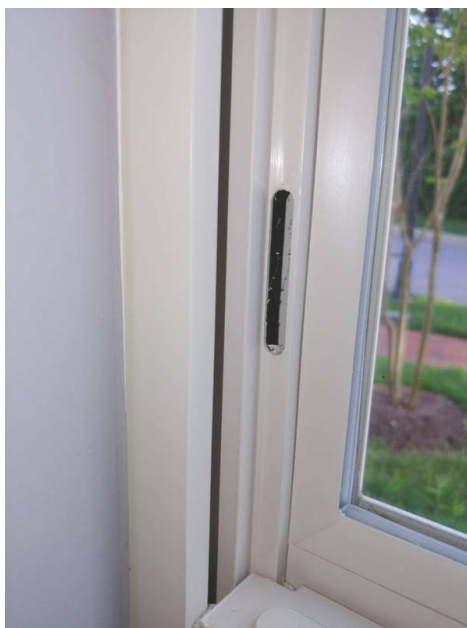
MISSING HARDWARE

One or more windows were hardware.

Contact a qualified professional.

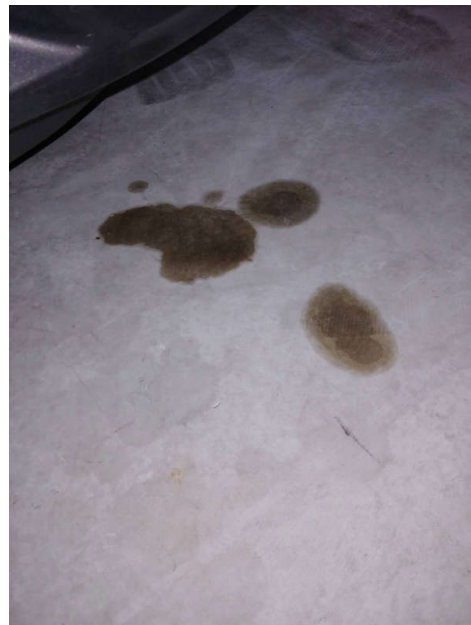
STAINING

Garage floor shows visible staining from oil/grease. Recommend scrubbing with a degreaser or cleaning solution.
