SUMMARY

1234 Main St. El Paso TX 79928

Desert Pro Home Inspections, LLC
915-208-0091
desertproinspections@gmail.com

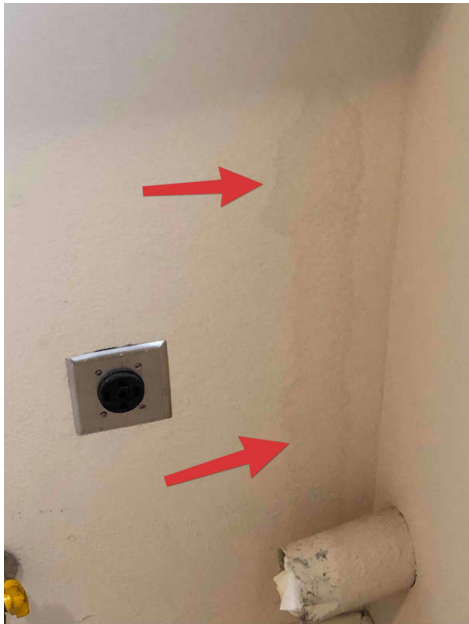
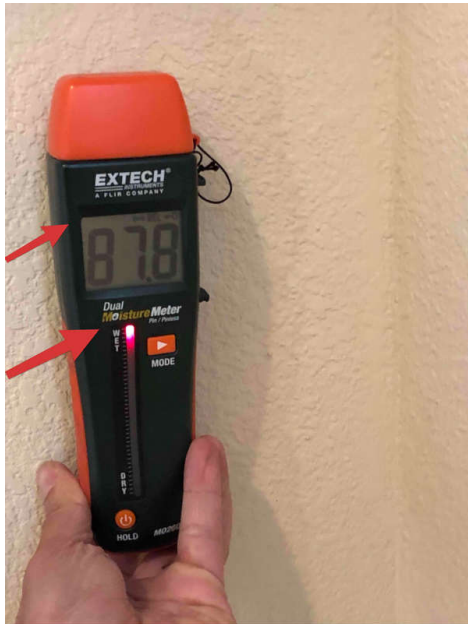
LOCATION: LAUNDRY ROOM

MOISTURE DETECTED ON INTERIOR WALL

Thermal imaging and/or a moisture meter indicated the possibility of moisture in interior wall, this may be an indication of a leak. Recommend further evaluation by a qualified professional to determine cause and if any corrective measure needs to be taken.

Moisture meter reading

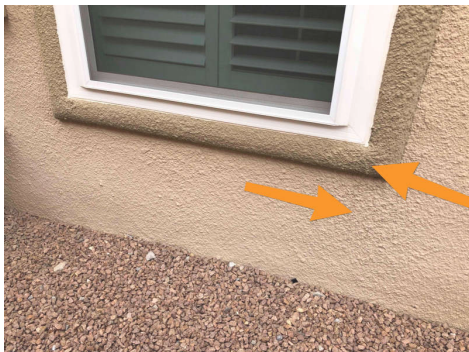
West side of home

MINOR STUCCO CRACKS

Minor cracks were observed in the stucco around the home. These cracks should be sealed with a stucco crack flex sealant to prevent further expansion and moisture penetration into the home structure by a qualified professional.

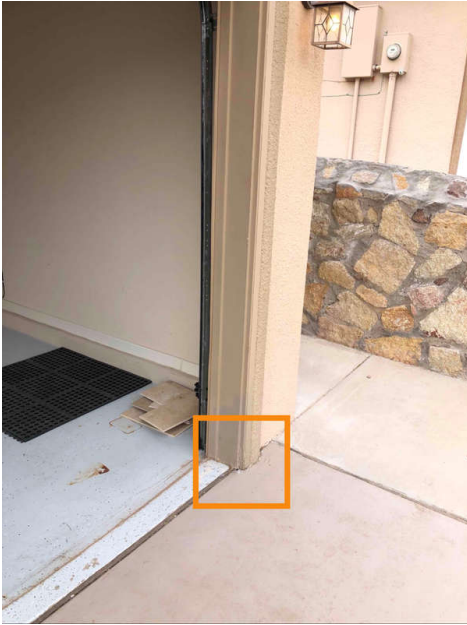
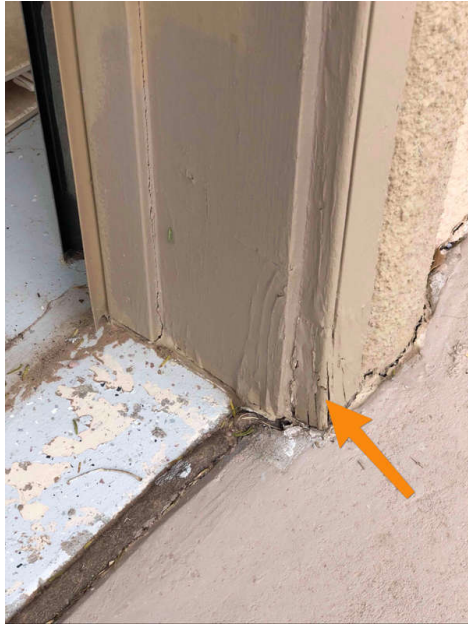
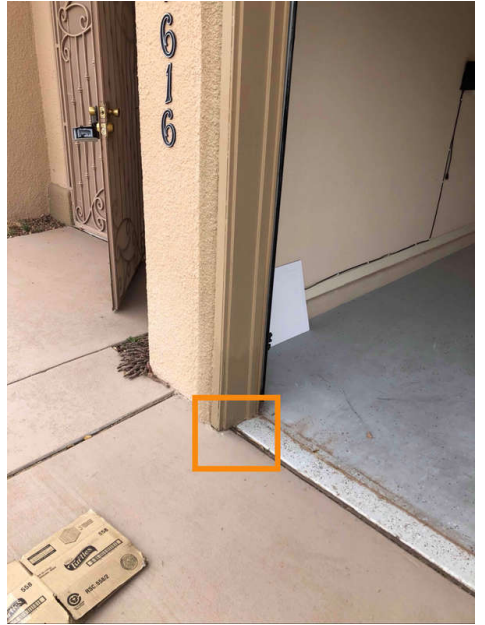
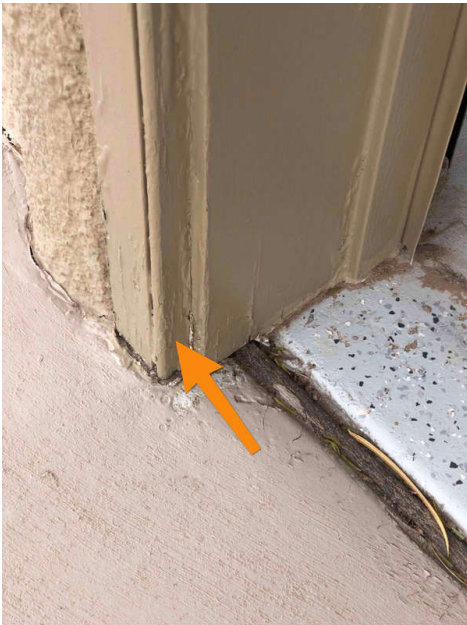
LOCATION: GARAGE DOOR TRIM

WOOD TRIM - DAMAGED/DETERIORATED

Exterior wood trim was found to be damaged and or deteriorated. This should be repaired to help prevent further damage to trim.

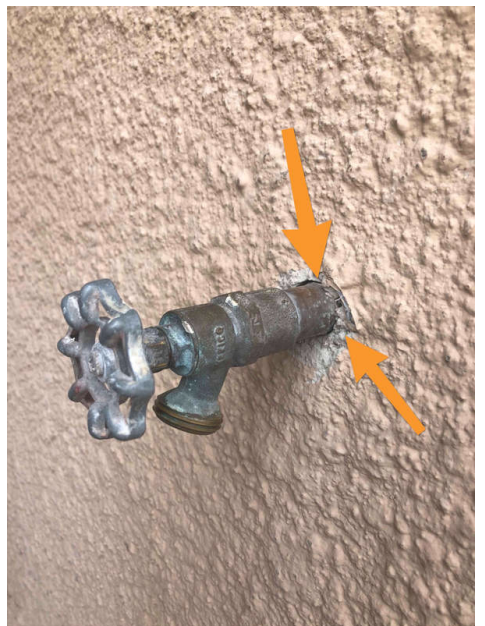
EXTERIOR WALL - PENETRATIONS NOT SEALED

Exterior water lines at the exterior wall intersection had gaps and were not properly sealed. These lines should be sealed with an approved sealant at the wall penetrations to prevent moisture from getting into the structure of the home.

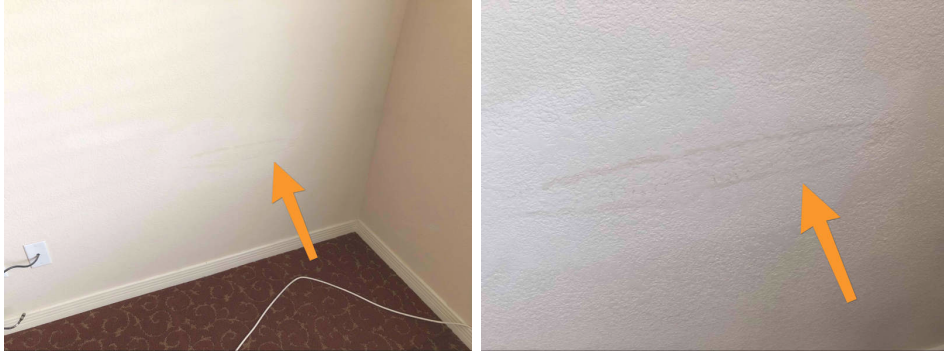
LOCATION: BEDROOM FACING STREET

WATER STAINS ON WALL

Water Stains visible on the interior wall at the time of inspection which may be from a previous leakage. The moisture meter and/or thermal imaging was negative for moisture at time of inspection, which may suggest the leak has been repaired.

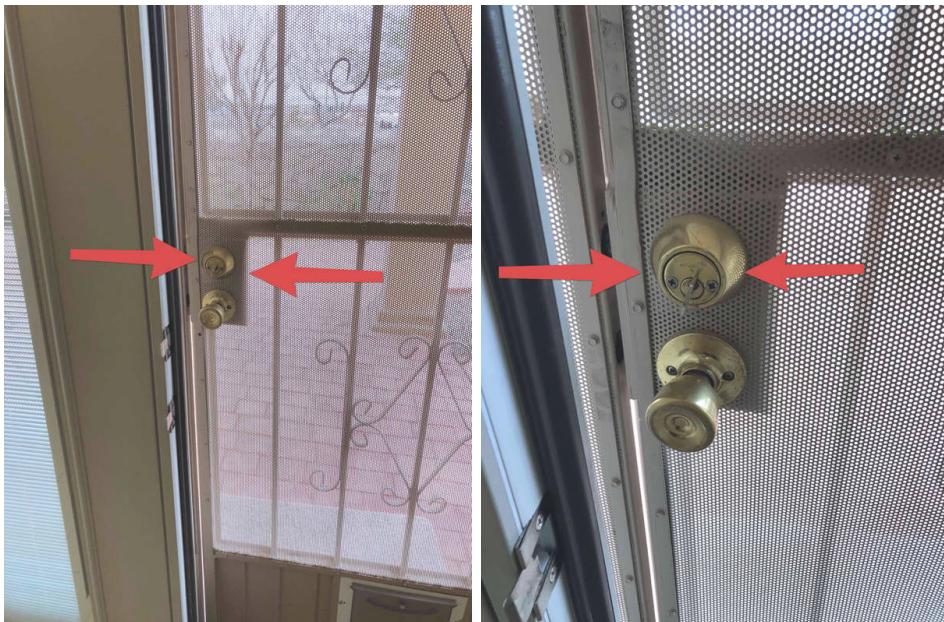
LOCATION: EXTERIOR SCREEN DOORS

DOUBLE KEYED DEADBOLT

Safety Hazard/Significant Defect

A door to the exterior had a deadbolt which required a key for operation from the inside. This condition is unsafe as it may slow or prevent exit during an emergency. Installation of these types of deadbolts is no longer a standard practice in new construction. The Inspector recommends that all deadbolts in the home that require a key for exit from the home interior be replaced with a deadbolt that operates from the inside with a lever.

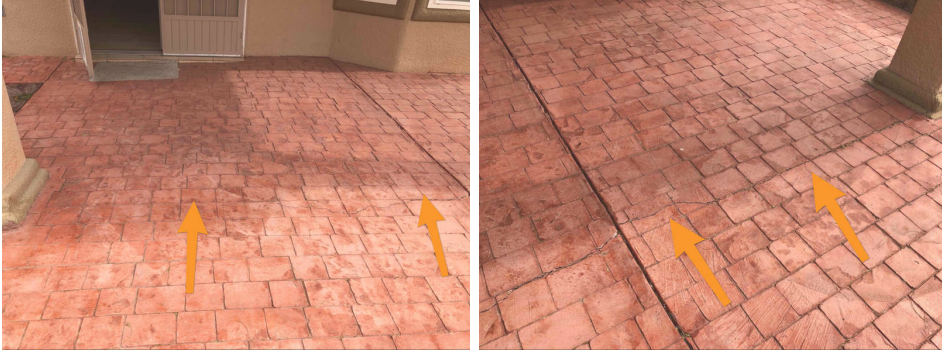
LOCATION: BACK PORCH

COMMON CRACKS

Common cracks were visible in the sidewalk/porch cement at the time of the inspection. Monitor and repair as necessary

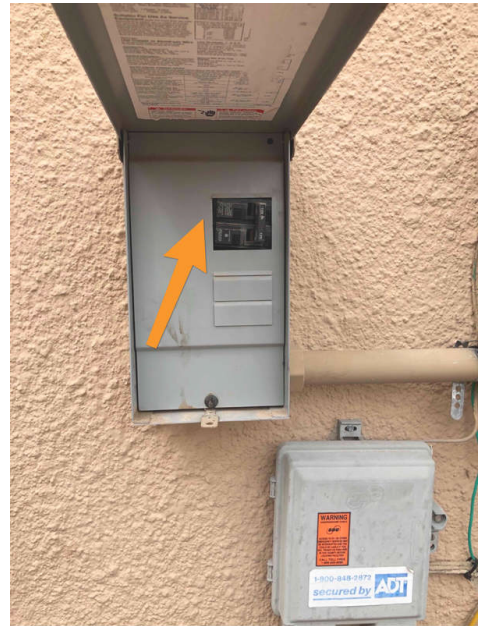
LOCATION: MAIN PANEL ON SIDE OF HOME

3.1.1 A. Service Entrance and Panels
MAIN PANEL BREAKERS NOT LABELED

A Circuit Directory identifying individual electrical circuits was missing, illegible or inaccurate at this panel. The panel should contain a clearly-marked label identifying individual circuits so that in an emergency, individual circuits can be quickly shut off.

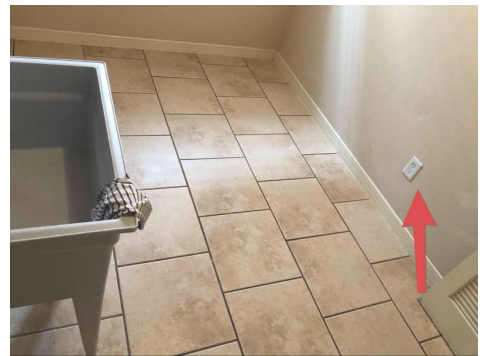
Laundry Room

3.2.1 B. Branch Circuits,
Connected Devices and Fixtures
NO GFCI

Safety Hazard/Significant Defect

No ground fault circuit interrupter (GFCI) protection of home electrical receptacles was provided in laundry room at the time of inspection. For safety reasons, current standards recommend that electrical receptacles located within 6 feet of a plumbing fixture be provided with ground fault circuit interrupter (GFCI) protection in good working order to avoid potential electric shock or electrocution hazards by a qualified professional.

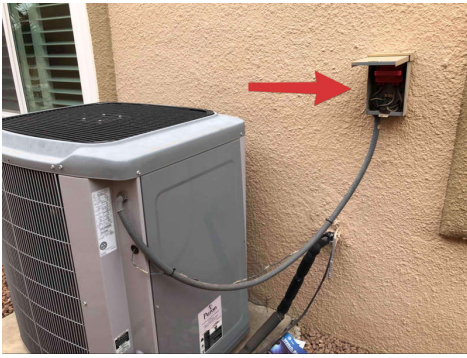
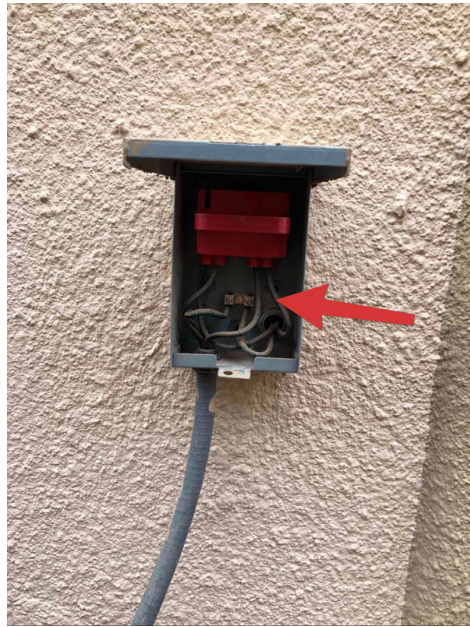
4.2.1 B. Cooling Equipment
A/C DISCONNECT - MISSING PANEL COVER

Safety Hazard/Significant Defect

The electrical panel that housed the air-conditioner disconnect was missing the front panel cover which is exposing the electrical wires. This is a safety concern that should be corrected by replacing the missing cover by a qualified professional.

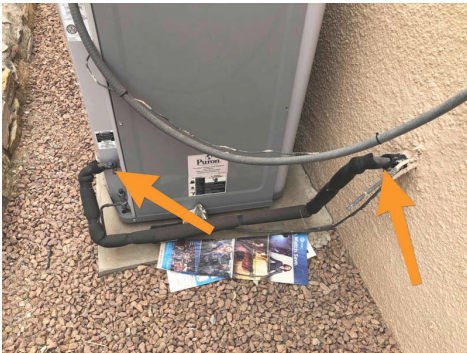
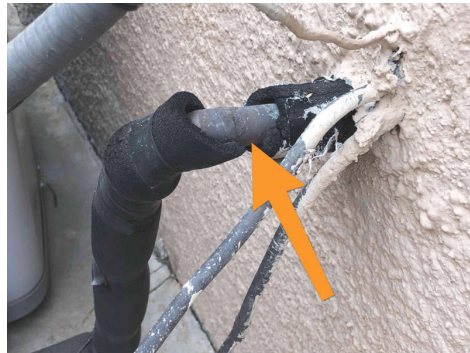
CONDENSATION LINE INSULATION - DAMAGED

The insulation on the condensate line for the air conditioner was found to be damaged and or missing foam insulation. Tho should be corrected by replacing any missing or damaged insulation in the line to prevent condensation buildup.

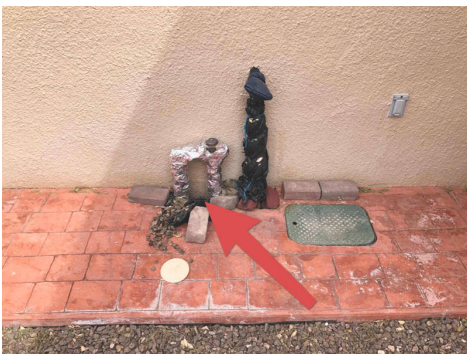
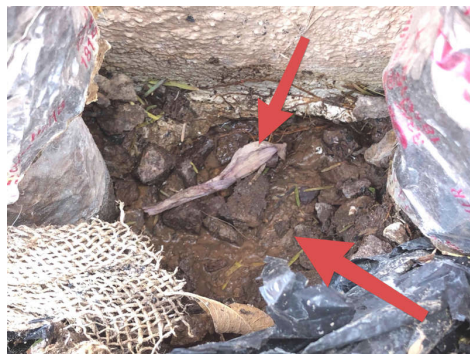
POSSIBLE WATER LINE LEAK

Safety Hazard/Significant Defect

At the time of inspection I checked the water meter after all the water in the home had been turned off and the meter was still turning, indicating water was still flowing to the house due to a possible leak in a water supply line. I did observe a wet area around irrigation water line in the back of the home. I recommend further evaluation for a possible leak in the home by a licensed plumber .

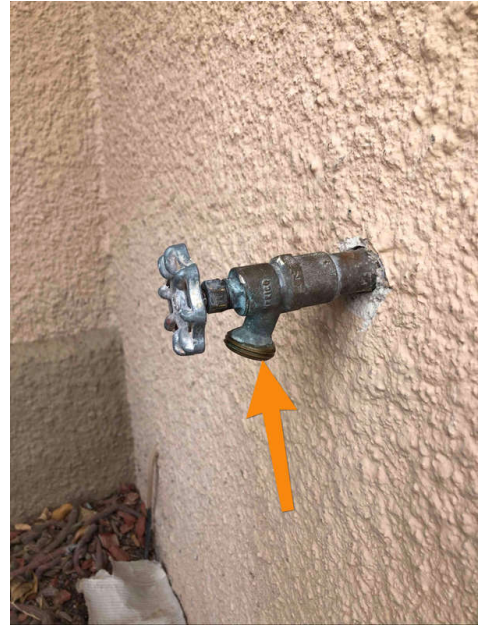
HOSE BIB BACKFLOW PREVENTER - MISSING

Exterior hose bibs were found to be missing backflow preventer devices (vacuum breakers). Vacuum breakers are easy to install, inexpensive and should be in place on all exterior bibs (water hose faucets) to help prevent exterior water from getting siphoned into the homes water supply. [Click here for more information](#)

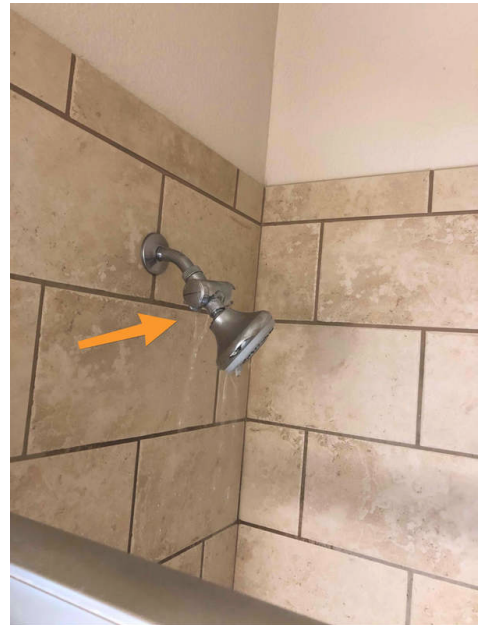
LOCATION: HALLWAY BATHROOM

LEAKING SHOWER HEAD

The showerhead connection leaked when the shower was operated.
