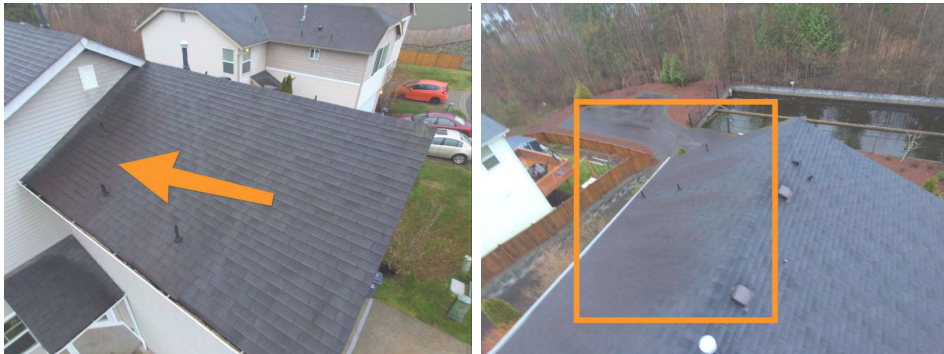
2.1.1 General

DISCOLORATION

Roof shingles were discolored, which can be caused by moisture, rust or soot. Recommend a qualified roofing contractor evaluate and remedy with a roof cleaning or repair.

Contact a qualified professional.

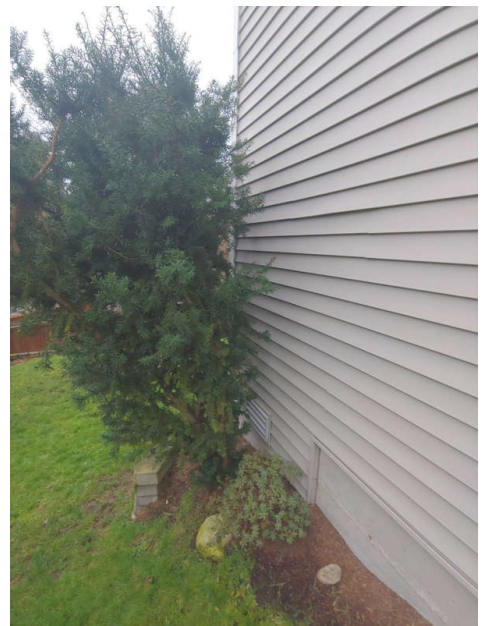
3.2.1 Vegetation

VEGETATION TOO CLOSE / IN CONTACT WITH BUILDING

Vegetation such as trees, shrubs and/or vines was in contact with or close to the building exterior and/or other structures. Vegetation can serve as a pathway for wood-destroying insects and can retain moisture against the exterior after it rains. This is a conducive condition for wood-destroying organisms. Recommend pruning, moving or removing vegetation as necessary to maintain at least 6 inches of space between it and the building exterior. A 1-foot clearance is better.

Contact a qualified lawn care professional.

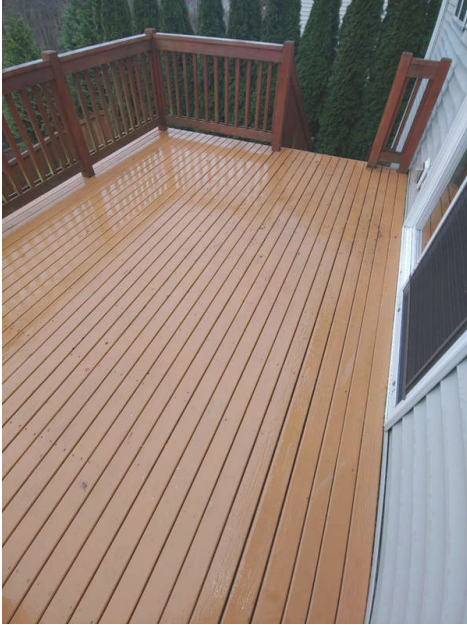
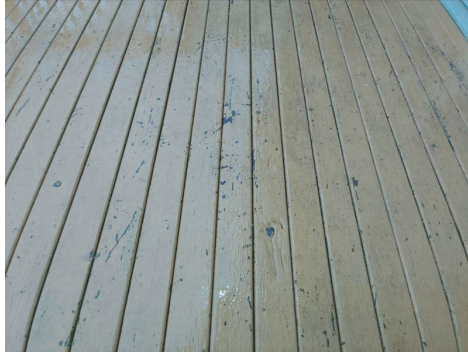
3.6.1 Decks/Stairs

DECK IN NEED OF PAINTING / SEALING / MAINTENANCE

Wooden deck or porch surfaces were overdue for normal maintenance. Recommend that a qualified person clean and preserve as necessary. Restaining the decking and railing will help preserve the lifespan of the deck.

Recommendation
Recommended DIY Project

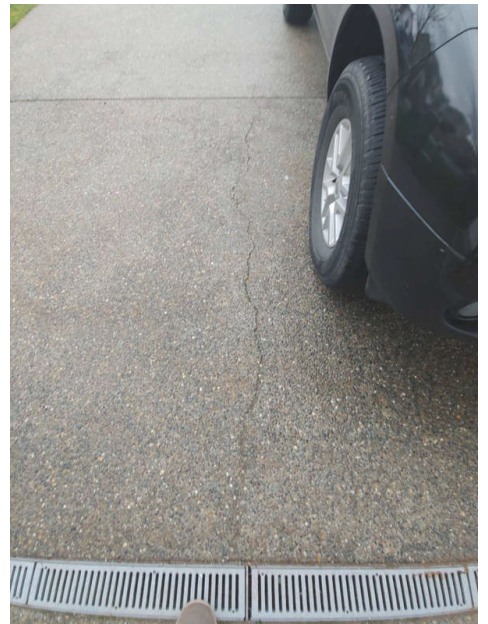
4.2.1 Driveway, Walkway, Patio

MINOR DRIVEWAY DAMAGE

Minor deterioration (e.g. cracks, holes, settlement, heaving) was found in the driveway, but no trip hazards were found. The client may wish to have repairs made for cosmetic reasons.

Recommendation
Contact a qualified professional.

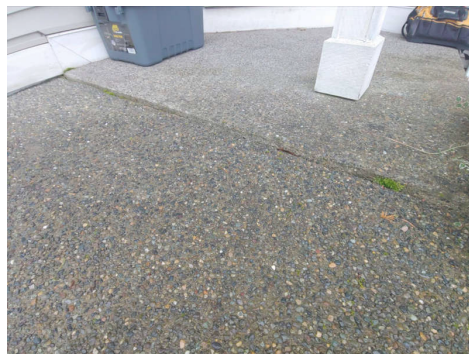
4.2.2 Driveway, Walkway, Patio

**MINOR DAMAGE-
SIDEWALK/PATIO**

To the left of the front door, the concrete patio has had a small amount of settling happen. It has settled down about 1/4" or so. Leaving a little lip that could cause a potential trip hazard. Be aware when using this area to prevent any potential tripping hazards.

Contact a qualified professional.

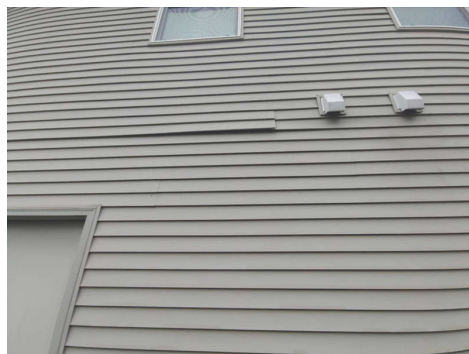
4.3.1 Exterior issues

LOSE SIDING

The vinyl siding on the right-hand side of the house has come loose in one or more areas. I recommend resecuring the siding so further damage from wind and rain does not occur.

Contact a qualified professional.

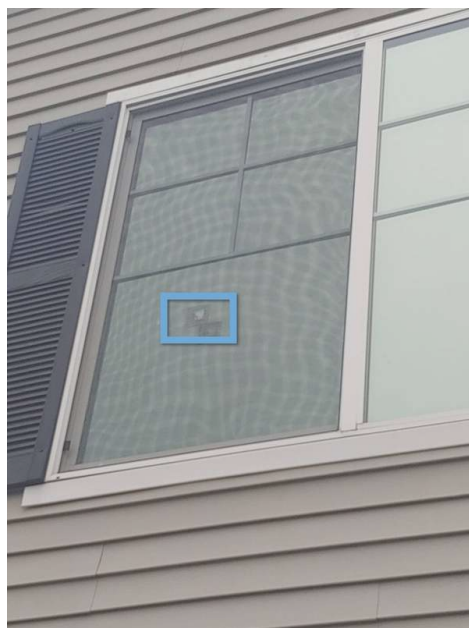
4.5.1 Windows and Door

SCREEN DAMAGED

The screen on one or more windows has been damaged and patched. I recommend rescreening the window.

Contact a qualified professional.

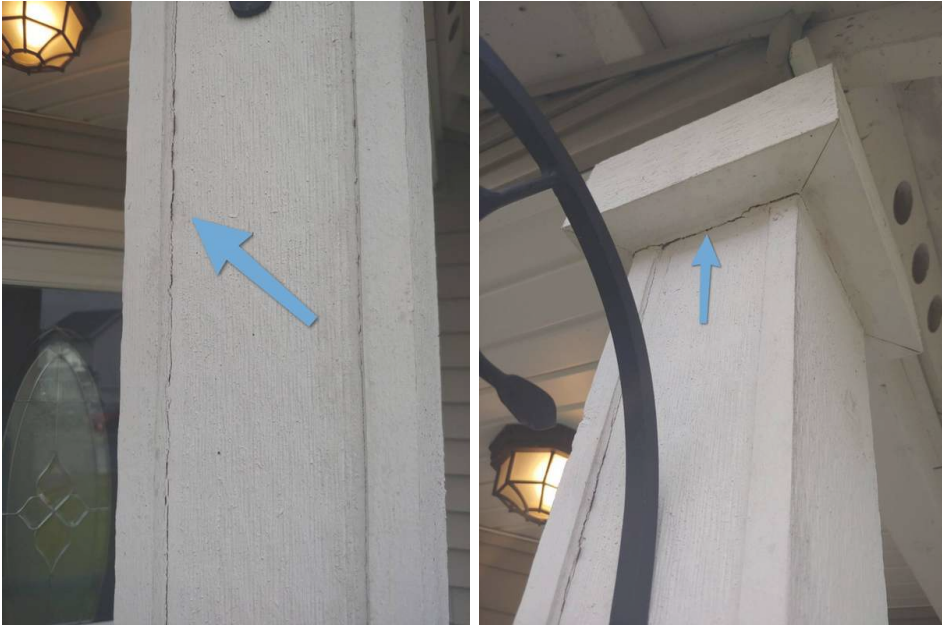
4.8.1 Wood Siding And Trim

CAULKING AT JOINTS

Caulk was *missing / deteriorated / substandard* in some areas. For example, *around windows / around doors / at siding butt joints / at siding-trim junctions / at wall penetrations*. Recommend that a qualified person renew or install caulk as necessary. Where gaps are wider than 1/4 inch, an appropriate material other than caulk should be used.

Photos only represent a couple of spots around the house where caulking was noted. I recommend that all caulking is further evaluated and replaced where needed around the house.

Recommendation
Contact a qualified handyman.

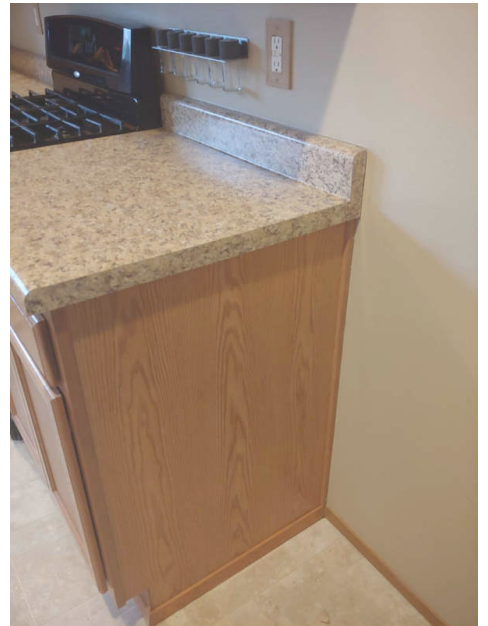
6.1.1 Cabinets

CABINETS LOOSE

One or more cabinets were loose, or were secured with too few or substandard fasteners. An adequate number of appropriate fasteners should be used. For wall-hung cabinets, inadequate fasteners can pose a safety hazard if cabinets fall. Recommend that a qualified person repair as necessary.

Contact a qualified cabinet contractor.

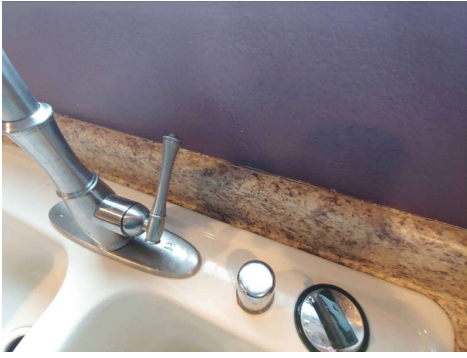
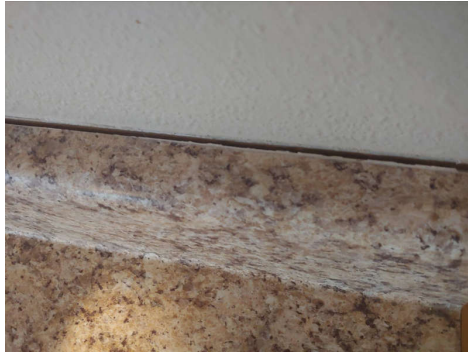
6.2.1 Countertops-Backsplash

CAULKING

One or more areas of the kitchen counter top(s) are recommended to be re-sealed (caulked) to keep any moisture and or water out and prevent future damage.

Recommended DIY Project

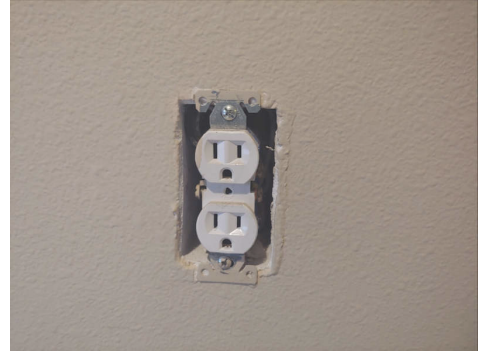
6.3.1 Electrical

COVER PLATE MISSING

Cover plate(s) are missing from one or more electric boxes, such as for receptacles, switches and/or junction boxes. They are intended to contain fire and prevent electric shock from exposed wires. This is a safety hazard due to the risk of fire and shock. Cover plates should be installed where missing.

Contact a qualified electrical contractor.

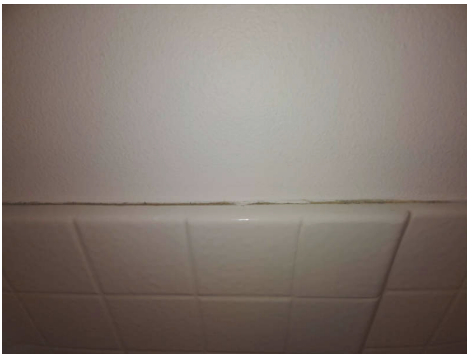
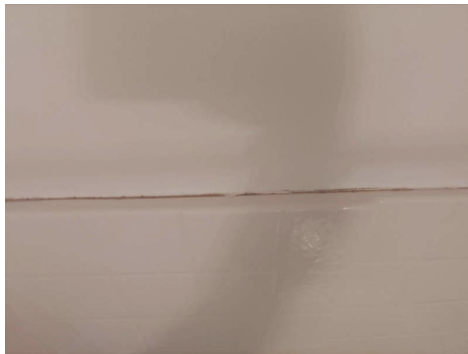
7.1.1 Bathub

CAULKING AT SURROUND

Caulk is missing or deteriorated above one or more bathtubs, where the tub surround meets the tub. It should be replaced where deteriorated and/or applied where missing to prevent water intrusion and damage to the wall structure.

Recommended DIY Project

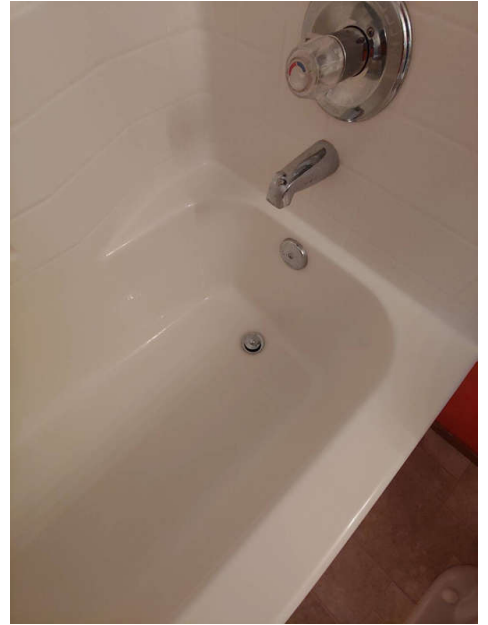
7.1.2 Bathub

CLOGGED OR DRAINS SLOWLY

One or more bathtub drains are clogged or drain slowly. Drain(s) should be cleared as necessary, and by a qualified plumber if necessary.

Contact a qualified plumbing contractor.

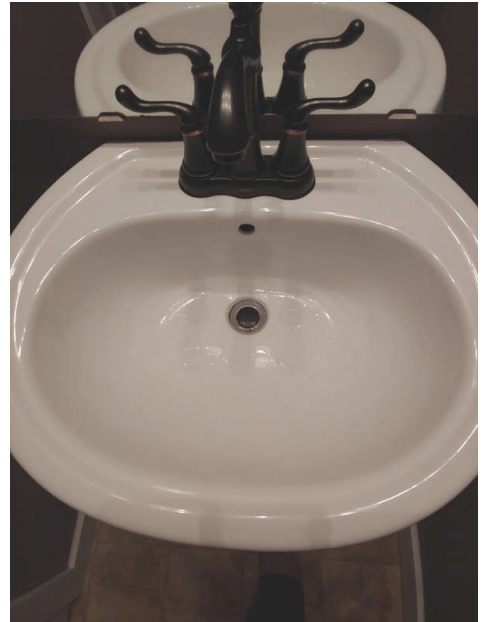
7.7.1 Sink/countertop

STOPPER ISSUE

One or more sink stopper(s) mechanisms are missing, or need adjustment or repair. Stopper mechanisms should be installed where missing and/or repairs should be made so sink stoppers open and close easily.

Contact a qualified plumbing contractor.

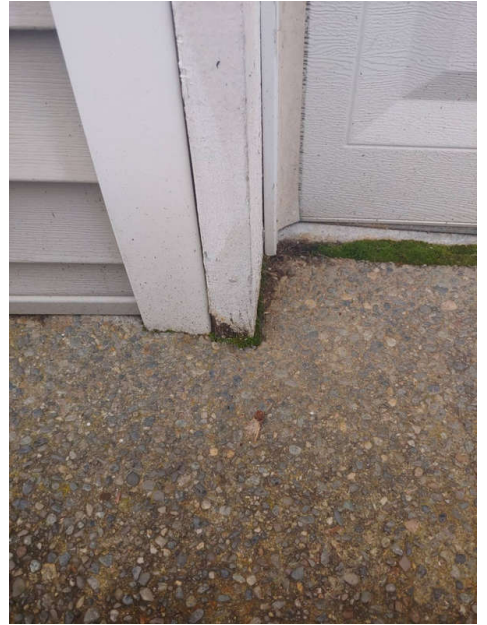
11.1.1 Interior-Exterior doors-Windows

GARAGE DOOR TRIM GROUND CONTACT

The trim on the outside of the garage door is in contact with the concrete. This allows water to wick up on an unfinished end. I recommend touch up painting and keeping these sealed so the trim pieces do not rot.

Contact a qualified professional.

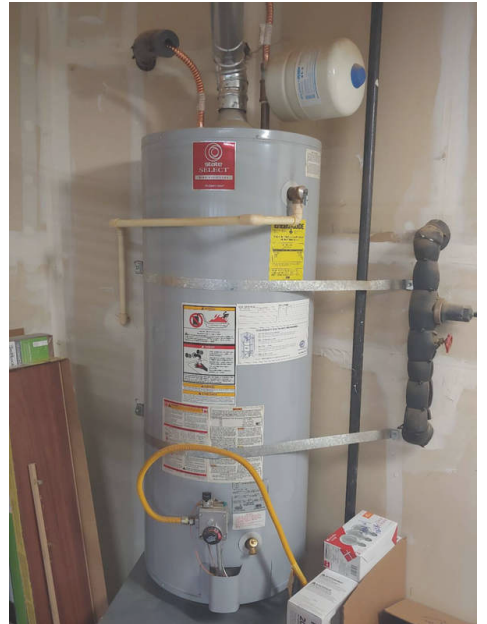
12.1.1 Water Heater

NEAR LIFE EXPECTANCY

The estimated useful life for most water heaters is 8 to 12 years. This water heater appears to be approaching this age and may need replacing at any time. Recommend budgeting for a replacement in the near future.

Contact a qualified plumbing contractor.

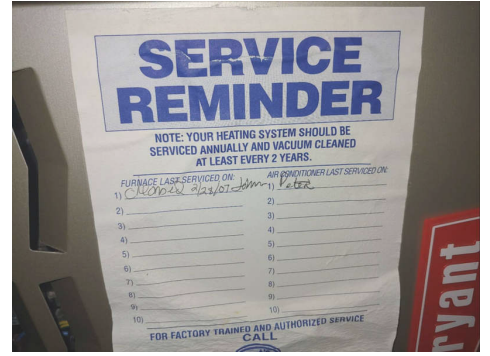
13.1.1 General comments

SERVICE HEATING / COOLING SYSTEM

The last service date of the forced air heating / cooling system appeared to be more than 1 year ago, or the inspector was unable to determine the last service date. Ask the property owner when it was last serviced. If unable to determine the last service date, or if this system was serviced more than 1 year ago, recommend that a qualified HVAC contractor service this system and make repairs if necessary. Because this system has a compressor and refrigerant system, this servicing should be performed annually in the future. Any needed repairs noted in this report should be brought to the attention of the contractor when it's serviced.

Contact a qualified HVAC professional.

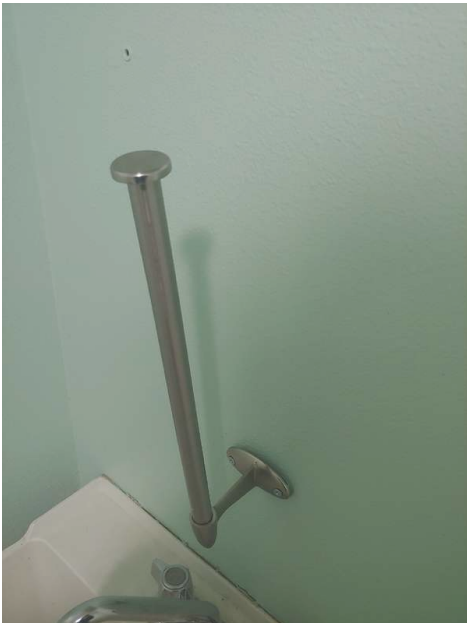
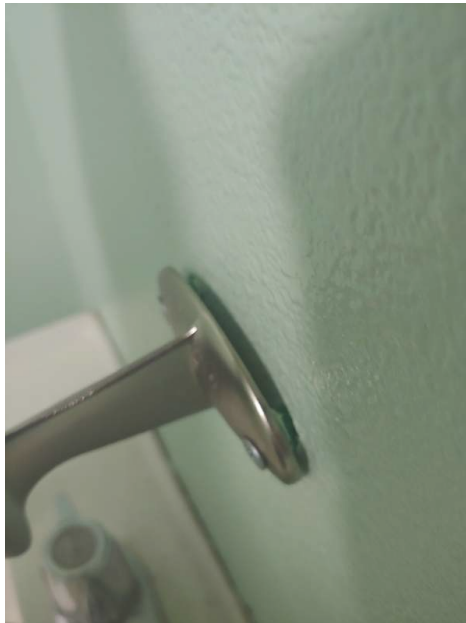
14.1.1 General

PAPER TOWLE HOLDER

Paper towel holder was loose and coming away from the wall. I recommend securing it before use.

Contact a qualified professional.

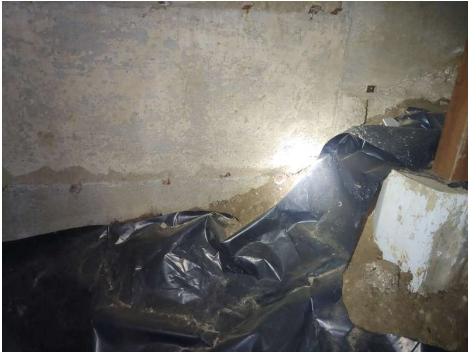
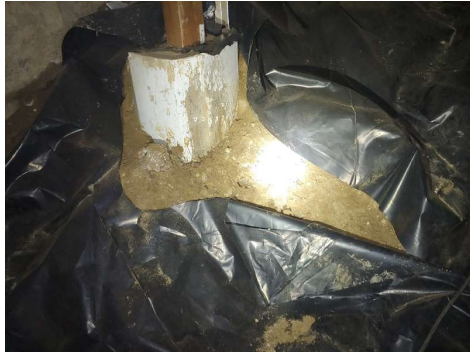
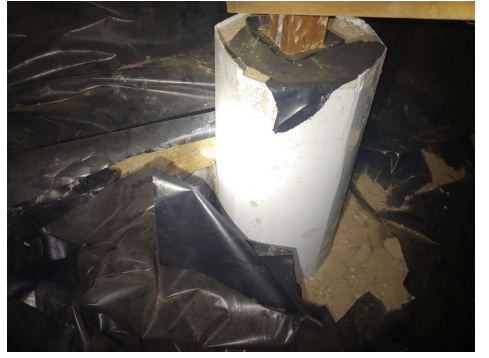
17.1.1 General

VAPOR BARRIER

The vapor barrier in several places has shifted and needs to be repositioned back over the exposed dirt. I recommend repositioning the the vapor barrier back into its proper place.

Contact a qualified professional.
