SUMMARY

1234 Main St. Tempe AZ 85284

Aaron Westman
AZ #68161, NACHI18091738
22 HOME INSPECT LLC
(480) 506-6610
westman.a@22homeinspect.com

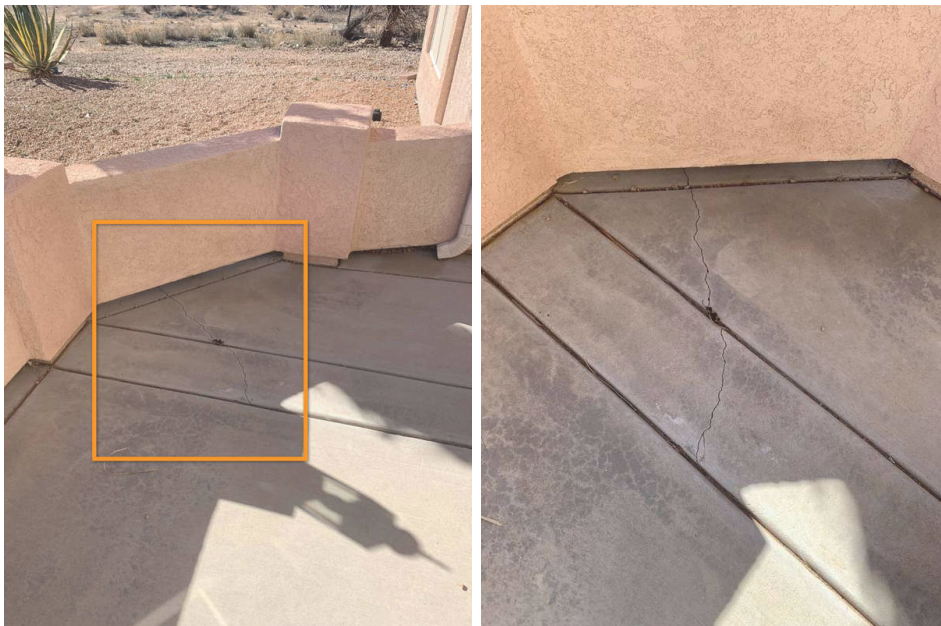
PATIO (FRONT)

WALKWAY - COMMON CRACKING

Common cracks (1/4-inch or less) were visible in the Walkway. Cracks exceeding 1/4 inch should be filled with an appropriate material to avoid continued damage to the Walkway surface from water intrusion.

Contact a handyman or DIY project

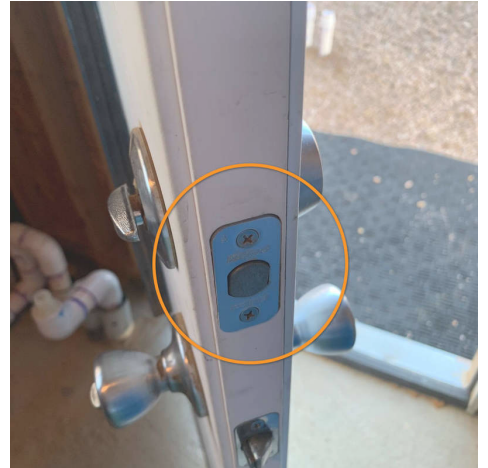
DETACHED STRUCTURE

DEADBOLT INOPERABLE / DIFFICULT

Concern/Moderate

One or more deadbolts were inoperable or difficult to operate. Recommend that a qualified person repair as necessary.

Recommendation
Contact a qualified handyman.

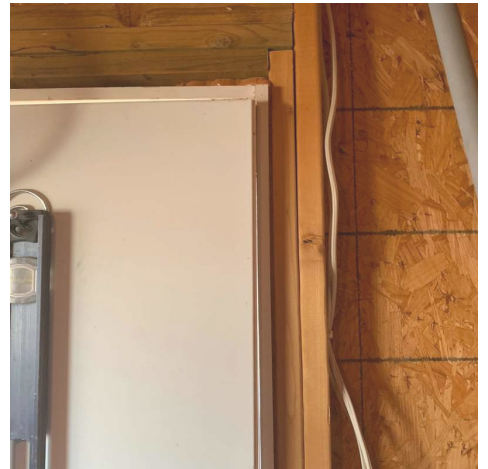
DETACHED STRUCTURE

DOOR - OUT OF SQUARE

Concern/Moderate

One or more doorways were visibly out of square and doors did not close. Recommend making repairs by a Qualified Contractor to ensure proper function. (Detached Structure)

Recommendation
Contact a qualified professional.

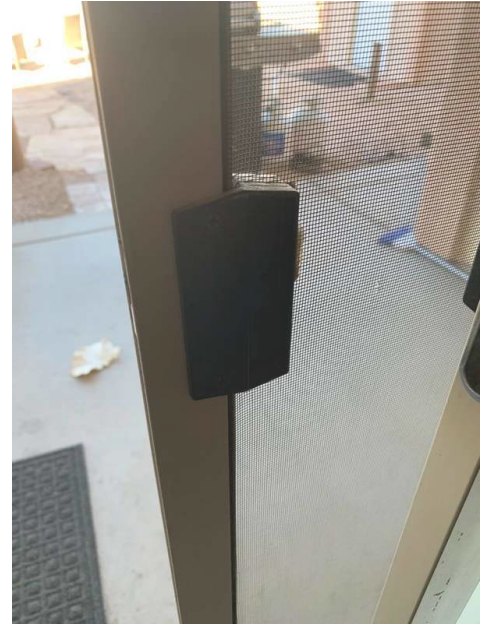
KITCHEN / DINNING ROOM

SCREEN DOOR - LOCK DAMAGED

Concern/Moderate

Rear screen door latch was damaged or missing. Recommend that a qualified person repair or replace as necessary.

Contact a qualified handyman.

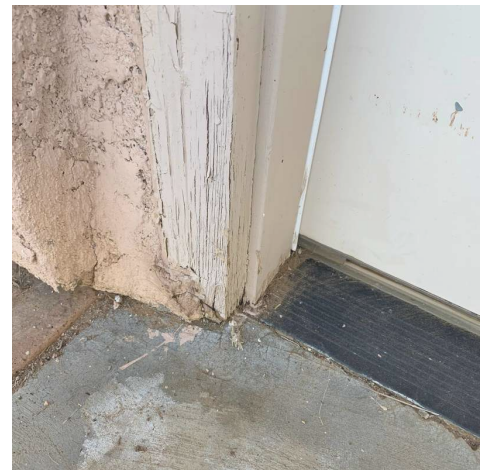
WEST (SIDE)

DOOR - FRAME MOISTURE DAMAGE (MINOR)

Maintance/Minor

Minor moisture damaged observed on the exterior door trim. Recommend repainting in order to prevent further damage. (Garage side access)

Contact a qualified professional.

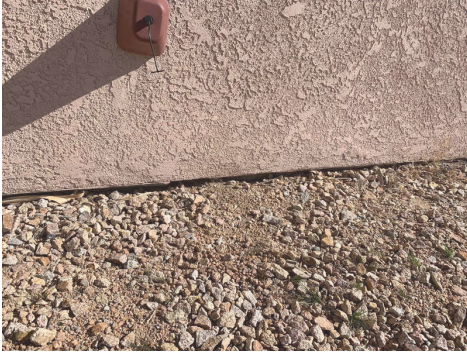
East (Exterior)

STUCCO SIDING - GROUND CLEARANCE

Stucco covering exterior walls of the home had inadequate clearance from grade. Stucco should terminate a minimum of 4 inches above grade and 2 inches from hardscape. Condensed water behind the veneer may not be able to escape, and moisture can accumulate in the wood structure behind. This also presents a pathway for wood destroying organisms to enter the dwelling undetected. Recommend grading and/or removing soil as necessary to maintain a 4-6 inches clearance and continue to monitor. Hardscape corrections should be further evaluated and discussed with a licensed contractor for repair options.

Contact a qualified professional.

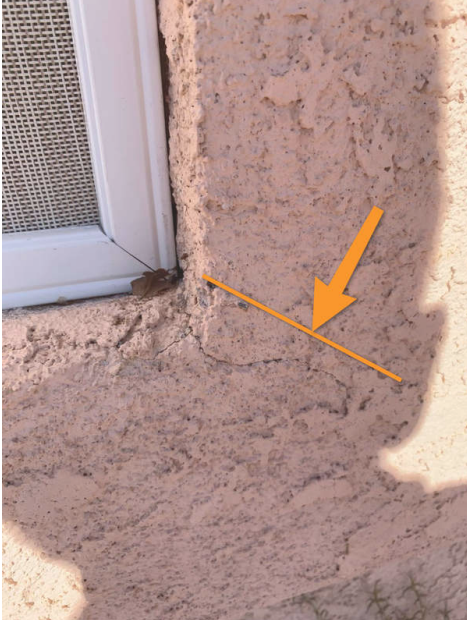
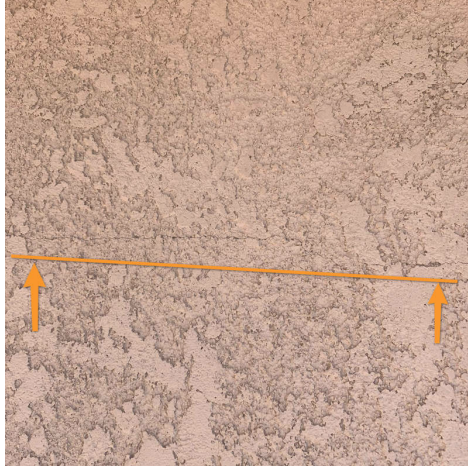
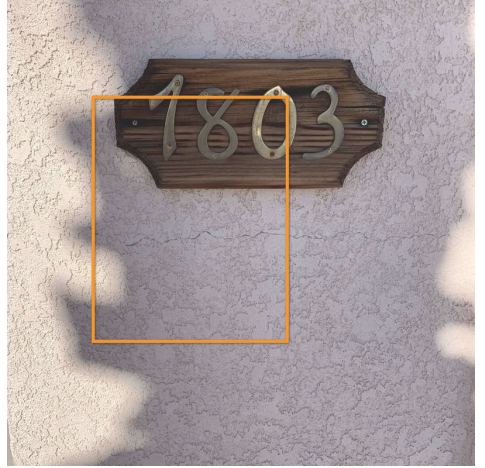
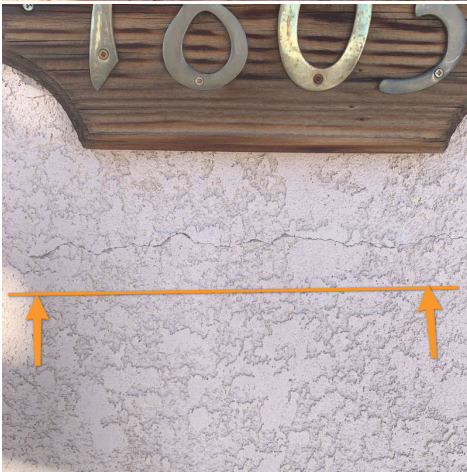
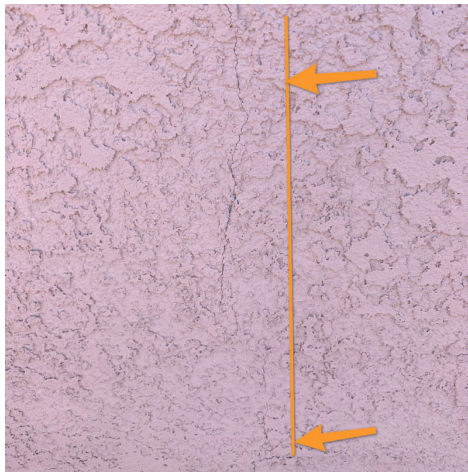
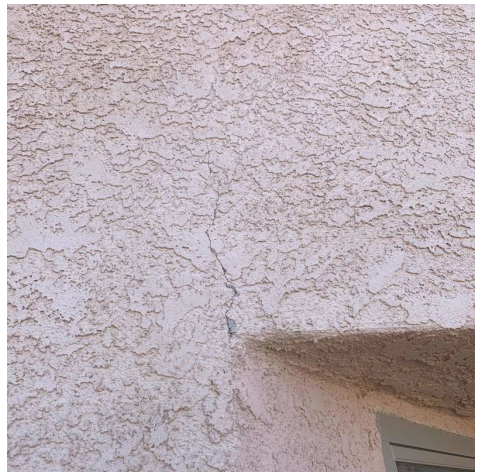
OBSERVED AROUND ENTIRE HOME

STUCCO SIDING - MINOR THERMAL CRACKING

The stucco covering exterior walls showed widespread minor cracking. This type of cracking, called "thermal cracking" is typically due to internal stresses created by temperature changes. It is common as stucco ages and is currently a cosmetic concern, not a structural problem. However, recommend continuing monitoring and cracks exceeding 1/16-inch in width should be filled with an appropriate material to minimize future damages.

Contact a qualified professional.

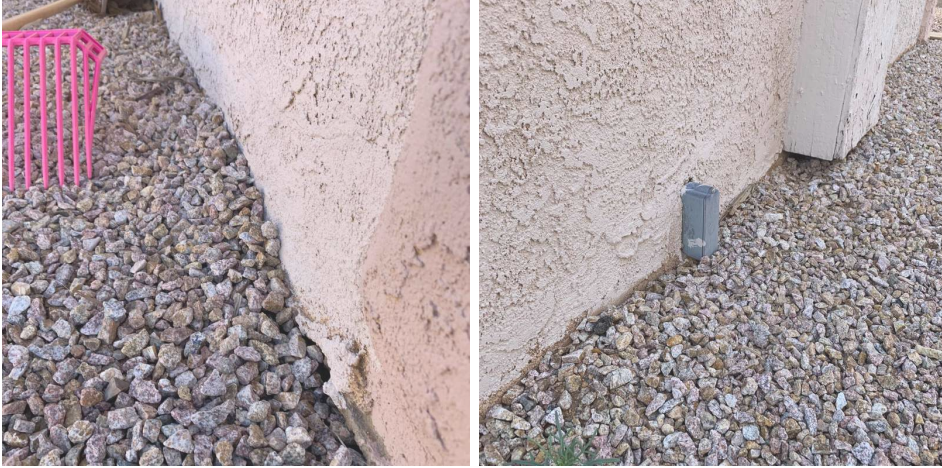
DETACHED STRUCTURE

STUCCO SIDING - POOR INSTALLATION

Stucco covering exterior walls of the home showed evidence of poor installation practices. Stucco was in complete contact with ground to prevent potential damage from moisture intrusion to the (Detached Structure) materials, potential structural damage from wood decay, and possible development of microbial growth such as mold. Recommend consulting with a Licenced contractor for repair options.

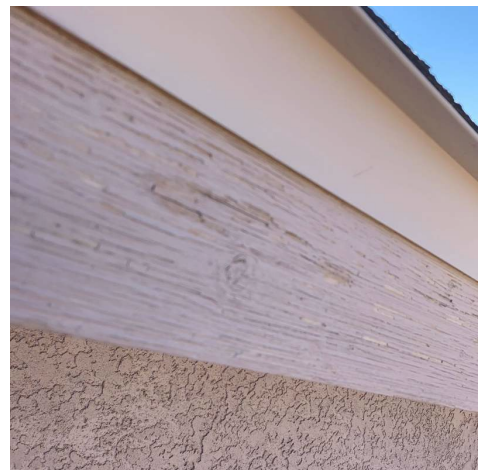
MANY LOCATIONS THOUGHOUT HOME

PAINT FINISH - FADING/FAILING

The paint finish is fading, chipping, and/or failing. Failure to maintain the finish coating can lead to ultraviolet and/or moisture damage, reducing the lifespan of the siding. Recommend monitoring or have areas be properly prepared and painted by a Qualified Painter.

Recommend monitoring.

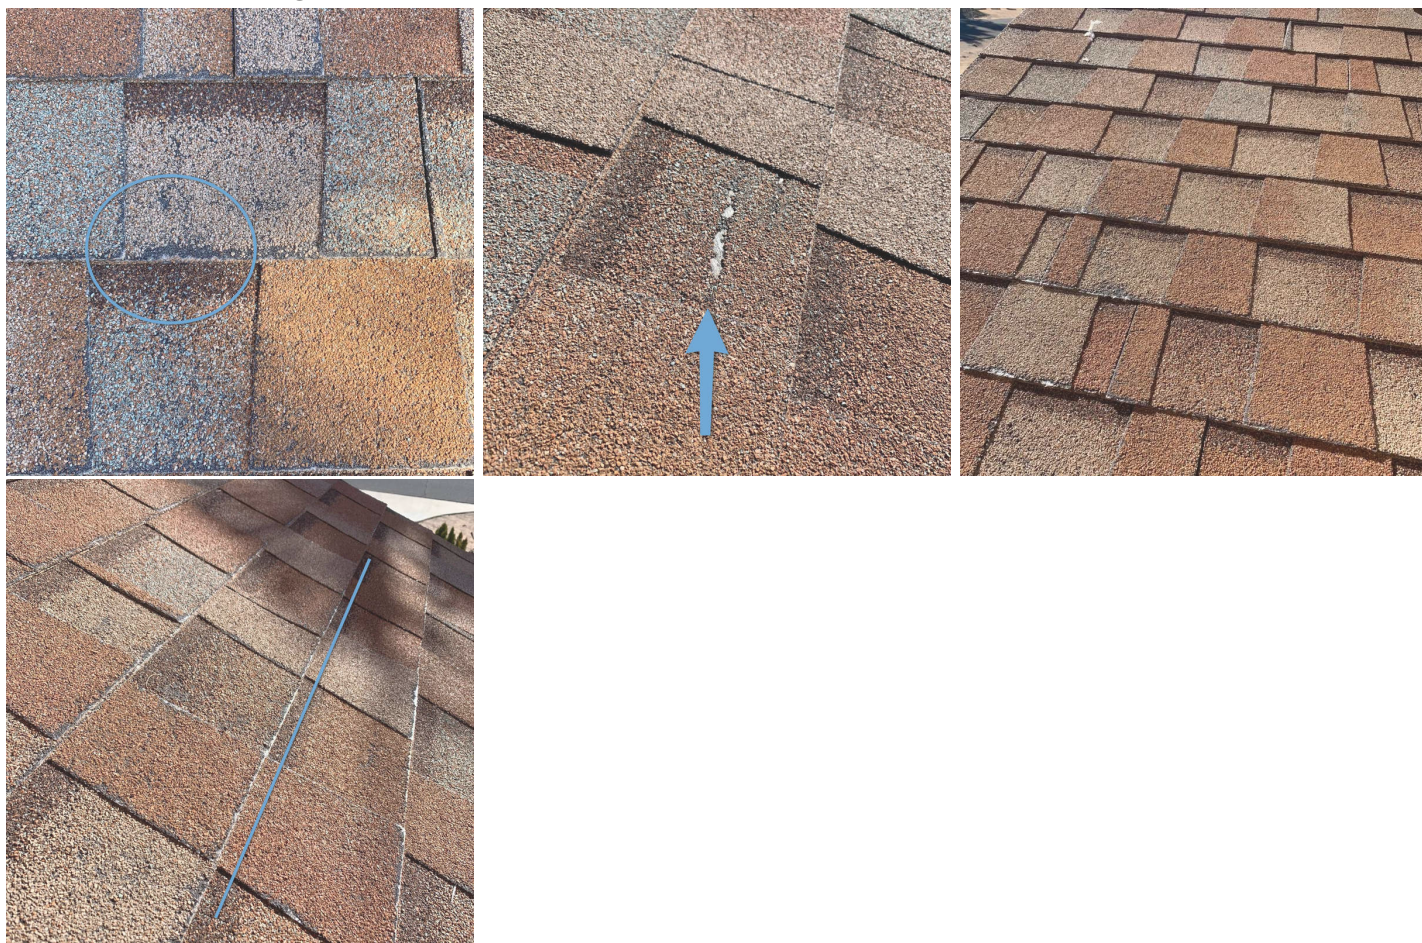
ROOF - AGING

The general condition of the roof appears to be in serviceable condition with signs of weathering and aging. Recommend regular maintenance and inspection.

Recommendation
Recommend monitoring.

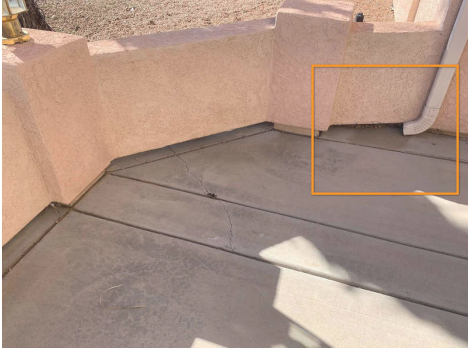
Patio (Front)

DOWNSPOUT - IMPROPER TERMINATION

Concern/Moderate

One or more downspouts discharged roof drainage next to the foundation or sloped back into the foundation. This condition can result in excessively high moisture levels in soil at the foundation and can cause damage related to soil/foundation movement. Recommend installation of downspout extensions to discharge roof drainage a minimum of 6 feet from the foundation.

Contact a qualified professional.

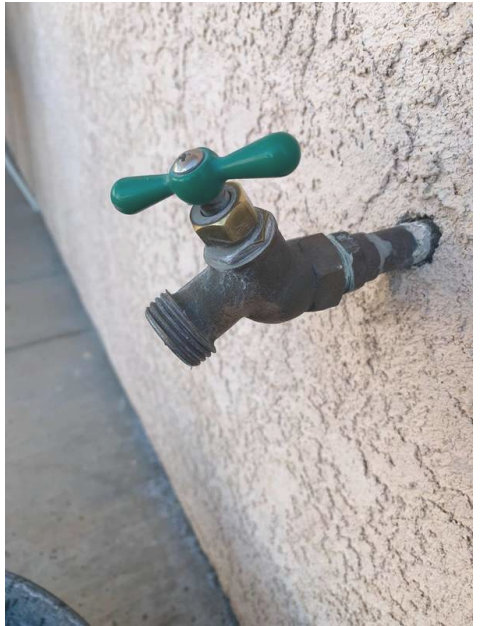
HOSE BIB MISSING

Concern/Moderate

A hose bib was missing/removed and capped. This could lead to a possible cross connection which can contaminate the water supply. Recommend that repairs be made by a qualified licensed plumbing contractor.

Contact a qualified plumbing contractor.

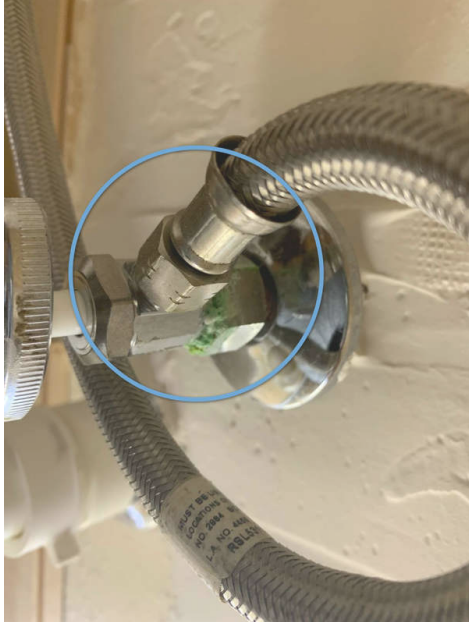
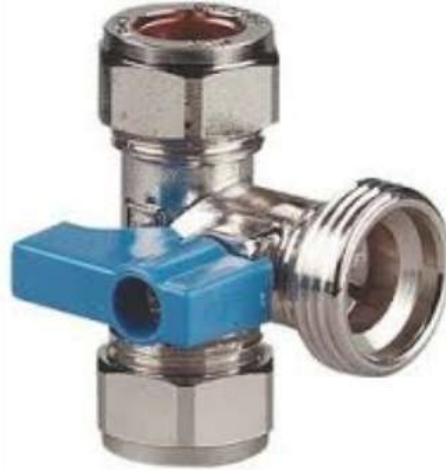
VALVES - MINOR CORROSION / UPGRADE

Minor corrosion observed on valves in one or more locations. No test performed on gate valves at the time of the inspection. Recommend upgrading to ball valve design for better reliability and ensuring proper operation of all shut-off valves.

Recommendation
Contact a qualified professional.

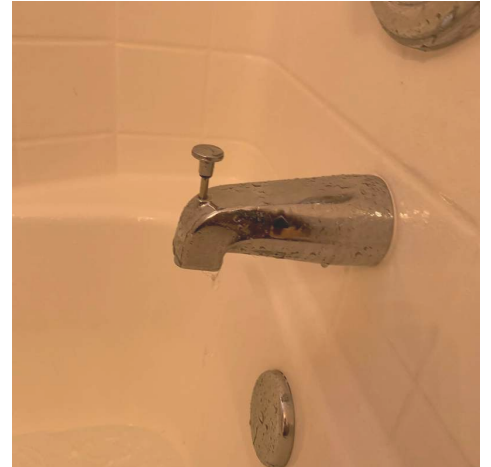
BATHROOM 2

DIVERTER PULL DAMAGED

The diverter pull was not functioning properly. Recommend repair.

Recommendation
Contact a qualified plumbing contractor.

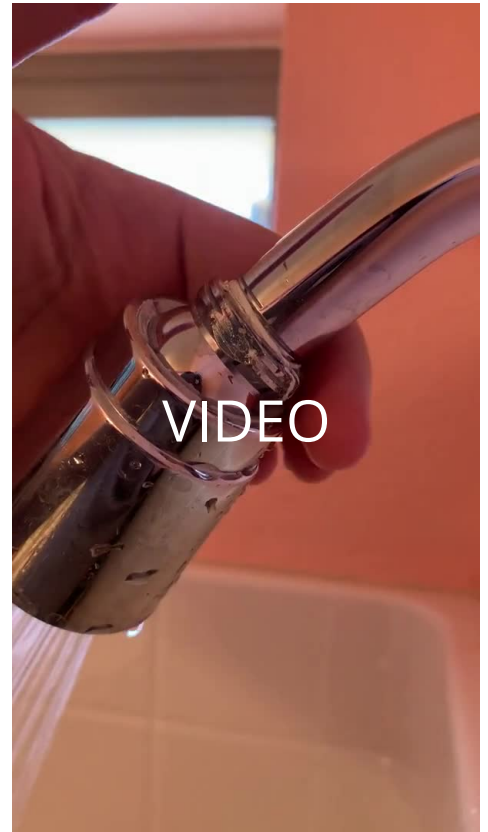
BATHROOM 2

SHOWER/BATHTUB - FAUCET LEAK

Maintenance/Minor

Faucet handles leaked when testing operation, which is causing wasted water and is not performing as intended. Recommend making repairs or replacing the faucet.

Contact a handyman or DIY project

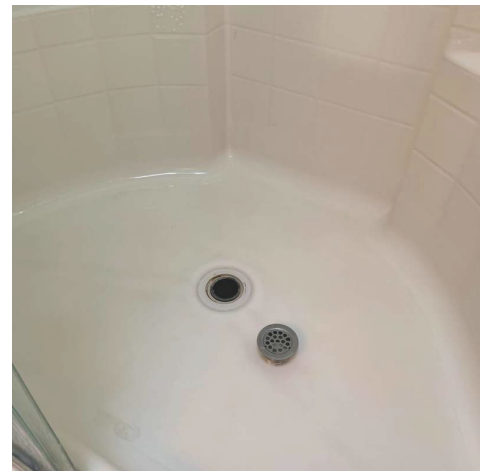
SHOWER DRAIN - DAMAGED OR MISSING

Concern/Moderate

The shower drain guard was missing or damaged during the time of inspection. Recommend reairing or replacing as needed.

Contact a handyman or DIY project

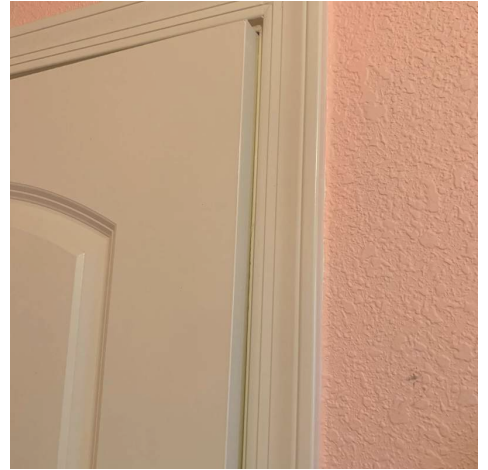
BEDROOM B

DOOR - STICK/RUB(S)

Potential safety hazards and cosmetic implications. One or more door(s)stick and/or rub when opening. Recommend making adjustments or repairs if necessary, preventing possible emergency egress concerns.

Maintance/Minor

Contact a handyman or DIY project

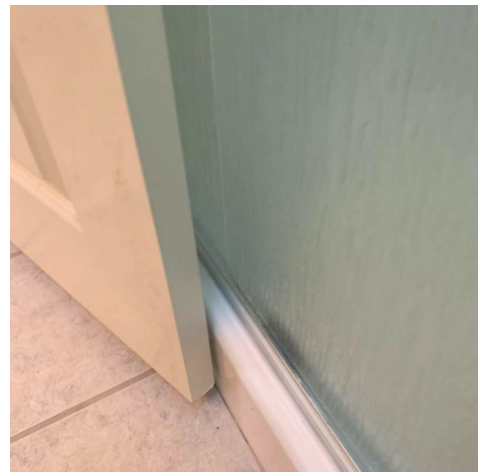
BATHROOM 1

DOOR STOPPER(S)

Door stoppers were damaged or missing. Recommend installing or replacing as needed.

Maintance/Minor

Contact a handyman or DIY project

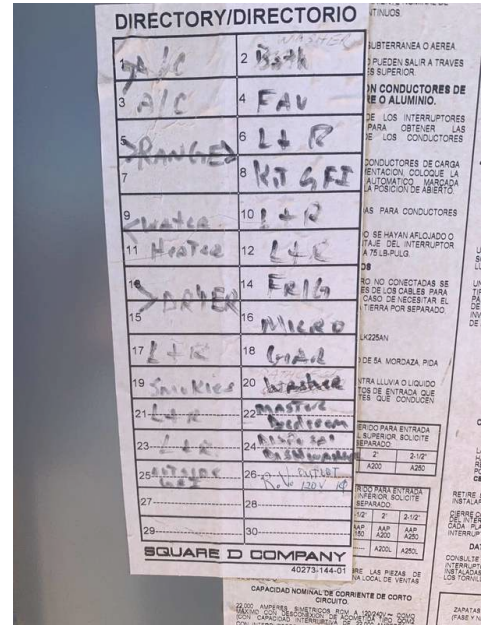
MAIN PANEL

PANEL MISSING LABELS

At the time of inspection, the panel was missing labeling for one or more breakers. To include, some of the labels are difficult to read and understand. In the case of emergency, if a breaker needed to be shut-off, the homeowner needs an accurate and legible key.

Recommend a qualified electrician or person identify and map out locations.

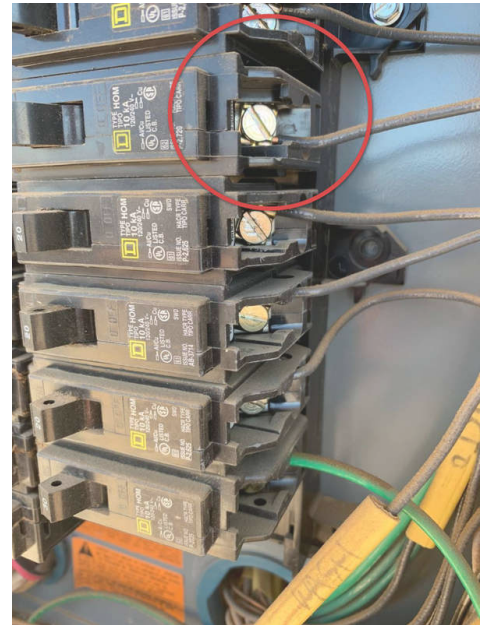
MAIN PANEL

BREAKER OVERSIZE

During the time of inspection, one or more breakers were oversized for the wire size. This is a safety and fire hazard, due to the possibility of the correct being overloaded and not tripping the breaker.

Recommend that a Qualified Electrician make necessary corrections.
(12 gauge wire on 30AMP Breaker)

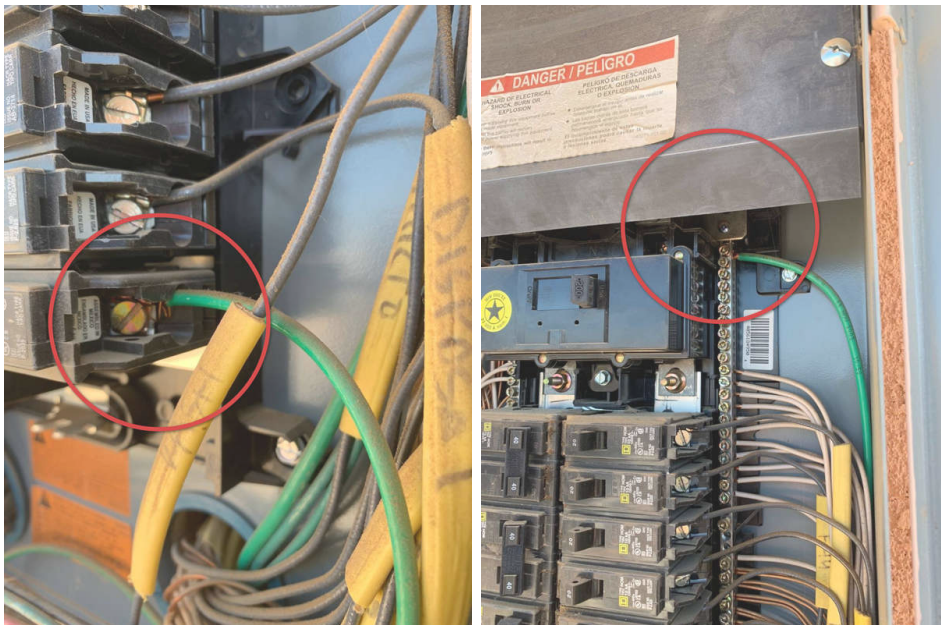
UNPROFESSIONAL WIRING

Unprofessional wiring was observed in the main panel box during the time of inspection. Recommend that qualified licensed contractor further evaluate and make repairs if necessary.

Contact a qualified professional.

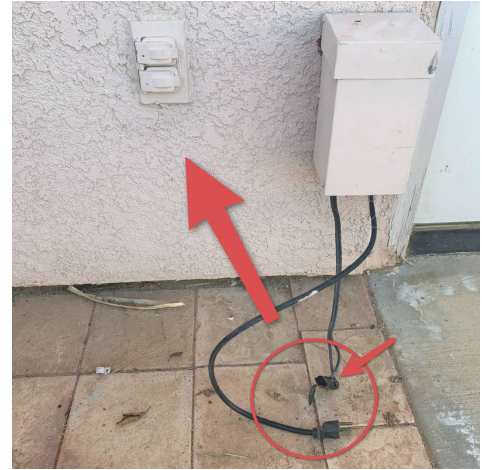
WEST (SIDE)

LOOSE WIRE(S) NOT PROPERLY TERMINATED

Bare wire ends, or wires with a substandard termination were found at one or more locations. This is a potential shock hazard. Recommend that a qualified electrician repair as necessary. For example, by cutting wires to length and terminating with wire nuts in a permanently mounted, covered junction box. (Outdoor lighting improperly terminated, recommend removing box)

Recommendation
Contact a qualified electrical contractor.

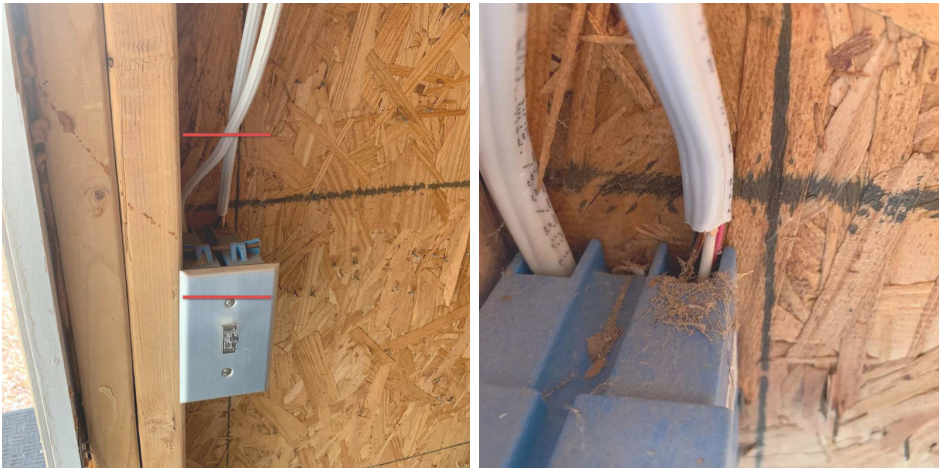
DETACHED STRUCTURE (NORTH)

WIRING - EXPOSED

Condit wire was not properly terminated in the junction box. This could be a potential shock hazard. Recommend pulling exposed wire into the junction box.

Recommendation
Contact a handyman or DIY project

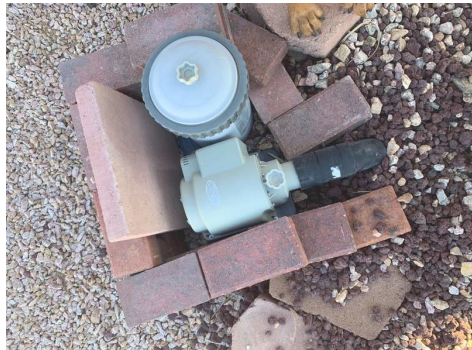
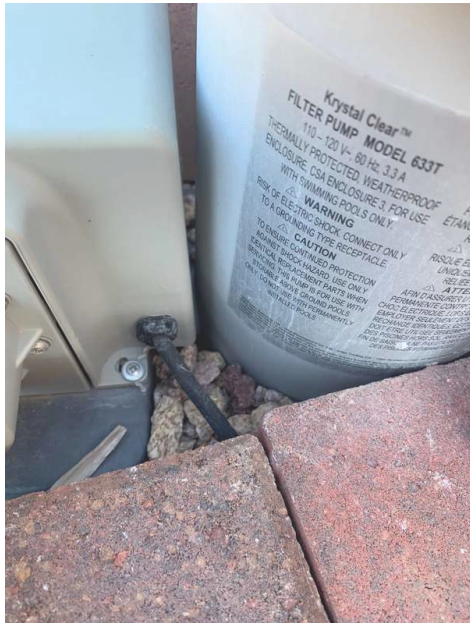
BACKYARD (NORTH)

UNPROFESSIONAL INSTALL

During the time of inspection, an outdoor water pump/filter was observed, wiring appears not to be rated for underground installation. Recommend a Licenced electrician evaluate and make repairs if necessary. This error could result in a potential shock hazard.

Contact a qualified professional.

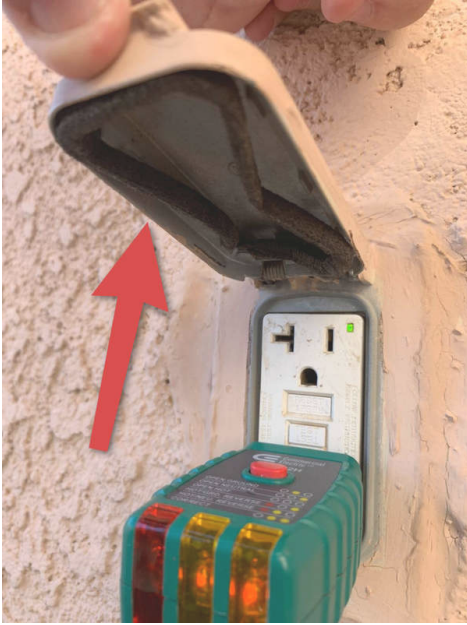
(Front) North

EXTERIOR RATED COVER PLATE DAMAGED / MISSING

One or more, exterior receptacle covers were Damaged and/or missing. This is a potential shock hazard. Some corrections are simple for a DIY/Handyman repair (or) Recommend that a Qualified Contractor make all repairs and replace covers where necessary to ensure proper function and installation. (All exterior receptacles were missing or had damaged seals)

Contact a qualified electrical contractor.

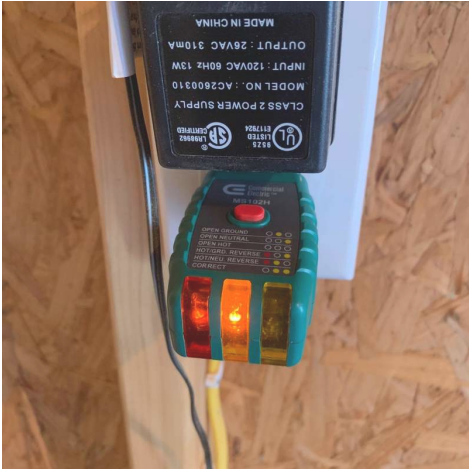
DETACHED STRUCTURE

REVERSE POLARITY

Safety/Attention

1. One or more receptacles have been wired with reverse polarity. This can create a shock hazard. Recommend handyman or licensed electrician to evaluate & repair.

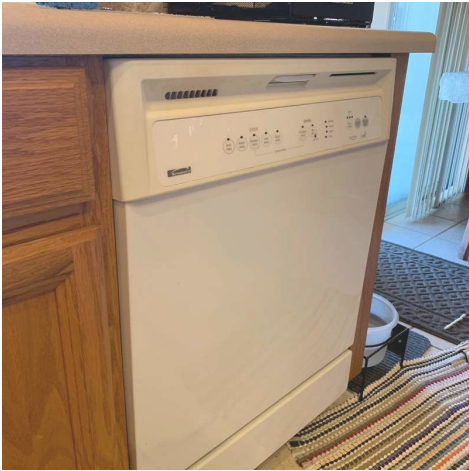
KITCHEN

INOPERABLE

During the time of inspection, the homeowner stated that the dishwasher was inoperable, therefore the dishwasher was not tested for functionality. Recommend a qualified appliance repair person to evaluate and repair or replace as necessary.

Contact a qualified appliance repair professional.

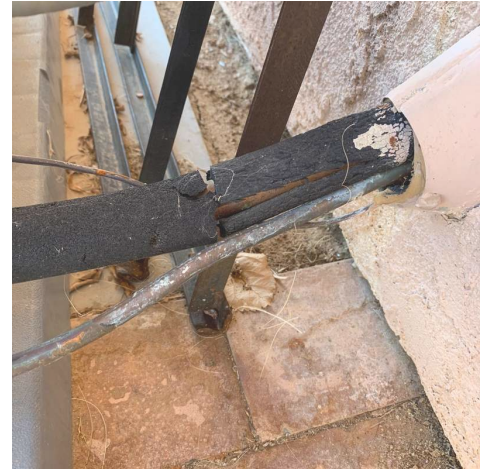
WEST (EXTERIOR)

A/C - INSULATION MISSING OR DAMAGED

Maintenance/Minor

Insulation on the air-conditioning suction (large, insulated) line was damaged or missing. This may result in reduced efficiency and increased energy costs. In attics, it can cause sweating. Recommend qualified HVAC contractor replace or install insulation where necessary.

Contact a qualified heating and cooling contractor

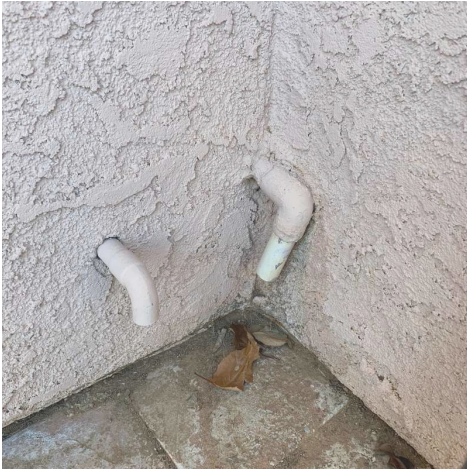
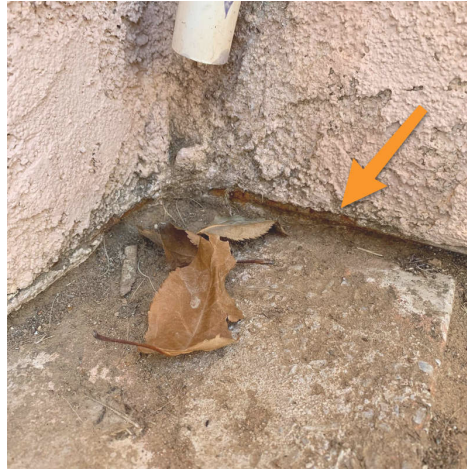
WEST (SIDE)

DRIP LINE - IMPROPER TERMINATION

Concern/Moderate

Drip Line for HVAC system has termination near or in contact with the home exterior, this can lead to potential structural damage from wood decay and possible development of microbial growth such as mold. Recommend a Qualified professional make corrections.

Contact a qualified professional.

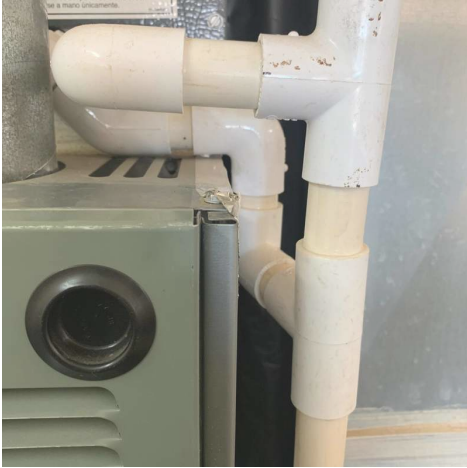
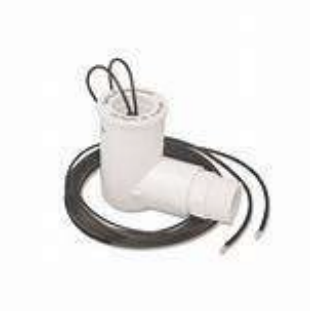
IMPROPER INSTALLATION - CONDENSATION LINES

No trap was visible in the condensation drain line at the time of the inspection, this trap is used to prevent backflow into the coil area. here was no secondary fitting to allow for condensation to run into a secondary pan and/or Recommend adding a Safe T switch to the condensate drain line to help identify blocked condensate lines.

Recommendation
Contact a qualified professional.

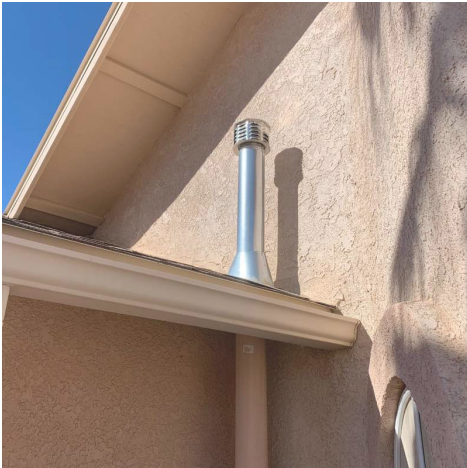
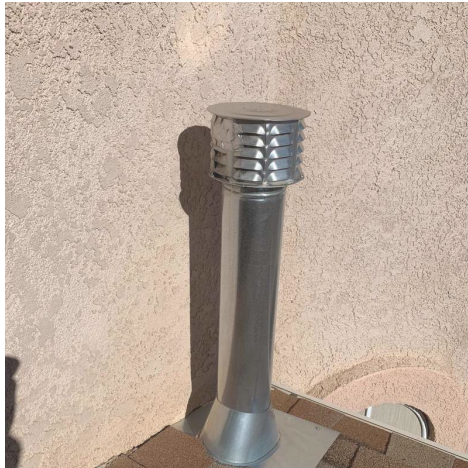
FRONT / LIVING ROOM

VENT - IMPROPER TERMINATION

Unused vent (Possible future Pellet Stove connection) Vent should have adequate clearance from the wall of 12 inchs and 36 inchs from combustibles. Recommend removing and properly sealing the vent or before installing any stove or equipment be sure to check with manufacturer clearance requirements.

Recommendation
Contact a qualified professional.

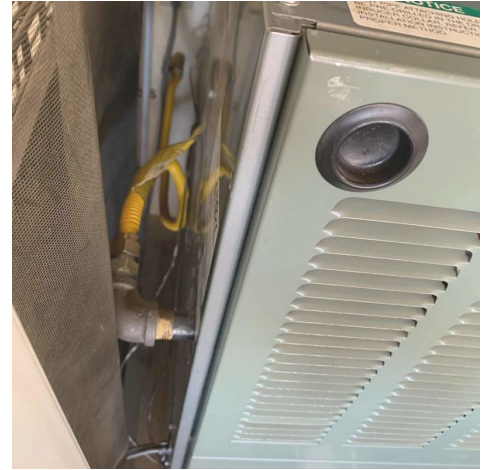
GAS LINE - MISSING DRIP LEG

Concern/Moderate

No visible drip leg/sediment trap observed on the water heater gas line. Recommend ensuring the device is installed for appliance safety.

Recommendation
Contact a qualified professional.

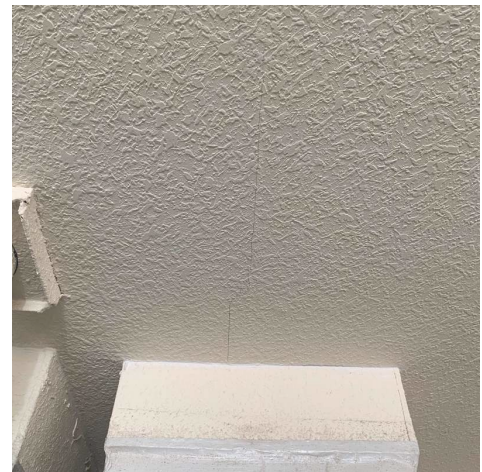
GARAGE

DRYWALL CRACK(S) - COMMON

Common Cracks were observed in drywall during the time of inspection. Recommended minor repairs by a qualified professional or handyman in order to maintain aesthetics.

Recommendation
Contact a qualified professional.

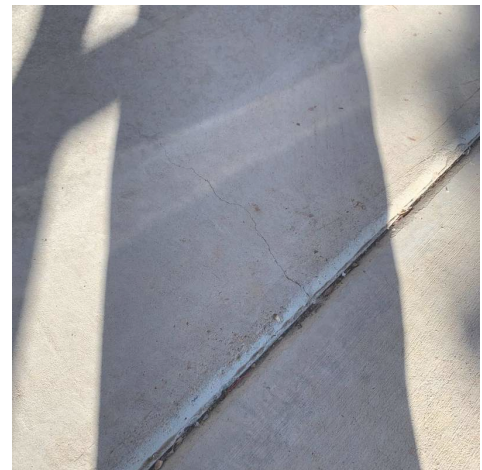
GARAGE

CONCRETE FLOOR - COMMON CRACKING

Common cracks (1/4-inch or less) were visible in the Garage. Cracks exceeding 1/4 inch should be filled with an appropriate material to avoid continued damage to the driveway surface from water intrusion.

Recommendation
Contact a handyman or DIY project
