## SUMMARY

1234 Main St. Weaverville NC 28787

Buyer Name  
07/09/2018 9:00AM

Michael Van Hall  
Licensed NC Home Inspector &  
Certified Radon Inspection Specialist  
Blue Mountain Home Inspections of  
WNC

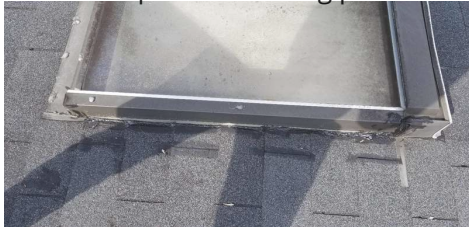
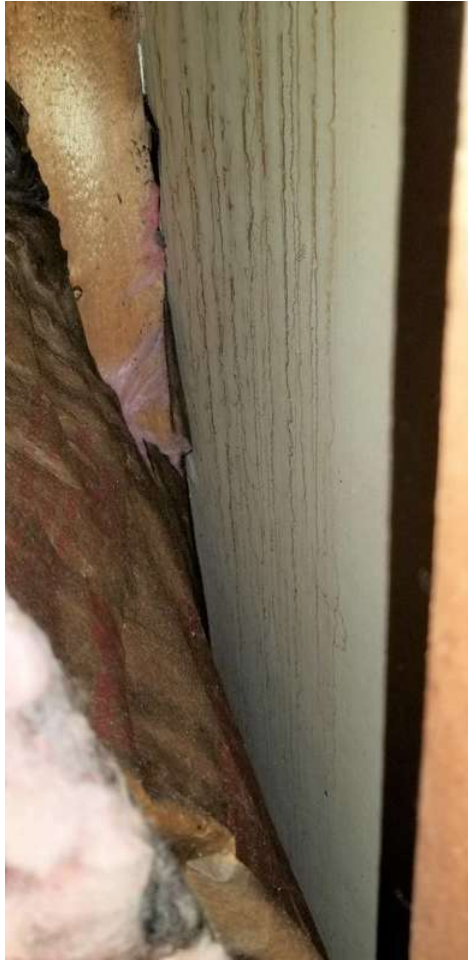
MAIN BATHROOM/CENTER ROOF/ATTIC

#### **PAST SKYLIGHT WATER PENETRATION**

There are signs of past moisture penetration at or near one or more skylights as evidenced by skylight caulking on the roof and water stains running down the boxed out sheetrock enclosure in the attic behind the insulation. Moisture penetration into the building envelope can cause structural damage and undesirable environmental conditions. Monitoring is recommended. If signs of moisture penetration appear in the future, a Licensed Roofing Contractor should be consulted for evaluation and repair.

Contact a qualified roofing professional.

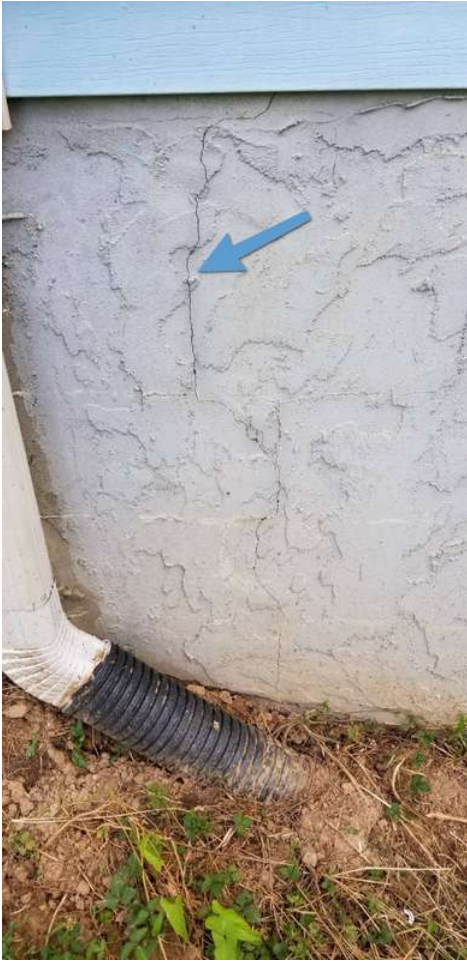
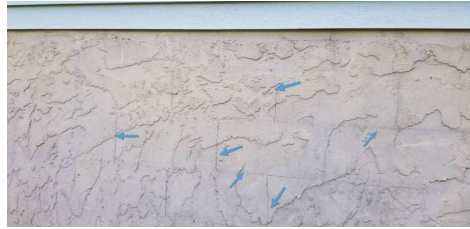
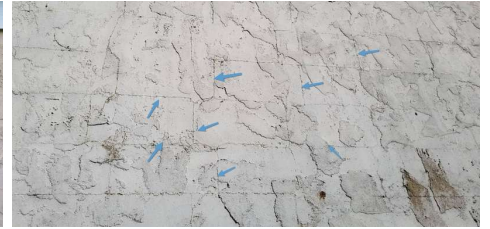
##### NUMEROUS AREAS

#### **STUCCO CRACKING OF LESS THAN MEASURABLE WIDTH**

The Stucco has cracking of less than measurable width in one or more places. If the cracks were to widen over time, they could allow moisture penetration into the building envelope, structural damage and undesirable environmental conditions. A Licensed Stucco Contractor should be consulted for further evaluation and repair if deemed necessary.

Under screened in patio

Contact a stucco repair contractor

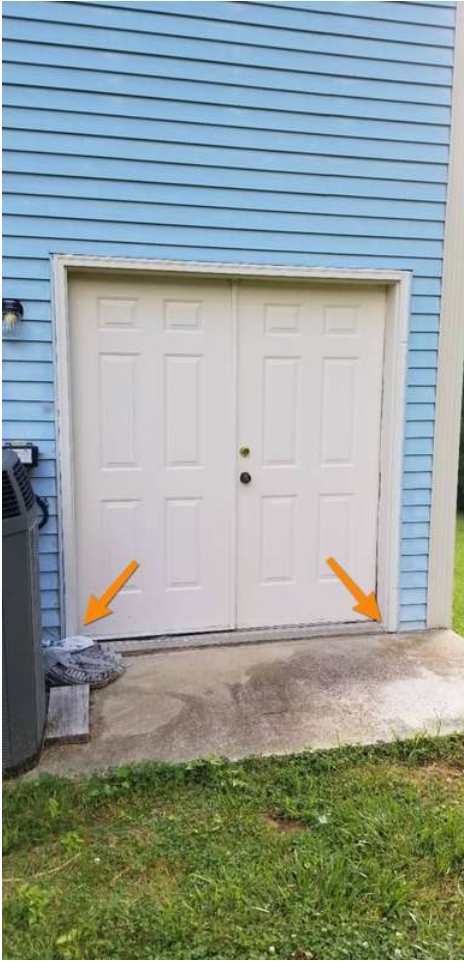
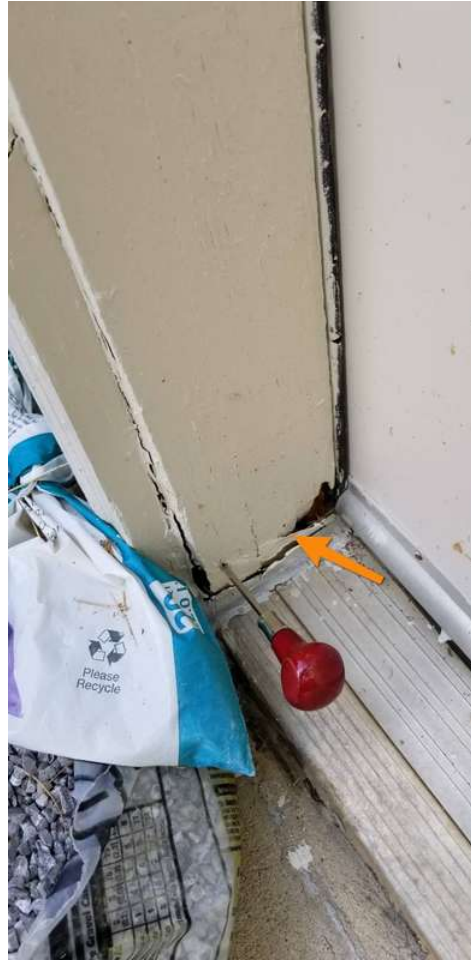
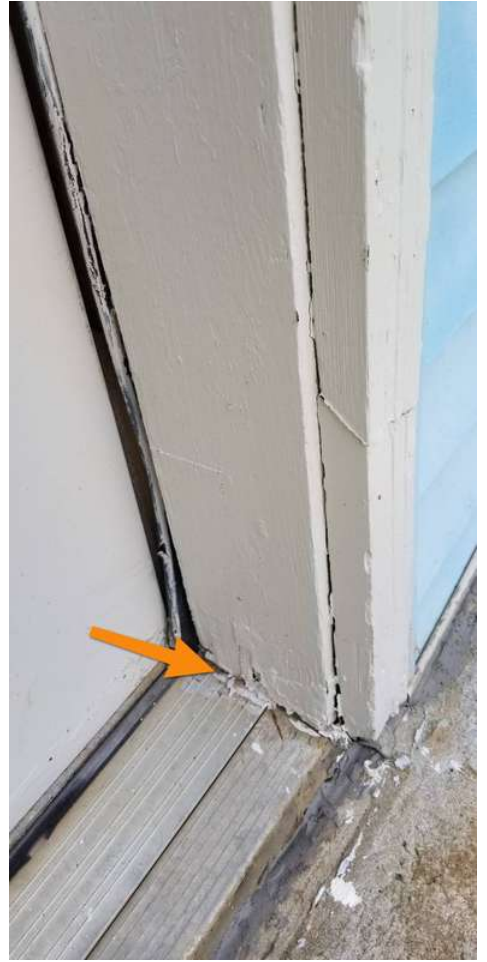
##### BASEMENT DOUBLE DOOR TRIM

#### **DETERIORATING TRIM**

One or more areas of exterior trim are deteriorating. Deteriorated wood trim can lead to moisture penetration into the building envelope, structural damage, and undesirable environmental conditions. A Licensed General Contractor should be consulted for evaluation and repair.

Contact a qualified general contractor.

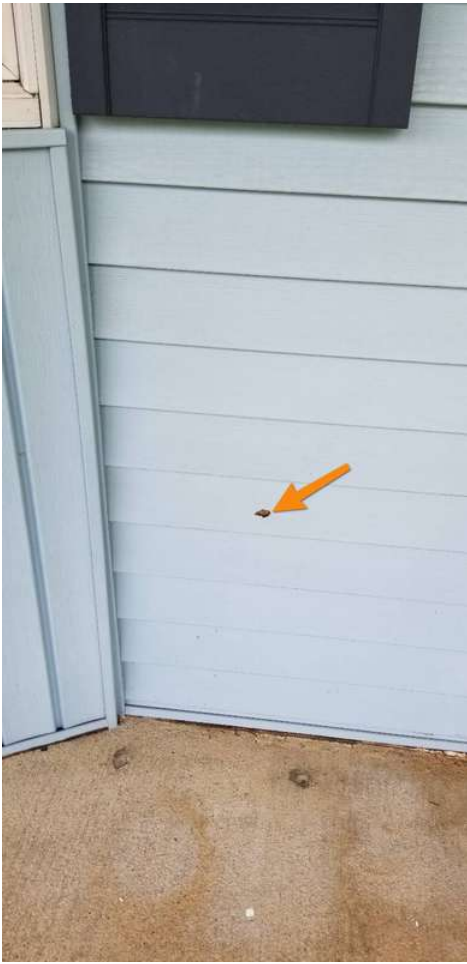
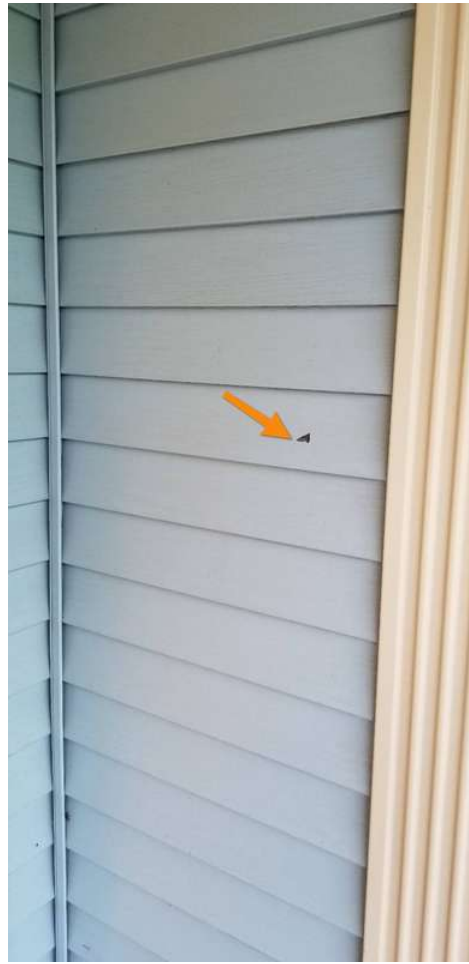
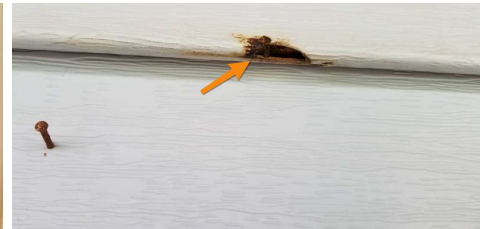
FRONT CENTER/LEFT

#### **SIDING DAMAGED**

One or more areas of siding appeared to have been damaged/cut. Damaged siding can allow moisture penetration into the building envelope from wind driven rain, structural damage and undesirable environmental conditions. A Licensed Siding Contractor should be consulted for evaluation and repair.

Contact a qualified siding specialist.

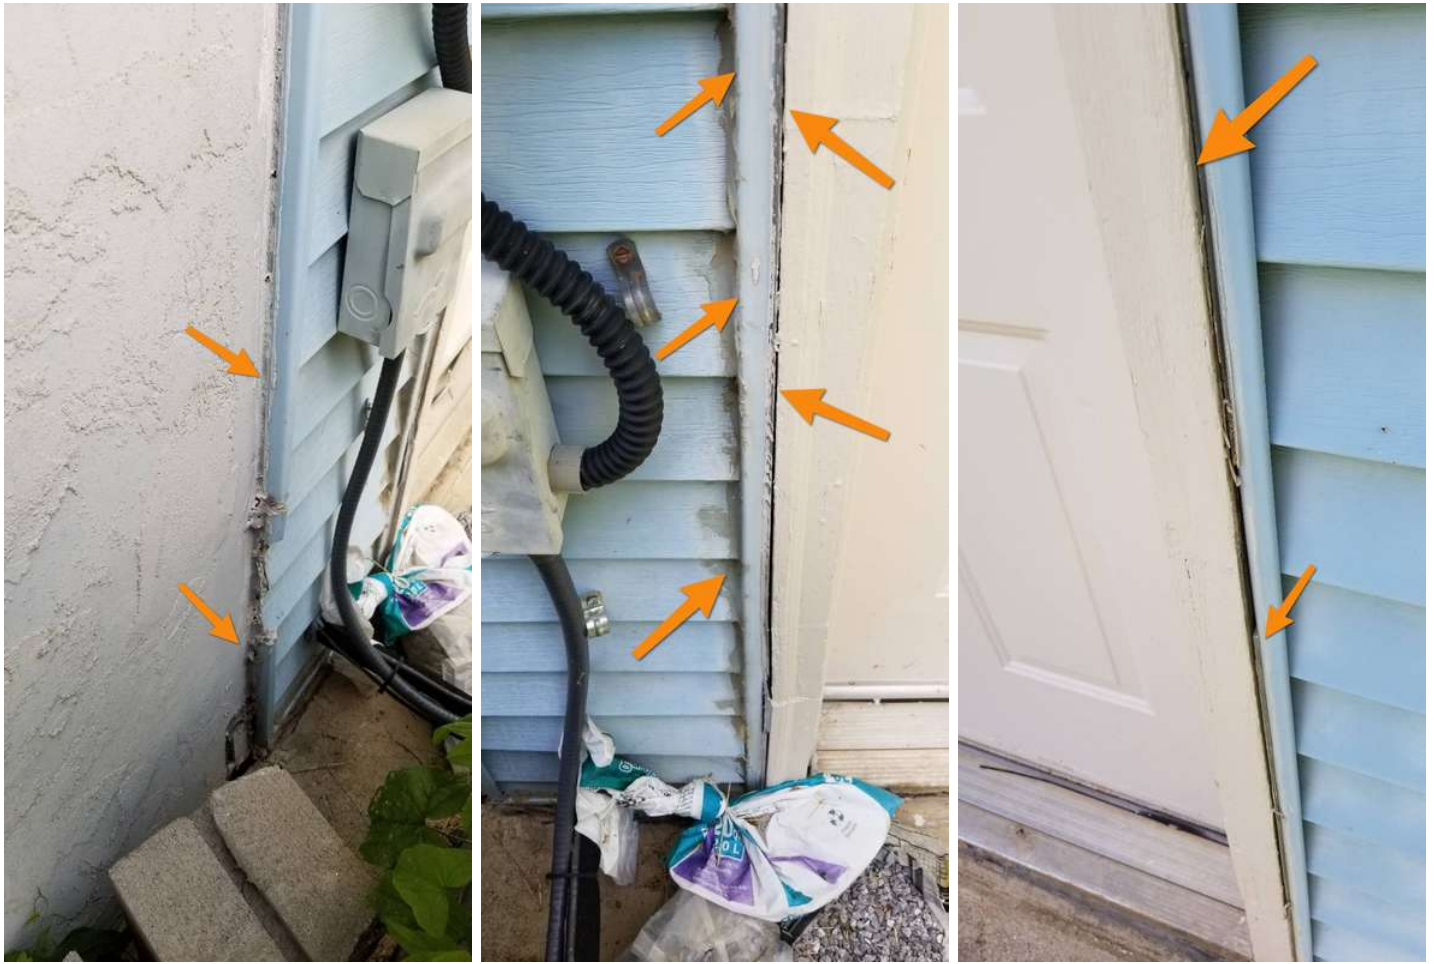
BACK RIGHT NEAR DOORS

#### **HEAVY CAULKING**

There is heavy caulking in one or more places evidencing past moisture penetration. Heavy caulking is not a permanent fix. Moisture penetration into the building envelope can cause structural damage over time and undesirable environmental conditions. A Licensed General Contractor should be consulted for evaluation and repair.

Contact a qualified general contractor.

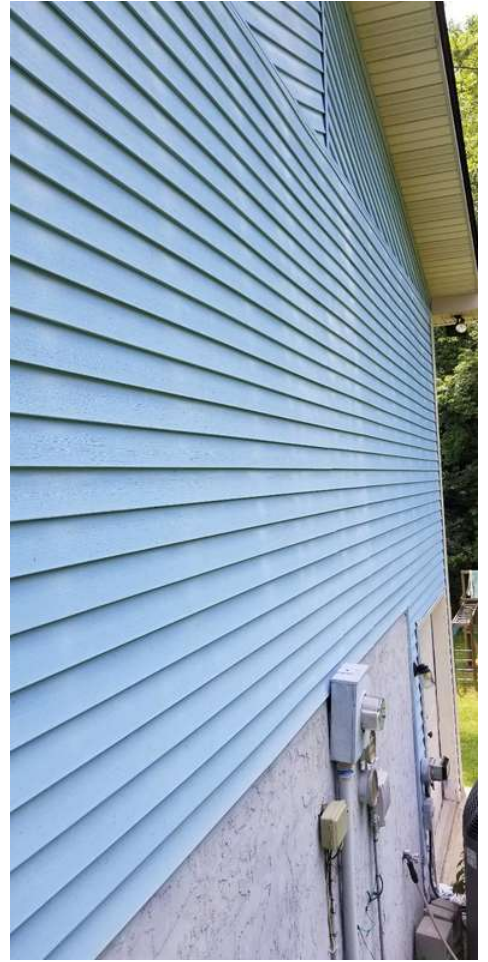
RIGHT SIDE MOST PREVALENT

## VINYL SIDING DISCOLORATION

The siding in one or more places shows signs of discoloration. Discoloration of vinyl siding can occur from many causes. A Licensed Siding Contractor should be consulted for evaluation and repair if deemed necessary.

Recommendation  
Contact a qualified siding specialist.

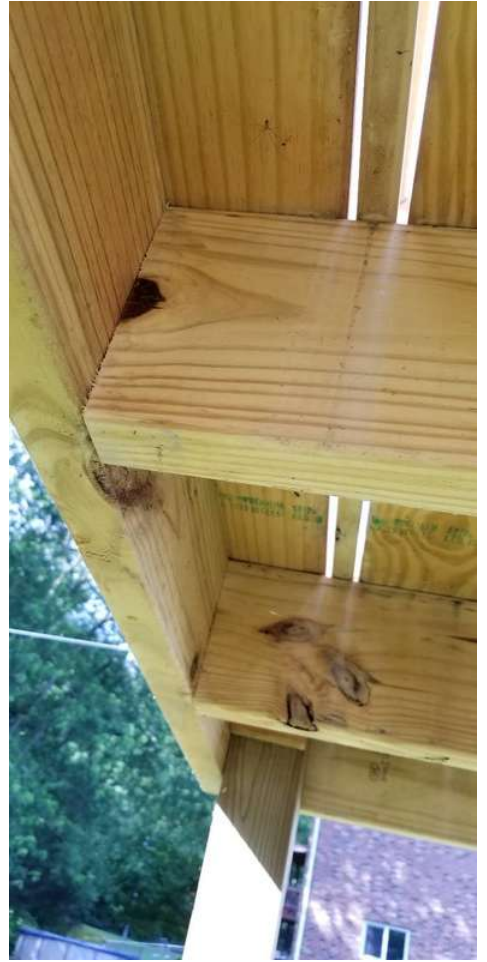
BACK

### **JOIST HANGERS MISSING OR IMPROPERLY INSTALLED**

One or more areas of the deck have missing or improperly installed joist hangers, or lack of ledger boards, relying on nail connections only. This could cause the deck to collapse under load. A Licensed Deck Contractor should be consulted for evaluation and repair.

Contact a qualified deck contractor.

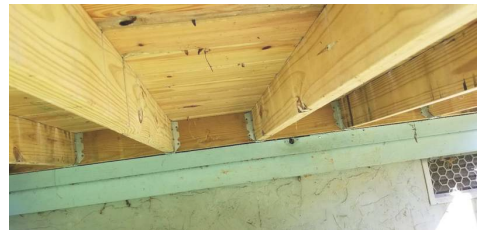
BACK

### **DECK CONNECTION**

The deck appears to be nailed to the home with no other visible means of attachment. Nails can corrode and fail behind the deck band causing the deck to collapse. Concealed damage to framing and/or siding behind the deck can also result in deck collapse. Unless it can otherwise be demonstrated that the deck attachment to the house is secure, the deck should be directly supported from below or bolted to the house. A Licensed General Contractor or Licensed Structural Engineer should be consulted for a full evaluation of the deck attachment and modify or repair as deemed necessary.

Contact a qualified general contractor.

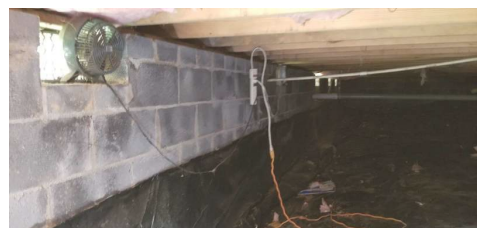
CRAWLSPACE

### **INTERMITTENT EXCESSIVE MOISTURE CONDITIONS**

There is evidence of intermittent excessive moisture conditions in the crawlspace. Excessive moisture in the crawlspace can lead to undesirable environmental conditions, wood destroying organism growth, structural damage and rusting of metal components of the HVAC systems. A License General Contractor should be consulted for evaluation and repair.

Contact a qualified general contractor.

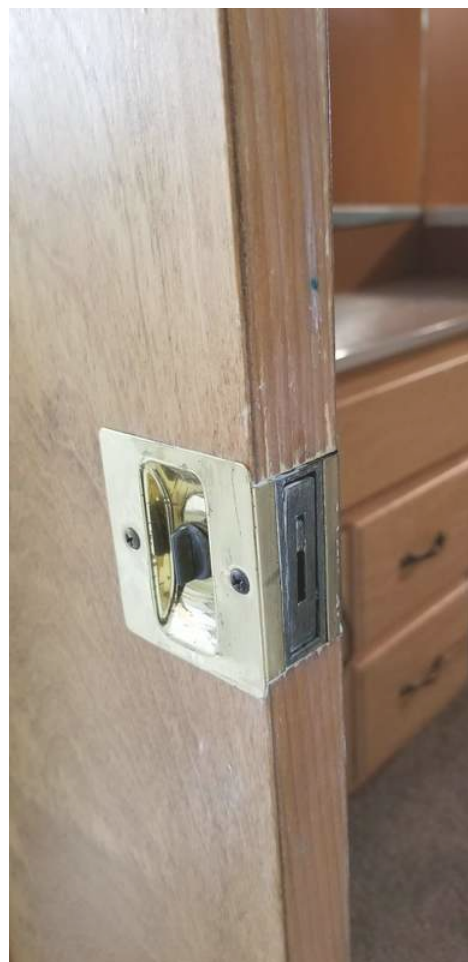
MASTER BATHROOM SLIDING DOOR

### **DOOR DOES NOT LATCH**

One or more interior doors do not latch properly. A Door Repair and Installation Contractor should be consulted for evaluation and repair.

Contact a qualified door repair/installation contractor.

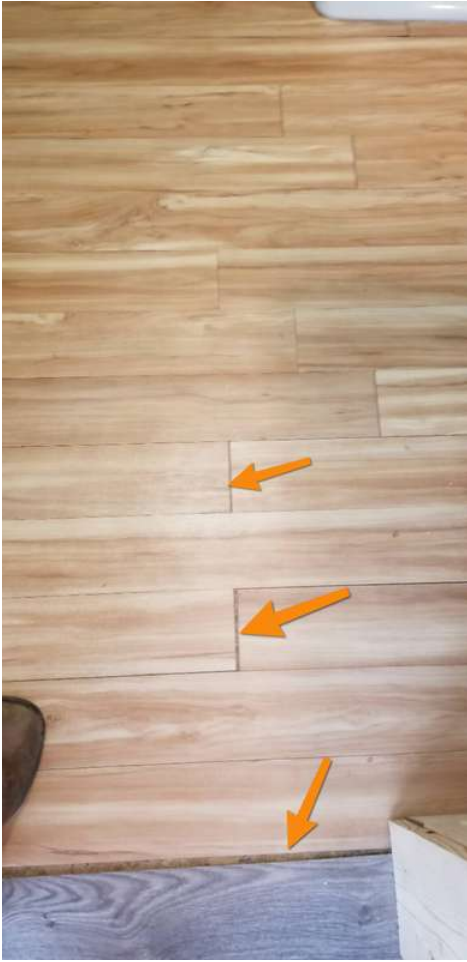
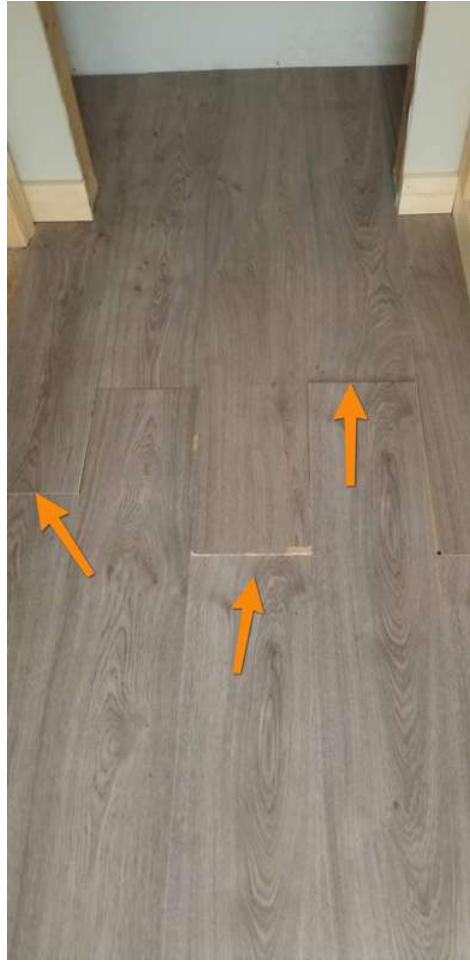
LOWER LEVEL BATH AND HALLWAY

### **FLOOR NOT INSTALLED TO INDUSTRY STANDARDS**

One or more areas of the flooring are not installed to industry standards with gaps between pieces and overlapping of pieces. A Licensed Flooring Contractor should be consulted for evaluation and repair.

Contact a qualified flooring contractor

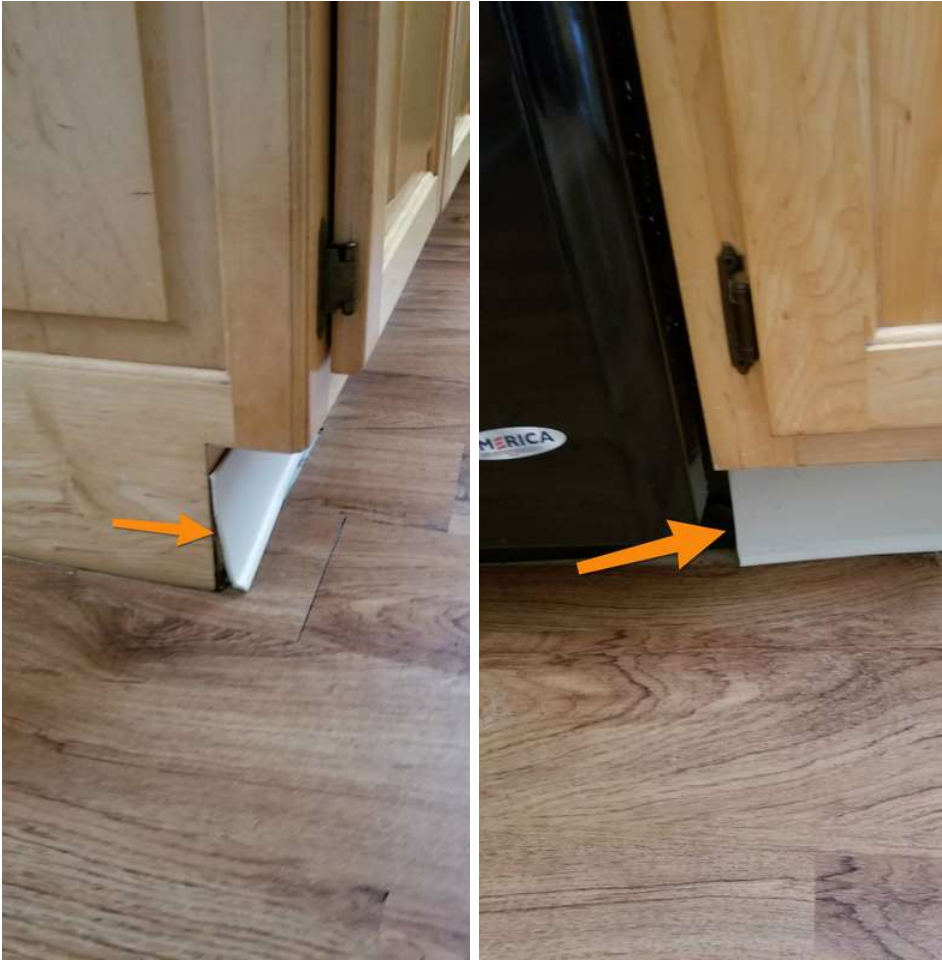
### KITCHEN FLOOR

## **LOOSE VINYL TRIM**

The vinyl trim is loose in one or more places. A Licensed Flooring Contractor should be consulted for evaluation and repair.

Contact a qualified flooring contractor

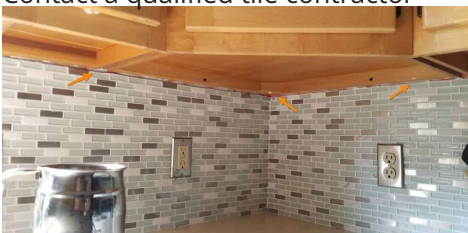
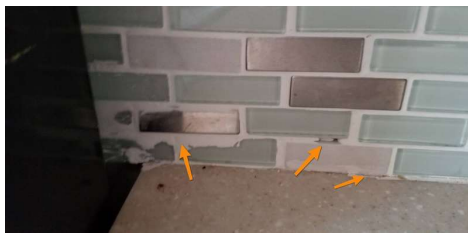
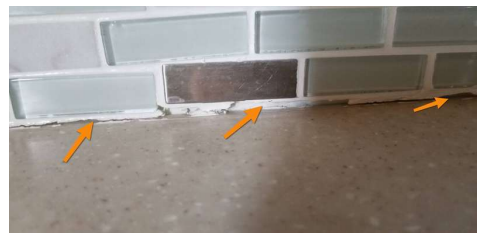
KITCHEN BACKSPLASH

**TILE NOT INSTALLED TO INDUSTRY STANDARDS**

The tile has not been grouted to industry standards. A Licensed Tile Contractor should be consulted for evaluation and repair.

Contact a qualified tile contractor

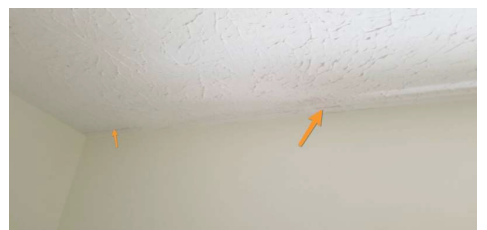
MASTER BATHROOM

**LOOSE TAPE**

One or more areas of the sheet rock taping are coming loose. A Drywall Contractor should be consulted for evaluation and repair.

Contact a qualified drywall contractor.

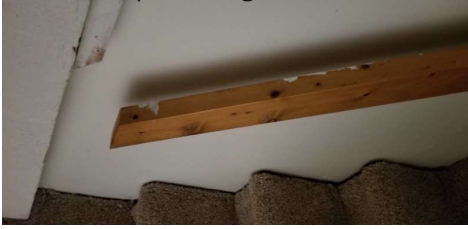
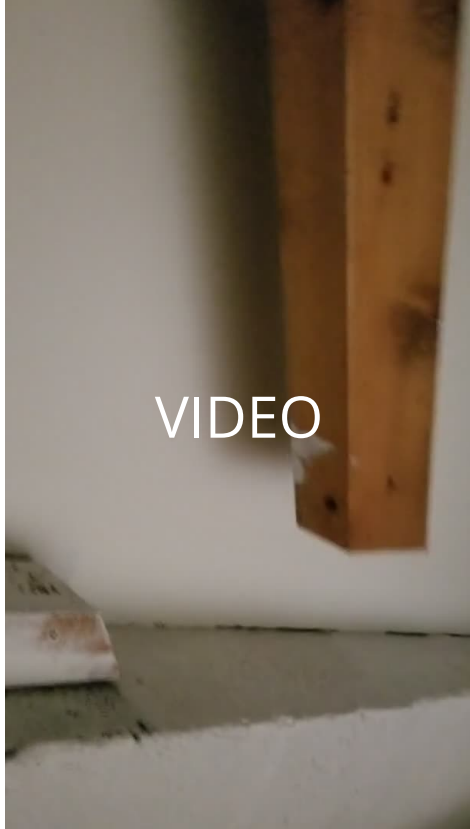
LOWER LEVER STAIRWAY

**LOOSE HANDRAIL**

The stair handrail is loose in one or more places. Loose handrails are a safety hazard and should be repaired as soon as possible. A Licensed General Contractor should be consulted for evaluation and repair.

Contact a qualified general contractor.

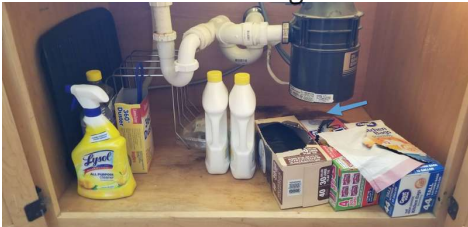
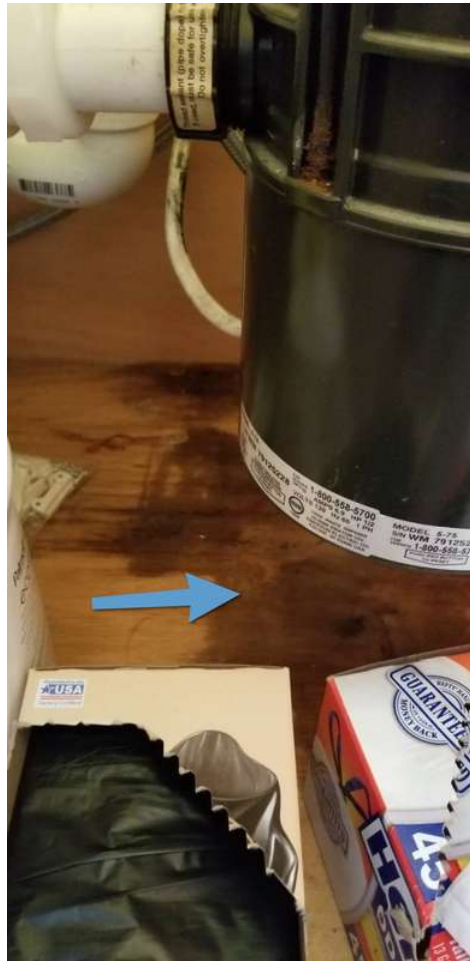
KITCHEN SINK BASE

**EVIDENCE OF PAST LEAKING**

There is evidence of past leaking in one or more cabinet sink bases. This may be from a plumbing leak or from leaking bottles that have been stored under the sink. Recommend continued monitoring.

Recommend monitoring.

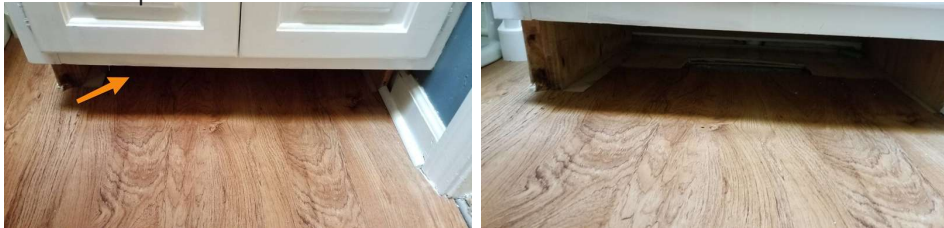
#### **CABINET KICK PLATE MISSING**

The main bathroom sink cabinet is missing its kick plate. This plate should also have a duct register in it as the HVAC is venting out the front of the cabinet. A Licensed cabinet contractor should be consulted for evaluation and repair.

Contact a qualified cabinet contractor.

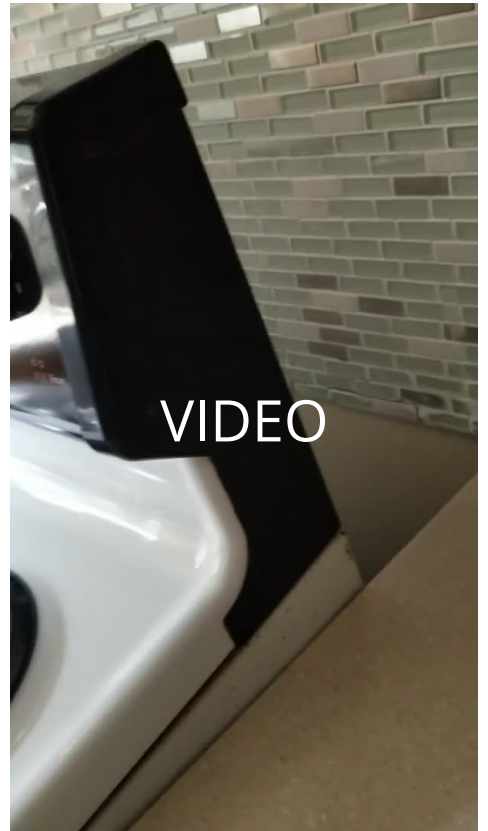
#### **RANGE NOT FASTENED WITH ANI-TILT DEVICE**

The range was not securely fastened to an anti tilt device. This poses a safety hazard, especially to children. A Qualified Professional should be consulted for evaluation and repair or installation of an approved anti tilt device.

Contact a qualified professional.

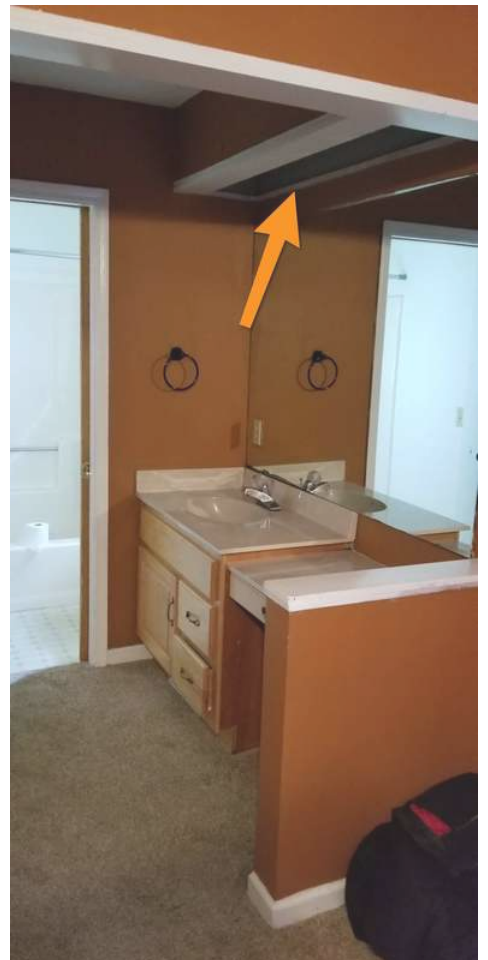
MASTER BATHROOM

**LIGHT INOPERABLE**

One or more lights were not operational at the time of inspection. The light bulb(s) should be replaced and the light fixtures retested. If the light still does not operate, a Licensed Electrical Contractor should be consulted for evaluation and repair.

Contact a qualified electrical contractor.

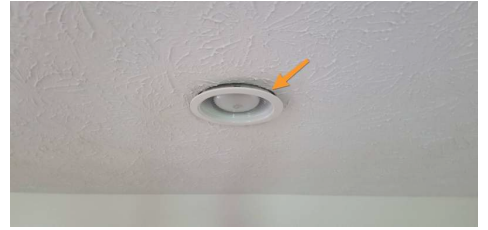
LIVING ROOM

**LOOSE LIGHT FIXTURE**

One or more can light fixtures are loose in the ceiling. A Licensed Electrical Contractor should be consulted for evaluation and repair.

Contact a qualified electrical contractor.

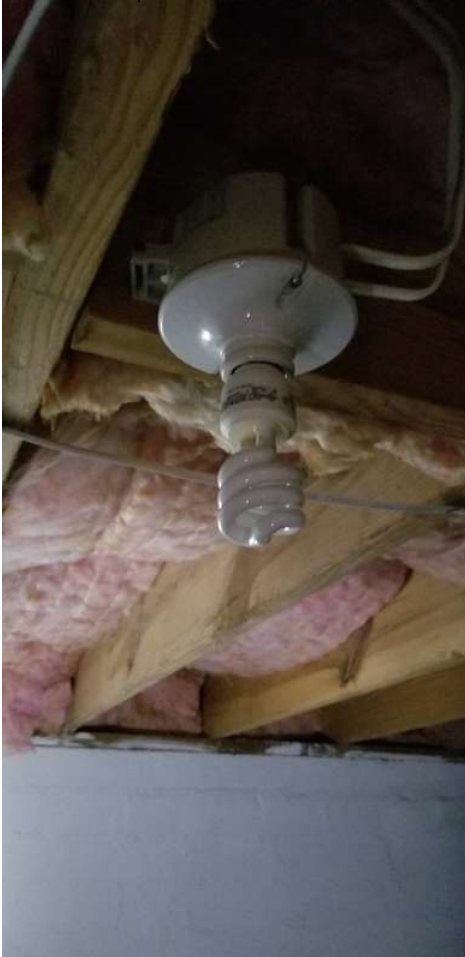
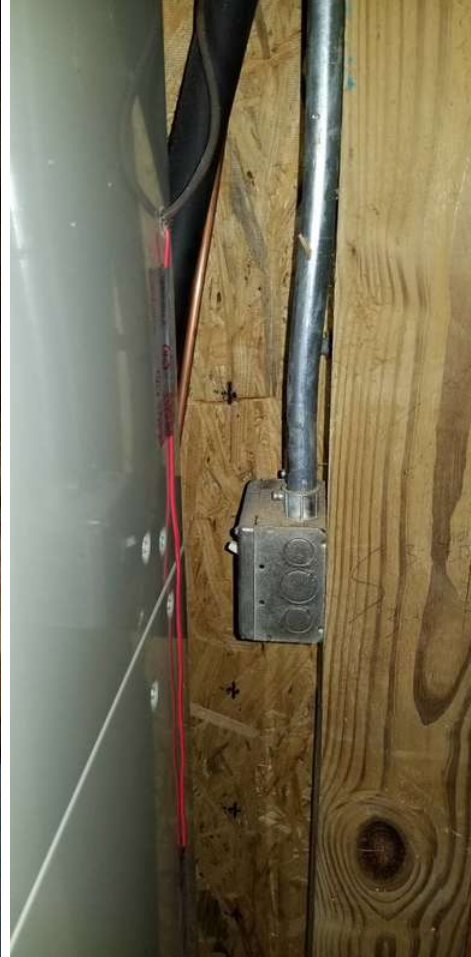
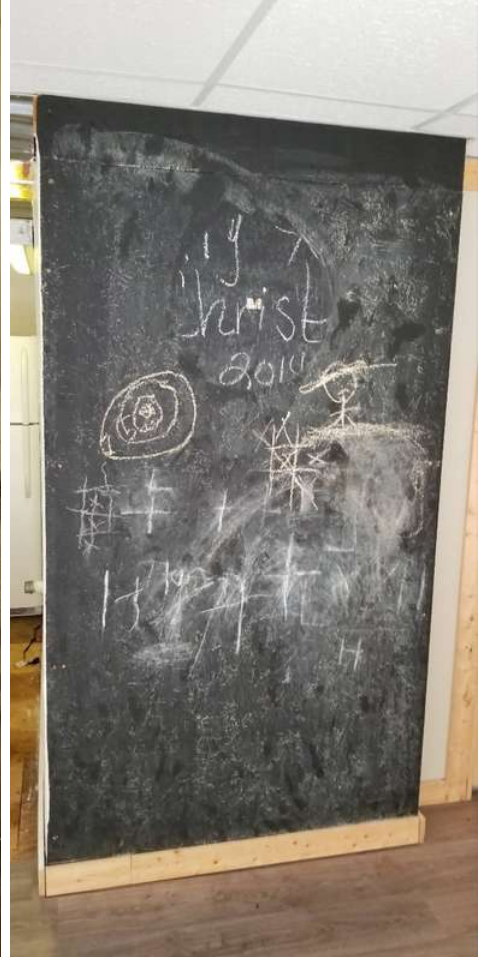
FRONT LEFT BASEMENT

**INACCESSIBLE LIGHT SWITCH**

The light switch to the front right basement store room is inaccessible since it is located in the area where the HVAC air handler and water heater are located (under the stairs). A chalk board panel must be removed to access the switch to this light as well as the air handler and water heater.

Chalkboard panel must be removed to access light switch as well as the HVAC air handler and water heater.

Contact a qualified electrical contractor.

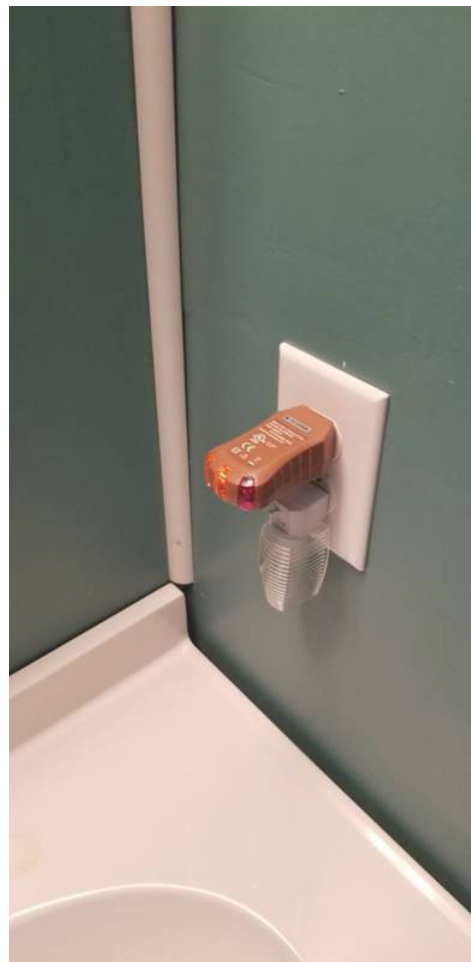
LOWER BATHROOM

**NO GFCI PROTECTION INSTALLED**

The outlet in the lower bathroom does not appear to be GFCI protected. This is a shock hazard. A Licensed Electrical Contractor should be consulted for evaluation and repair.

Contact a qualified electrical contractor.

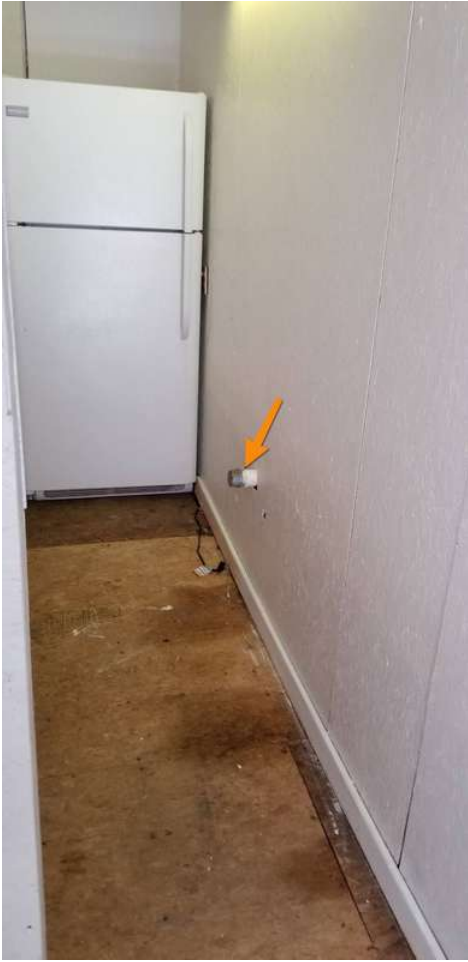
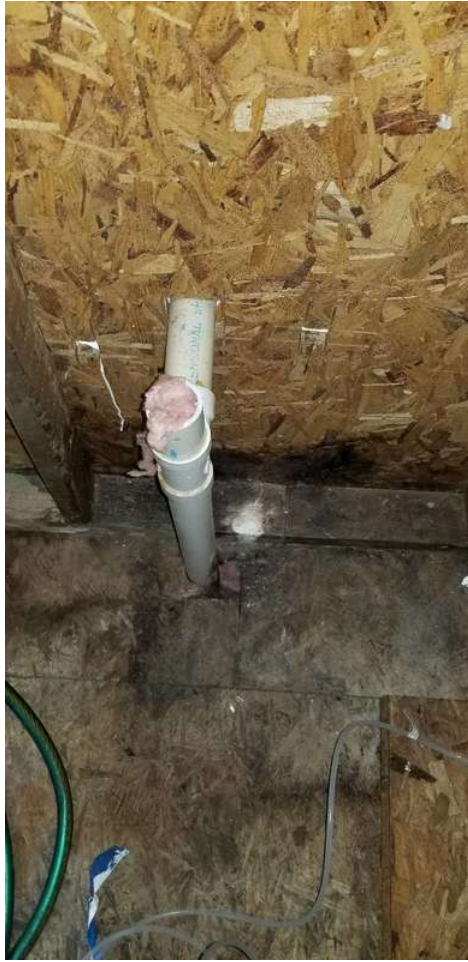
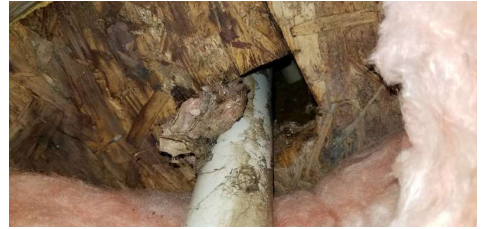
WATER HEATER AREA/BEHIND COUNTER

### LEAKING PIPE

A drain pipe shows signs of a past leak. This piping does not appear to be connected to anything at this time. If the pipe is put in use in the future, a Licensed Plumbing Contractor should be consulted for evaluation and repair.

Contact a qualified plumbing contractor.

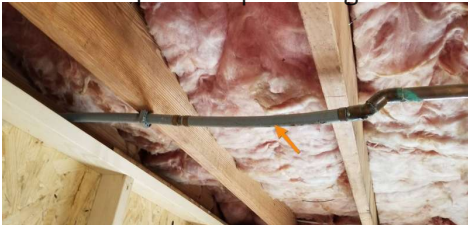
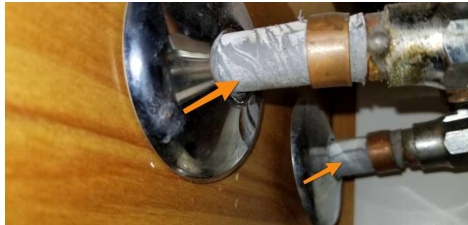
#### **POLYBUTYLENE DISTRIBUTION LINES**

This home has a plumbing supply system that uses polybutylene plastic distribution lines and compression band fittings. Even though this plumbing system was installed in many homes from 1978 until mid-1990s, it is no longer an approved plumbing system due to a history of material failures. The failures were related to improper installation, improper handling, improper storage, and plastic deterioration due to chemical reactions with the water supply. Due to the nature of this latent defect, it was not possible to adequately assess the condition of the plumbing system during the home inspection. A Licensed Plumbing Contractor should be consulted for a complete evaluation of the plumbing system to determine the significance of this concern.

Contact a qualified plumbing contractor.
