SUMMARY

1234 Main St. Roanoke VA 24018

Brian Cullop
VA LIC#3380001082
Ace Home Services LLC
540.293.6622
brian@theacecrew.com

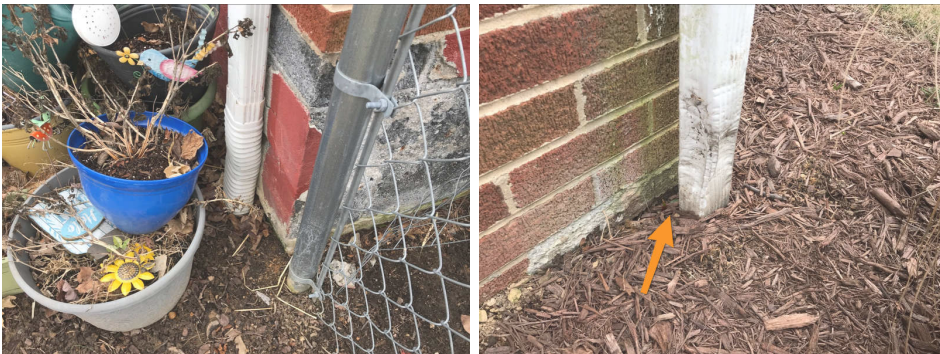
WEST AND EAST DINING ROOM

2.4.1 Roof Drainage System

BLOCKAGE- QC

Some downspouts designed to discharge roof drainage appeared to be clogged with debris. This condition can cause excessively high moisture levels in soil next to the foundation that can effect the ability of the soil to support the weight of the structure above and/or can cause damage related to soil/foundation movement. The Inspector recommends repair or replacement of the downspout by a qualified contractor.

Contact a qualified professional.

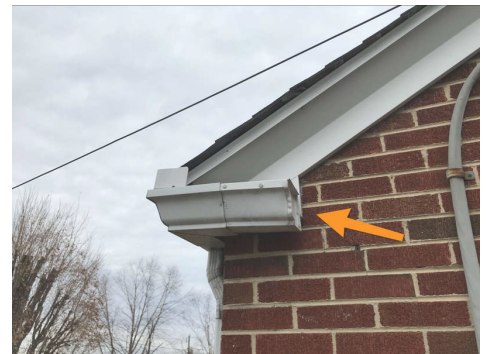
NORTHEAST

2.4.2 Roof Drainage System

IMPROPER SLOPE- QC

Gutters in certain areas sloped incorrectly. This will result in spillage and runoff draining to the foundation. This condition can result in excessively high moisture levels in soil at the foundation. Excessive moisture levels in soil near the foundation can effect the ability of the soil to support the weight of the structure above. The Inspector recommends correction to help protect the home structure and occupants. All work should be performed by a qualified contractor.

Contact a qualified professional.

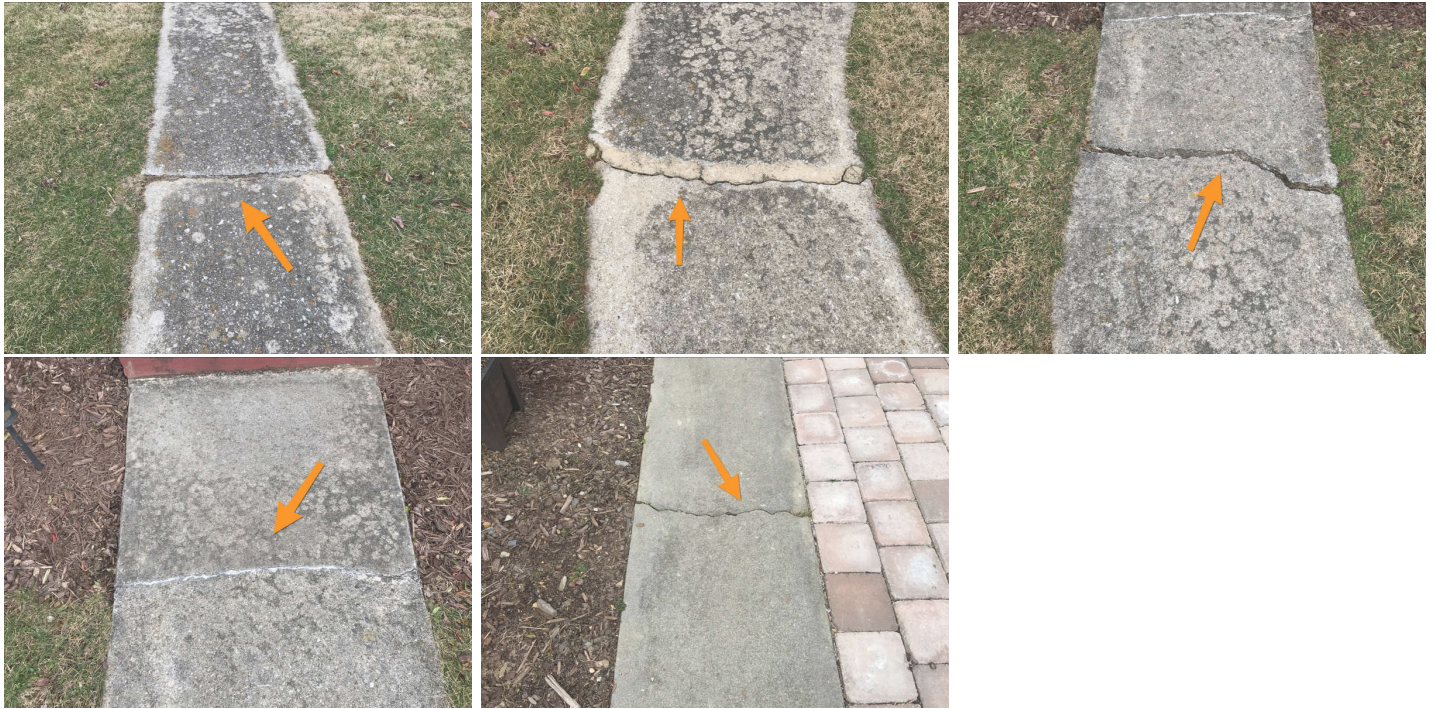
West

4.2.1 Walkways

COMMON CRACKS

Common cracks (1/4 inch or less) were visible in the sidewalk at the time of the inspection. Cracks exceeding inch should be patched with an appropriate sealant to avoid continued damage to the walkway surface from freezing moisture.

Contact a qualified professional.

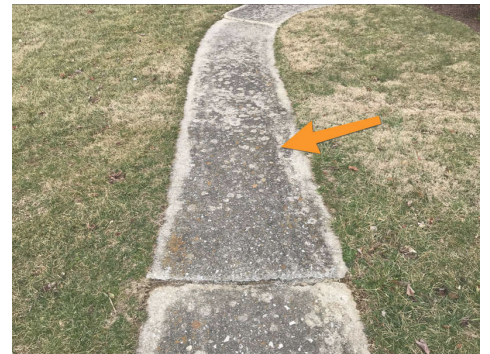
4.2.2 Walkways

EXPOSED AGGREGATE

Some walkways exhibited concrete pitting with aggregate (concrete-embedded stones) visible in the bottoms of pits. This condition is typical of the use of types of aggregate that absorb water and expand during freezing weather, causing the immediately-overlying concrete to fracture.

Contact a qualified professional.

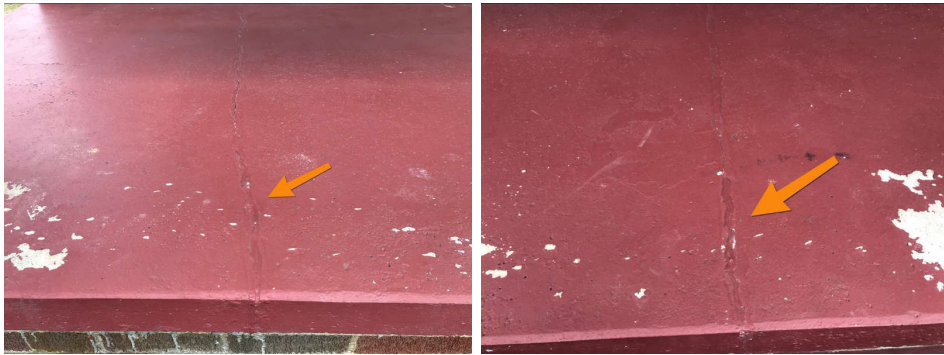
EAST

4.5.1 Porch

MODERATE CRACKING- SE/QC

Moderate porch foundation cracking was visible at the time of the inspection. This condition appeared to be consistent with cracking caused by soil movement. If this condition was caused by inadequate compaction at the time of original construction, soil will have stabilized by now. If it was caused by expansive soil, or excessive amounts of moisture in the soil supporting the foundation, movement and cracking may continue. Determining the soil condition would require the services of a soils (geotechnical) engineer. The Inspector recommends crack repair by a qualified masonry contractor to help prevent future damage from freezing moisture.

Contact a qualified professional.

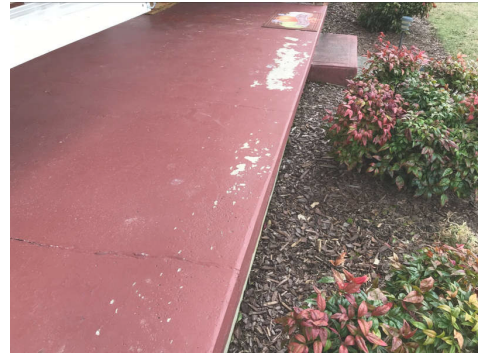
4.5.2 Porch

AGE- WEATHERING

The porch exhibited weathering commensurate with its age.

Contact a qualified professional.

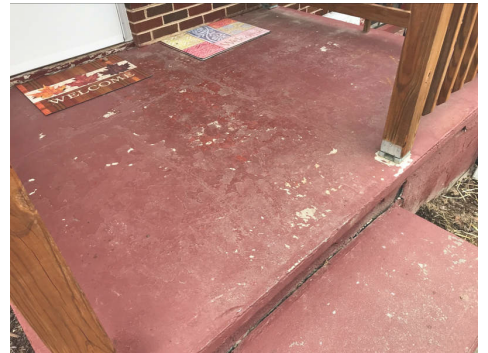
WEST

4.6.1 Deck, Balcony, Bridge and Porch,

PEELING PAINT

The back porch had peeling paint that needed maintenance. Failure to maintain the finish coating will allow Ultra Violet (UV) radiation from sunlight, heat, moisture and freezing moisture to reduce the lifespan of concrete exposed to weather. The Inspector recommends repainting the porch to protect it from further damage.

Contact a handyman or DIY project

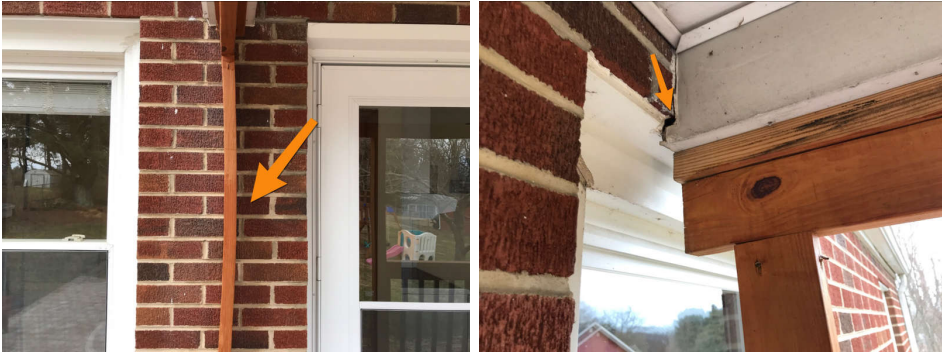
WEST PORCH

4.6.2 Deck, Balcony, Bridge and Porch,

POOR CONNECTIONS

Framing members at this porch cover were poorly connected. This condition could result in structural failure, expensive damage, or injury. The Inspector recommends that you consult with a qualified contractor to gain an idea of options and costs for correction.

Contact a qualified professional.

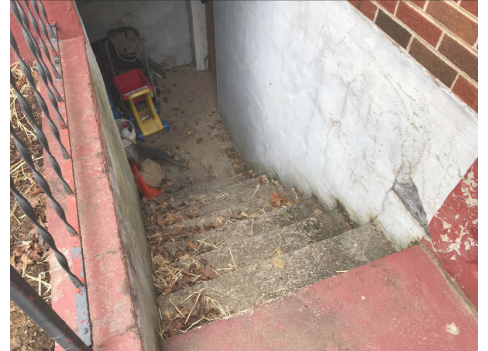
4.7.1 Exterior Stairs

NO HANDRAIL- QC

This exterior staircase had no handrail. Generally-accepted current safety standards mandate that stairs with 4 or more risers should have a handrail.

Contact a qualified professional.

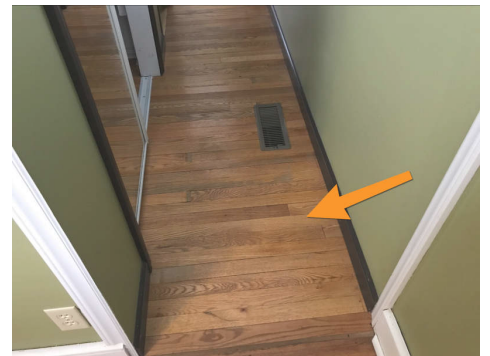
6.1.2 Floors

SEVERE SQUEAKING, SPECIFIC- QC

Wood floors in the Master bedroom exhibited severe squeaking along the major path of travel. This is usually due to fastener movement- either of the wood flooring or the subfloor beneath it. If the fault lies with the flooring fasteners it can be difficult to correct because the flooring is fastened as it is installed in such a manner that fasteners are not accessible once installation is complete. You may wish to consult with a flooring contractor to discuss options and costs for correction.

Contact a qualified professional.

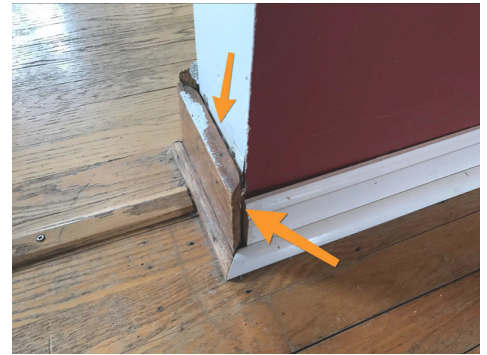
1ST FLOOR LIVING ROOM

6.7.1 Interior Trim

POOR QUALITY INSTALLATION-SPECIFIC

Interior trim in the living room is different sizes.

Contact a qualified professional.

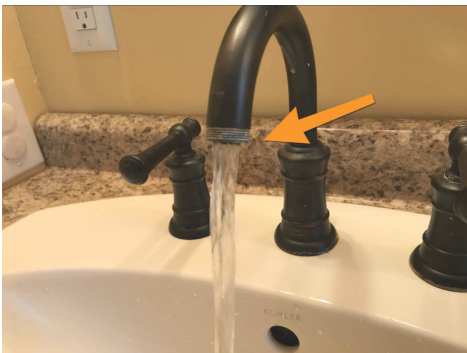
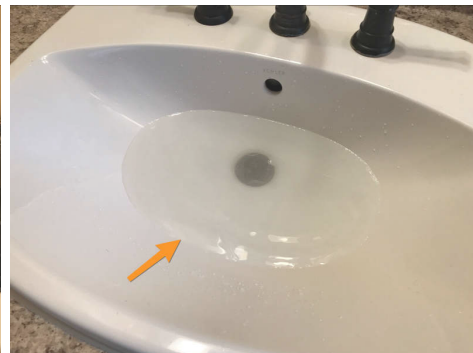
9.15.1 Bathroom Components

SINK FAUCET

Bathroom faucet at sink is missing aerator and slow drain, recommend repairing

Contact a qualified professional.

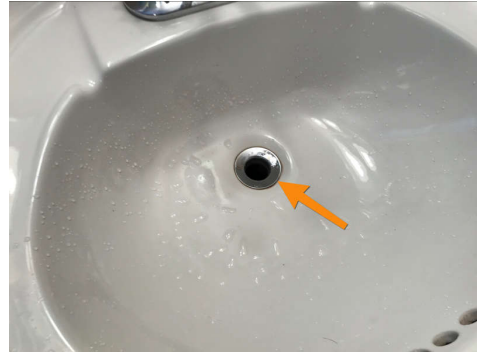
11.15.1 Bathroom Components

INOPERABLE STOPPER

In the 2nd floor bathroom the sink stopper was inoperable.

Contact a qualified professional.

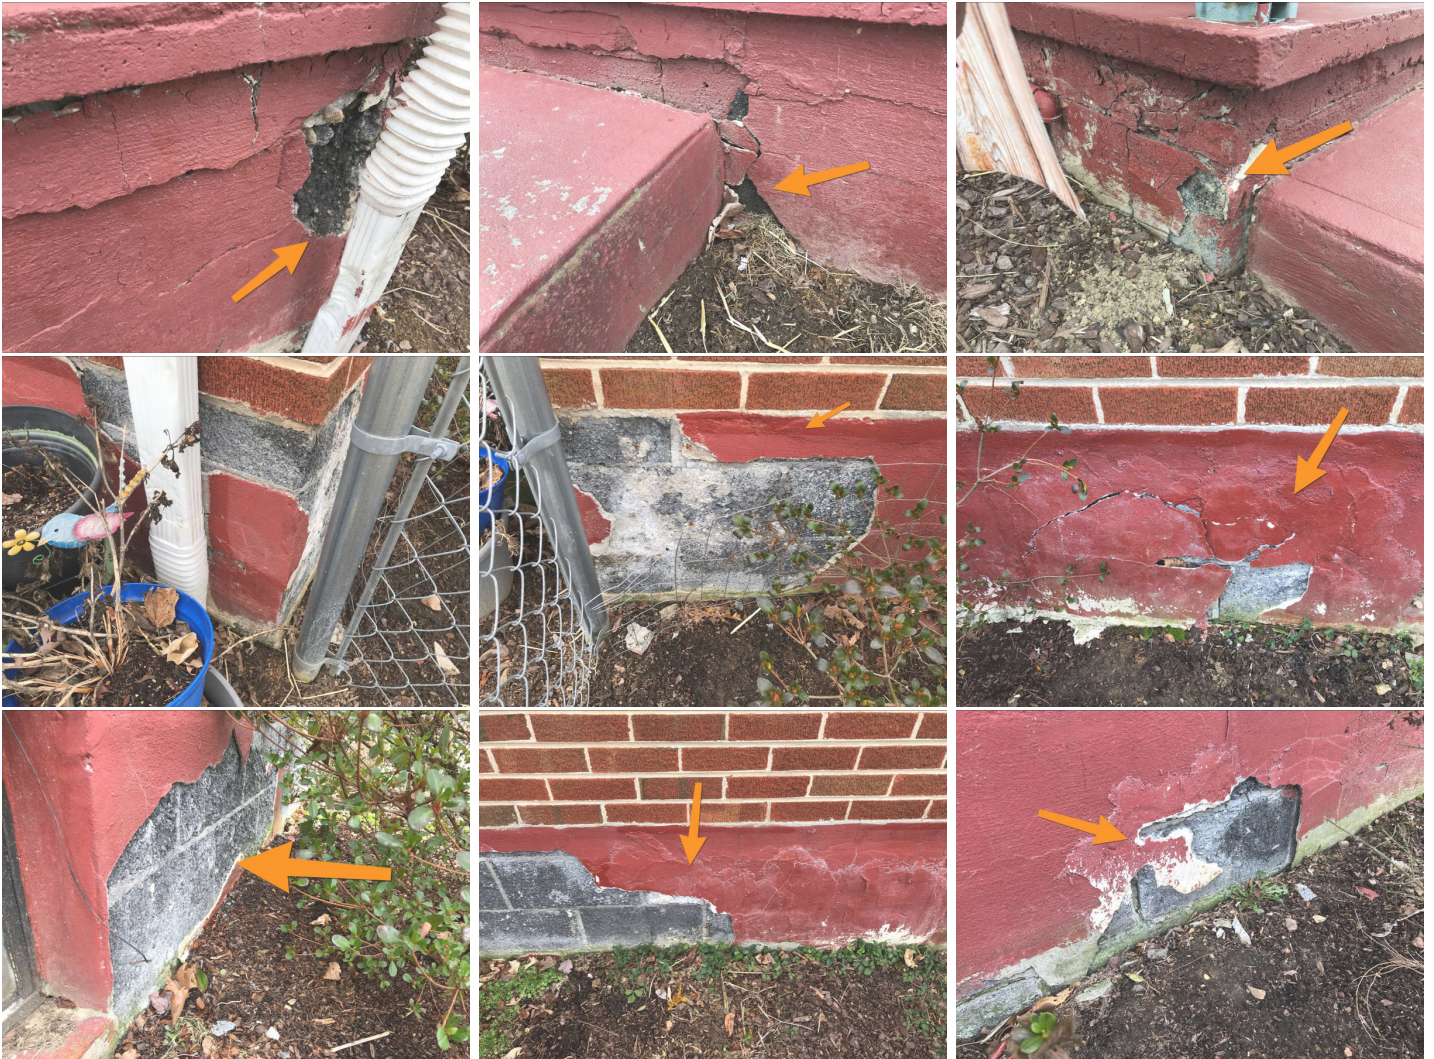
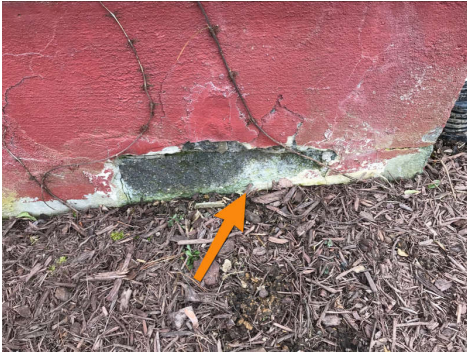
12.1.1 Exterior Wall Construction

MODERATE BLOCK CRACKING- QC

Concrete Masonry Unit (CMU) exterior walls had moderate cracking visible in CMU blocks. Cracking should be patched to avoid freeze damage and the cause of cracking should be determined and corrected. The Inspector recommends that you consult with a qualified contractor to discuss options and costs for stabilization or correction.

Contact a qualified professional.

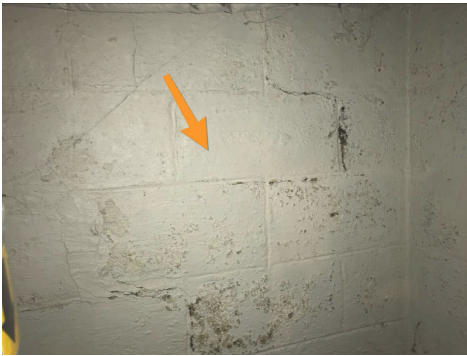
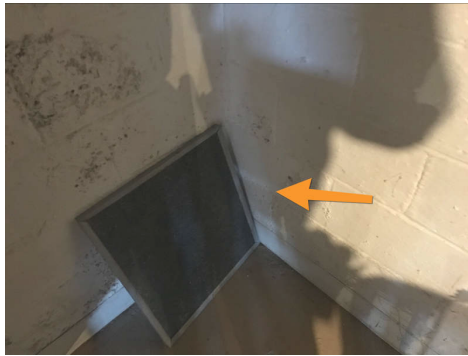
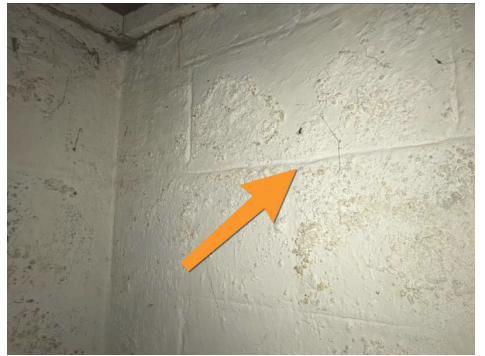
12.3.1 Foundation

EFFLORESCENCE VISIBLE

Efflorescence (white powdery deposits) visible on the surface of the concrete floor slab is an indication of moisture intrusion. Moisture intrusion can affect the ability of the soil beneath the foundation to carry the weight of the structure above and may cause structural damage from soil movement. Moisture intrusion can also damage materials and encourage the growth of microbes such as mold. Efforts should be made to identify the source of the moisture and correct this condition.

Contact a qualified professional.

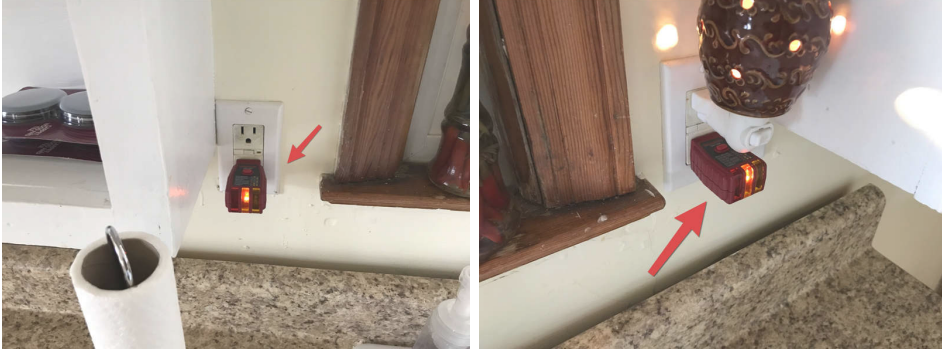
1ST FLOOR KITCHEN

15.7.1 Receptacles and Switches

GFCI PROTECTED RECEPTACLE NON-RESPONSIVE- QC

A ground fault circuit interrupter (GFCI)-protected electrical receptacle in the kitchen did not respond to testing at the time of the inspection. The Inspector recommends that this condition be corrected by a qualified electrical contractor.

Contact a qualified professional.

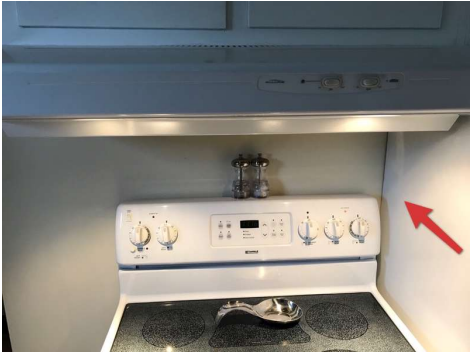
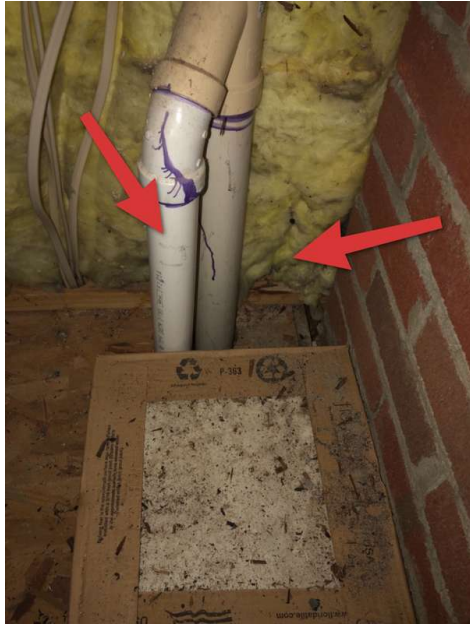
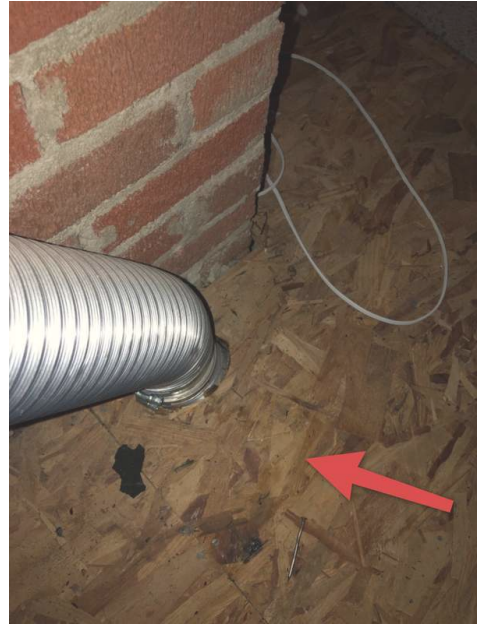
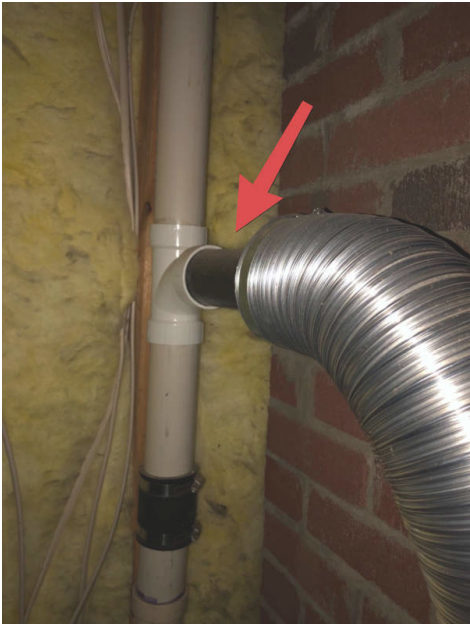
1ST FLOOR KITCHEN

15.11.1 Range Hood

VENTS TO OUTSIDE

The exhaust vent of the range hood discharged exhaust to the home exterior. However it is connected to the plumbing vent. These are separate systems and should not be connected. Inspector recommends licensed contractor to evaluate and correct. This could be a safety issue

Plumbing stack

Hood exhaust

Joining of the two

Contact a qualified professional.

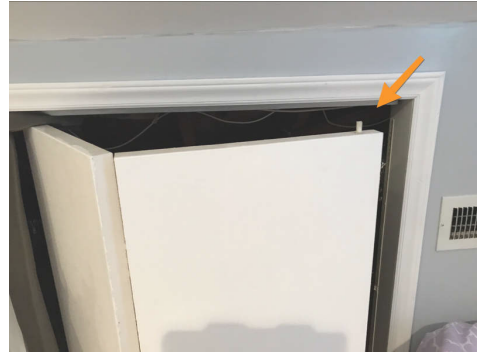
16.1.1 Attic Access

Doors to attic access are broken recommend repairing

Recommendation
Contact a qualified professional.
