SUMMARY

1234 Main St. Porter TX 773654687

Buyer Name
04/06/2019 9:00AM

Ralph Swan Jr.
INTERNACHI Certified Home...
Swan Home Inspections PLLC
(832) 517-6625
ralph@swanhomeinspections.com

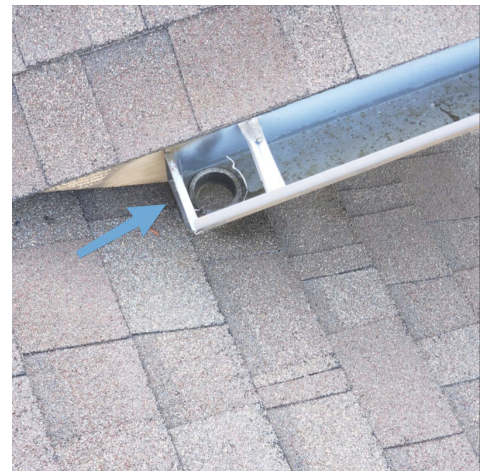
2.2.1 B. Grading and Drainage

GUTTER DISCHARGES TO ROOF

ROOF COVERING

One or more gutters around the home was found to be discharging directly to the roof surface. This condition should ideally be corrected to help prevent premature deterioration of the shingles in this area due to high water volumes. This is a common issue for new homes.

Contact a qualified gutter contractor

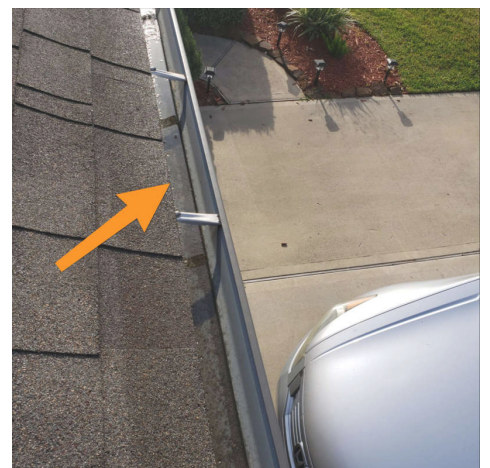
2.2.2 B. Grading and Drainage

GUTTER - SLOPE

SOUTH EXTERIOR

Gutters around the home appeared to be sloped incorrectly. This condition can result in excessively high moisture levels and decay. The Inspector recommends correction to help promote proper drainage.

Contact a qualified gutter contractor

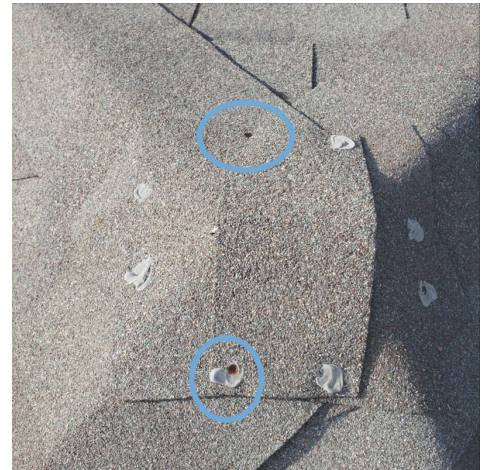
2.3.1 C. Roof Covering Materials

FASTENERS-EXPOSED

ROOF COVERING

Some areas of the roof had fasteners visible. Fasteners have been installed to secure shingles or flashings from being blown loose by wind. Exposed fasteners should be sealed periodically to prevent moisture intrusion into the roof structure.

Contact a qualified professional.

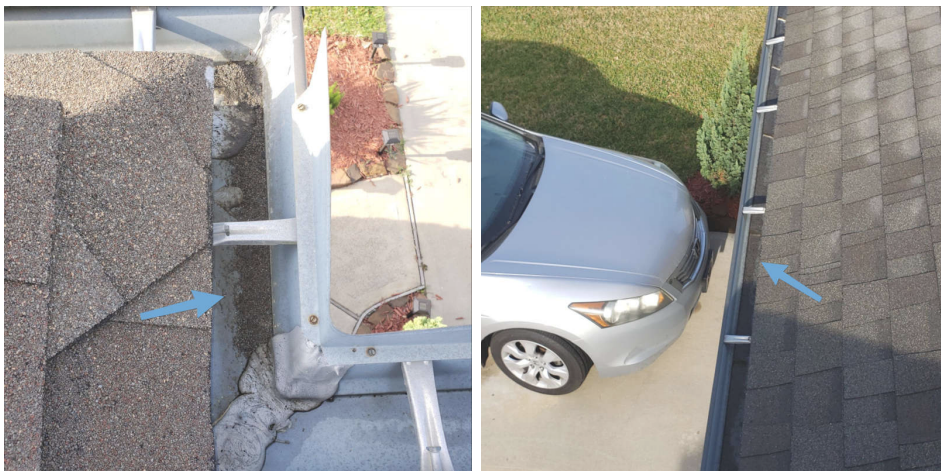
2.3.2 C. Roof Covering Materials

GRANULES IN GUTTER

GUTTERS

Granules from the asphalt shingles were accumulated in the gutters. This is not a defective condition, but is common and expected. However, the granules trap sediment which hardens and prevents fully functional drainage of the gutters and may hasten rust or corrosion. The Inspector recommends thorough cleaning to help prevent deterioration of the gutters.

Contact a qualified professional.

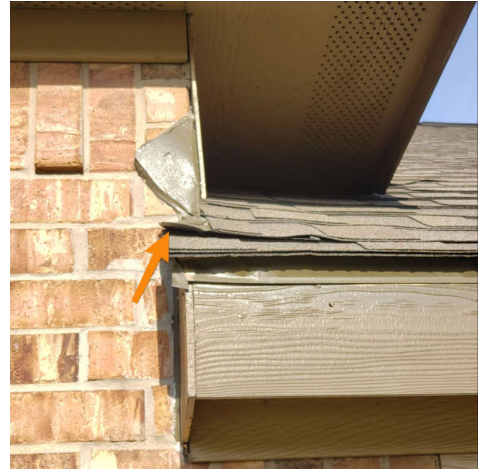
2.3.3 C. Roof Covering Materials

RAISED FLASHING

EAST EXTERIOR ROOF

Raised areas of flashing was observed. Raised flashing can allow wind driven rain access to the attic. Proper repair is recommended.

Contact a qualified roofing professional.

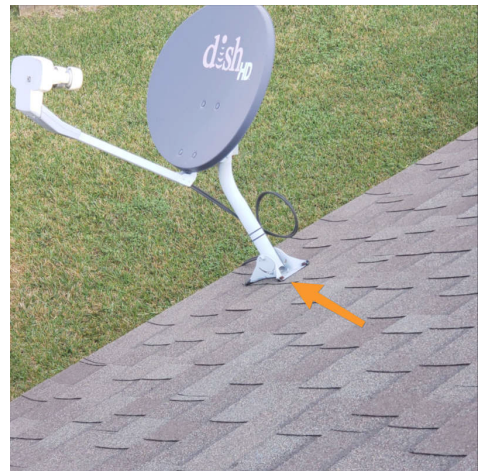
2.3.4 C. Roof Covering Materials

SATELLITE BOLTED THROUGH ROOF

WEST EXTERIOR ROOF

Satellite dishes bolted through the roof surfaces is not a recommended configuration. The penetrations should be properly sealed.

Contact a qualified professional.

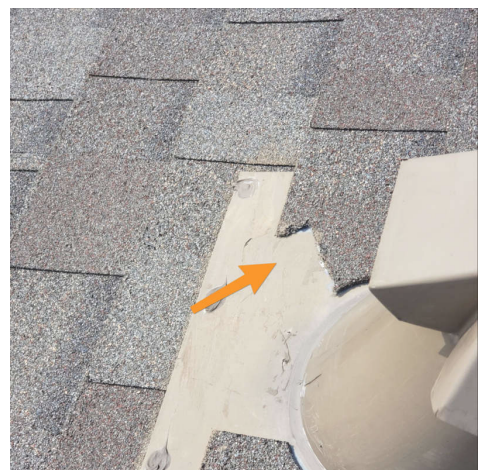
2.3.5 C. Roof Covering Materials

DAMAGED SHINGLES

EAST EXTERIOR

Damage to areas of the shingles were observed. Damaged areas and/or shingles should be repaired or replaced.

Contact a qualified roofing professional.

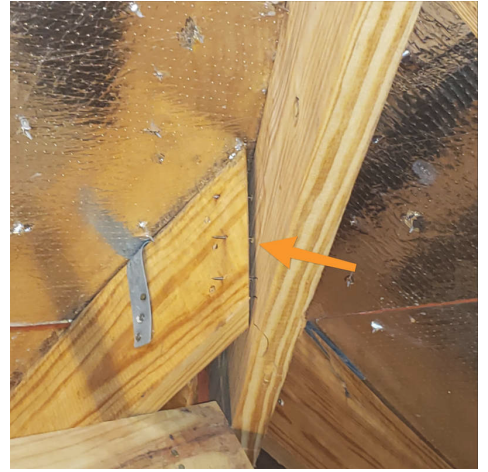
2.4.1 D. Roof Structures and Attics

RAFTERS - POOR TOP CUTS

ATTIC

Plumb cuts where rafters connected to the ridge were badly cut. This condition can reduce the strength of these connections. While this condition is improper, it should not warrant roof replacement at this time.

Contact a qualified professional.

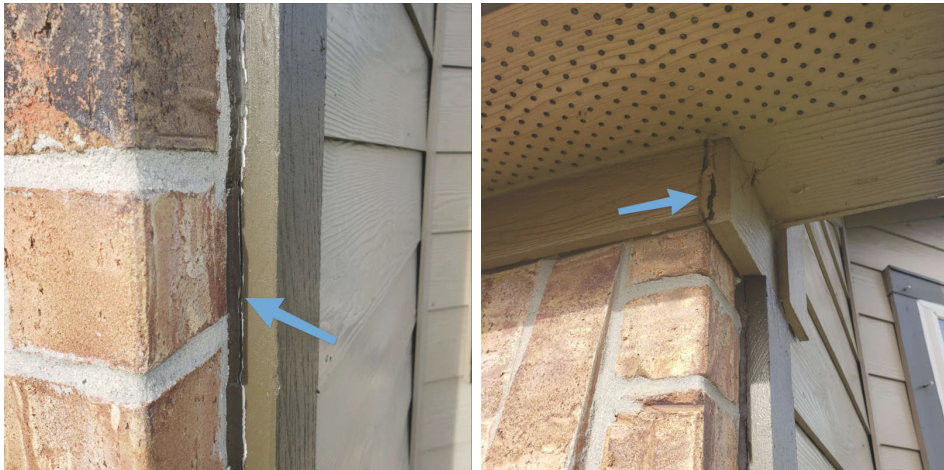
2.5.1 E. Walls (Interior and Exterior)

GAPS NEED SEALANT

VARIOUS LOCATIONS

The home had visible gaps or holes in areas of the siding covering exterior walls. The Inspector recommends application of an appropriate sealant at these areas to help prevent damage from moisture intrusion to the home materials, the exterior wall structure and to prevent development of microbial growth such as mold.

Contact a qualified professional.

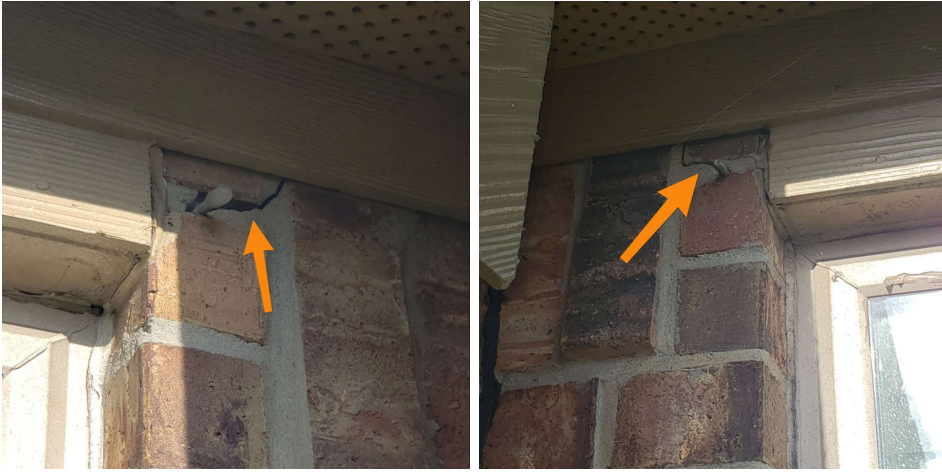
2.5.2 E. Walls (Interior and Exterior)

MORTAR DETERIORATION

EAST EXTERIOR WALL

Brick exterior walls had areas of mortar joint deterioration. These areas should ideally be re-pointed to help prevent continued deterioration. You should consult with a qualified masonry contractor before the expiration of your Inspection Objection Deadline to determine options and costs.

Contact a qualified masonry professional.

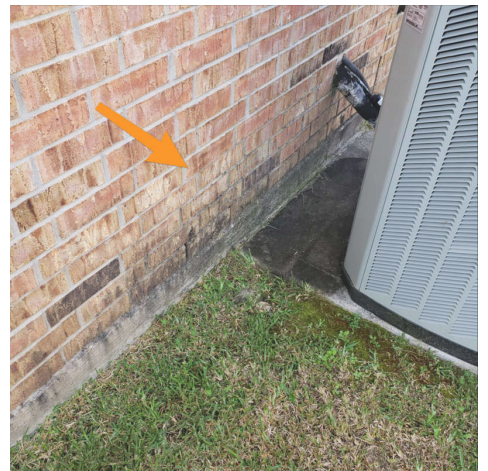
2.5.3 E. Walls (Interior and Exterior)

ROOF RUNOFF STAINS

WEST EXTERIOR WALL

Stains were observed on areas of the exterior walls. These stains appeared to be where moisture is discharging from the roof down the exterior walls. We recommend the areas be cleaned and that improvements be undertaken to promote moisture away from the walls/structure.

Contact a qualified professional.

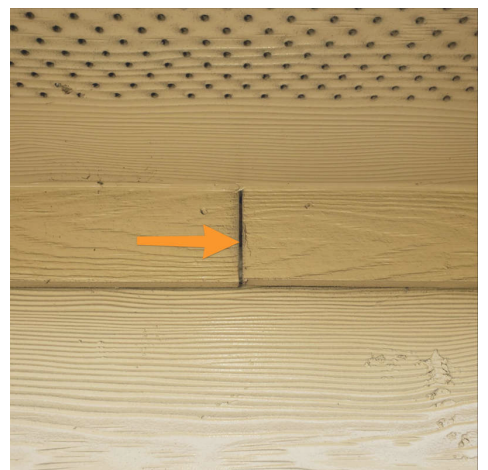
2.5.4 E. Walls (Interior and Exterior)

SIDING CAULKING

VARIOUS LOCATIONS

Cracking, deteriorated, and/or missing sealant was observed around exterior wall connection joints. It is recommended all joints be properly sealed to prevent moisture intrusion.

Contact a qualified professional.

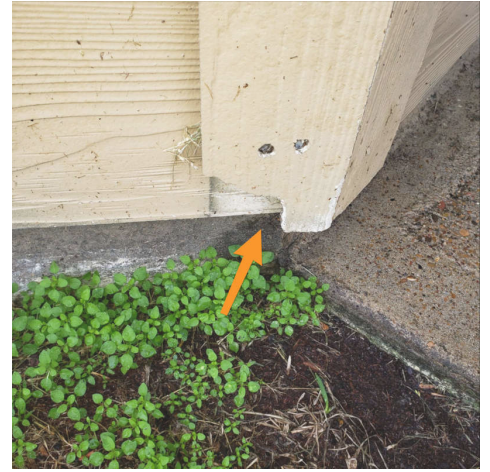
2.5.5 E. Walls (Interior and Exterior)

SIDING DAMAGED

NORTH EXTERIOR WALL

Areas of the exterior siding/trim were observed to be damaged. We recommend these sections of siding/trim be repaired or replaced.

Recommendation
Contact a qualified siding specialist.

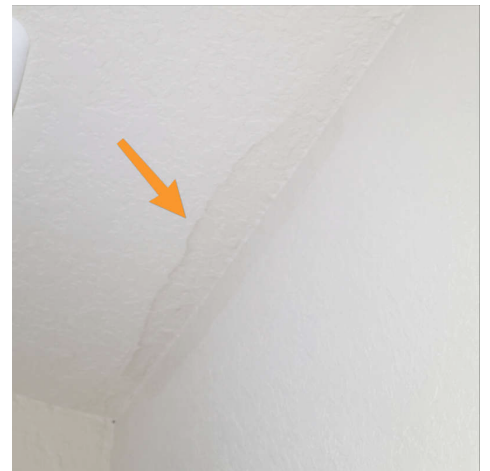
2.5.6 E. Walls (Interior and Exterior)

MOISTURE STAINS

MASTER BATHROOM

What appeared to be a moisture stain was observed on the interior wall in the laundry room. A thermal imaging scan and moisture meter determine that the leak was not active. Further investigation into this issue may be necessary.

Recommendation
Contact a qualified professional.

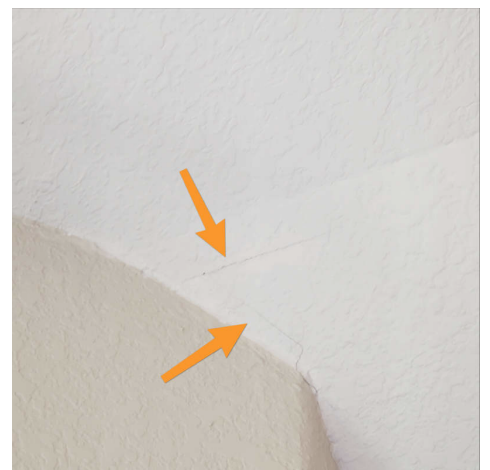
2.6.1 F. Ceilings and Floors

GAMBRELL CEILING DEFICIENCIES

HALLWAY IN FRONT OF MASTER, VARIOUS LOCATIONS

Gambrell ceilings are present within the home. It is typical that these ceiling structures will, as the home settles and "racks" or moves with high winds, develop cracks and nail pops at the corner area which intersects with the vertical wall surface below. The cause is generally accepted that the Sheetrock is attach to the rafters and as the roof flexes, the Sheetrock moves as well. This will cause the cosmetic issues mentioned earlier.

Recommendation
Contact a qualified professional.

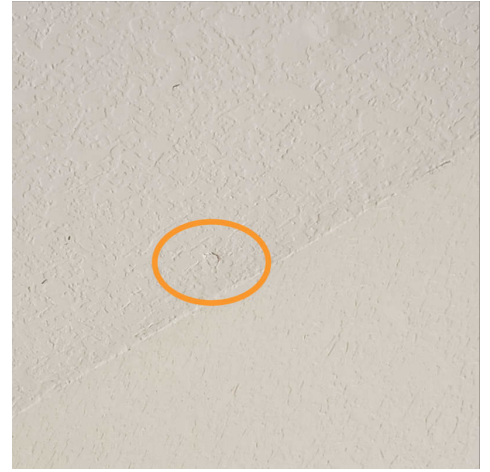
2.6.2 F. Ceilings and Floors

NAIL POP

DINING ROOM, VARIOUS LOCATIONS

Nail pops were observed on the interior ceilings. Cosmetic improvements are recommended.

Recommendation
Contact a qualified professional.

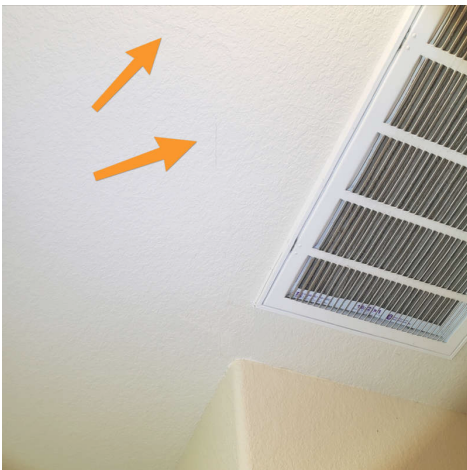
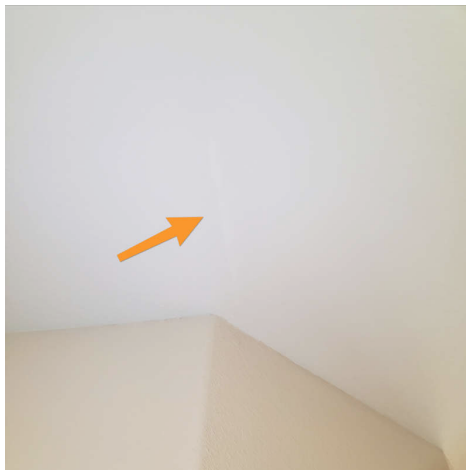
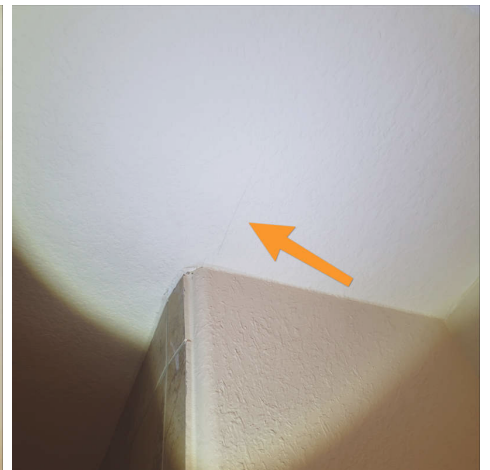
2.6.3 F. Ceilings and Floors

TYPICAL CEILING CRACKS

HALLWAY IN FRONT OF MASTER BEDROOM, KITCHEN, BATHROOM #1

Interior ceiling cracks were observed on the interior ceilings of the structure. In my opinion, the ceiling cracks appeared to be typical for a home of this age. This can imply some structural movement of the structure has occurred, as is typical of most houses. We recommend the cracks be monitored.

Recommendation
Recommend monitoring.

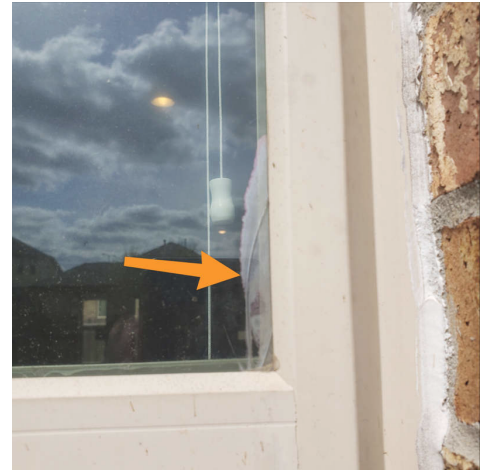
2.8.1 H. Windows

CRACKED OR BROKEN PANE

LEFT DINING ROOM WINDOW

One or more windows in the home had a cracked or broken pane.

Contact a qualified window repair/installation contractor.

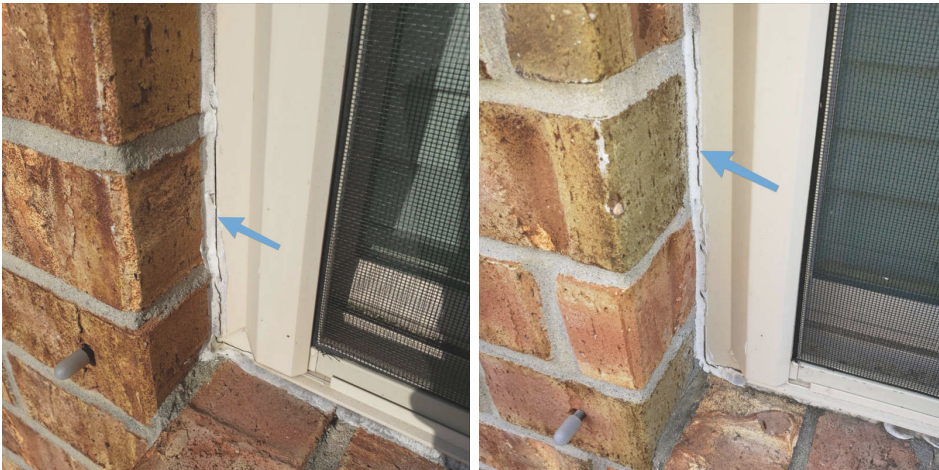
2.8.2 H. Windows

WINDOW CAULK

VARIOUS LOCATIONS

Cracking, deteriorated, and/or missing caulking/sealant was noted around the interior/exterior of windows. Repair/replacement of the caulking/sealant is recommended.

Contact a qualified professional.

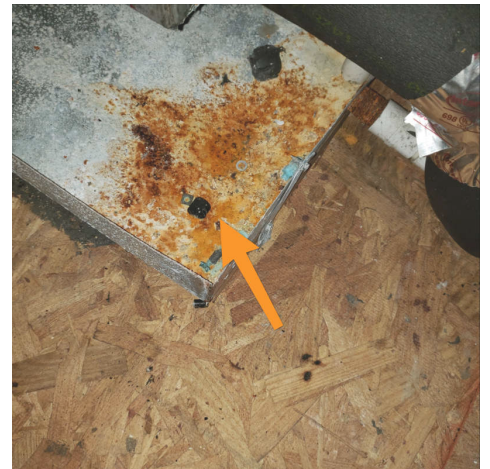
4.2.1 B. Cooling Equipment

RUSTED DRAIN PAN

BENEATH AIR HANDLER IN ATTIC

The drain pan is rusted and may fail prematurely. This should ideally be corrected to help prevent water intrusion into the wall/ceiling structure.

Recommendation
Contact a qualified professional.

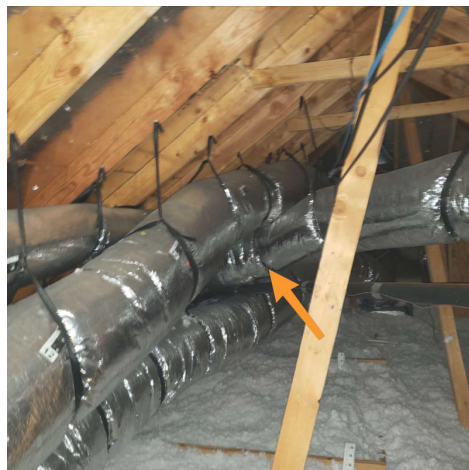
4.3.2 C. Duct Systems, Chases and Vents

DUCTS TOUCHING

VARIOUS LOCATIONS IN ATTIC

Various supply/return ducts were observed to be in contact with each other. Condensation can develop between contacted areas of the duct work. Separation of contacted ducts is recommended.

Contact a qualified professional.

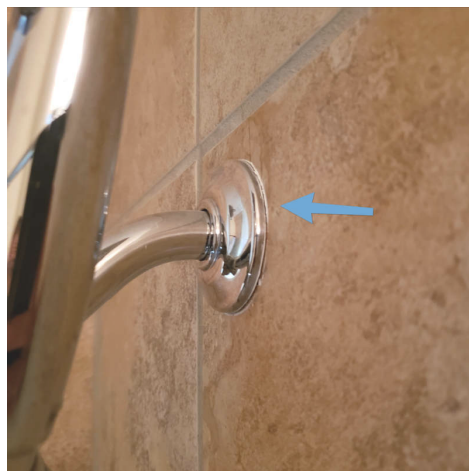
5.1.1 A. Plumbing Supply, Distribution System and Fixtures

DETERIORATED CAULKING

BATHROOMS

Cracking, deteriorated, and/or missing shower caulk should be replaced.

Recommended DIY Project

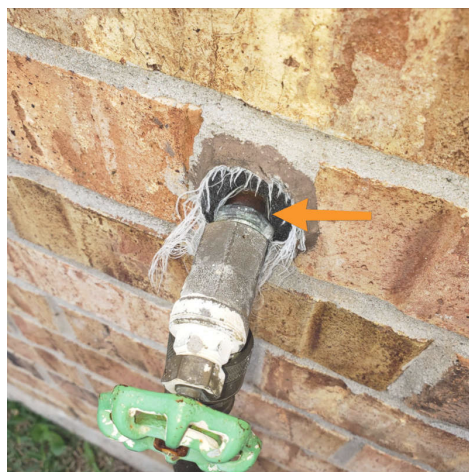
5.1.2 A. Plumbing Supply, Distribution System and Fixtures

HOSE BIBS MISSING INSULATION

WEST EXTERIOR WALL

One or more hose bibs were observed to be missing insulation.

Contact a qualified professional.

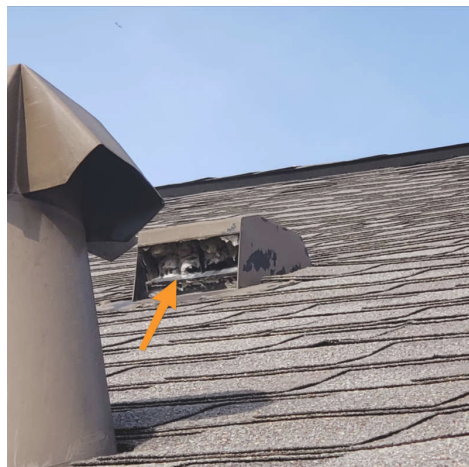
6.8.1 H. Dryer Exhaust System

VENT DIRTY

ROOF

The dryer vent was observed to have lint/be dirty. Recommend having the vent clean by a qualified professional.

Recommendation
Contact a qualified professional.
