SUMMARY
1234 Main St. Melissa TX 75454
Buyer Name
12/11/2018 9:00AM

Chris Scanland
Professional Inspector TREC# 23176
Savior Inspection Services, LLC
469-678-9011
chris@saviorinspections.com

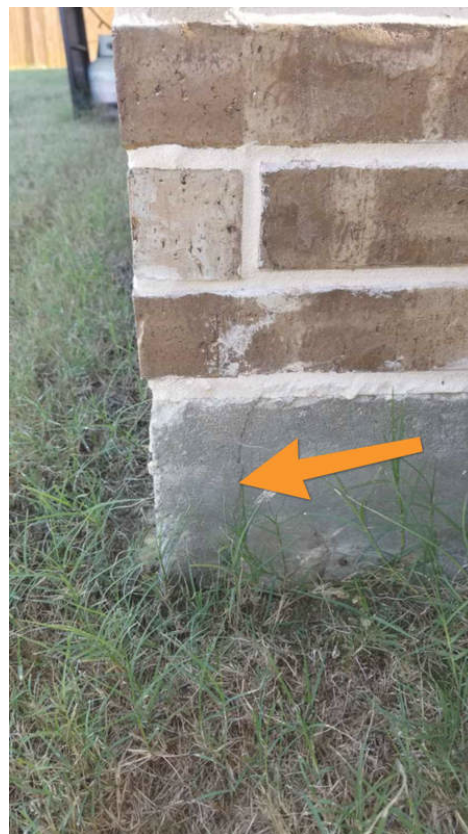
Northwest

2.1.1 A. Foundations

CORNER POP

One or more corners of the foundation had cracking and/or damage. This is cosmetic in nature and does not effect the overall integrity of the foundation. However, the inspector recommends having corner pops repaired to prevent future damage to the brick siding.

Contact a qualified masonry professional.

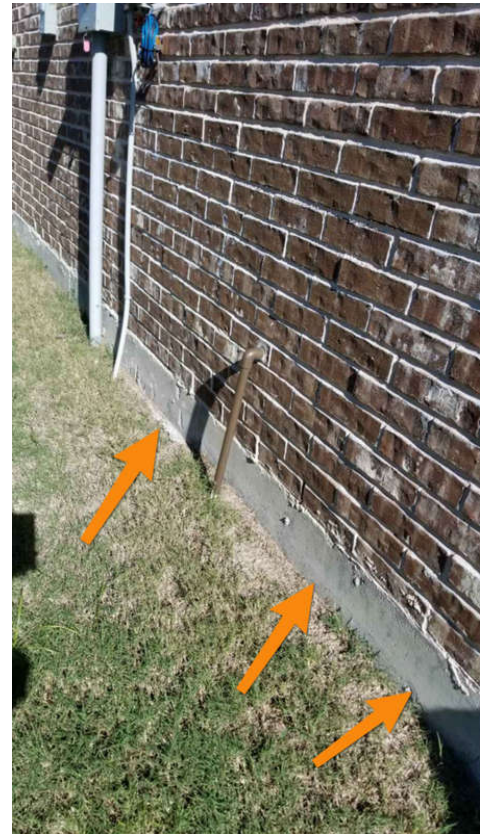
West

2.2.1 B. Grading and Drainage

LOW SOIL LEVEL

Low soil level on foundation. Recommend back-filling area to allow 4-6 inches of foundation to be visible above grading.

Contact a qualified professional.

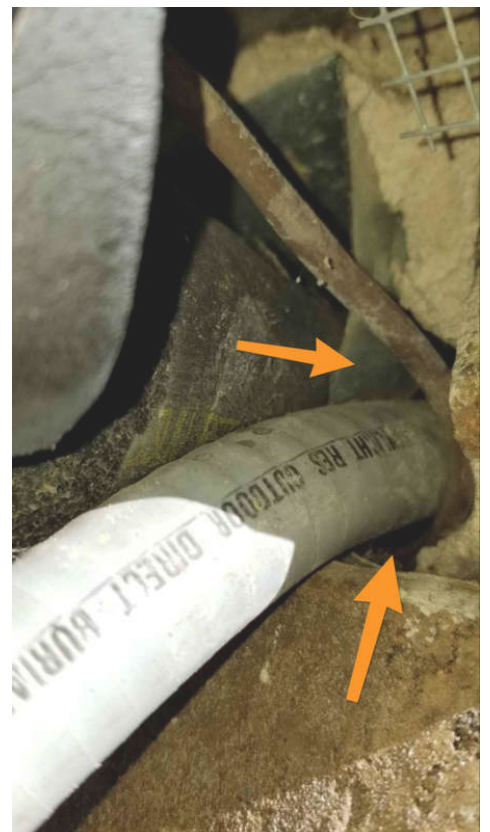
Air Conditioner Lines

SEAL EXTERIOR PENETRATIONS

Exterior wall penetrations had gaps that should to be sealed with an appropriate sealant to prevent moisture and insect entry.

Contact a qualified handyman.

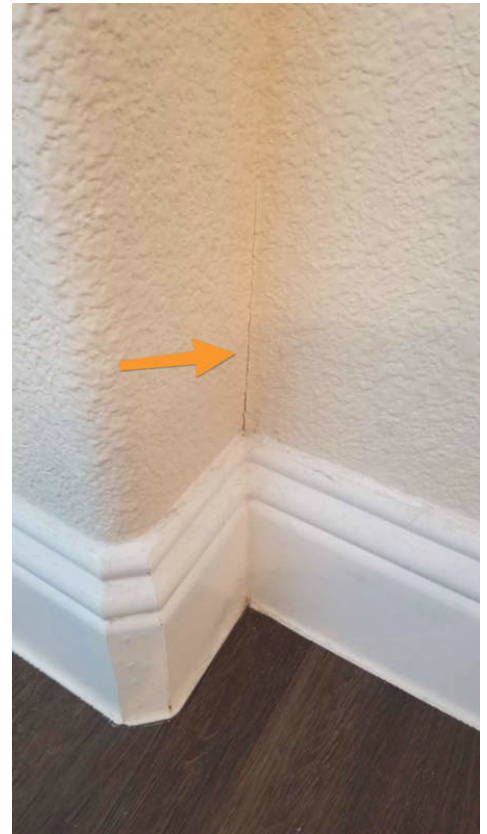
North

CRACKS - MINOR

Minor cracking was observed in drywall throughout the home. This is common and is cosmetic in nature.

Contact a qualified painter.

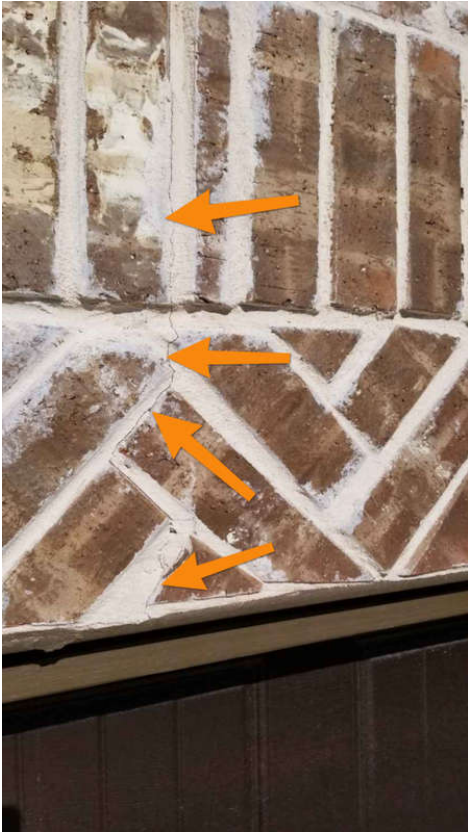
Above Garage

CRACKS IN BRICK AND MORTAR

At time of inspection, there were one or more minor cracks in brick and mortar. These appear to be mostly cosmetic in nature, however, should be repaired to prevent moisture intrusion and further damage.

Contact a qualified masonry professional.

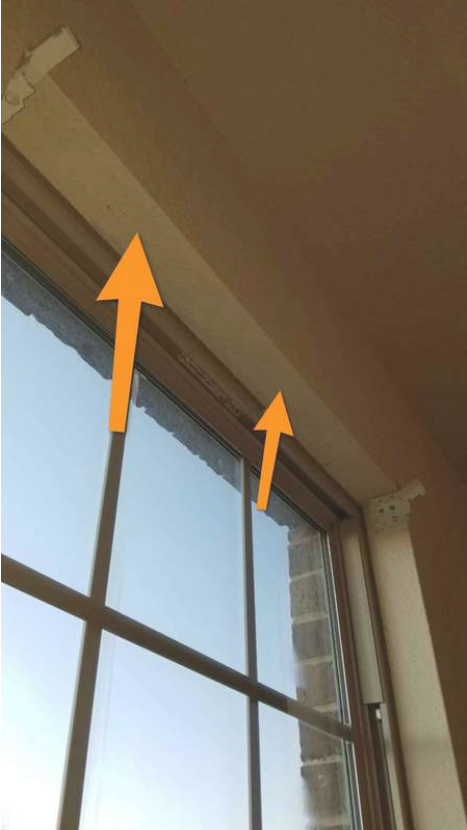
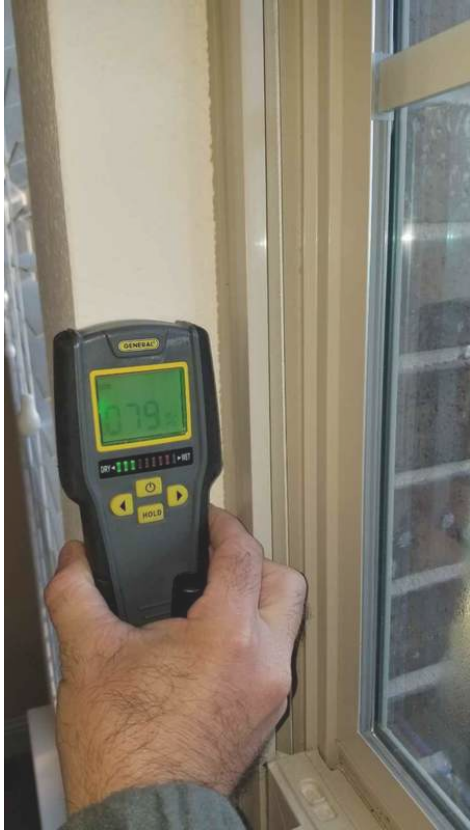
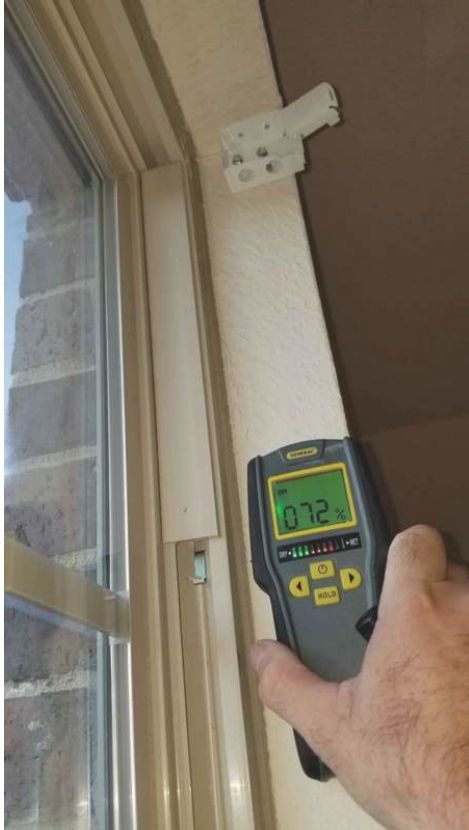
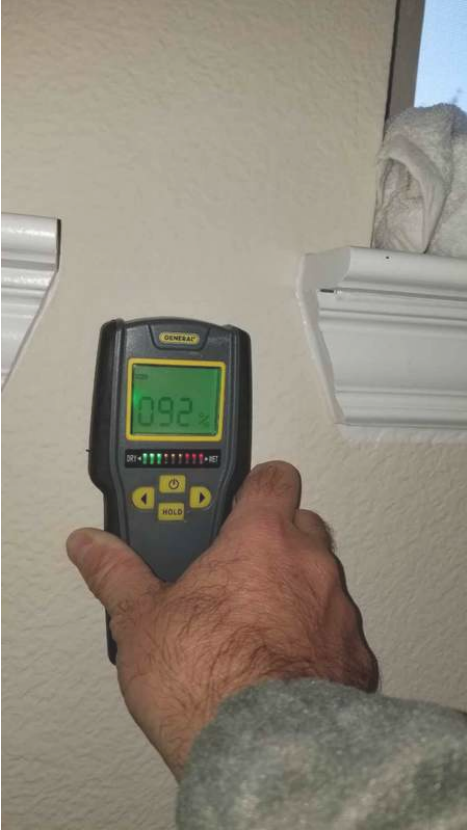
1st Floor South Bedroom

2.5.4 E. Walls (Interior and Exterior)
MOISTURE DAMAGE- ACTIVE LEAK
MULTIPLE LOCATIONS

A stain on the wall was visible at the time of the inspection and appeared to be the result of moisture intrusion. The moisture meter showed elevated moisture levels in the affected areas at the time of the inspection, indicating that the leakage has been recent.

Recommendation
Contact a qualified professional.

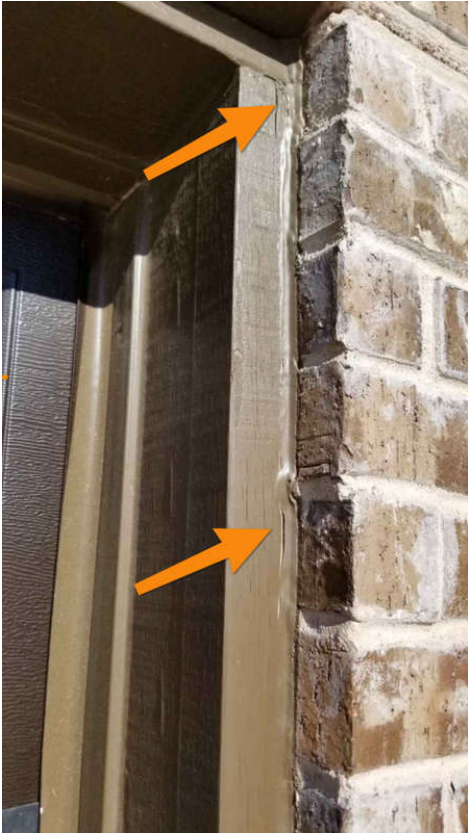
Right Side Garage Door

TRIM CAULKING

One or more locations need caulking replaced around trim/molding to prevent moisture and/or pest intrusion.

Contact a handyman or DIY project

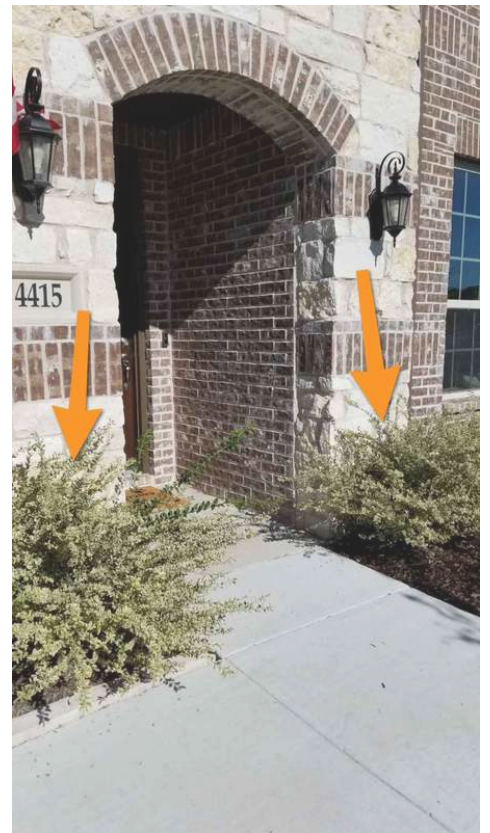
Front Porch Area

VEGETATION/STRUCTURE CONTACT

Trees/shrubs in contact with exterior structure. Recommend trimming shrubs/trees away from structure to help prevent mechanical, moisture and pest damage.

Contact a qualified lawn care professional.

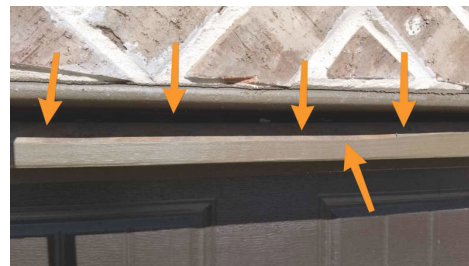
Above Garage

TRIM BOARDS NEED REPLACING

Overhead board above the garage door has a large gap above it. It appears as though the board was installed that way when the home was built.

Contact a qualified carpenter.

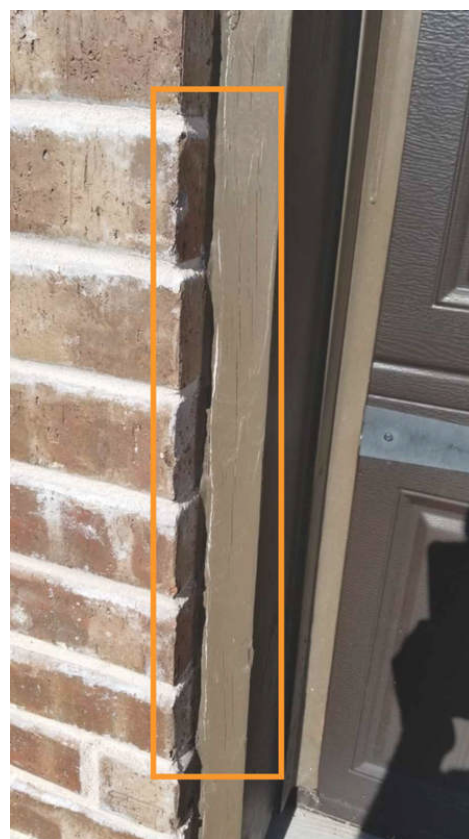
Garage Trim

TRIM NEEDS PAINT

Garage door trim needs touch-up paint where cracks are present. This will help prevent moisture intrusion and significantly prolong the life of the boards.

Contact a handyman or DIY project

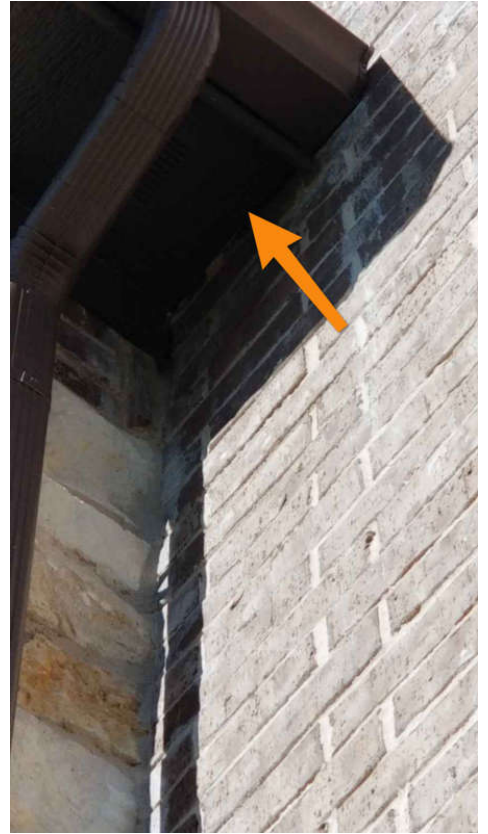
Front Roofline

MISSING FRIEZE BOARD

Missing small frieze board on the front of the home. It appears as though one was never installed.

Contact a qualified professional.

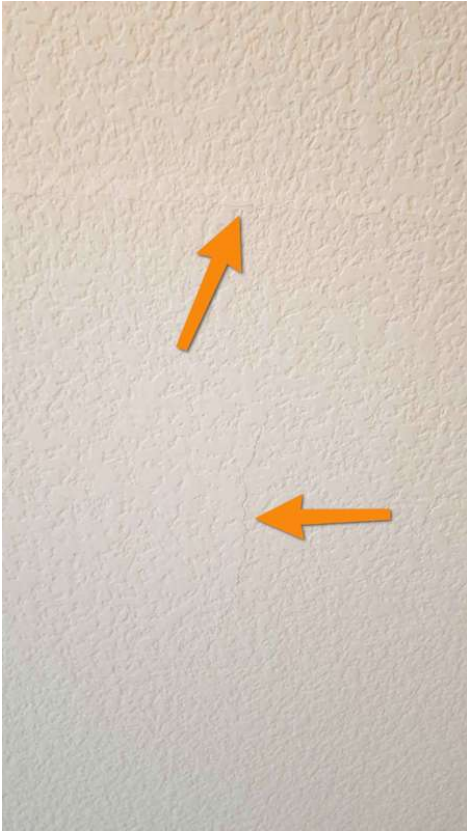
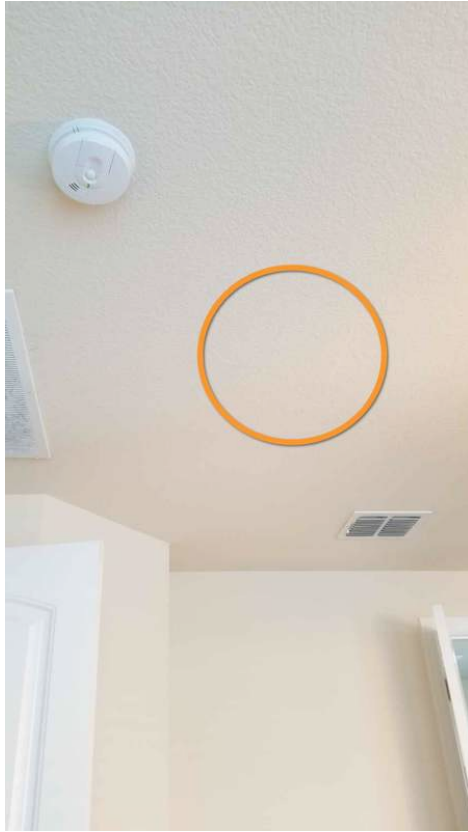
Master Bedroom

CEILING - MINOR DAMAGE

Minor damage/cracking to the ceiling was visible at the time of the inspection. This is possibly from stepping on the sheet rock, or dropping something on it, while walking in the attic.

Contact a qualified drywall contractor.

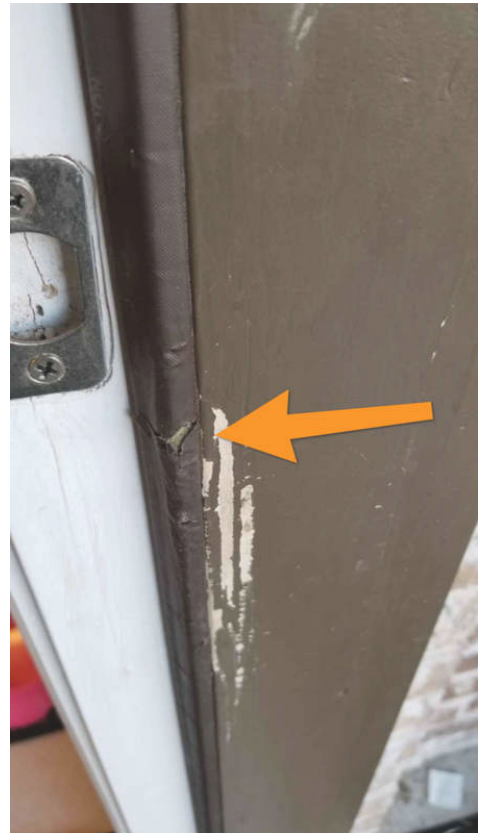
Back Door

WEATHERSTRIPPING/DOOR SWEEP INSUFFICIENT

One or more doors had deficient weatherstripping and/or door sweeps. This can result in significant energy loss and moisture/pest intrusion.

Contact a handyman or DIY project

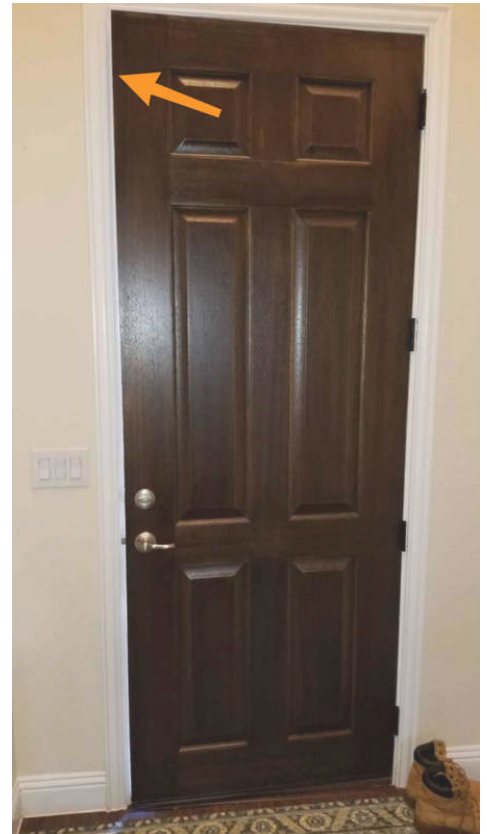
Front Door

DOOR IS BINDING

Door sticks and is tough to open and close.

Contact a handyman or DIY project

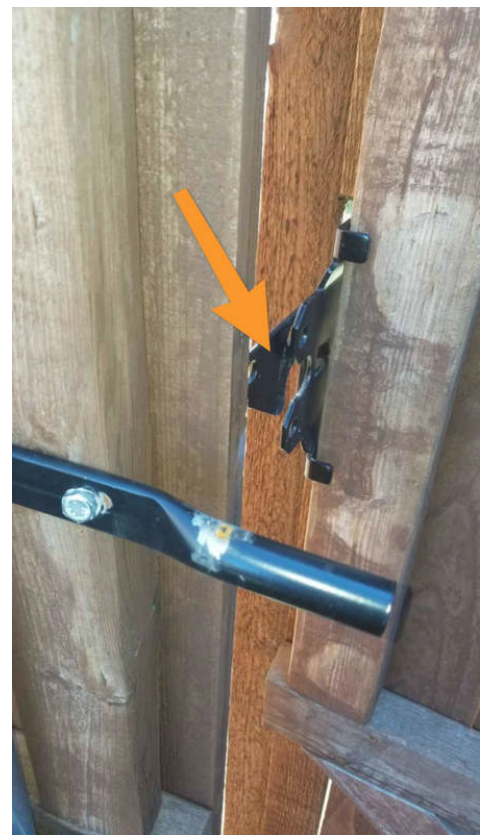
WEST

GATE LATCH

Gate does not latch properly without manipulating it.

Contact a handyman or DIY project

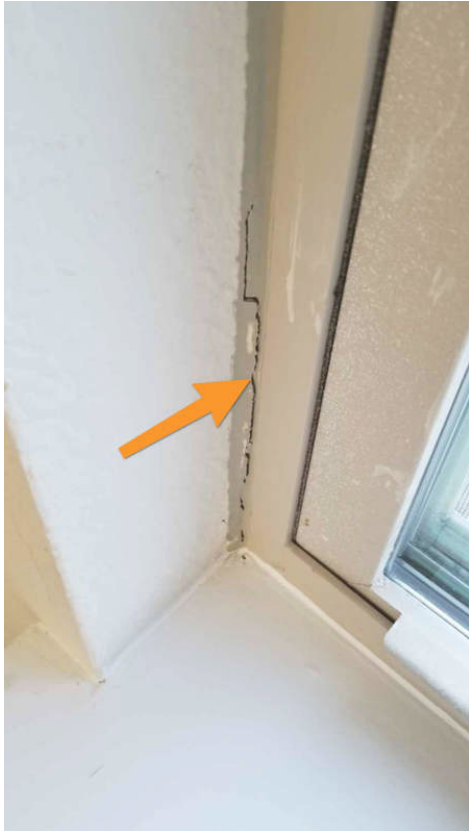
1st Floor South Bedroom

CAULKING

One or more windows need new caulking to prevent moisture intrusion. This applies to both the inside and outside. Some examples are listed below.

Contact a handyman or DIY project

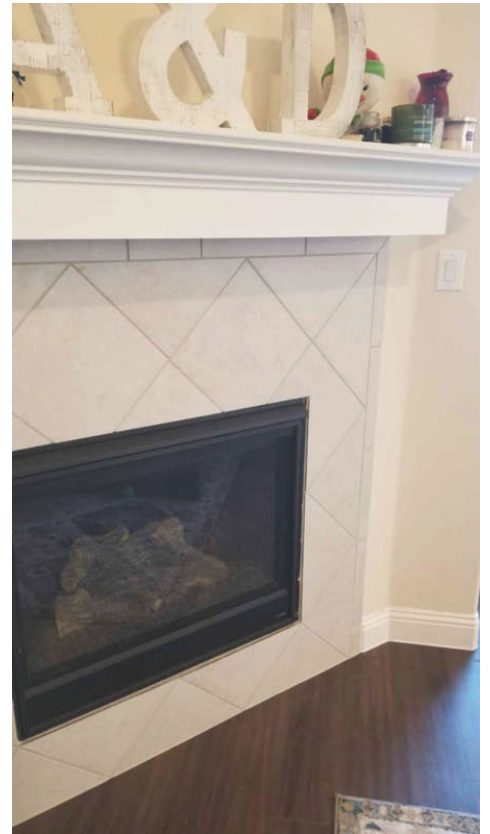
LIVING ROOM

WOULD NOT LIGHT

At time of inspection, the gas fireplace would not light.

Contact a qualified fireplace contractor.

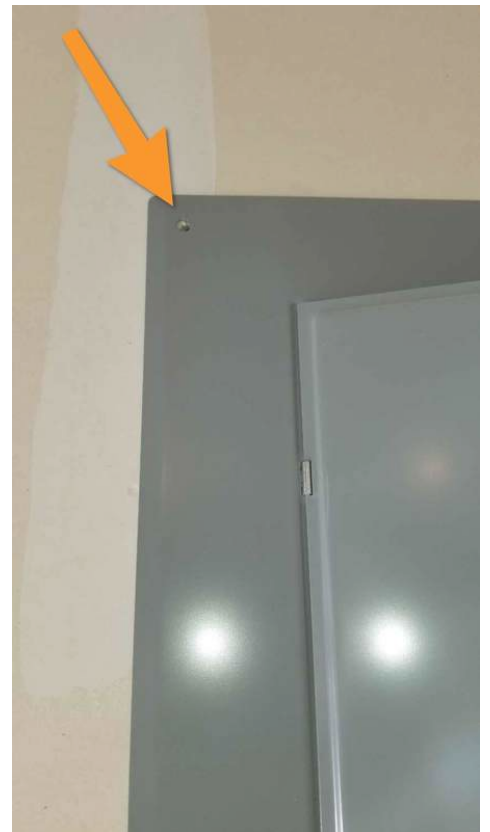
GARAGE

PANEL MISSING SCREWS

One screw is missing on panel.

Contact a qualified electrical contractor.

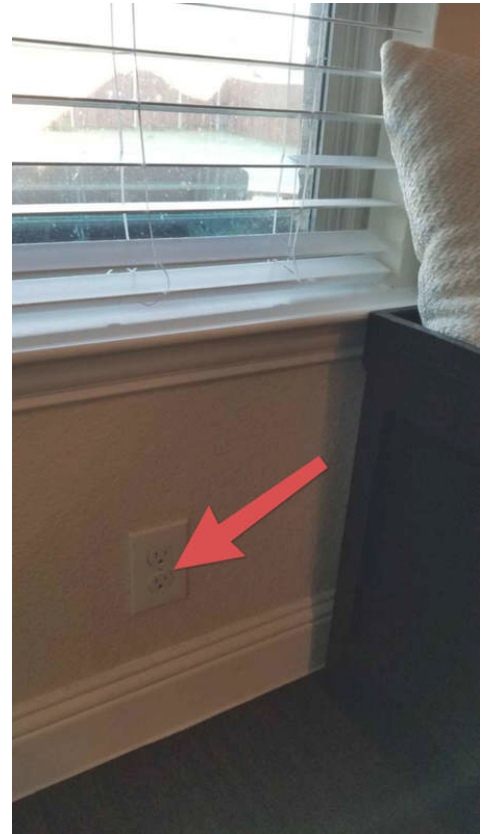
North

LOOSE OUTLET

One or more electrical receptacles in the home were improperly secured and moved when plugs were inserted. Receptacles should be securely installed to prevent fire, shock and/or electrocution hazard.

Contact a qualified electrical contractor.

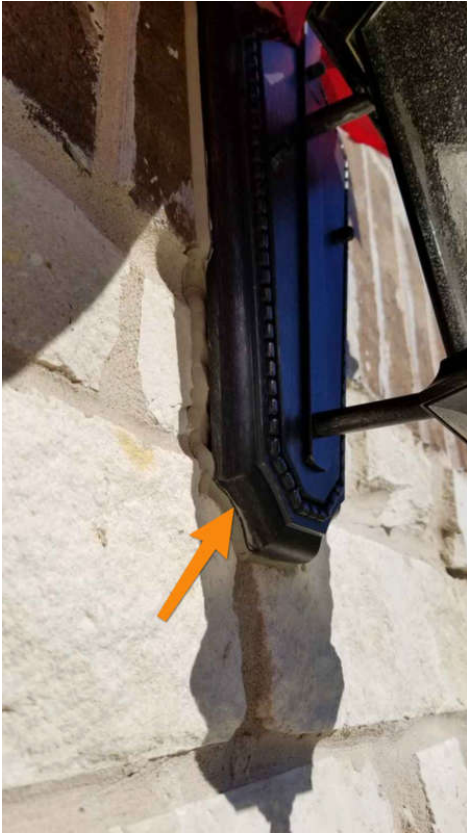
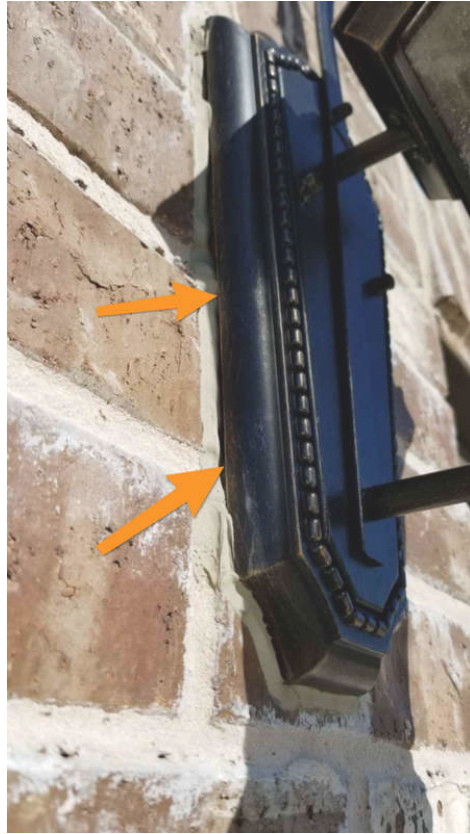
South

EXTERIOR LIGHT NOT SEALED

One or more exterior lights need to be sealed with caulk to prevent moisture intrusion.

Contact a handyman or DIY project

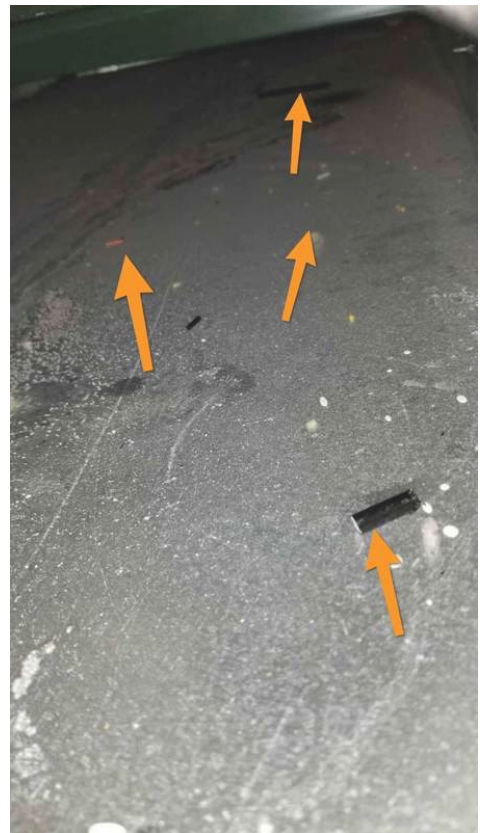
Attic

DRIP PAN DEBRIS

Secondary drip pan contains debris which can clog the drain line. If drain gets clogged it can result in overflowing the pan which will cause moisture damage to surrounding area. Recommend cleaning drip pan.

Recommended DIY Project

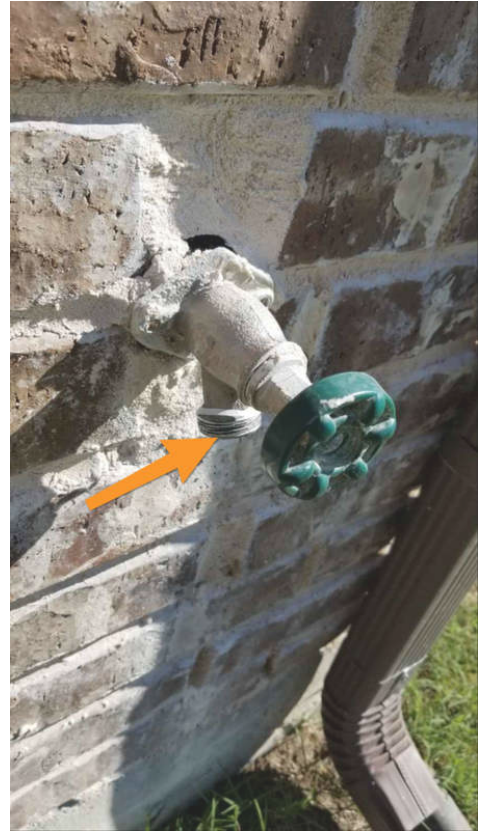
Southwest

MISSING BACKFLOW DEVICE

Back-flow device not installed on exterior spigot. Recommend installing back-flow device to prevent cross contamination of the potable water supply system.

Contact a qualified plumbing contractor.

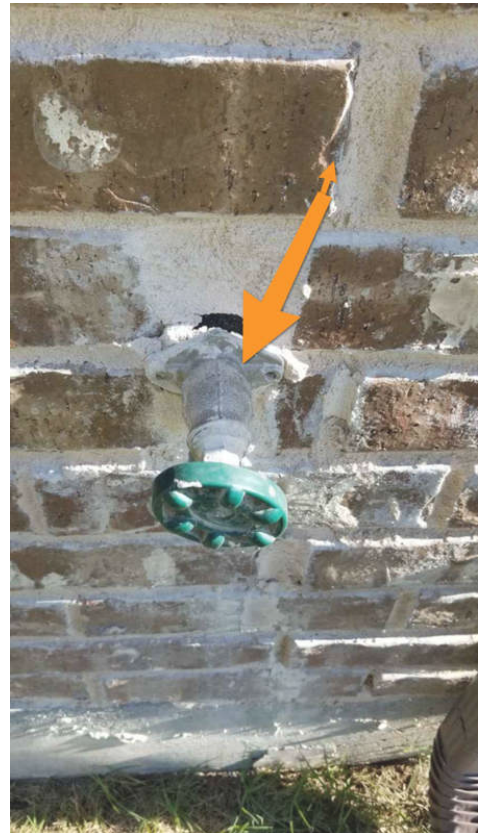
South

HOSE BIB NOT SECURED

Recommend securing both hose bibs so they do not move. Any movement of these also cause the pipe in the wall to move. Over time, this can cause the pipes to leak.

Contact a qualified professional.

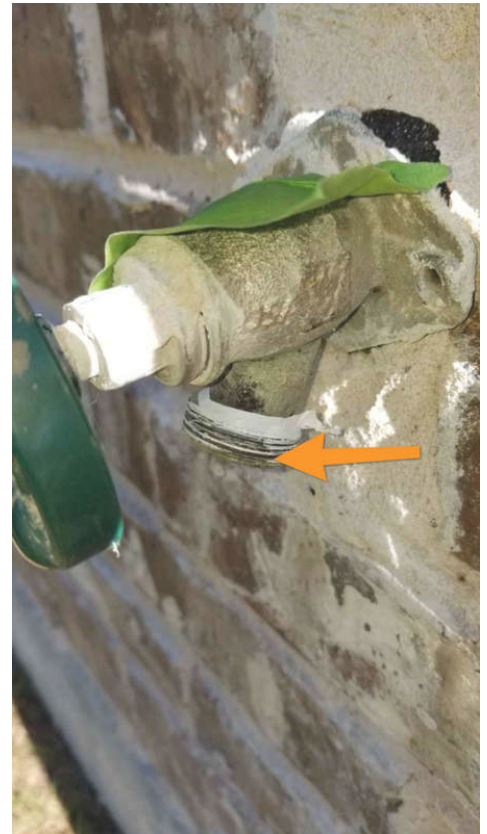
South

HOSE BIB THREADS STRIPPED

Stripped threads were found on hose bib.

Contact a qualified plumbing contractor.

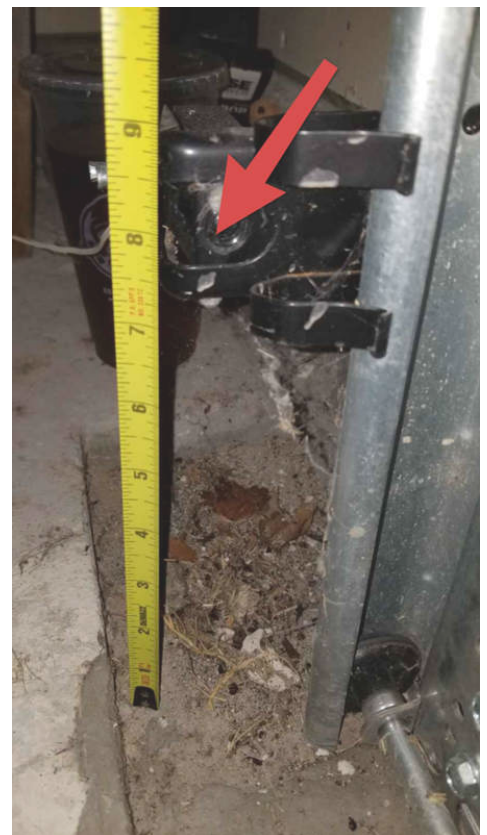
SENSORS TOO HIGH

Garage door sensors are too high. Should be 6 inches from the deck to prevent children from being able to get under the sensors. Recommend moving sensors down to 6 inches above the deck.

Contact a qualified professional.
