## SUMMARY

1234 Main St.Chattanooga TN 37421

Buyer Name  
07/01/2018 9:00AM

Jared Potts  
InterNACHI Certified Inspector  
Potts Home Inspections, LLC  
(423) 708-5755  
jaredphilippotts@gmail.com

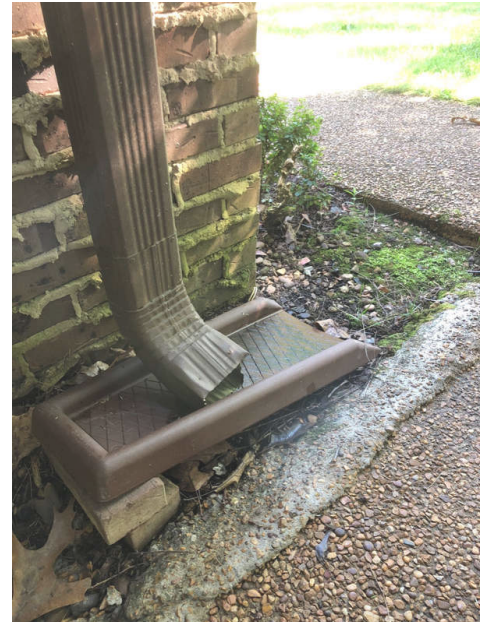
#### DOWNSPOUTS DRAIN NEAR HOUSE

One or more downspouts drain too close to the home's foundation. This can result in excessive moisture in the soil at the foundation, which can lead to foundation/structural movement.

Recommend a qualified contractor adjust downspout extensions to drain at least 6 feet from the foundation.

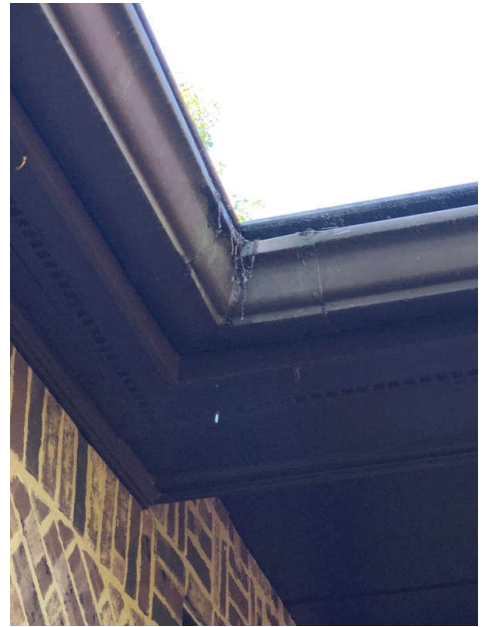
#### GUTTER DAMAGED

Gutters were damaged. This can result in excessive moisture in the soil at the foundation, which can lead to foundation/structural movement. Recommend a qualified contractor evaluate and repair.

Recommendation  
Contact a qualified roofing professional.

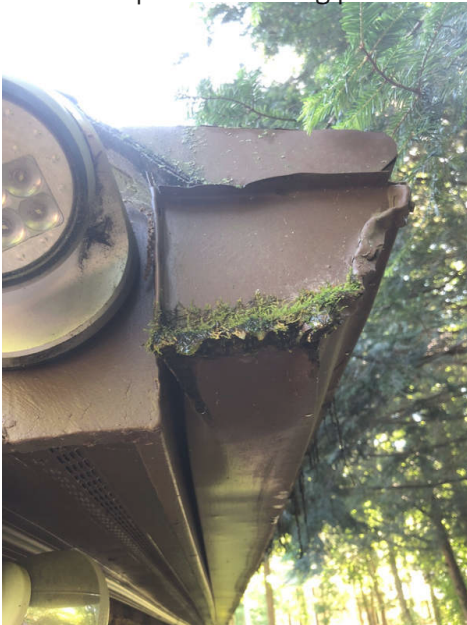
Gutters were observed to be leaking in one or more areas. This can result in excessive moisture in the soil at the foundation, which can lead to foundation/structural movement. Recommend a qualified contractor evaluate and repair gutters to proper functionality.

Moss Growing In Leak

Contact a qualified roofing professional.

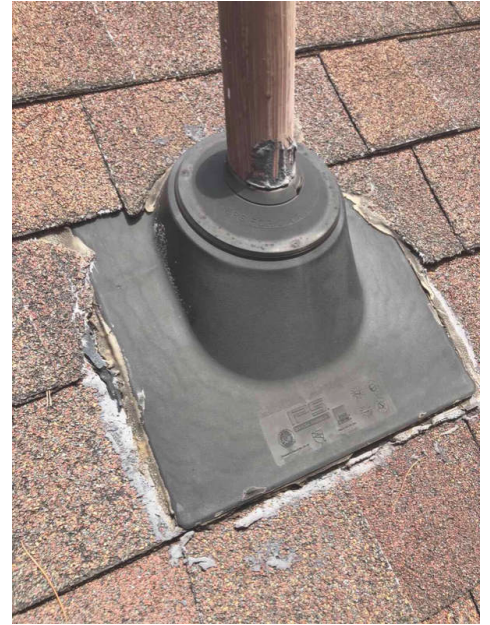
Back

### PLUMBING VENT BOOT

Plumbing boot shows signs of wear and age. Recommend that you monitor and be advised from roofing contractor on best way to waterproof and fix.

Recommendation  
Contact a qualified professional.

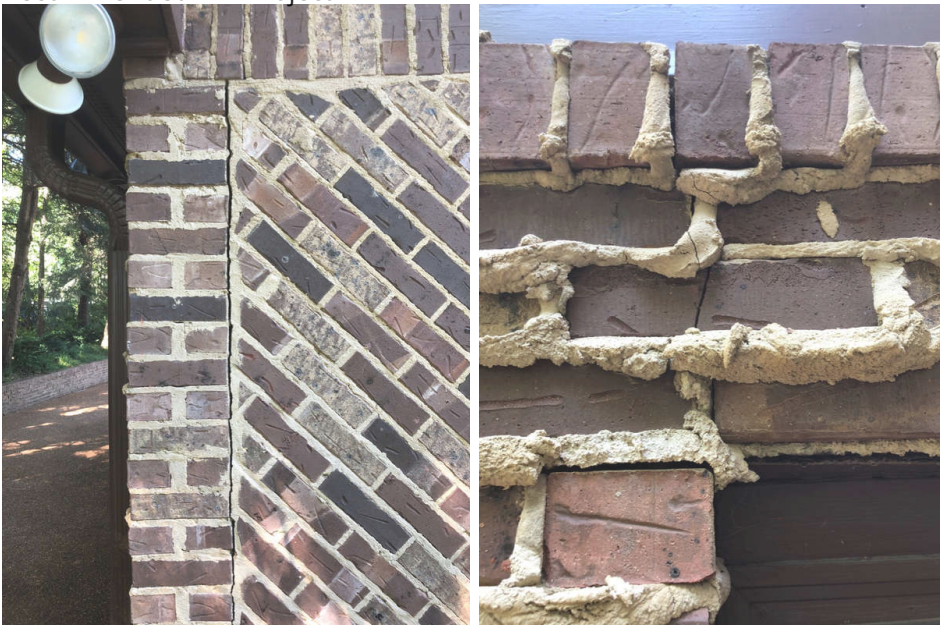
Back Door

Siding showed minor cracking in one or more places. Minor cracks / holes (14 or less) were present in siding. These should be sealed to prevent water infiltration. This is a result of soil changes, differential settlement and temperature changes, and are typical in homes of this age. Recommend periodic monitoring and evaluation.

Recommendation  
Recommended DIY Project

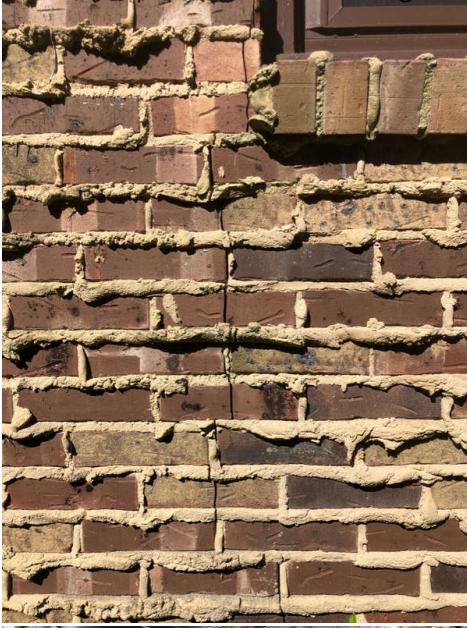
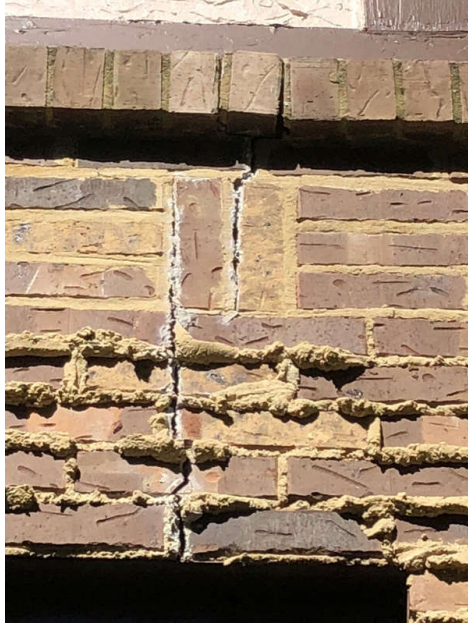
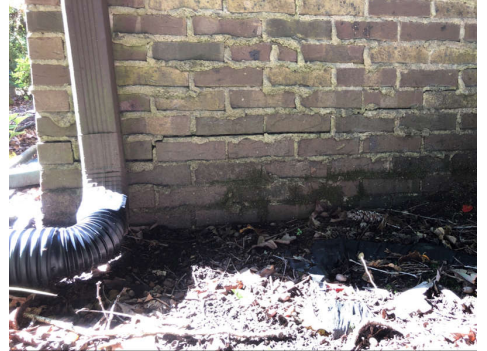
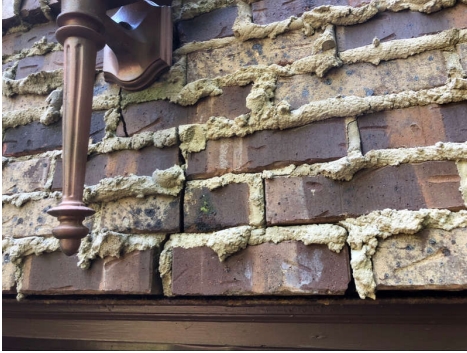
Moderate to major cracking was observed at one or more points on the exterior. Moderate cracks (14" to 34") were present in exterior siding. These may be a structural concern and deem further inspection.

*Recommend an evaluation by a qualified geotechnical and/or structural engineer to evaluate this property to determine the likelihood of future settlement and/or soil movement, and to determine the integrity of the structure.*

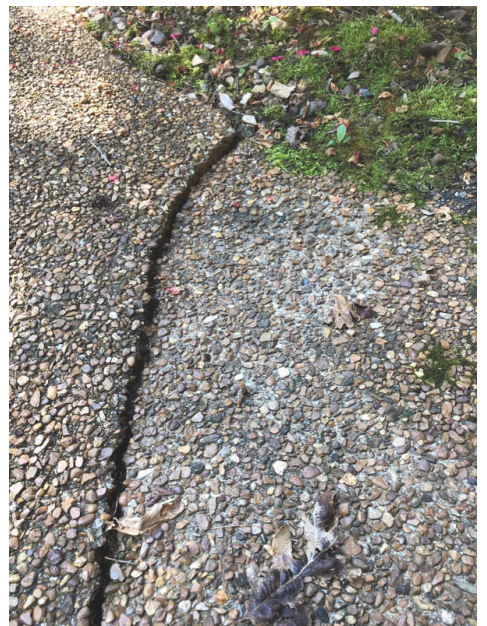
Moderate to major cracking was observed at one or more points on the exterior. Measured at 34 or more Major cracks/holes (more than 34 wide) present in the siding. This can be the result of poor original compaction of soil at the time of construction or excess moisture in the underlying soil.

*Recommend an evaluation by a qualified geotechnical and/or structural engineer to evaluate this property to determine the likelihood of future settlement and/or soil movement, and to determine the integrity of the structure.*

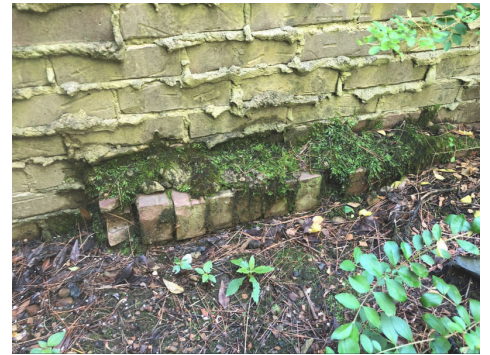
There are signs of algae and/or mildew on the siding. This is a cosmetic issue and is not uncommon especially on shaded portions of the home. Recommend that said areas be washed or cleaned on a regular basis.

Recommendation  
Contact a qualified professional.

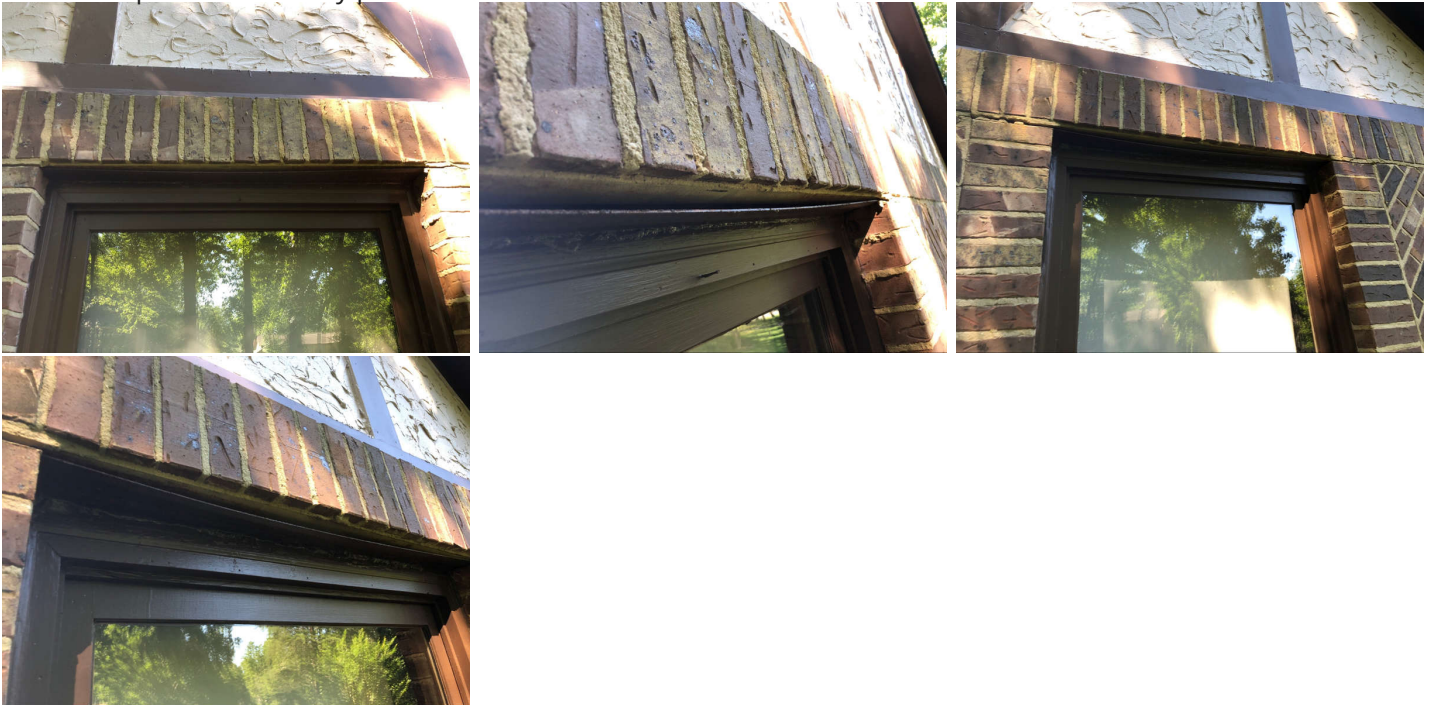
Lintels above some of the front windows are undersized and have bowed. *Recommend contacting Masonry Contractor to evaluate and repair.*

Recommendation  
Contact a qualified masonry professional.

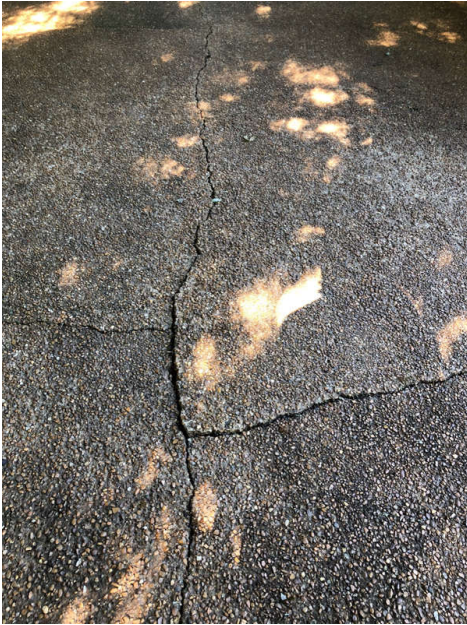
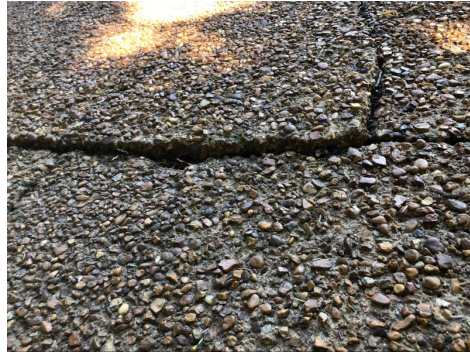
Trip hazard was noted in the walkway. Rear brick walkway shows signs of settling with soil movement. Recommend contractor to level and grade properly so water dispersed away from the house.

Recommendation  
Contact a qualified professional.

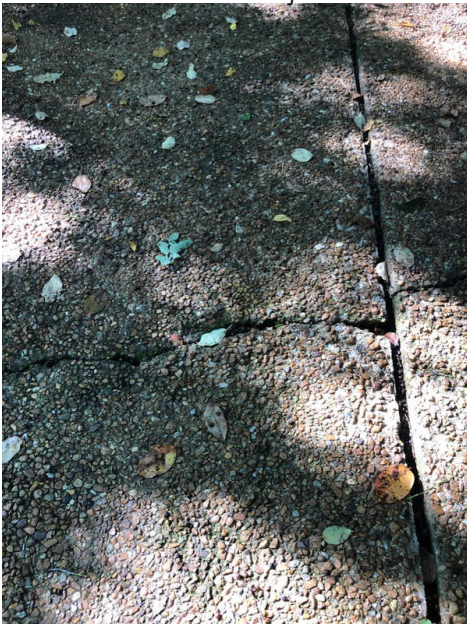
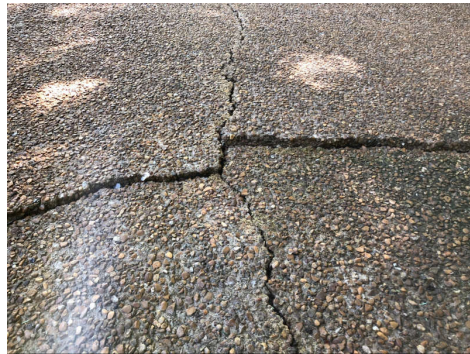
Minor cosmetic cracks observed. Cracks of this type are typical of the area and can be a minor trip hazard. Recommend monitor and/or patch/seal.

Recommended DIY Project

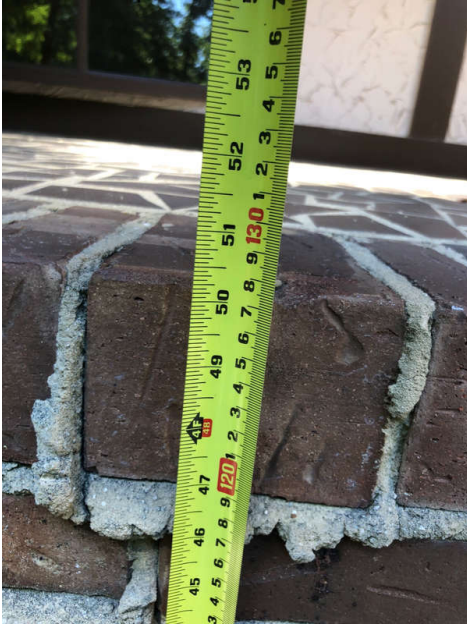
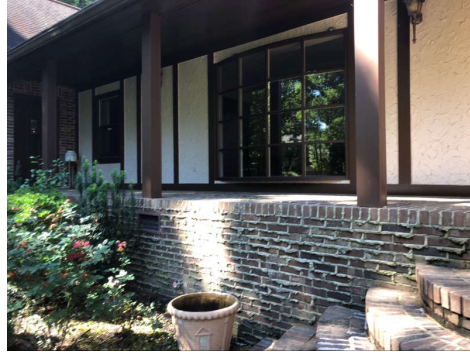
FRONT PORCH

Measure the height of the elevated floor level. All decks and porches, including those with insect screening, landings, balconies, mezzanines, galleries, ramps, or raised floor surfaces located more than 30 inches (US), above the floor or ground should have guards. *Recommend contacting Handyman/Contractor to discuss options.*

Recommendation  
Contact a qualified professional.

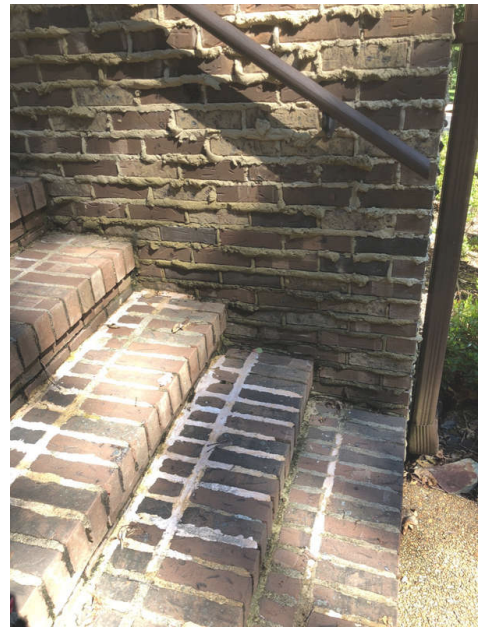
Water damage was noted at the stairs. This may be due to incorrect gutter installation. *Recommend gutter contractor to evaluate and remedy.*

Recommendation  
Contact a qualified gutter contractor

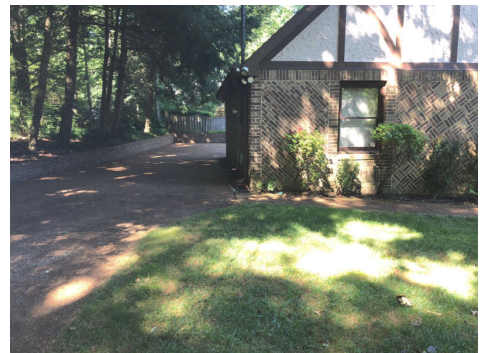
Grading is sloping towards the home in some areas. This could lead to water intrusion and foundation issues. Recommend qualified landscaper or foundation contractor regrade so water flows away from home.

Grade must fall a minimum of 6in within the first 10ft or to a swale when 10ft is not available.

Recommendation  
Contact a qualified landscaping contractor

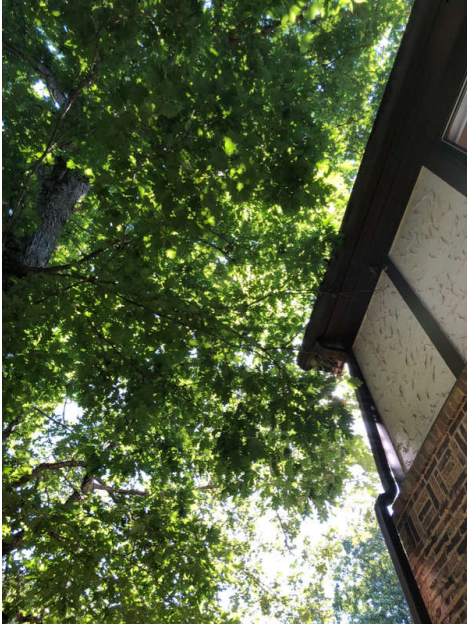
Front Left

Multiple trees were noted overhanging the property. Recommend contacting a tree service or arborist to evaluate and remove potential hazards.

Contact a qualified tree service company.

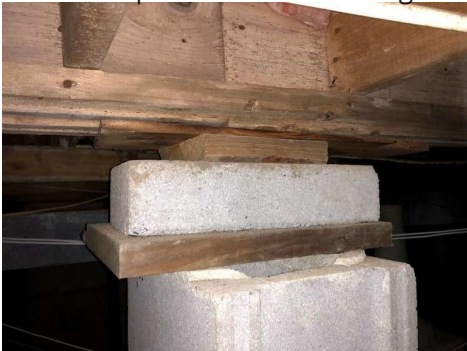
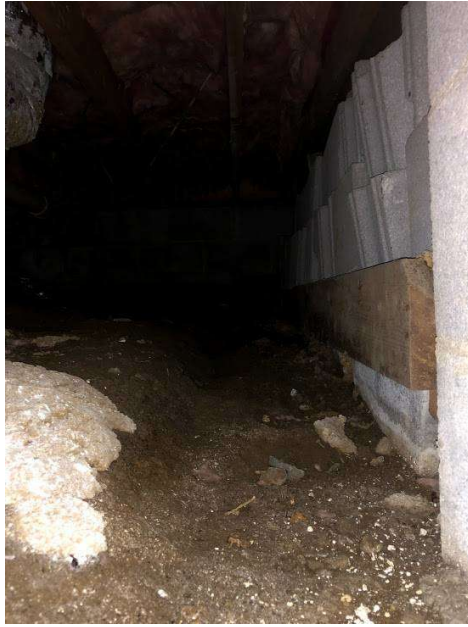
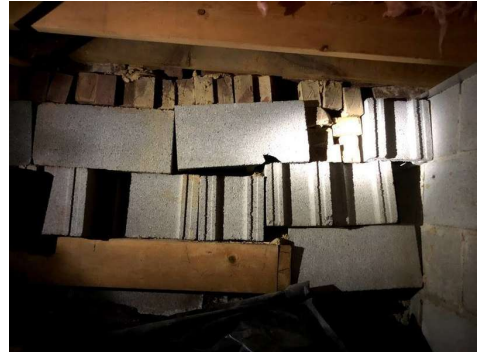
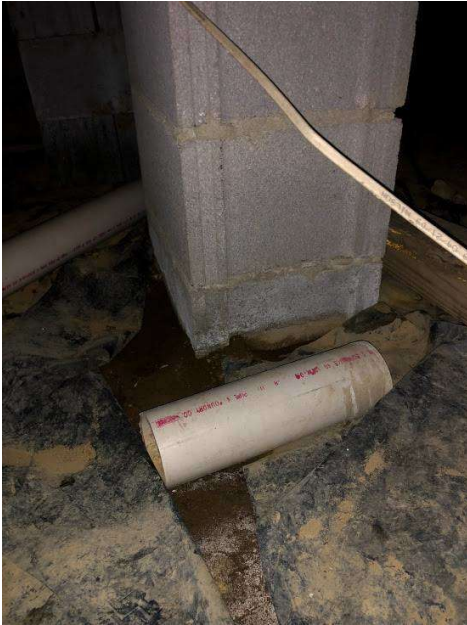
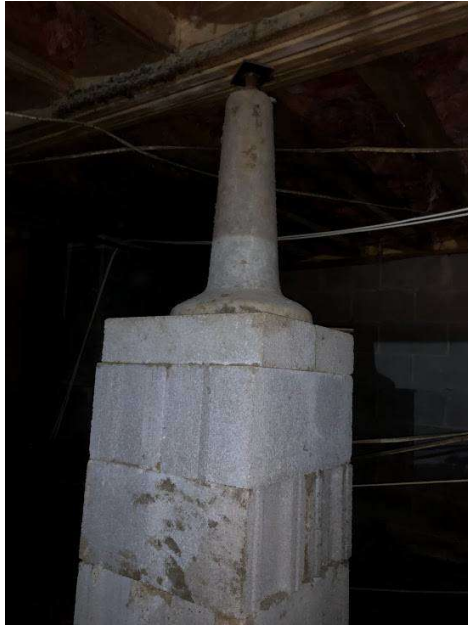
FOUNDATION / CRAWLSPACE

Improper or sub-standard construction practices were noted at the foundation wall or slabs/piers. Multiple places had revealed in-field support and repair jobs to the foundation. The mix of long-term replacements with short-term fixes can reveal a large issue and should be looked into by an expert in that field. Due to the overwhelming number of post construction supports - not all of the photos show all of the *new* footings/piers.

*Recommend a structural engineer evaluate and advise on how to bring the construction up to standards.*

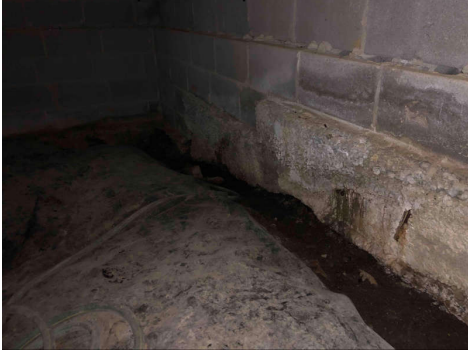
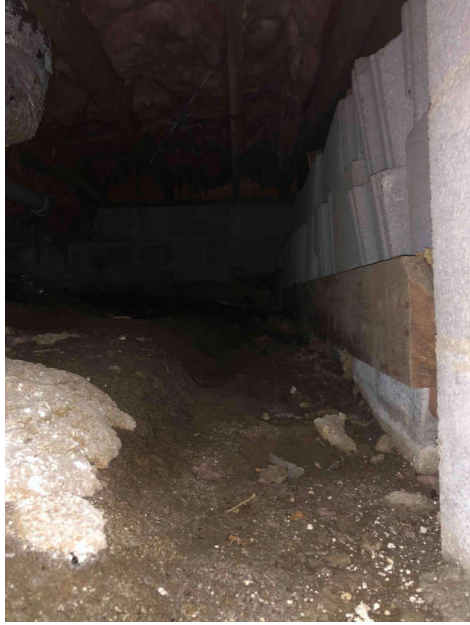
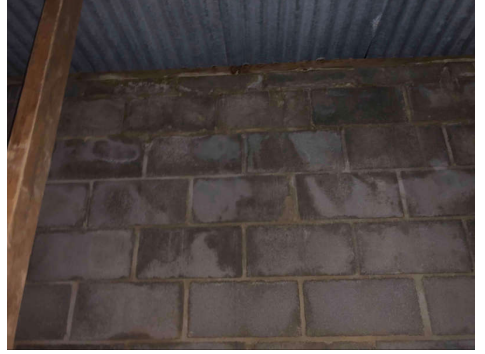
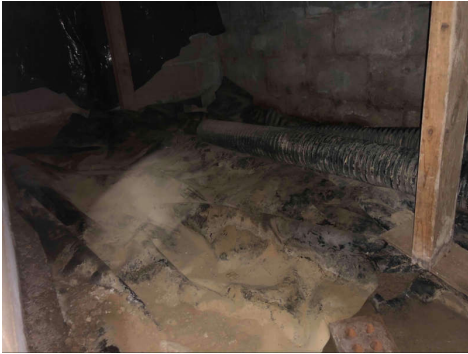
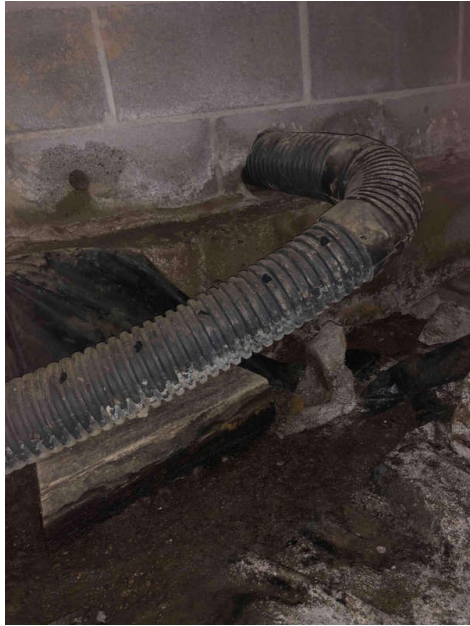
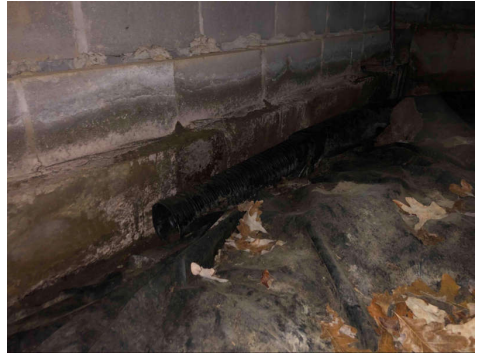
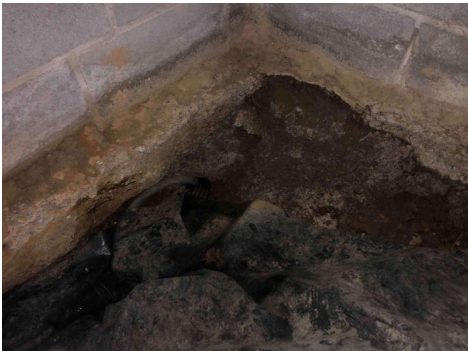
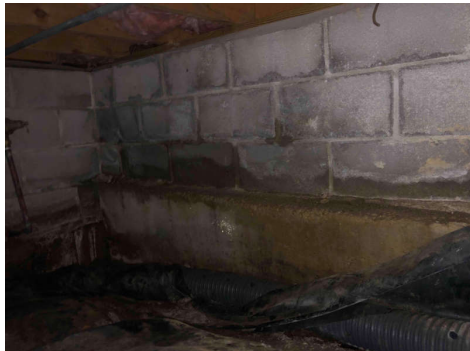
#### CRAWLSPACE

Soil in the crawlspace was damp or wet. This condition may be the result of rising ground water or may result from surface runoff seeping under and/or through the foundation walls. *You should ask the seller for any information they can provide about this condition.*

Moisture intrusion can affect the ability of the soil beneath the foundation to carry the weight of the structure above and may cause structural damage from soil movement. Moisture intrusion can also damage home materials and encourage the growth of microbes such as mold.

*Recommend taking action to identify the source of the moisture intrusion and correct the condition.*

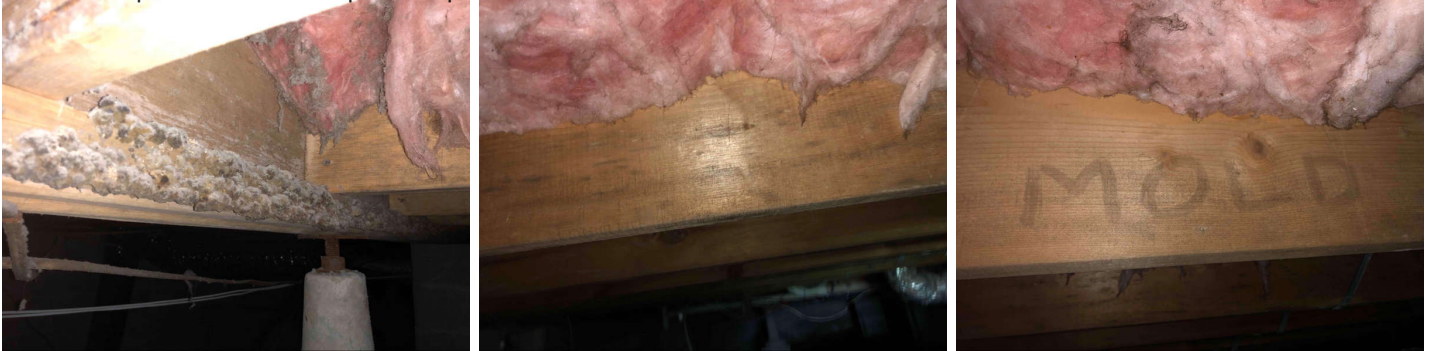
### CRAWLSPACE

Evidence of Mold and mold spores were noted during the inspection.

Mold cannot exist without moisture. Therefore, any moisture whatsoever, whether it be from inadequate grading and drainage, a leaking roof, window, or door, or moisture from a faulty exhaust vent, a condensate pipe, an evaporator coil, or a component of a plumbing system should be serviced immediately, or the potential for mold contamination will remain.

*Recommend Mold Mitigation company assess the extent of the issue and provide remedy on removing active spores.*

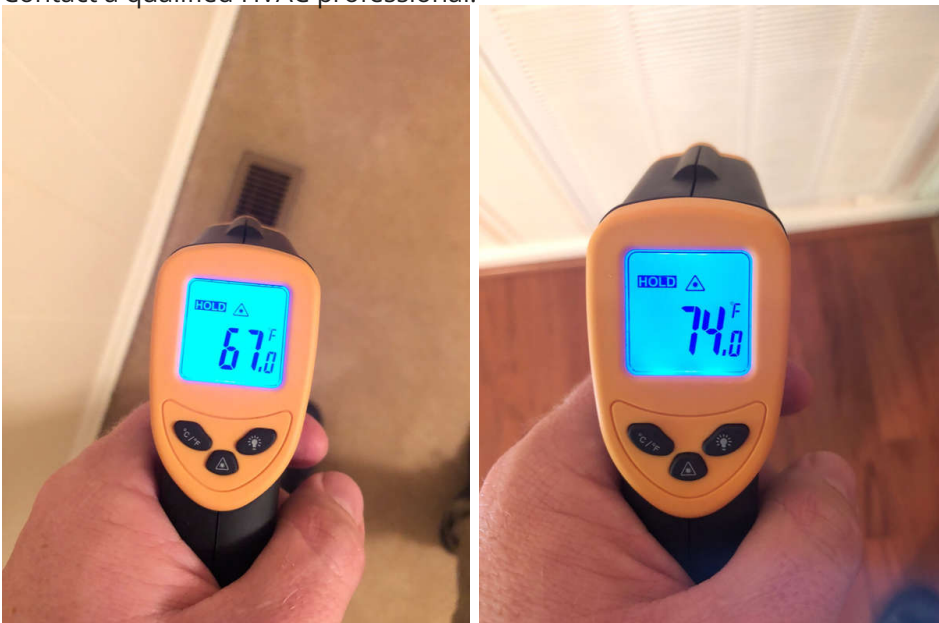
Inadequate temperature differential. Supply air from the air conditioning system was not cool enough. It should be 14 to 20 degrees Fahrenheit cooler than at the return duct(s), or current room temperature. This may be caused by refrigerant loss, dirty coils, a failing compressor, an oversized fan, or a deficient return air system.

As the house has two separate systems; a package unit and a split system. An evaluation should be done to see which of these systems wasn't operating optimately. **One unit tested an acceptable temperature differential, the other did not.**

*A qualified heating and cooling contractor should evaluate and repair as necessary.*

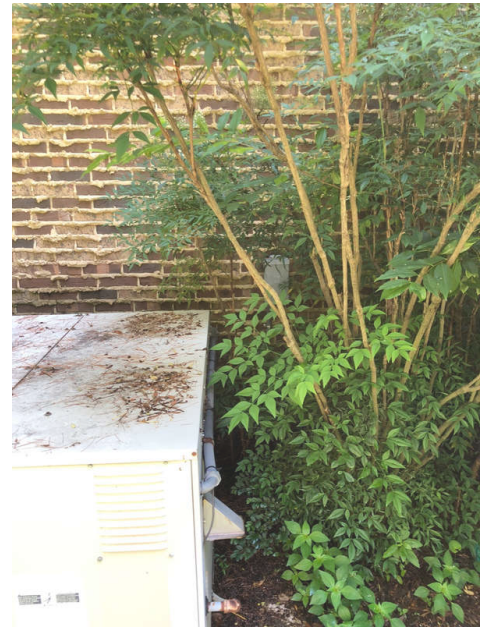
Vegetation such as trees, shrubs and/or vines are too close to the outdoor condensing unit. Standard building practices require that there be at least 12 inches of clearance on all sides and at least four to six feet above. Inadequate clearances around the condensing unit can result in reduced efficiency, increased energy costs and/or damage to equipment. Vegetation should be pruned and/or removed as necessary to maintain these clearances.

Contact a qualified landscaping contractor

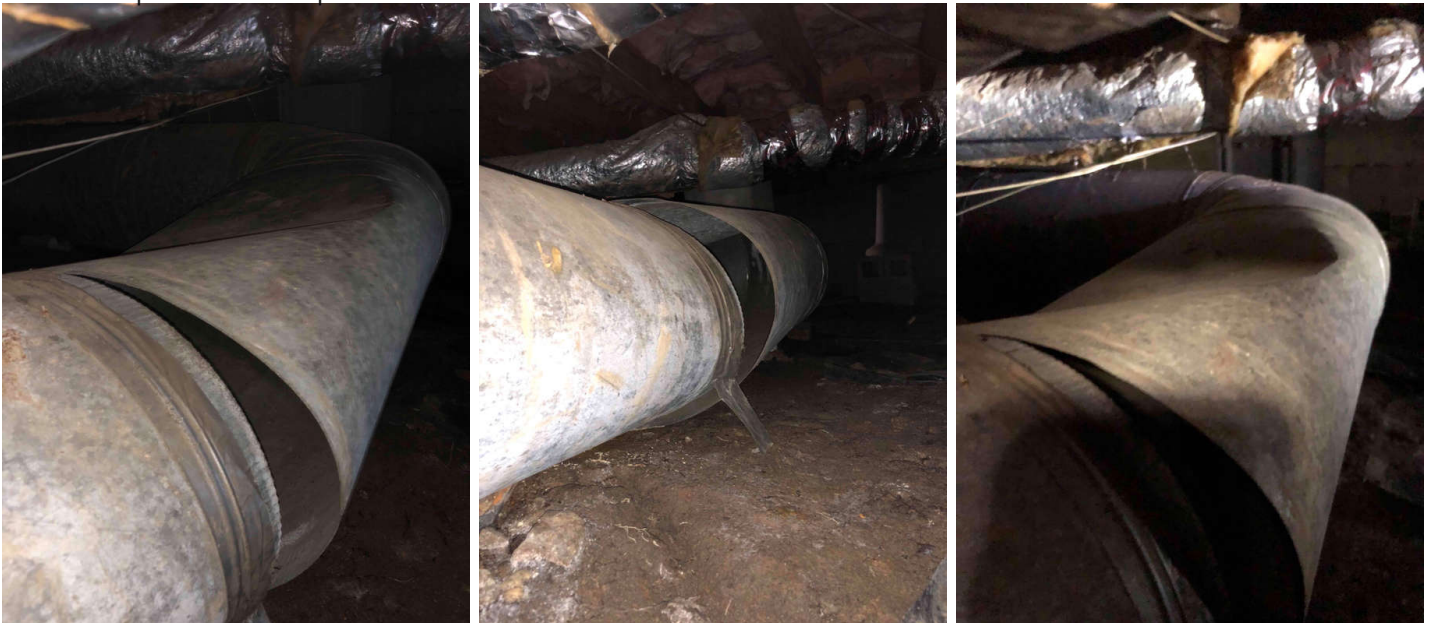
One or more air supply ducts are broken or disconnected. Increased moisture levels in unconditioned spaces and higher energy costs may result. A qualified contractor should evaluate and make permanent repairs as necessary.

Contact a qualified HVAC professional.

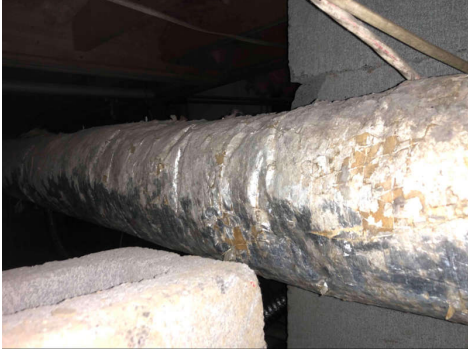
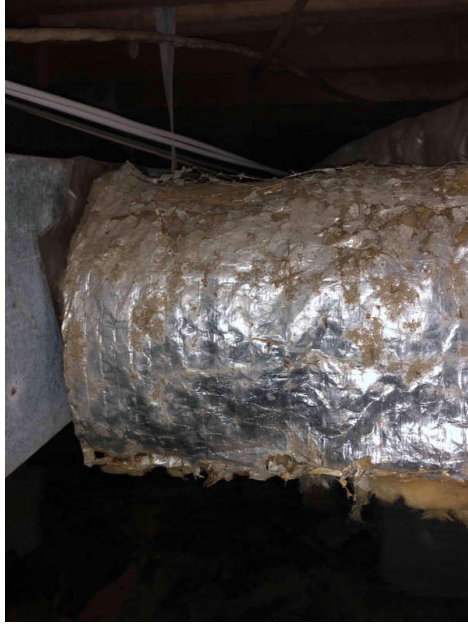
Insulation on one or more heating/cooling ducts in unconditioned spaces is damaged and/or deteriorated. A qualified contractor should evaluate and replace insulation and/or ducts as necessary and as per standard building practices.

Recommendation  
Contact a qualified HVAC professional.

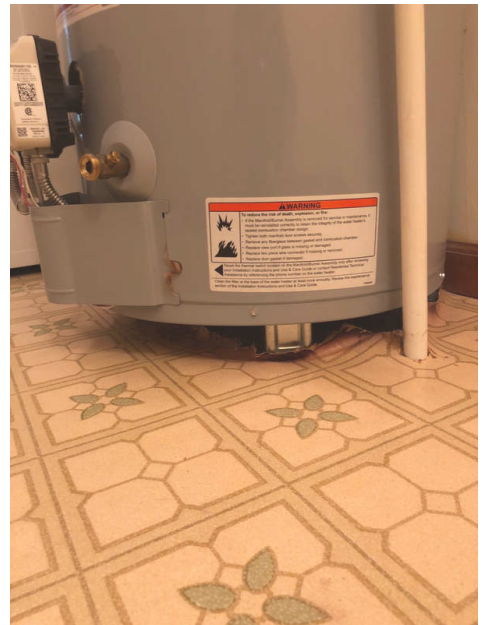
No drip pan was present. Where a leak from a water heater tank would cause damage, a pan is required. The pan should be galvanized steel, aluminum, or plastic. A plastic pan must not be installed under a gas-fired water heater tank. The pan must be drained by an indirect waste pipe and should terminate over an indirect waste receptor, or should extend to the exterior and terminate between 6 and 24 inches of the ground surface.

Recommend installation by a qualified plumber.

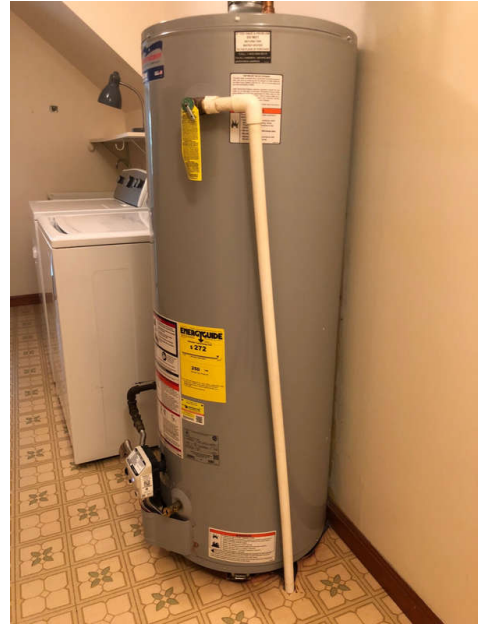
LAUNDRY ROOM

TPR Valves are required to have a drainpipe of approved materials that can withstand high temperatures and must be no smaller than 3/4" with no bends reductions all the way to within 6" of the ground. For an article about TPR Valve requirements please read from my Home Inspection Articles Page - [TPR Valves](#)

Incorrect TPR Valve

*Recommend a licensed plumber, qualified professional or handyman to add the correct drainpipe.*

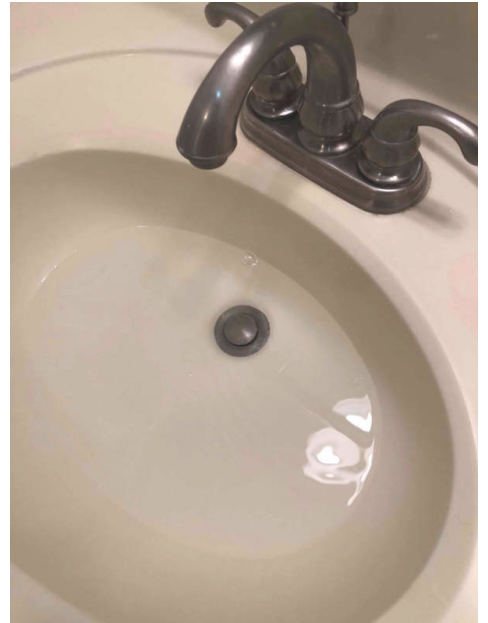
UPSTAIRS HALLWAYS BATHROOM

Sink had slow/poor drainage. Recommend a qualified plumber repair.

Contact a qualified plumbing contractor.

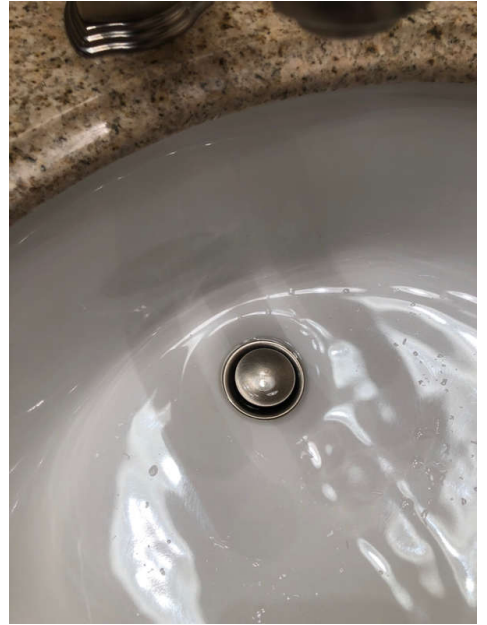
Downstairs Bathroom

The automatic plug in the vanity is not working as it should. Recommend a DIY or contractor to update and remedy.

Contact a handyman or DIY project

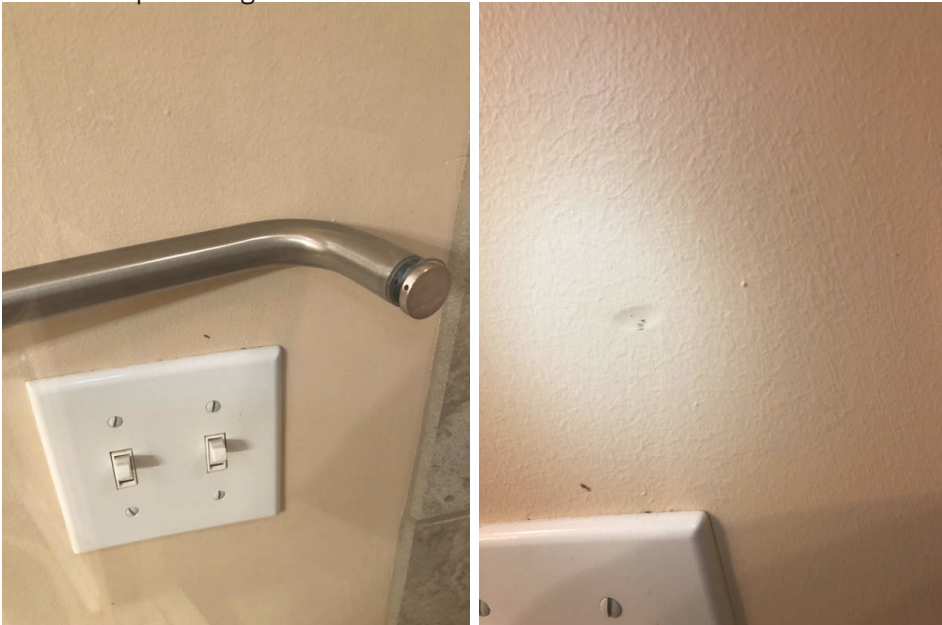
The shower door clearance was not large enough, as the handle kids up against the drywall and is a potential to bust through the wall above light switches. *Recommend calling a licensed contractor to evaluate and remedy.*

Recommendation  
Contact a qualified general contractor.

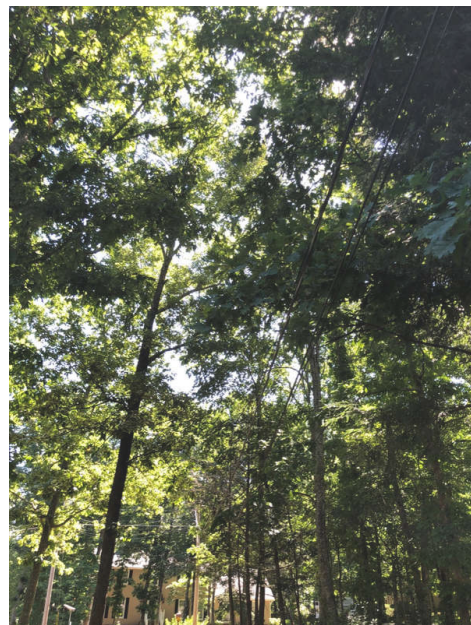
Vegetation is close to the electrical supply lines. Your electrical service provider is responsible for any cables and vegetation removal to your drip loop service connection. Recommend contacting EPB and requesting vegetation trim trees/branches back to prevent power outages.

Contact a qualified professional.

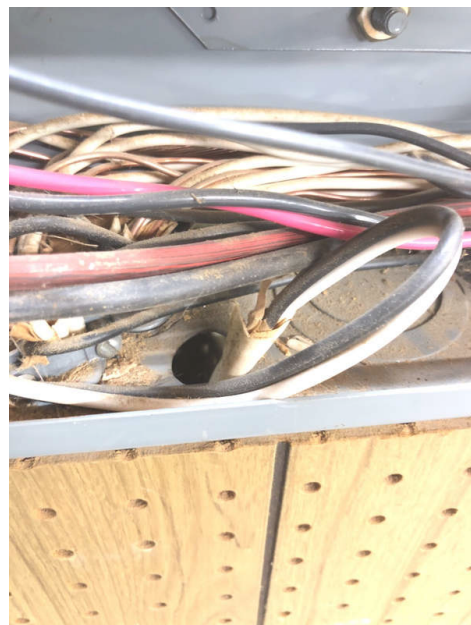
**One or more bushings were missing or loose from where wires enter holes in panel. This is a potential safety hazard because the wiring insulation can be cut or abraded on the metal edge of the hole(s). Recommend that a qualified electrician install or repair bushings where necessary.**

Contact a qualified electrical contractor.

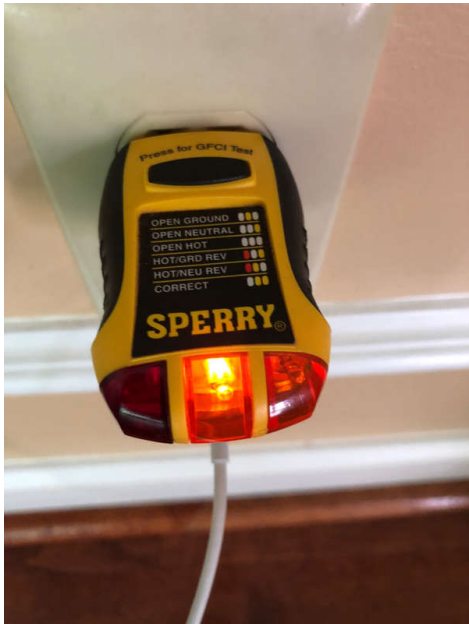
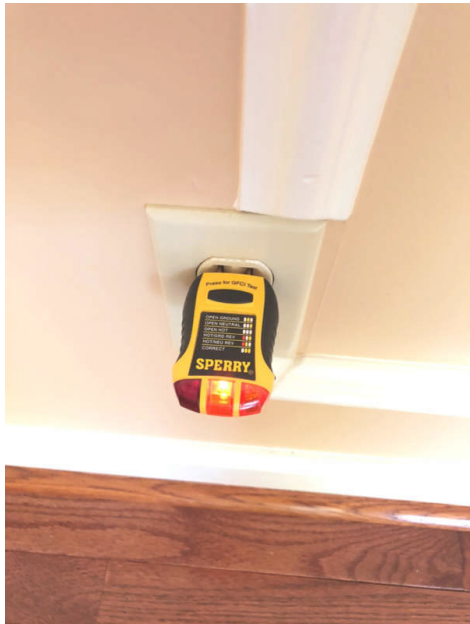
Sunroom - Switch Activated

Testing revealed ungrounded 3 prong outlets; change to 2, or establish ground. *Recommend a certified electrician evaluate.*

Contact a qualified electrical contractor.

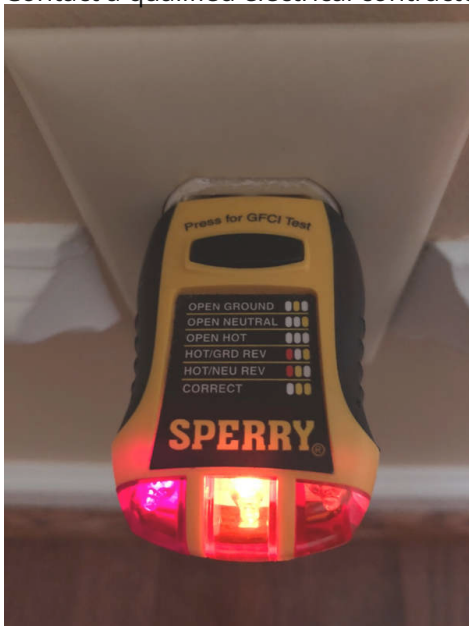
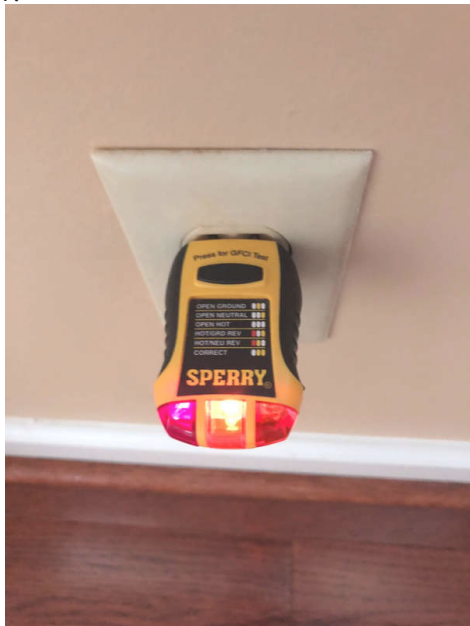
Dining Room

One or more outlets had their wiring reverse so that hot and neutral wires were reversed. Recommend a qualified electrician to evaluate and fix.

Contact a qualified electrical contractor.

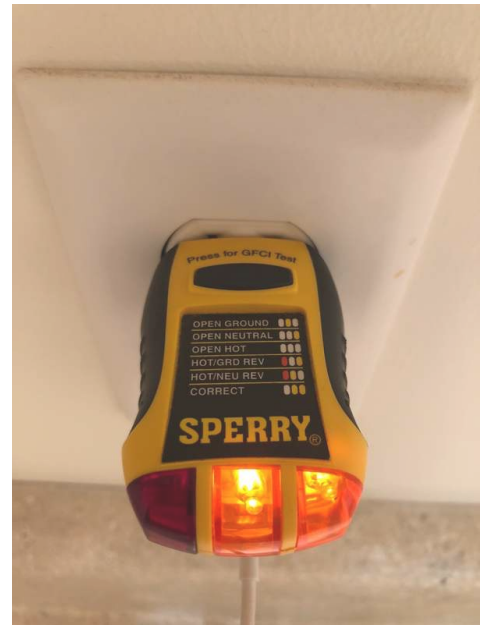
#### WET BAR

GFCI outlets were not noted at the time of the inspection. GFCI outlets are recommended within 3ft if any water source. Recommended license electrician to update these outlets.

Contact a qualified professional.

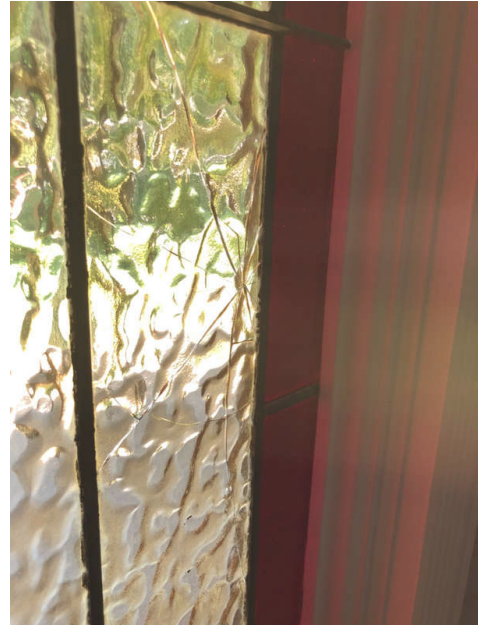
FRONT ENTRANCE

One or more windows had cracks in the glass. *Recommend replace or repair.*

Contact a qualified professional.

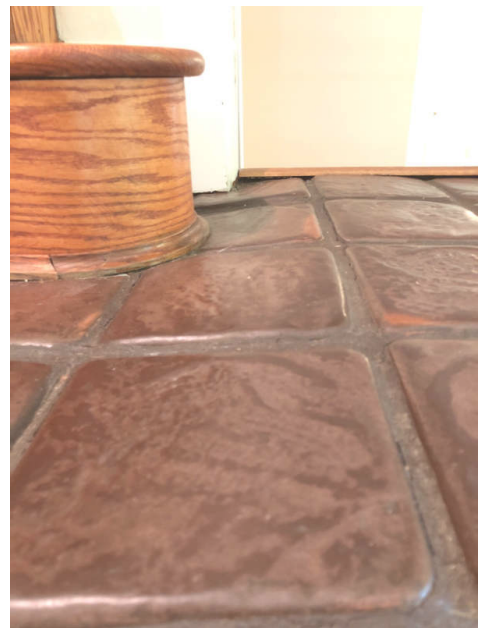
ENTRYWAY

Some noticeable sagging was noted at the floor. *Recommend having licensed contractor or structural engineer out to investigate and evaluate if structural concern.*

Contact a qualified professional.

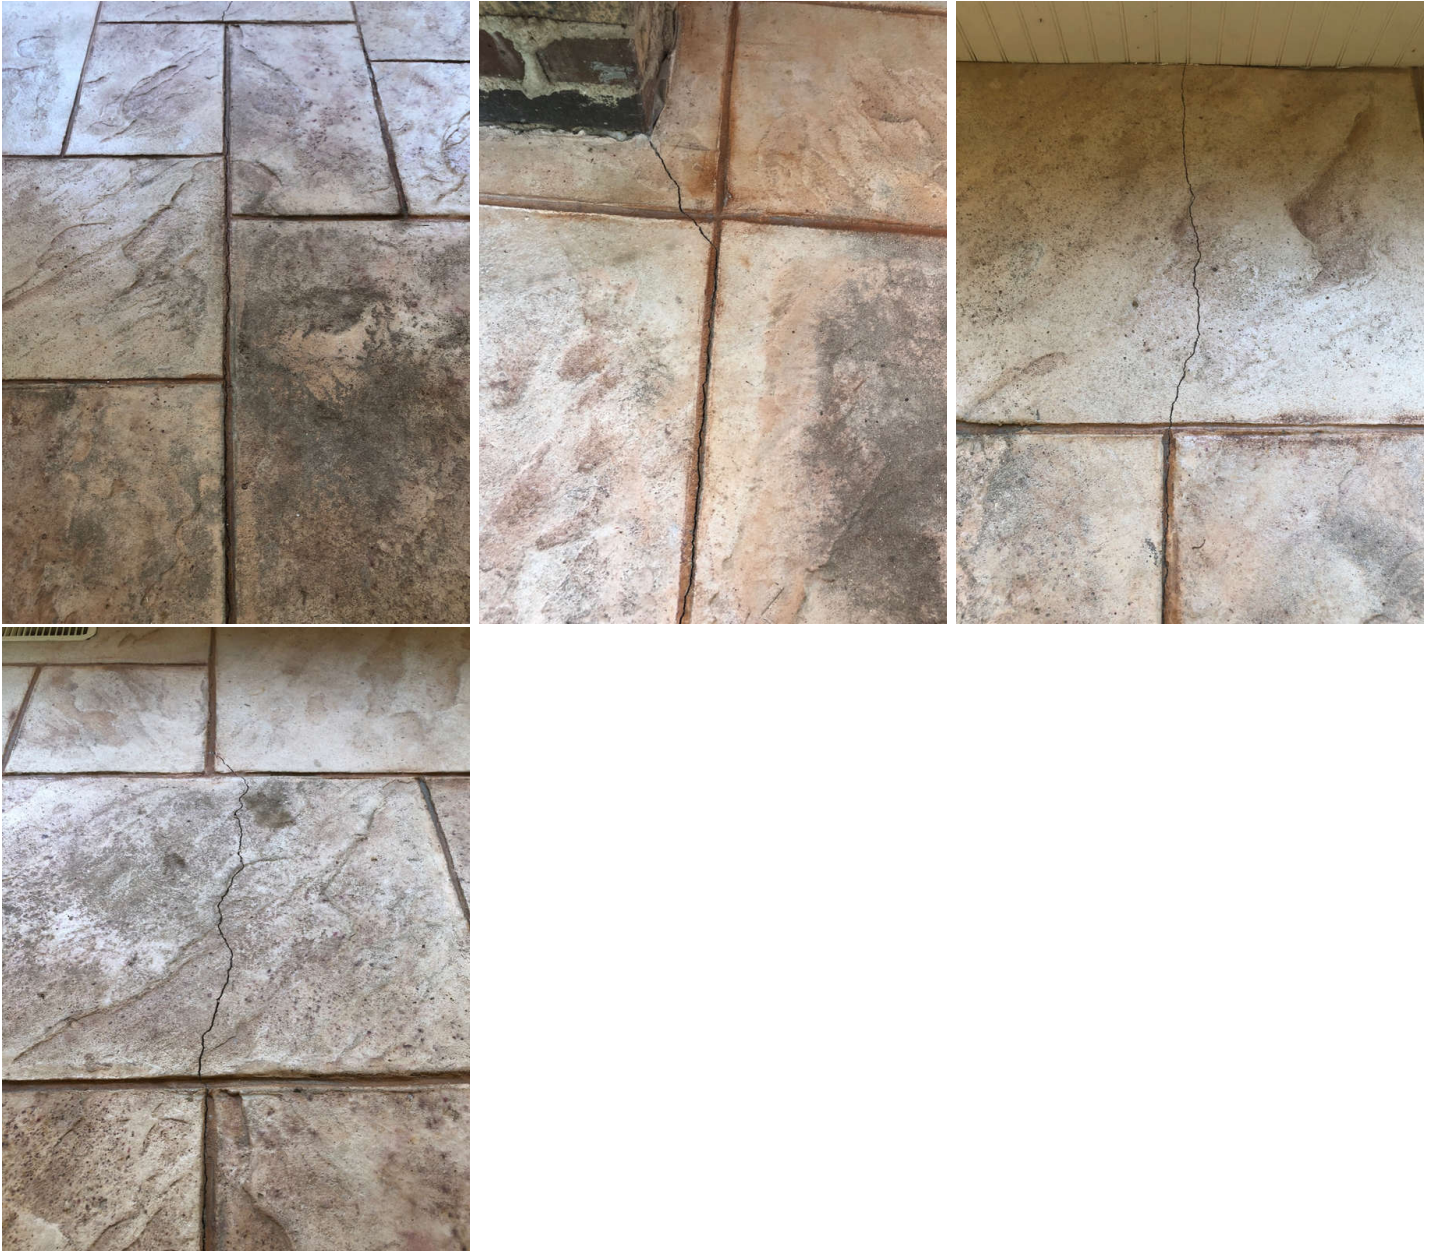
BACK PATIO

Several tiles were cracked at the back covered patio. Recommend monitoring to determine if movement will continue.

Recommend monitoring.

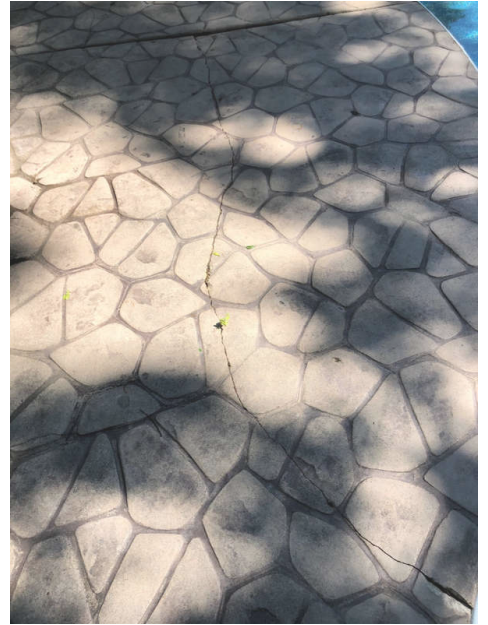
#### **WALKWAY - MINOR CRACKING**

Recommendation  
Contact a qualified professional.

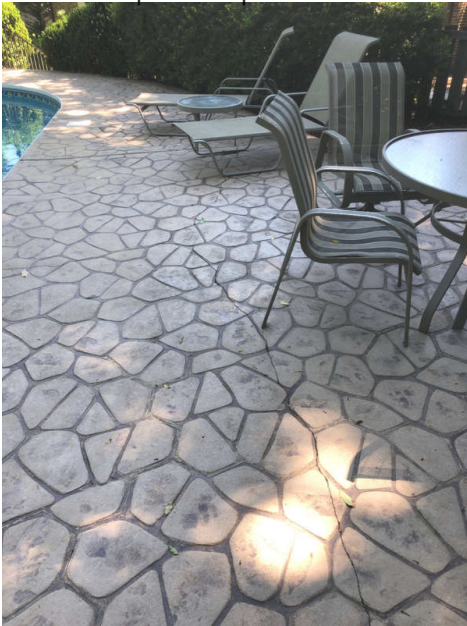
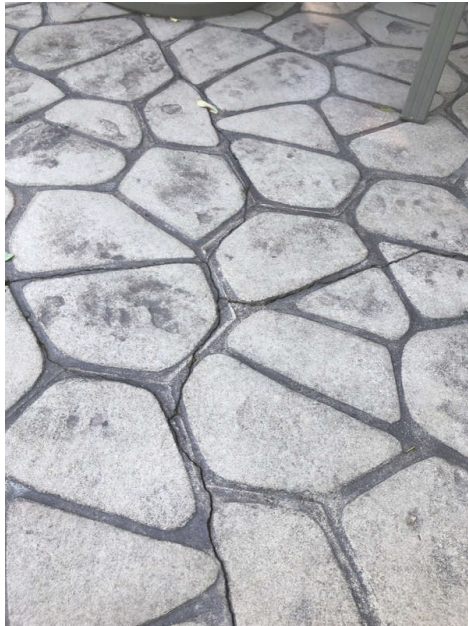
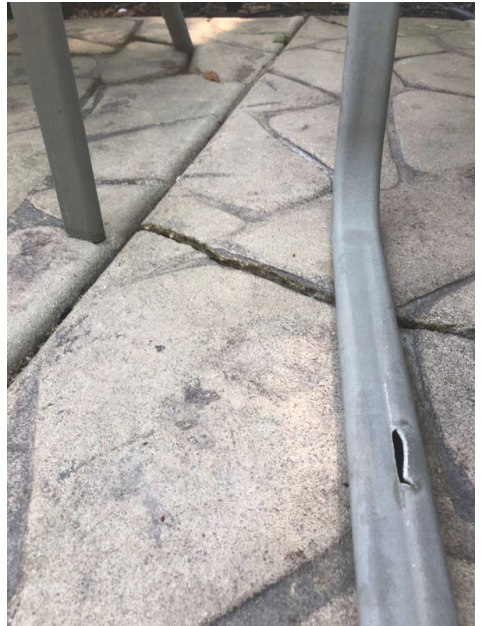
**WALKWAY - MODERATE CRACKING**

Recommendation  
Contact a qualified professional.
