SUMMARY

1234 Main St. Yorktown Heights NY
10598

Buyer Name
05/10/2018 9:00AM

Andrew Wuench
InterNachi Certified Professional
Inspector, NYS License #16000083028,
CT License #HOI.0000881
Empire Inspectors, LLC

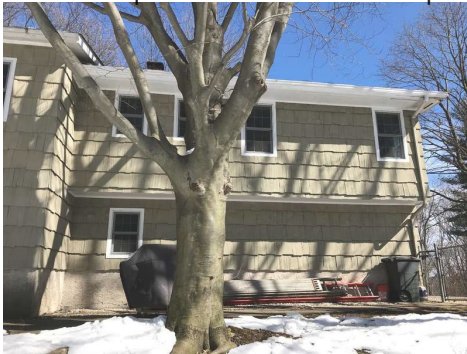
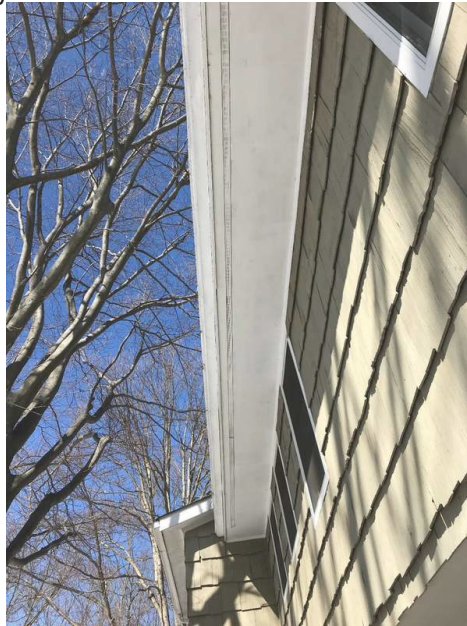
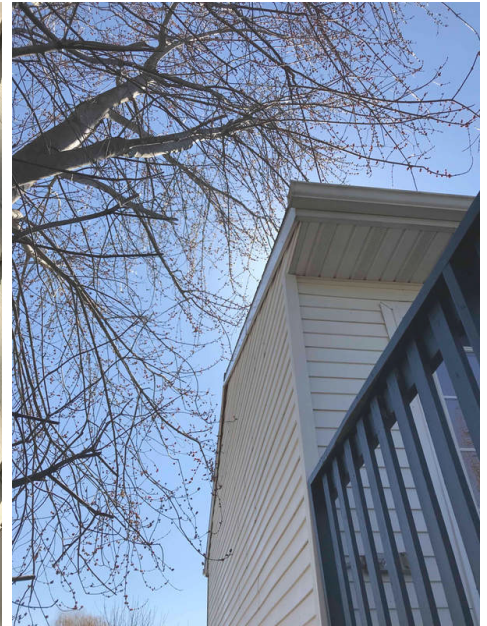
2.1.1 Vegetation, Grading, Drainage & Retaining Walls

TREE OVERHANG

Trees observed overhanging the roof. This can cause damage to the roof and prevent proper drainage. Recommend a qualified tree service trim to allow for proper drainage.

Contact a qualified tree service company.

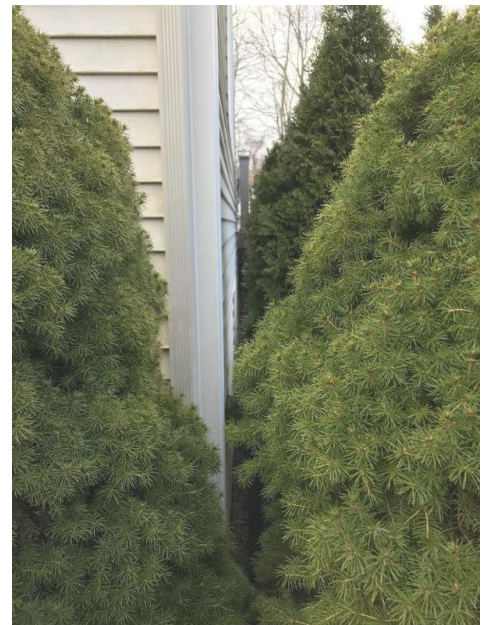
2.1.2 Vegetation, Grading, Drainage & Retaining Walls

SHRUB AND TREE GROWTH - TOO CLOSE

RIGHT

Shrub and tree growth were not far enough away from the siding of the house. Regular maintenance and pruning should be done on an ongoing basis to prevent contact with the house or roof which could lead to unwanted moisture contacting the siding of the house. Recommend trimming back shrubs so they are not touching the siding.

Recommendation
Contact a qualified landscaping contractor

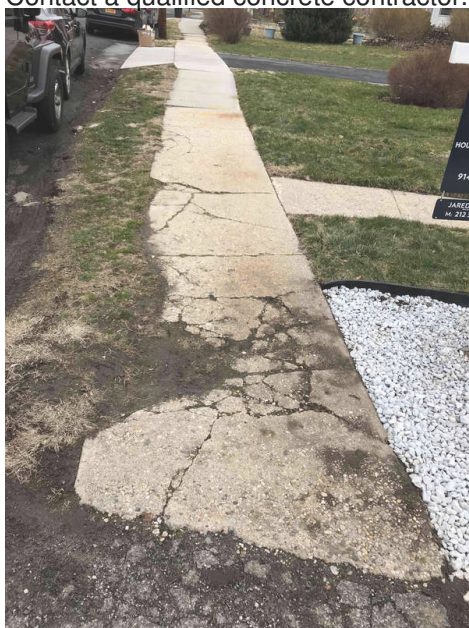
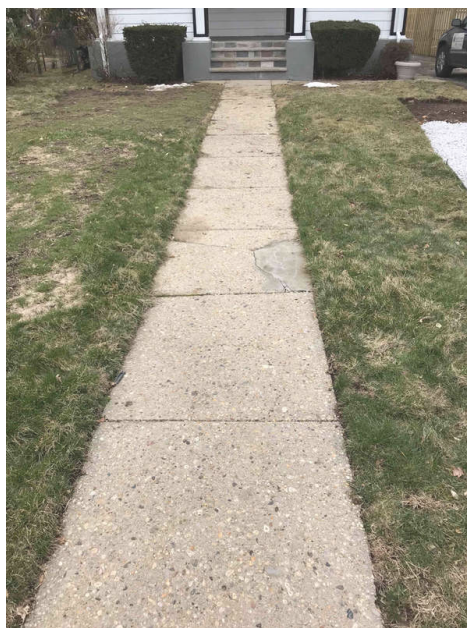
2.3.1 Walkways

WALKWAY CRACKING - MAJOR

FRONT

The walkway was cracked and deteriorated. Recommend having a qualified contractor repair.

Recommendation
Contact a qualified concrete contractor.

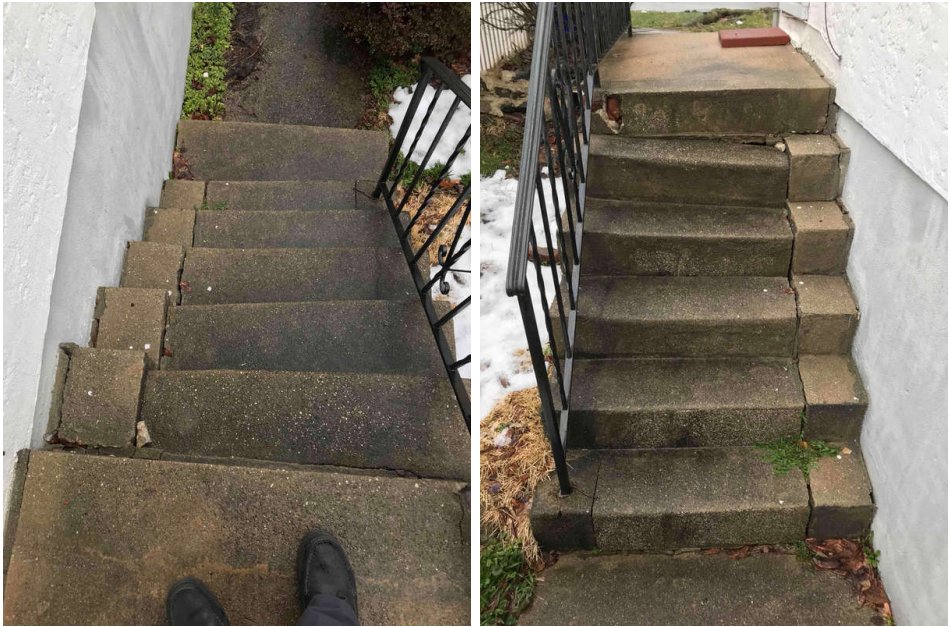
2.4.1 Steps

STEPS POOR CONDITION

RIGHT

The side steps were in poor condition with cracks, surface deterioration, settling/heaving and loose railings. Recommend hiring a qualified masonry contractor to evaluate and repair or replace as necessary.

Recommendation
Contact a qualified masonry professional.

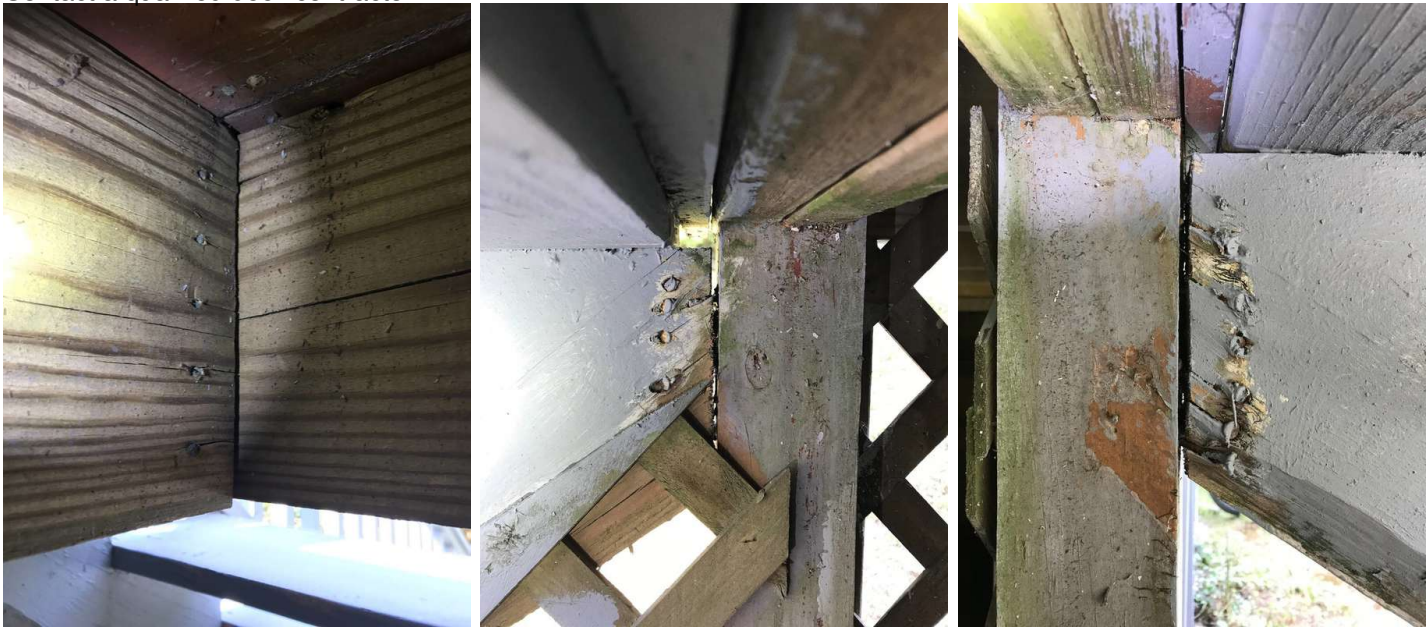
2.5.1 Decks, Balconies, Porches

IMPROPER DECK CONSTRUCTION PRACTICES

Deck was observed to have general poor construction. Improper fasteners, lack of lag bolts and joist hangers, improper post to beam connections were noted. Recommend having a qualified deck contractor evaluate and repair all defects as necessary

Recommendation
Contact a qualified deck contractor.

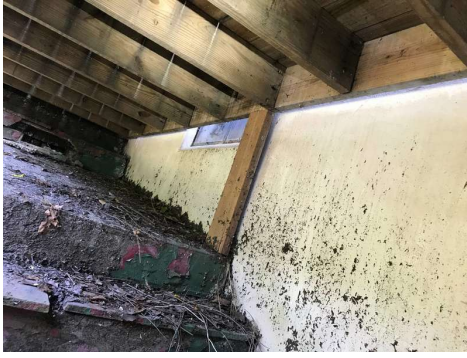
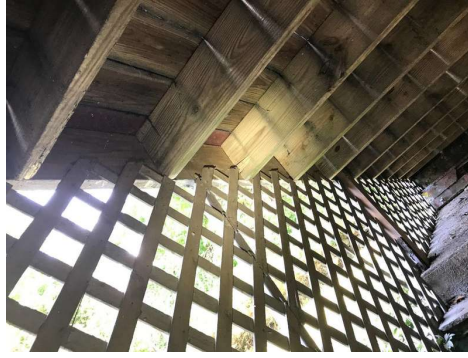
2.5.2 Decks, Balconies, Porches

JOIST HANGERS

Joist hanger(s) are missing or improperly installed. This could cause the deck structure to fail. Recommend that joist hangers be properly installed by qualified contractor.

Recommendation
Contact a qualified deck contractor.

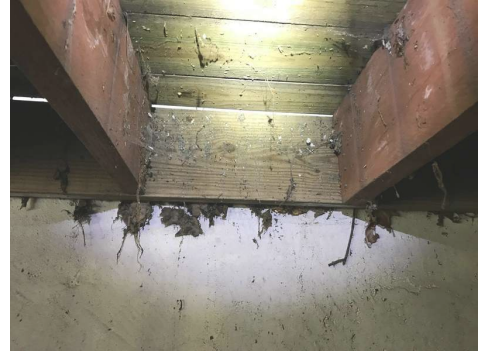
2.5.3 Decks, Balconies, Porches

LEDGER BOARD IMPROPERLY INSTALLED

The ledger board is not properly attached to the building. This can cause the deck to pull away from the building and possibly collapse. Recommend that the deck and/or ledger board be properly attached by qualified contractor.

Contact a qualified deck contractor.

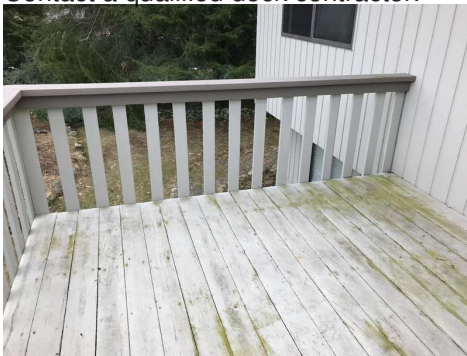
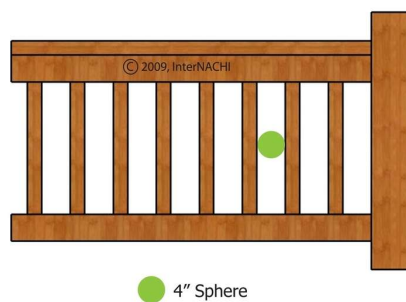
2.5.4 Decks, Balconies, Porches

RAILING UNSAFE

There is an unsafe opening in the railing. The spacing on the rail should not exceed 4". An opening greater than 4" is a serious safety hazard especially for children as their head or other body part can become trapped.

Contact a qualified deck contractor.

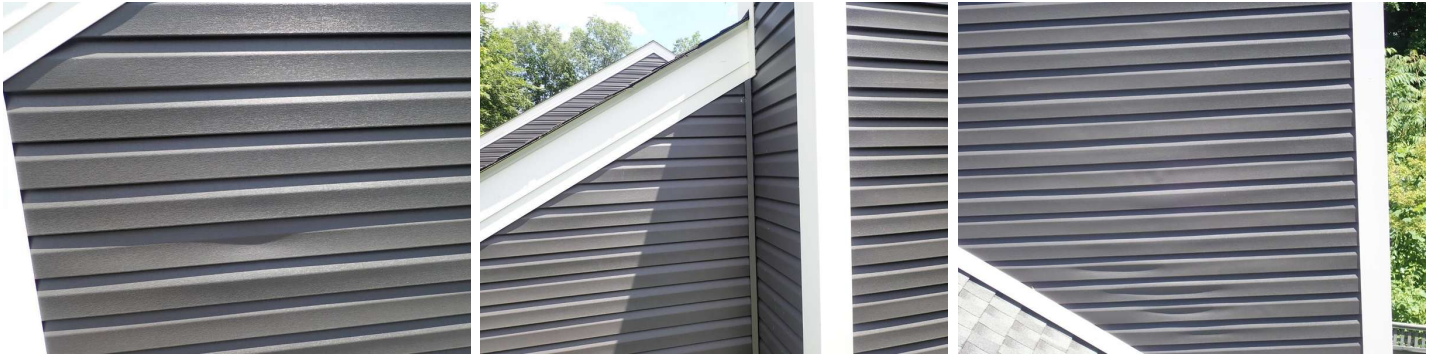
3.1.1 Siding, Flashing & Trim

WARPING/BUCKLING

RIGHT 2ND FLOOR

Vinyl siding was warping or buckling in areas. This is often as a result of nailing siding boards too tight to the home, preventing expansion/contraction. This can also be caused by excessive heat from sunlight reflecting off LowE windows/skylights. Recommend a qualified siding contractor evaluate and repair.

Contact a qualified siding specialist.

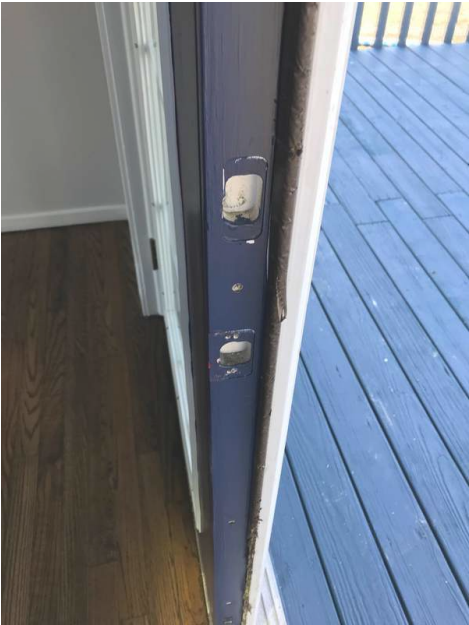
3.3.1 Exterior Doors

HARDWARE MISSING

BACK

Rear entry door is missing one or more pieces of hardware. Recommend replacing or upgrading.

Recommendation
Contact a qualified door repair/installation contractor.

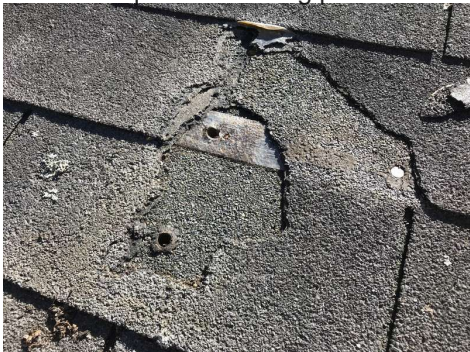
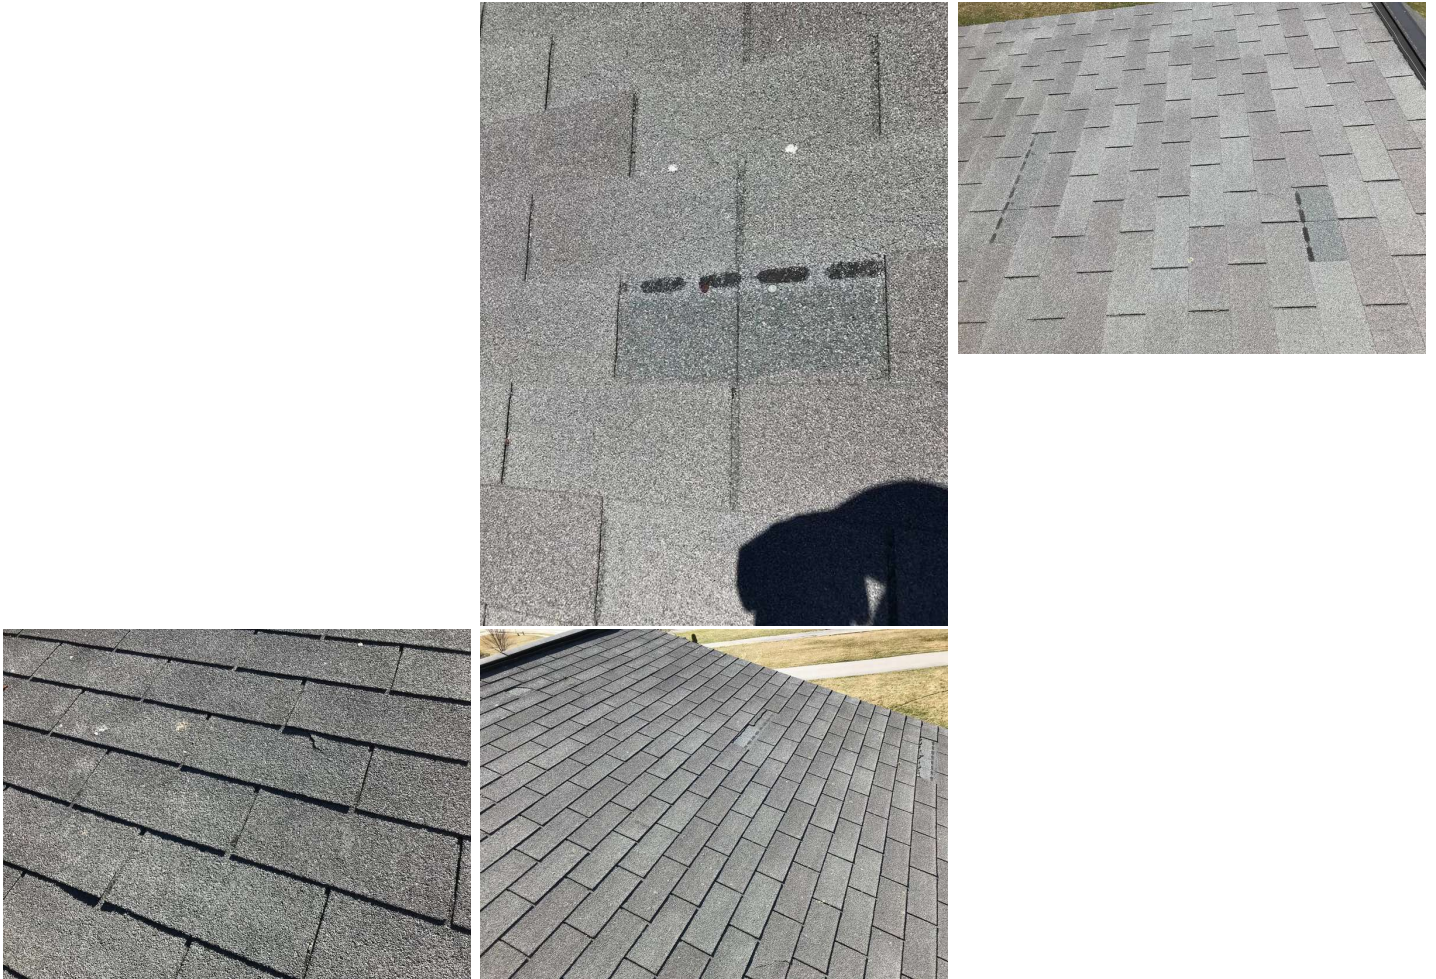
4.1.1 Coverings

DAMAGED (GENERAL)

Roof coverings showed moderate damage. Recommend a qualified roofing professional evaluate and repair.

Recommendation
Contact a qualified roofing professional.

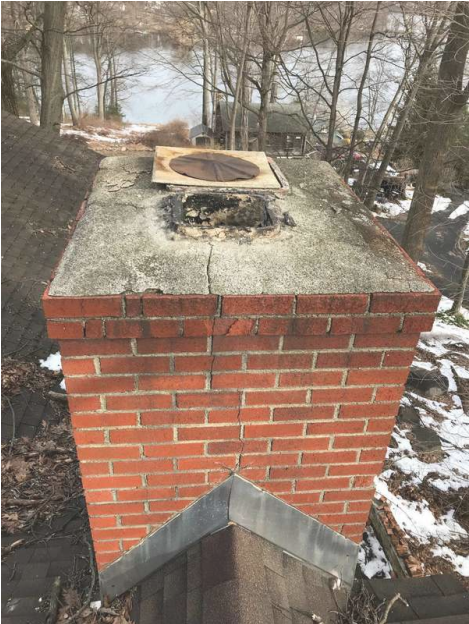
4.3.1 Skylights, Chimneys & Other Roof Penetrations

CHIMNEY POOR CONDITION

The chimney(s) had no spark arrestor or cap. The Inspector recommends that all chimneys have an approved spark arrestor installed by a qualified contractor to prevent pest entry and to help protect the roof-covering materials from potential chimney-source ignition. There was cracking in the brick and mortar and the flue pipe did not extend far enough out of the chimney. Recommend having a qualified contractor evaluate and repair.

Recommendation
Contact a qualified chimney contractor.

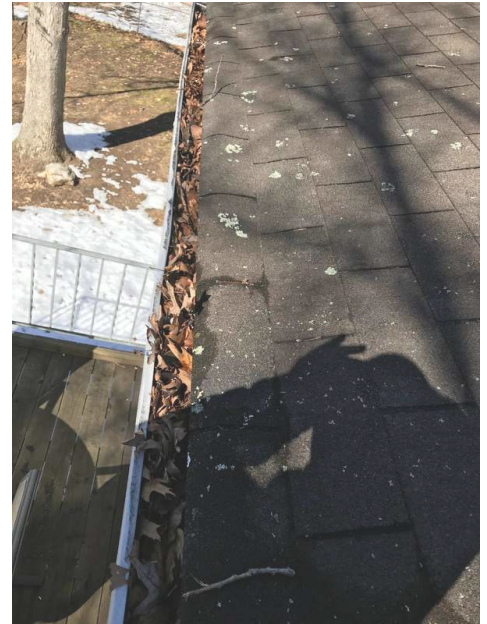
4.4.1 Roof Drainage Systems

DEBRIS

Debris has accumulated in the gutters. Recommend cleaning to facilitate water flow.

Contact a handyman or DIY project

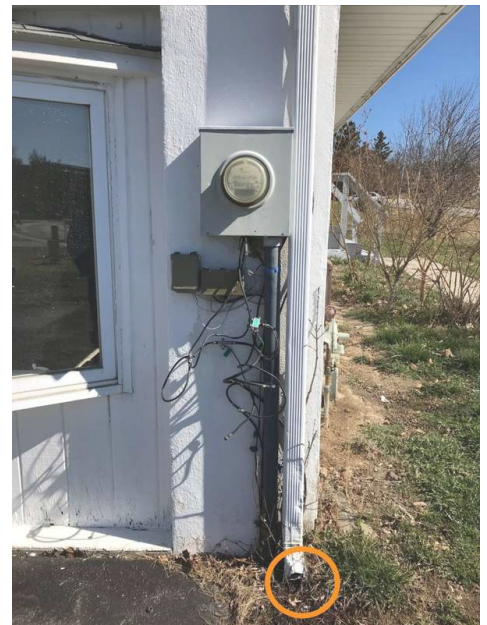
4.4.2 Roof Drainage Systems

DOWNSPOUTS DRAIN NEAR HOUSE

One or more downspouts drain too close to the home's foundation. This can result in excessive moisture in the soil at the foundation, which can lead to foundation/structural movement. Recommend a qualified contractor adjust downspout extensions to drain at least 4-6 feet from the foundation.

Contact a handyman or DIY project

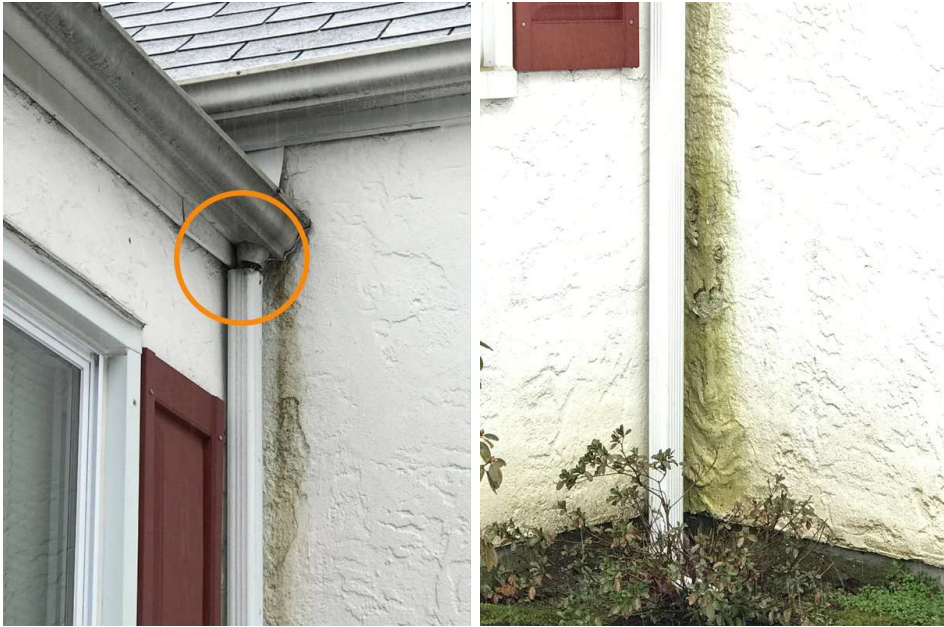
4.4.3 Roof Drainage Systems

DOWNSPOUT DISCONNECTED

One or more downspouts designed to discharge roof drainage needed to be re-connected in order to properly control roof run-off. This condition can result in excessively high moisture levels in soil at the foundation and can cause damage related to soil/foundation movement. Excessive moisture levels in soil near the foundation can effect the ability of the soil to support the weight of the structure above and can cause damage related to soil/foundation movement. The Inspector recommends re-connection of any disconnected downspouts to help protect the home structure. All work should be performed by a qualified contractor..

Contact a qualified roofing professional.

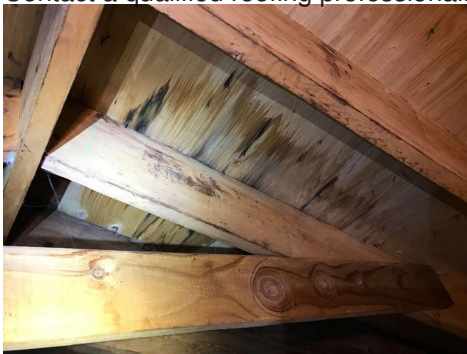
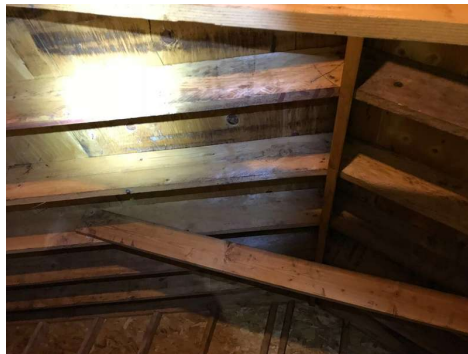
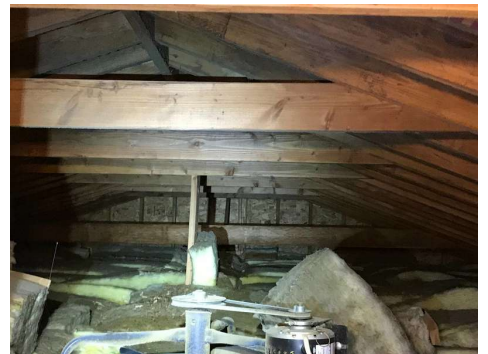
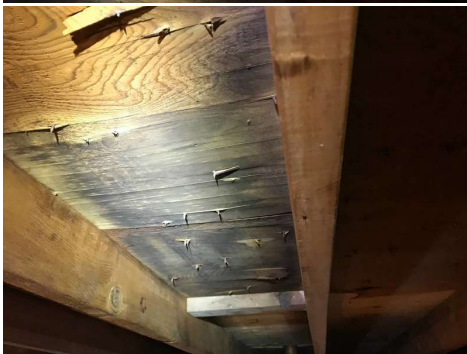
4.5.1 Roof Structure & Attic

ATTIC MOISTURE

There were signs of moisture staining and previous roof leaks in the attic. The plumbing stack was noted and through the roof. Recommend having a qualified roofing contractor evaluate and repair all defects as necessary.

Contact a qualified roofing professional.

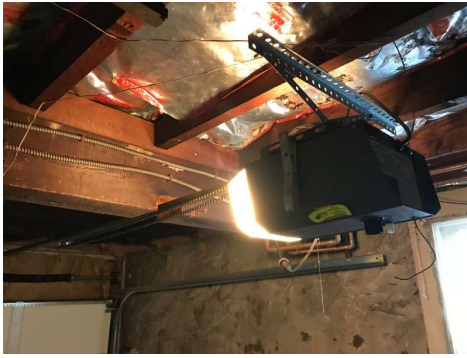
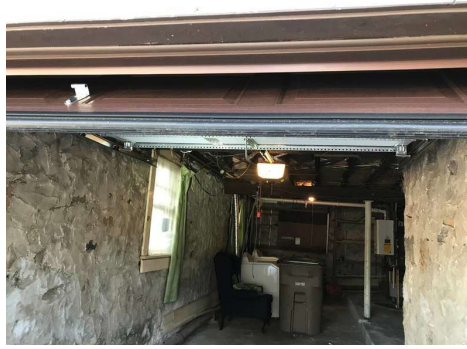
5.1.1 Walls and Ceiling

NO DRYWALL

There was no drywall present on the garage ceiling. It is required to 5/8" fire rated drywall on garage ceilings when living space is directly above. Recommend having a qualified drywall contractor repair as necessary.

Contact a qualified drywall contractor.

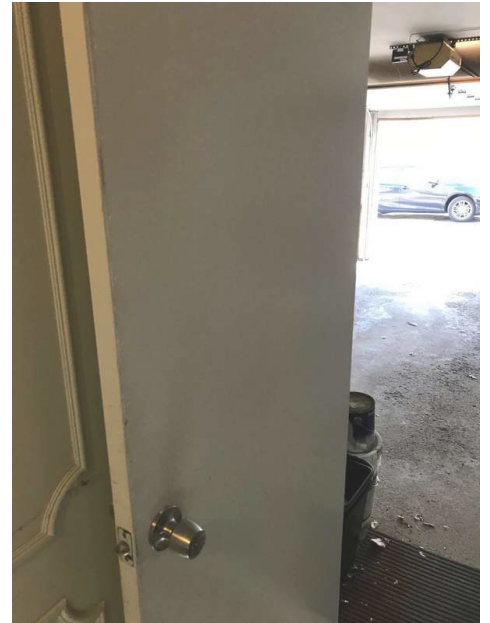
5.5.1 Occupant Door (From garage to inside of home)

DOOR DOES NOT MEET SEPARATION REQUIREMENTS

Door separating garage and home does not meet safety standards. Doors must be at least 1 3/8-inch thick, solid wood/metal/steel, or a 20-minute fire-rated door with self-closing hinges. Recommend having a qualified contractor replace the door as necessary.

Contact a qualified door repair/installation contractor.

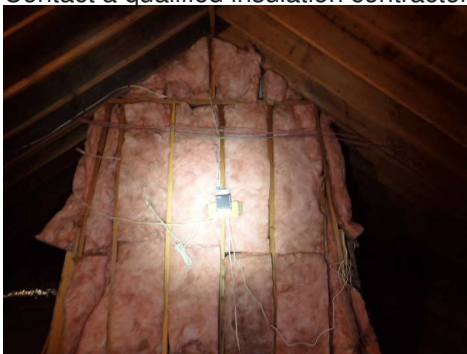
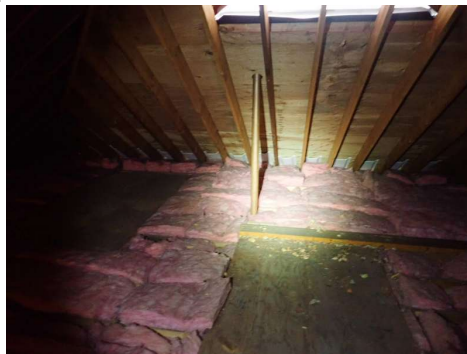
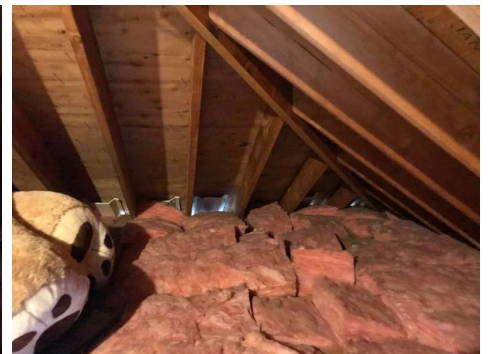
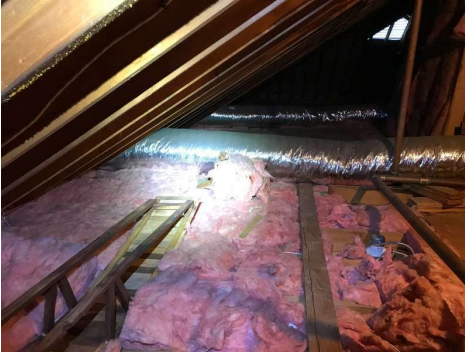
7.1.1 Attic Insulation

IMPROPER INSTALLATION

Thermal insulation in the attic was poorly-installed and had significant gaps which will result in unwanted heat gain or loss. This condition will increase heating and cooling costs and reduce comfort levels and may contribute to ice damming of the roof during the winter. The Inspector recommends that insulation be properly distributed to cover all portions of the attic located above the home living space.

Contact a qualified insulation contractor.

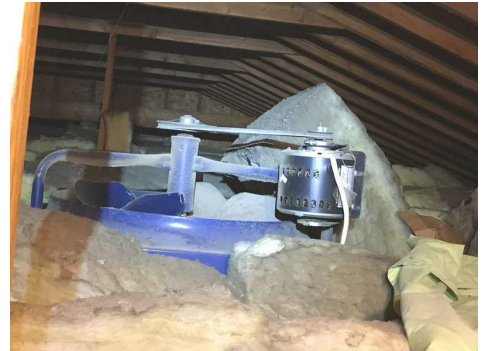
7.2.1 Ventilation

WHOLE-HOUSE FAN- NO INSULATED COVER

No cover was provided for sealing and insulating the whole-house fan penetration during the heating season. This condition will result in the loss of home heat and increased heating costs. The fan was also rubbing on the displaced fiberglass insulation.

Contact a handyman or DIY project

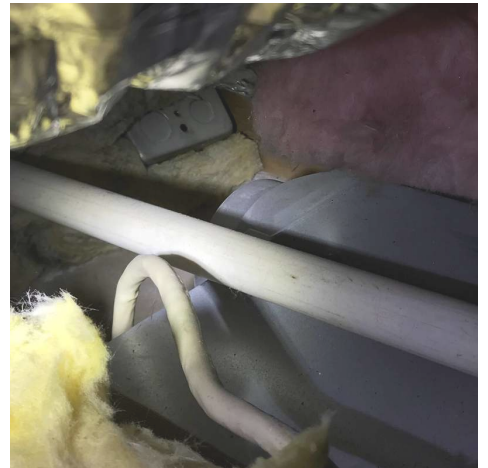
7.3.1 Exhaust Systems

BATHROOM VENTS INTO ATTIC

Bathroom fan vents into the attic, which can cause moisture and mold. Recommend having a qualified contractor properly install ductwork to terminate exhaust to the exterior.

Contact a qualified professional.

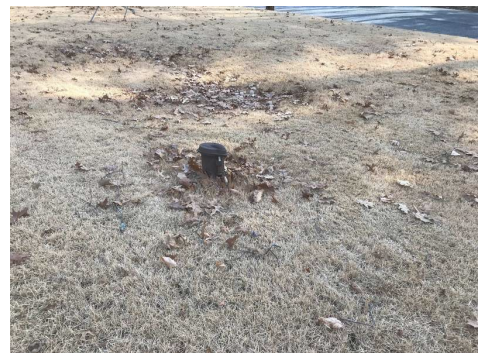
10.2.1 Water Supply, Distribution Systems & Fixtures

NON-SANITARY WELL CAP

The well cap was a non-sanitary cap and should be replaced with a sanitary cap to prevent bacteria from entering the well shaft. Recommend hiring a qualified well company to replace the cap with a sanitary one.

Contact a qualified well service contractor.

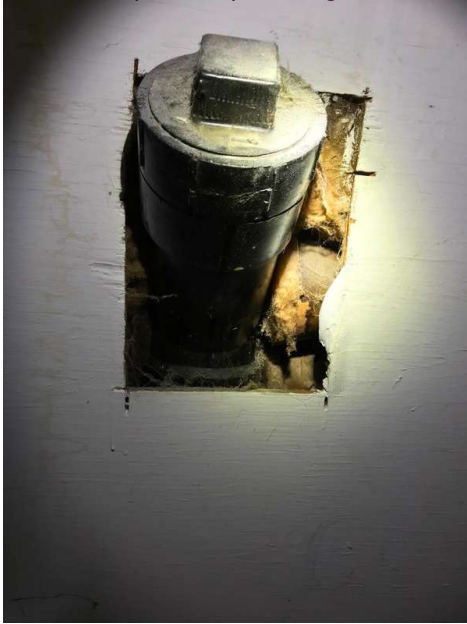
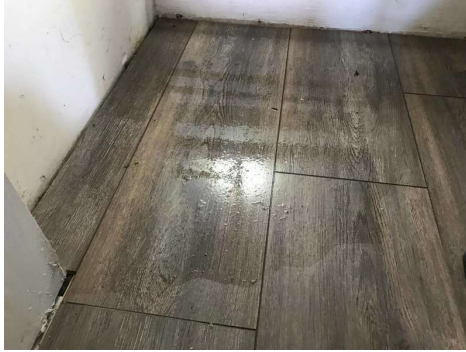
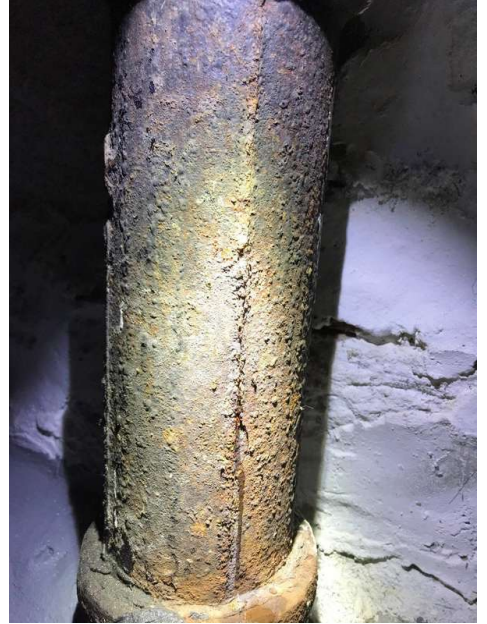
10.3.1 Sewage & Drain, Waste, & Vent (DWV) Systems

LEAKING PIPE

A drain, waste and/or vent pipe showed signs of a leak. Recommend a qualified plumber evaluate and repair.

Contact a qualified plumbing contractor.

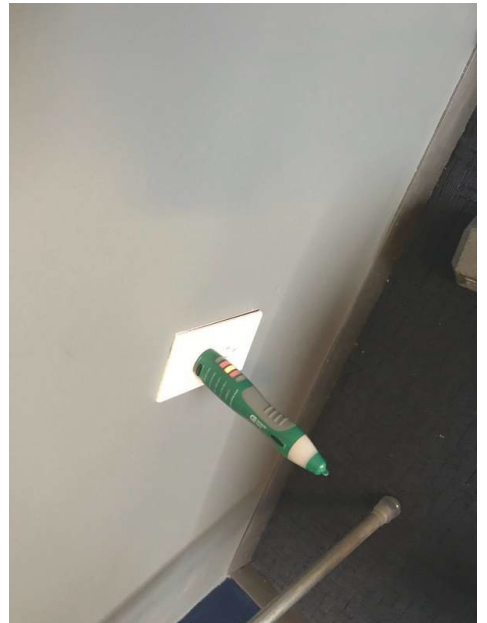
11.4.1 Lighting Fixtures, Switches & Receptacles

HOT-NEUTRAL REVERSED RECEPTACLE

An electrical receptacle had hot and neutral wires reversed. This condition should be corrected by a qualified electrical contractor

Contact a qualified electrical contractor.

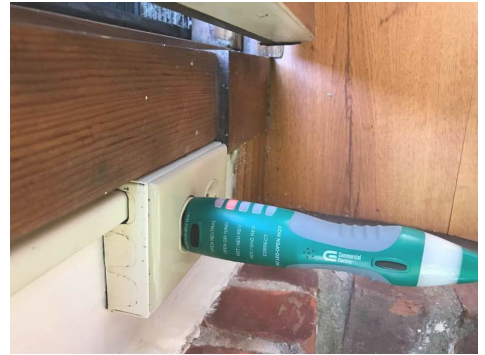
11.4.2 Lighting Fixtures, Switches & Receptacles

OPEN GROUND RECEPTACLE(S)

BACK WALL LIVING ROOM

An electrical receptacle had an open ground. Other receptacles in the home were grounded. This receptacle should have a functional equipment grounding conductor installed by qualified electrical contractor.

Recommendation
Contact a qualified electrical contractor.

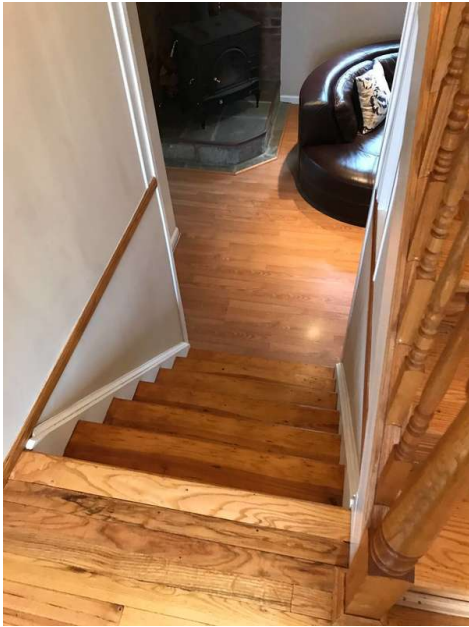
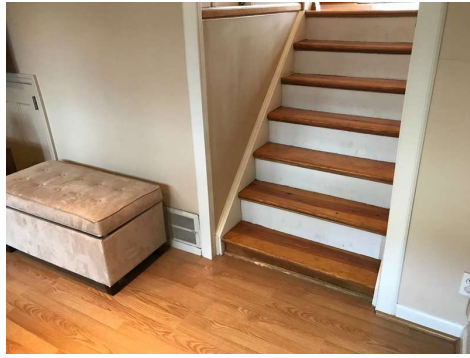
13.6.1 Steps, Stairways & Railings

STAIRCASE- NO HANDRAIL

BASEMENT

Although it had 4 or more risers, this staircase had no handrail installed. This condition is a potential fall hazard. In order to comply with generally-accepted current standards which require a handrail at staircases with 4 or more risers, this staircase would need a handrail installed. The Inspector recommends that a handrail be installed that complies with modern safety standards. All work should be performed by a qualified contractor.

Recommendation
Contact a qualified carpenter.

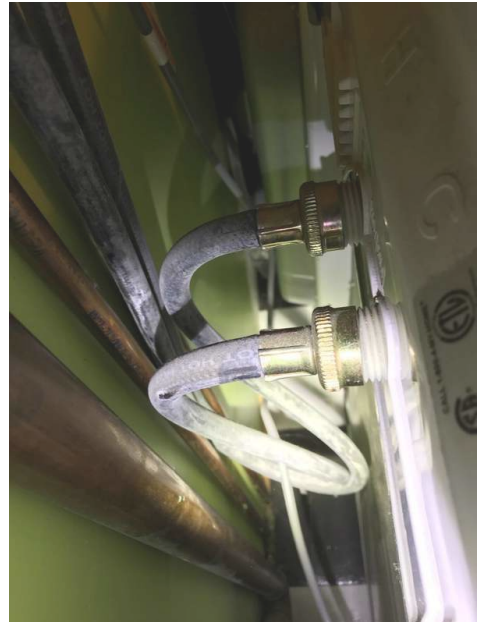
15.2.1 Washer

WASHING MACHINE HOSES

Washing machine supply hoses are standard black rubber non-pressure tested hoses. These hoses can rupture without warning and have been responsible for causing extensive damage from flooding. Recommend replacing with stainless steel braided pressure tested hoses.

Recommendation
Recommended DIY Project
